DEKRA's commission No. : PKOL(W)/LODZ/13118/25/02/20  
 commission/ damage No. : 24/011028  
 Date of commission: 20-02-2025

**Vehicle data**

Measurement of thickness of the vehicle lacquer coating

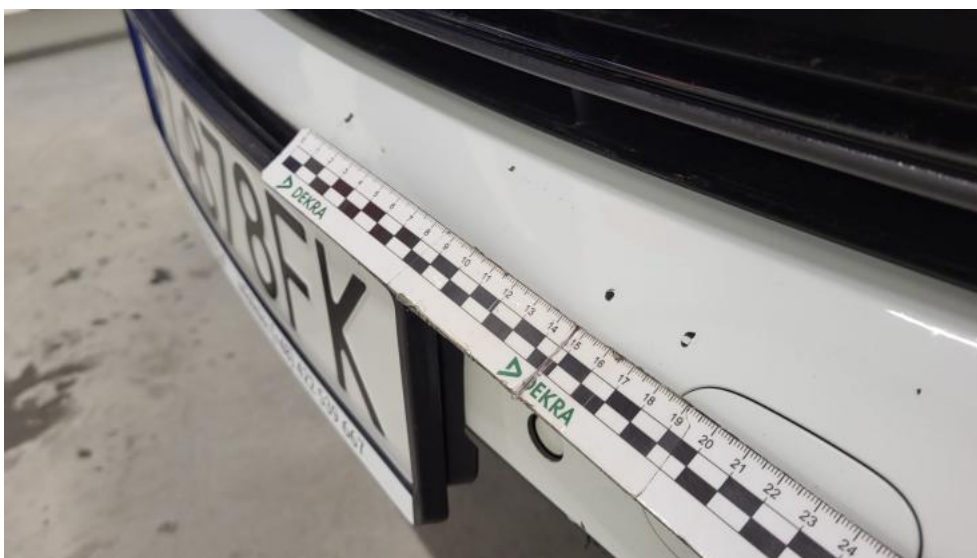
**Photo 46.**  
Zderzak - Rysa/odprysk 1

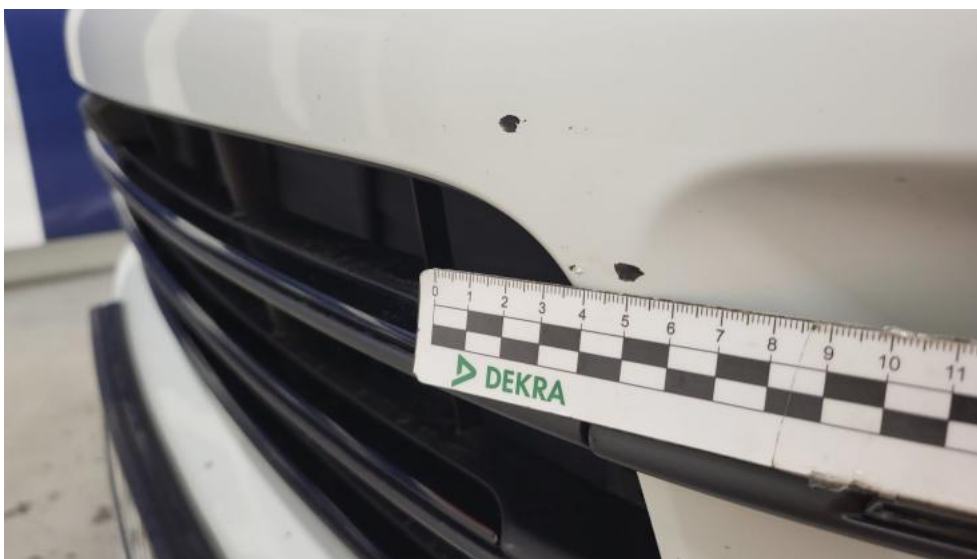
**Photo 47.**

Zderzak - Rysa/odprysk 2

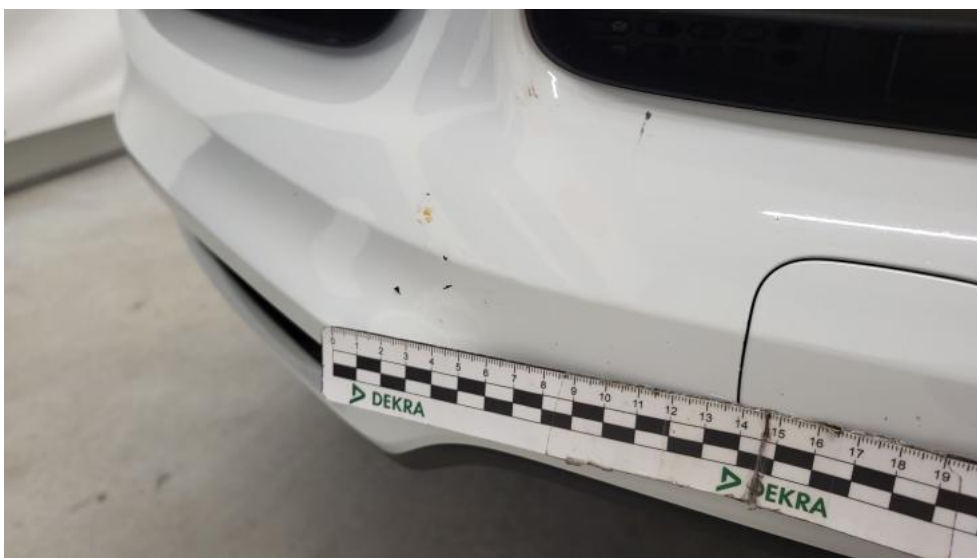
**Photo 48.**

Zderzak() - Rysa/odprysk 3

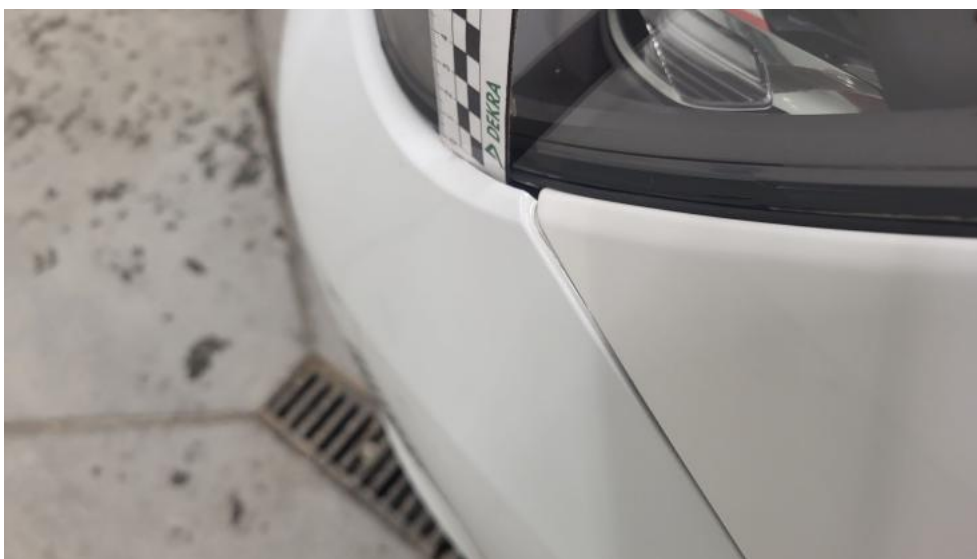
**Photo 49.**  
Zderzak - Inne 1

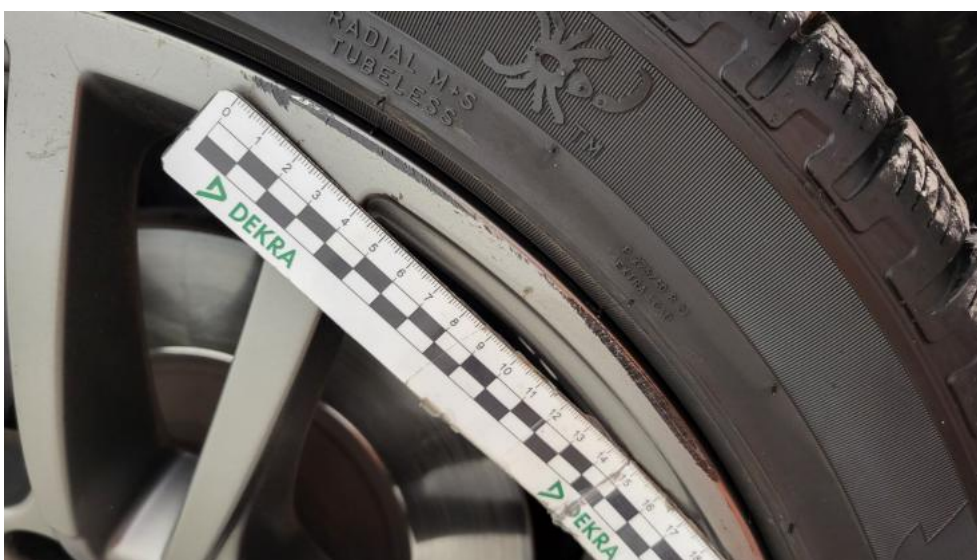
**Photo 50.**  
Felga aluminiowa przednia P - Rysa/odprysk 1

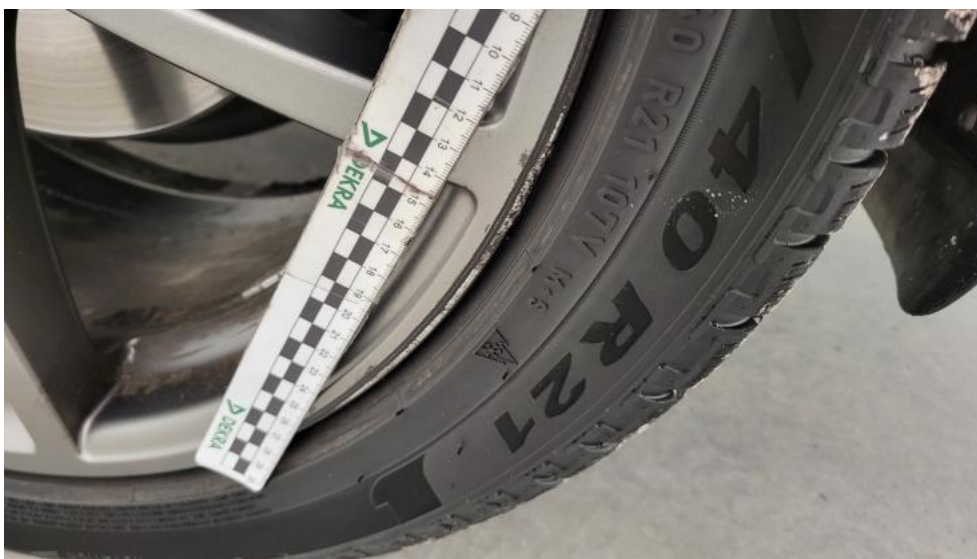
**Photo 51.**  
Felga aluminiowa przednia P - Rysa/odprysk 2

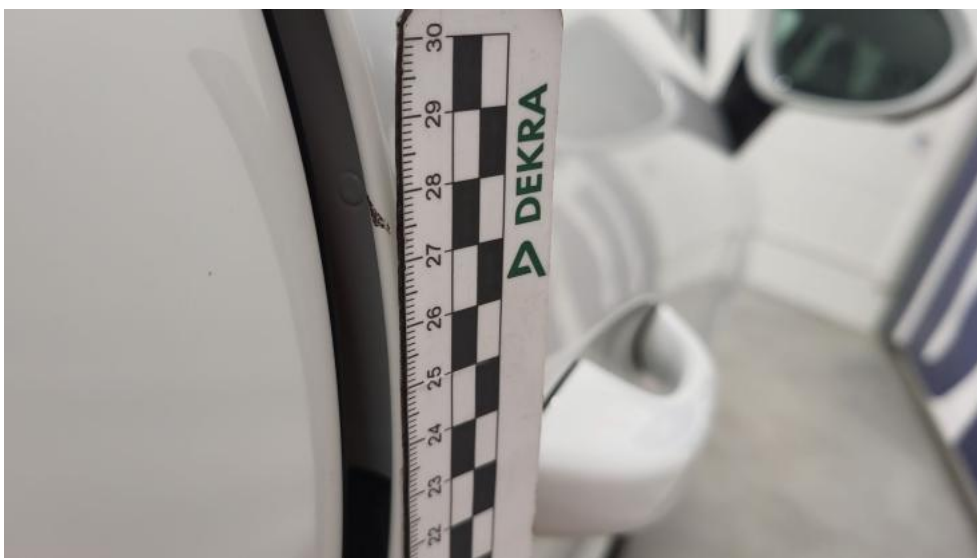
**Photo 52.**  
Drzwi przednie P - Rysa/odprysk 1

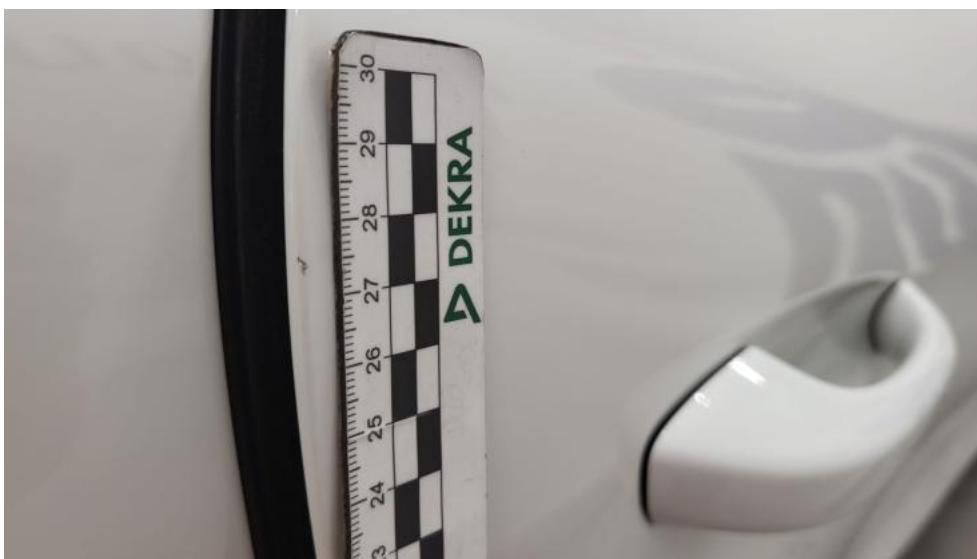
**Photo 53.**

Drzwi tylne P - Rysa/odprysk 1

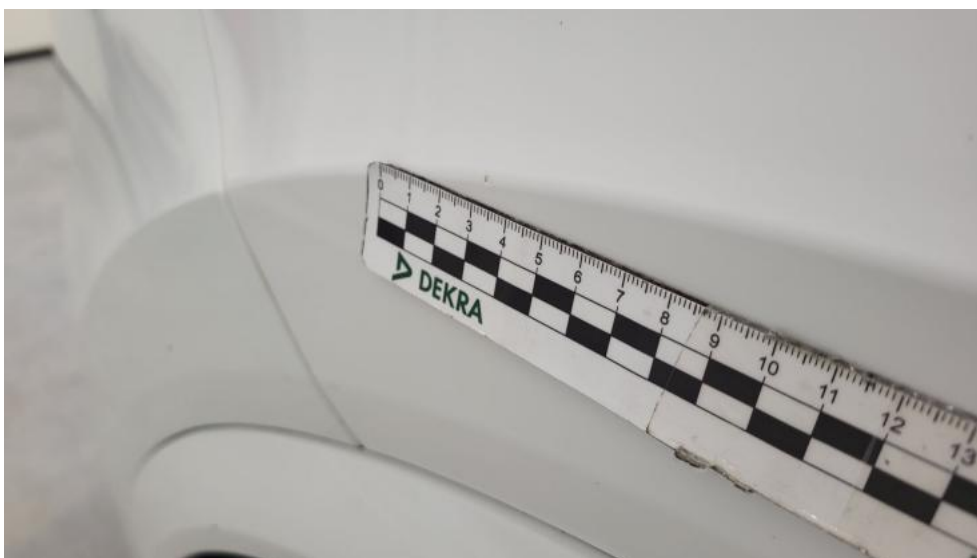
**Photo 54.**

Błotnik tylny P / Ściana boczna P - Rysa/odprysk 1

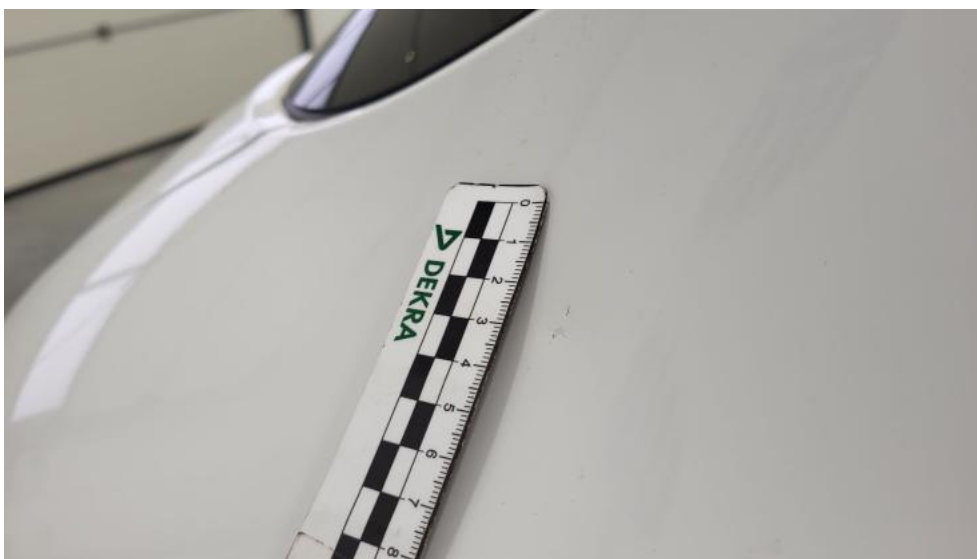
**Photo 55.**

Błotnik tylny P / Ściana boczna P - Rysa/odprysk 2

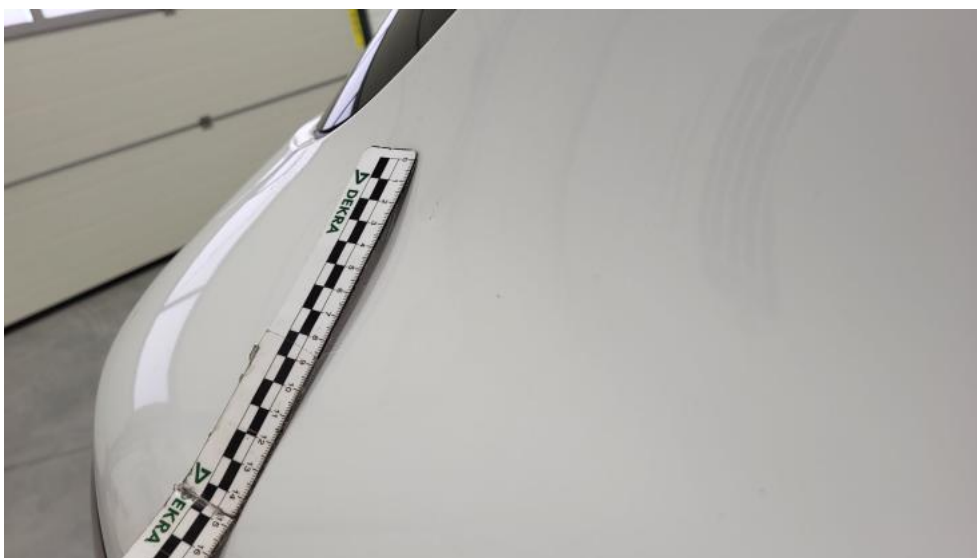
**Photo 56.**

Błotnik tylny P / Ściana boczna P - Wgniecenie/odkształcenie 1

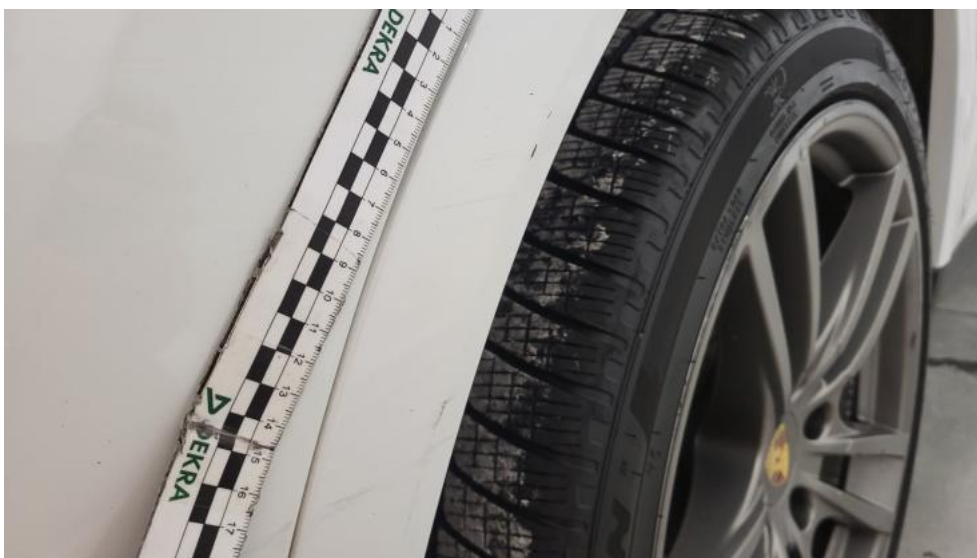
**Photo 60.**

Listwa krawędzi błotnika tył P - Rysa/odprysk 1

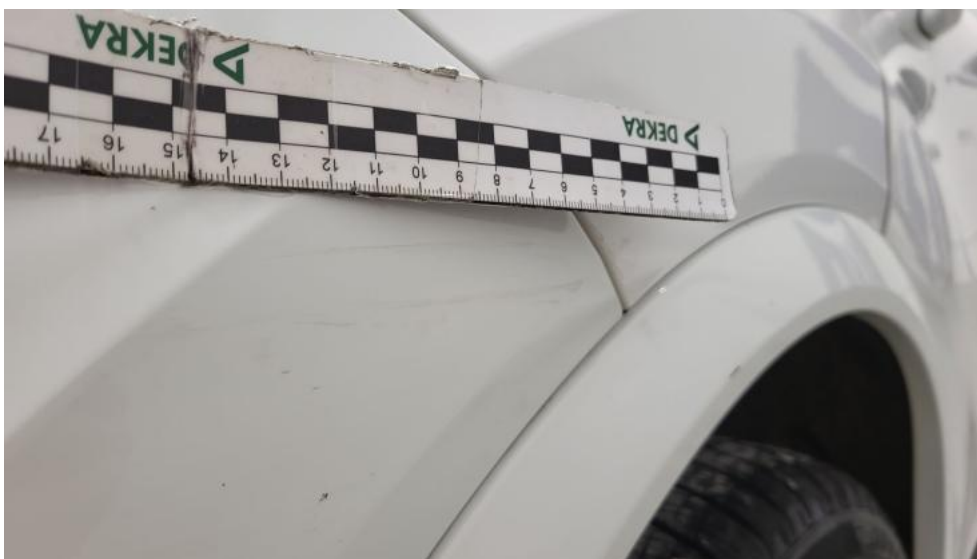
**Photo 61.**  
Zderzak tylny - Rysa/odprysk 1

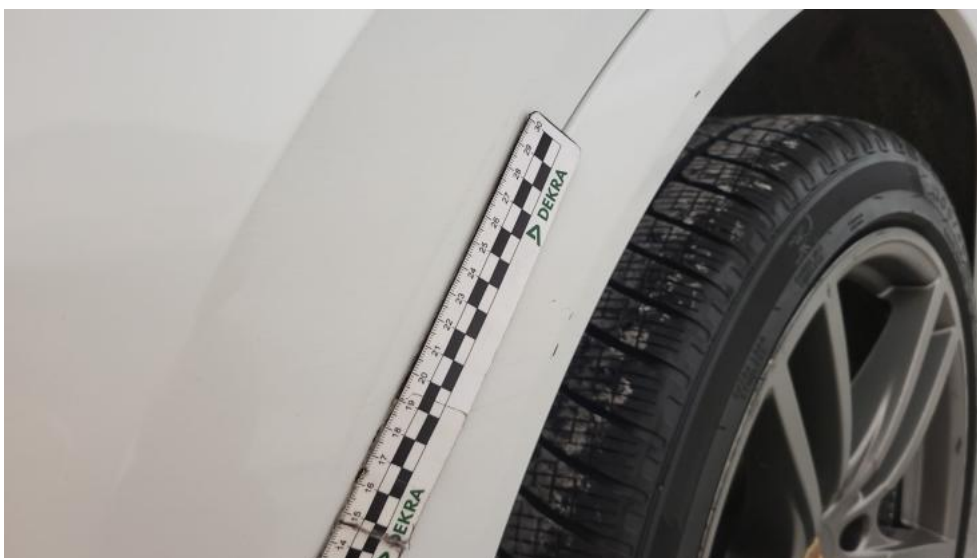
**Photo 62.**  
Zderzak tylny - Rysa/odprysk 2

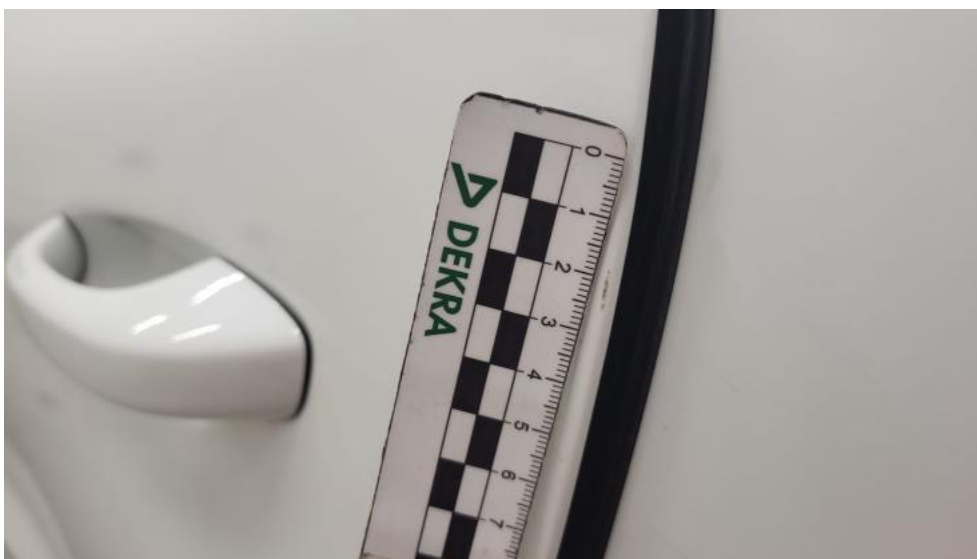
**Photo 65.**  
Drzwi tylne L - Rysa/odprysk 1

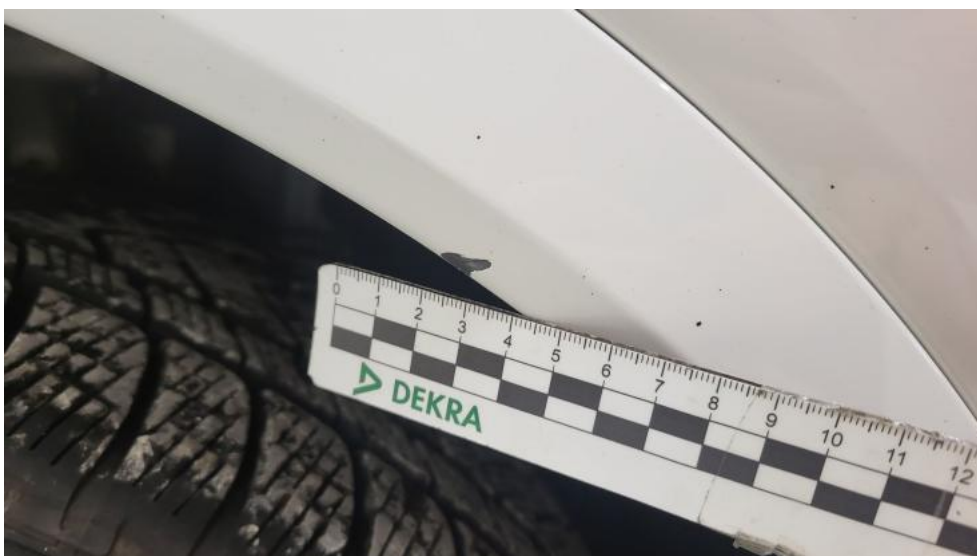
**Photo 66.**  
Listwa krawędzi błotnika prz L - Rysa/odprysk 1

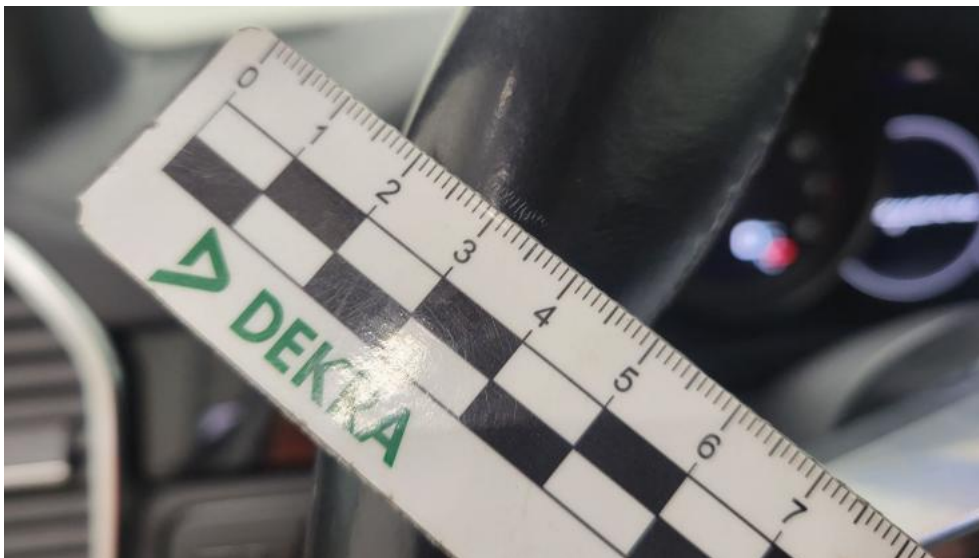
**Photo 67.**  
Koło kierownicy - Rysa/odprysk 1

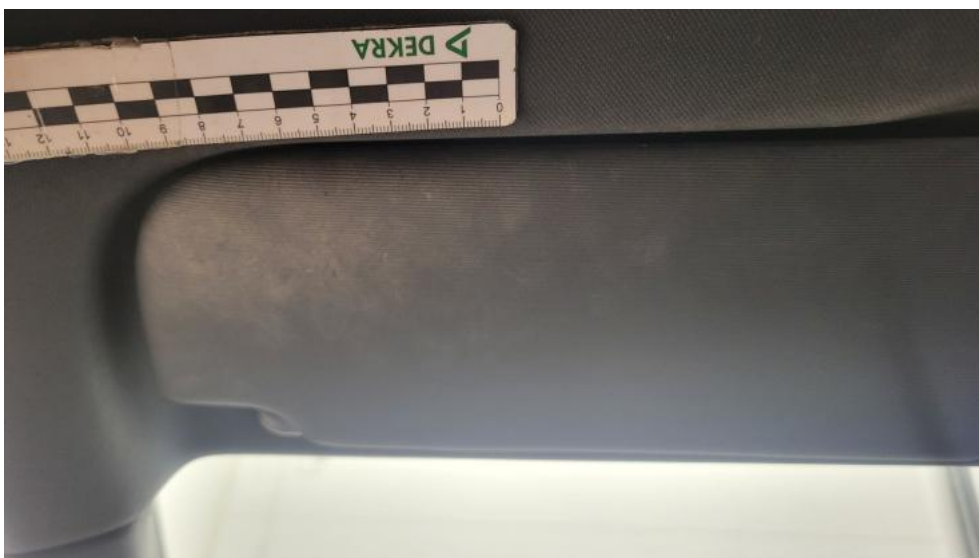
**Photo 68.**  
Osłona p/słoneczna lewa - Inne 1
