DEKRA's commission No. : PKOL(W)/LODZ/36317/25/05/20  
commission/ damage No. : FUTURA  
Date of commission: 20-05-2025

PKO Leasing SA  
Świętokrzyska 36  
00-116 Warszawa

| Manufacturer | RENAULT |
| Type / version | Clio 0.9 Energy TCe Alize |

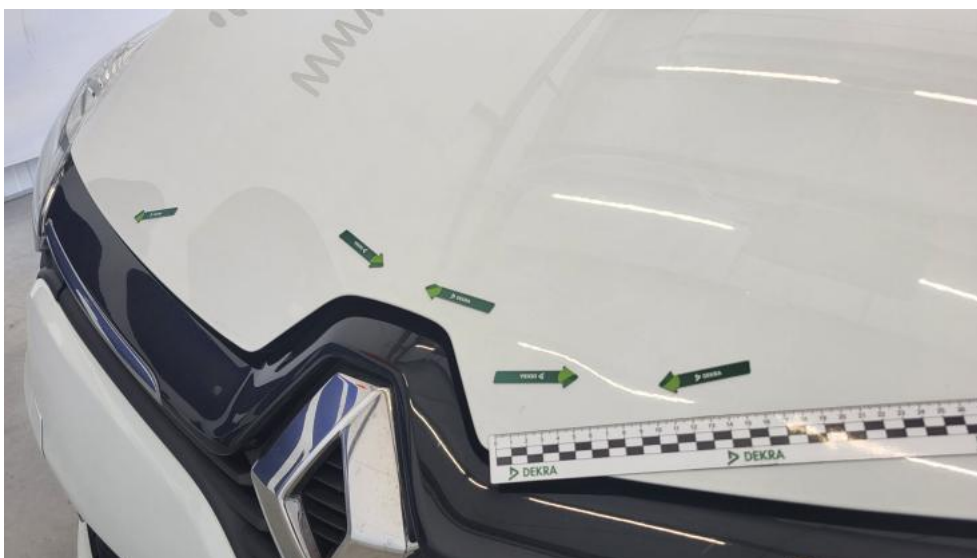
**Photo 36.**

Pokrywa komory silnika - Wgniecenie/odkształcenie 1

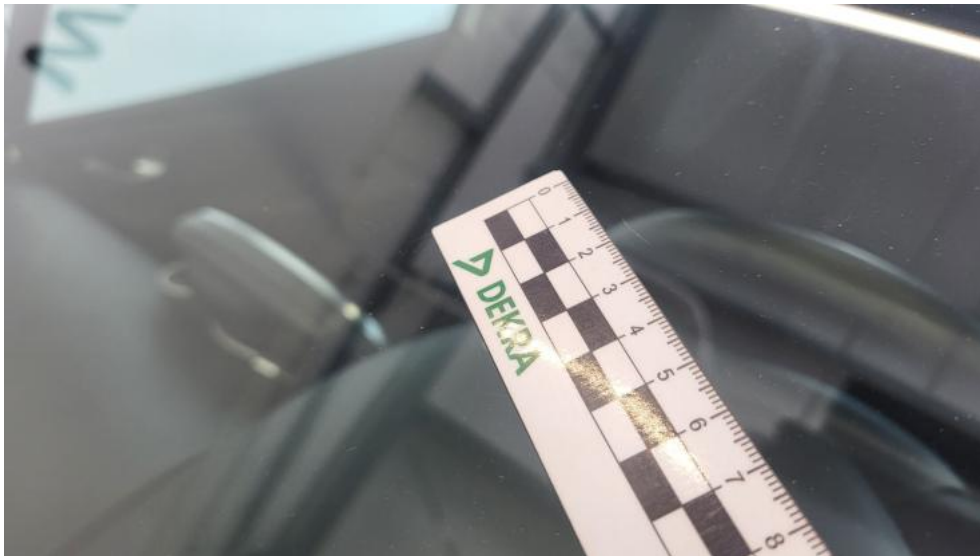
**Photo 37.**

Rysy na samochodzie. Brak zaślepek w tylnej kanapie. Odpryski na szybie czołowej. Widoczne ślady po grafice reklamowej.

Szyba czołowa - Rysa/odprysk 1

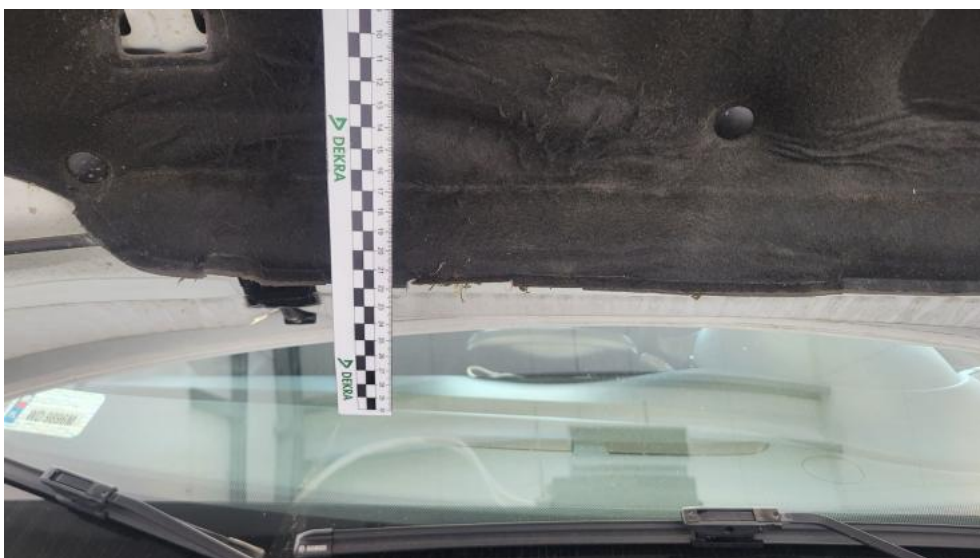
**Photo 38.**

Wykładzina pokrywy komory silnika - Pęknięcie/rozerwanie 1

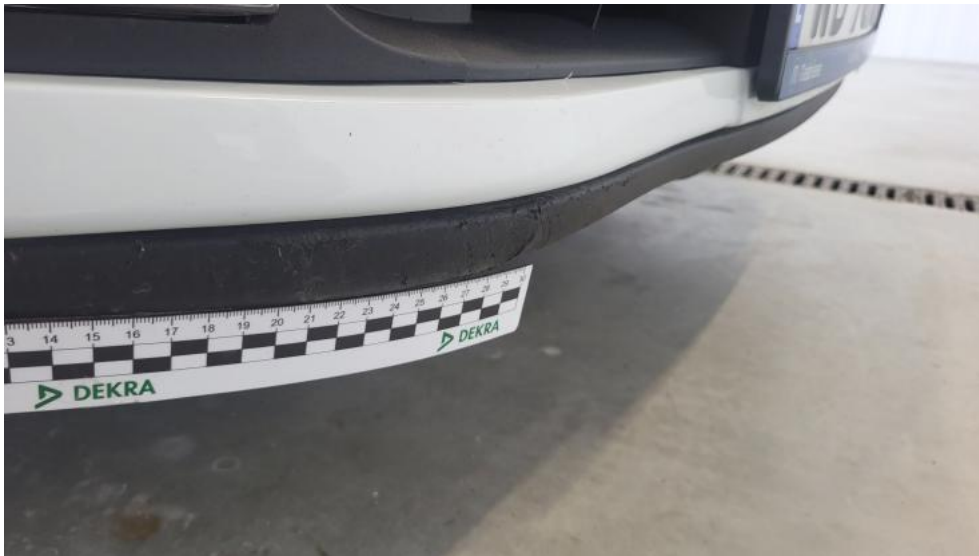
**Photo 39.**

Zderzak przedni cz dolna - Rysa/odprysk 1

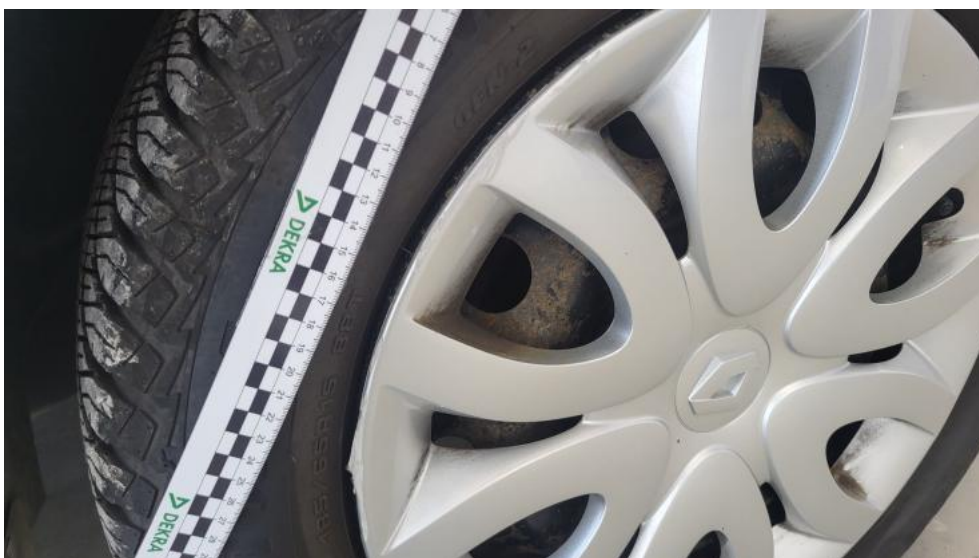
**Photo 40.**

Kołpak przedni P - Rysa/odprysk 1

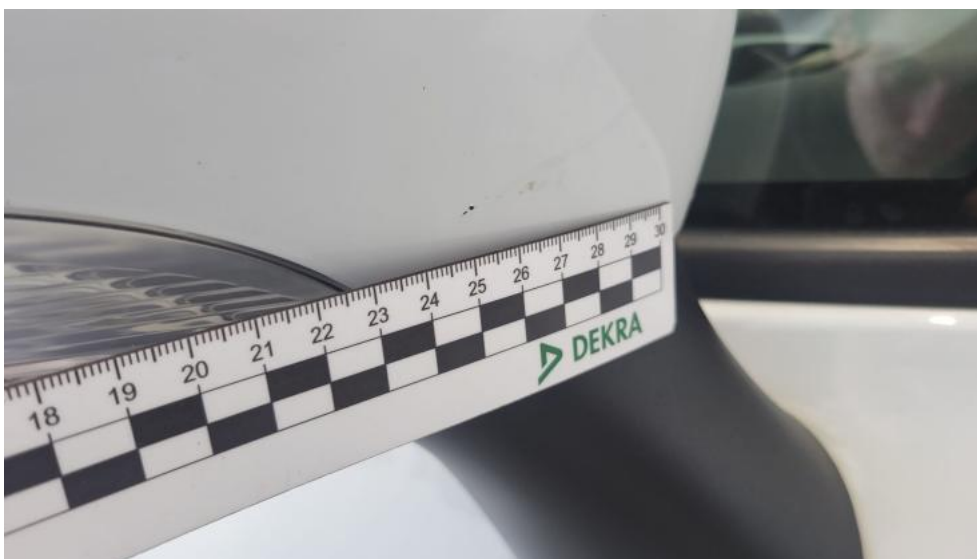
**Photo 41.**

Lusterko zew P - Rysa/odprysk 1

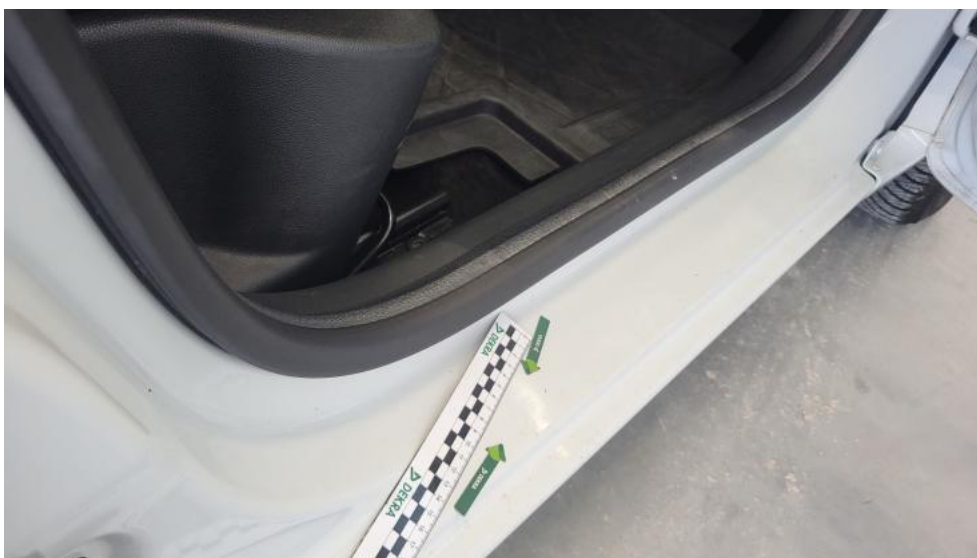
**Photo 42.**

Próg P - Wgniecenie/odkształcenie 1

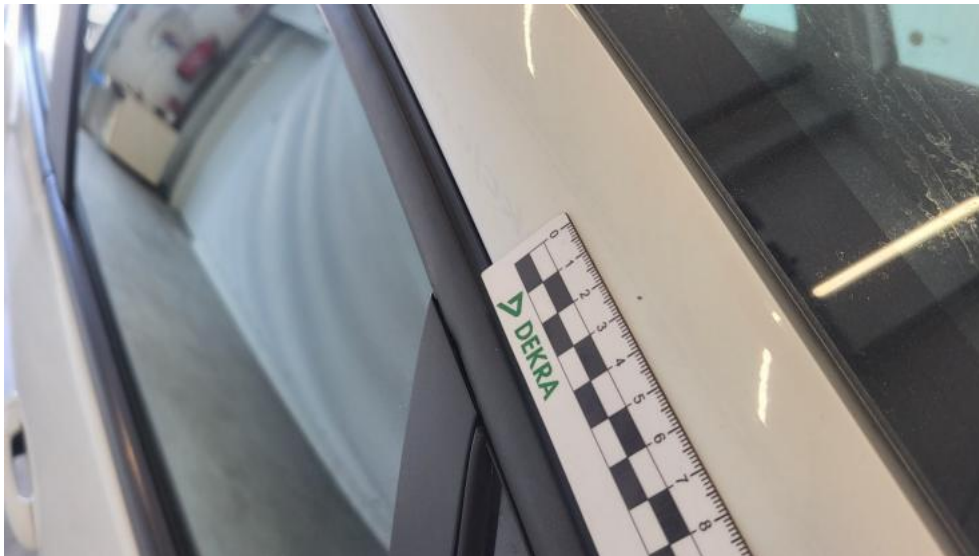
**Photo 43.**

Słupek przedni P - Rysa/odprysk 1

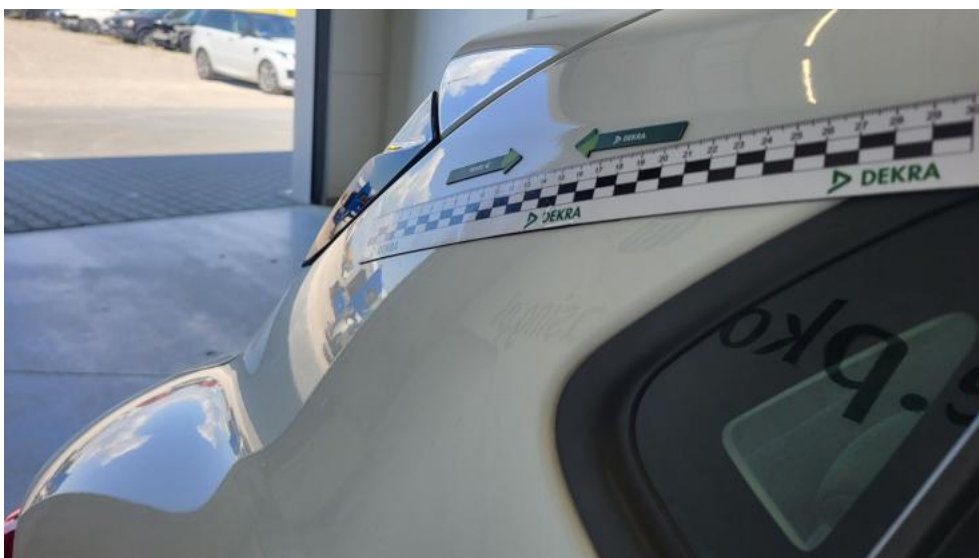
**Photo 44.**

Ścianka tylna P / Ścianka boczna P - Wgniecenie/odkształcenie 1

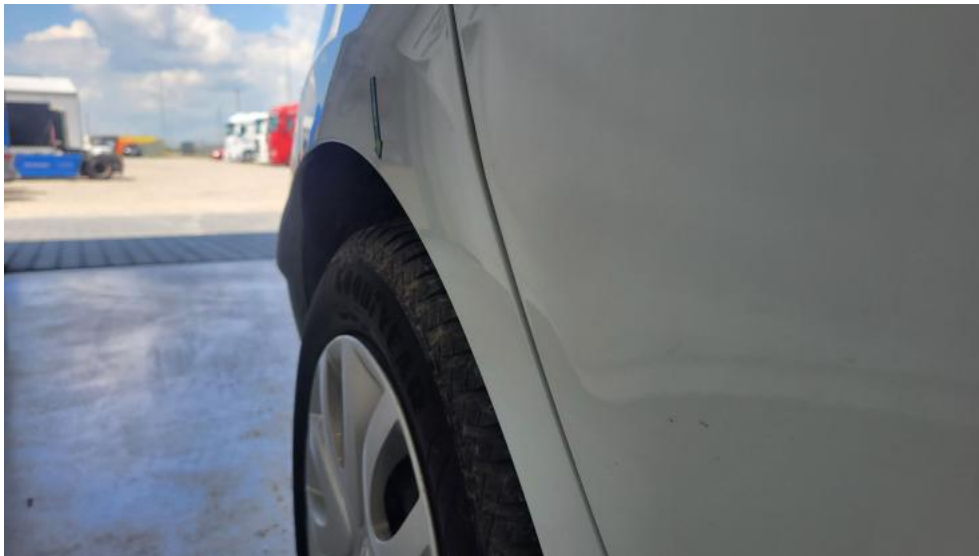
**Photo 45.**

Błotnik tylny P / Ściana boczna P - Wgniecenie/odkształcenie 2

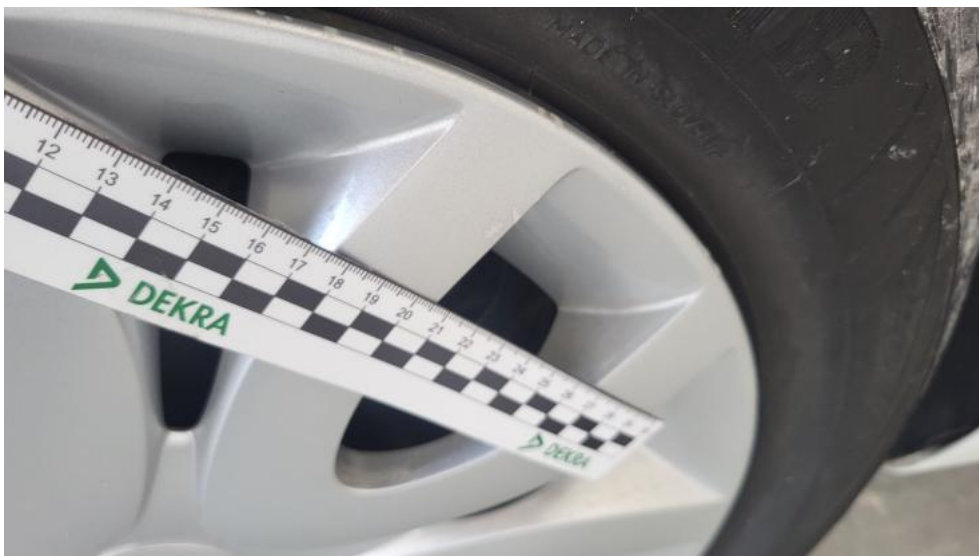
**Photo 46.**

Kołpak tylny P - Rysa/odprysk 1

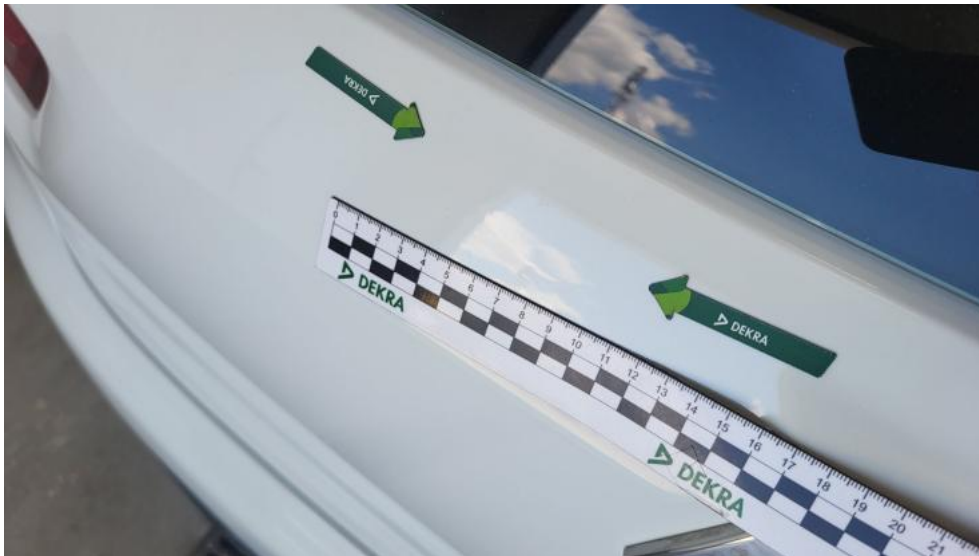
**Photo 47.**

Pokrywy bagażnika - Wgniecenie/odkształcenie 1

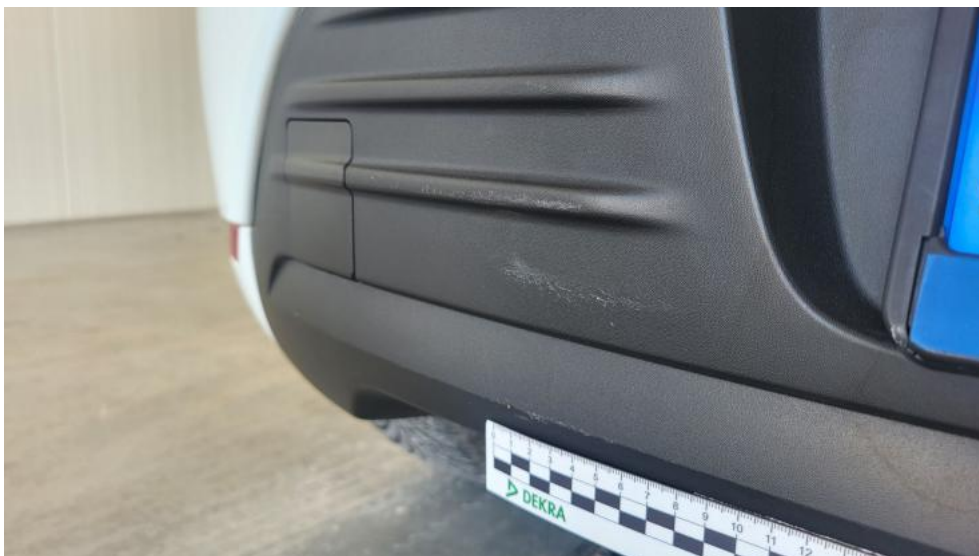
**Photo 48.**

Zderzak tylny cz dolna - Rysa/odprysk 1

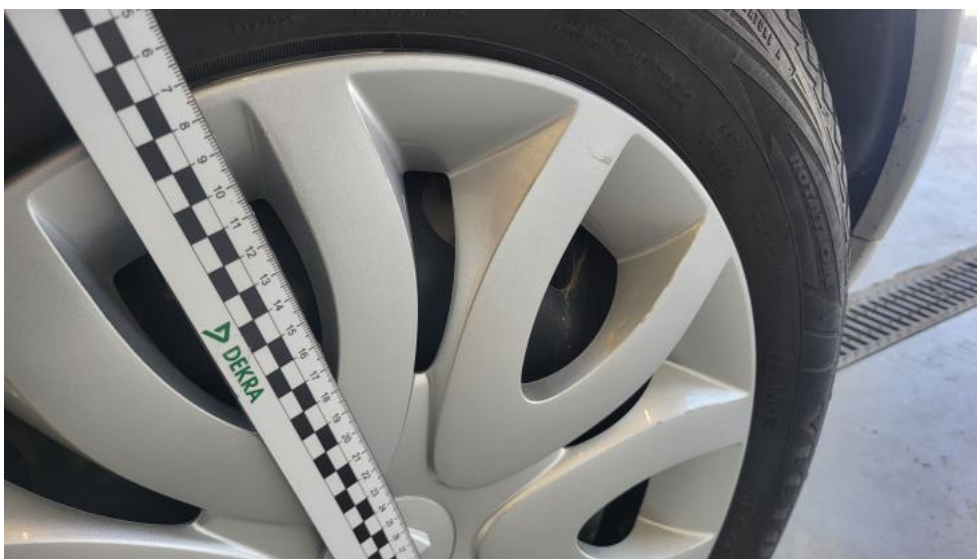
**Photo 49.**

Kołpak tylny L - Rysa/odprysk 1

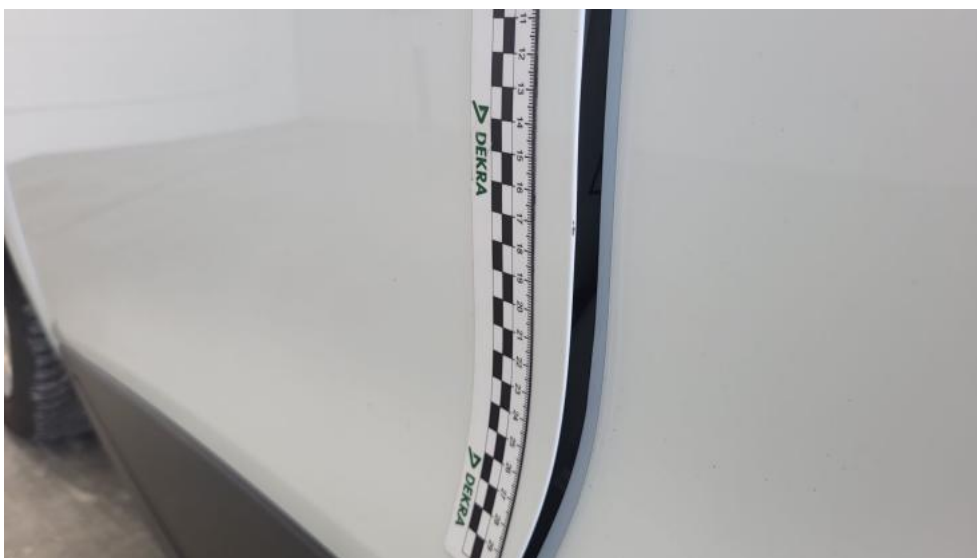
**Photo 50.**

Drzwi przed L - Rysa/odprysk 1

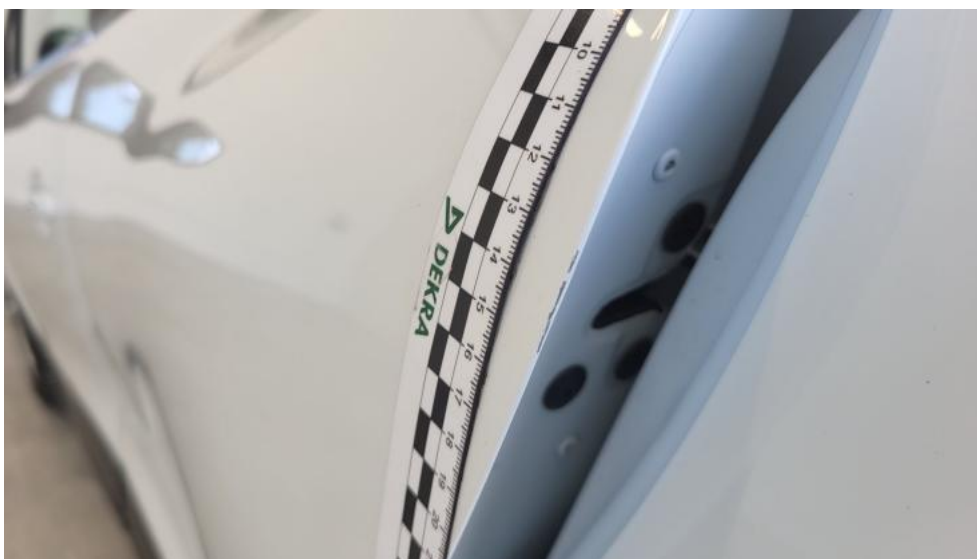
**Photo 51.**

Drzwi tylne L - Rysa/odprysk 1

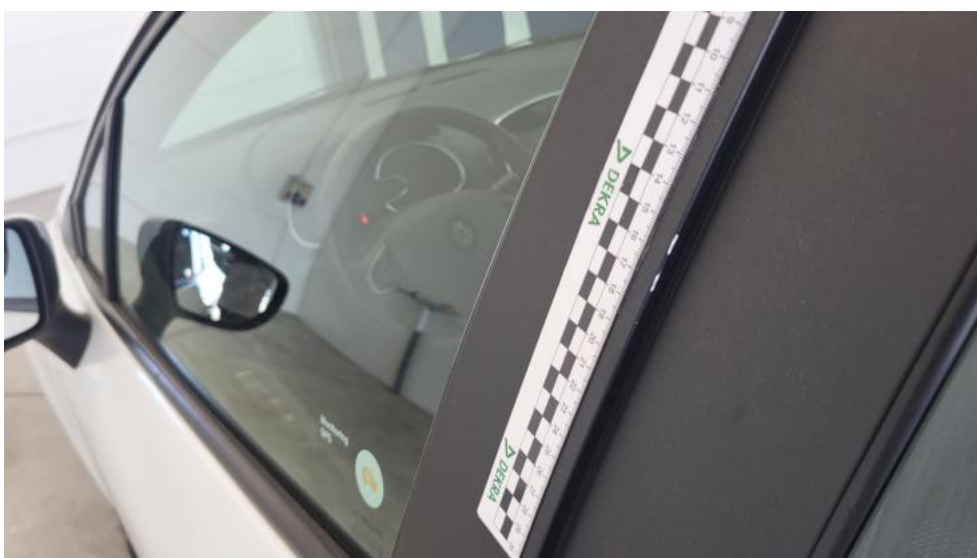
**Photo 52.**

Listwa drzwi przednich L - Rysa/odprysk 1

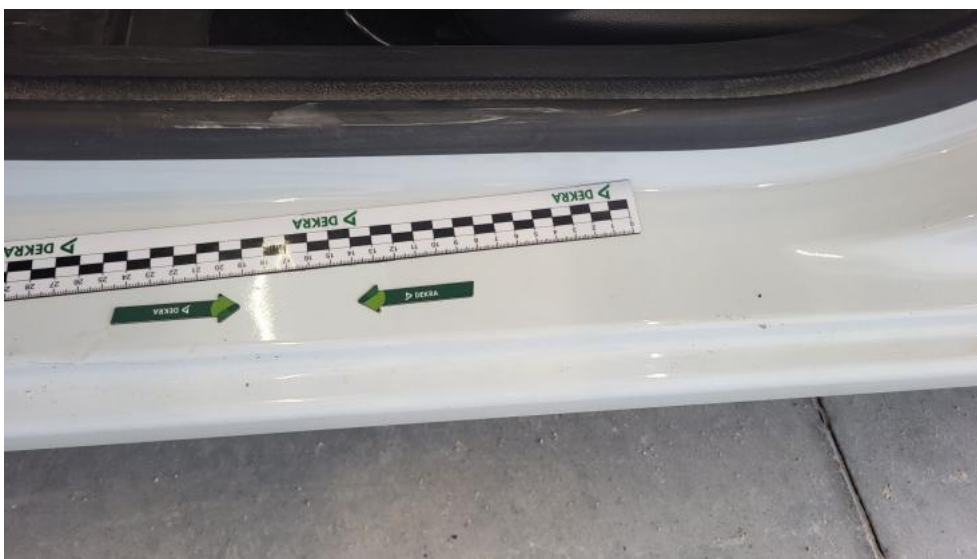
**Photo 53.**

Próg L - Wgniecenie/odkształcenie 1

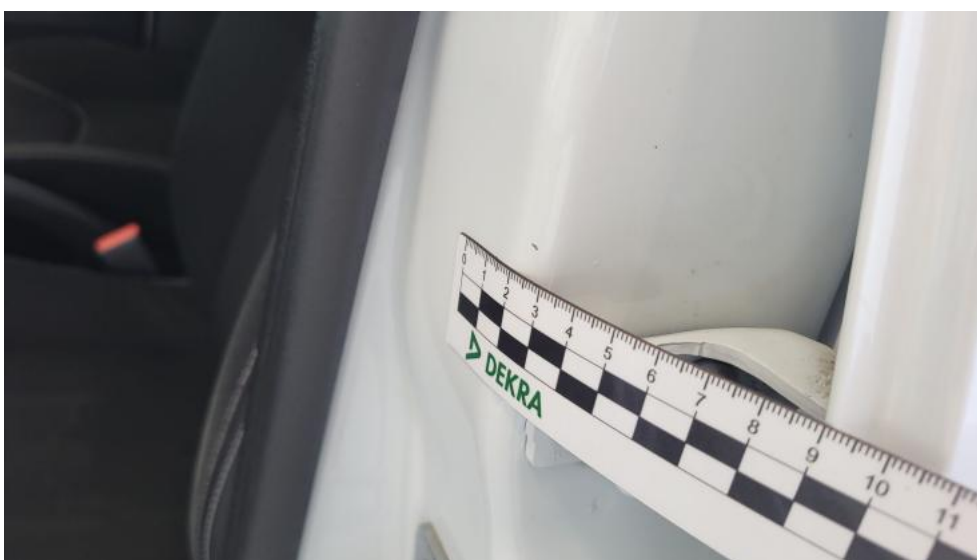
**Photo 54.**

Słupek środkowy L - Rysa/odprysk 1

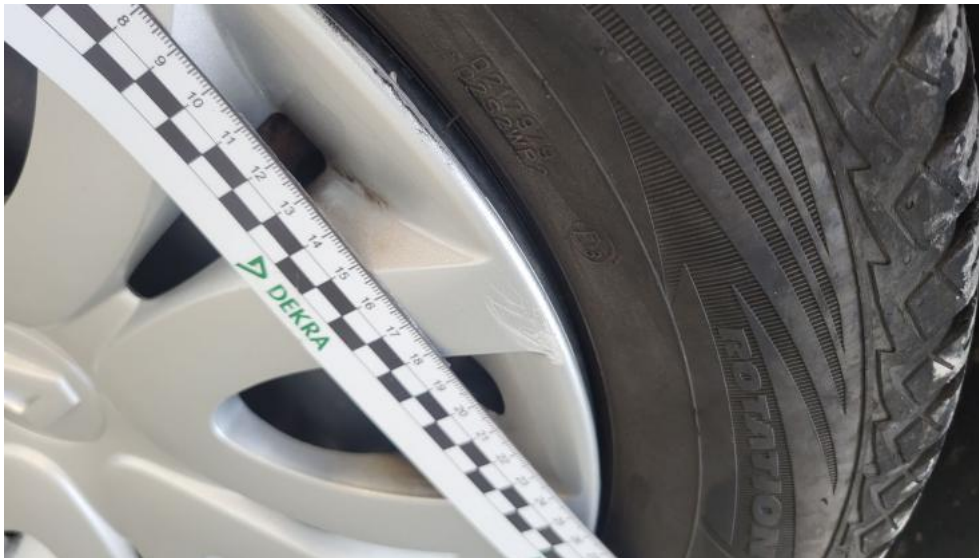
**Photo 55.**

Kołpak przedni L - Rysa/odprysk 1

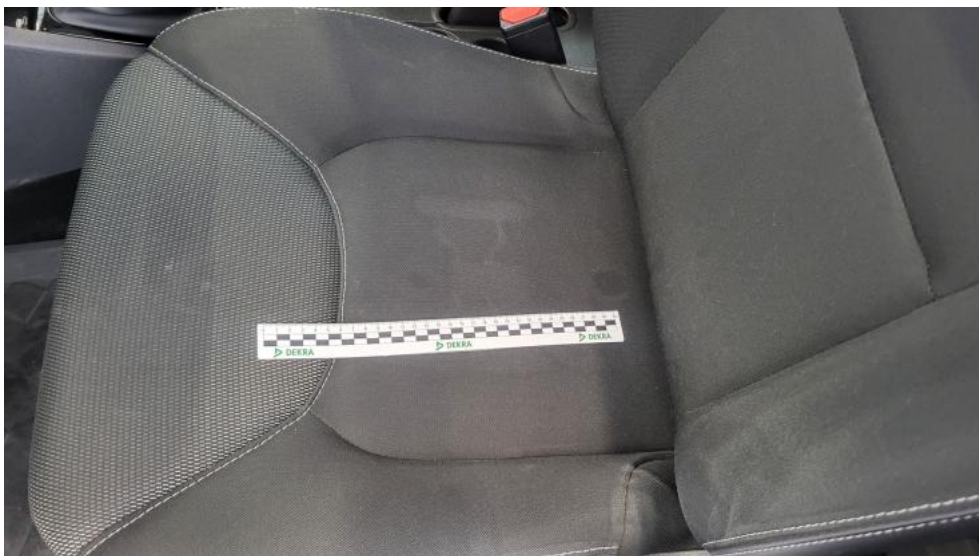
**Photo 56.**

Fotel prz. lew. - Inne 1

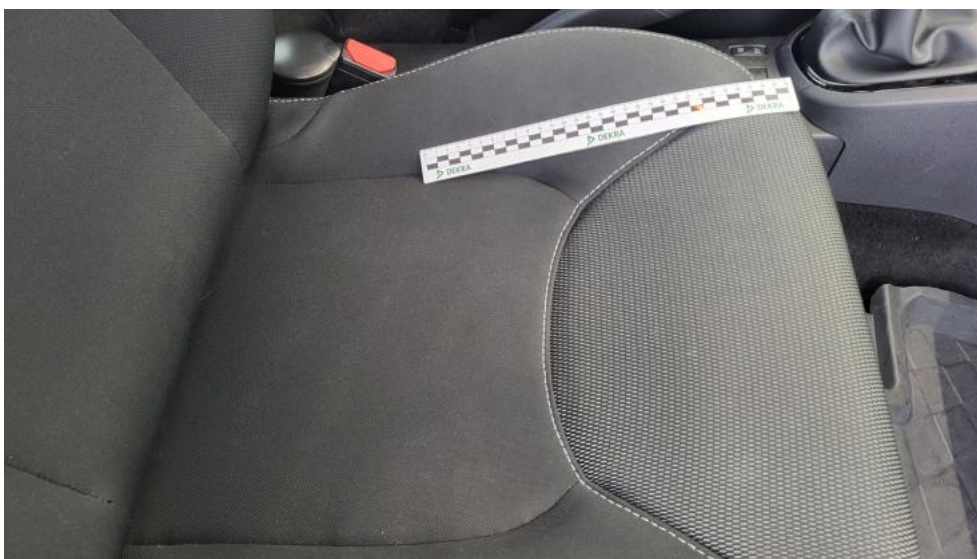
**Photo 57.**

Fotel prz. praw. - Inne 1

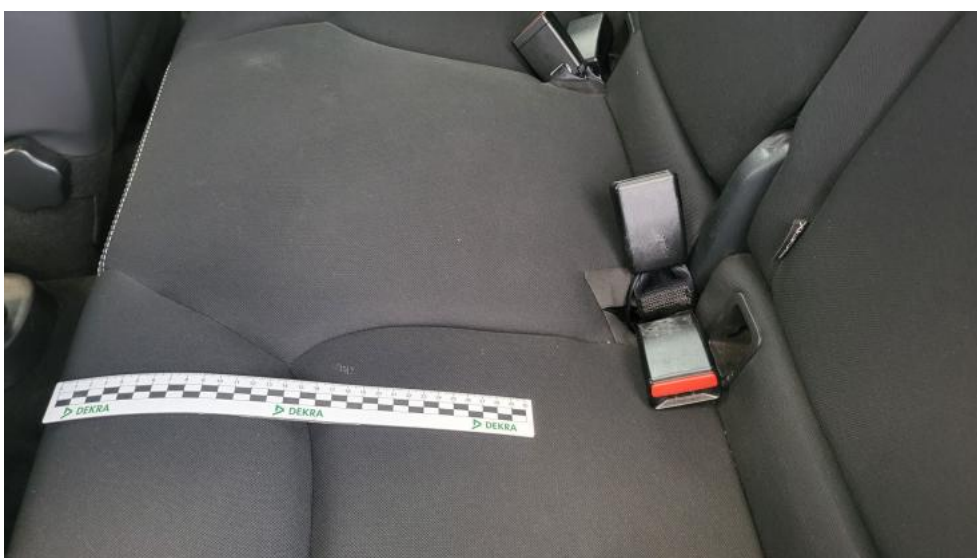
**Photo 58.**

Kanapa tyl. - Inne 1

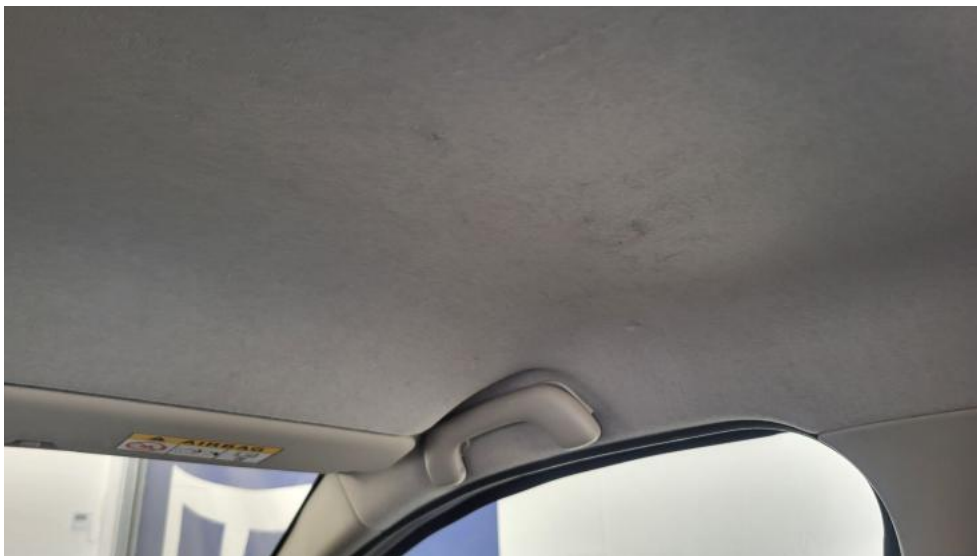
**Photo 59.**

Podsufitka - Inne 1
