DEKRA's commission No. : PKOL(W)/LODZ/17842/25/03/11
 commission/ damage No. : 21/030808
 Date of commission: 11-03-2025

Vehicle data

Group of objects (Eurotax)	cars
EC code (Eurotax)	0123801
Manufacturer	BMW
Model	Seria 5 [G30/F90] 16-20
Type / version	520d xDrive Luxury Line aut
Body type	sedan
Number of doors / seats	4/5
Curb weight [kg]	1650
Gross vehicle weight [kg]	2330
Wheelbase 1/2	2975
Engine type	Automatic ignition
Pollution reduction system	DPF
Engine capacity [ccm]	1995
Engine Power [hp/kW]	190/140
Gearbox	automatic 8- gear
Registration /record No.	WZ433CW
VIN / serial number	WBAJF51040WW66223
Date of first registration	27-11-2019
Date of next. tech. test	27-11-2024
Year of manufacture	2019
Readout [km]	127 845 (read)
Body color / type of coating	black/UNI

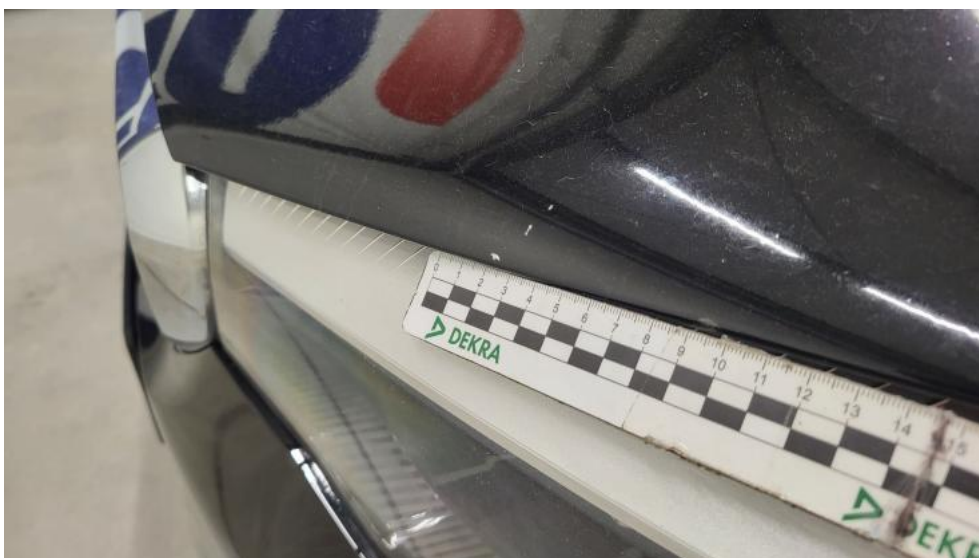
Photo 38.
Pokrywa komory silnika - Rysa/odprysk 1

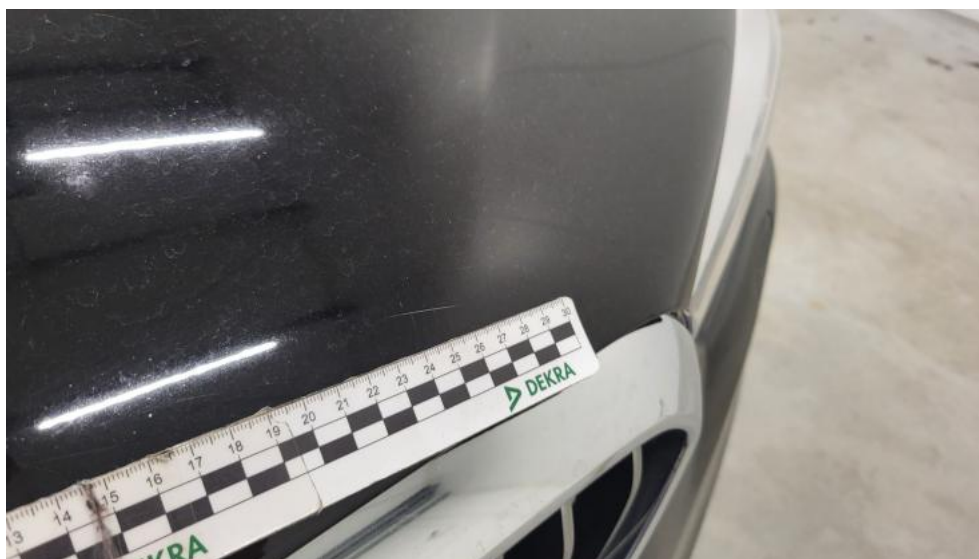
Photo 39.

Pokrywa komory silnika - Rysa/odprysk 2

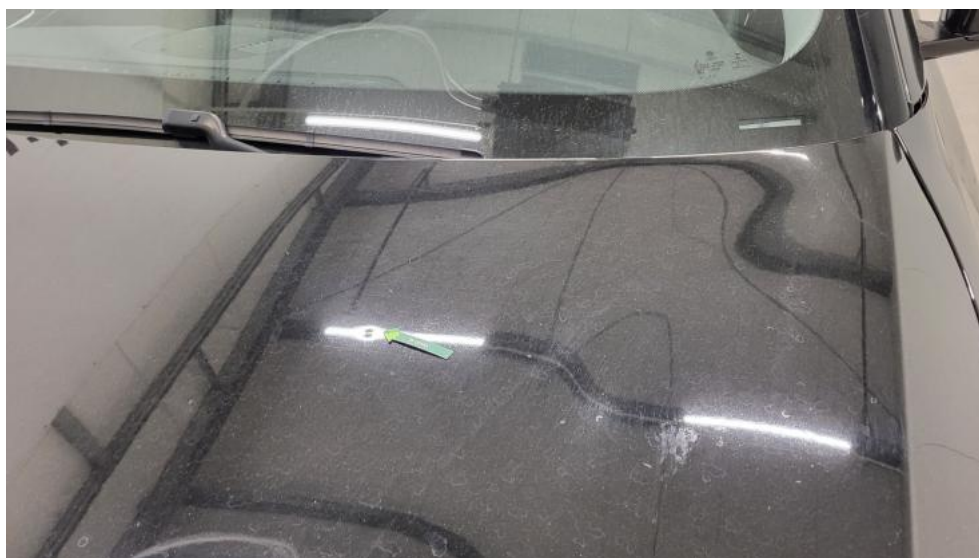
Photo 40.

Pokrywa komory silnika - Wgniecenie/odkształcenie 1

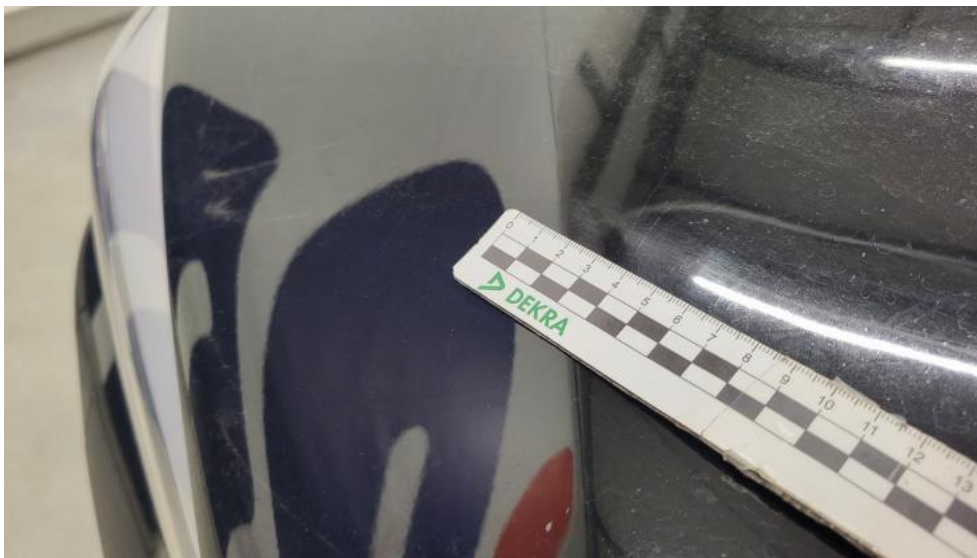
Photo 41.
Pokrywa komory silnika - Inne 1

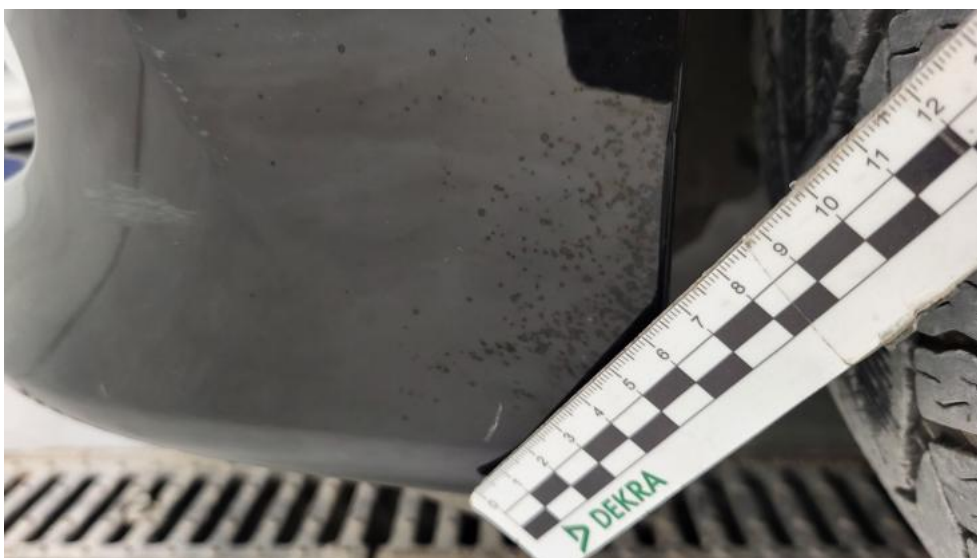
Photo 42.
Zderzak - Rysa/odprysk 1

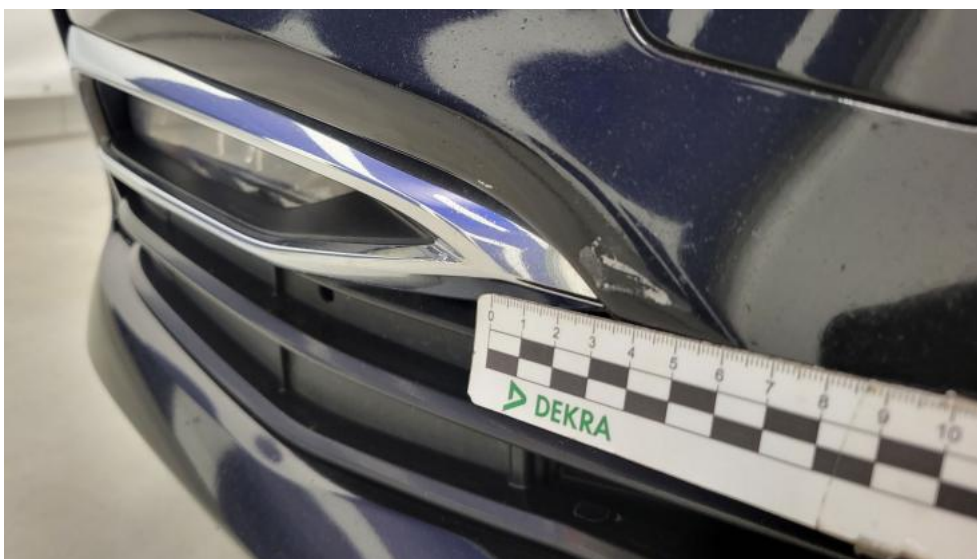
Photo 43.
Zderzak - Rysa/odprysk 2

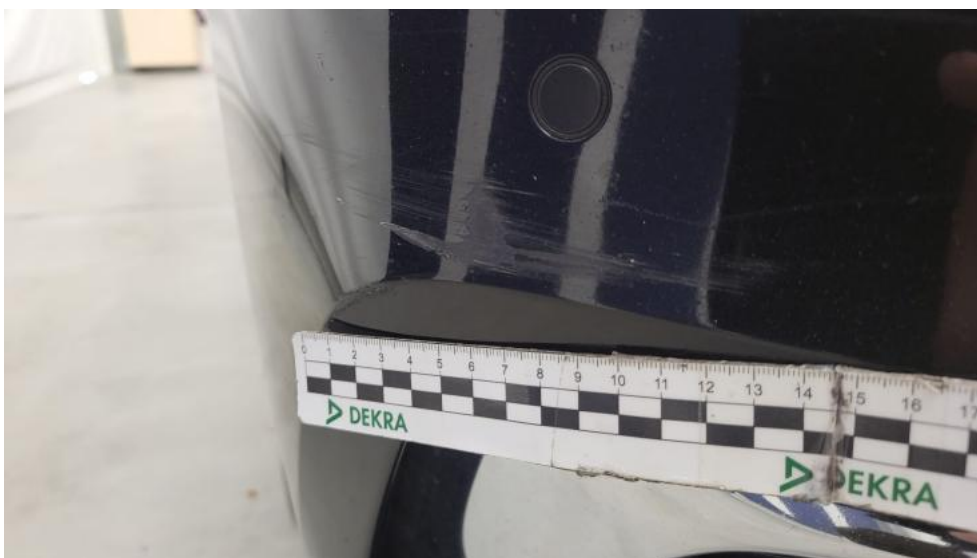
Photo 44.
Zderzak() - Rysa/odprysk 3

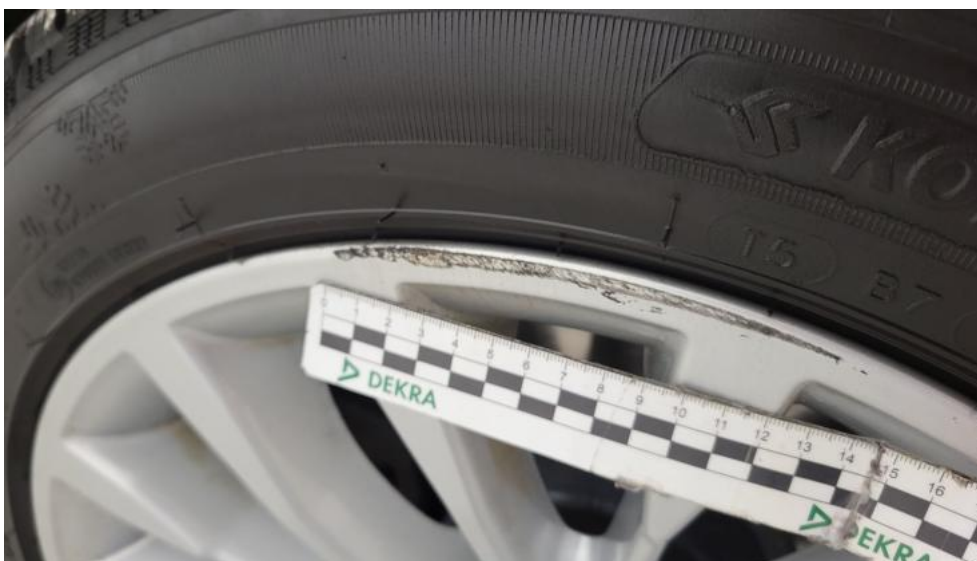
Photo 45.
Felga aluminiowa przednia P - Rysa/odprysk 1

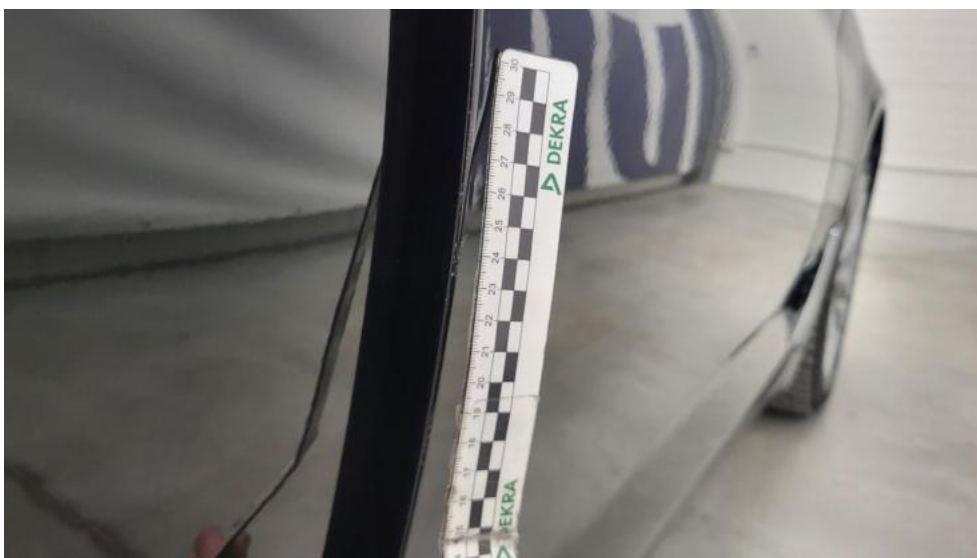
Photo 46.
Drzwi przednie P - Rysa/odprysk 1

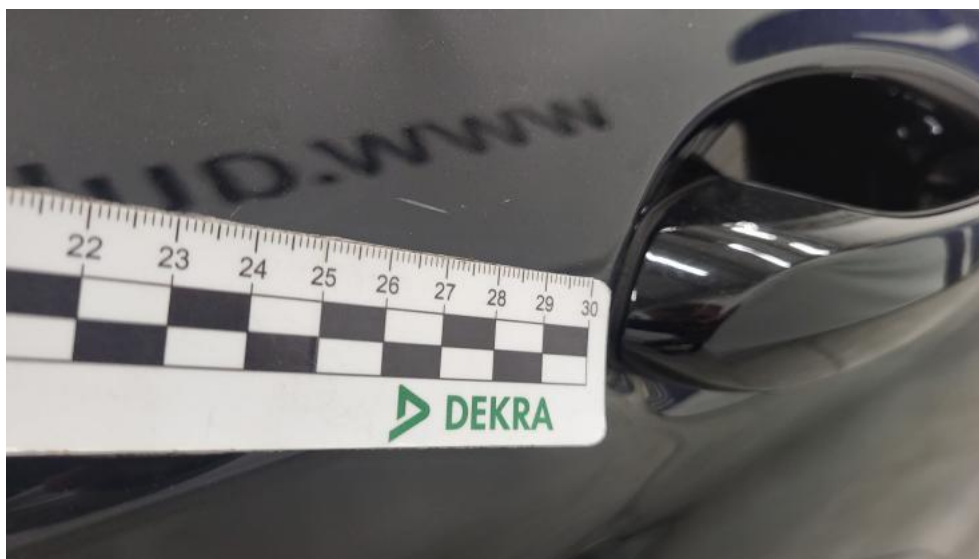
Photo 47.
Drzwi tylne P - Rysa/odprysk 1

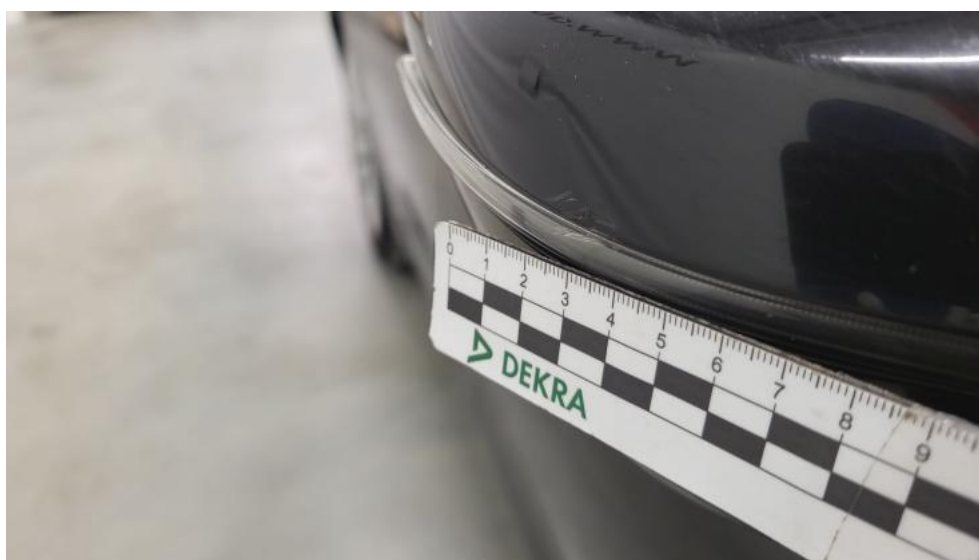
Photo 48.
Lusterko zew P - Rysa/odprysk 1

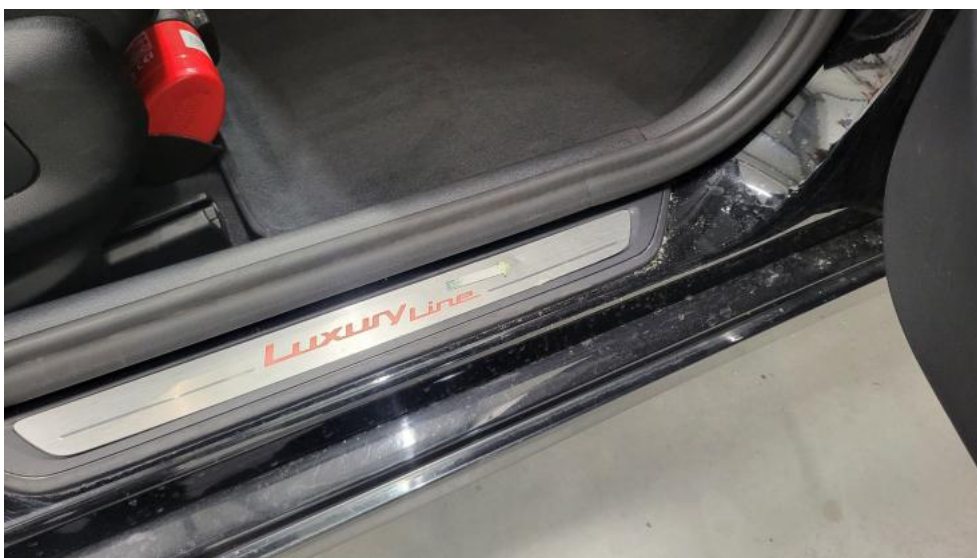
Photo 50.
Próg P - Wgniecenie/odkształcenie 1

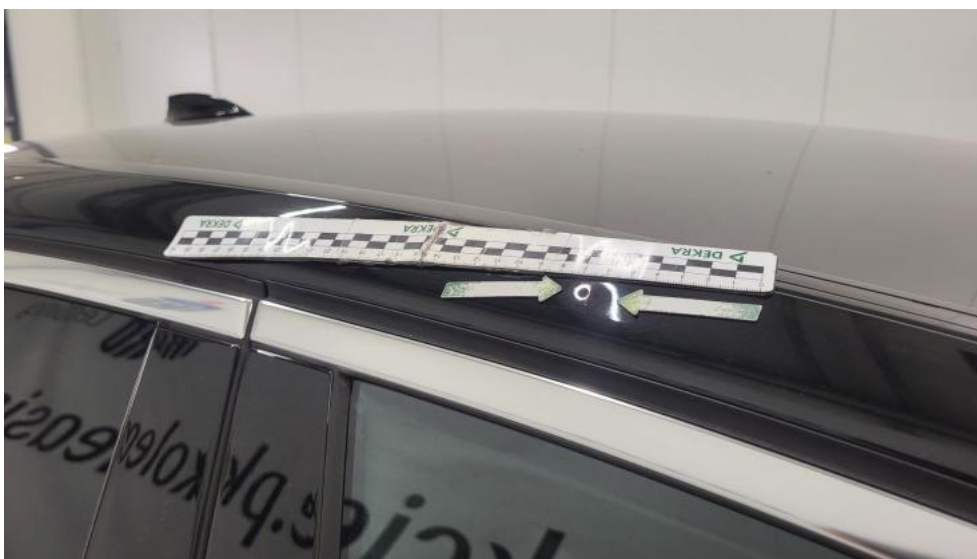
Photo 51.
Stupek przedni P - Wgniecenie/odkształcenie 1

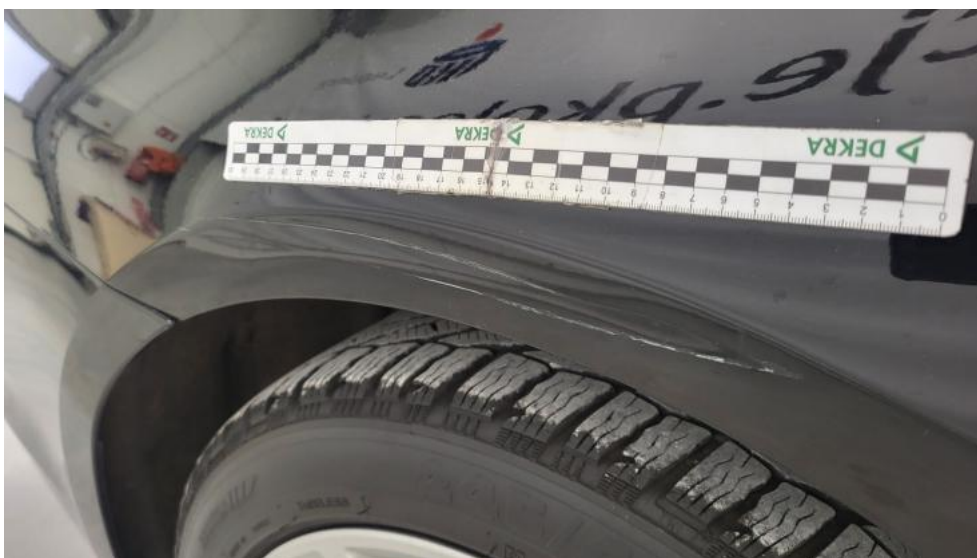
Photo 52.
Błotnik tylny P / Ściana boczna P - Rysa/odprysk 1

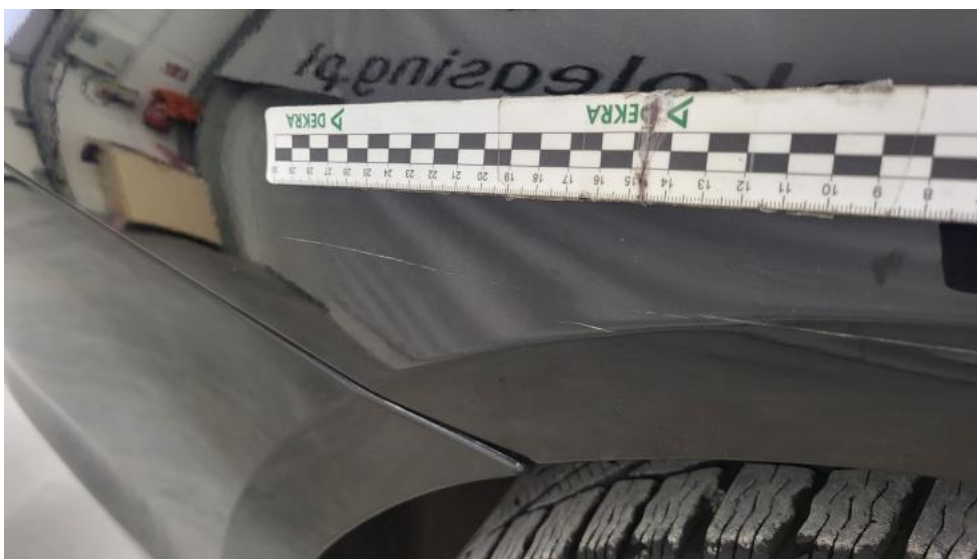
Photo 53.

Błotnik tylny P / Ściana boczna P - Rysa/odprysk 2

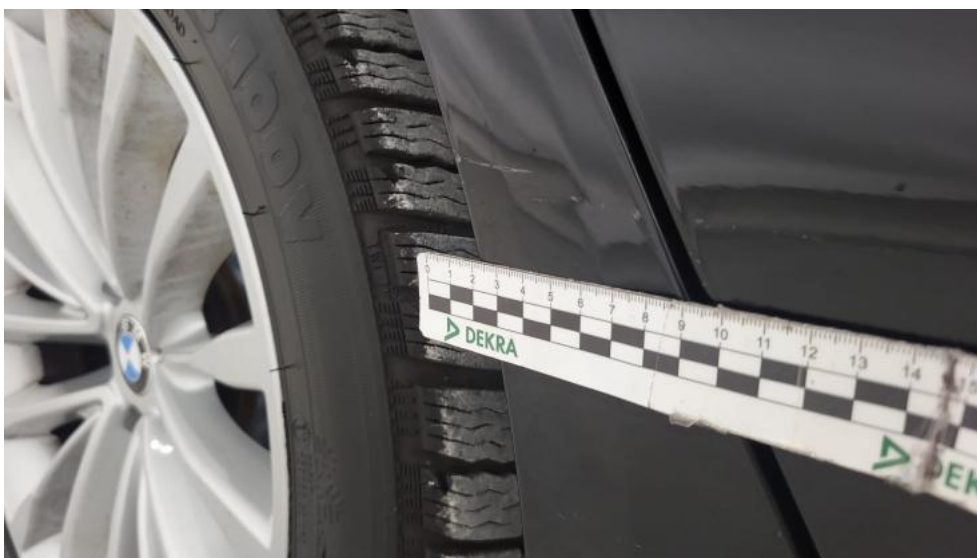
Photo 54.

Błotnik tylny P / Ściana boczna P() - Rysa/odprysk 3

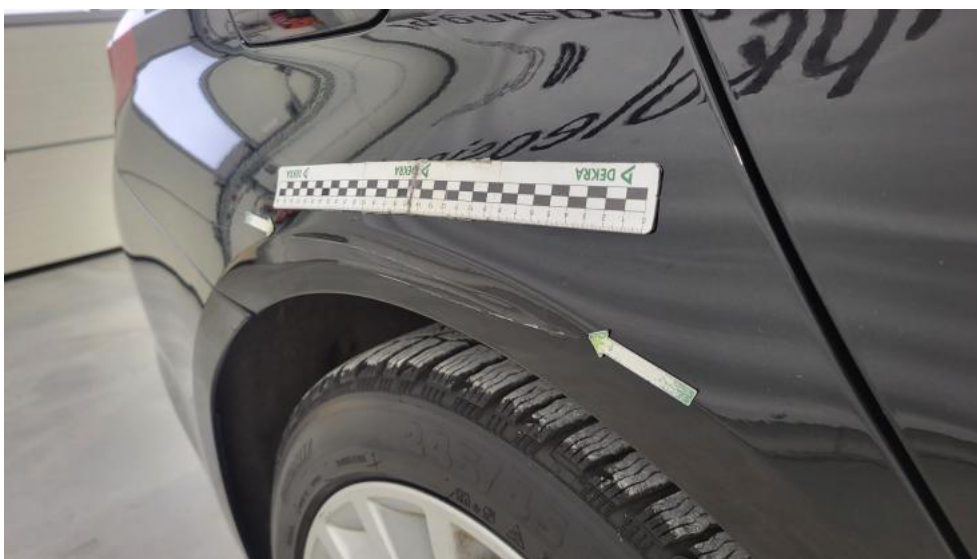
Photo 55.
Błotnik tylny P / Ściana boczna P - Wgniecenie/odkształcenie 1

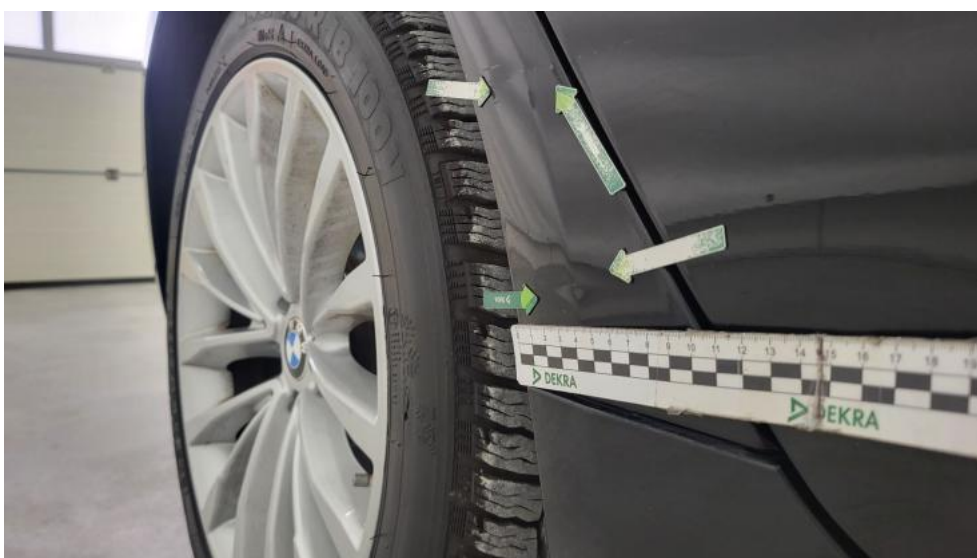
Photo 56.
Błotnik tylny P / Ściana boczna P - Wgniecenie/odkształcenie 2

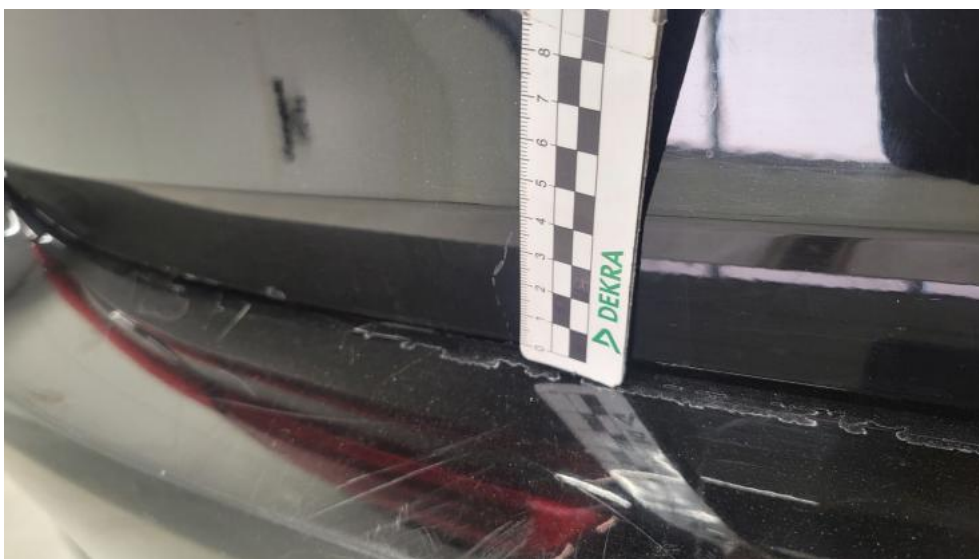
Photo 57.
Pokrywy bagażnika - Rysa/odprysk 1

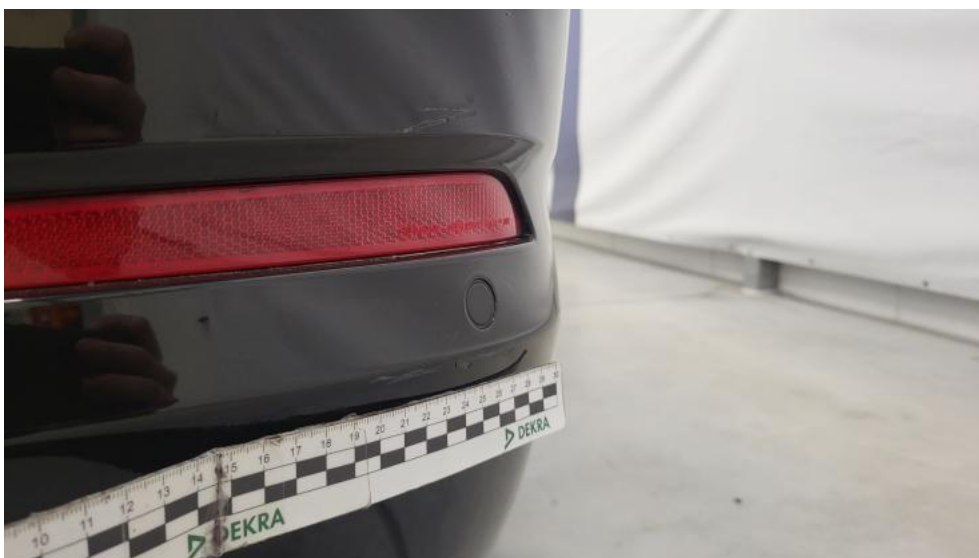
Photo 58.
Zderzak tylny - Rysa/odprysk 1

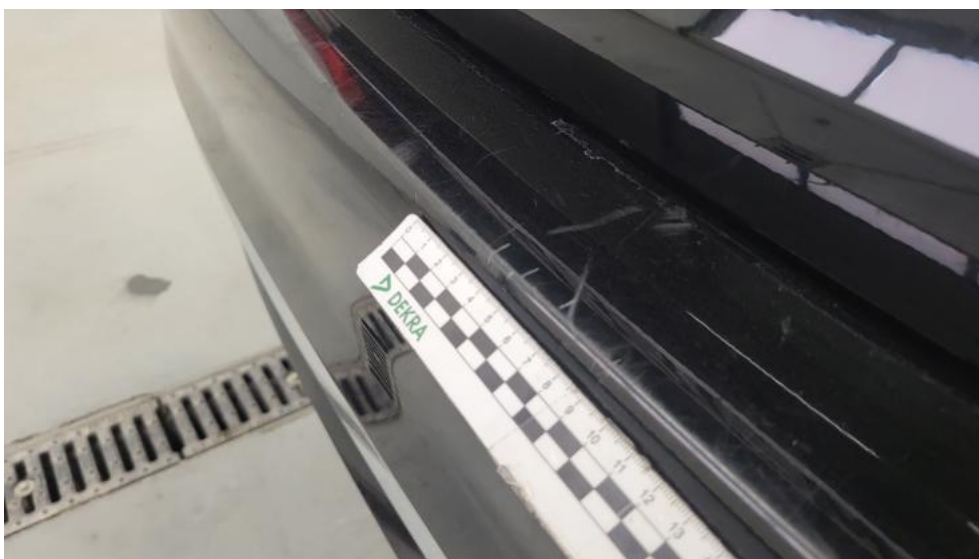
Photo 59.
Zderzak tylny - Rysa/odprysk 2

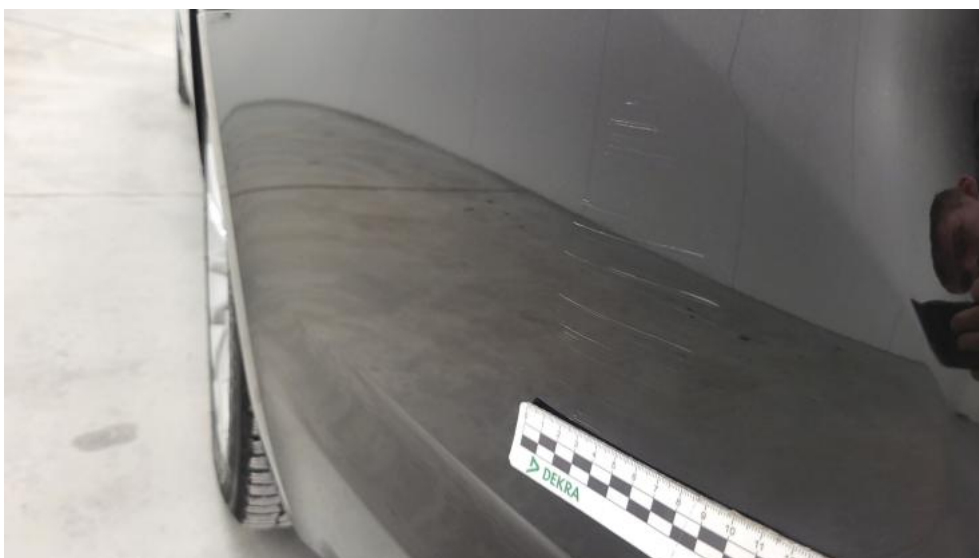
Photo 60.
Zderzak tylny() - Rysa/odprysk 3

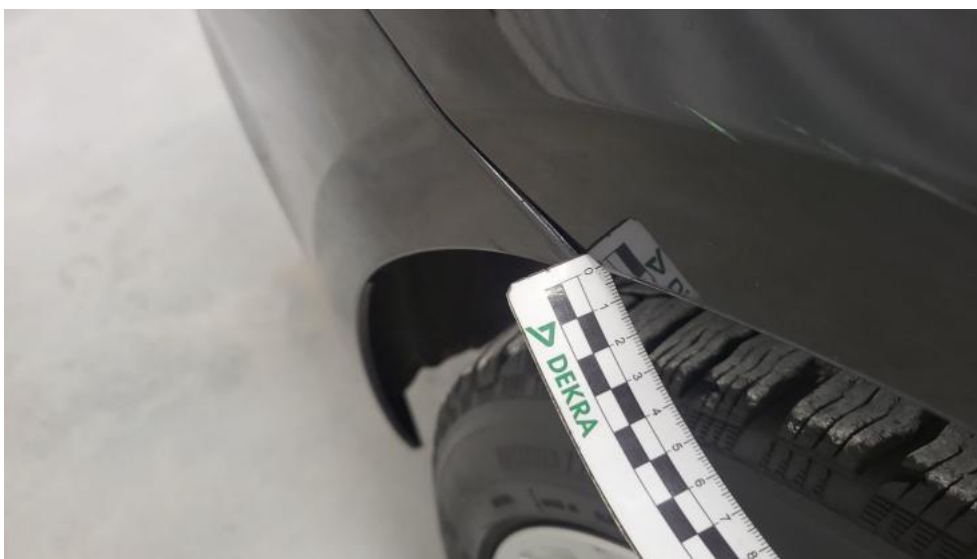
Photo 61.
Zderzak tylny - Inne 1

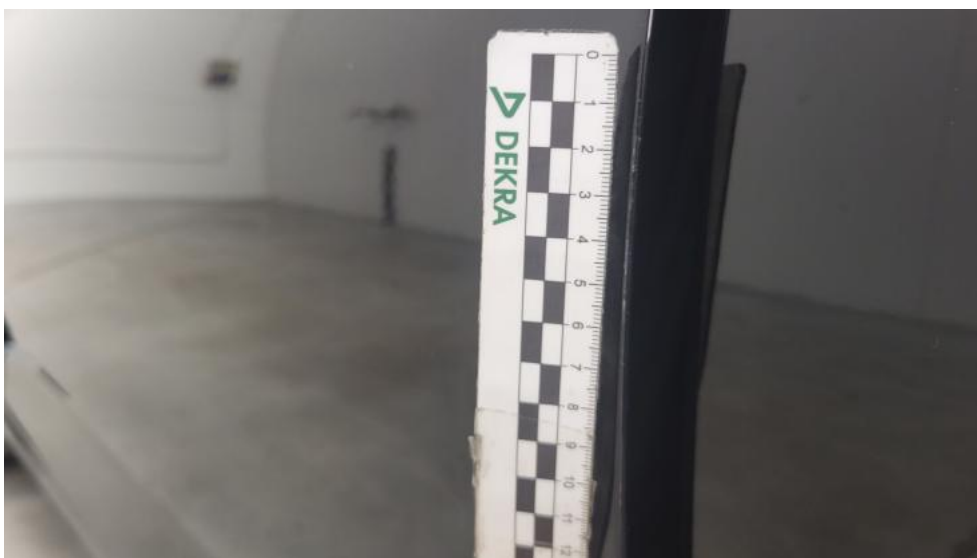
Photo 62.
Drzwi przed L - Rysa/odprysk 1

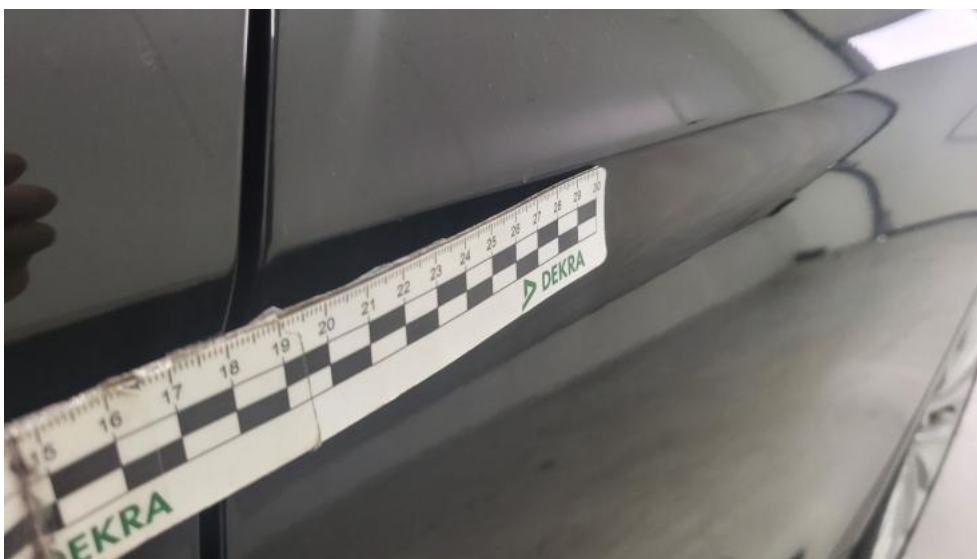
Photo 63.
Drzwi tylne L - Rysa/odprysk 1

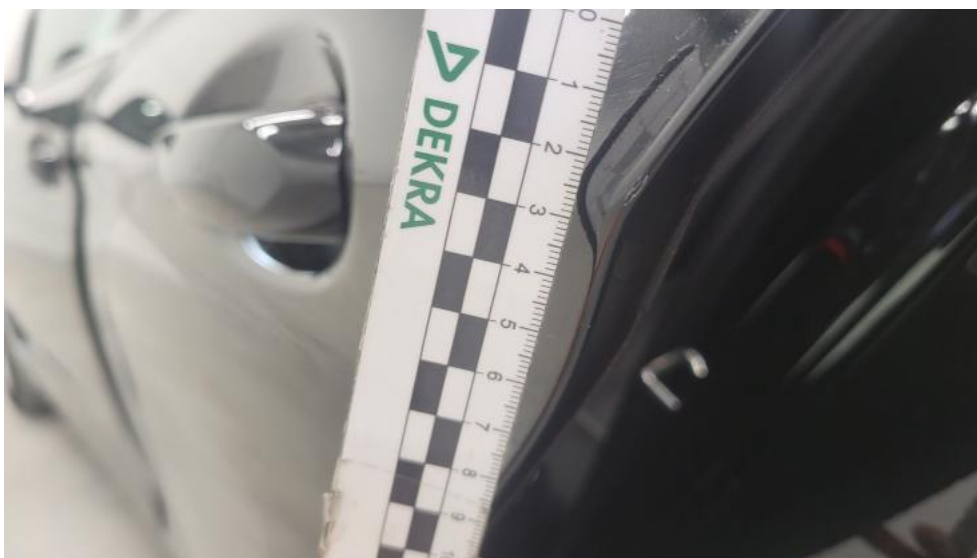
Photo 64.
Drzwi tylne L - Rysa/odprysk 2

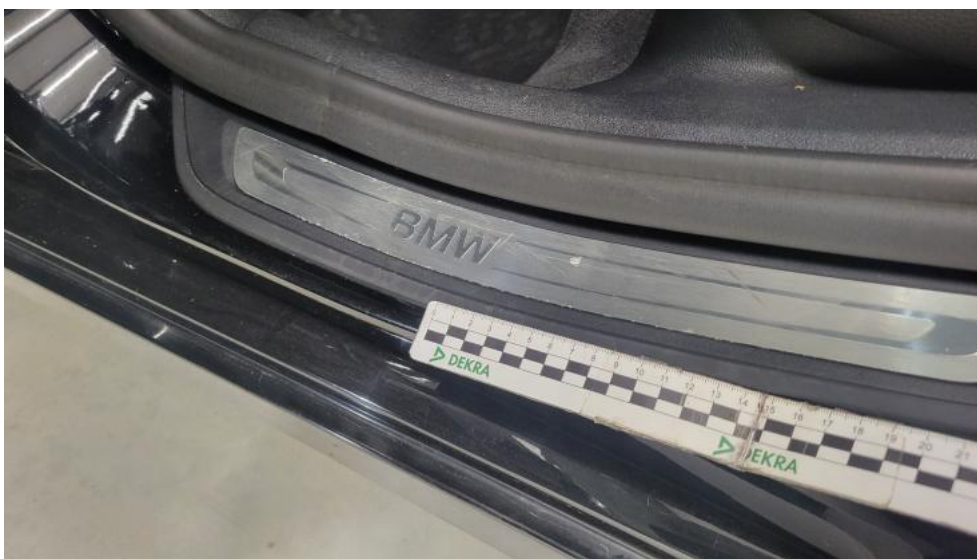
Photo 65.
Próg L - Rysa/odprysk 1

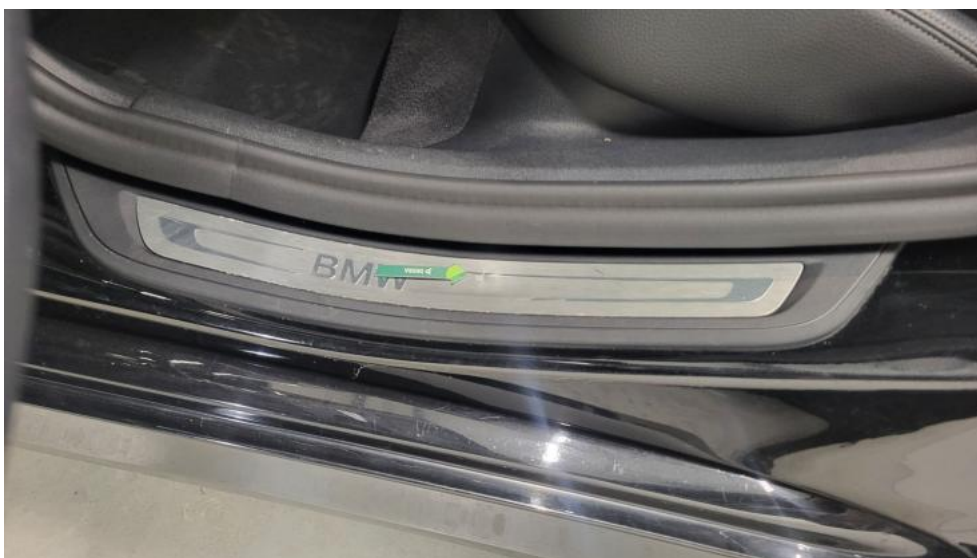
Photo 66.
Próg L - Wgniecenie/odkształcenie 1

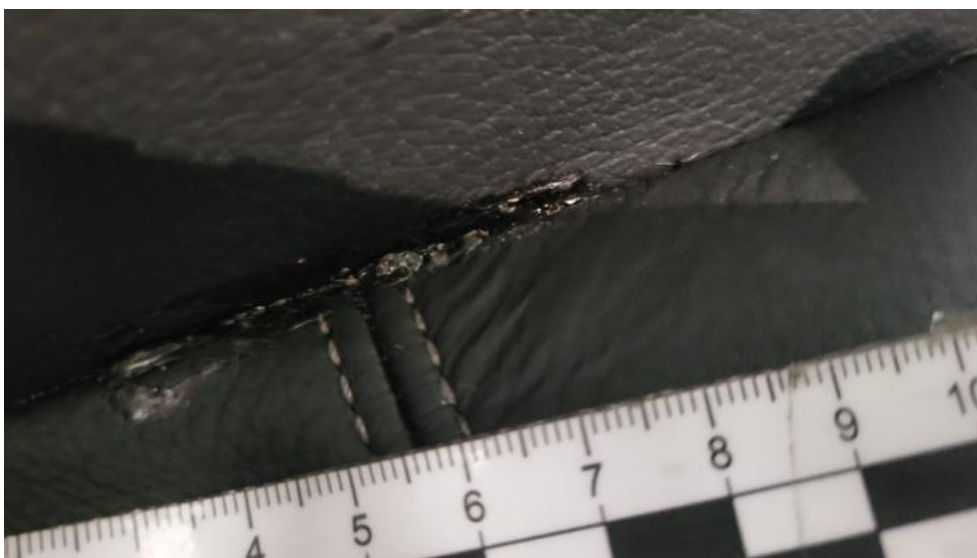
Photo 68.

Rysy na samochodzie. Odpryski na szybie czołowej. Brak zaślepek w tylnej kanapie. Dostarczono ksero pozwolenia czasowego.

Kanapa tyl. - Pęknięcie/rozerwanie 1

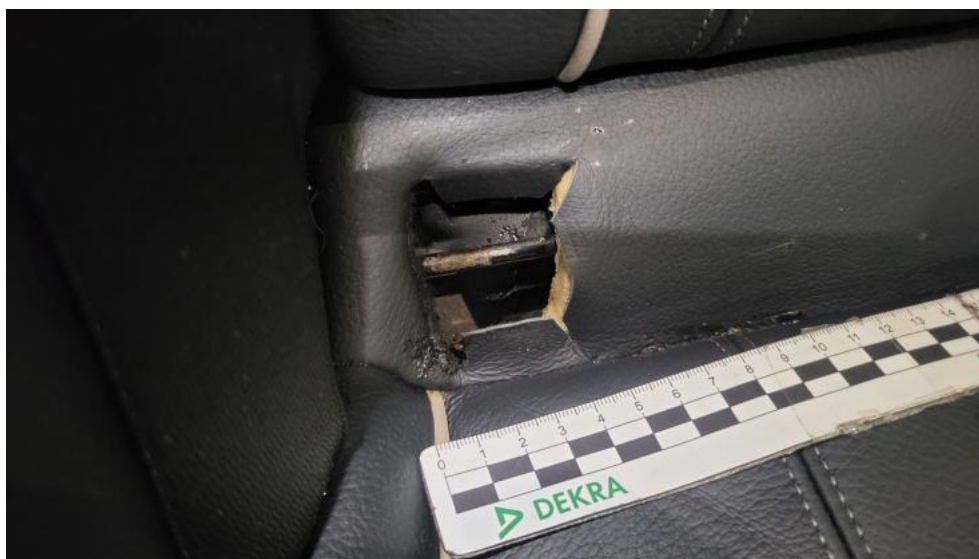
Photo 69.
Kanapa tyl. - Pęknięcie/rozerwanie 2

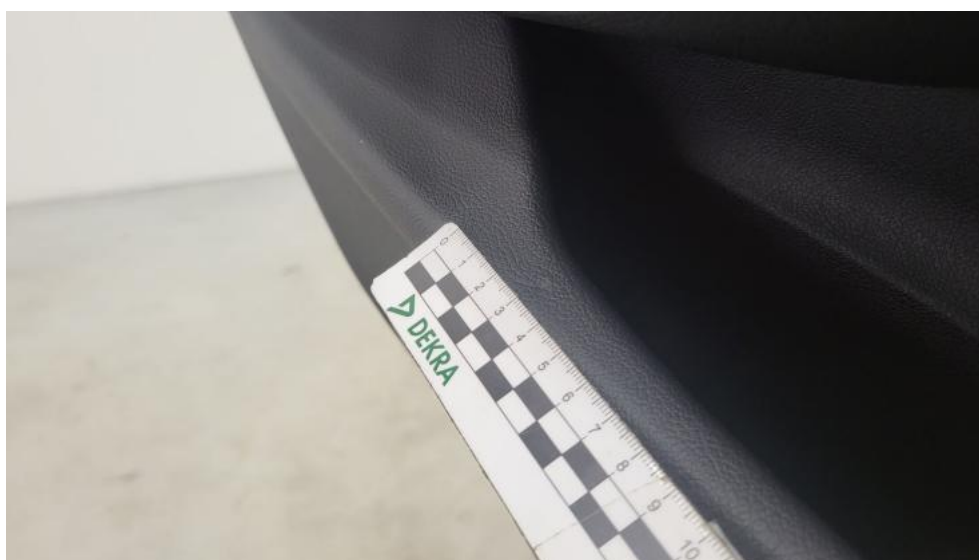
Photo 70.
Tapicerka drzwi tylnych L - Wgniecenie/odkształcenie 1

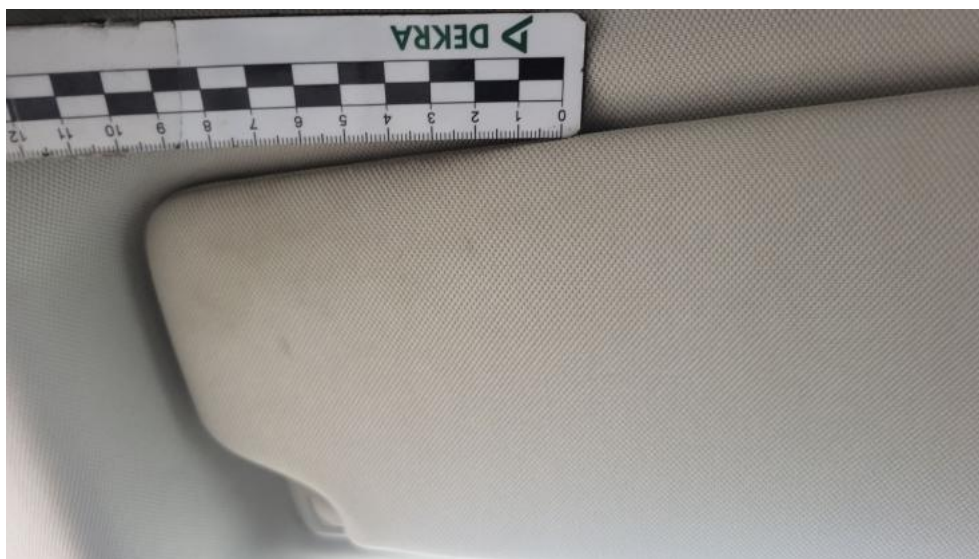
Photo 71.

Osłona p/słoneczna lewa - Inne 1

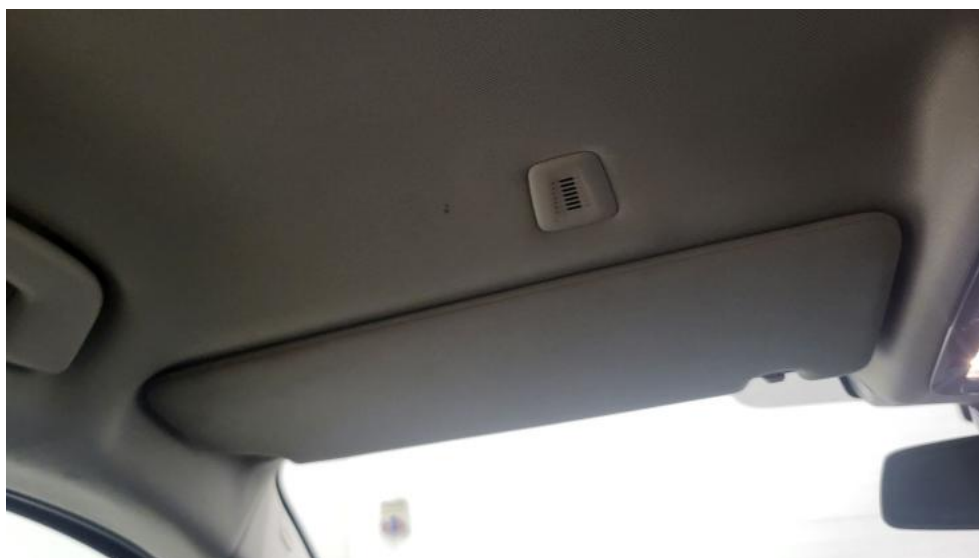
Photo 72.

Podsufitka - Inne 1

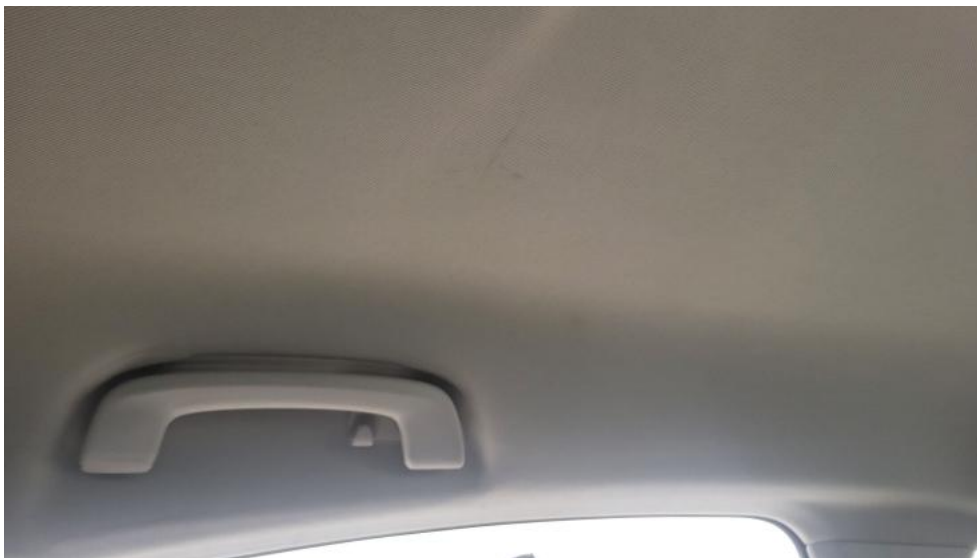
Photo 73.
Podsufitka - Inne 2

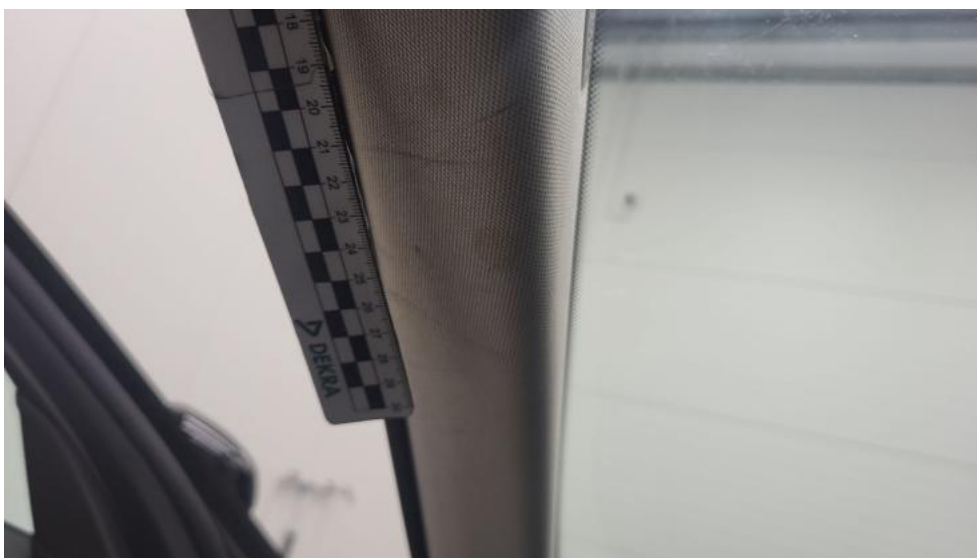
Photo 74.
Wykładzina(y) słupka przedniego L - Inne 1
