DEKRA's commission No. : PKOL(W)/LODZ/21753/25/03/25  
commission/ damage No. : Futura  
Date of commission: 25-03-2025

**DEKRA Poland - Headquarters**  
02-673 Warszawa, ul. Konstruktorska 12A

| Manufacturer | BMW |
| Type / version | 318i M Sport aut |

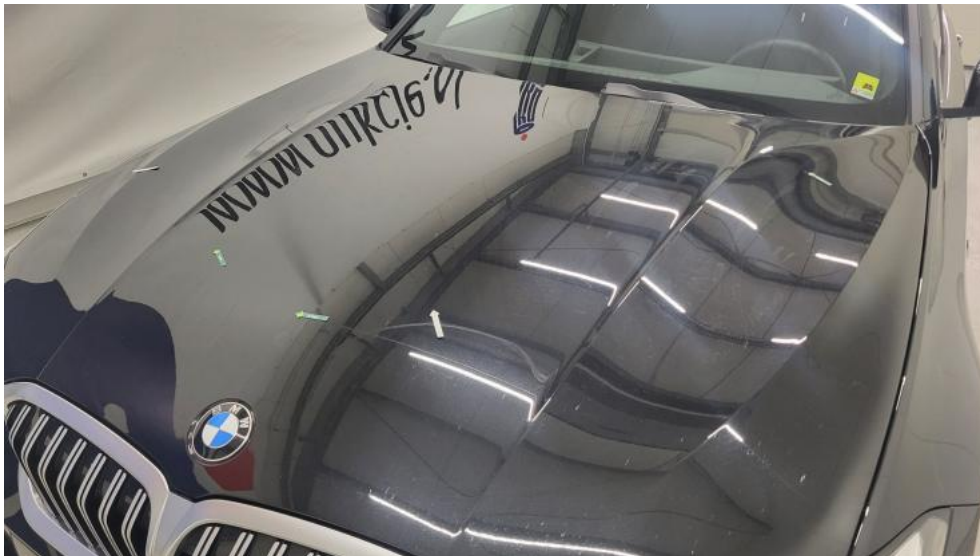
**Photo 41.**

Pokrywa komory silnika - Rysa/odprysk 1

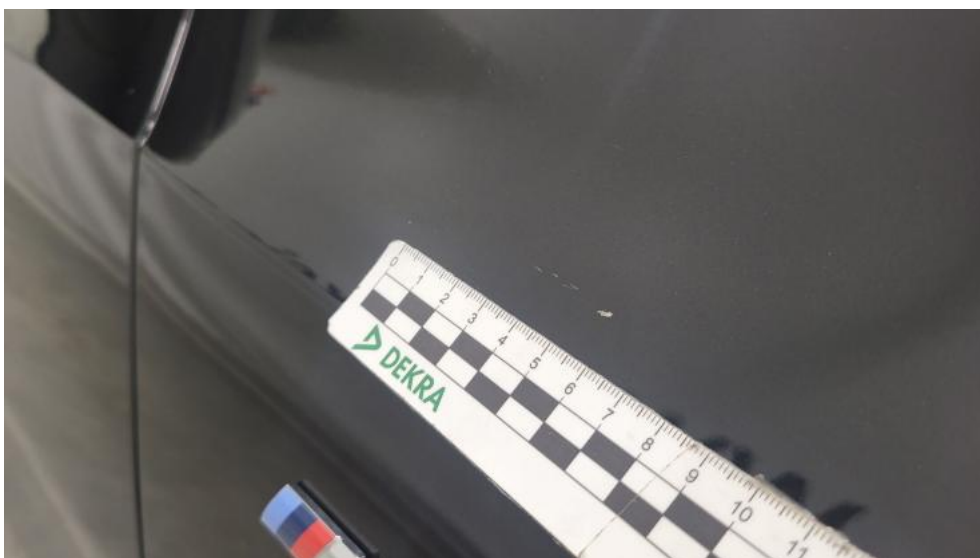
**Photo 42.**

Łotnik przedni P - Rysa/odprysk 1

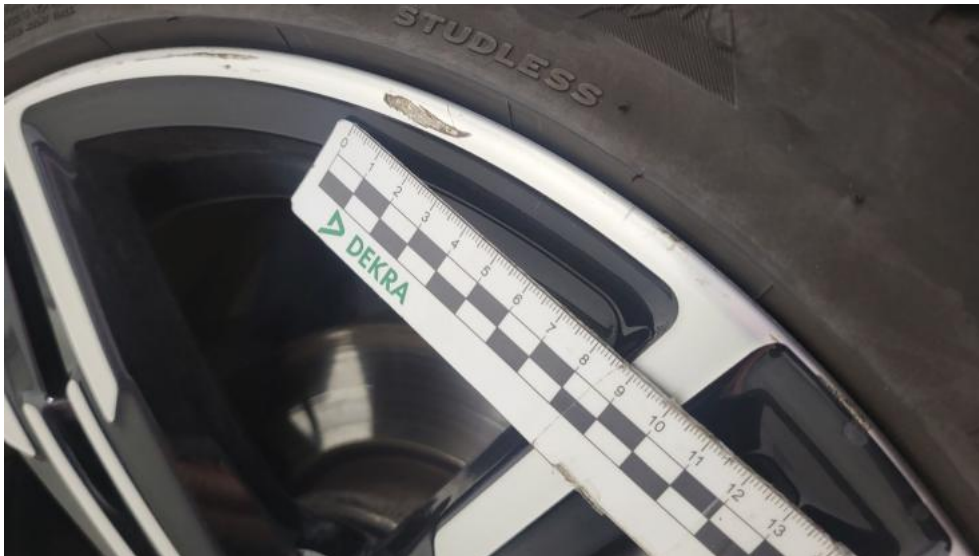
**Photo 43.**

Felga aluminiowa przednia P - Rysa/odprysk 1

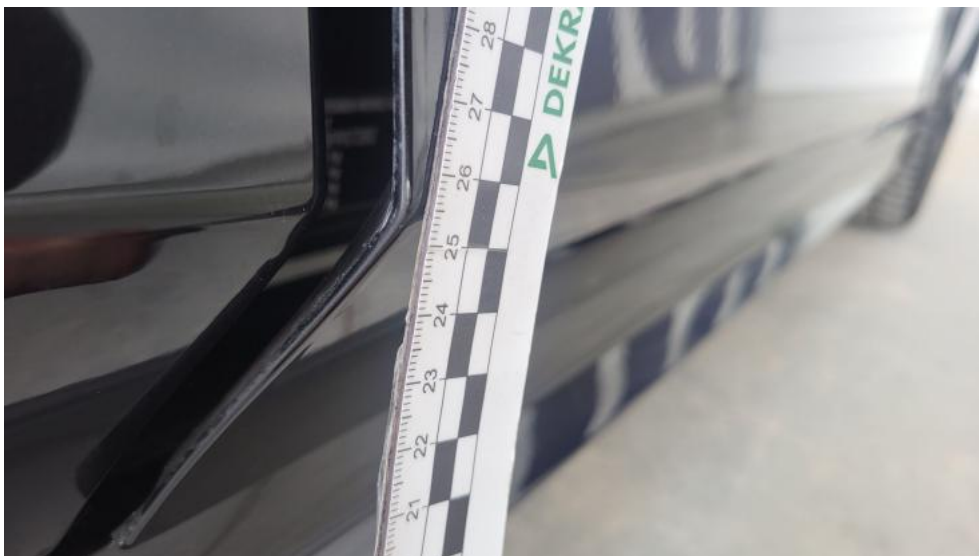
**Photo 44.**

Drzwi przednie P - Rysa/odprysk 1

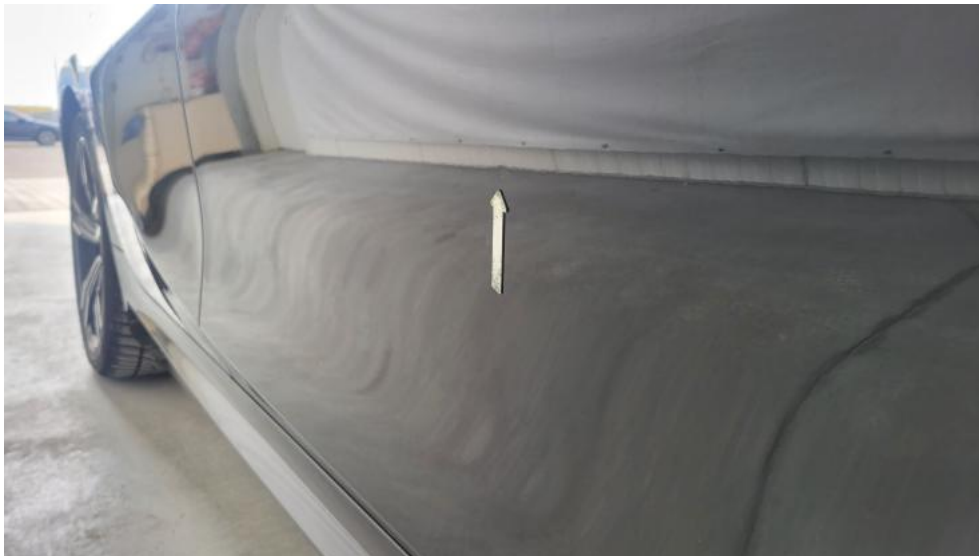
**Photo 45.**

Drzwi przednie P - Wgniecenie/odkształcenie 1

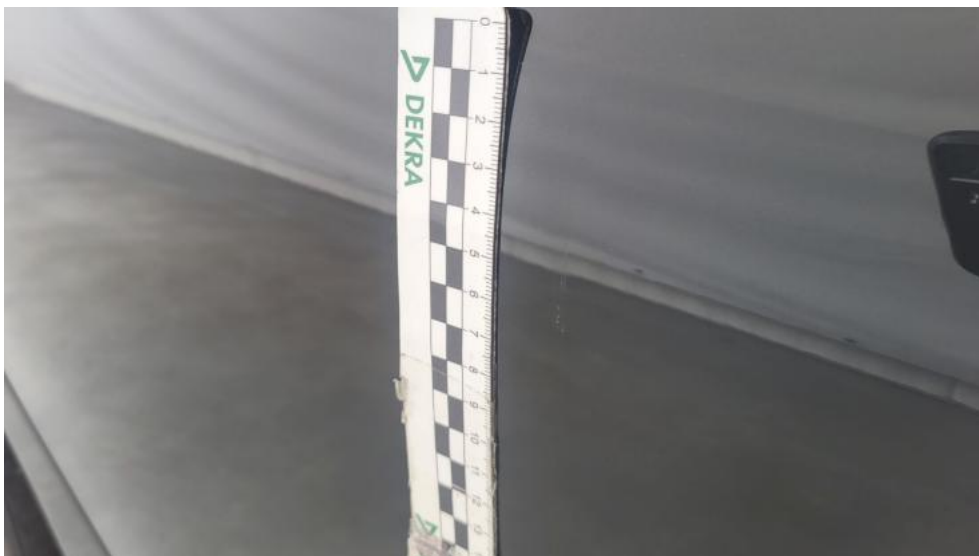
**Photo 46.**

Drzwi tylne P - Rysa/odprysk 1

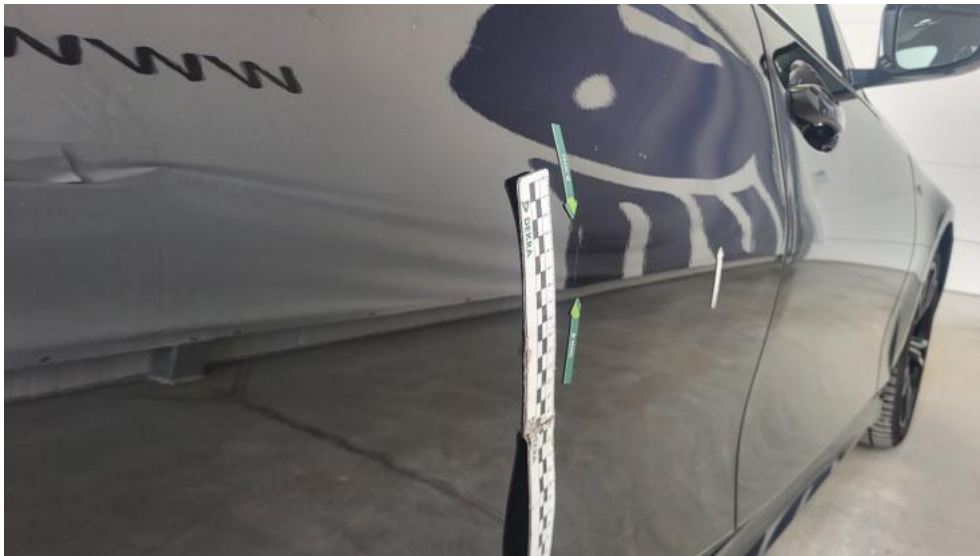
**Photo 47.**

Drzwi tylne P - Wgniecenie/odkształcenie 1

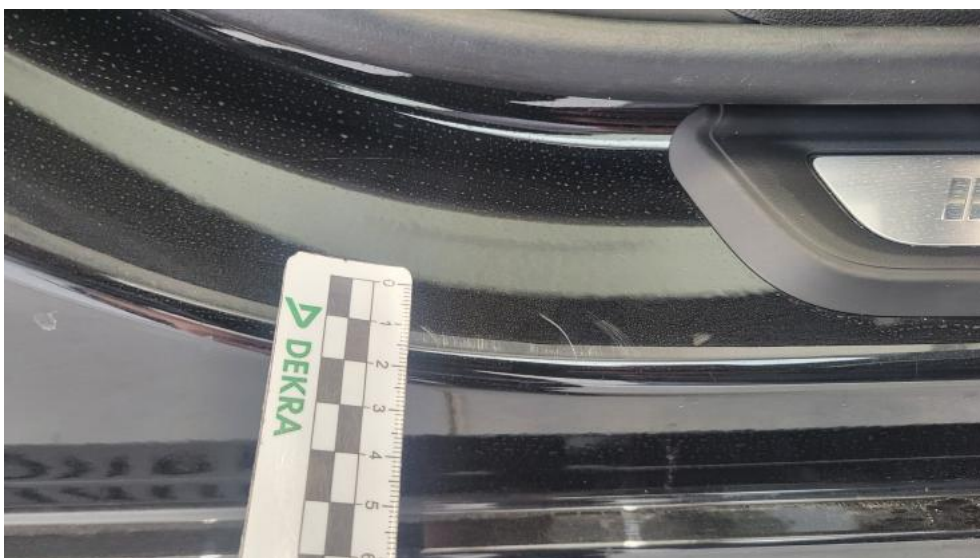
**Photo 48.**

Próg P - Rysa/odprysk 1

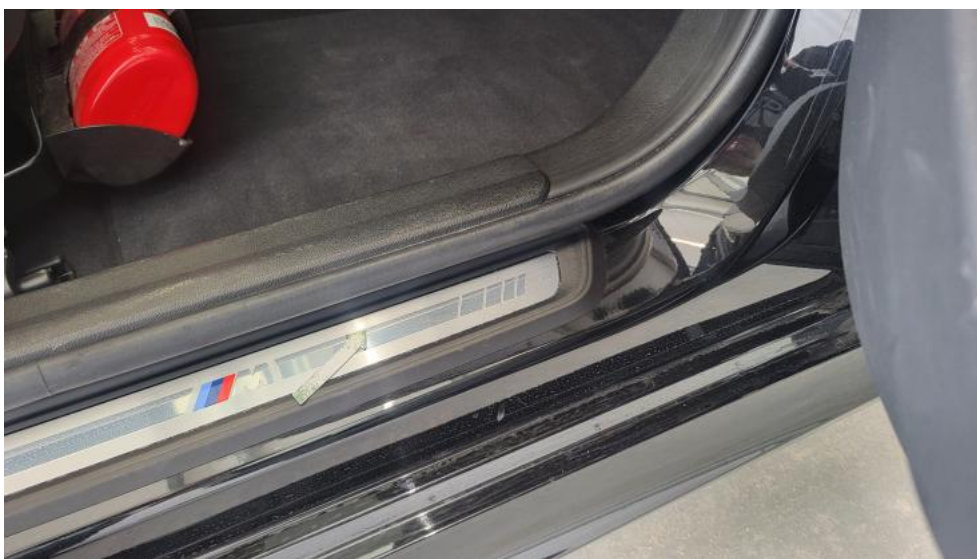
**Photo 49.**

Próg P - Wgniecenie/odkształcenie 1

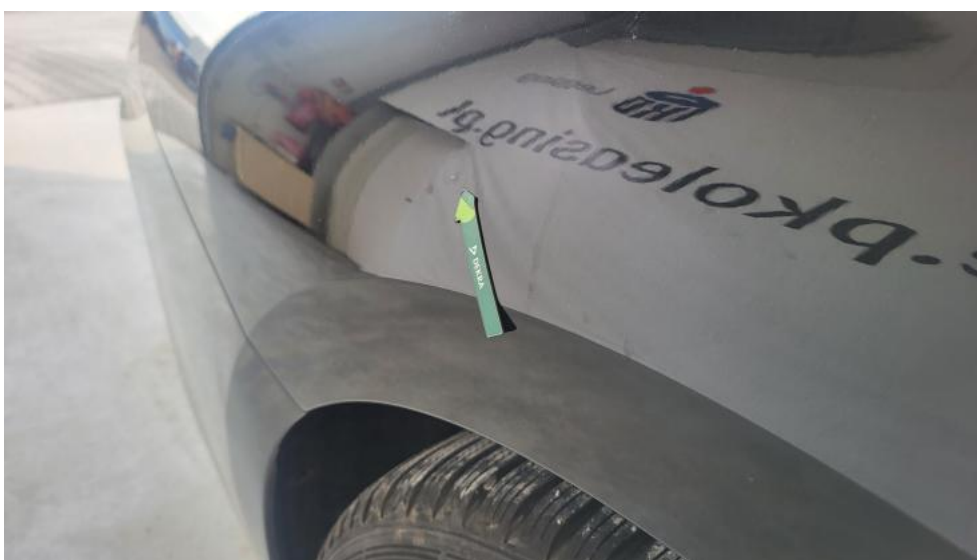
**Photo 50.**

Ścianka tylna P / Ścianka boczna P - Wgniecenie/odkształcenie 1

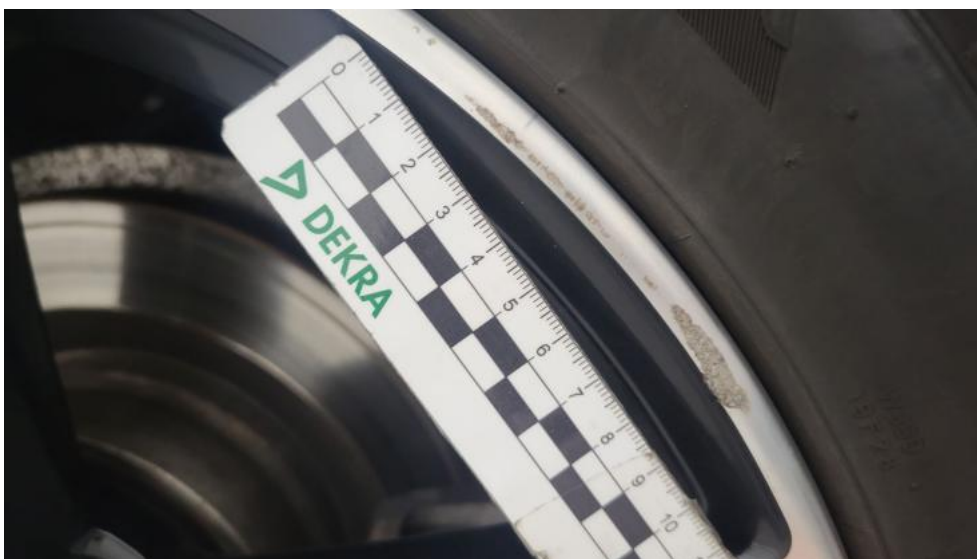
**Photo 51.**

Felga aluminiowa tylna P - Rysa/odprysk 1

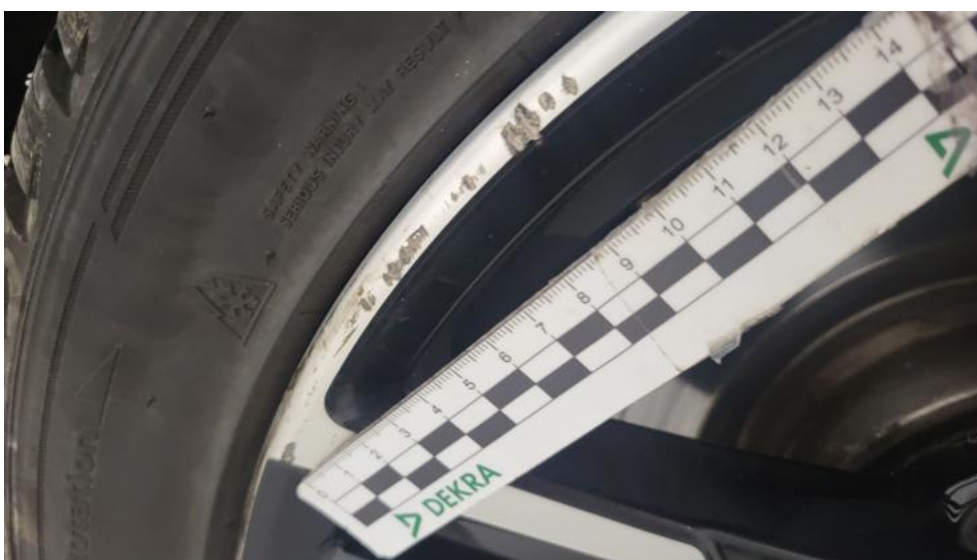
**Photo 52.**

Felga aluminiowa tylna P - Rysa/odprysk 2

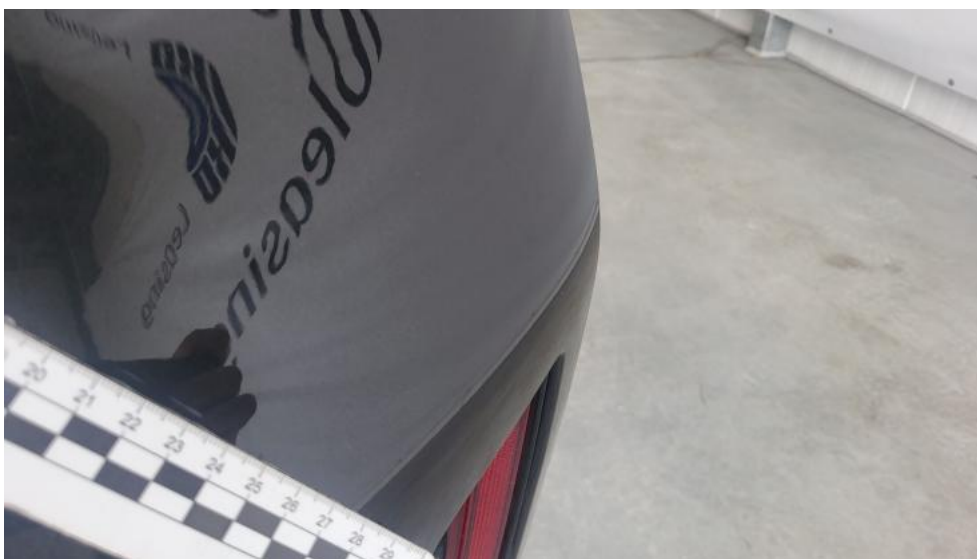
**Photo 53.**

Zderzak tylny - Rysa/odprysk 1

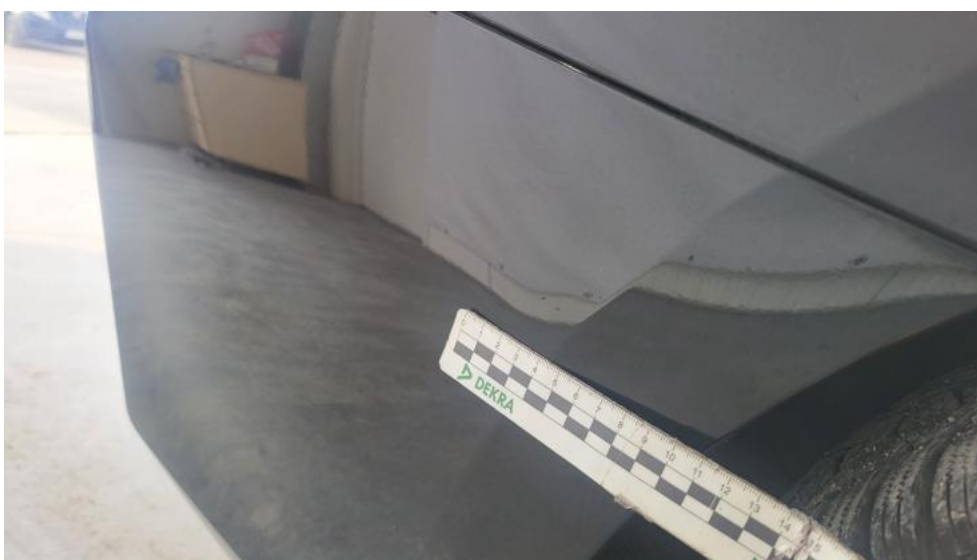
**Photo 54.**

Zderzak tylny - Wgniecenie/odkształcenie 1

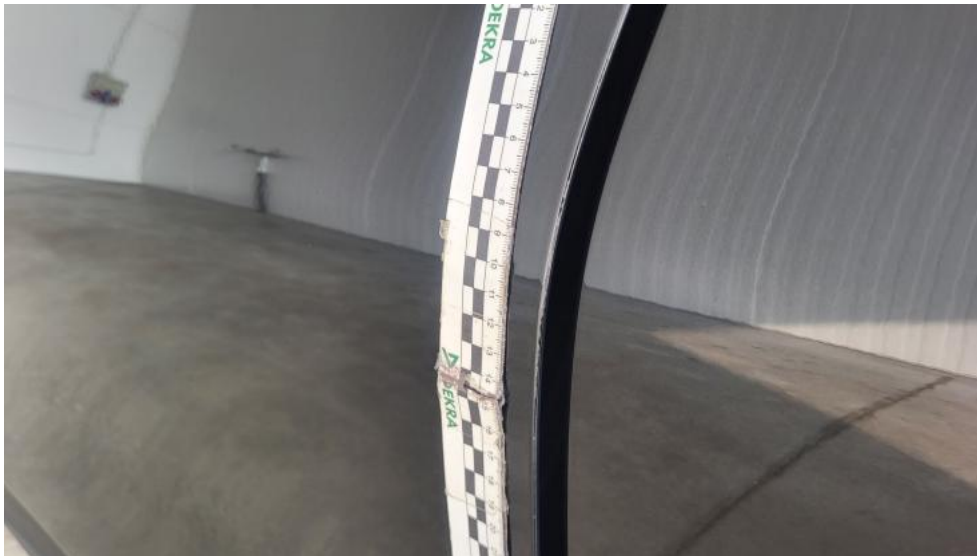
**Photo 55.**

Drzwi przed L - Rysa/odprysk 1

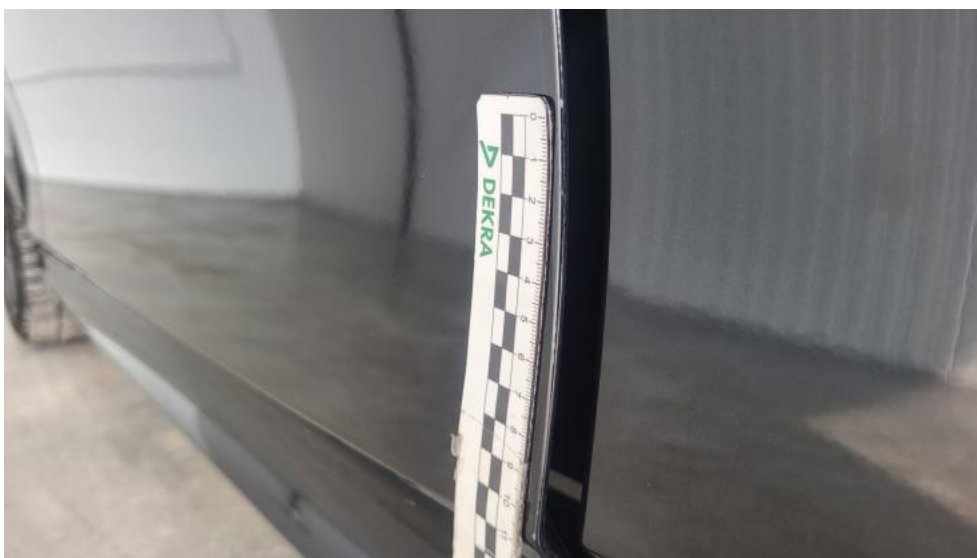
**Photo 56.**

Drzwi przed L - Rysa/odprysk 2

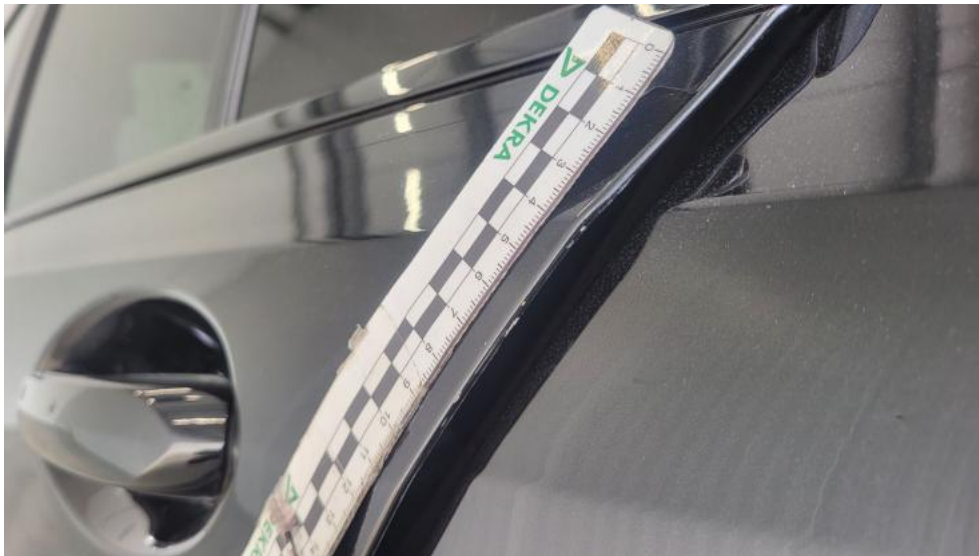
**Photo 57.**

Drzwi tylne L - Rysa/odprysk 1

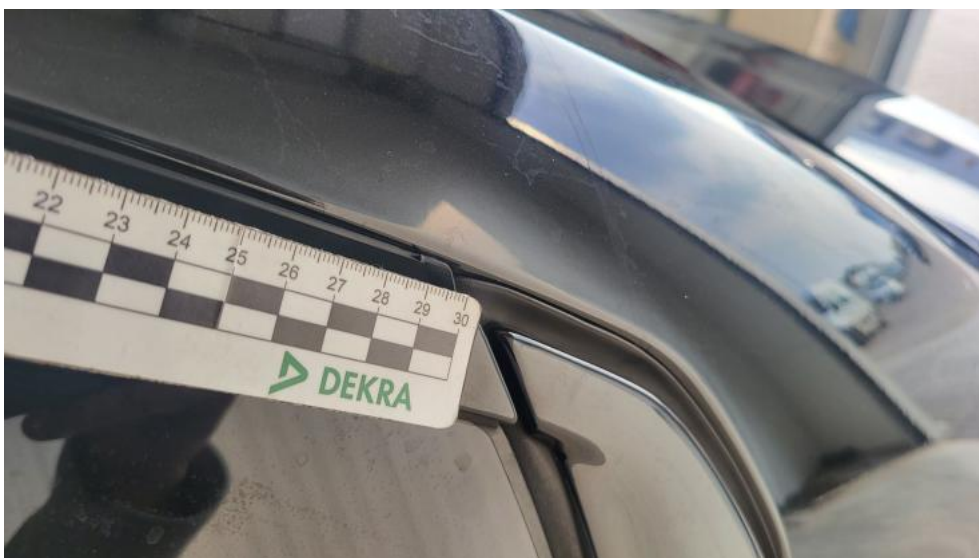
**Photo 58.**

Uszczelka szyby drzwi tyl L - Rysa/odprysk 1

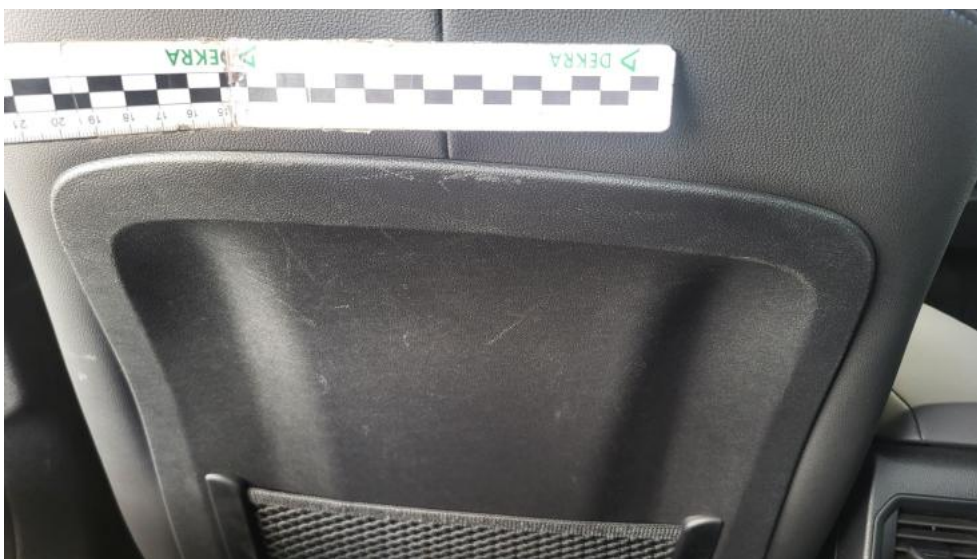
**Photo 59.**

Fotel prz. lew. - Rysa/odprysk 1

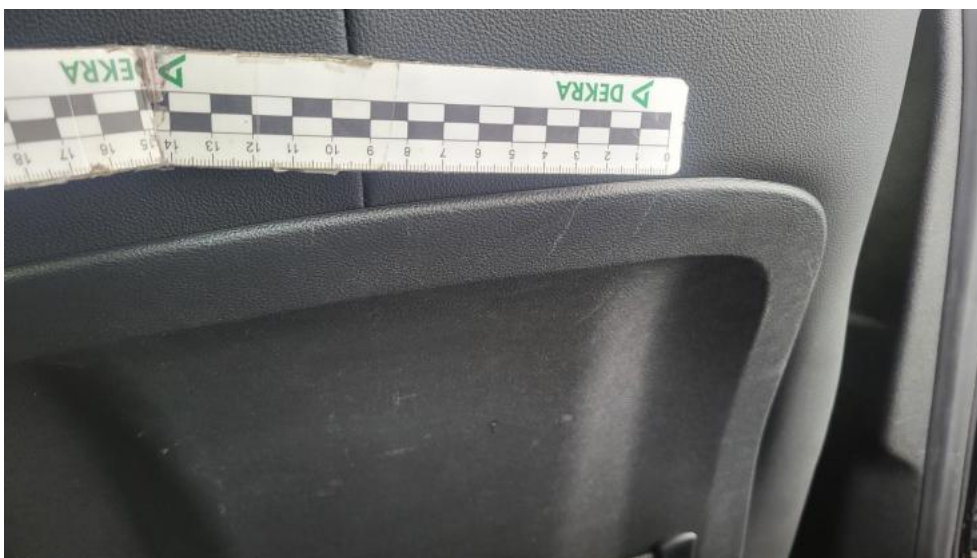
**Photo 60.**

Fotel prz. praw. - Rysa/odprysk 1

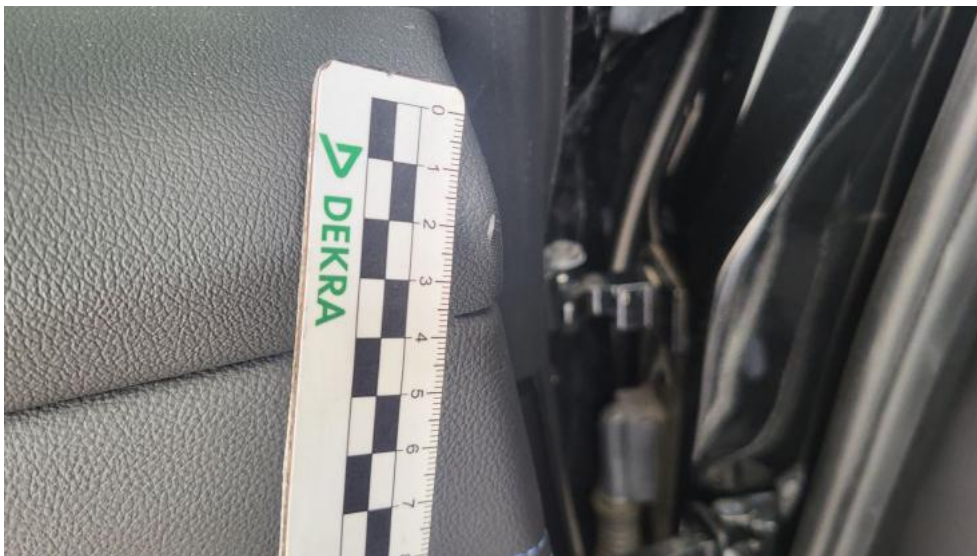
**Photo 61.**

Tapicerka drzwi tylnych L - Wgniecenie/odkształcenie 1
