DEKRA's commission No. : PKOL(W)/LODZ/19379/25/03/17
commission/ damage No. : Futura
Date of commission: 17-03-2025

Vehicle data

Group of objects (Eurotax)	cars
EC code (Eurotax)	0108839
Manufacturer	OPEL
Model	Corsa E Hatchback 14-19
Type / version	Corsa 1.4 Enjoy
Body type	hatchback
Number of doors / seats	5/5
Curb weight [kg]	1134
Gross vehicle weight [kg]	1620
Wheelbase 1/2	2510
Engine type	spark ignition
Pollution reduction system	three-way catalytic converter
Engine capacity [ccm]	1398
Engine Power [hp/kW]	75/55
Gearbox	manual 5- gear
Registration /record No.	WE250XC
VIN / serial number	W0V0XEP68K4449536
Date of first registration	26-08-2019
Date of next. tech. test	29-08-2025
Year of manufacture	2019 (year has been verified with the manufacturer's base)
Readout [km]	44 945 (read)
Body color / type of coating	silver/double-layered, metallized

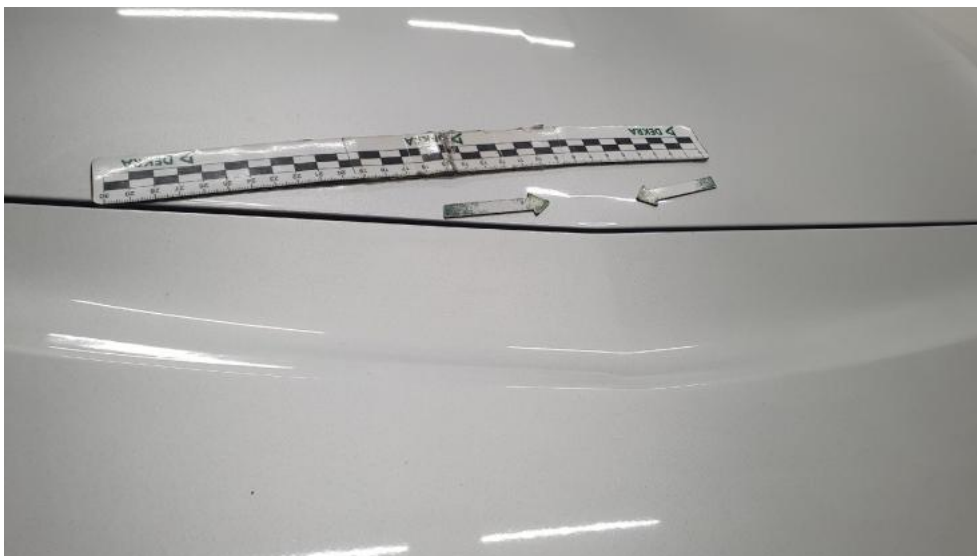
Photo 33.
Pokrywa komory silnika - Wgniecenie/odkształcenie 1

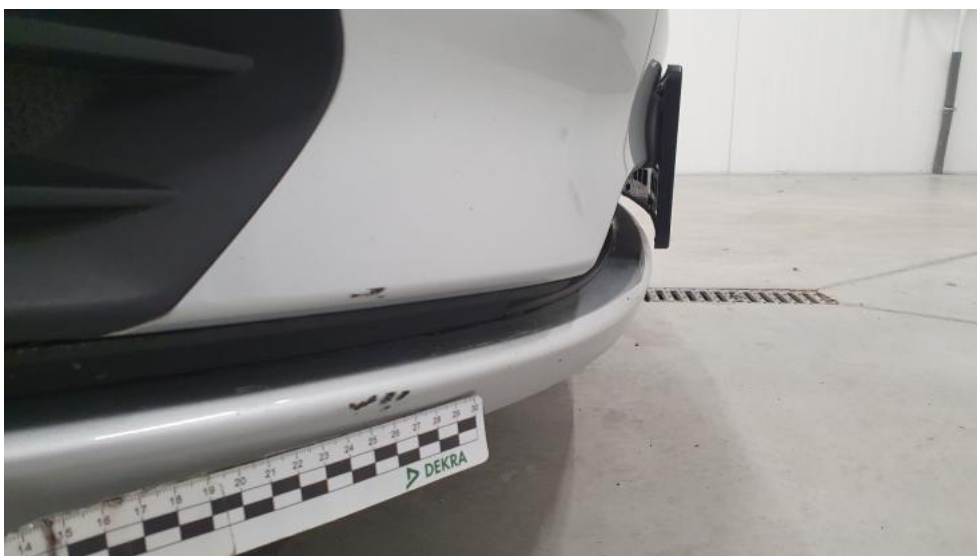
Photo 34.
Zderzak - Rysa/odprysk 1

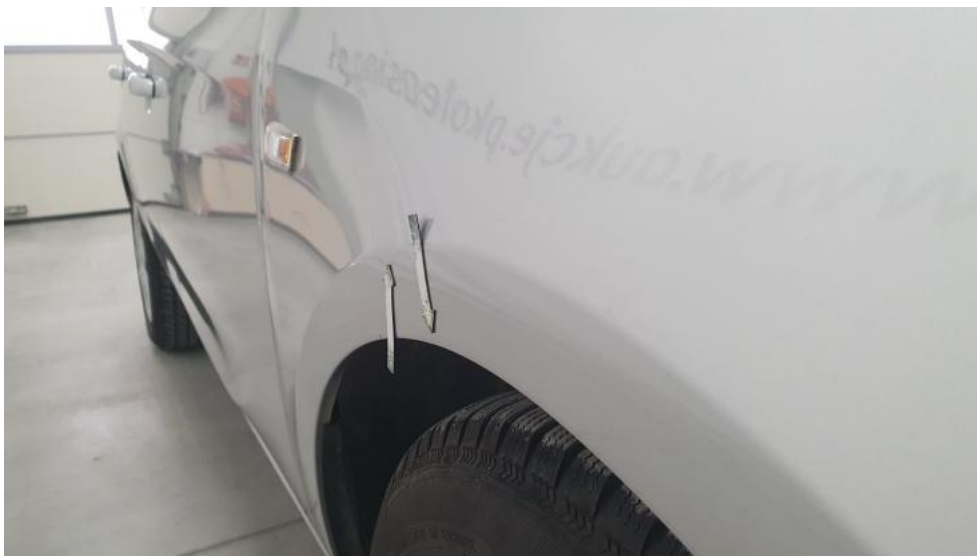
Photo 35.
Błotnik przedni P - Wgniecenie/odkształcenie 1

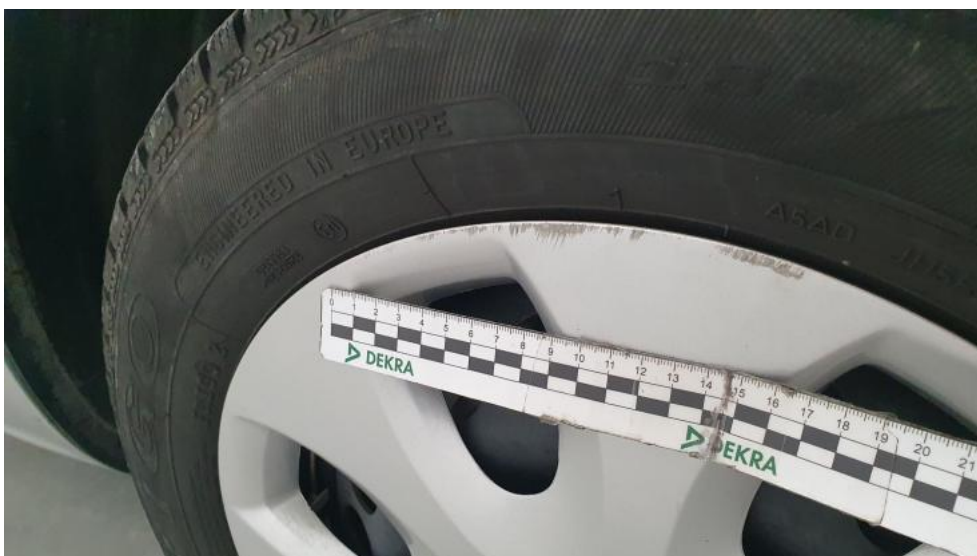
Photo 36.
Kołpak przedni P - Rysa/odprysk 1

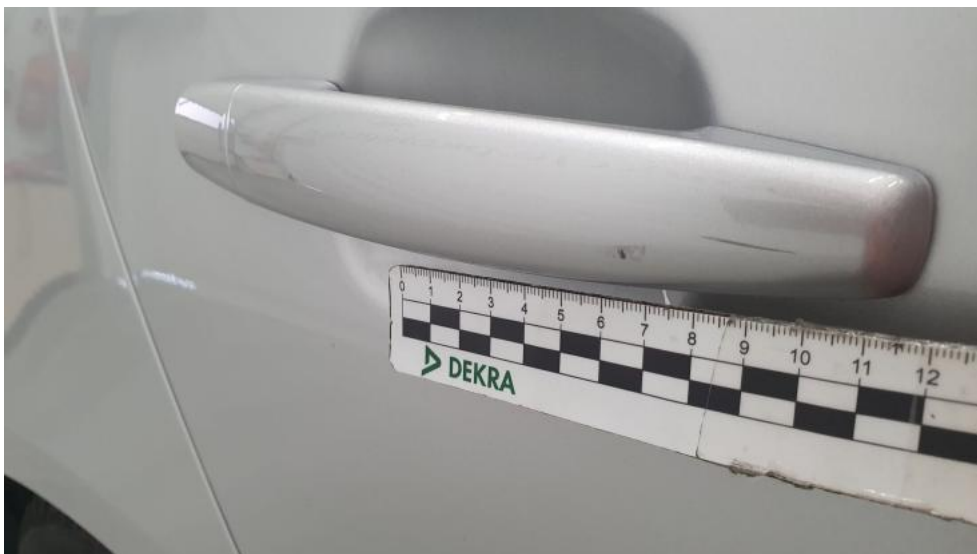
Photo 37.
Klamka drzwi tyl P - Rysa/odprysk 1

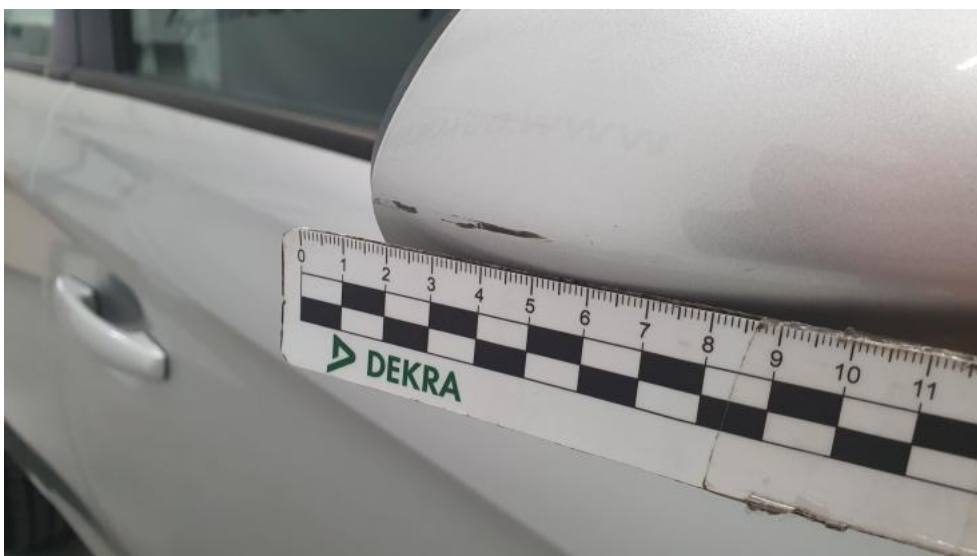
Photo 38.
Lusterko zew P - Rysa/odprysk 1

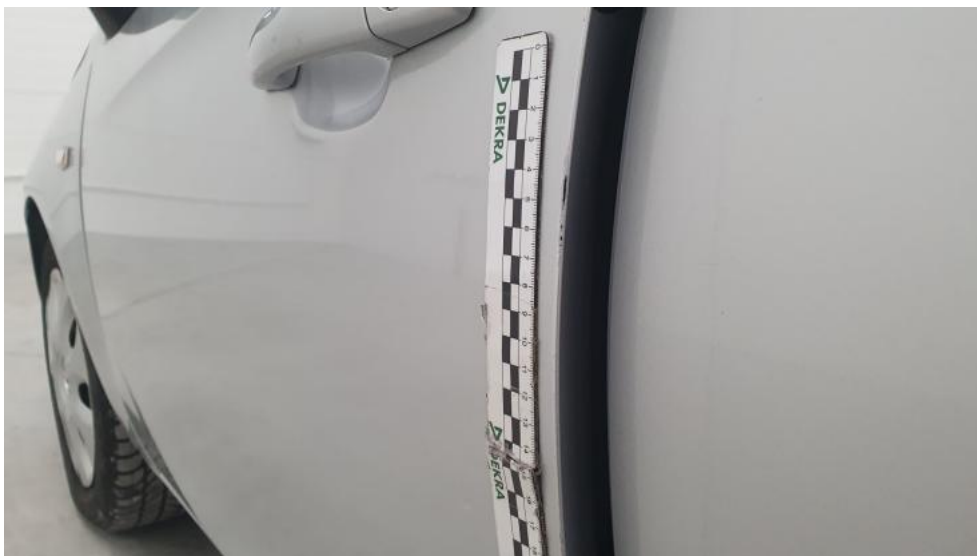
Photo 39.

Drzwi przed L - Rysa/odprysk 1

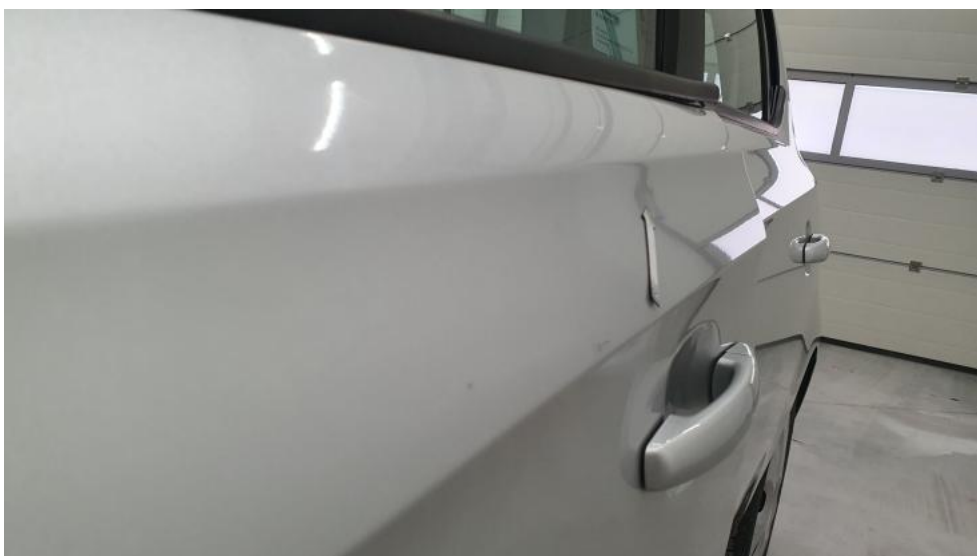
Photo 40.

Drzwi przed L - Wgniecenie/odkształcenie 1

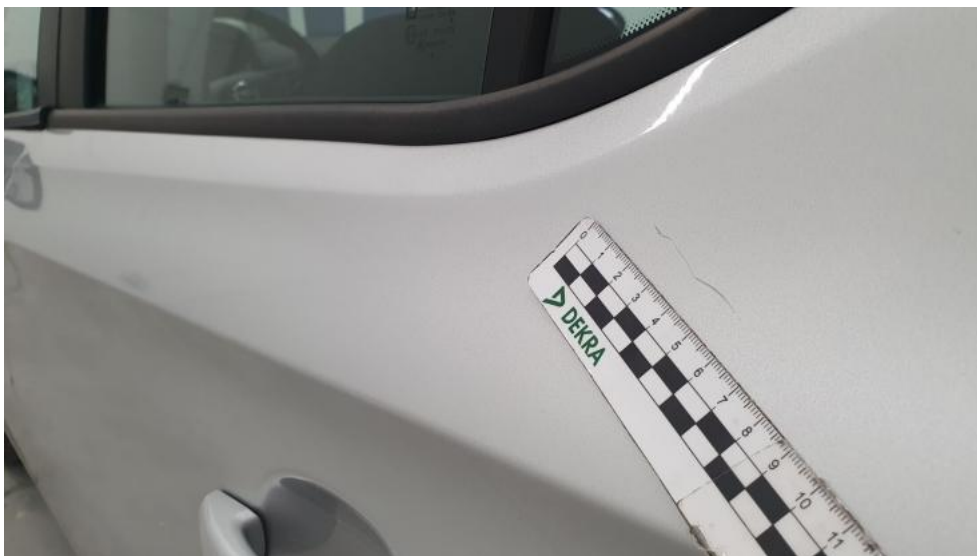
Photo 41.
Drzwi tylne L - Rysa/odprysk 1

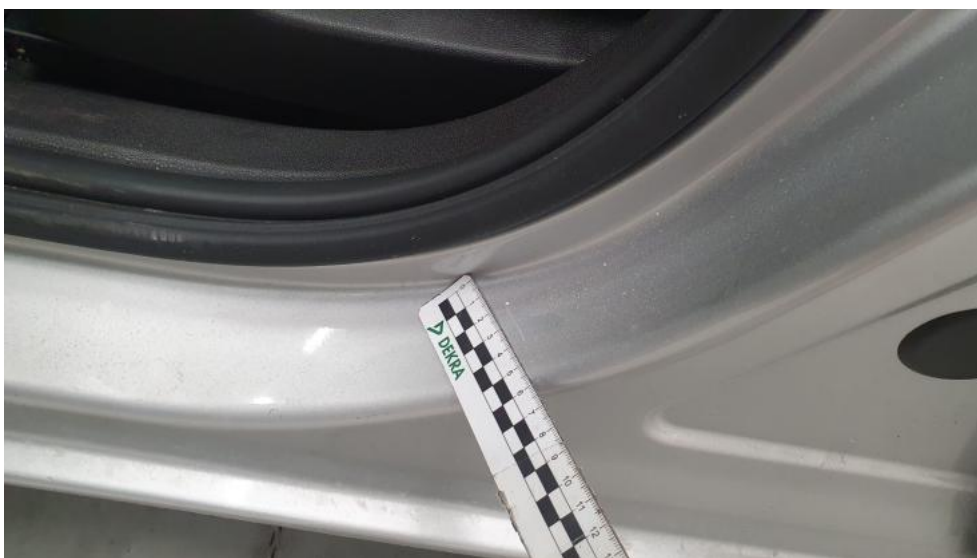
Photo 42.
Próg L - Rysa/odprysk 1

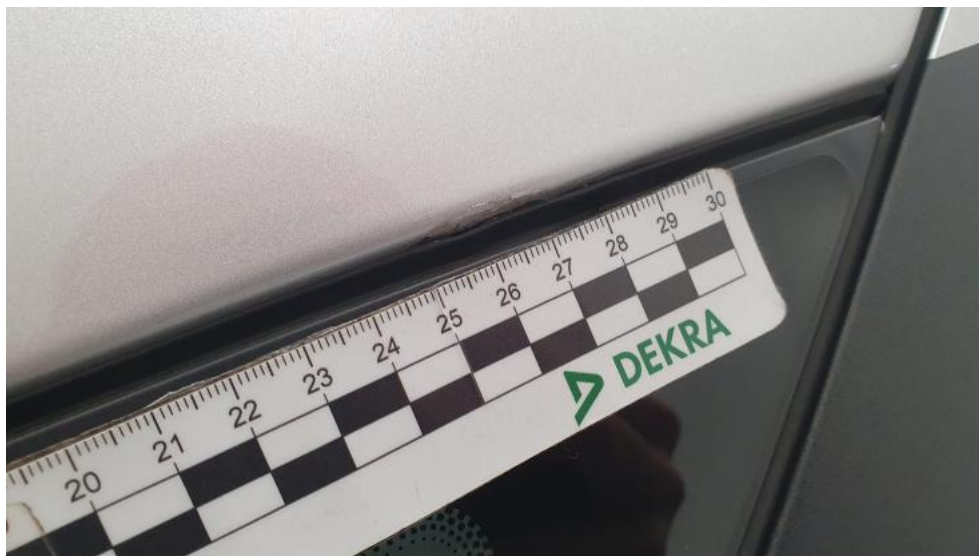
Photo 43.
Stupek przedni L - Inne 1

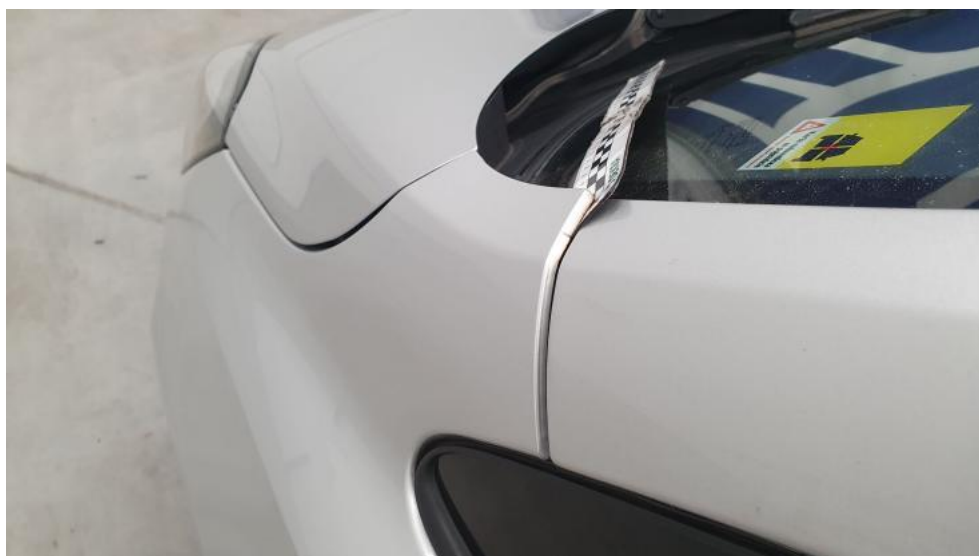
Photo 44.
Błotnik przedni L - Inne 1

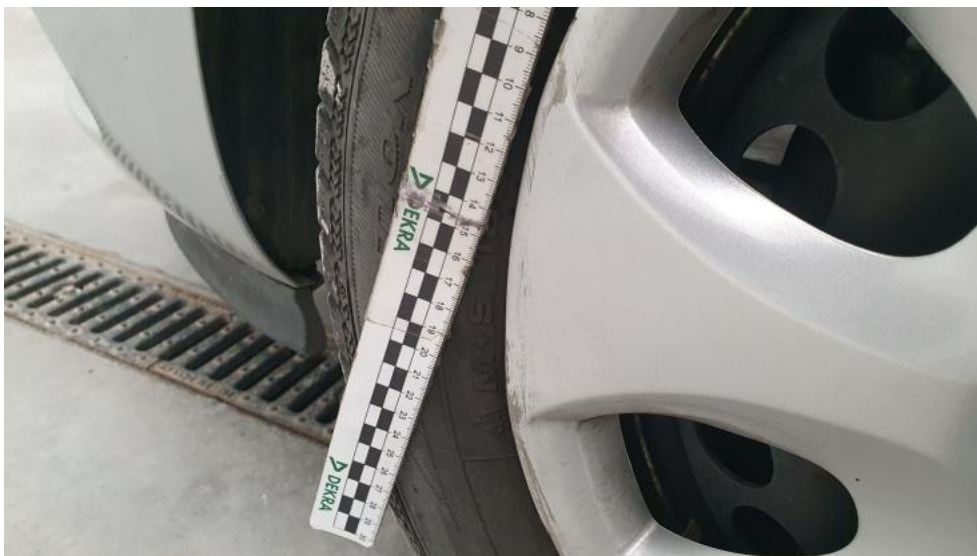
Photo 45.
Kołpak przedni L - Rysa/odprysk 1

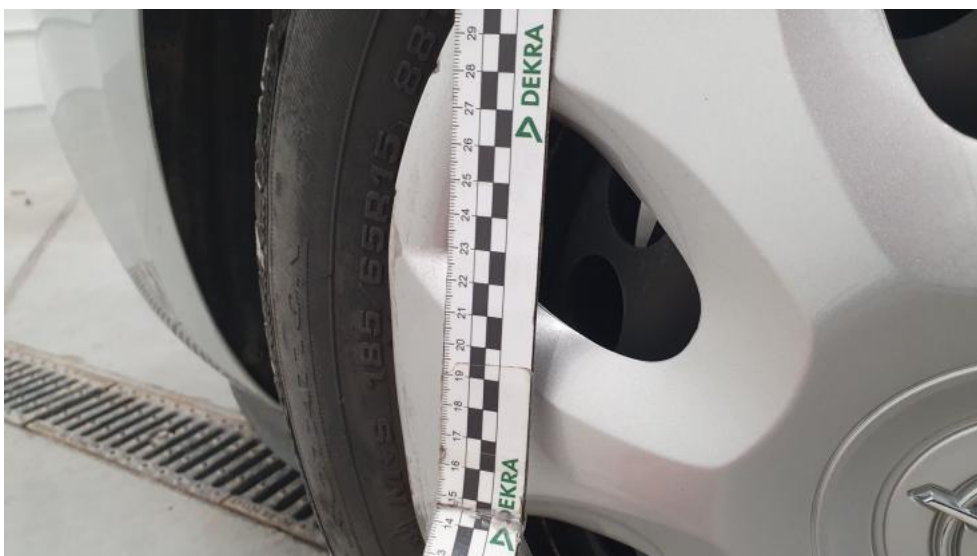
Photo 46.
Kołpak przedni L - Wgniecenie/odkształcenie 1
