DEKRA's commission No. : PKOL(W)/LODZ/60584/26/07/02  
commission/ damage No. : 24/003790  
Date of commission: 02-07-2026

| Manufacturer | MERCEDES-BENZ |
| Type / version | AMG CLA 45 S 4-Matic 8G-DCT |
| Registration /record No. | ZS643SV |

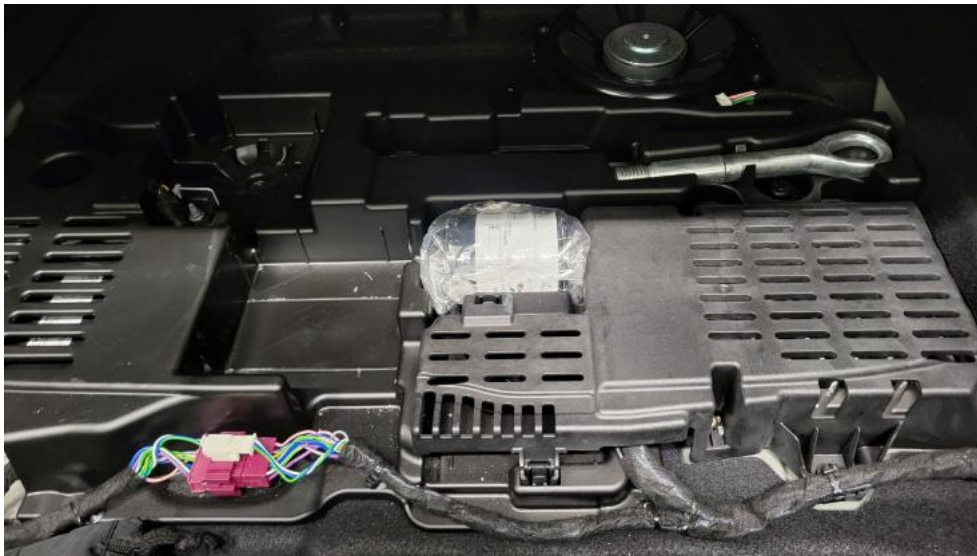
**Photo 37.**

Rysy na samochodzie. Brak kompresora zestawu naprawczego. Przegląd B wymagany od 254dni. Brak zaślepek w tylnej kanapie. Nieprawidłowe działanie przycisków konsoli tunelu środkowego. Odpryski na szybie czołowej.

Zestaw naprawczy koła

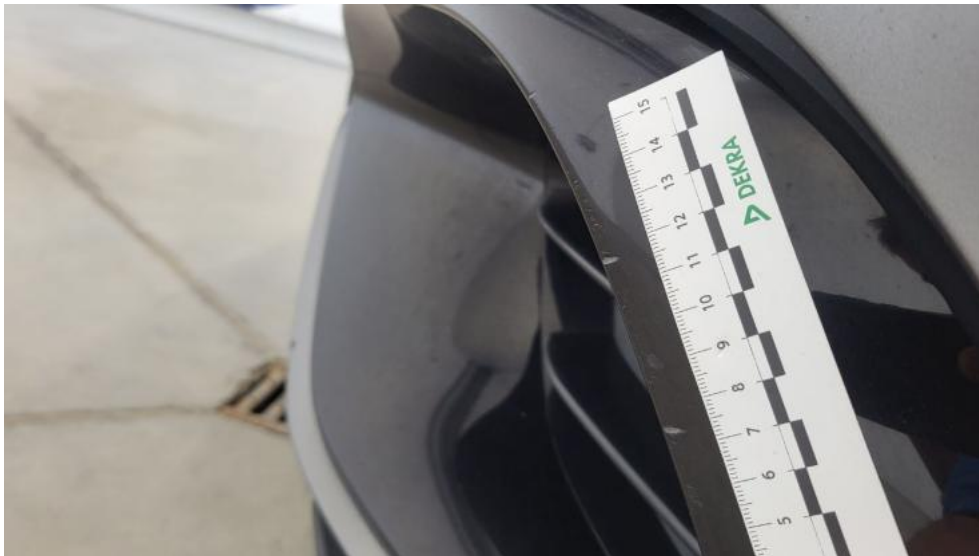
**Photo 45.**

Kratka/zaślepka halogenu L - Rysa/odprysk 1

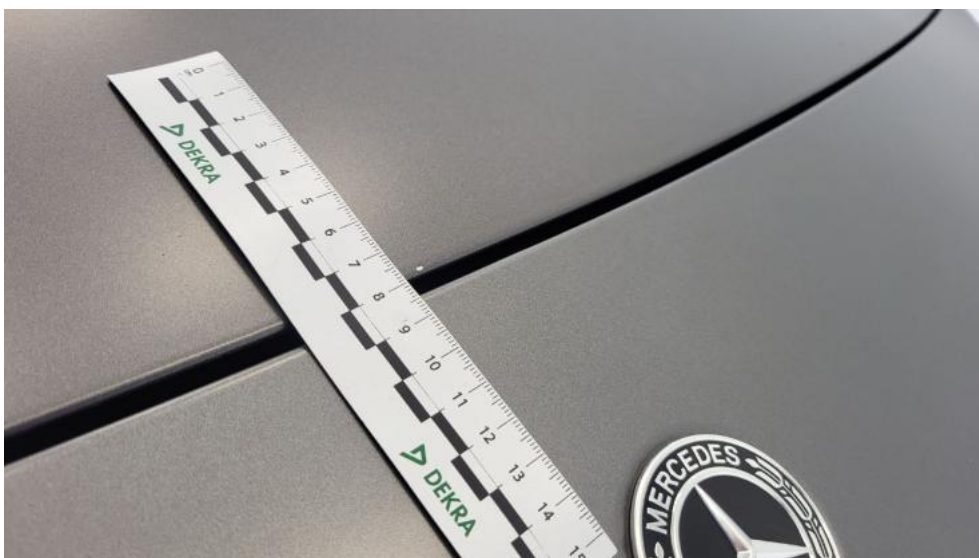
**Photo 46.**

Pokrywa komory silnika - Rysa/odprysk 1

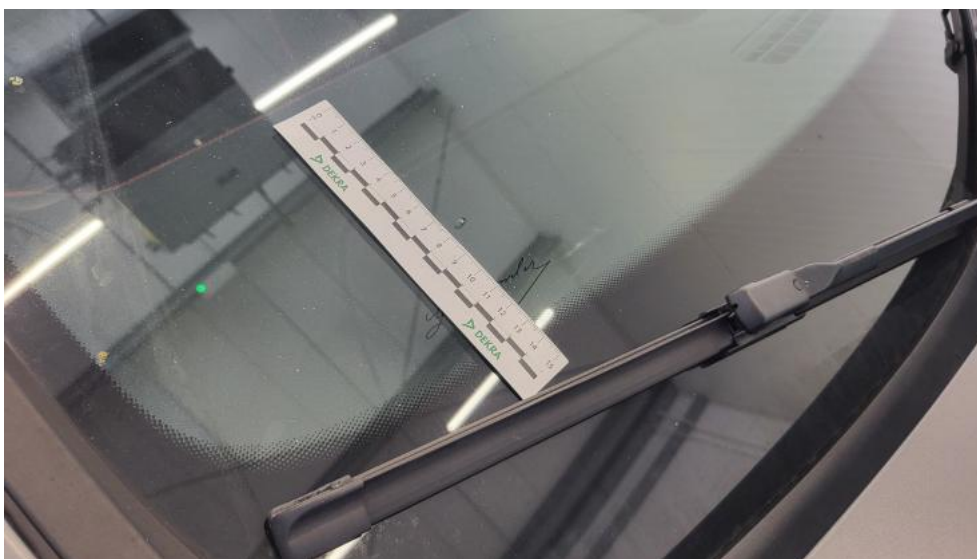
**Photo 47.**

Szyba czołowa - zdjęcie poglądowe 1

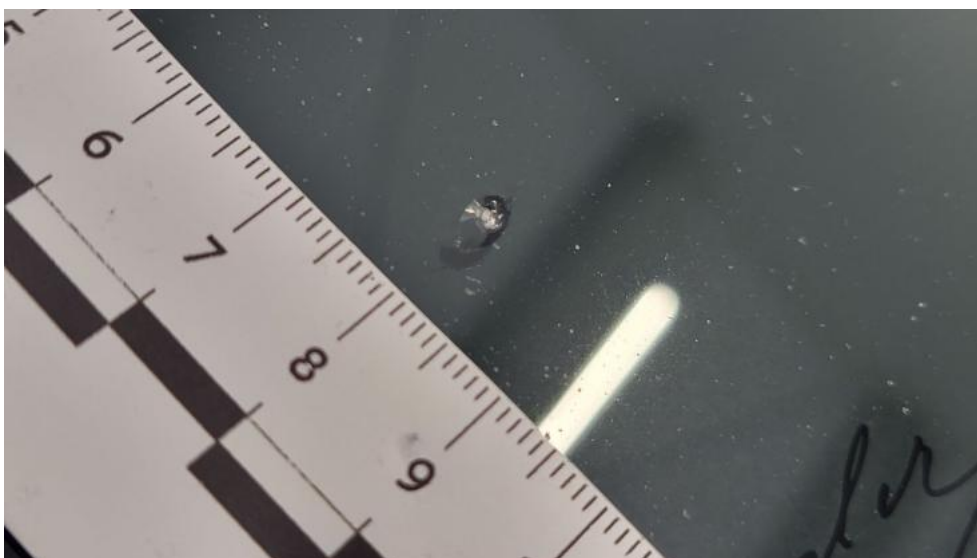
**Photo 48.**

Szyba czołowa - Pęknięcie/rozerwanie 1

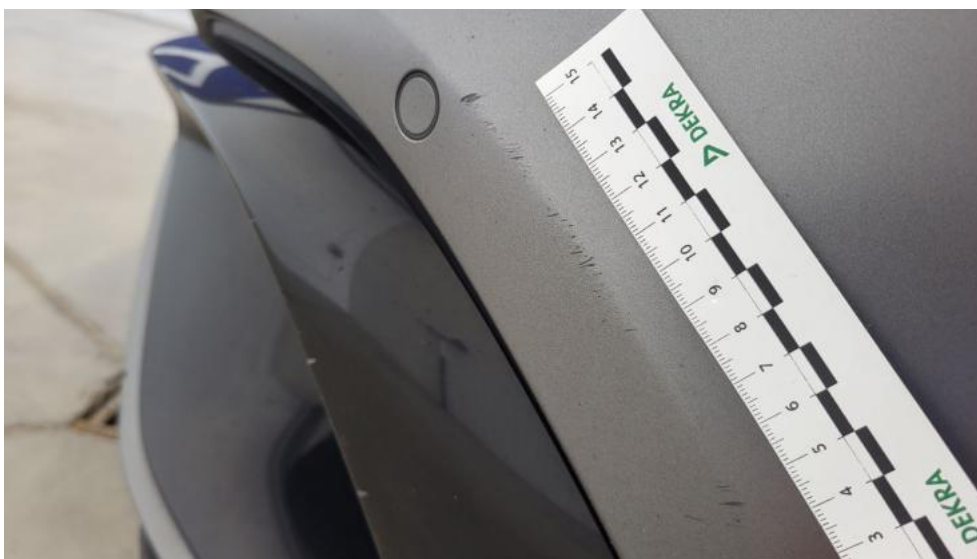
**Photo 49.**

Zderzak - Rysa/odprysk 1

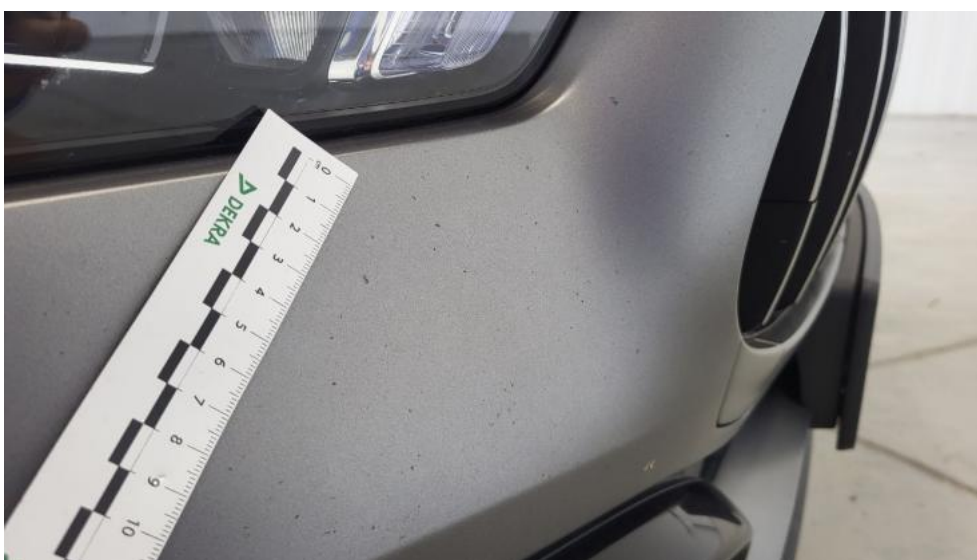
**Photo 50.**

Zderzak - Rysa/odprysk 2

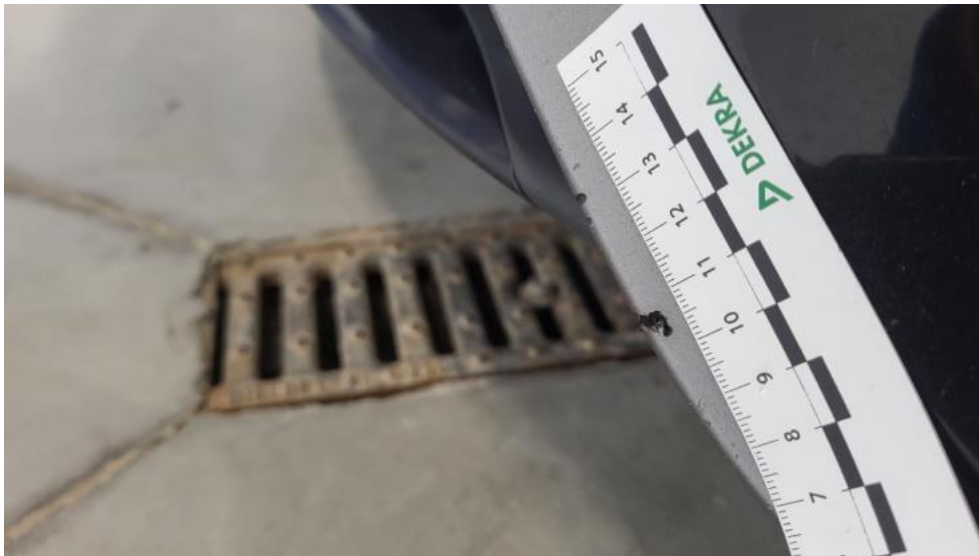
**Photo 51.**

Zderzak - Pęknięcie/rozerwanie 1

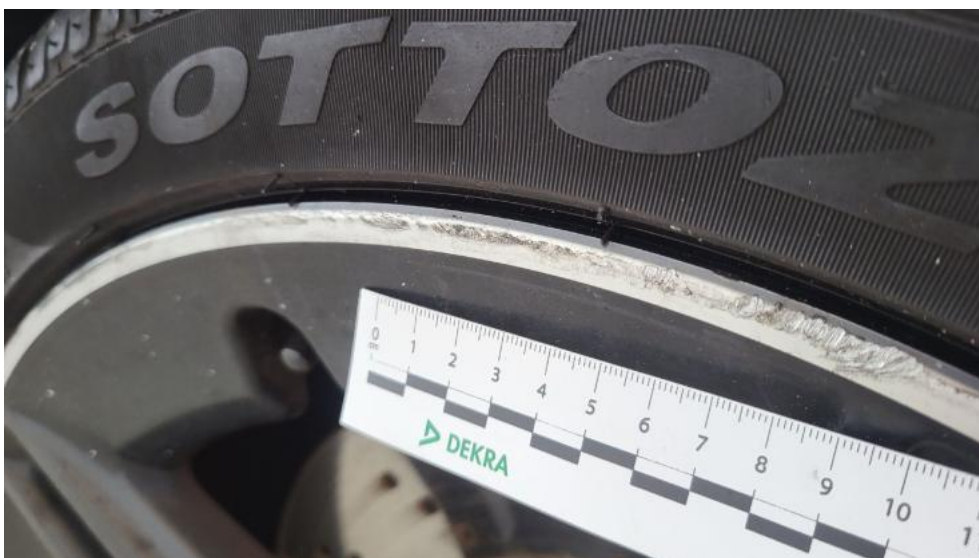
**Photo 52.**

Felga aluminiowa przednia P - Rysa/odprysk 1

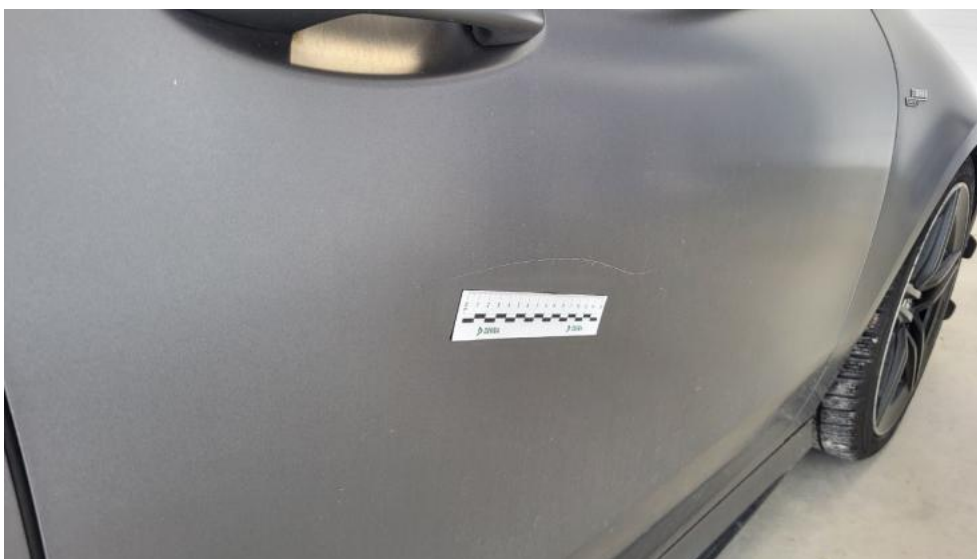
**Photo 53.**

Drzwi przednie P - Rysa/odprysk 1

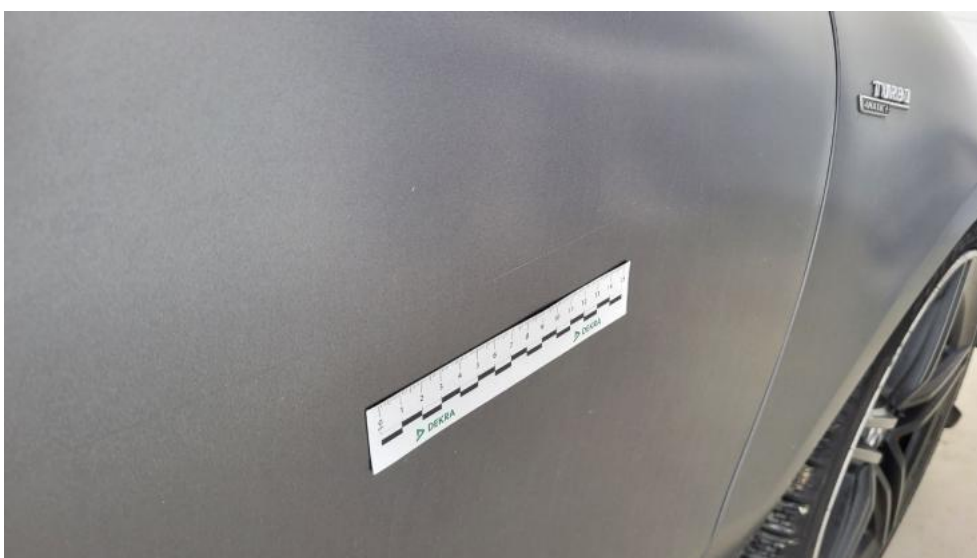
**Photo 54.**

Drzwi przednie P - Rysa/odprysk 2

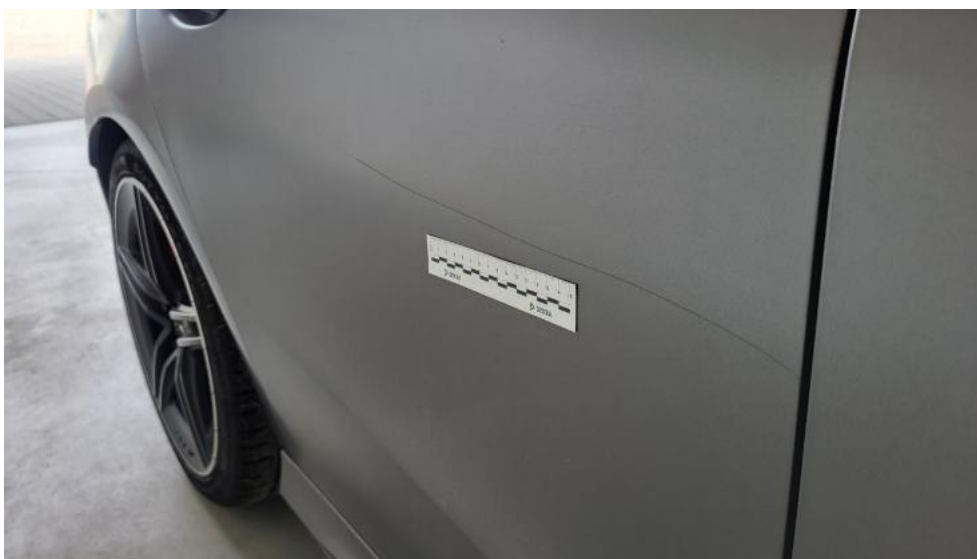
**Photo 55.**

Drzwi tylne P - Rysa/odprysk 1

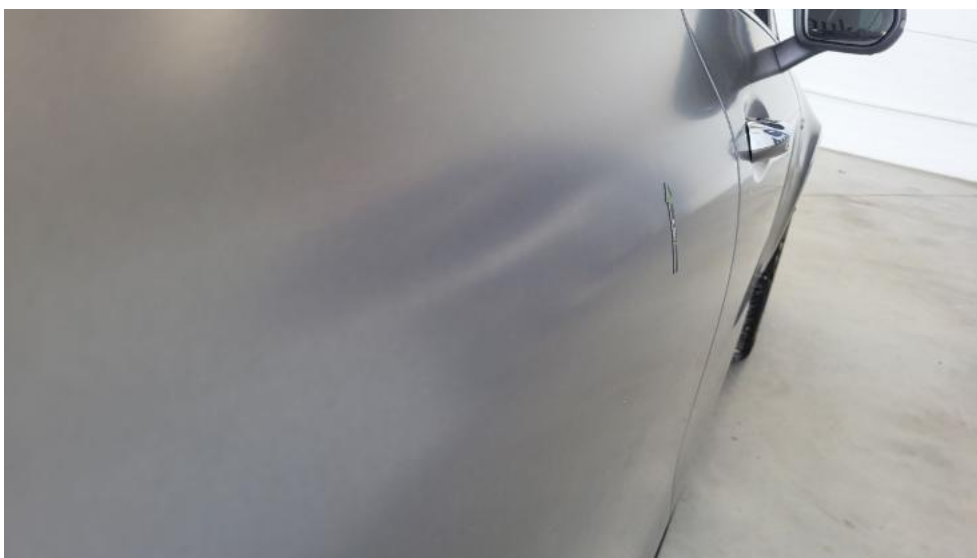
**Photo 56.**

Drzwi tylne P - Wgniecenie/odkształcenie 1

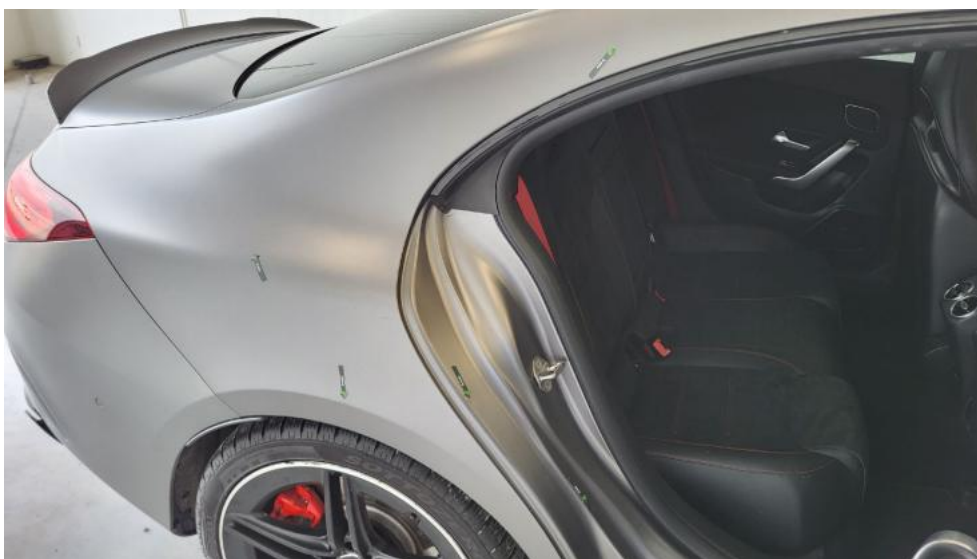
**Photo 57.**

Błotnik tylny P / Ściana boczna P - zdjęcie poglądowe 1

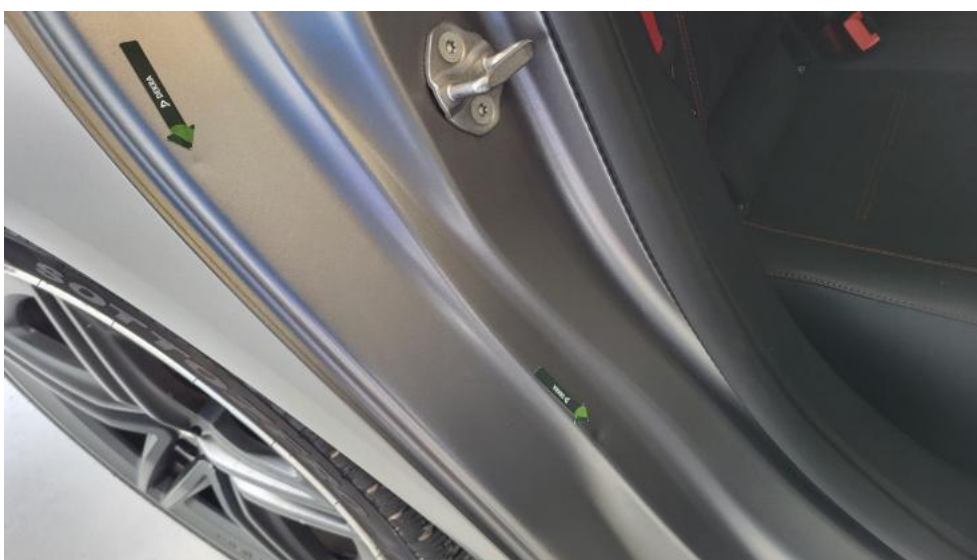
**Photo 58.**

Błotnik tylny P / Ściana boczna P - Wgniecenie/odkształcenie 1

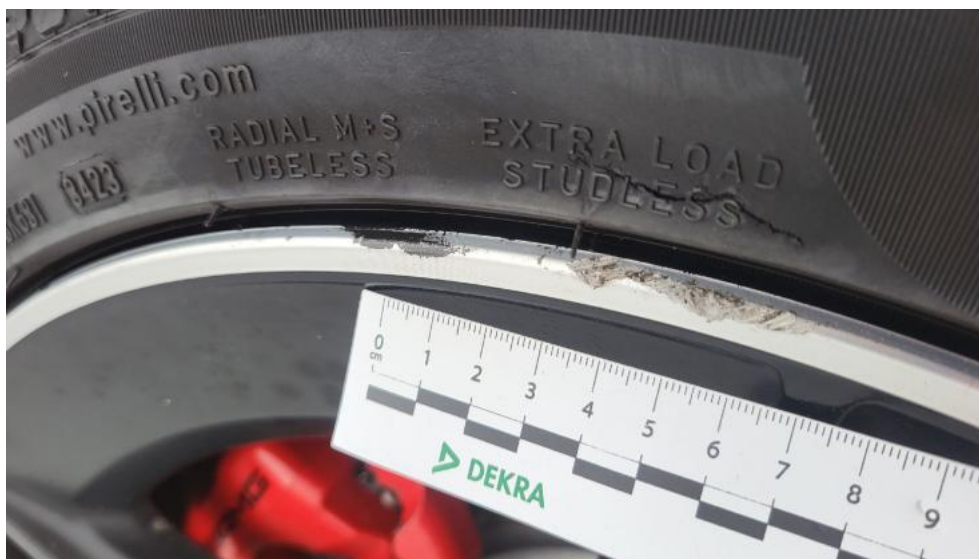
**Photo 59.**

Felga aluminiowa tylna P - Rysa/odprysk 1

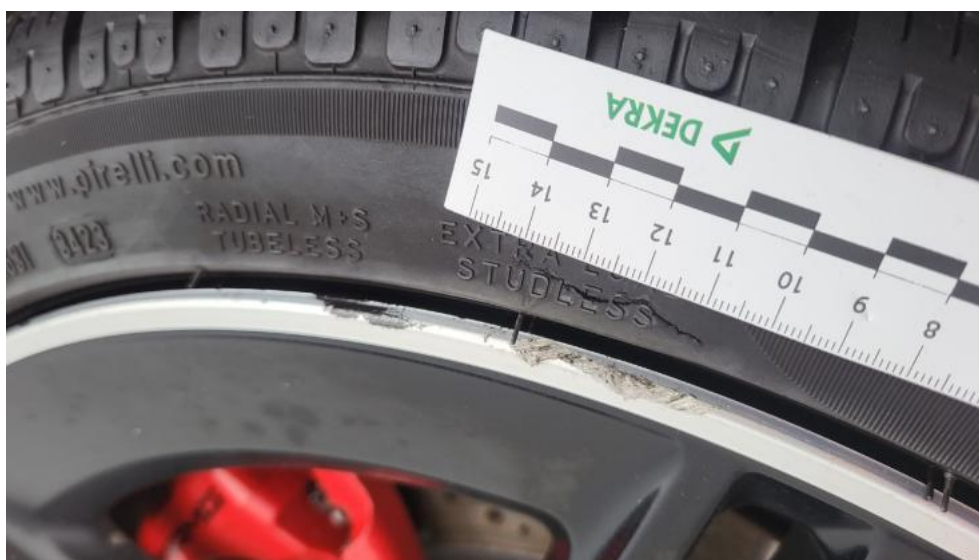
**Photo 60.**

Opona tylna P - Pęknięcie/rozerwanie 1

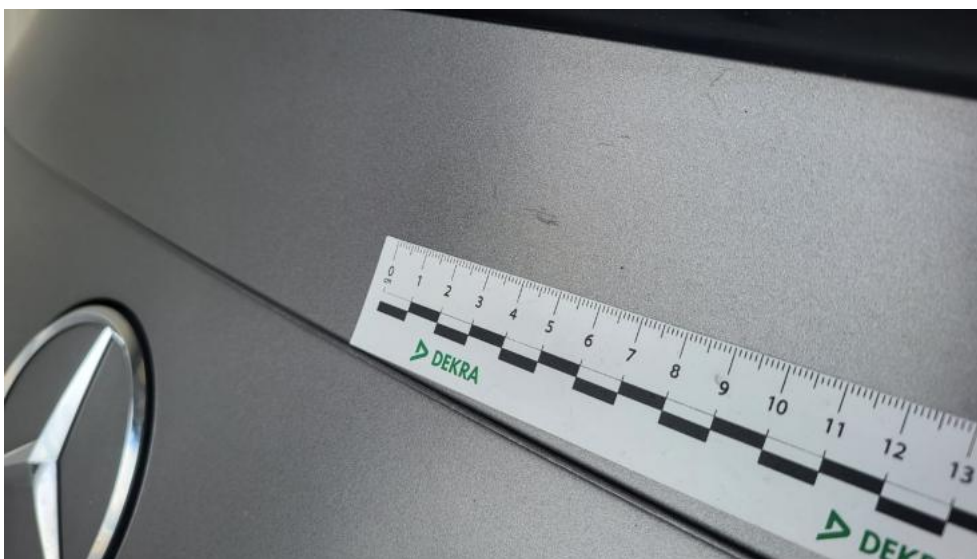
**Photo 61.**

Pokrywy bagażnika - Rysa/odprysk 1

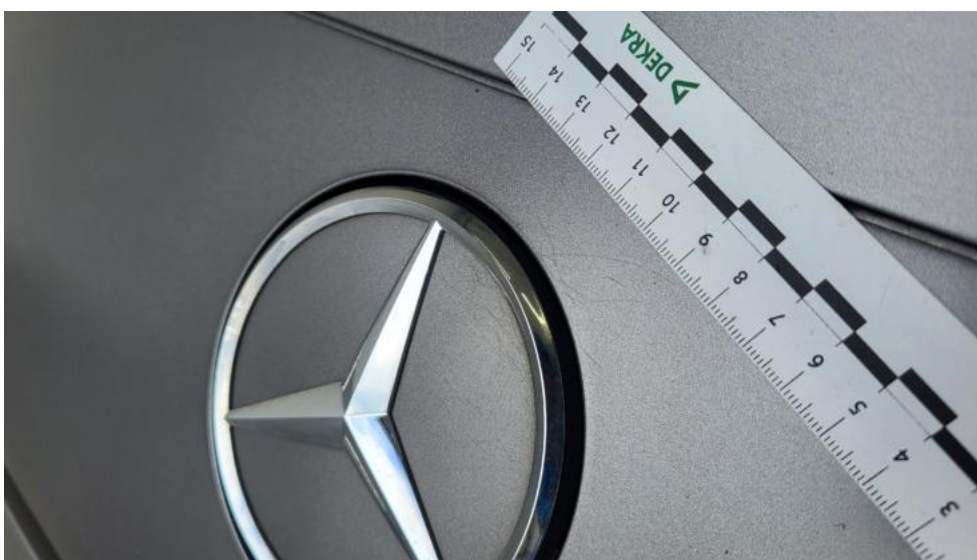
**Photo 62.**

Pokrywy bagażnika - Rysa/odprysk 2

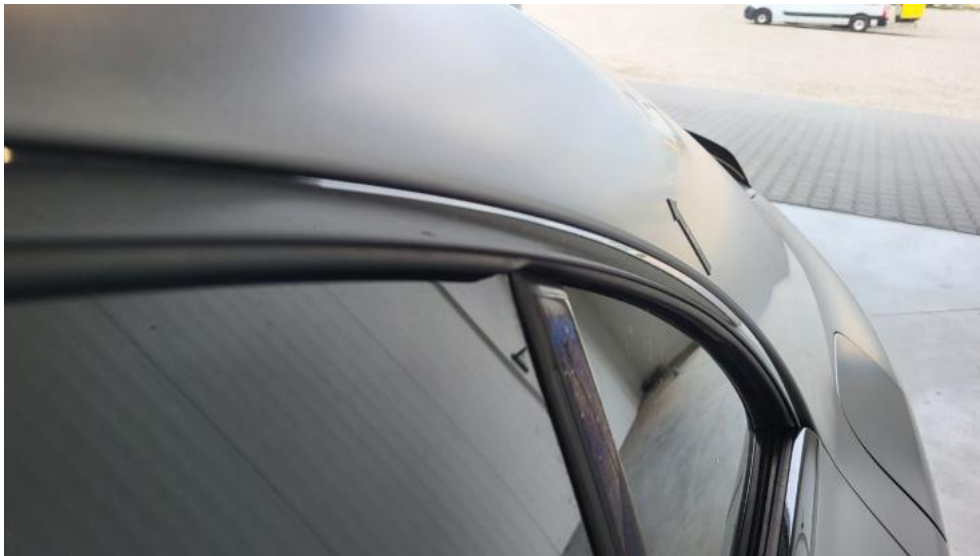
**Photo 63.**

Błotnik tylny L / Ściana boczna L - Wgniecenie/odkształcenie 1

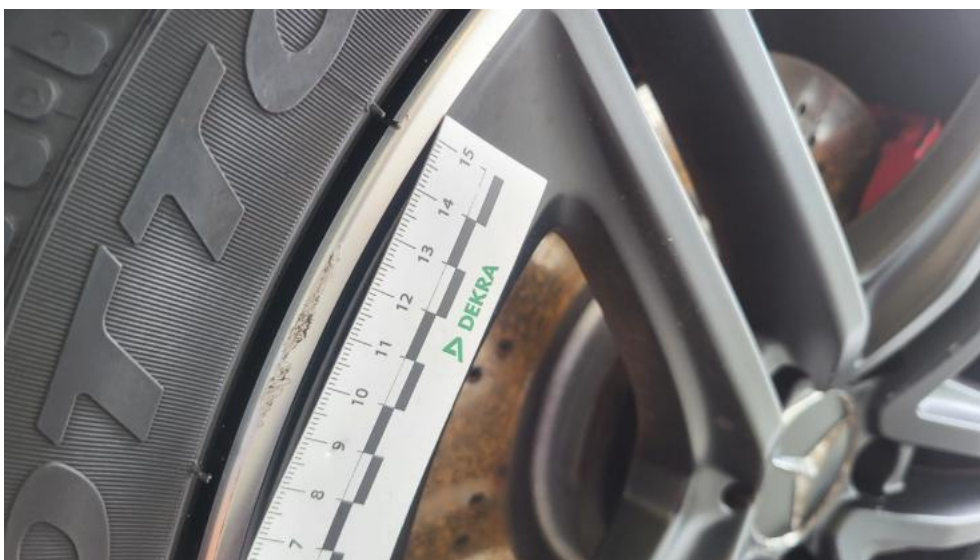
**Photo 64.**

Felga aluminiowa tylna L - Rysa/odprysk 1

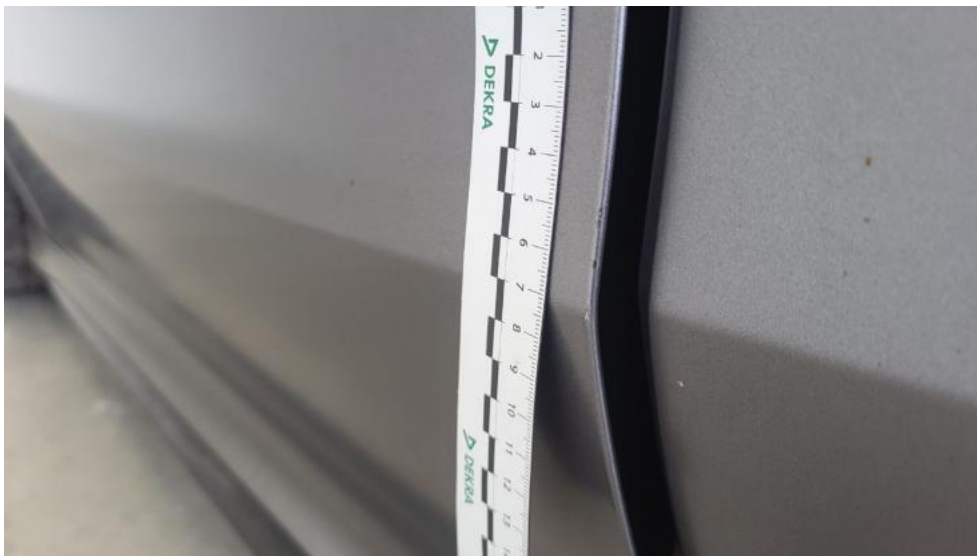
**Photo 65.**

Drzwi przed L - Rysa/odprysk 1

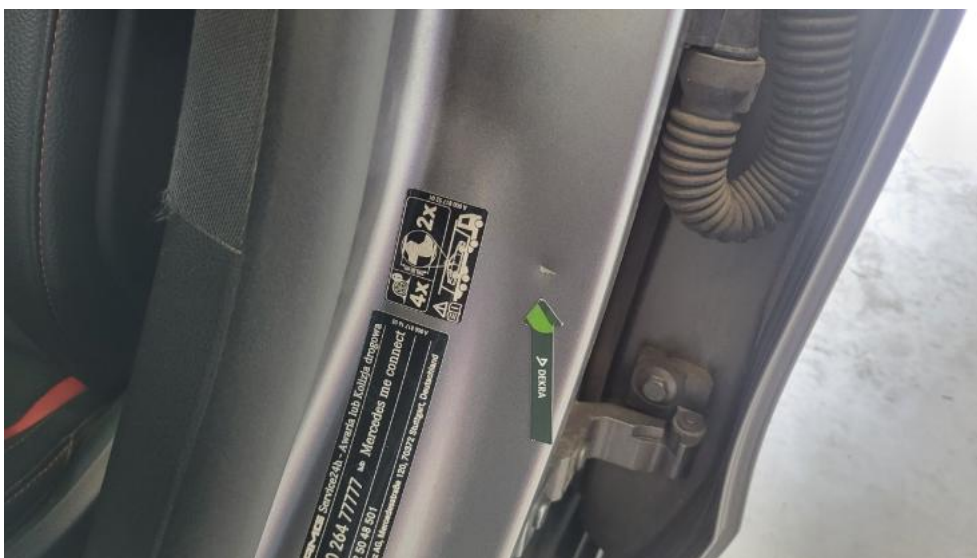
**Photo 66.**

Słupek środkowy L - Wgniecenie/odkształcenie 1

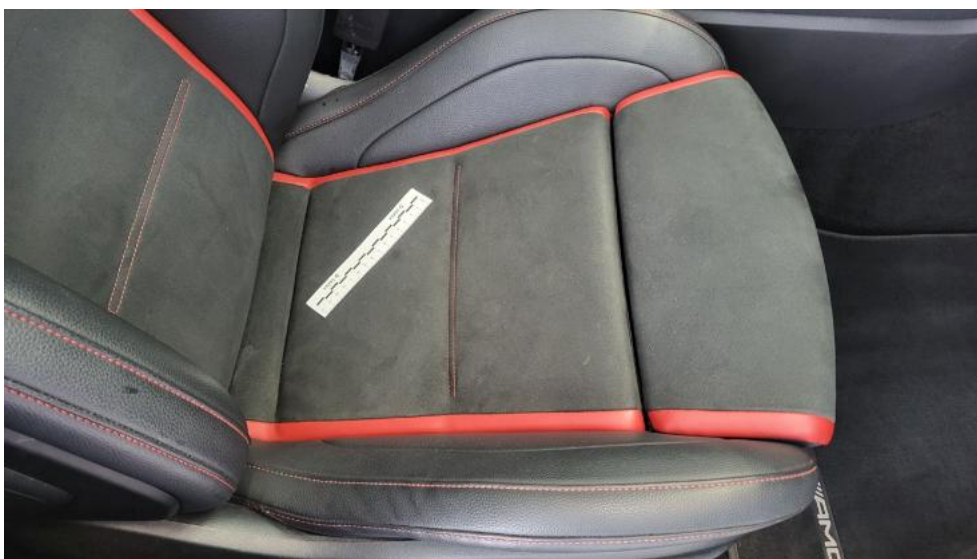
**Photo 67.**

Fotel prz. praw. - Inne 1

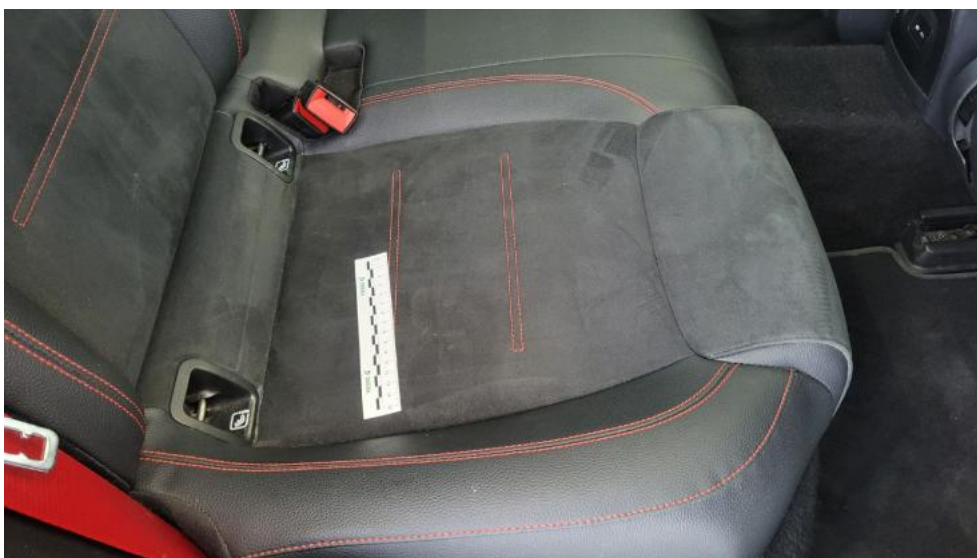
**Photo 68.**

Kanapa tyl. - Inne 1
