DEKRA's commission No. : PKOL(W)/LODZ/69870/26/07/28  
commission/ damage No. : 24/036235  
Date of commission: 28-07-2026

**Vehicle data**

| Model | Compass 20-25 |
| Type / version | Compass 1.5 T4 mHEV Upland FWD |

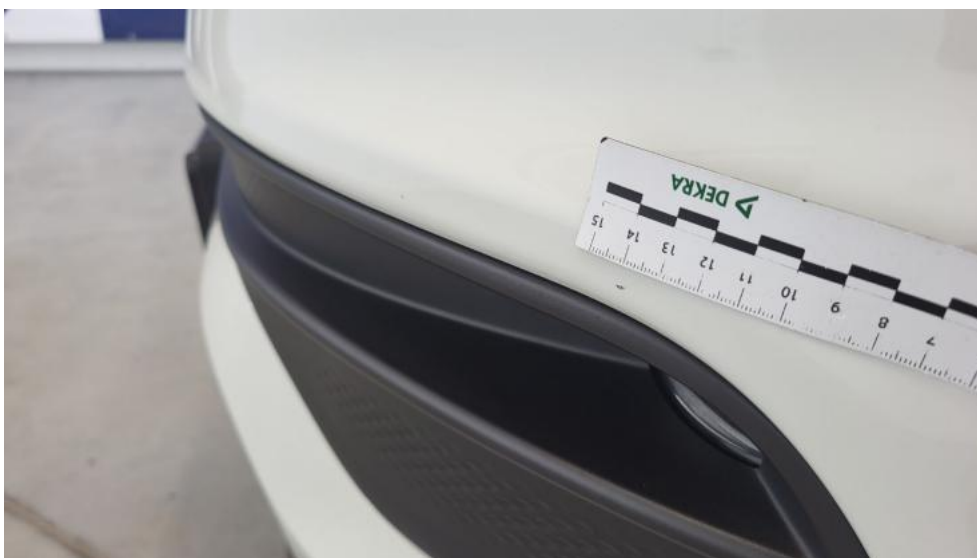
**Photo 42.**

Zderzak - Rysa/odprysk 1

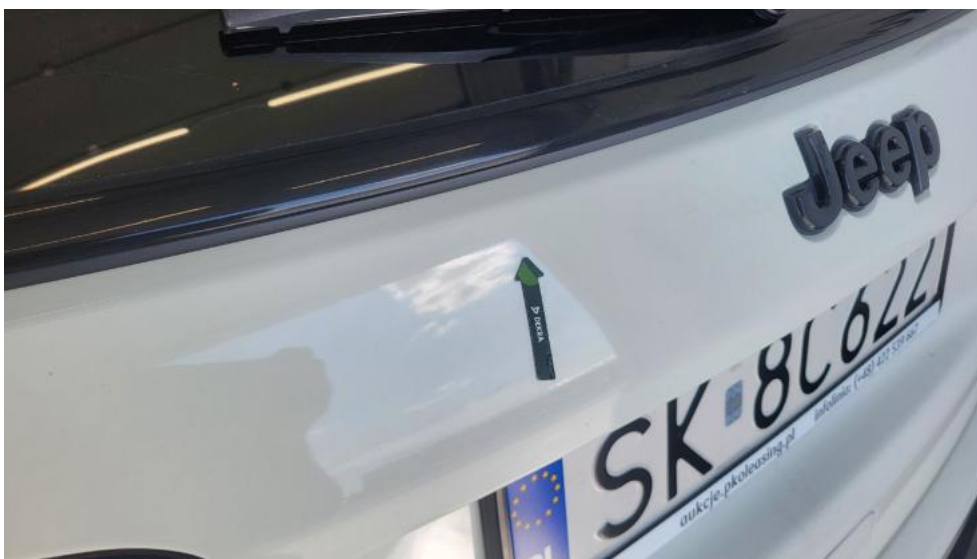
**Photo 45.**

Pokrywy bagażnika - Wgniecenie/odkształcenie 1

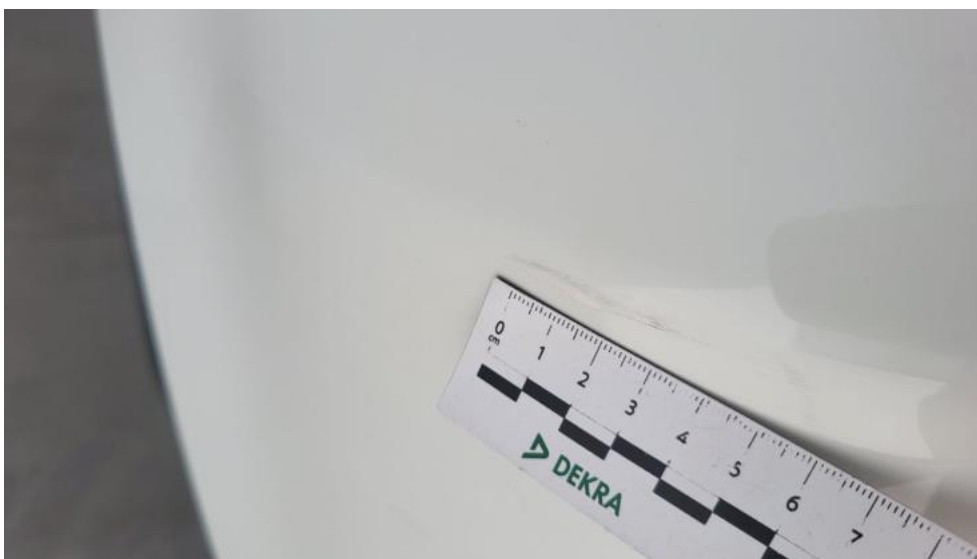
**Photo 47.**

Zderzak tylny - Rysa/odprysk 2

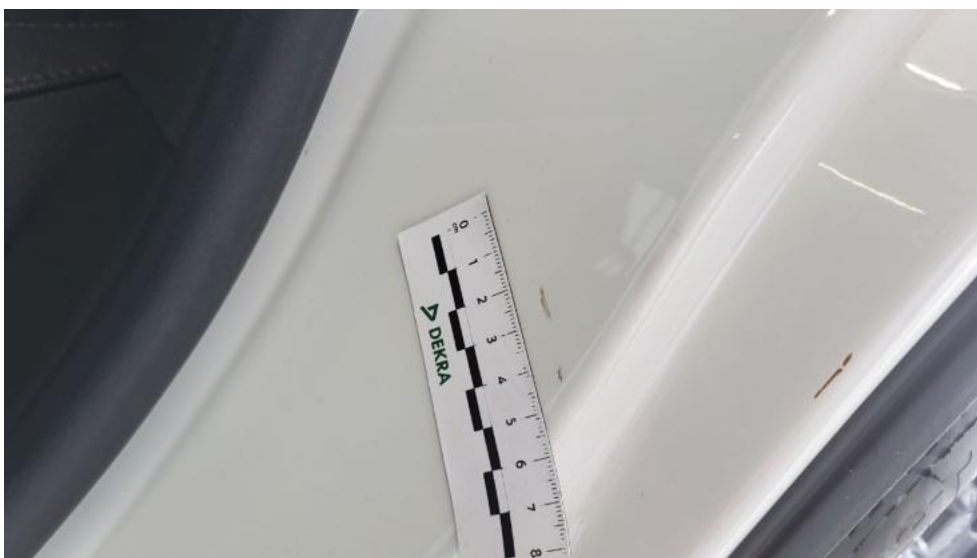
**Photo 48.**

Błotnik tylny L / Ściana boczna L - Rysa/odprysk 1

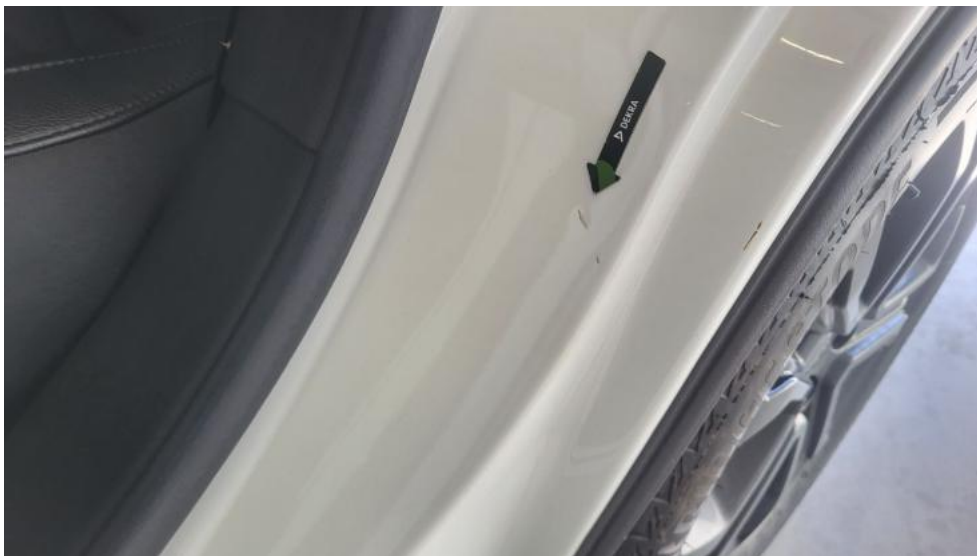
**Photo 49.**

Błotnik tylny L / Ściana boczna L - Wgniecenie/odkształcenie 1

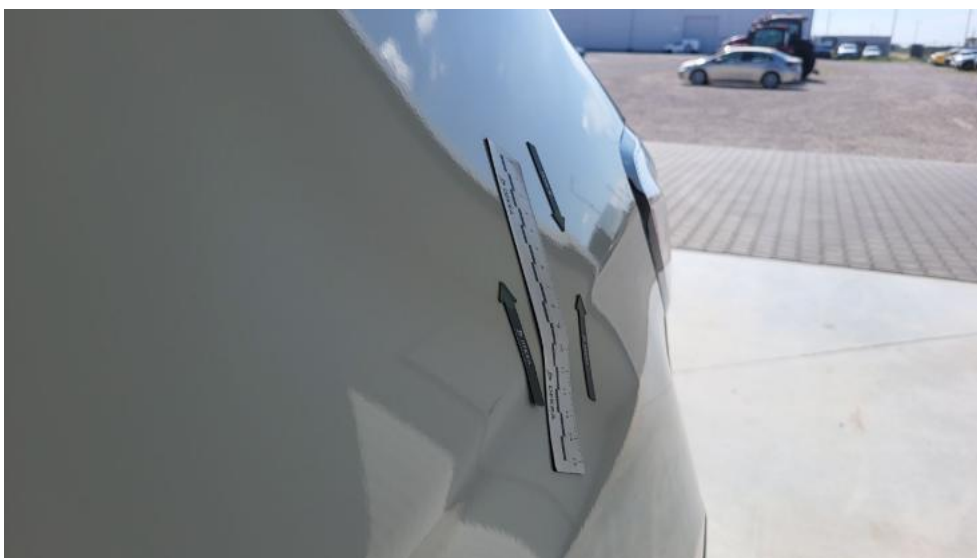
**Photo 50.**

Błotnik tylny L / Ściana boczna L - Wgniecenie/odkształcenie 2

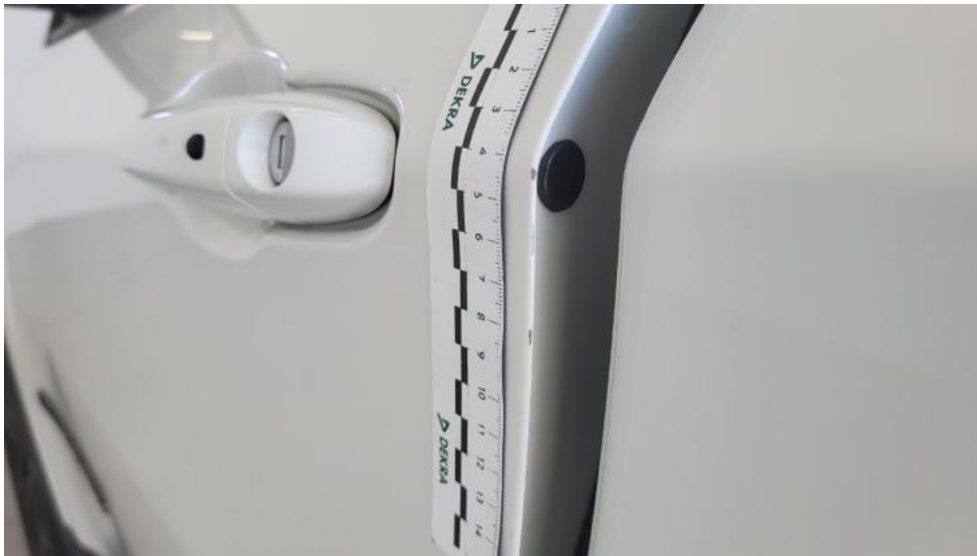
**Photo 51.**

Drzwi przed L - Rysa/odprysk 1

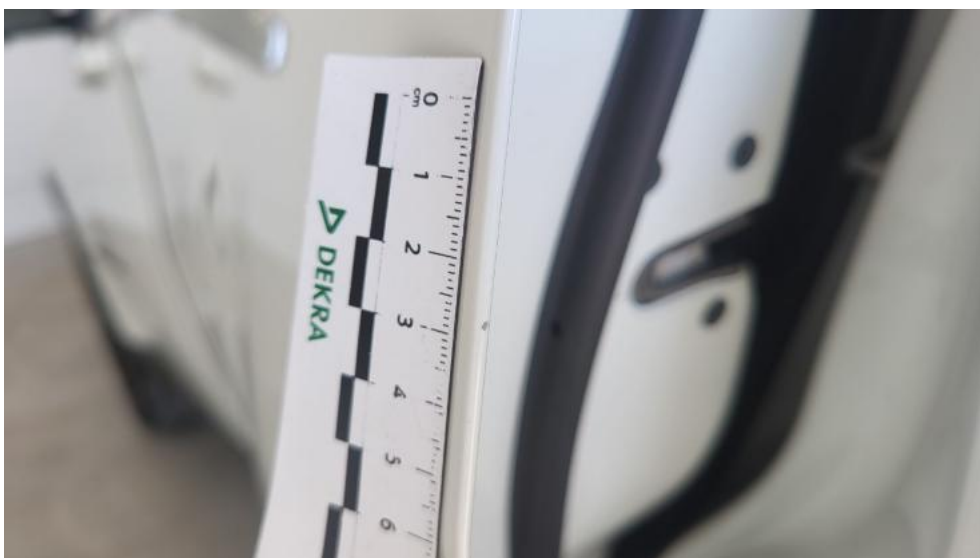
**Photo 54.**

Drzwi tylne L - Rysa/odprysk 1

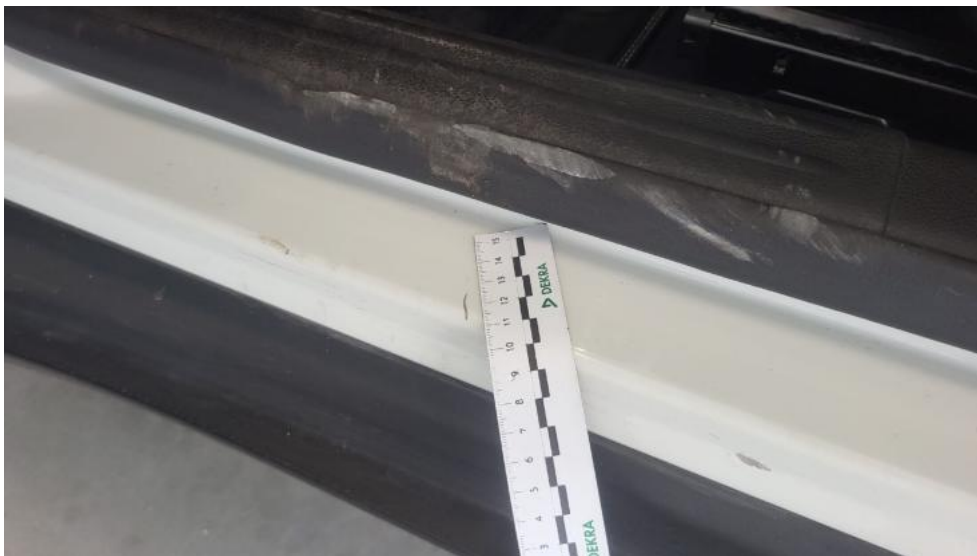
**Photo 57.**

Próg L - Rysa/odprysk 1

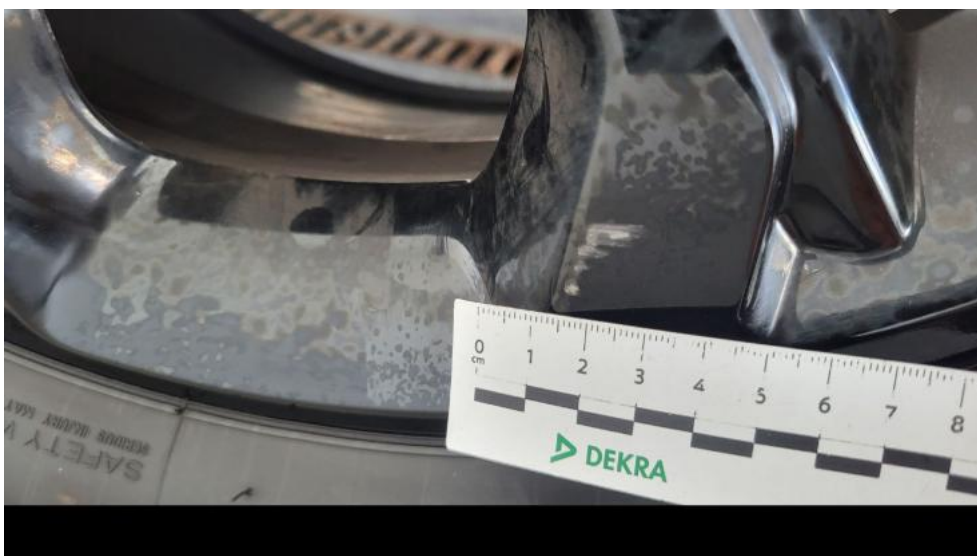
**Photo 58.**

Felga Aluminiowa przednia L - Rysa/odprysk 1

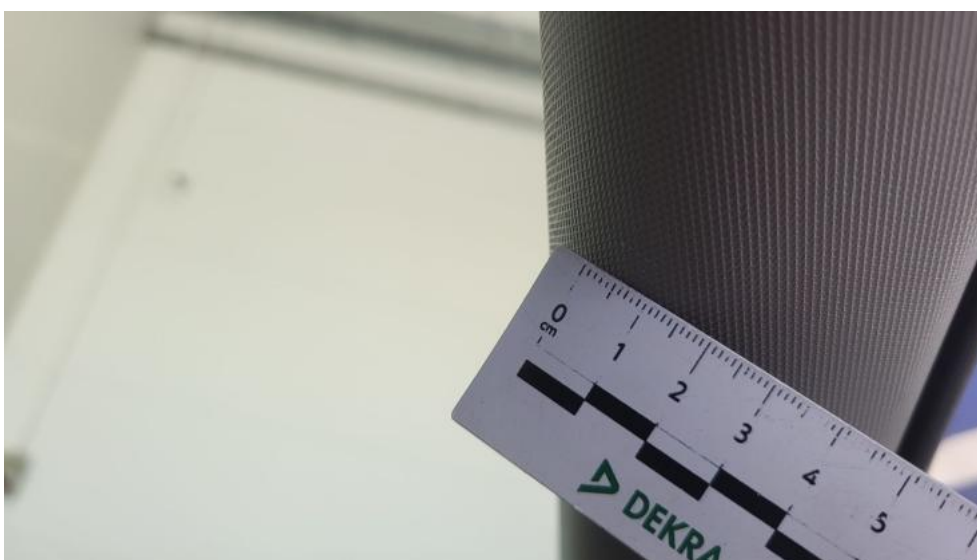
**Photo 60.**

Wykładzina(y) słupka przedniego P - Rysa/odprysk 1
