DEKRA's commission No. : PKOL(W)/LODZ/69918/26/07/28  
commission/ damage No. : 25/054498  
Date of commission: 28-07-2026

**Vehicle data**

| Model | Arteon Shooting Brake 20-24 |
| Type / version | Arteon 2.0 TSI Elegance DSG |

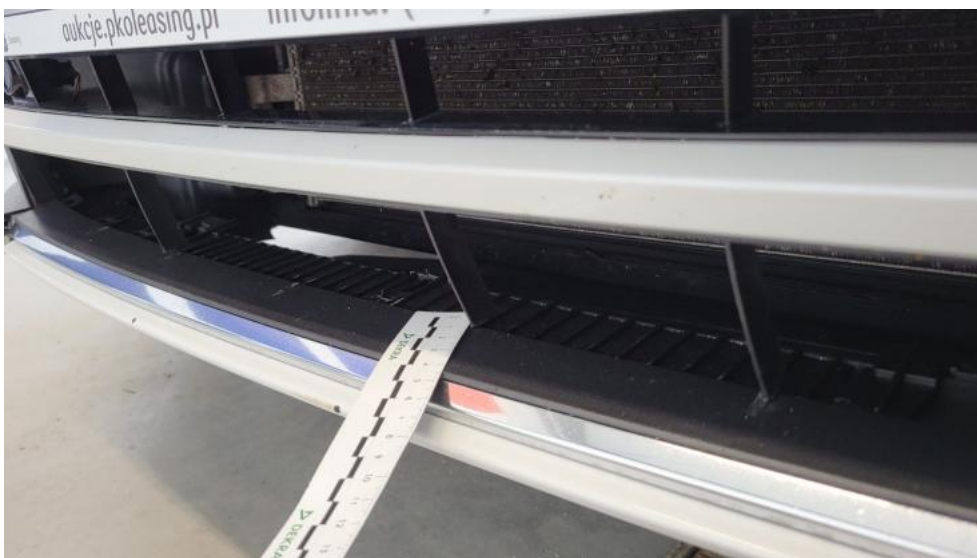
Krata zderzaka prz. - Pęknięcie/rozerwanie 1

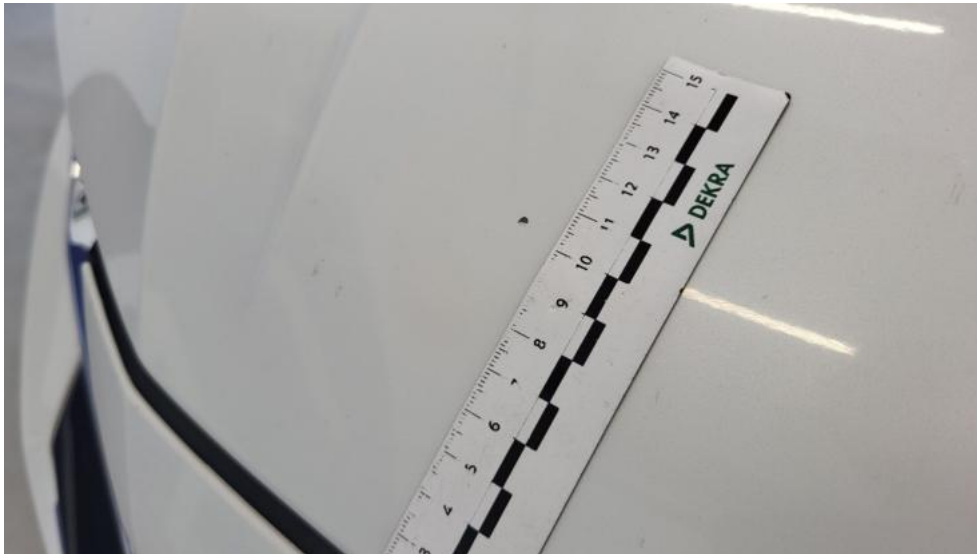
**Photo 43.**

Pokrywa komory silnika - Rysa/odprysk 1

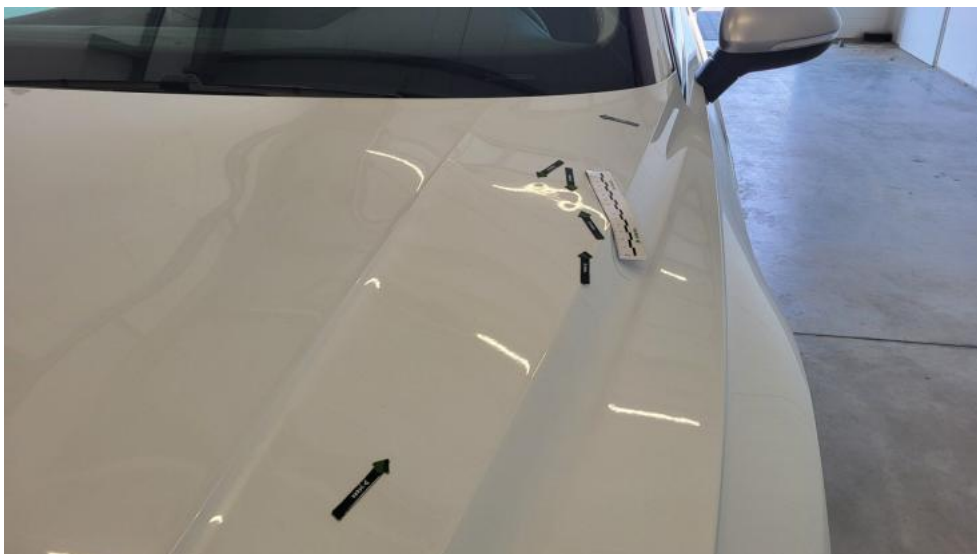
**Photo 44.**

Pokrywa komory silnika - Wgniecenie/odkształcenie 1

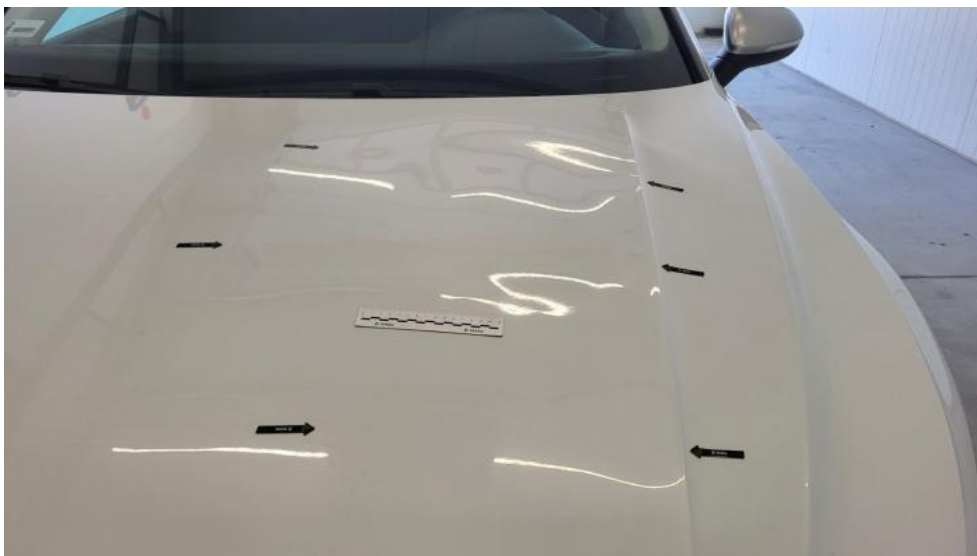
**Photo 45.**

Pokrywa komory silnika - Wgniecenie/odkształcenie 2

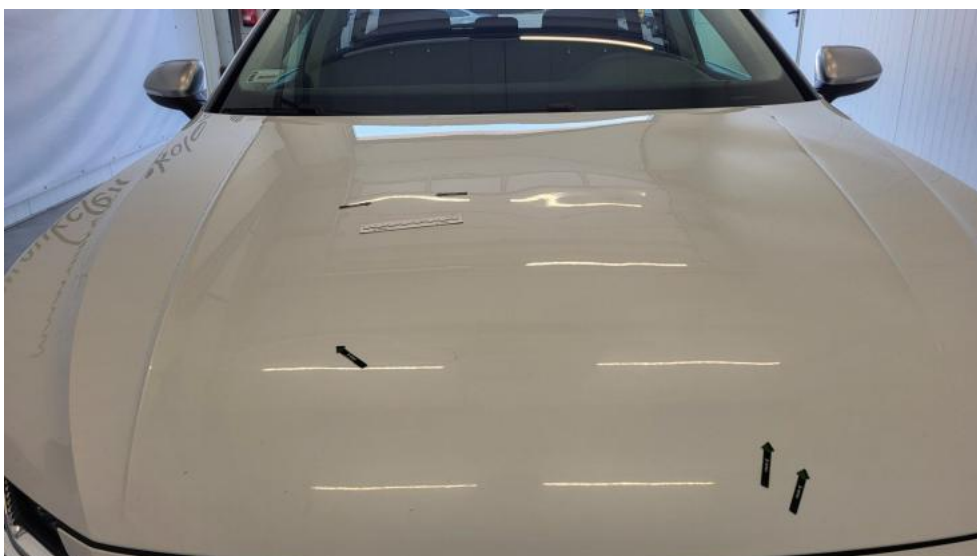
**Photo 46.**

Pokrywa komory silnika() - Wgniecenie/odkształcenie 3

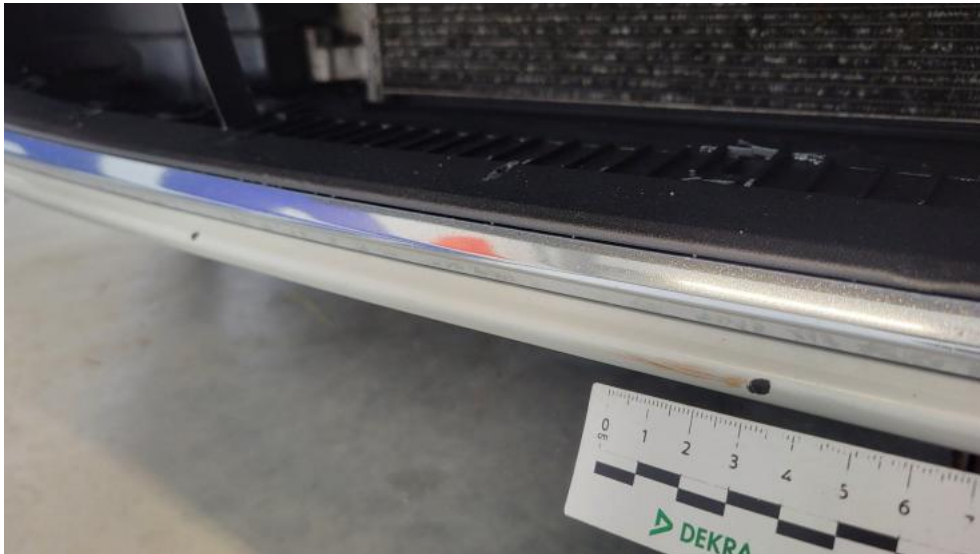
**Photo 47.**

Spoiler zderzaka przedniego - Rysa/odprysk 1

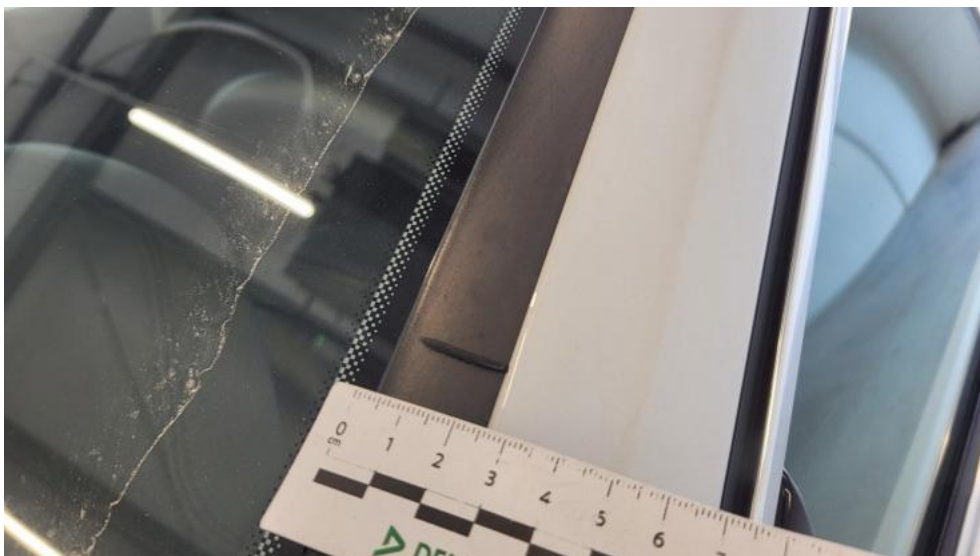
**Photo 48.**

Uszczelka/listwa szyby czołowej - Rysa/odprysk 1

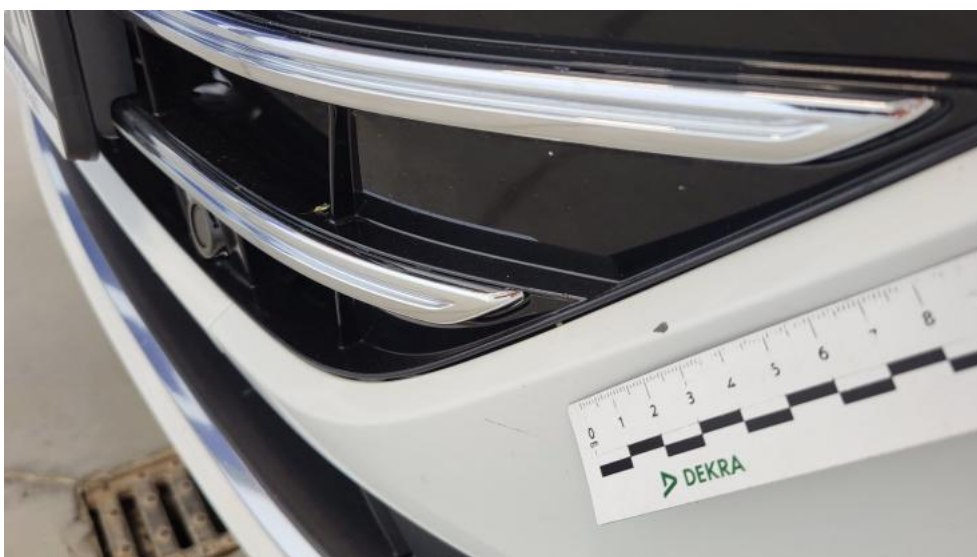
**Photo 49.**

Zderzak - Rysa/odprysk 1

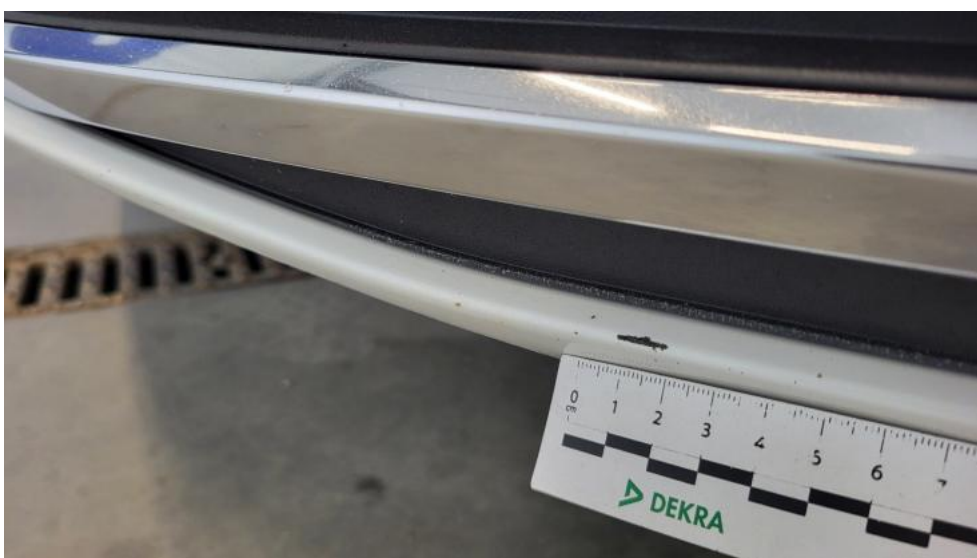
**Photo 50.**

Zderzak - Rysa/odprysk 2

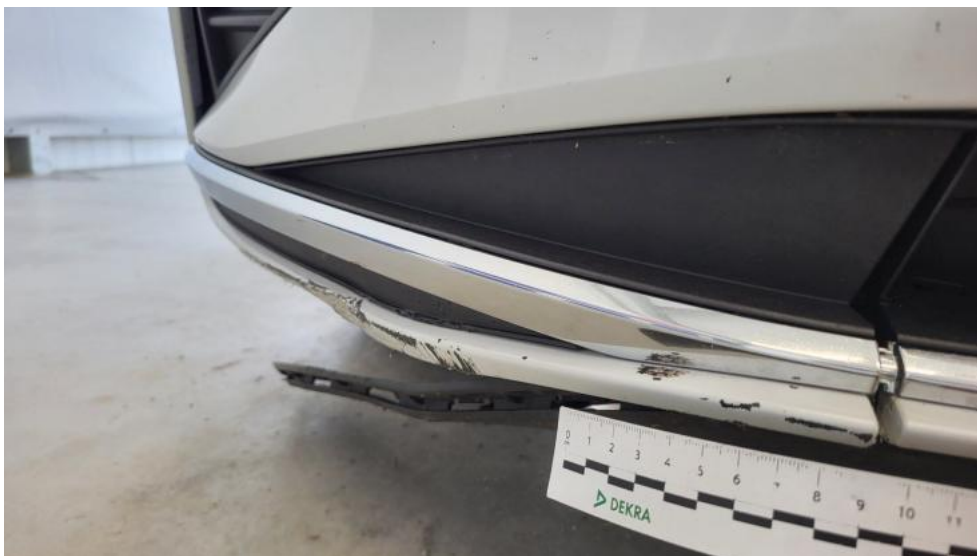
**Photo 52.**

Zderzak - Wgniecenie/odkształcenie 1

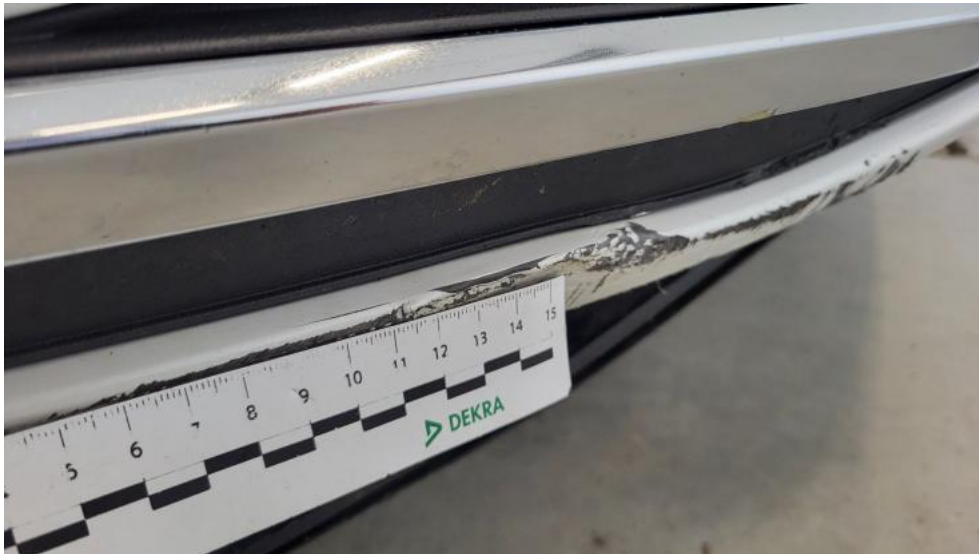
**Photo 53.**

Zderzak - Pęknięcie/rozerwanie 1

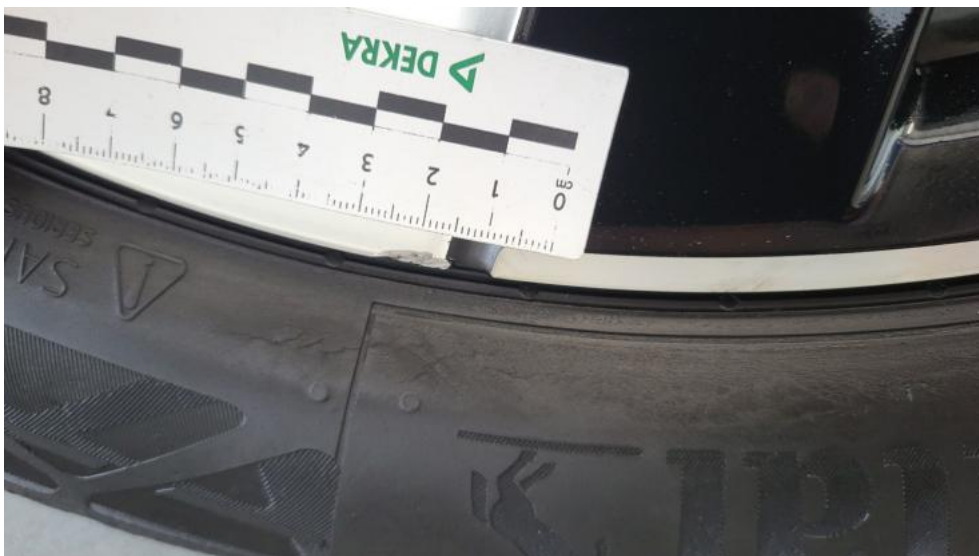
**Photo 54.**

Felga aluminiowa przednia P - Rysa/odprysk 1

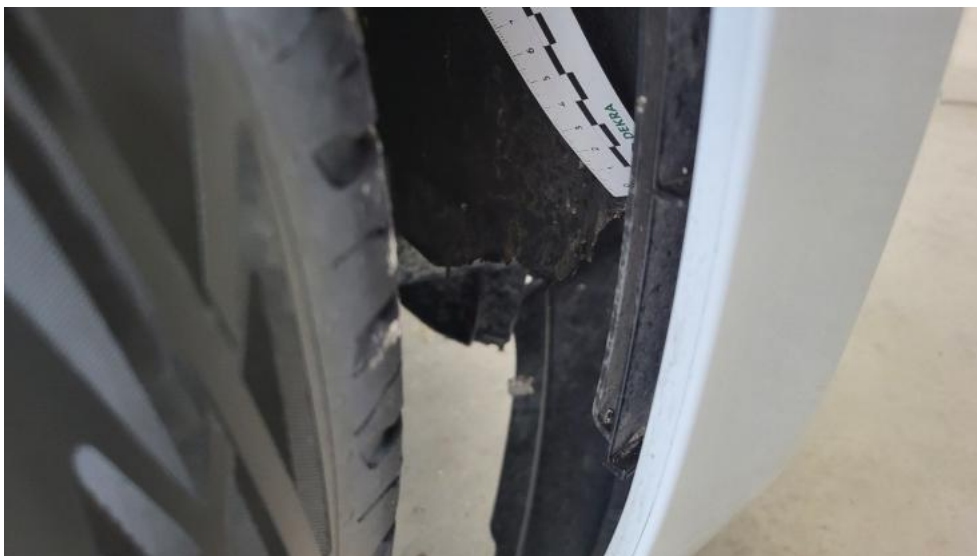
**Photo 55.**

Nadkole przednie P - Pęknięcie/rozerwanie 1

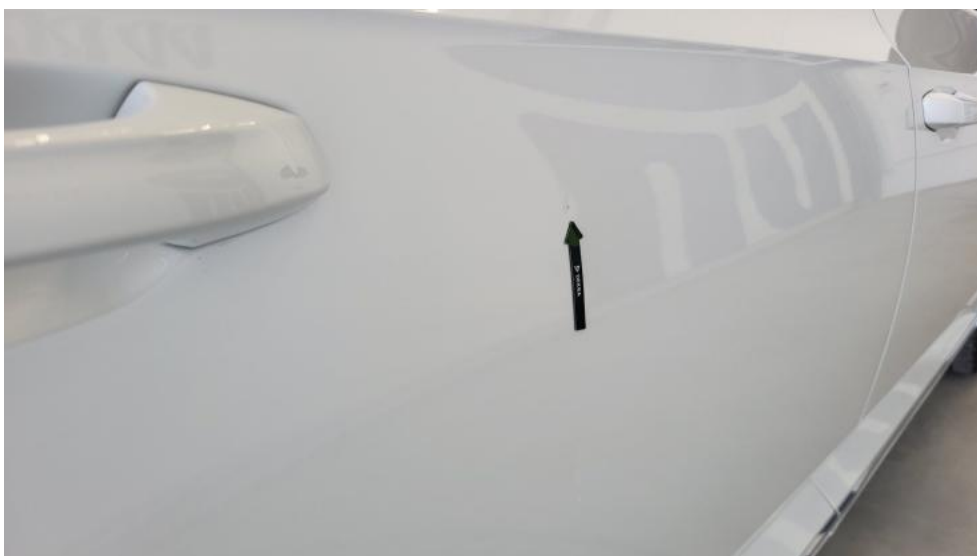
**Photo 56.**

Drzwi tylne P - Wgniecenie/odkształcenie 1

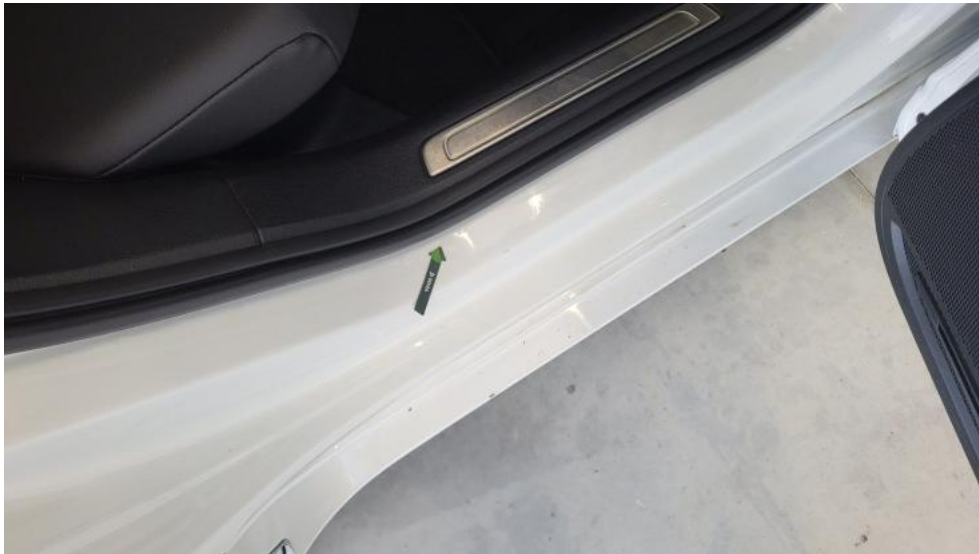
**Photo 57.**

Próg P - Wgniecenie/odkształcenie 1

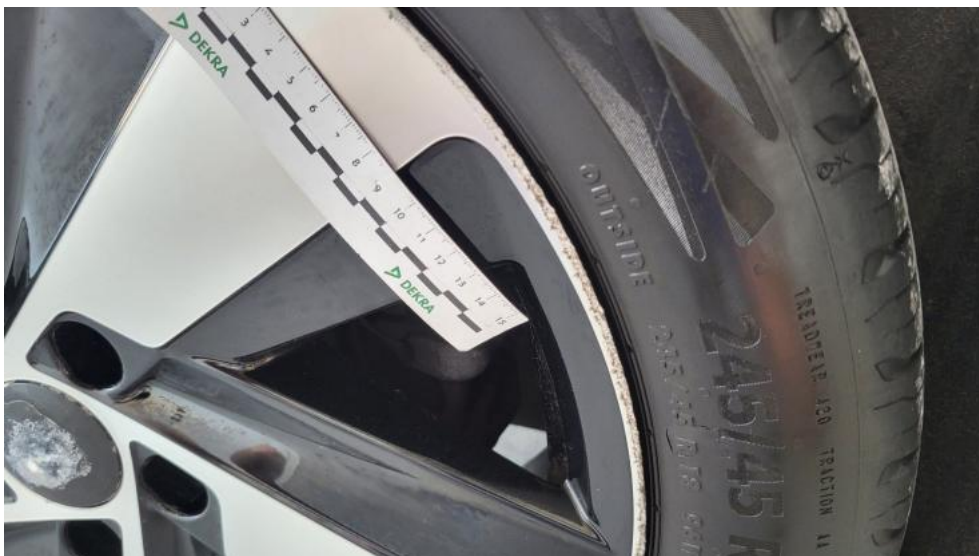
**Photo 58.**

Felga aluminiowa tylna P - Rysa/odprysk 1

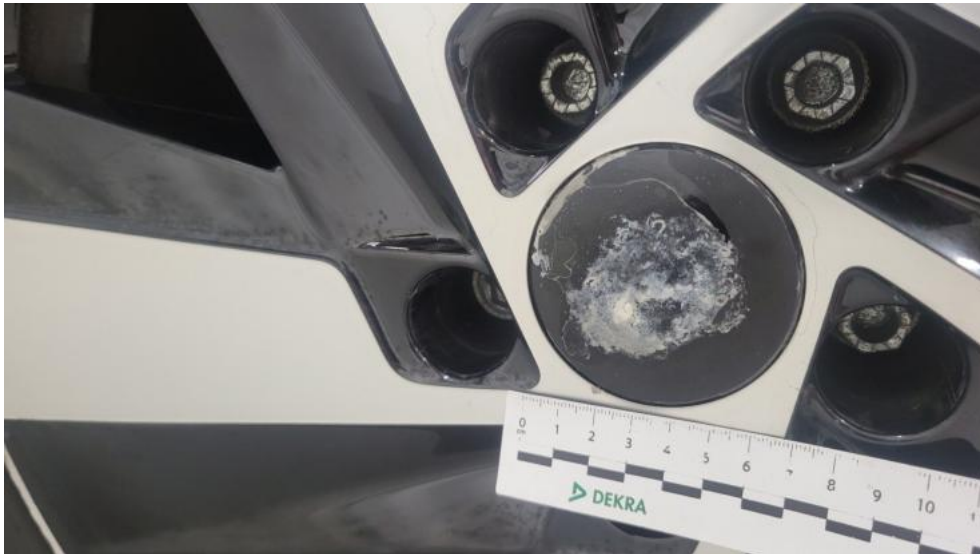
**Photo 59.**

Felga aluminiowa tylna P - Inne 1

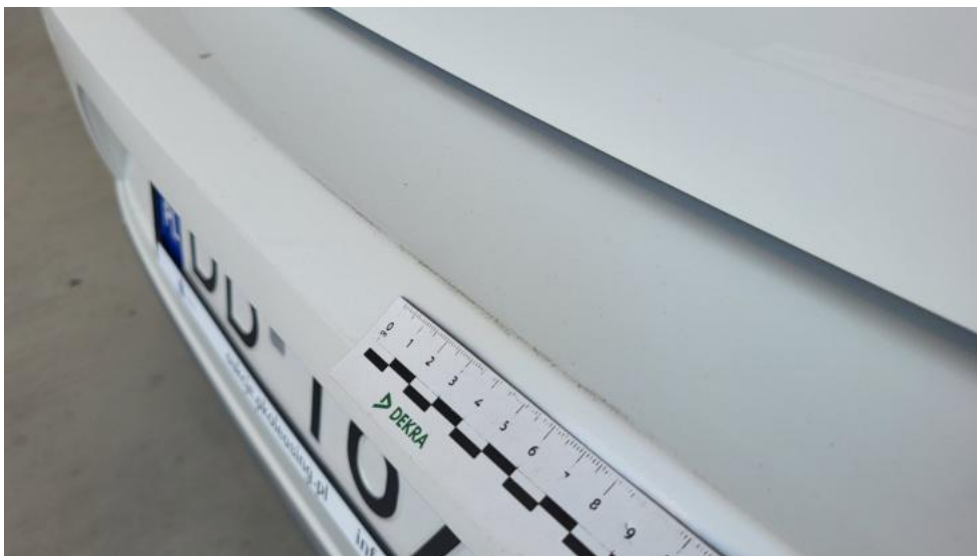
**Photo 61.**

Zderzak tylny - Rysa/odprysk 1

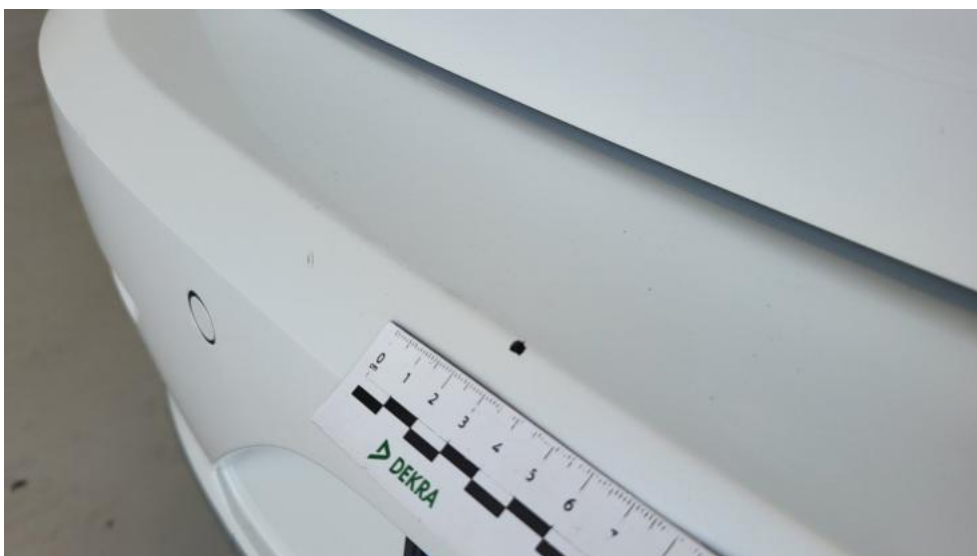
**Photo 62.**

Zderzak tylny - Rysa/odprysk 2

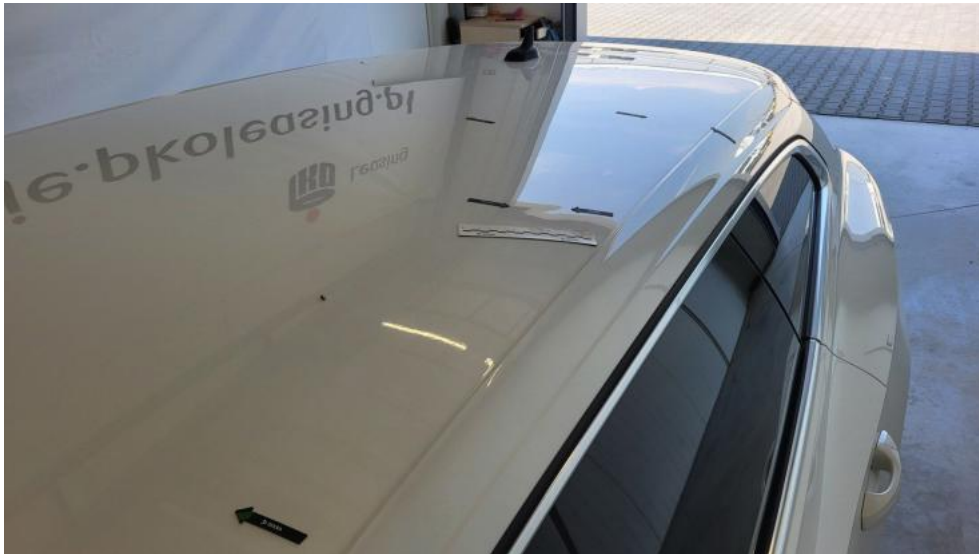
**Photo 63.**

Dach - Wgniecenie/odkształcenie 1

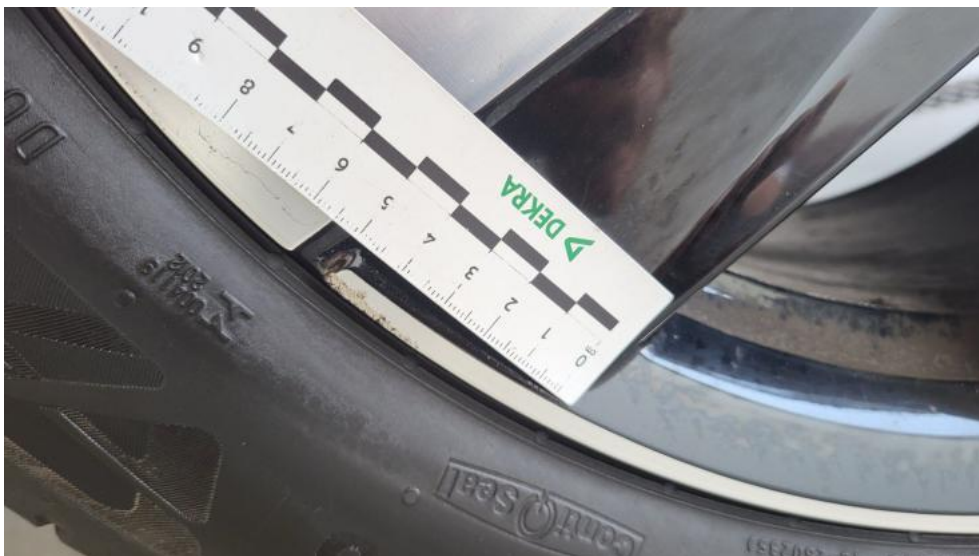
**Photo 64.**

Felga aluminiowa tylna L - Rysa/odprysk 1

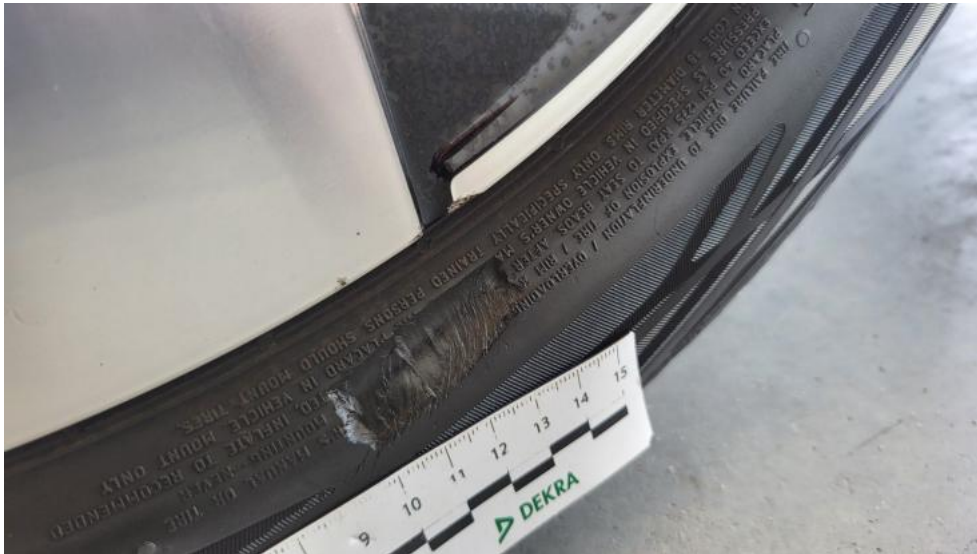
**Photo 65.**

Opona tylna L - Pęknięcie/rozerwanie 1

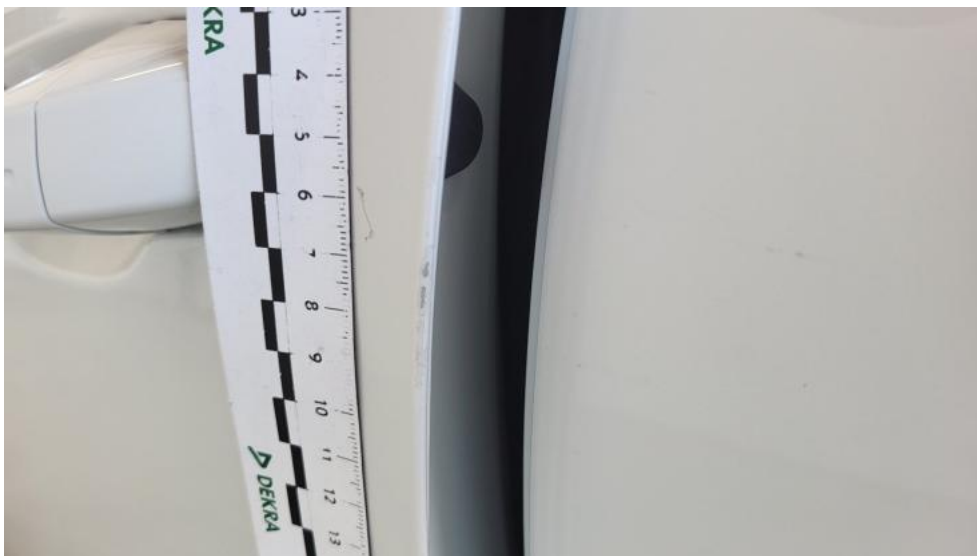
**Photo 66.**

Drzwi przed L - Rysa/odprysk 1

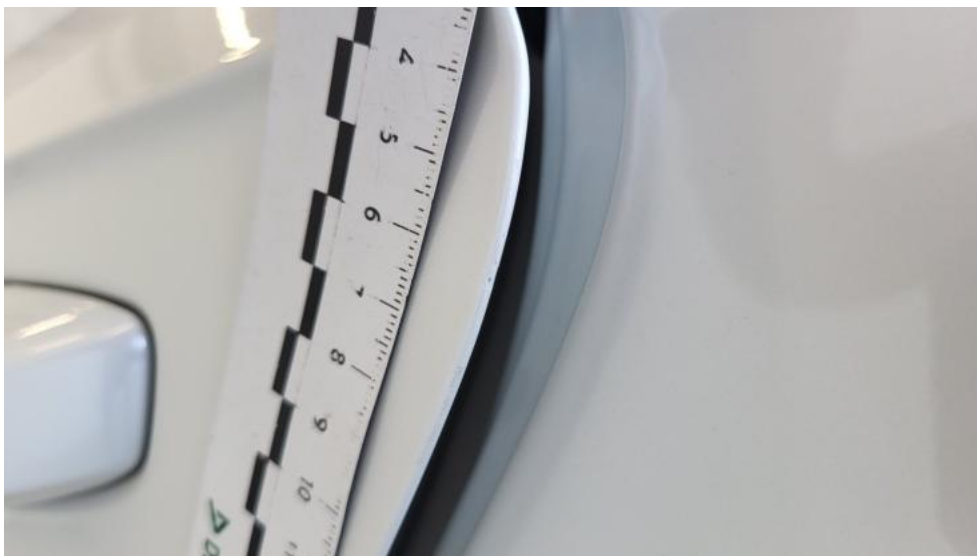
**Photo 67.**

Drzwi tylne L - Rysa/odprysk 1

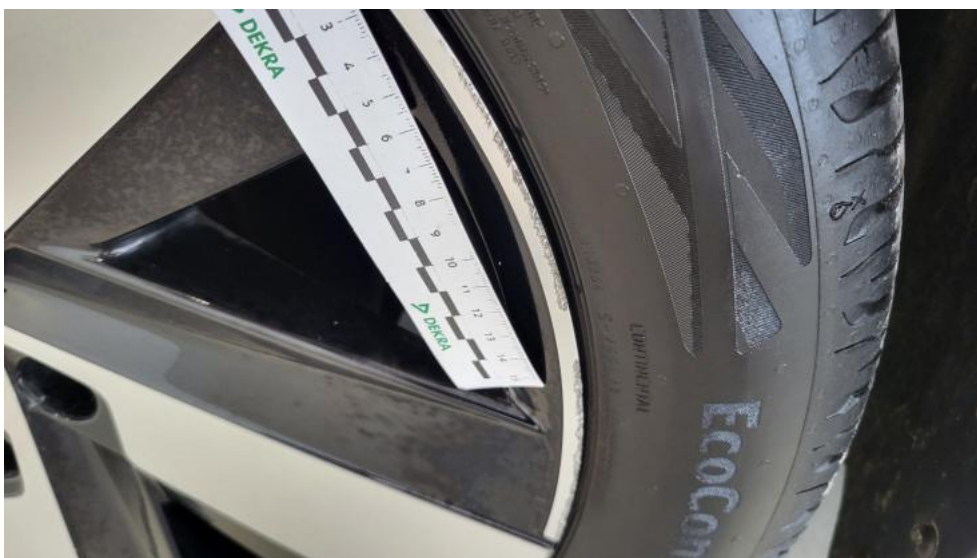
**Photo 68.**

Felga Aluminiowa przednia L - Rysa/odprysk 1

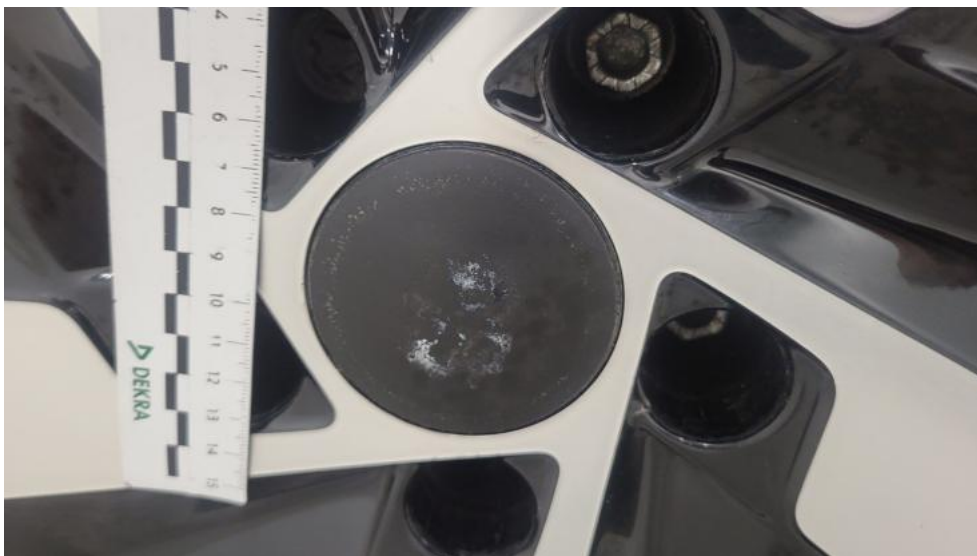
**Photo 69.**

Felga Aluminiowa przednia L - Inne 1

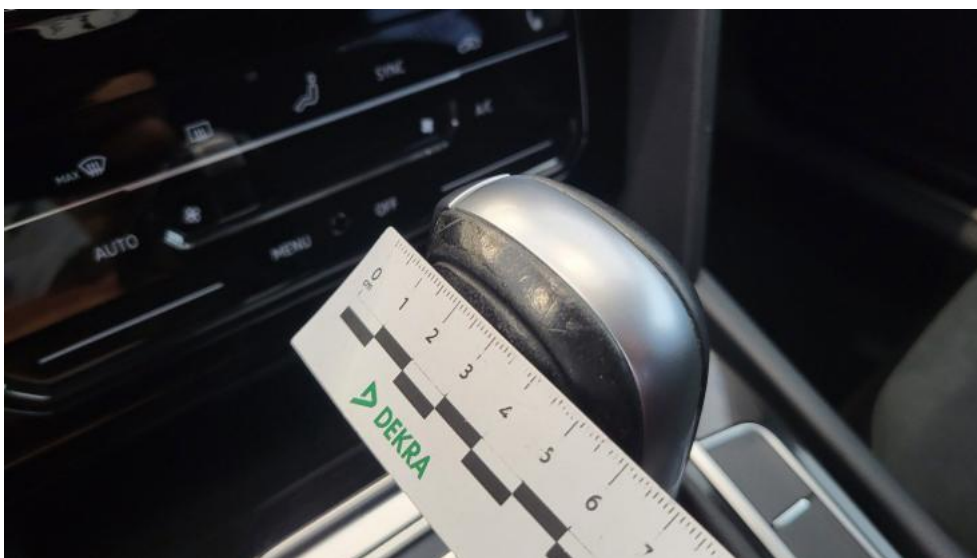
**Photo 70.**

Gałka dźwigni zmiany biegów - Rysa/odprysk 1

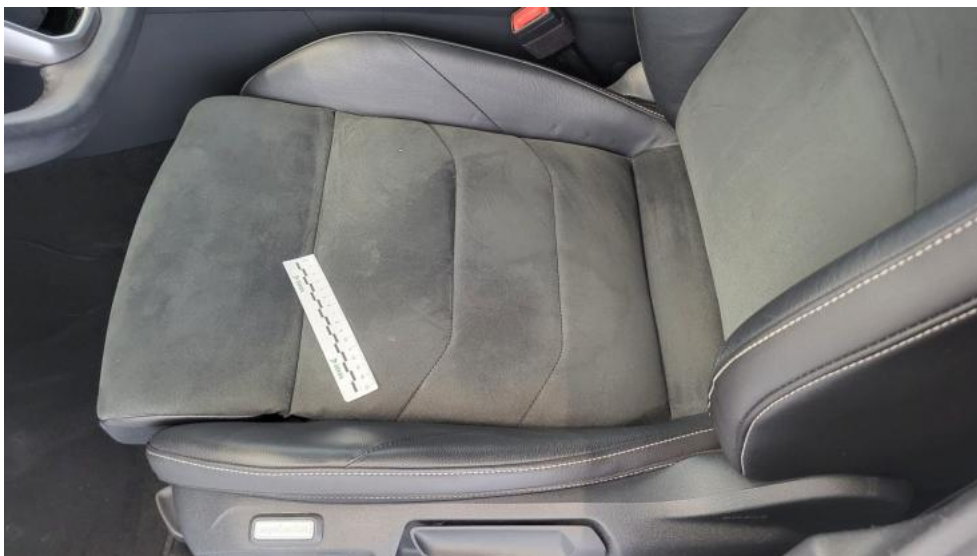
**Photo 71.**

Fotel prz. lew. - Inne 1

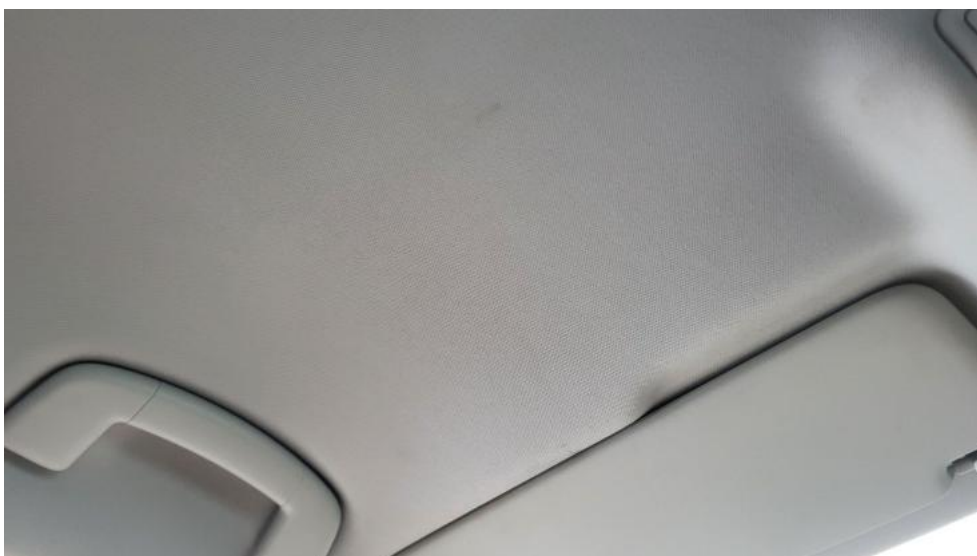
**Photo 72.**

Podsufitka - Inne 1

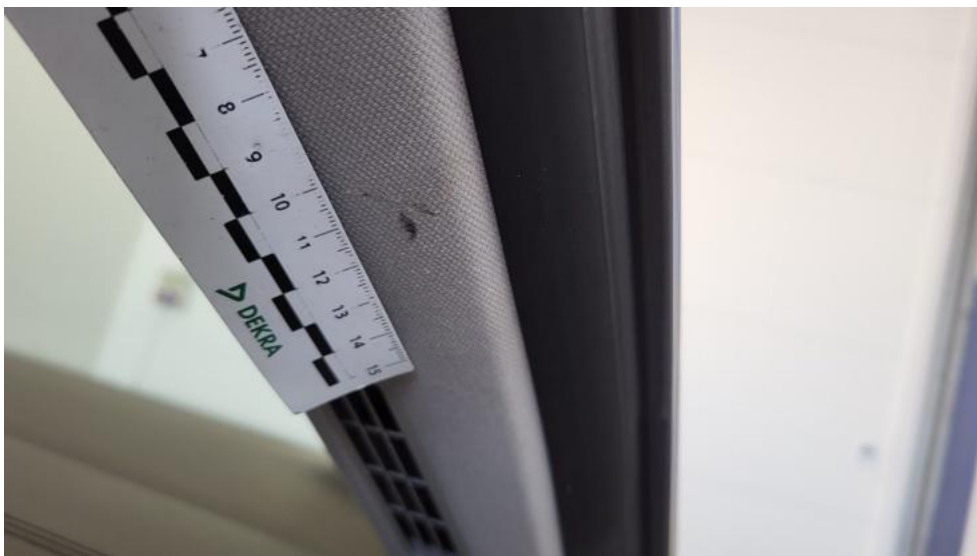
**Photo 73.**

Wykładzina(y) słupka przedniego P - Inne 1
