DEKRA's commission No. : PKOL(W)/LODZ/73057/25/09/26  
commission/ damage No. : 21/004953  
Date of commission: 26-09-2025

| Model | Mondeo Kombi 19-21 |
| Type / version | Mondeo 2.0 EcoBlue Titanium aut |
| VIN / serial number | WF0FXXWPCFLS08618 |

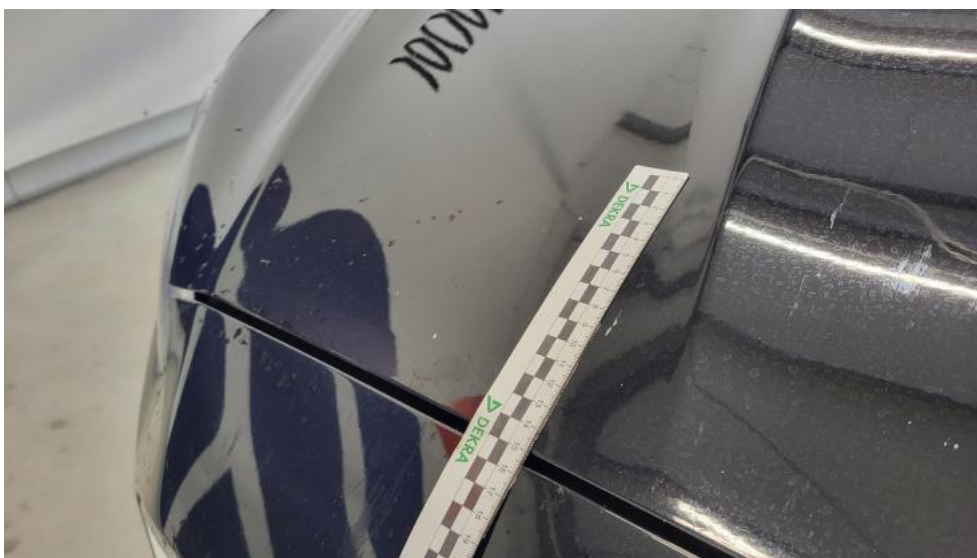
**Photo 38.**

Pokrywa komory silnika - Rysa/odprysk 1

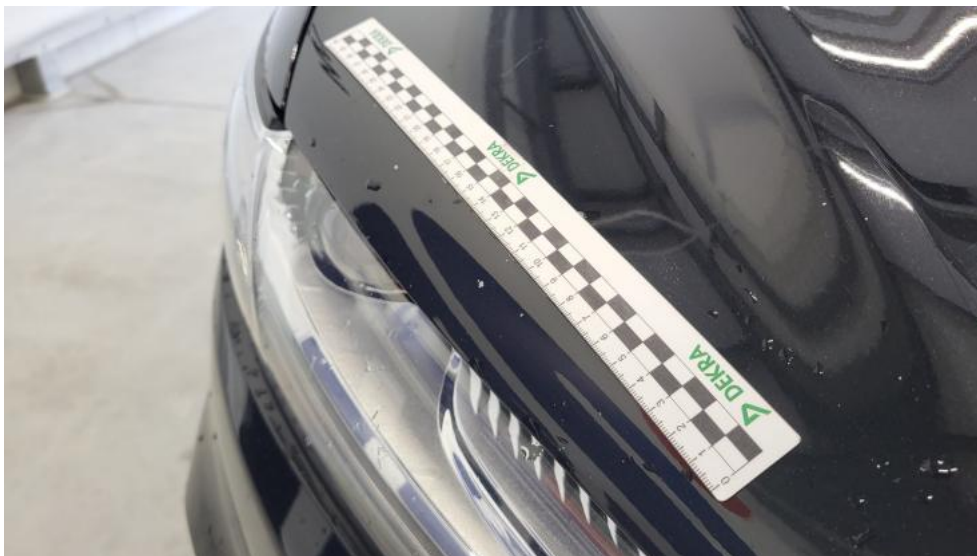
**Photo 39.**

Pokrywa komory silnika - Rysa/odprysk 2

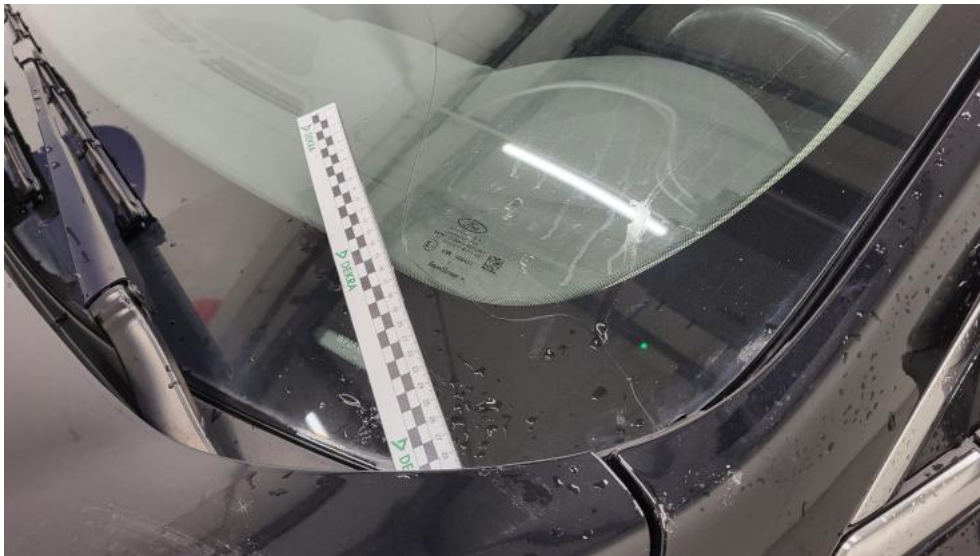
**Photo 41.**

Szyba czołowa - Pęknięcie/rozerwanie 1

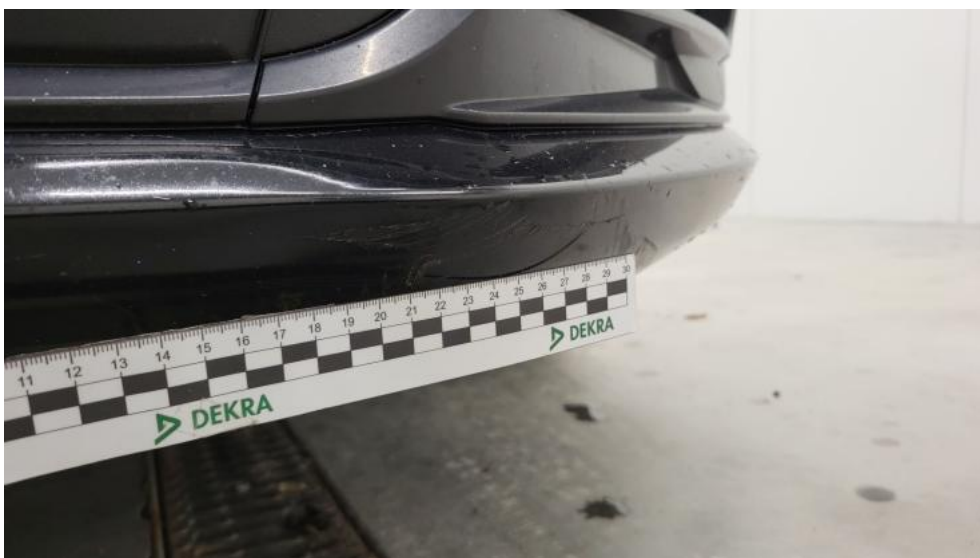
**Photo 42.**

Zderzak - Rysa/odprysk 1

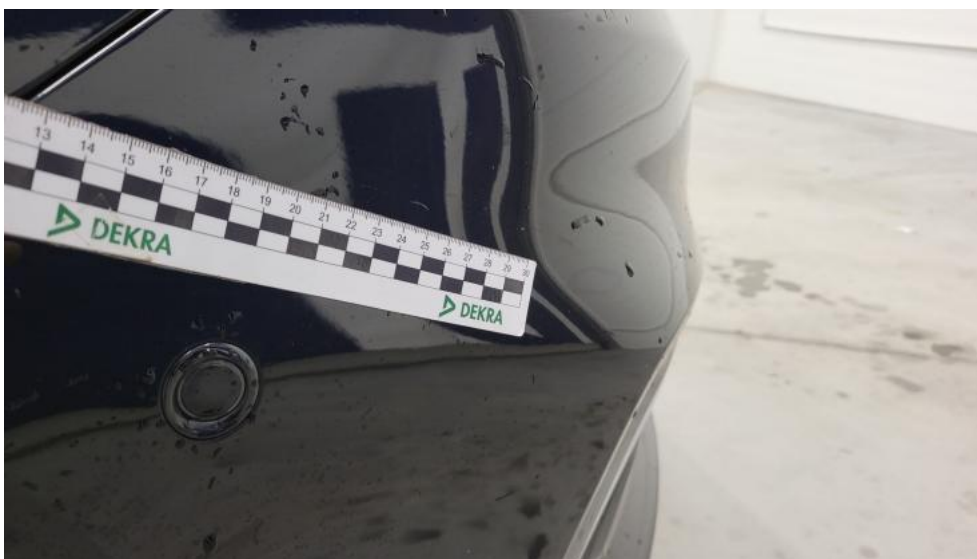
**Photo 43.**

Zderzak - Rysa/odprysk 2

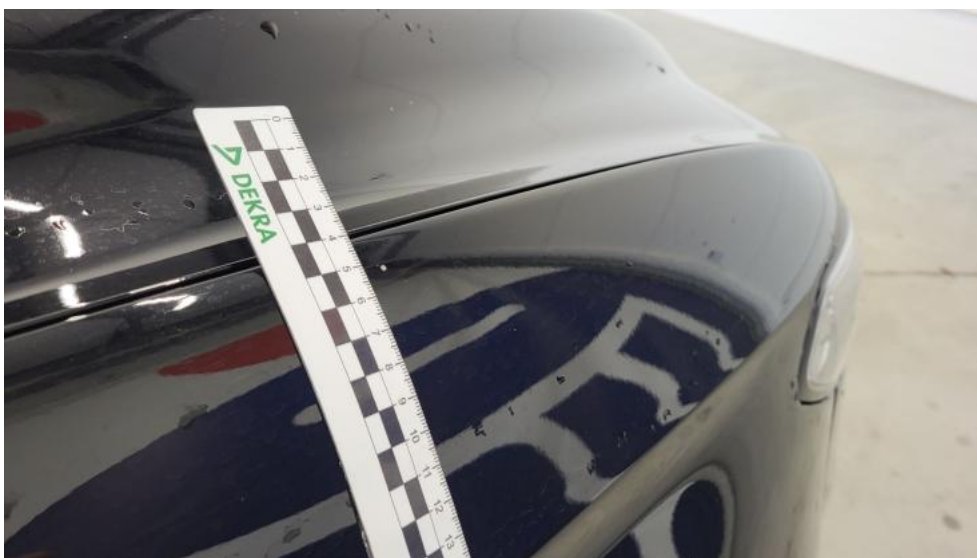
**Photo 44.**

Łotnik przedni P - Rysa/odprysk 1

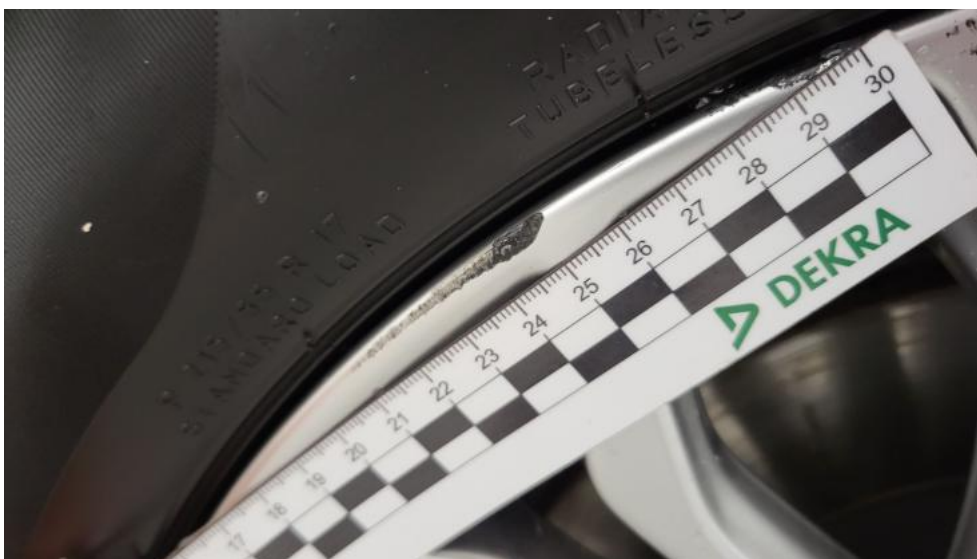
**Photo 45.**

Felga aluminiowa przednia P - Rysa/odprysk 1

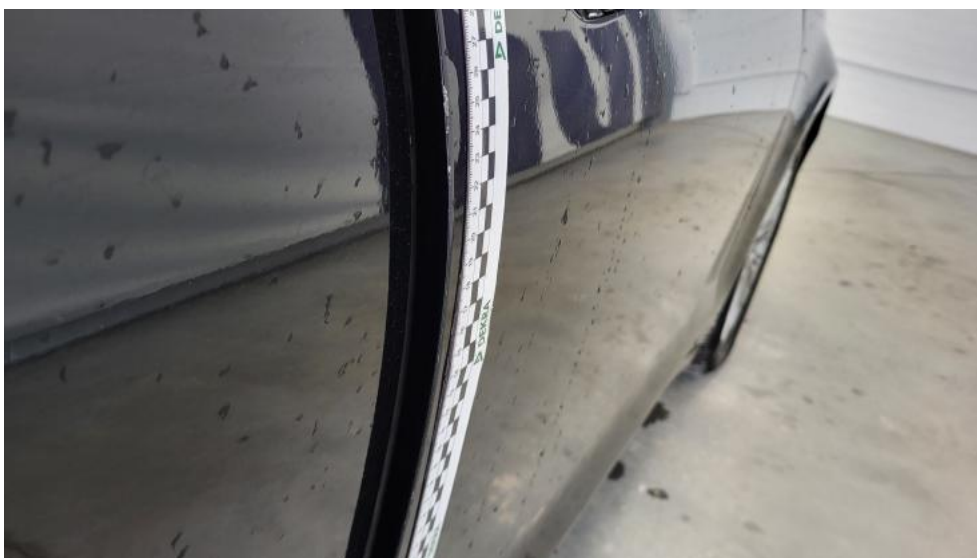
**Photo 46.**

Drzwi przednie P - Rysa/odprysk 1

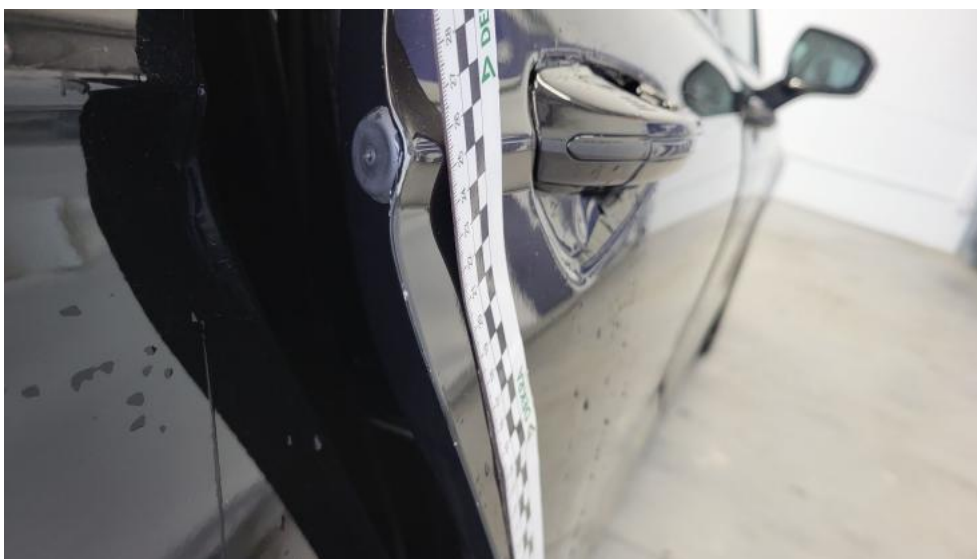
**Photo 47.**

Drzwi tylne P - Rysa/odprysk 1

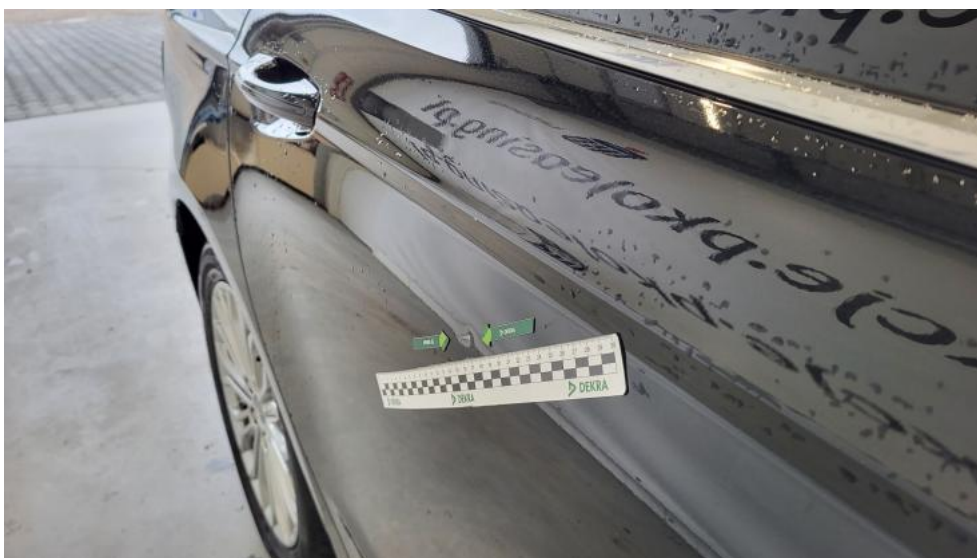
**Photo 48.**

Drzwi tylne P - Wgniecenie/odkształcenie 1

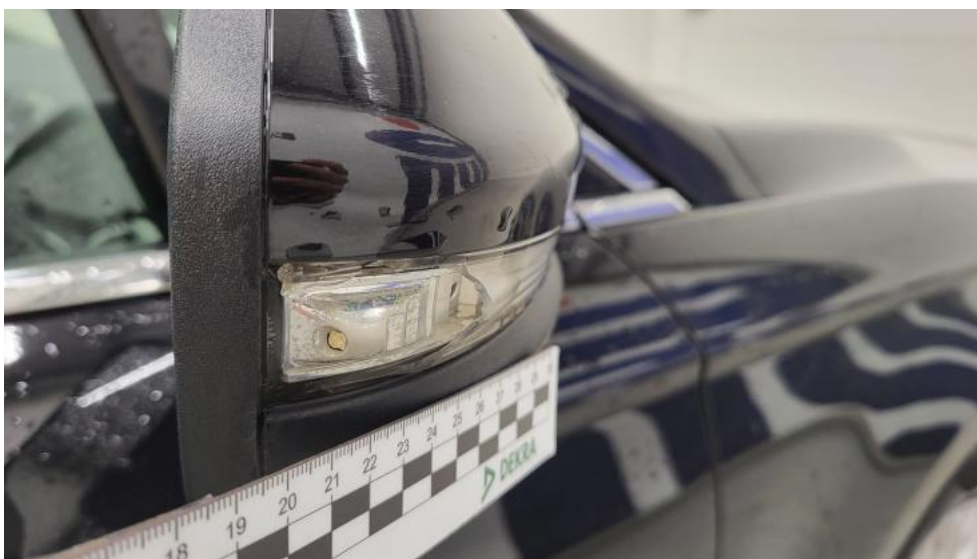
**Photo 49.**

Lusterko zew P - Pęknięcie/rozerwanie 1

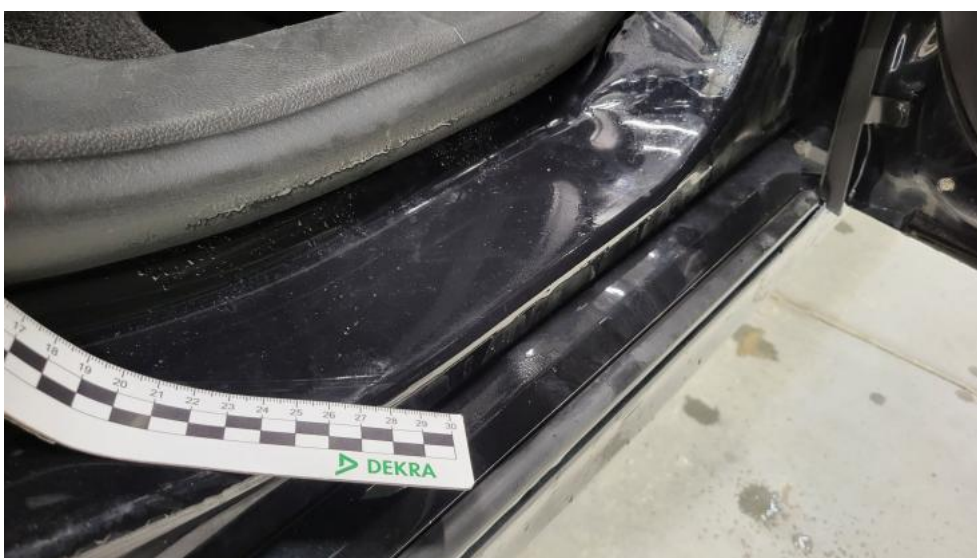
**Photo 50.**

Próg P - Rysa/odprysk 1

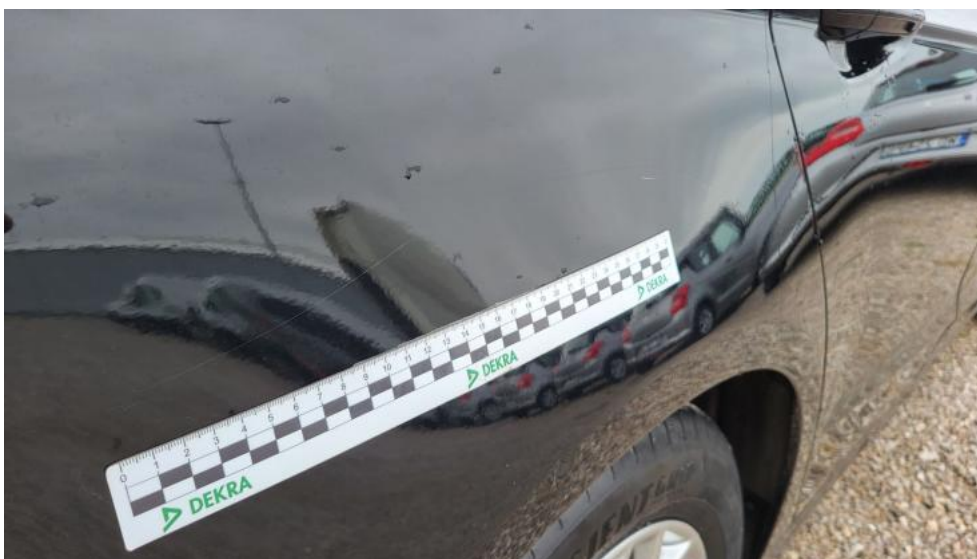
**Photo 51.**

Błotnik tylny P / Ściana boczna P - Rysa/odprysk 1

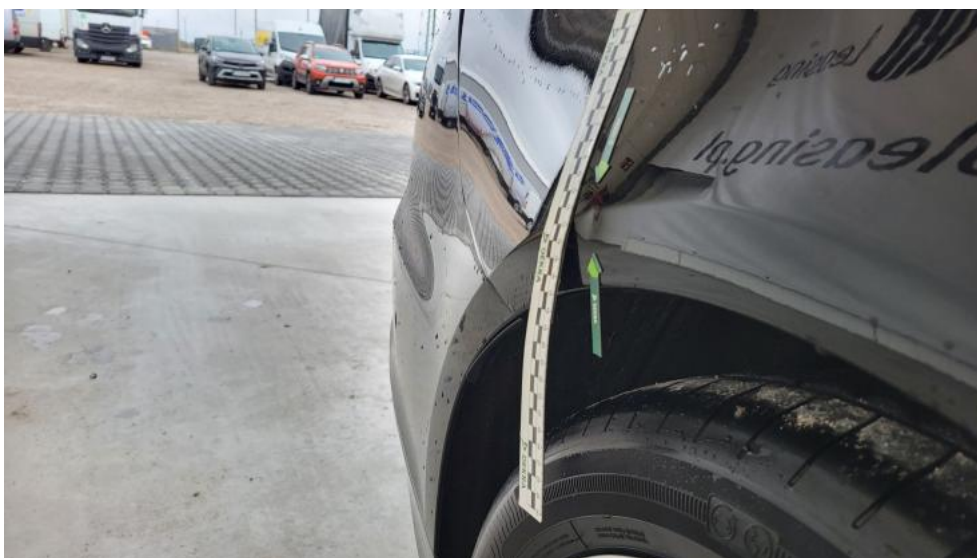
**Photo 52.**

Błotnik tylny P / Ściana boczna P - Wgniecenie/odkształcenie 1

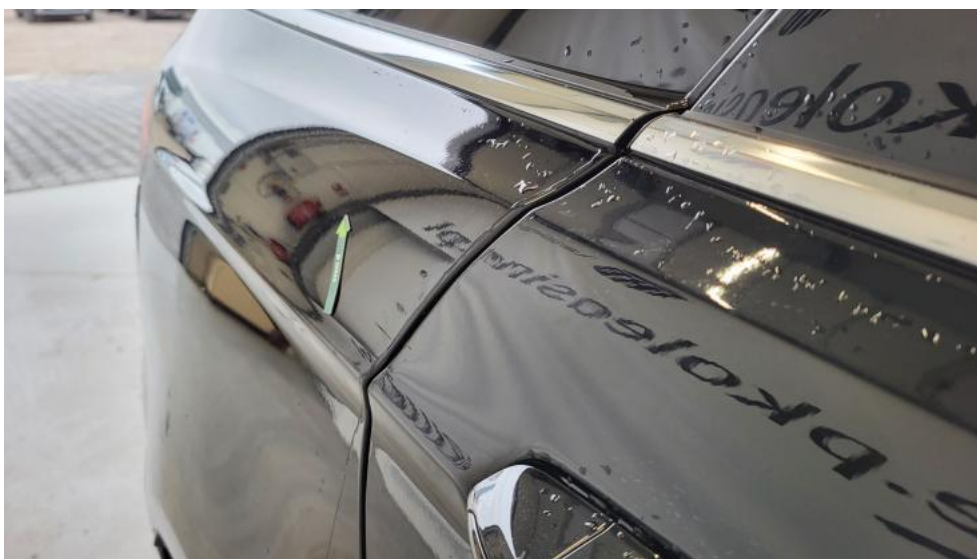
**Photo 53.**

Błotnik tylny P / Ściana boczna P - Wgniecenie/odkształcenie 2

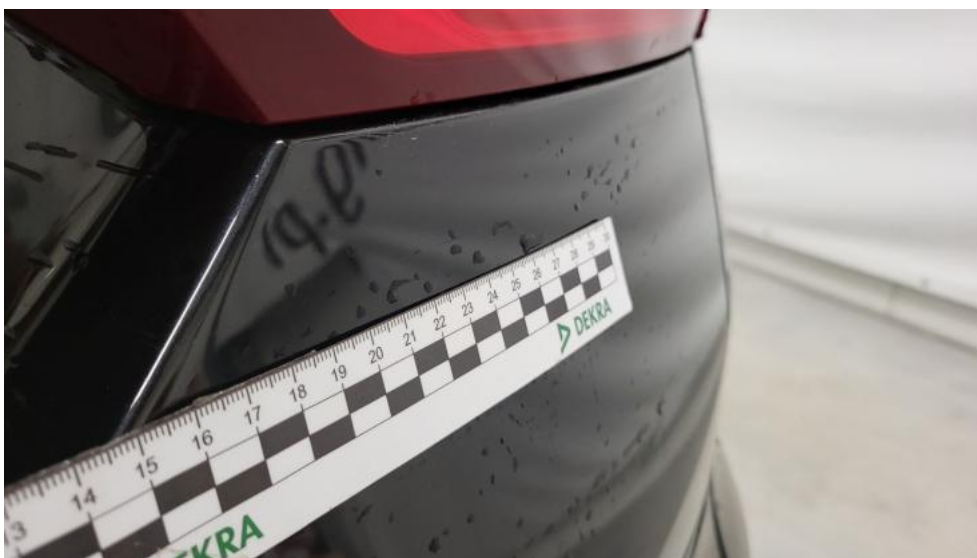
**Photo 54.**

Pokrywy bagażnika - Rysa/odprysk 1

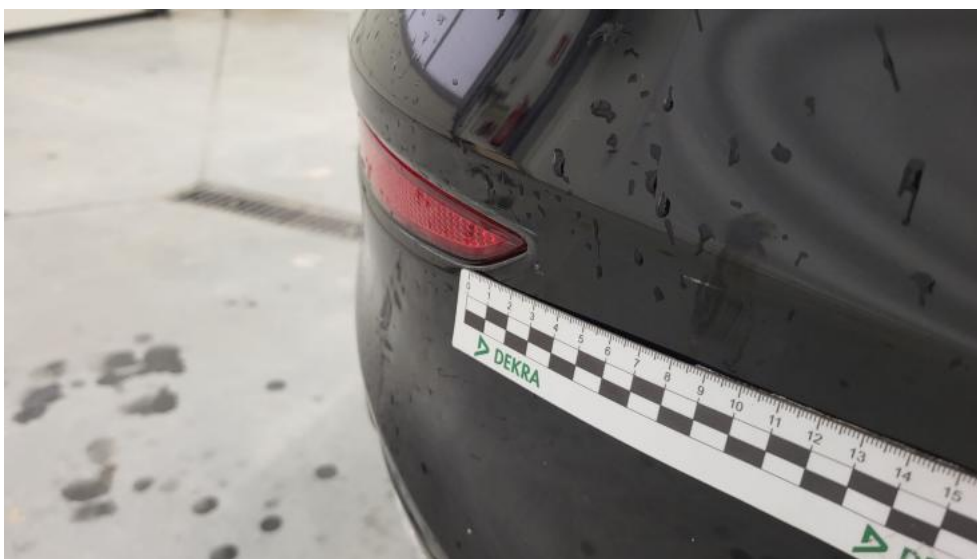
**Photo 55.**

Zderzak tylny - Rysa/odprysk 1

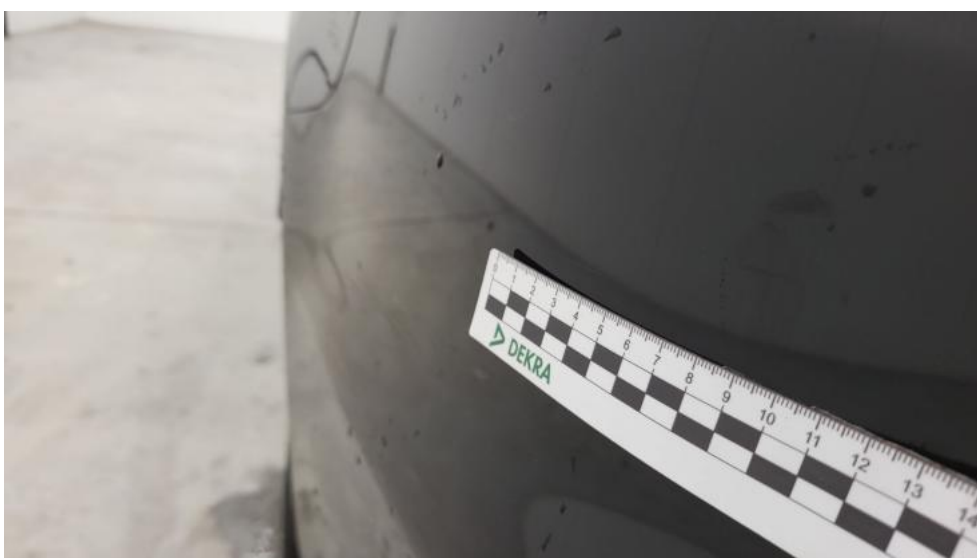
**Photo 56.**

Zderzak tylny - Rysa/odprysk 2

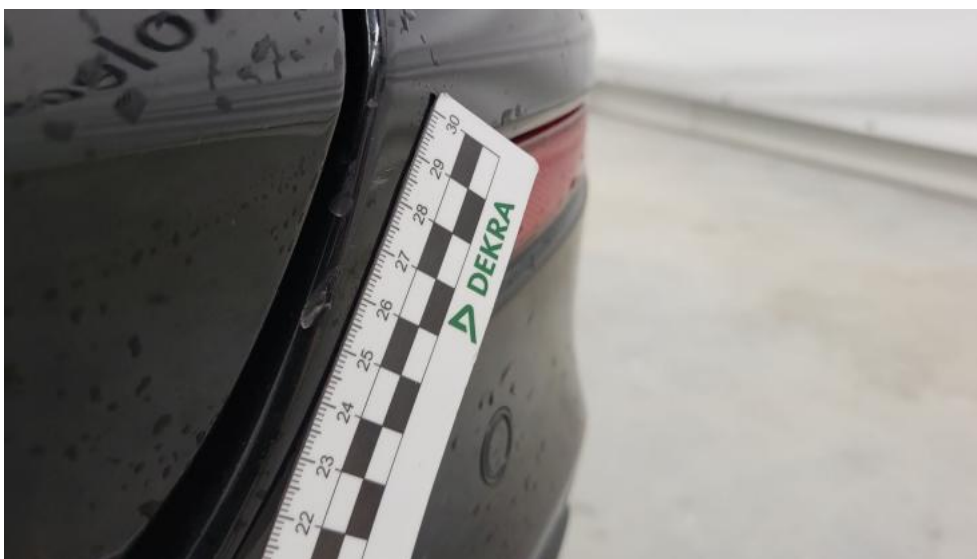
**Photo 57.**

Zderzak tylny() - Rysa/odprysk 3

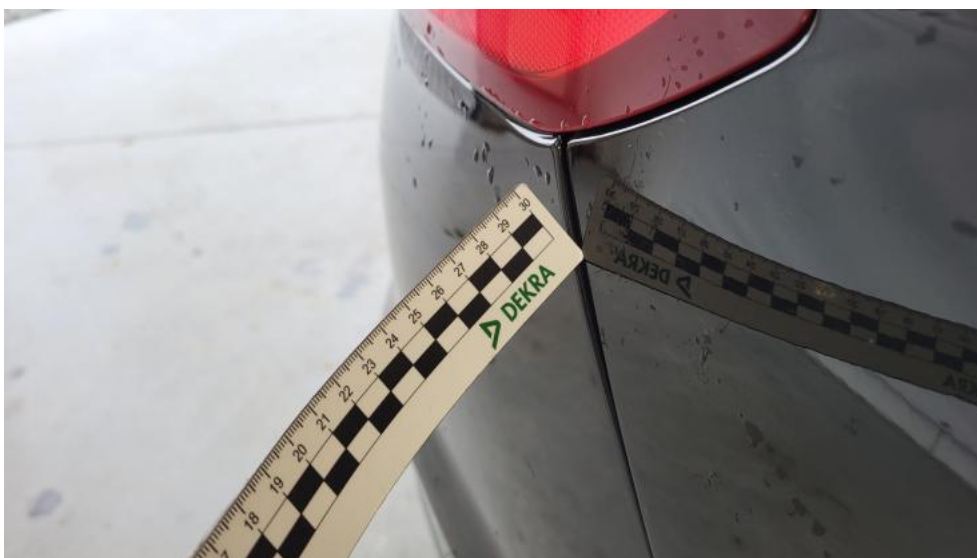
**Photo 58.**

Zderzak tylny - Inne 1

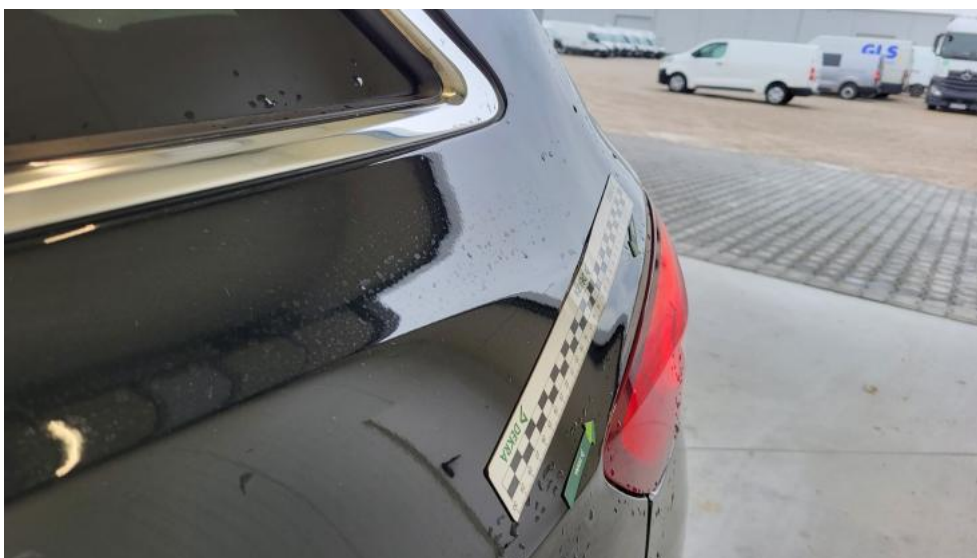
**Photo 60.**

Błotnik tylny L / Ściana boczna L - Wgniecenie/odkształcenie 1

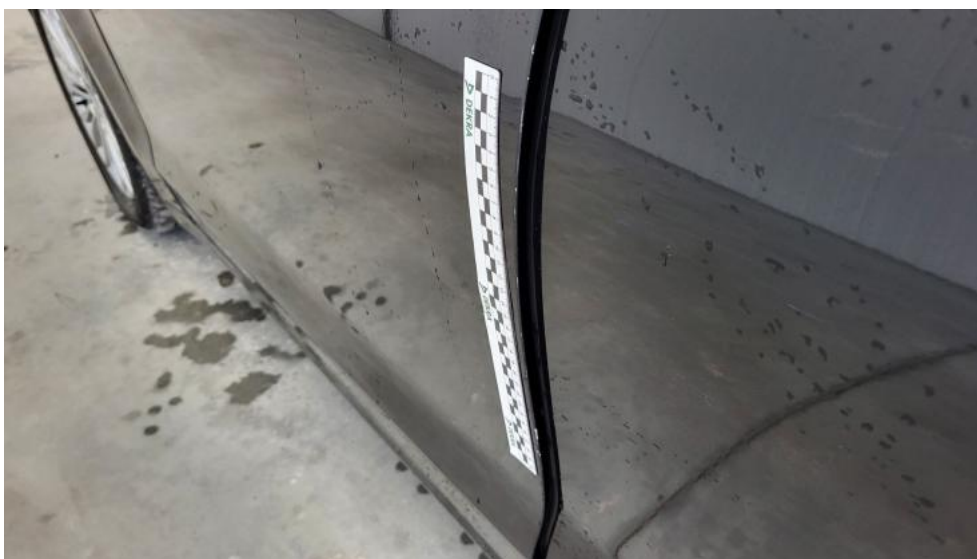
**Photo 61.**

Drzwi przed L - Rysa/odprysk 1

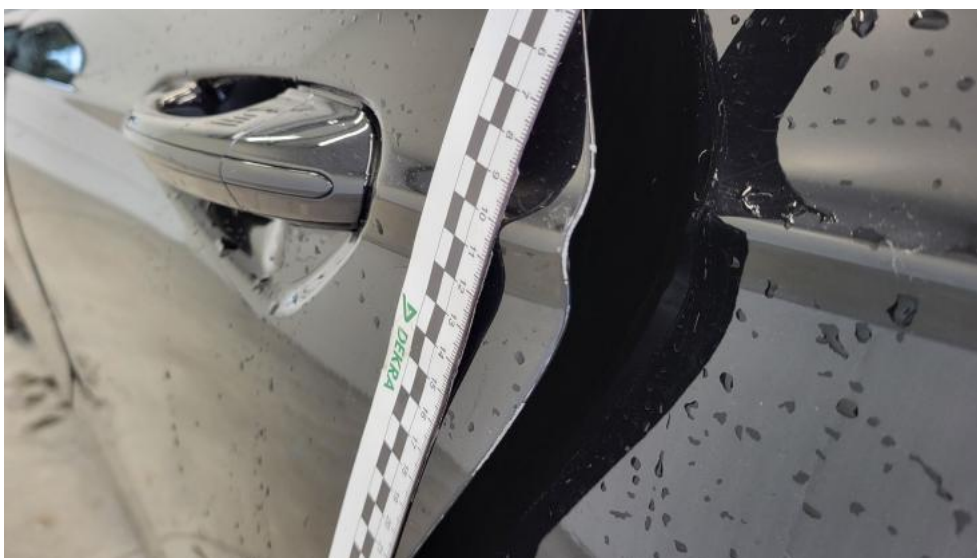
**Photo 62.**

Drzwi tylne L - Rysa/odprysk 1

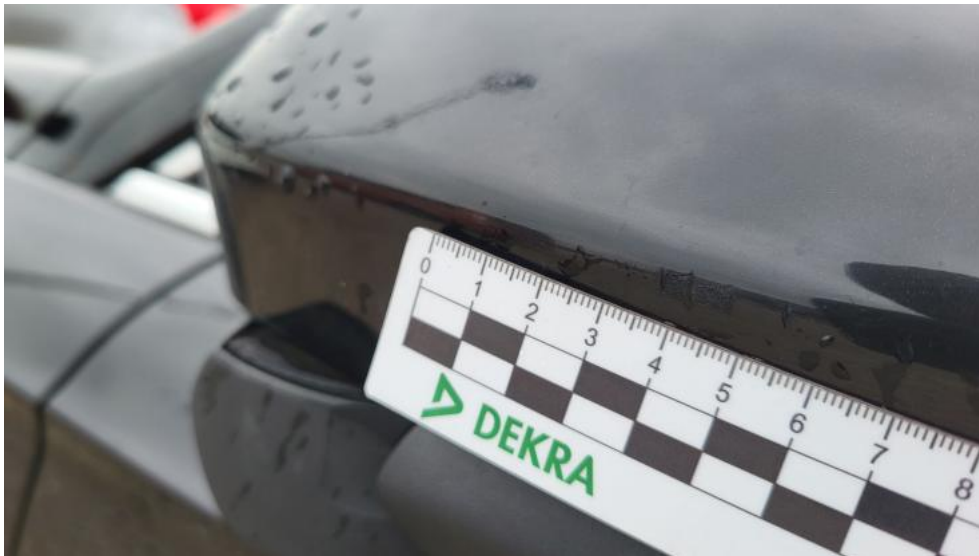
**Photo 63.**

Lusterko zew L - Rysa/odprysk 1

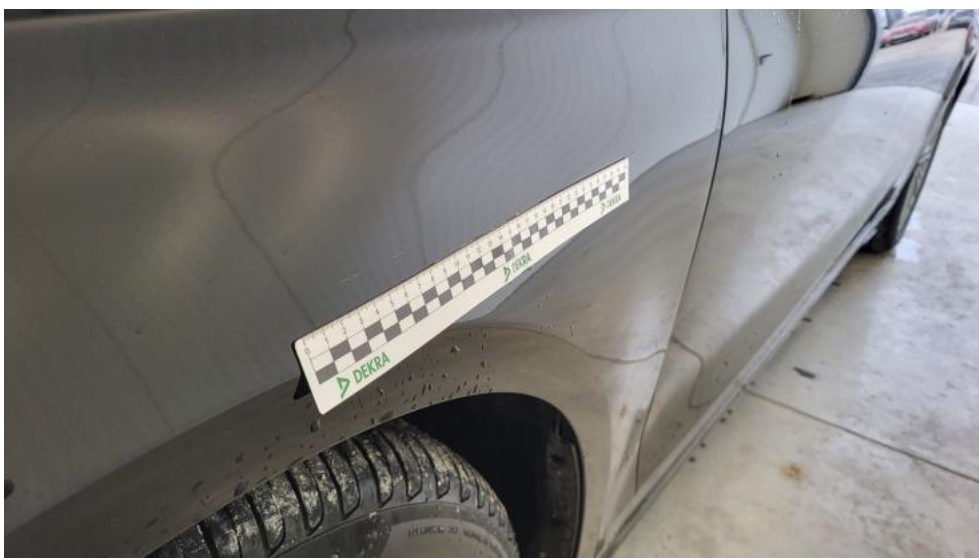
**Photo 64.**

Łotnik przedni L - Rysa/odprysk 1

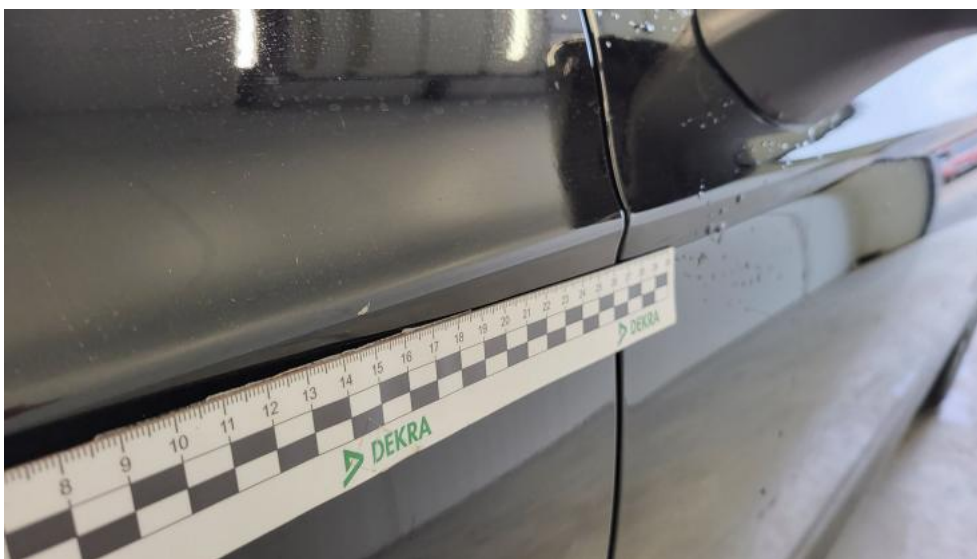
**Photo 65.**

Błotnik przedni L - Rysa/odprysk 2

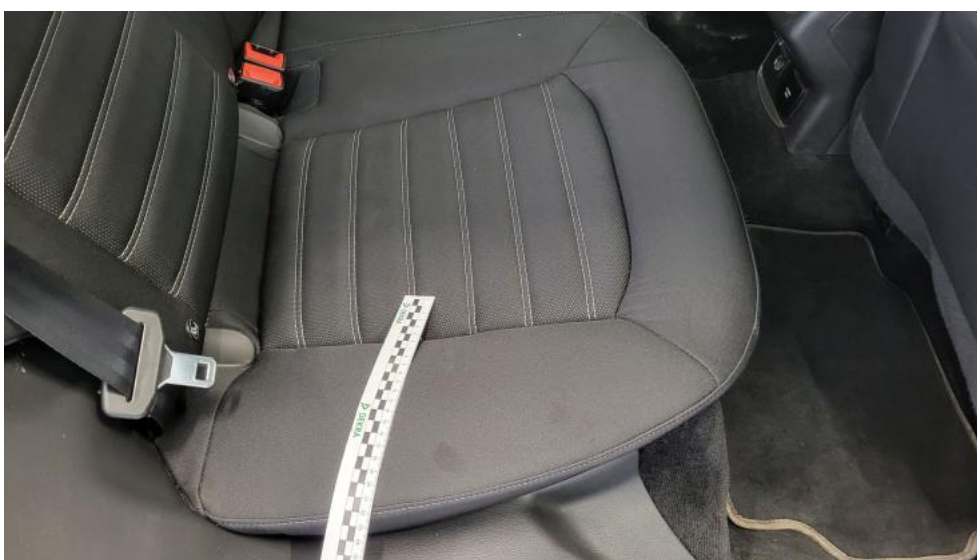
**Photo 66.**

Kanapa tyl. - Inne 1

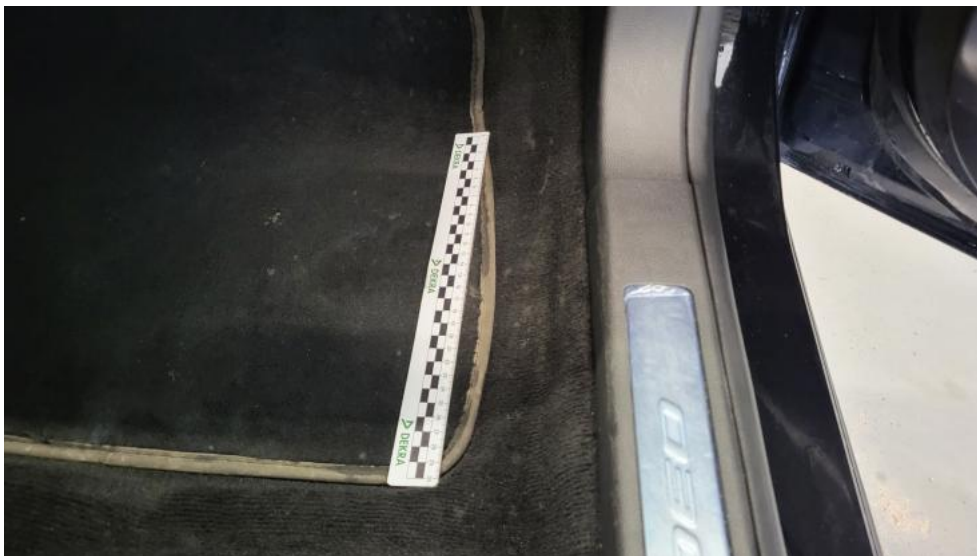
**Photo 67.**

Wykładzina podłogi - Inne 1
