DEKRA's commission No. : PKOL(W)/LODZ/69897/25/09/17  
commission/ damage No. : 24/041894  
Date of commission: 17-09-2025

| Manufacturer | KIA |
| Model | EV6 21-25 |
| Registration /record No. | WR057GU |

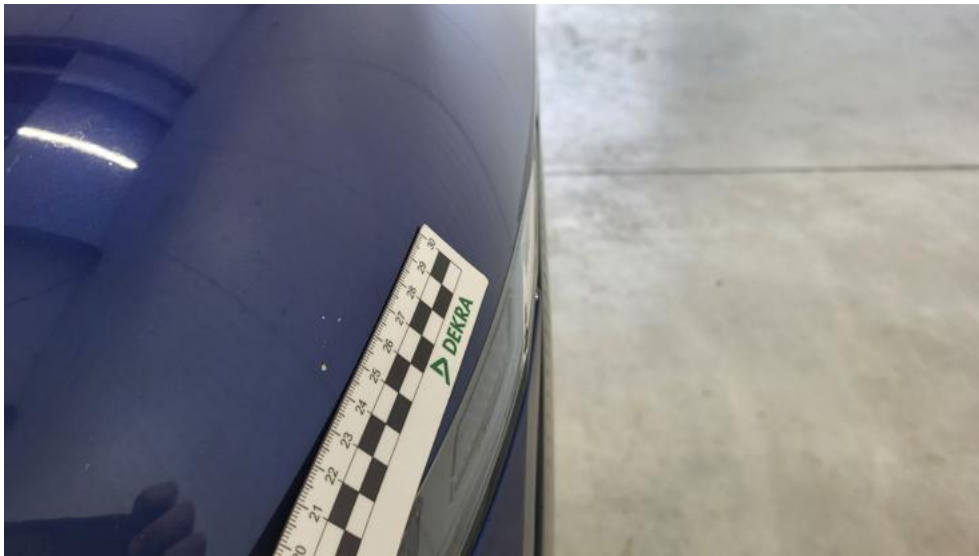
**Photo 45.**

Pokrywa komory silnika - Rysa/odprysk 1

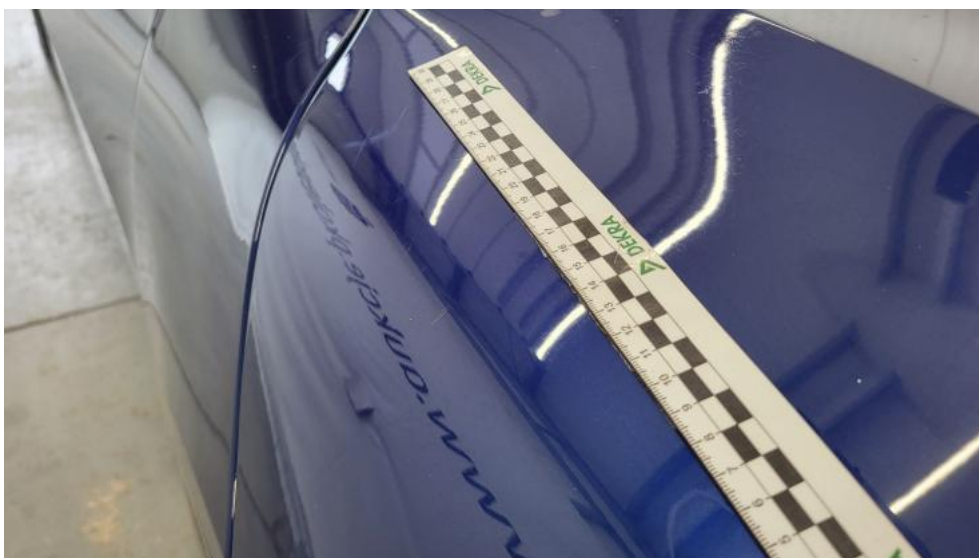
**Photo 46.**

Pokrywa komory silnika - Rysa/odprysk 2

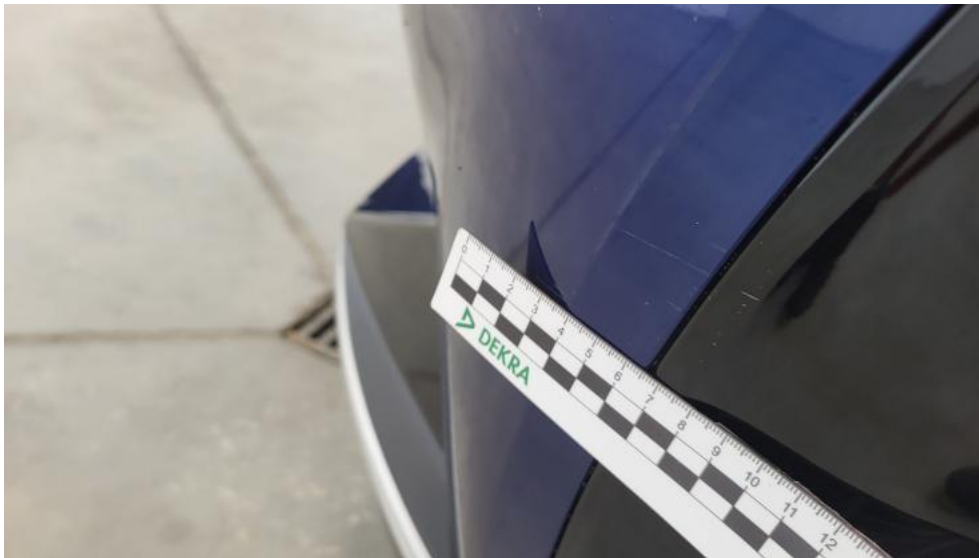
**Photo 47.**

Zderzak - Rysa/odprysk 1

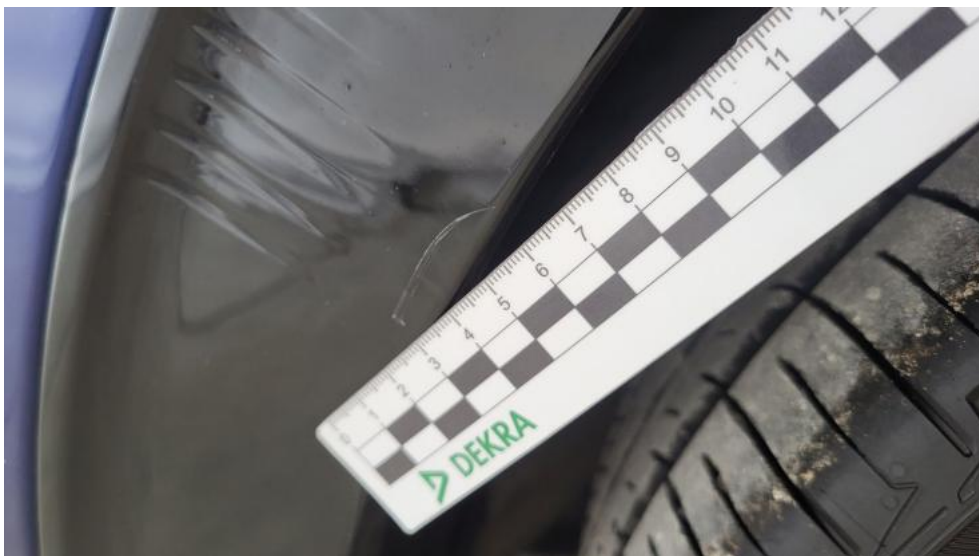
**Photo 48.**

Listwa błotnika przedniego P - Rysa/odprysk 1

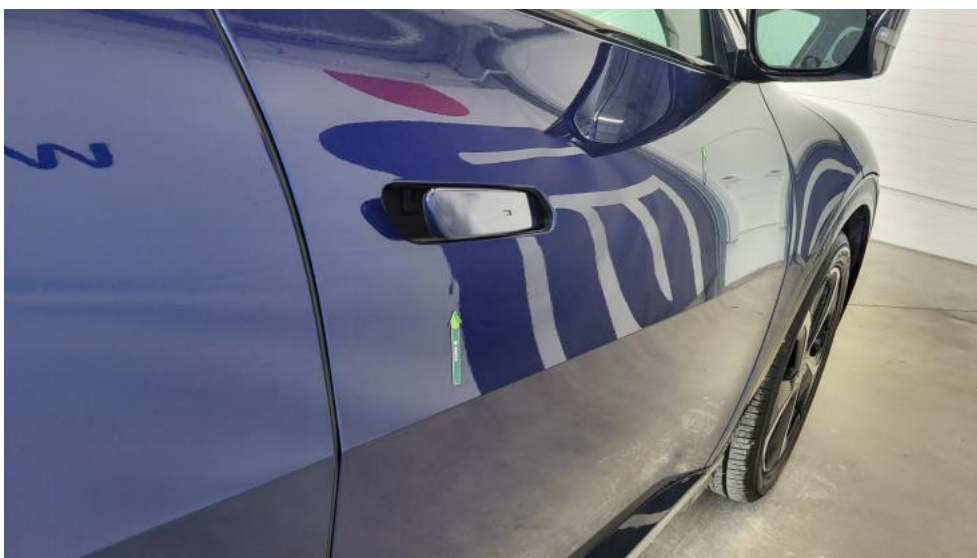
**Photo 50.**

Drzwi przednie P - Wgniecenie/odkształcenie 1

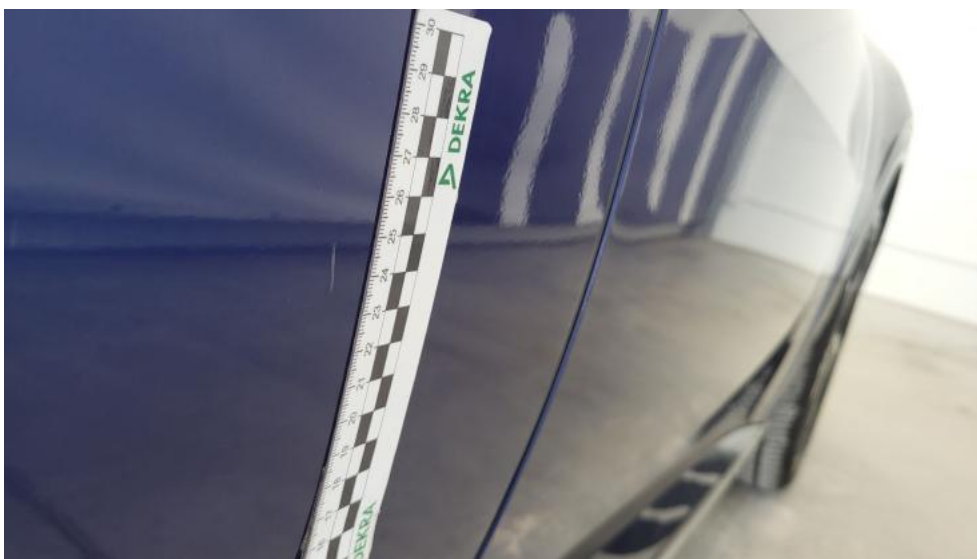
**Photo 51.**

Drzwi tylne P - Rysa/odprysk 1

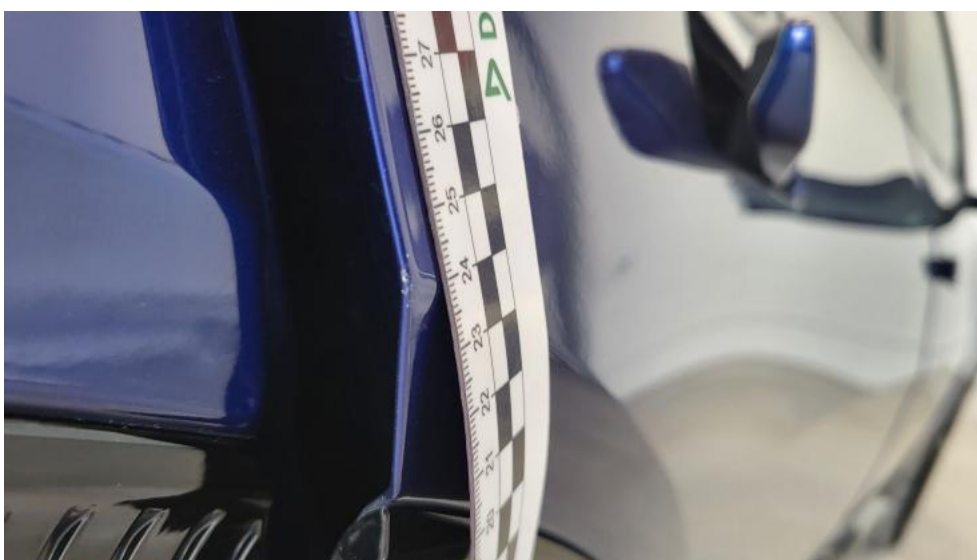
**Photo 52.**

Drzwi tylne P - Rysa/odprysk 2

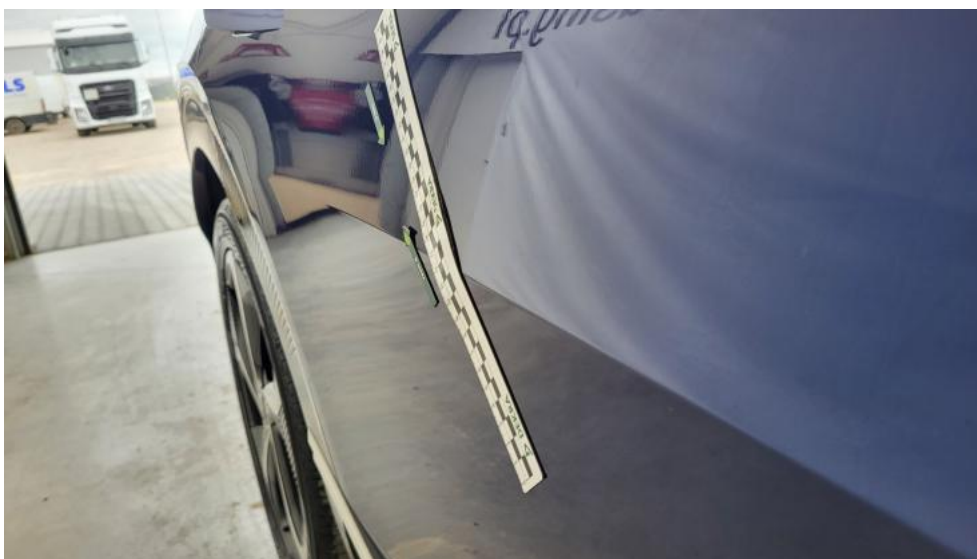
**Photo 53.**

Drzwi tylne P - Wgniecenie/odkształcenie 1

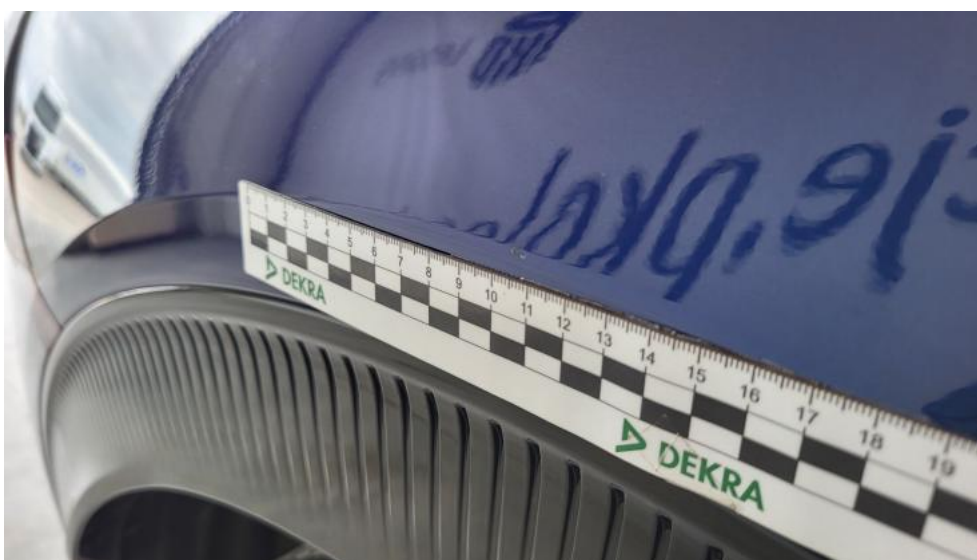
**Photo 54.**

Łotnik tylny P / Ściana boczna P - Rysa/odprysk 1

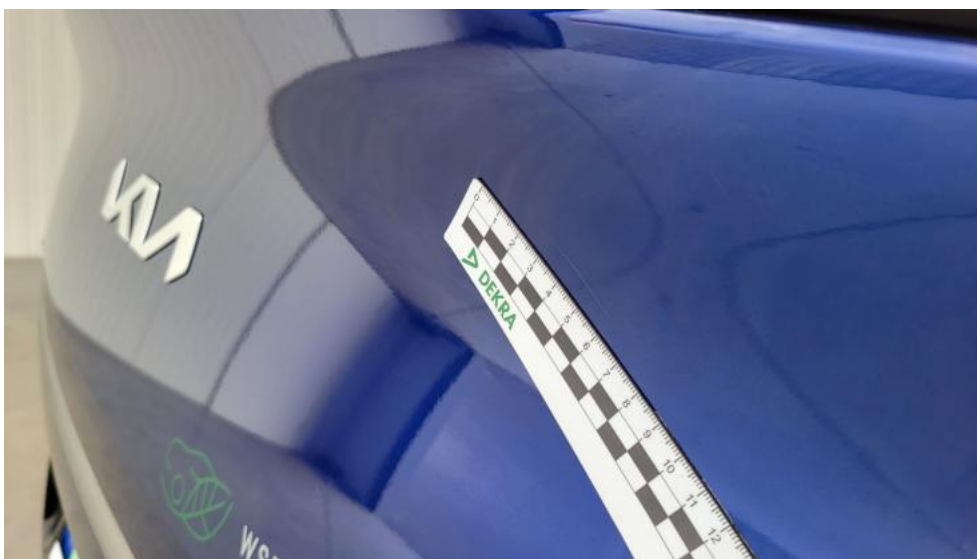
**Photo 55.**

Pokrywy bagażnika - Rysa/odprysk 1

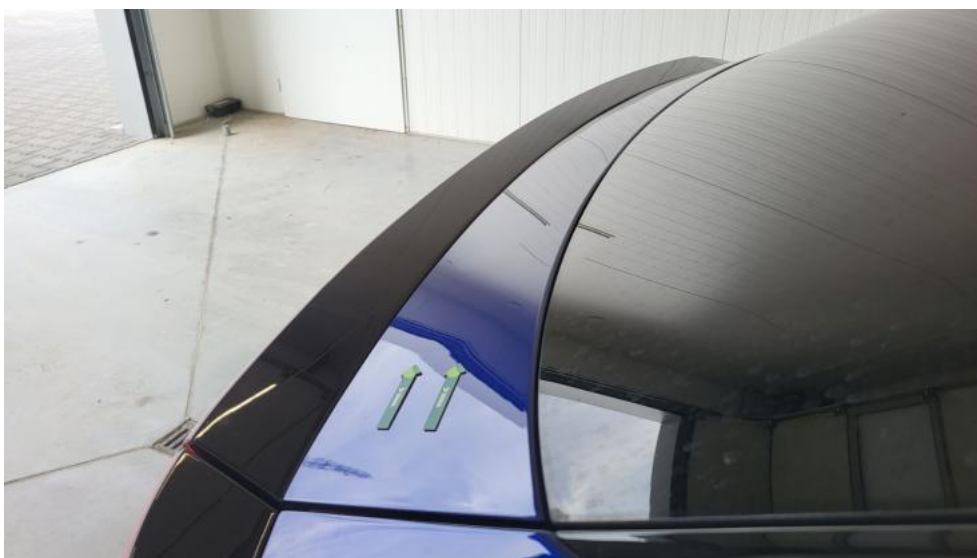
**Photo 56.**

Pokrywy bagażnika - Wgniecenie/odkształcenie 1

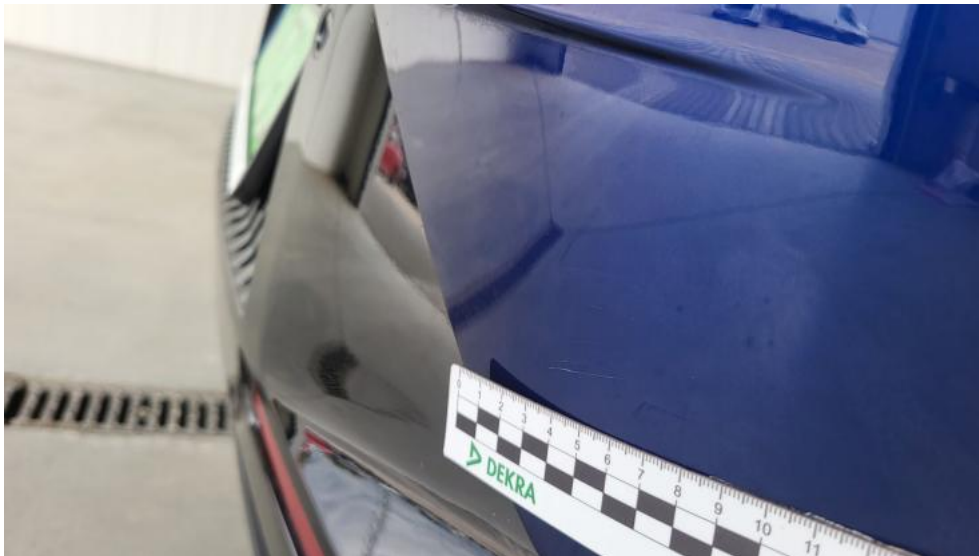
**Photo 57.**

Zderzak tylny - Rysa/odprysk 1

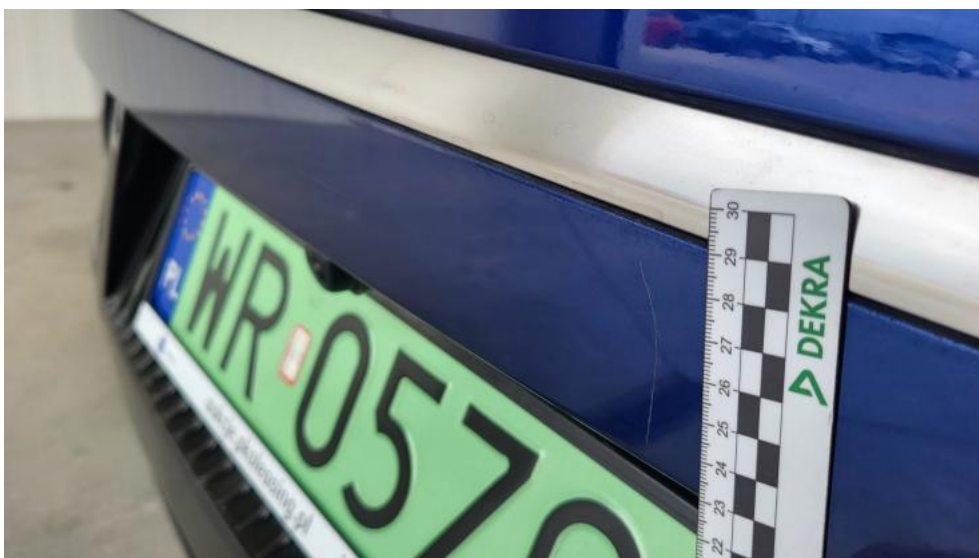
**Photo 58.**

Zderzak tylny - Rysa/odprysk 2

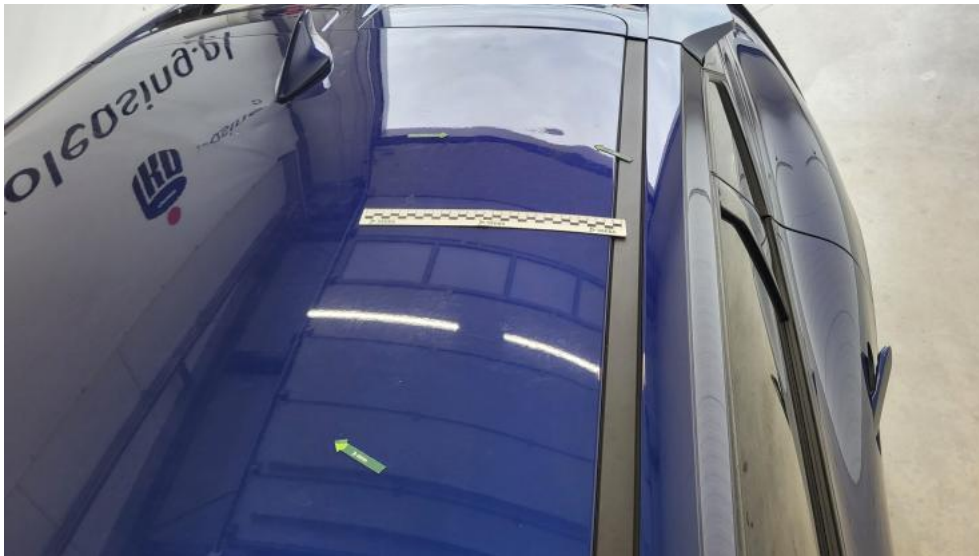
**Photo 61.**

Dach - Wgniecenie/odkształcenie 2

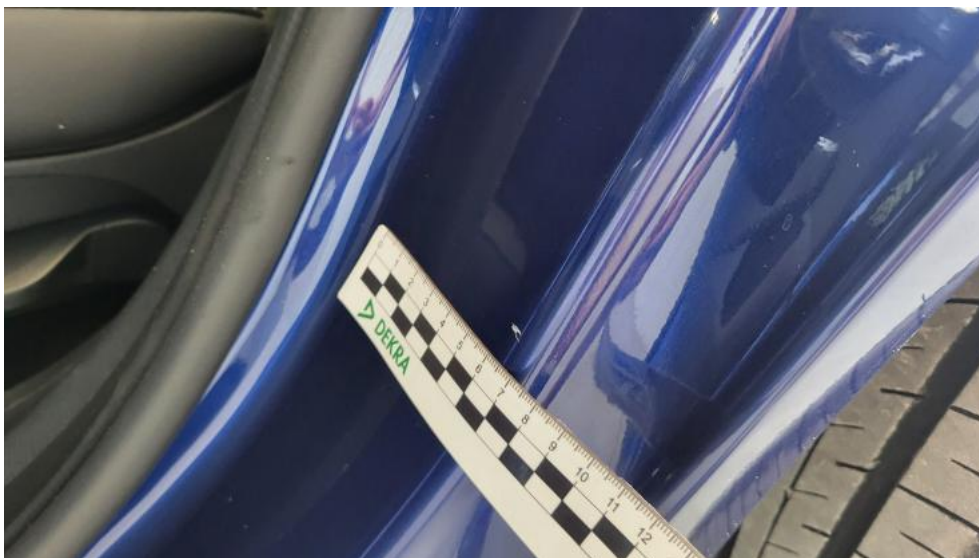
**Photo 62.**

Łotnik tylny L / Ściana boczna L - Rysa/odprysk 1

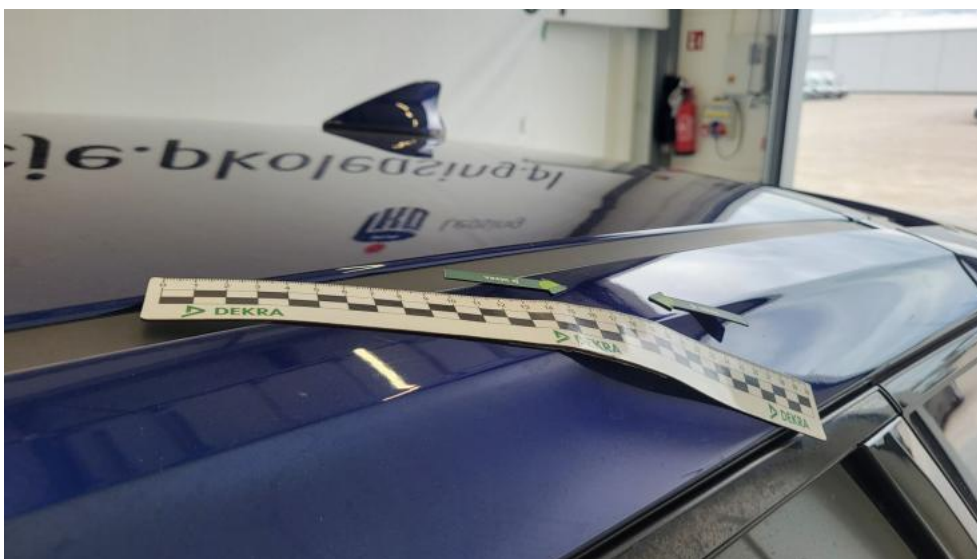
**Photo 63.**

Błotnik tylny L / Ściana boczna L - Wgniecenie/odkształcenie 1

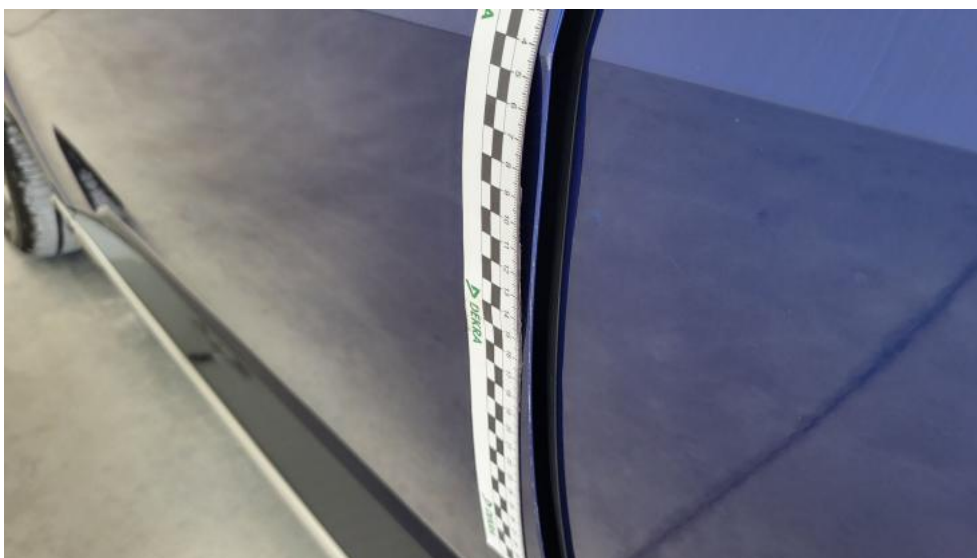
**Photo 64.**

Drzwi przed L - Rysa/odprysk 1

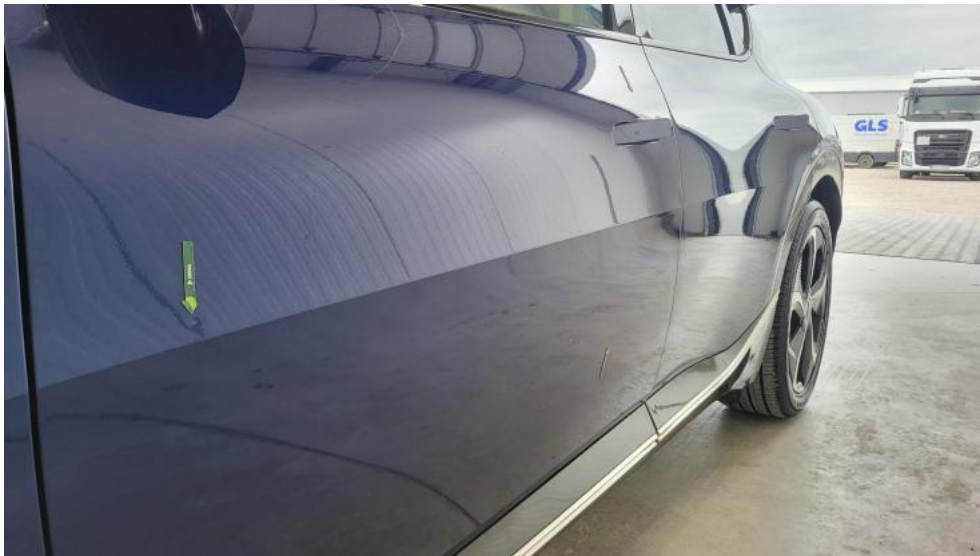
**Photo 65.**

Drzwi przed L - Wgniecenie/odkształcenie 1

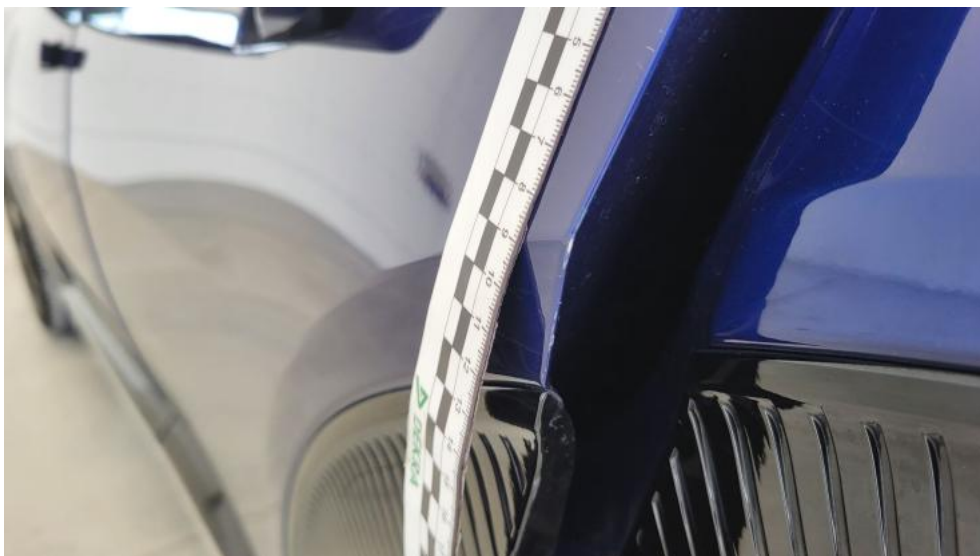
**Photo 66.**

Drzwi tylne L - Rysa/odprysk 1

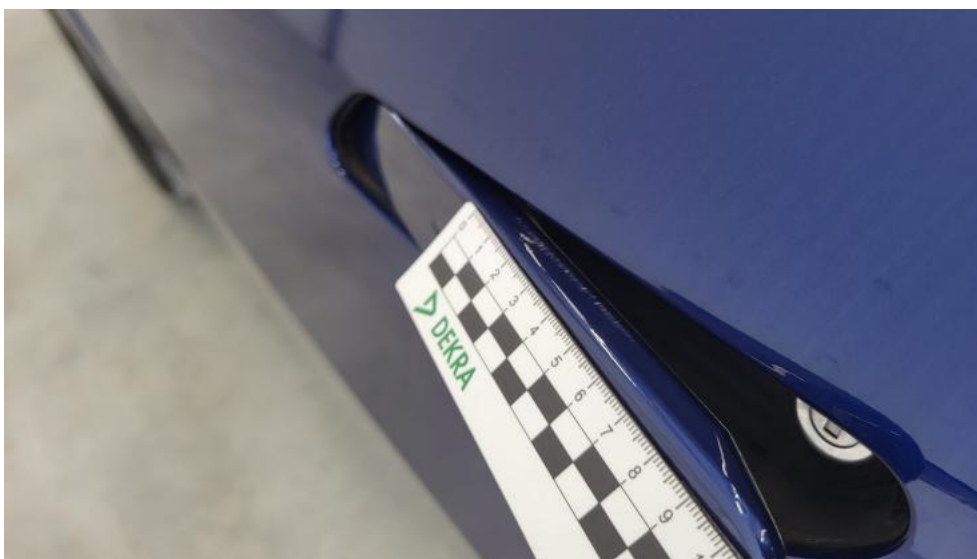
**Photo 67.**

Klamka drzwi prz L - Rysa/odprysk 1

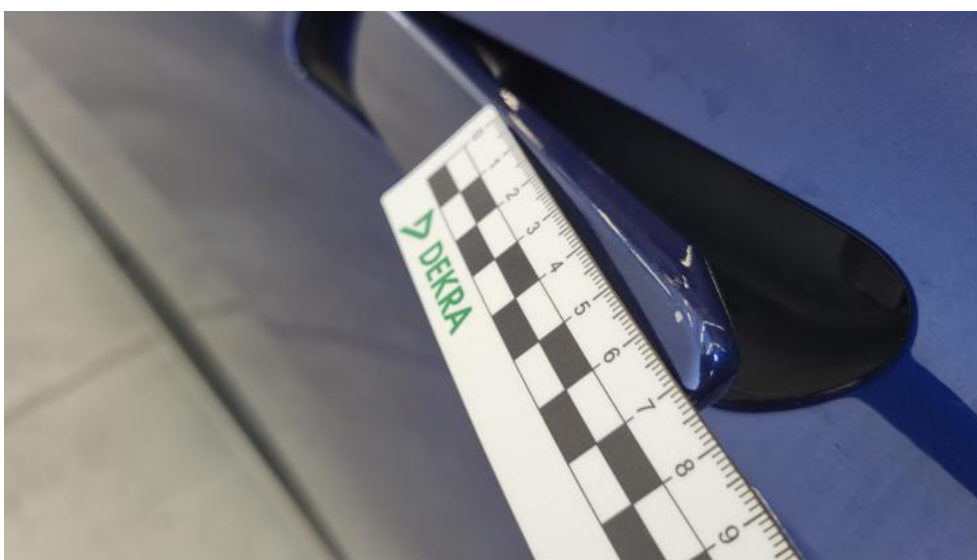
**Photo 68.**

Klamka drzwi tyl L - Rysa/odprysk 1

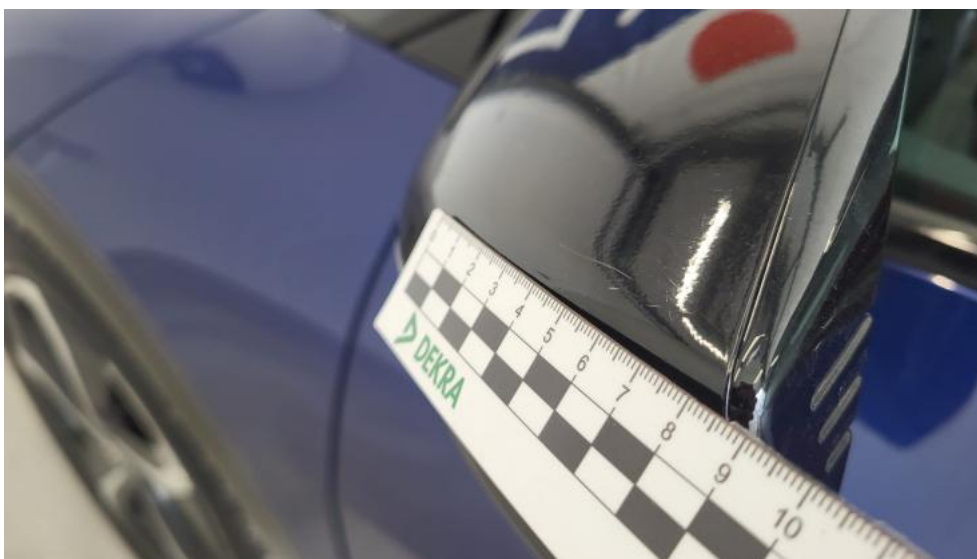
**Photo 69.**

Lusterko zew L - Rysa/odprysk 1

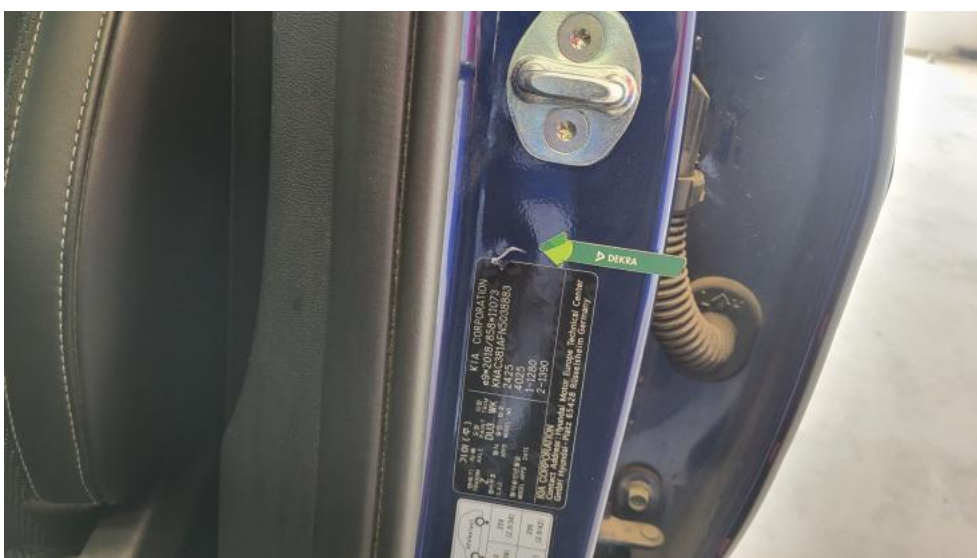
**Photo 70.**

Słupek środkowy L - Wgniecenie/odkształcenie 1

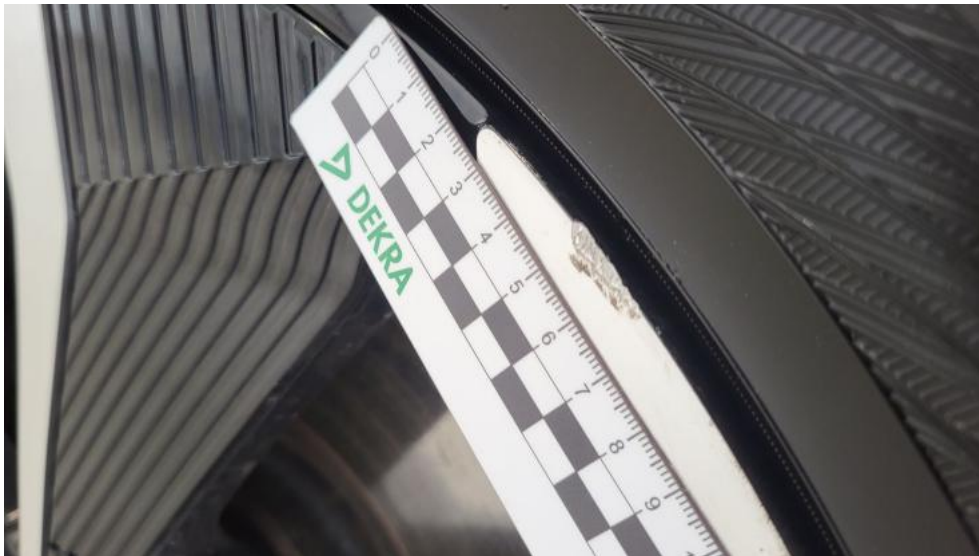
**Photo 71.**

Felga Alumiowa przednia L - Rysa/odprysk 1

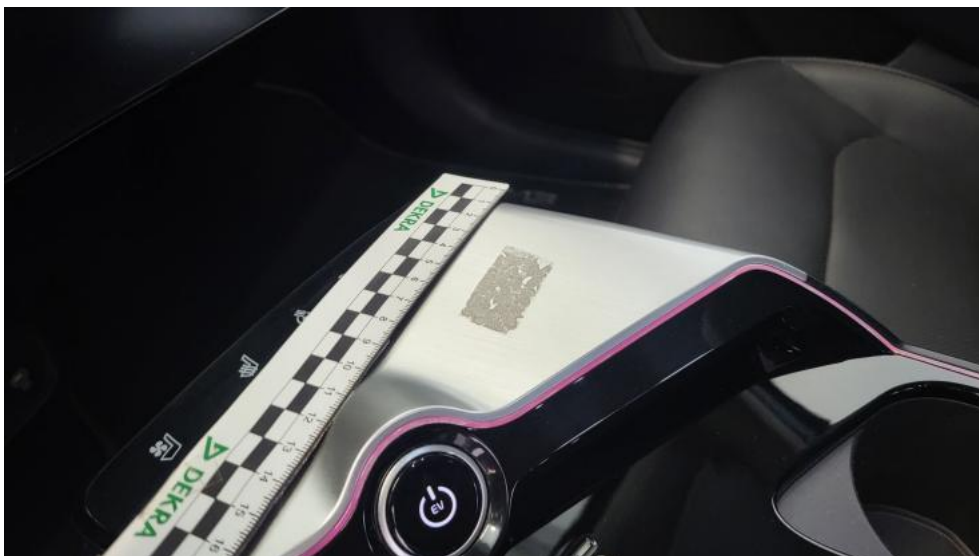
**Photo 72.**

Konsola tunelu śr. - Inne 1

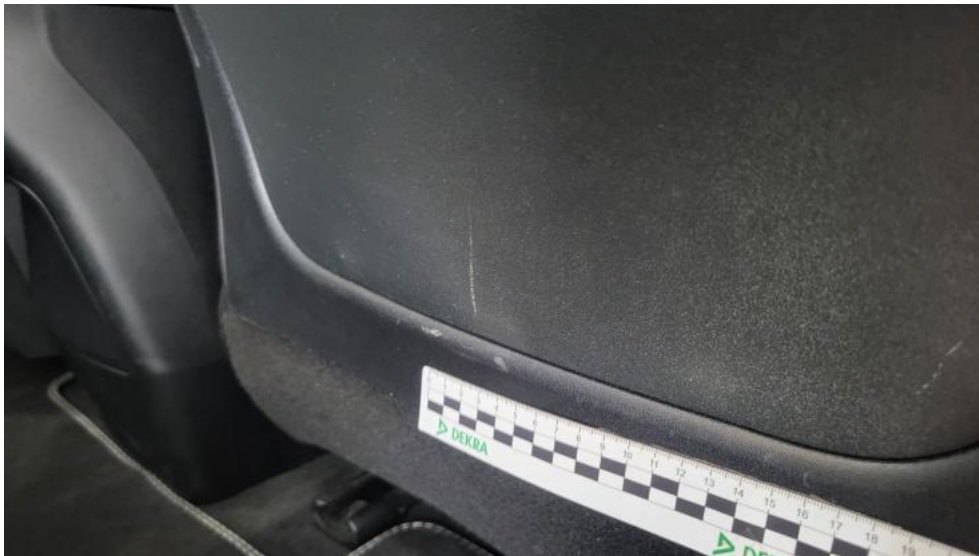
**Photo 73.**

Fotel prz. praw. - Rysa/odprysk 1

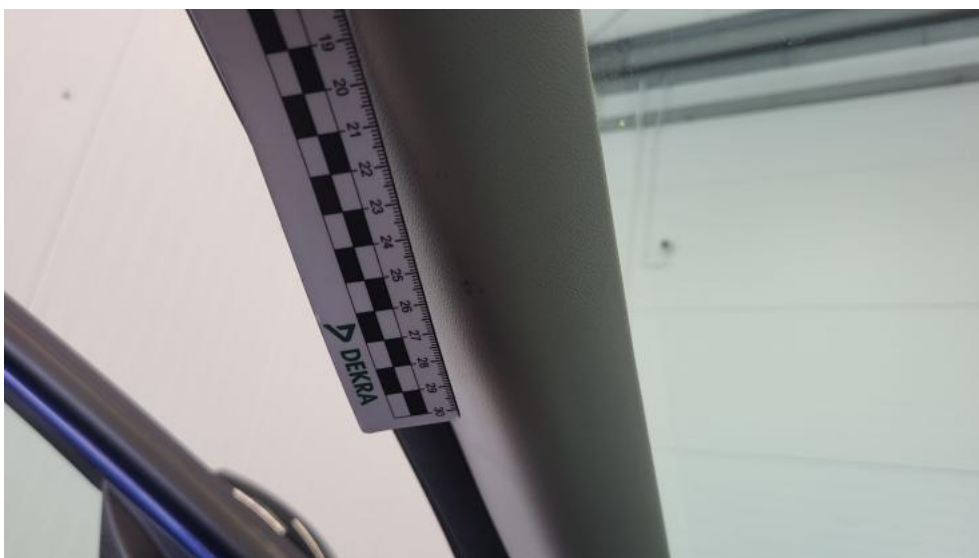
**Photo 74.**

Wykładzina(y) słupka przedniego L - Inne 1

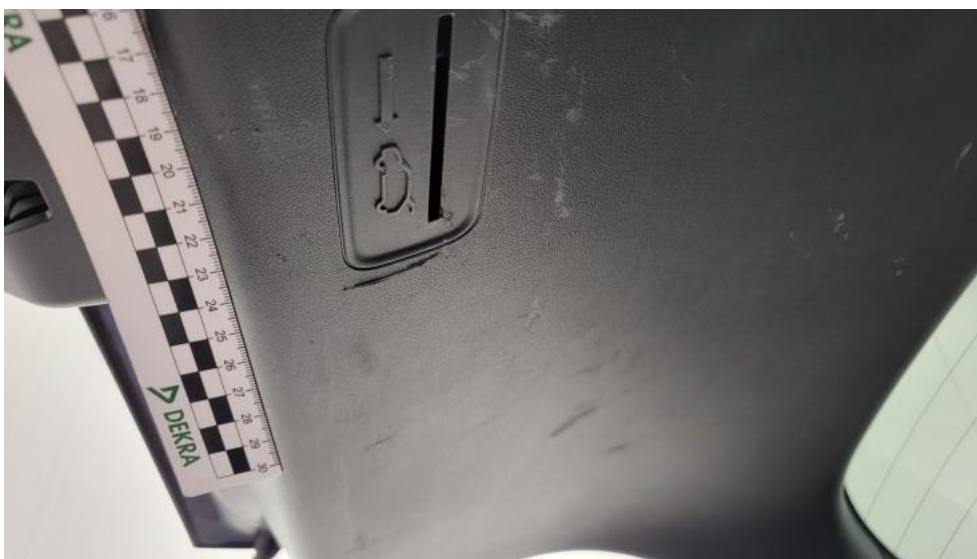
**Photo 75.**

Wykładzina pokrywy tylnej - Rysa/odprysk 1
