DEKRA' s commission No. : PKOL(W)/LODZ/92778/24/12/02
 commission/ damage No. : 22/032372
 Date of commission: 02-12-2024

Vehicle data

Group of objects (Eurotax)	cars
EC code (Eurotax)	0138626
Manufacturer	OPEL
Model	Corsa F Hatchback 19-23
Type / version	Corsa 1.2 Edition S&S
Body type	hatchback
Number of doors / seats	5/5
Curb weight [kg]	1024
Gross vehicle weight [kg]	1550
Wheelbase 1/2	2538
Engine type	spark ignition
Pollution reduction system	GPF
Engine capacity [ccm]	1199
Engine Power [hp/kW]	75/55
Gearbox	manual 5- gear
Registration /record No.	EL6GF67
VIN / serial number	VXKUPHMHDN4353199
Date of first registration	29-09-2022
Date of next. tech. test	29-09-2025
Year of manufacture	2022 (year has been verified with the manufacturer's base)
Readout [km]	39 540 (read)
Body color / type of coating	white/UNI

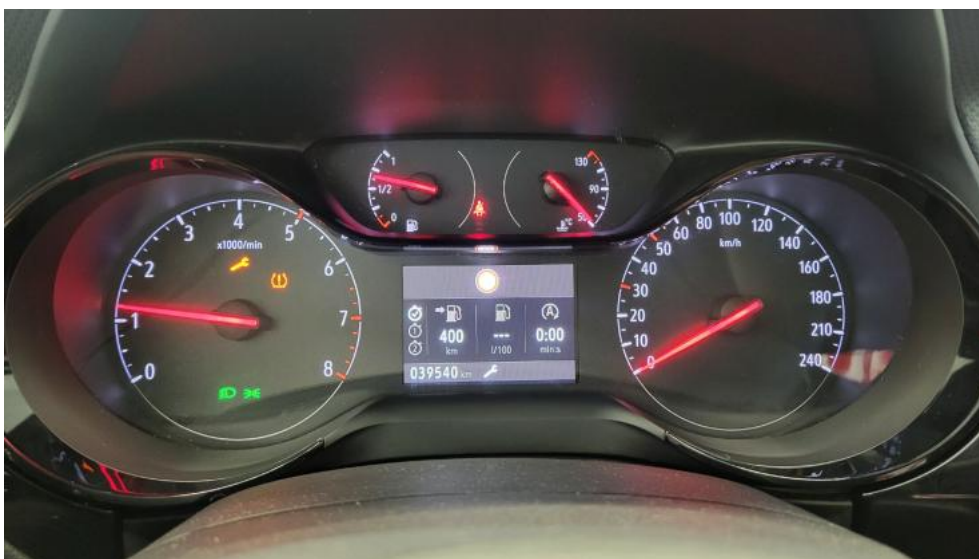
Photo 23.

Przegląd przekroczony o 26120 km. Aktywna kontrolka serwisu. Aktywna kontrolka ciśnienia w oponach. Rysy na samochodzie. Lewy zagłówek tylnej kanapy w bagażniku.

Zestaw wskaźników - przebieg

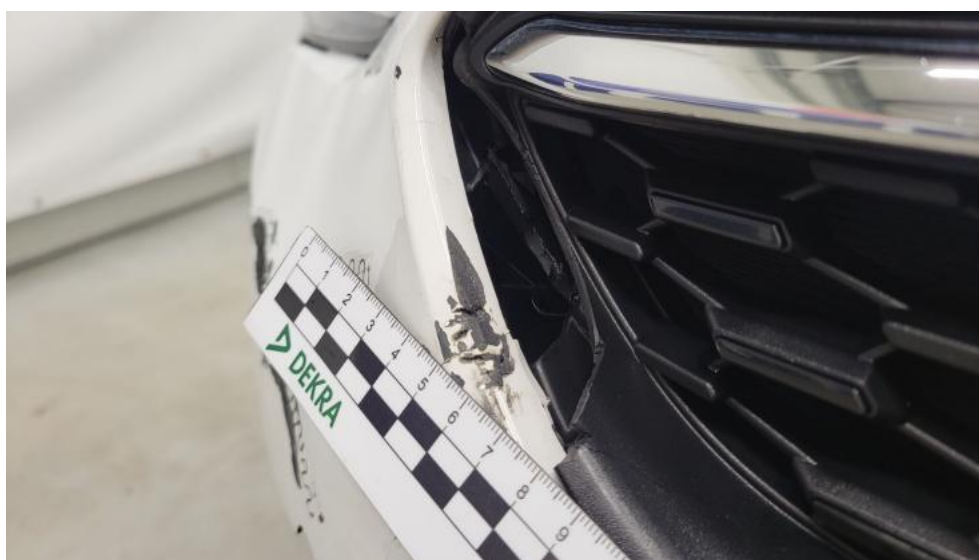
Photo 38.
Atrapa przednia - Pęknięcie/rozerwanie 1

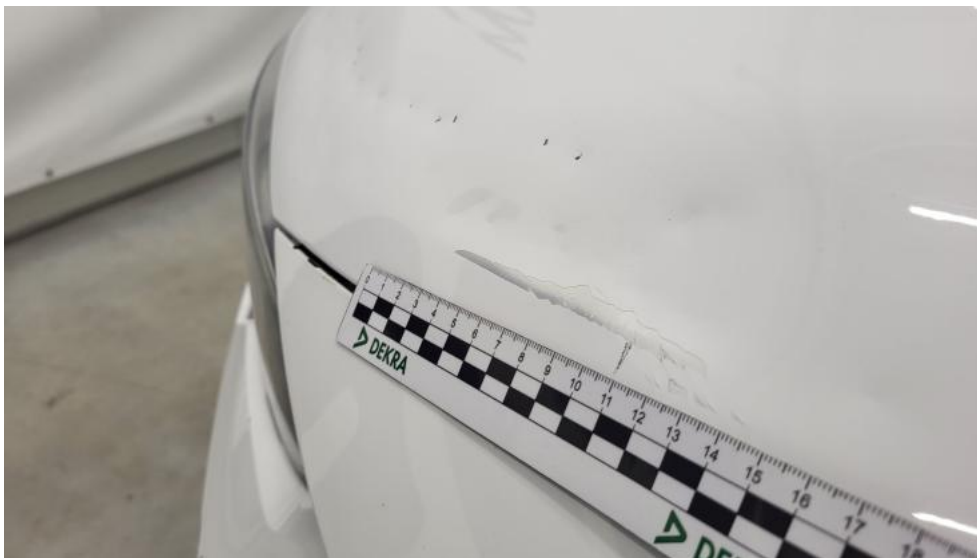
Photo 41.
Pokrywa komory silnika - Rysa/odprysk 1

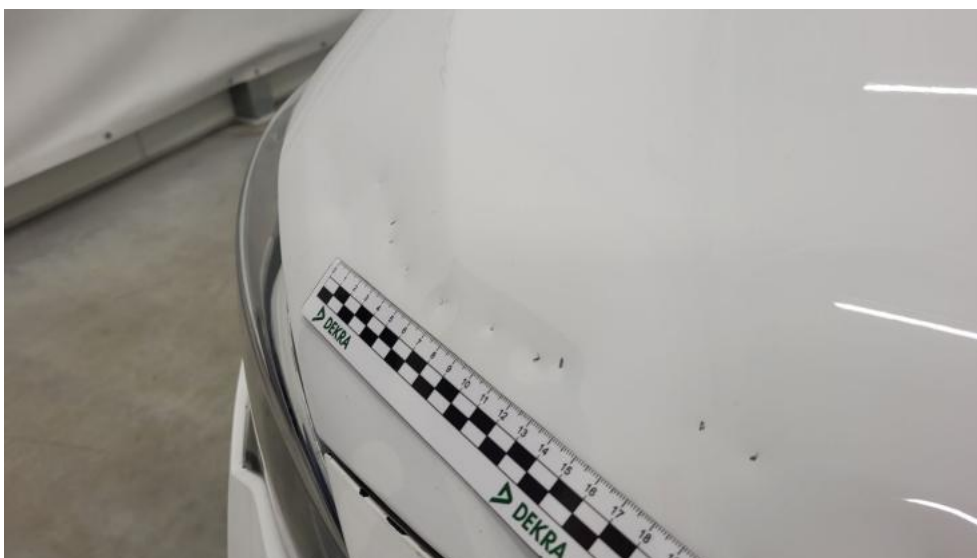
Photo 42.
Pokrywa komory silnika - Rysa/odprysk 2

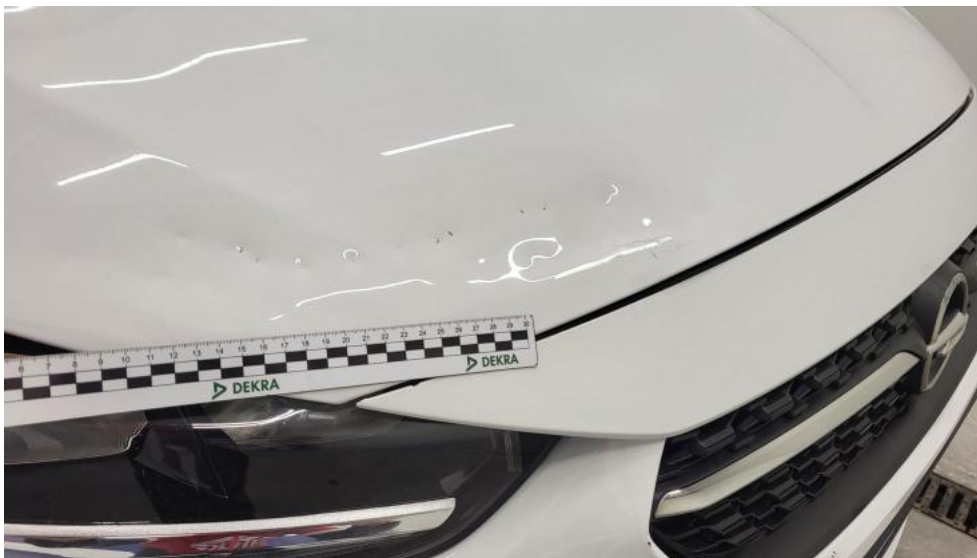
Photo 43.
Pokrywa komory silnika - Wgniecenie/odkształcenie 1

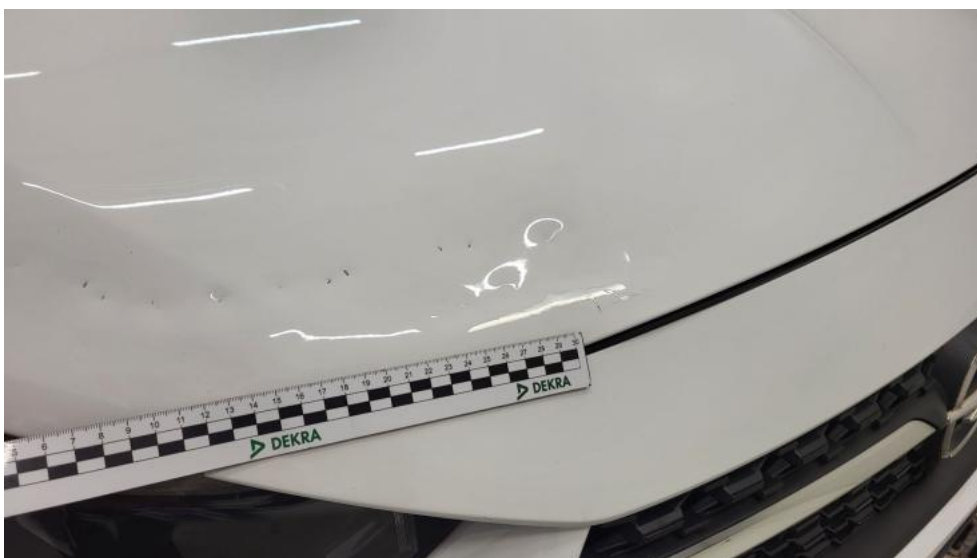
Photo 44.
Pokrywa komory silnika - Wgniecenie/odkształcenie 2

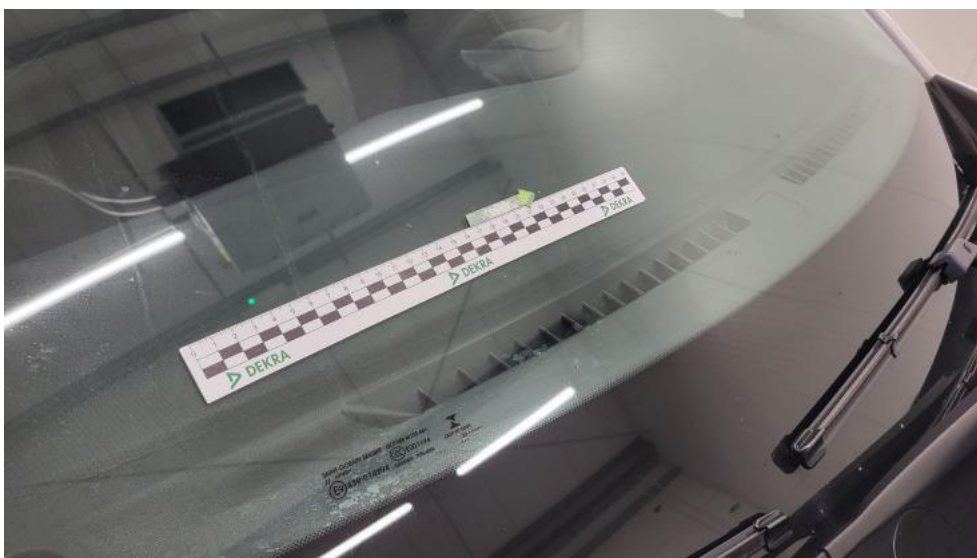
Photo 46.
Szyba czołowa - Rysa/odprysk 1

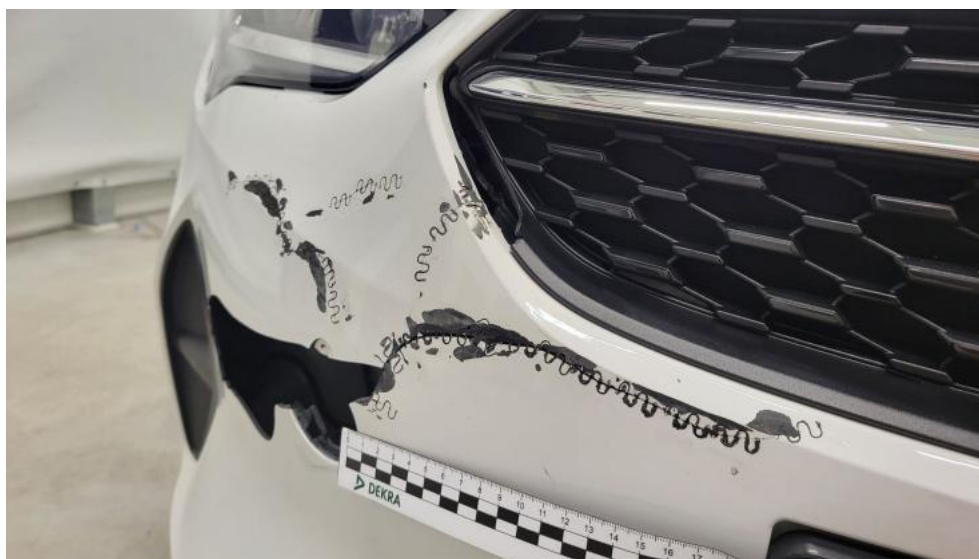
Photo 47.
Zderzak - Rysa/odprysk 1

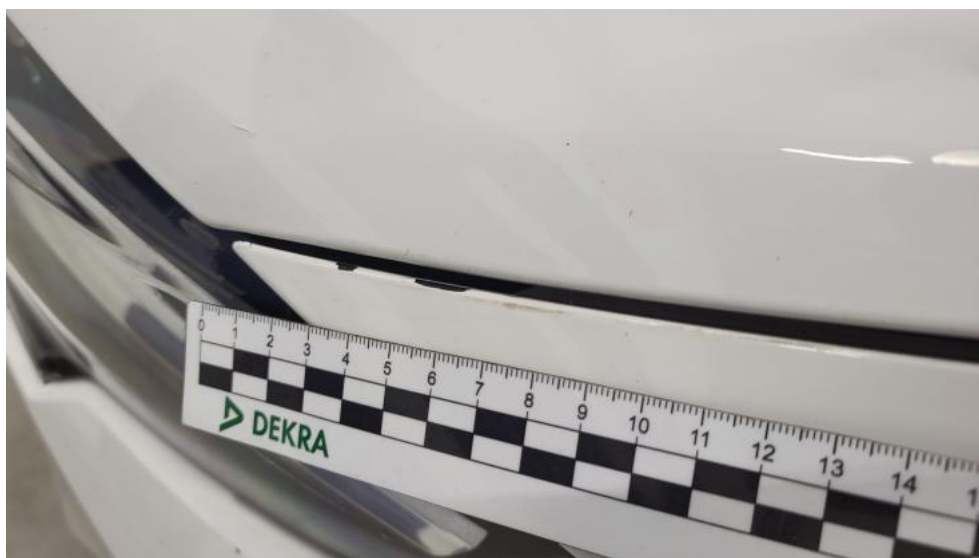
Photo 48.
Zderzak - Rysa/odprysk 2

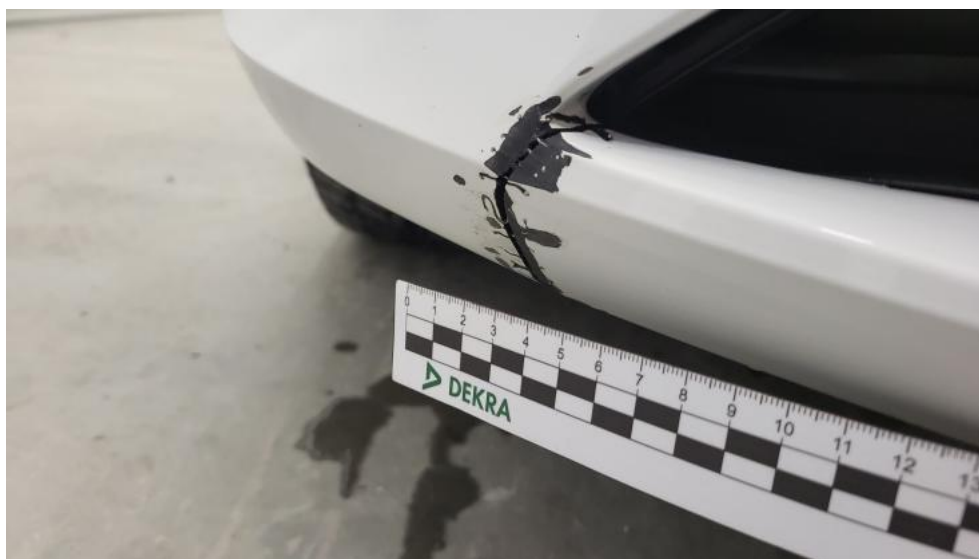
Photo 49.
Zderzak() - Rysa/odprysk 3

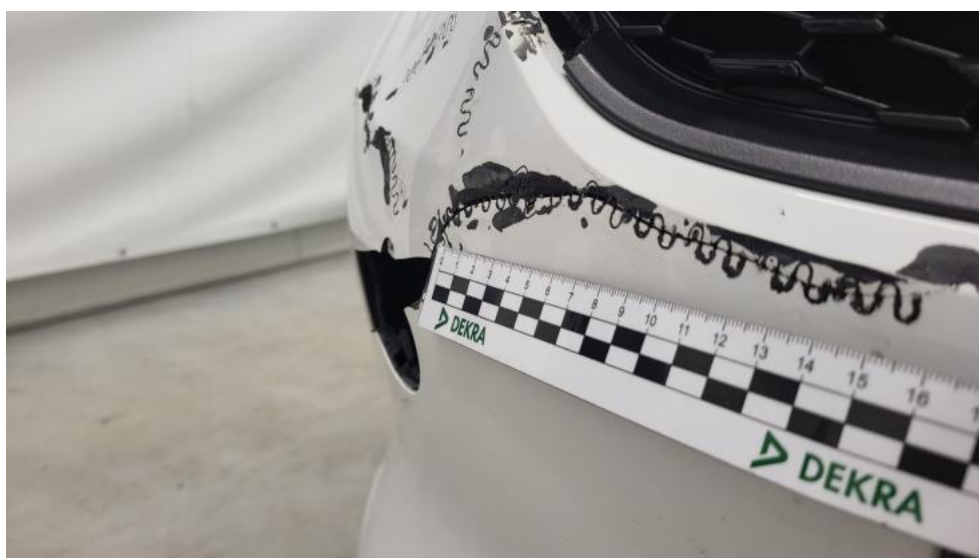
Photo 50.
Zderzak - Wgniecenie/odkształcenie 1

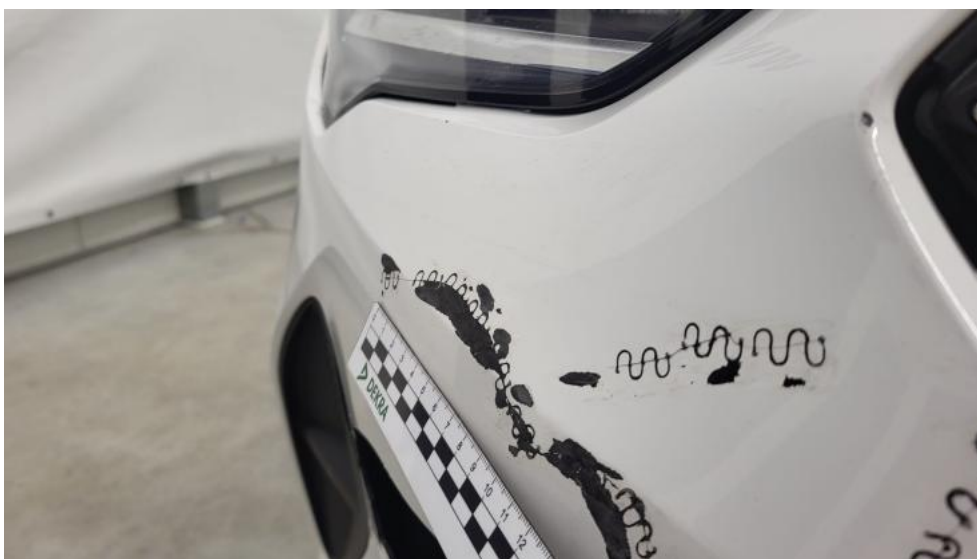
Photo 51.
Zderzak - Wgniecenie/odkształcenie 2

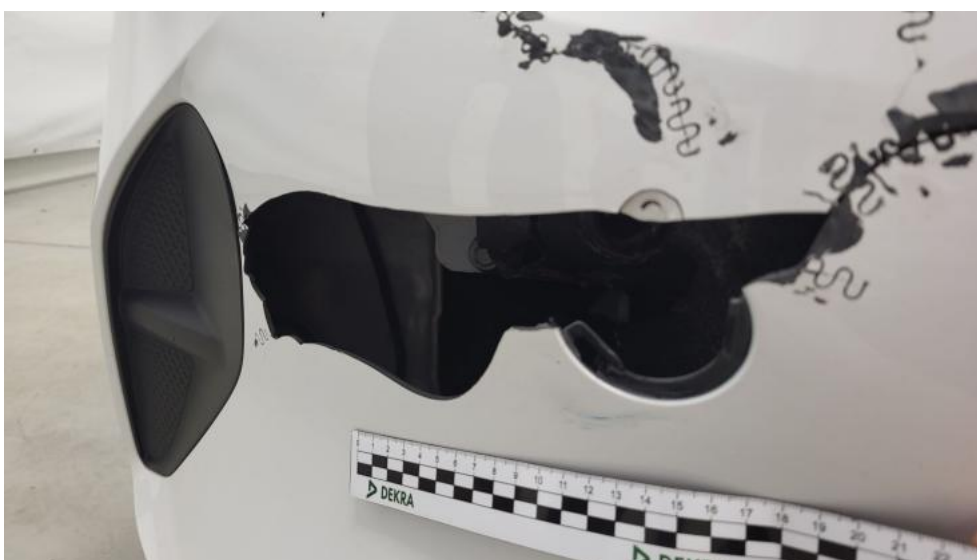
Photo 52.
Zderzak - Pęknięcie/rozerwanie 1

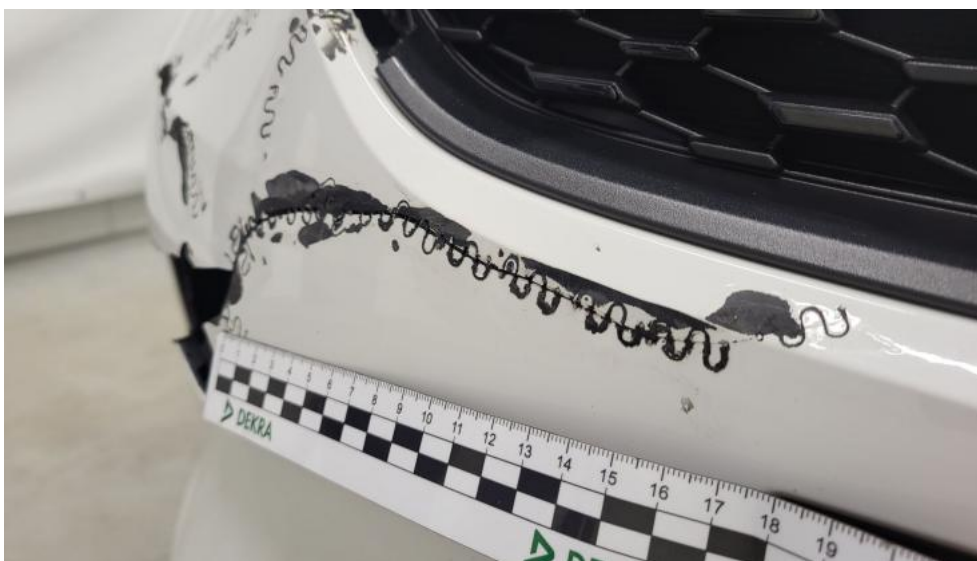
Photo 53.
Zderzak - Pęknięcie/rozerwanie 2

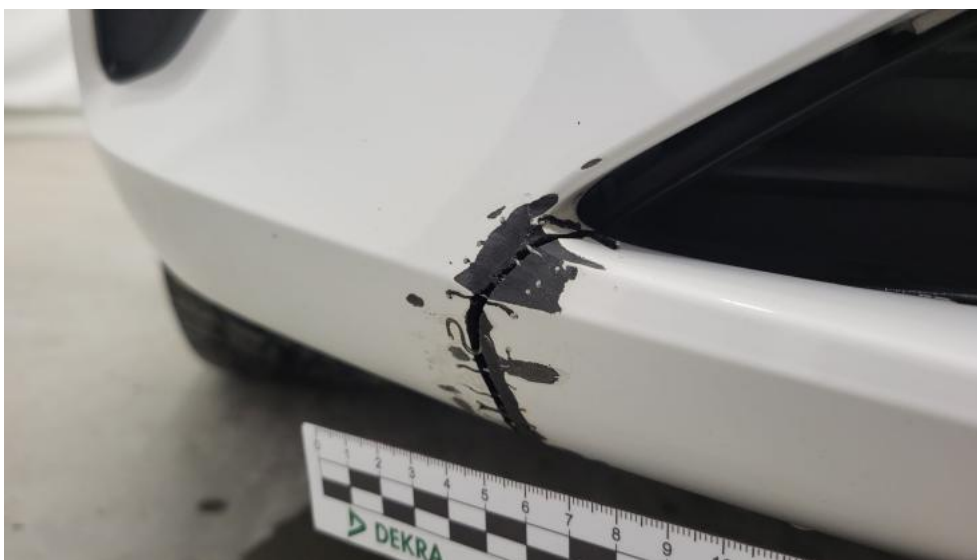
Photo 54.
Zderzak() - Pęknięcie/rozerwanie 3

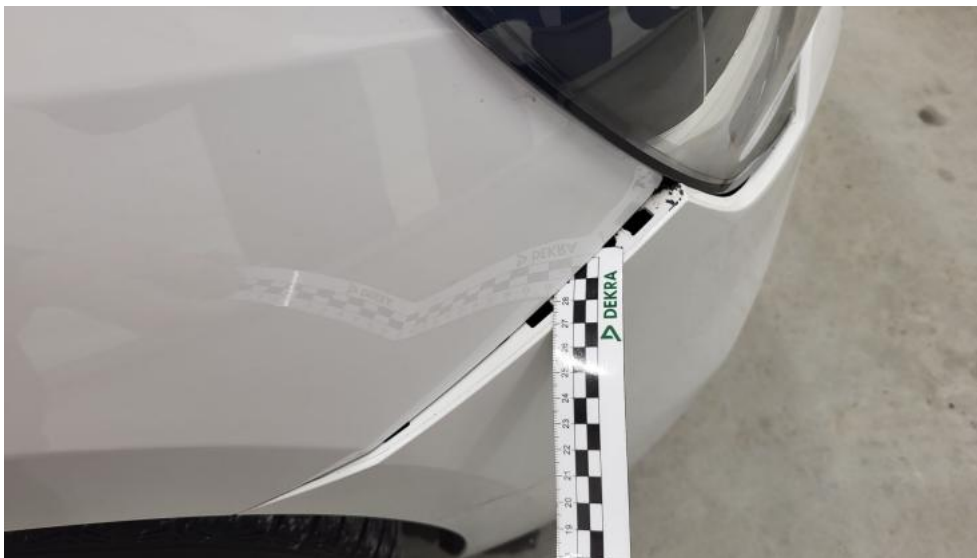
Photo 55.
Zderzak - Inne 1

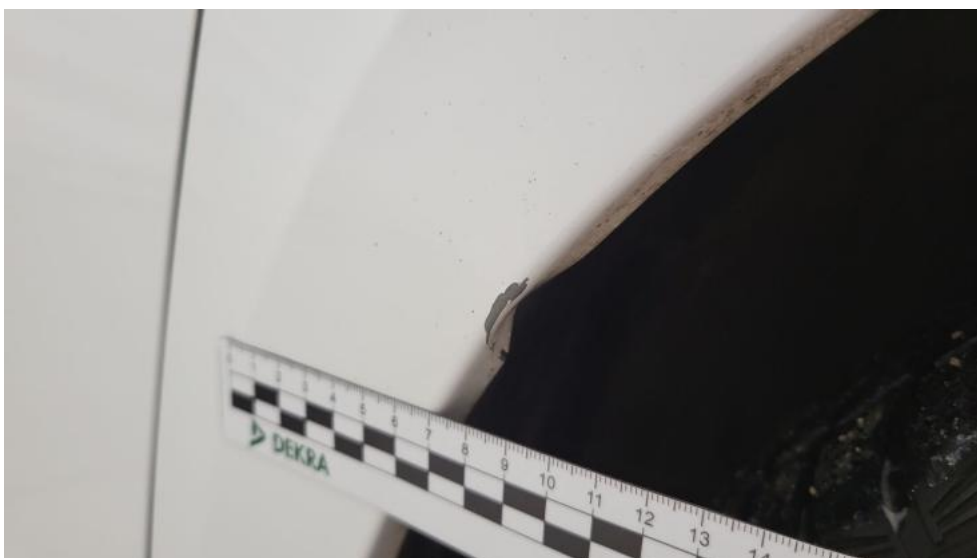
Photo 56.
Błotnik przedni P - Rysa/odprysk 1

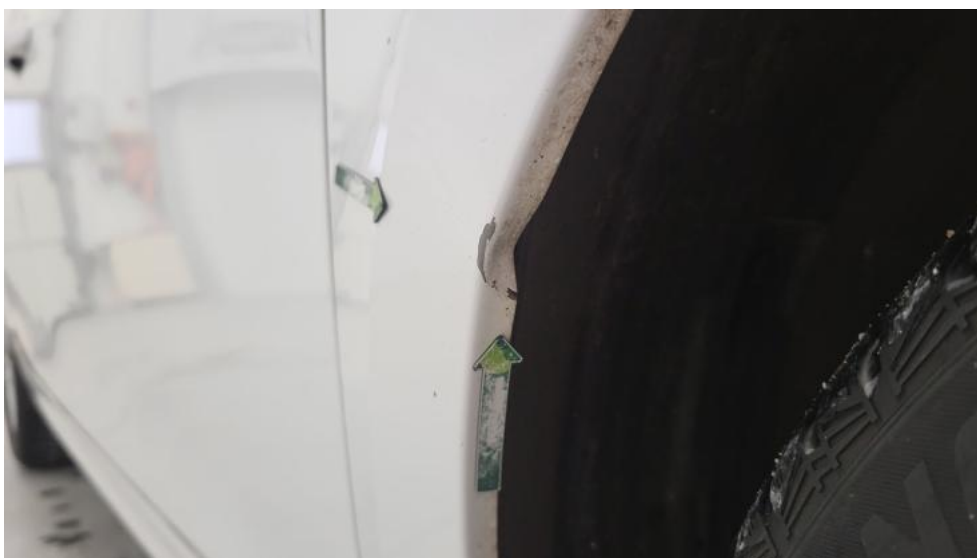
Photo 58.
Błotnik przedni P - Wgniecenie/odkształcenie 2

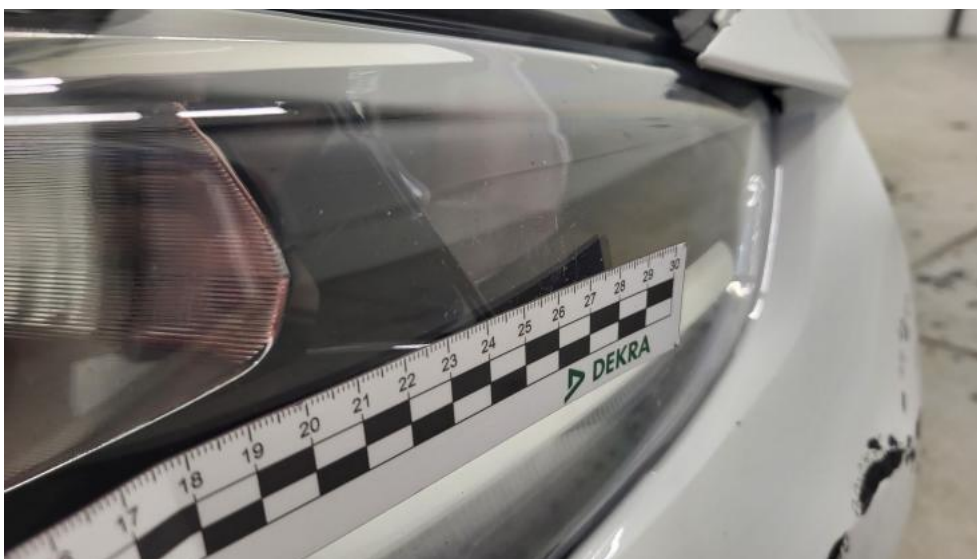
Photo 59.
Reflektor P - Rysa/odprysk 1

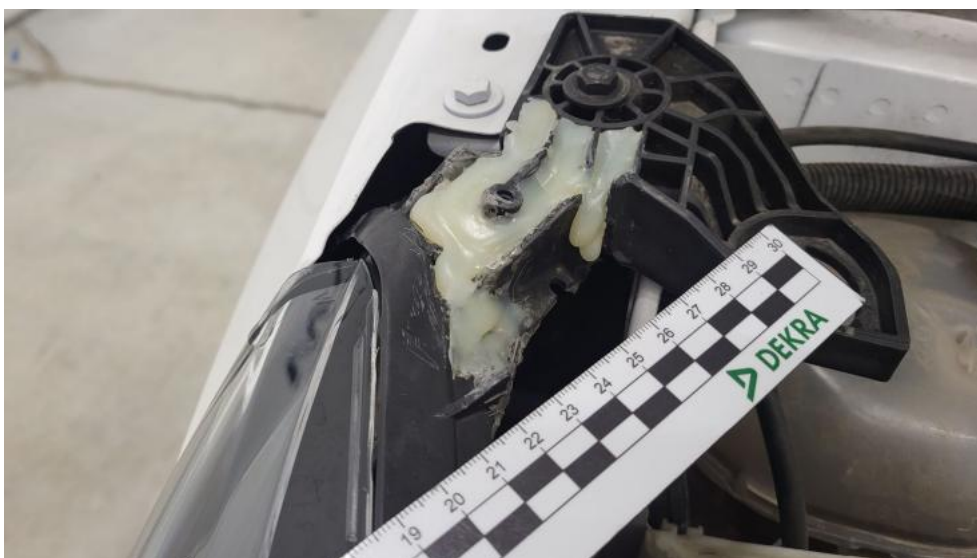
Photo 60.
Reflektor P - Inne 1

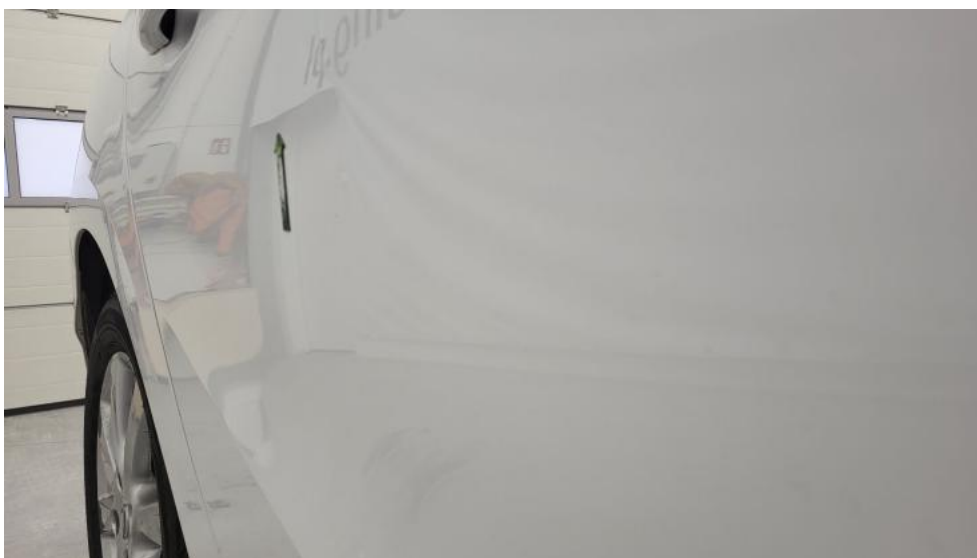
Photo 62.
Drzwi tylne P - Wgniecenie/odkształcenie 1

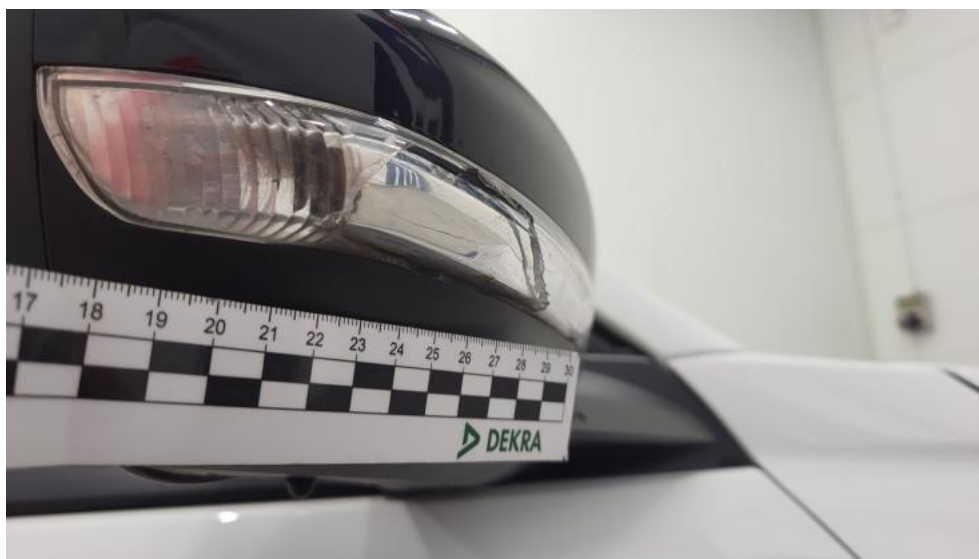
Photo 63.
Lusterko zew P - Pęknięcie/rozerwanie 1

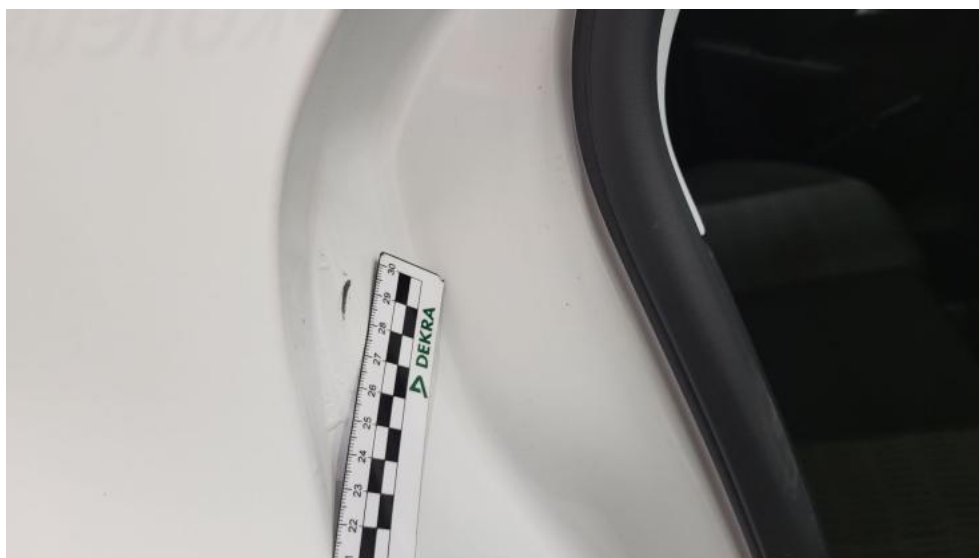
Photo 64.
Błotnik tylny P / Ściana boczna P - Rysa/odprysk 1

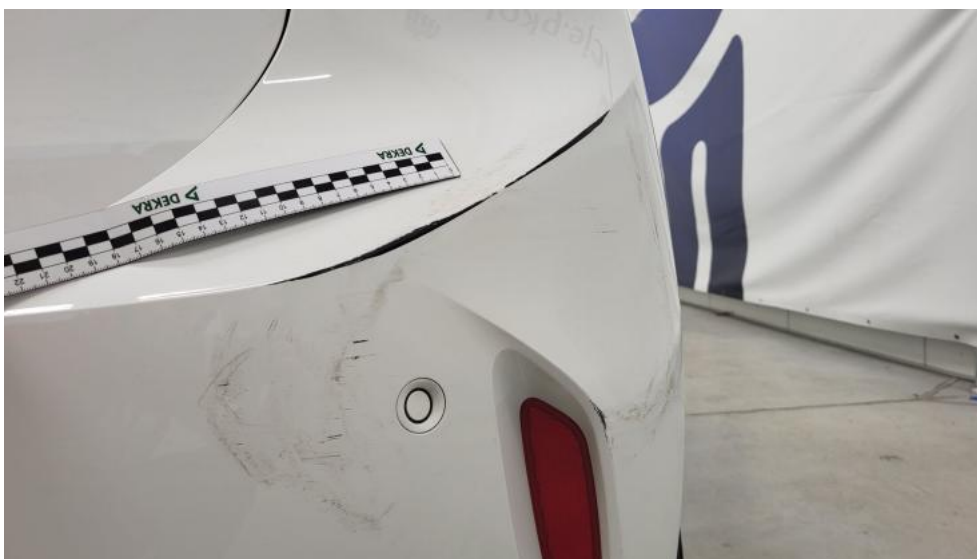
Photo 65.

Zderzak tylny - Rysa/odprysk 1

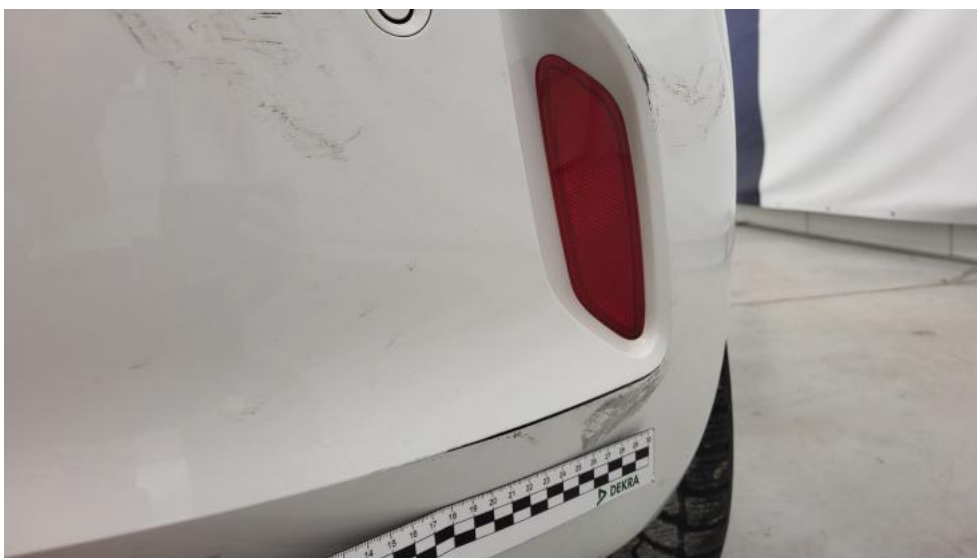
Photo 66.

Zderzak tylny - Rysa/odprysk 2

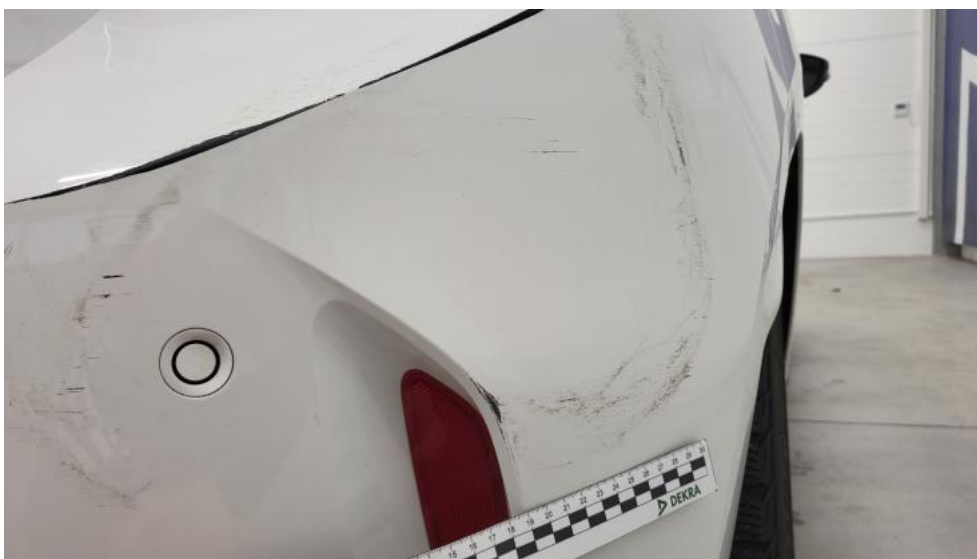
Photo 67.
Zderzak tylny() - Rysa/odprysk 3

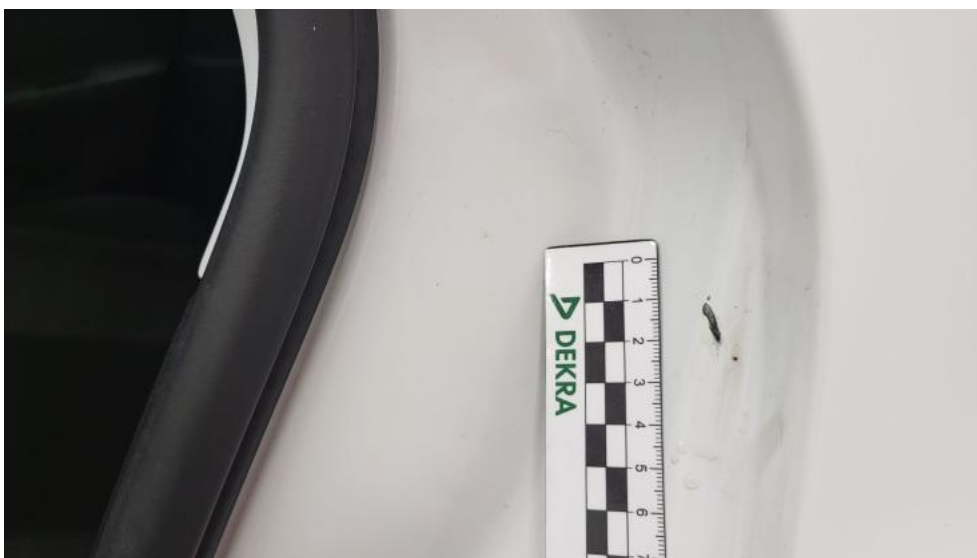
Photo 68.
Błotnik tylny L / Ściana boczna L - Rysa/odprysk 1

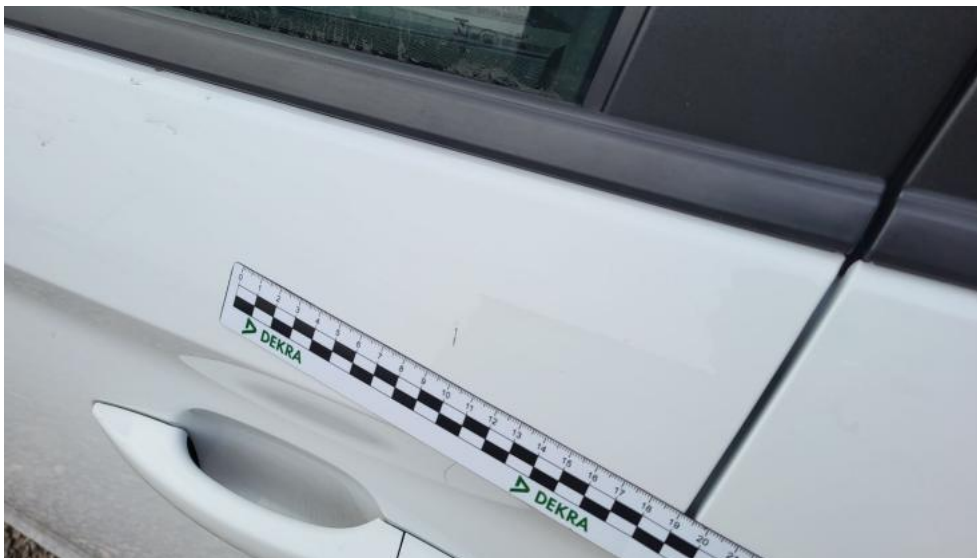
Photo 69.
Drzwi przed L - Wgniecenie/odkształcenie 1

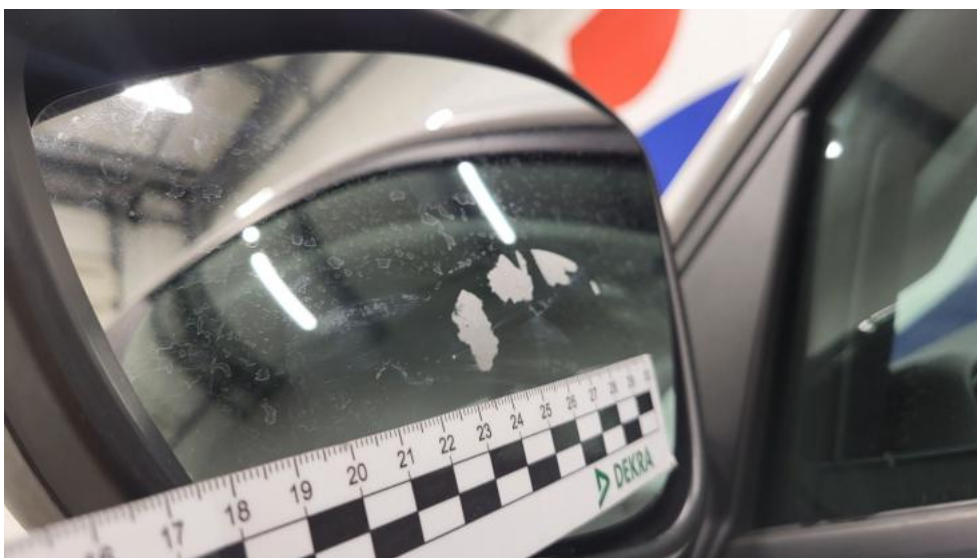
Photo 70.
Lusterko zew L - Inne 1

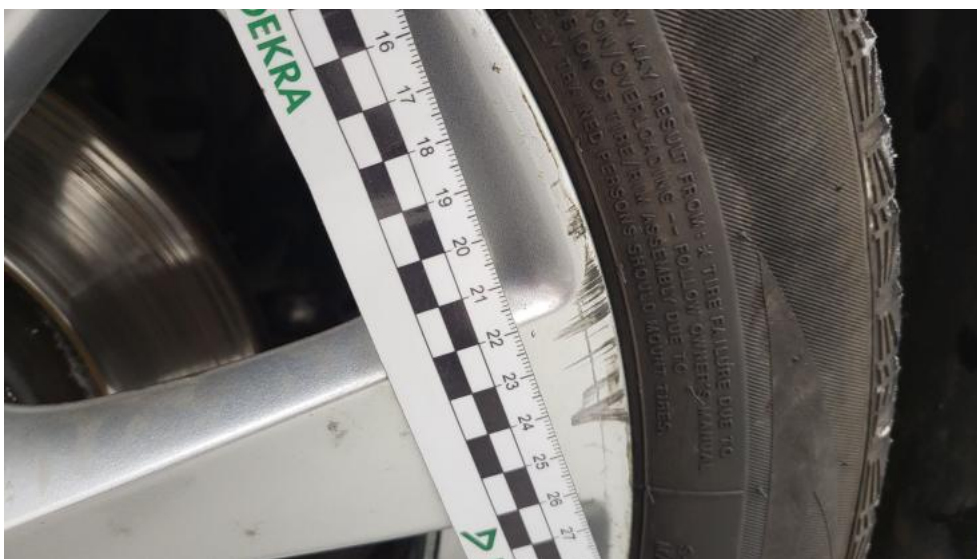
Photo 71.
Felga Aluminiowa przednia L - Rysa/odprysk 1

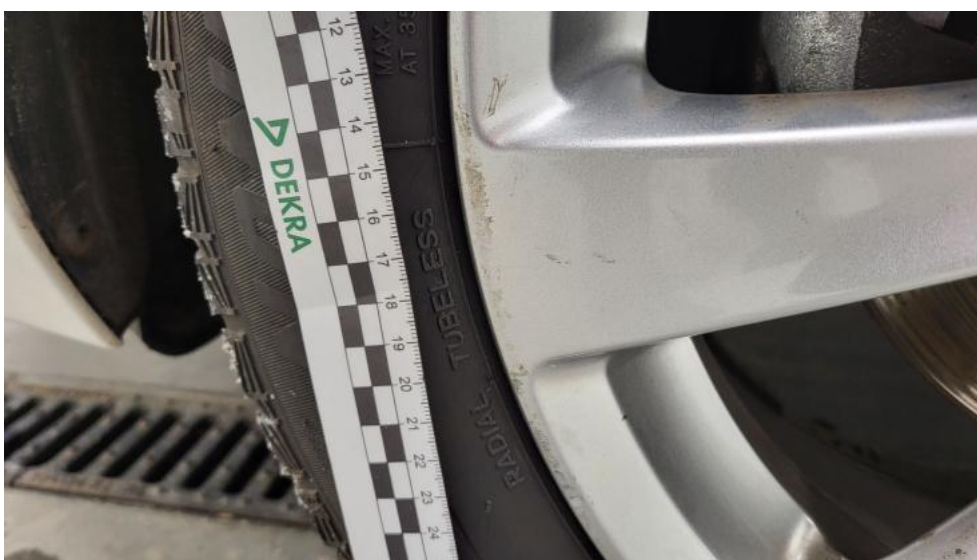
Photo 72.
Felga Aluminiowa przednia L - Rysa/odprysk 2

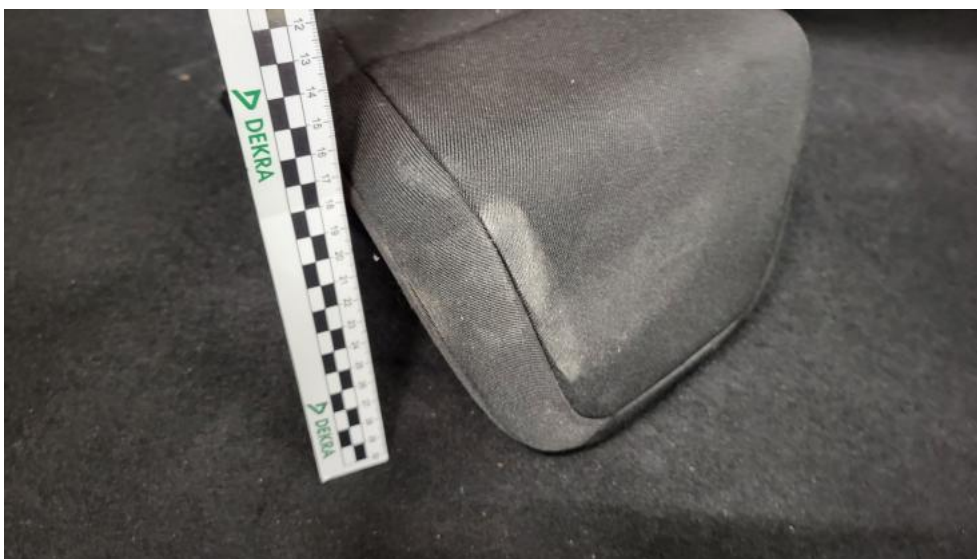
Photo 77.
Zaglówek lew. kanapy tyl. - Inne 2

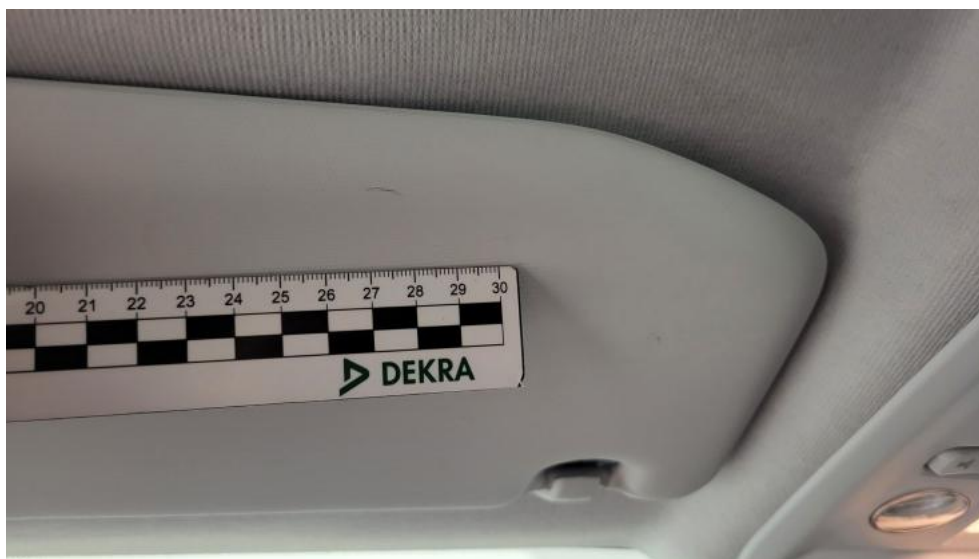
Photo 79.

Osłona p/słoneczna lewa - Inne 1

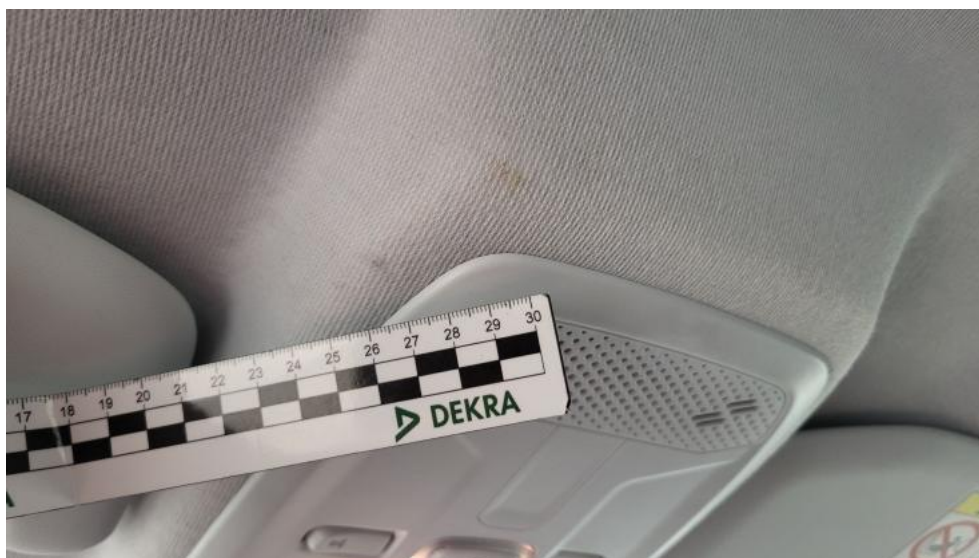
Photo 80.

Podsufitka - Inne 1

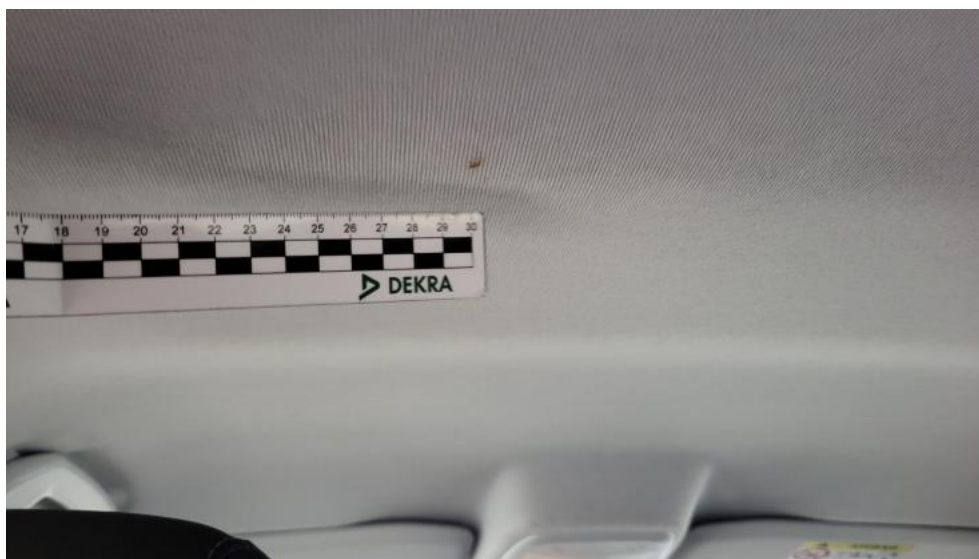
Photo 81.
Podsufitka - Inne 2

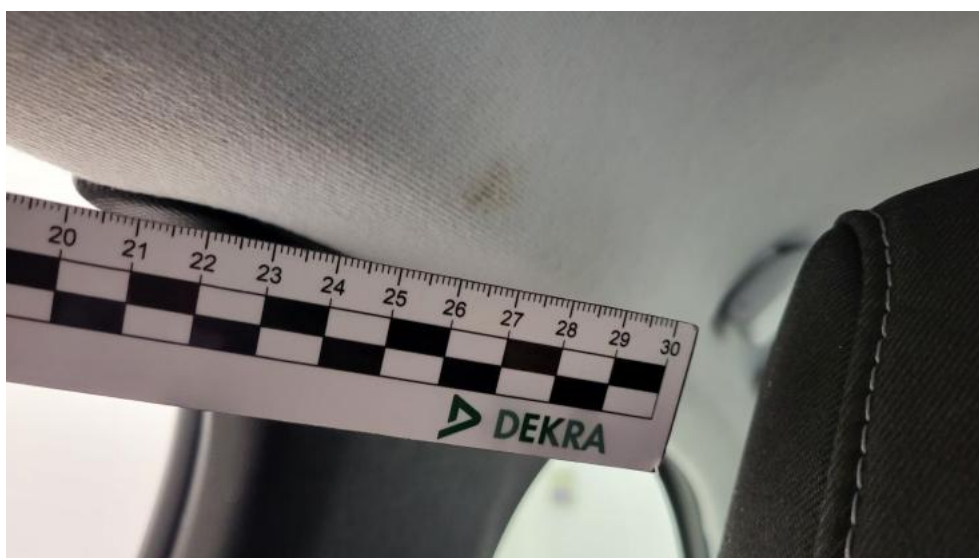
Photo 82.
Podsufitka() - Inne 3

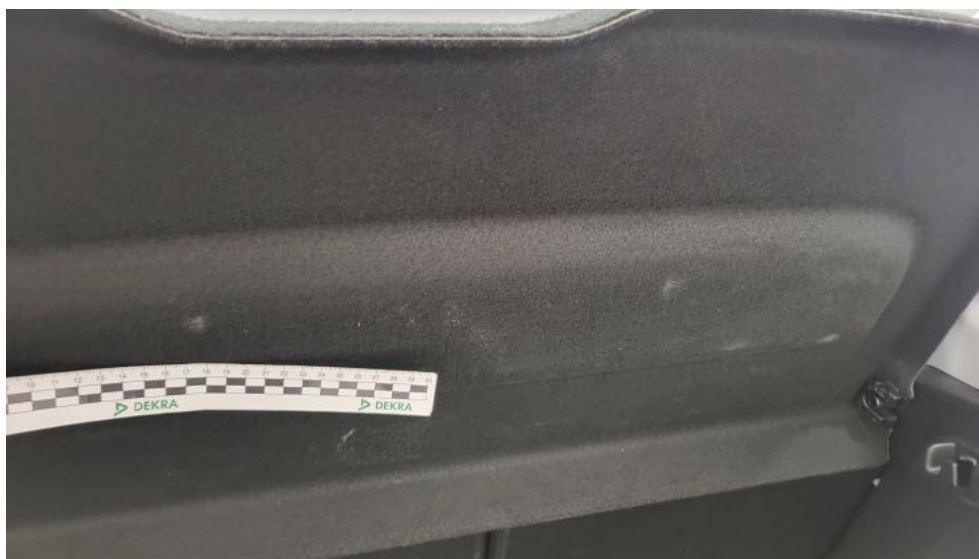
Photo 83.
Półka/roleta tylna - Inne 1
