DEKRA's commission No. : PKOL(W)/LODZ/33757/25/05/12  
commission/ damage No. : 24/008703  
Date of commission: 12-05-2025

**DEKRA Poland - Headquarters**  
02-673 Warszawa, ul. Konstruktorska 12A

| Manufacturer | JEEP |
| Model | Grand Cherokee 16-20 |

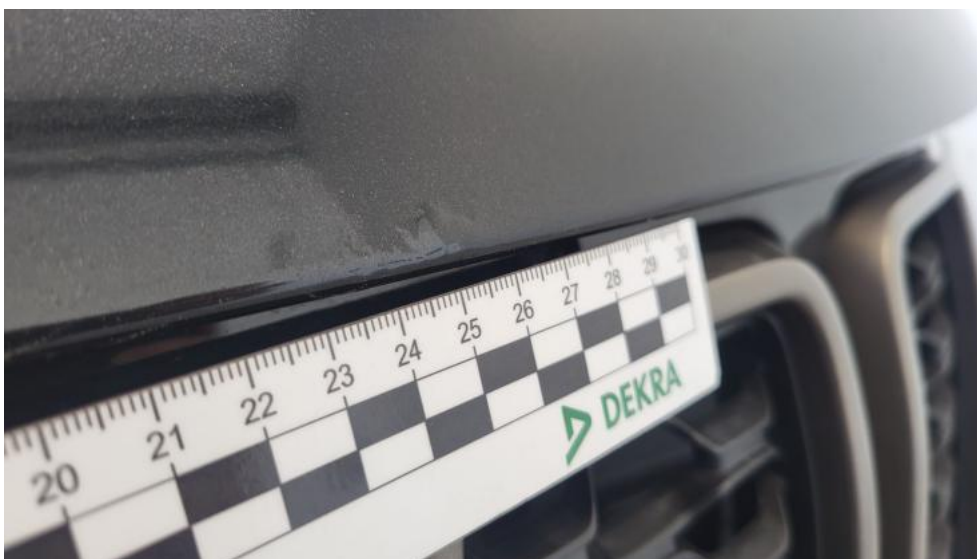
**Photo 43.**

Pokrywa komory silnika - Inne 1

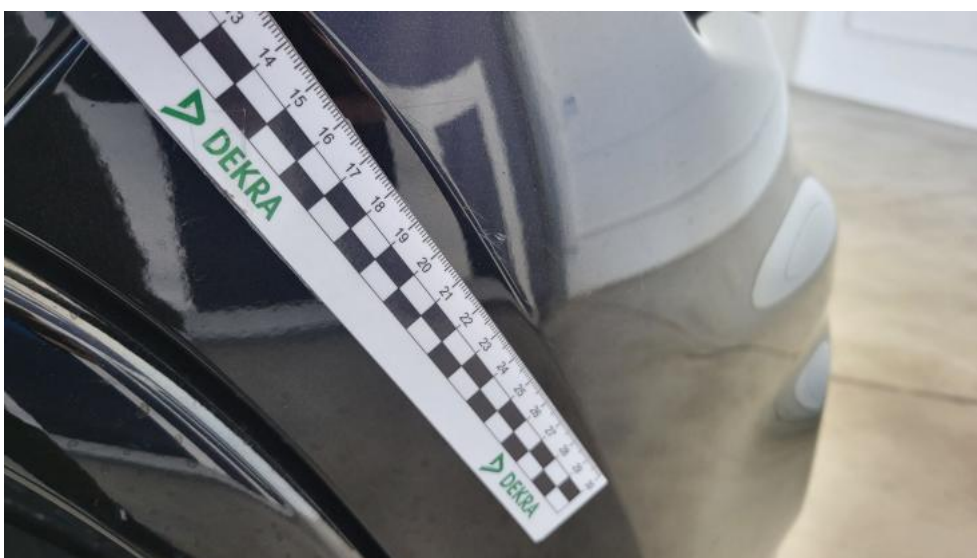
**Photo 44.**

Zderzak - Rysa/odprysk 1

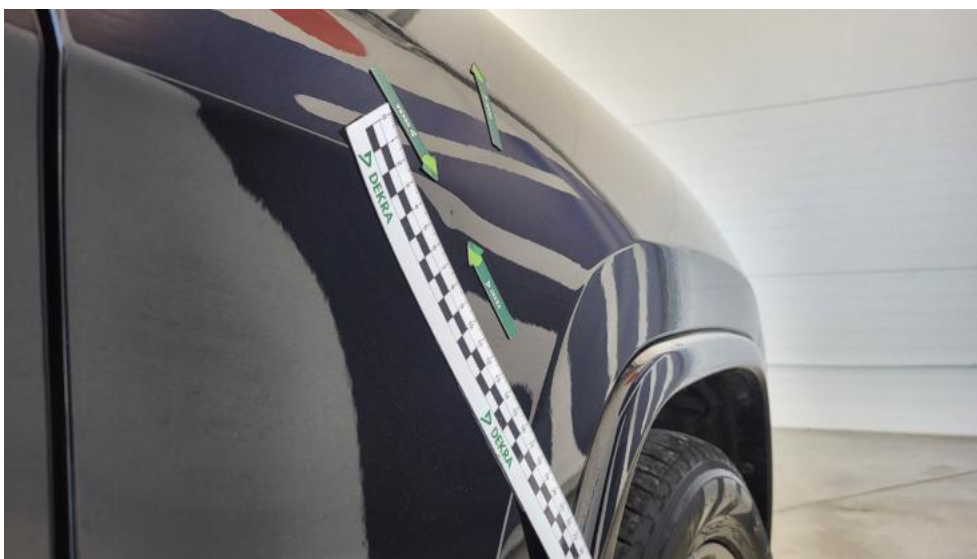
**Photo 45.**

Błotnik przedni P - Wgniecenie/odkształcenie 1

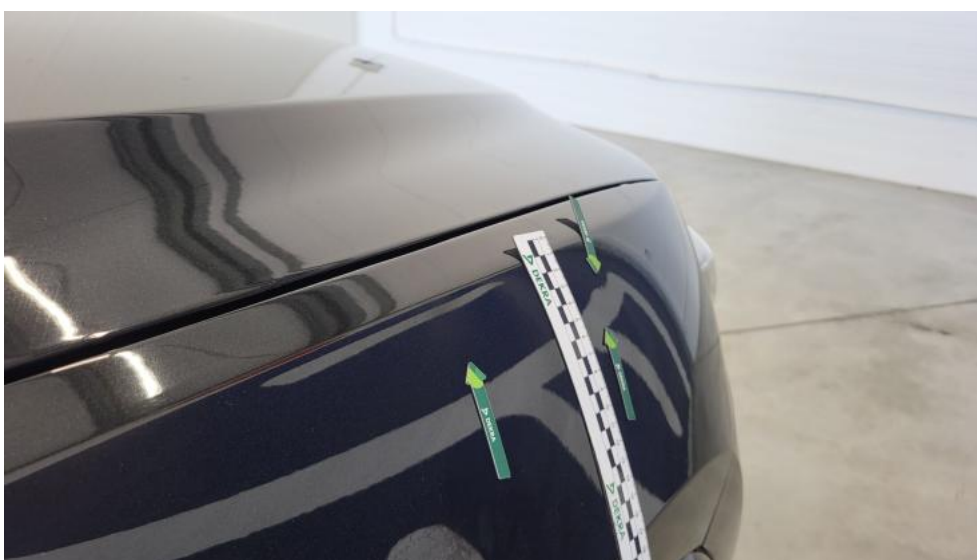
**Photo 46.**

Błotnik przedni P - Wgniecenie/odkształcenie 2

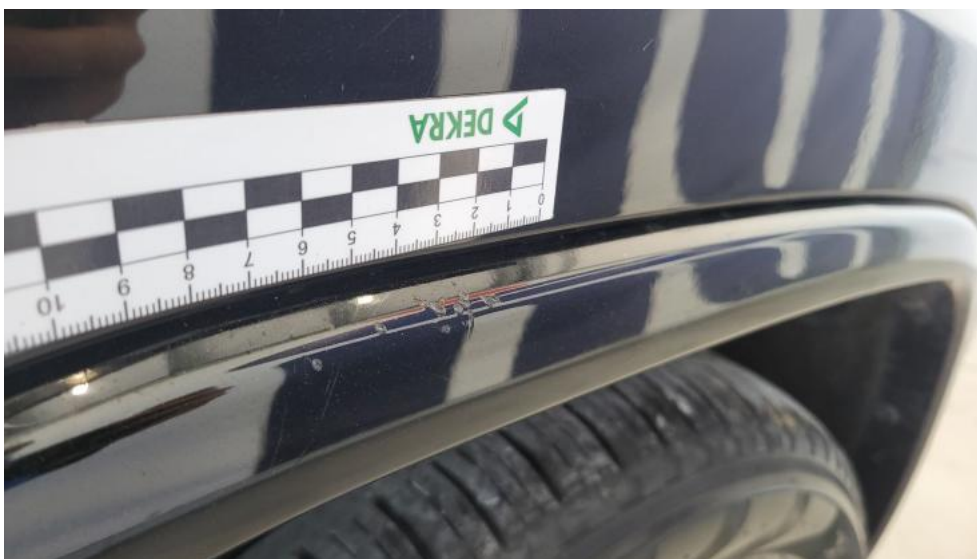
**Photo 47.**

Listwa błotnika przedniego P - Rysa/odprysk 1

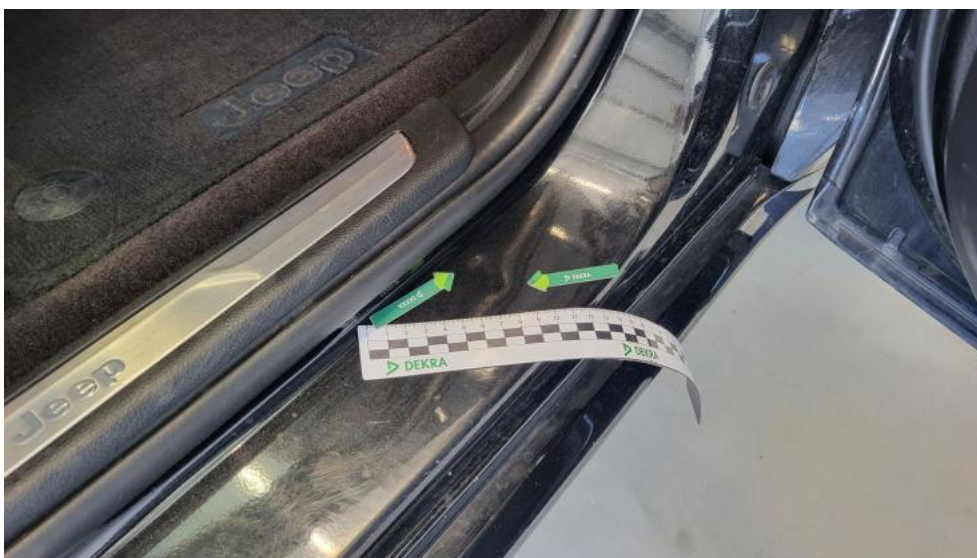
**Photo 48.**

Próg P - Wgniecenie/odkształcenie 1

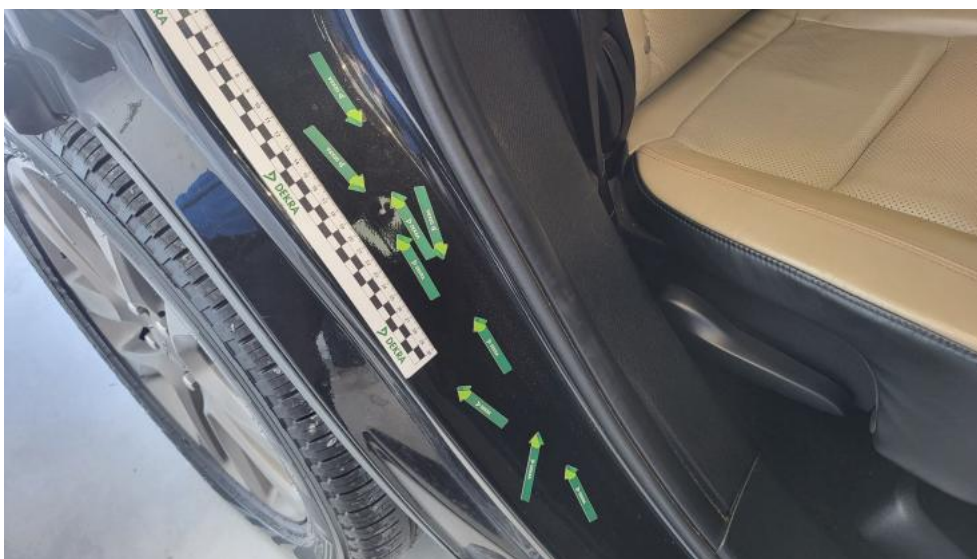
**Photo 49.**

Błotnik tylny P / Ściana boczna P - Wgniecenie/odkształcenie 1

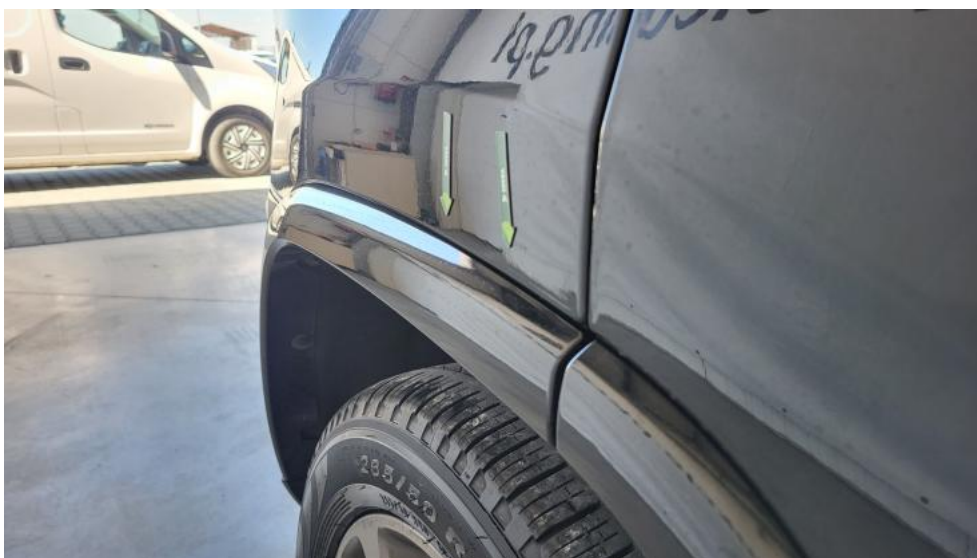
**Photo 50.**

Błotnik tylny P / Ściana boczna P - Wgniecenie/odkształcenie 2

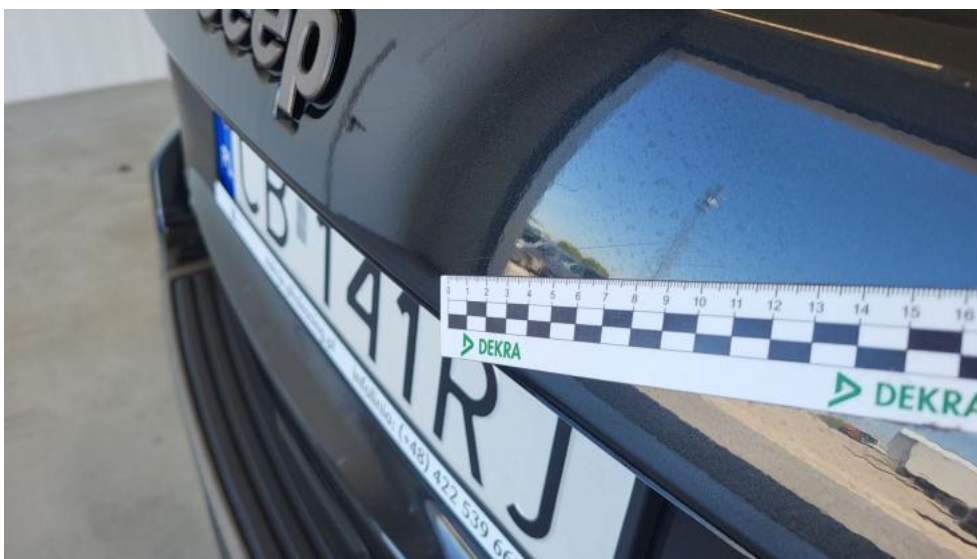
**Photo 51.**

Pokrywy bagażnika - Rysa/odprysk 1

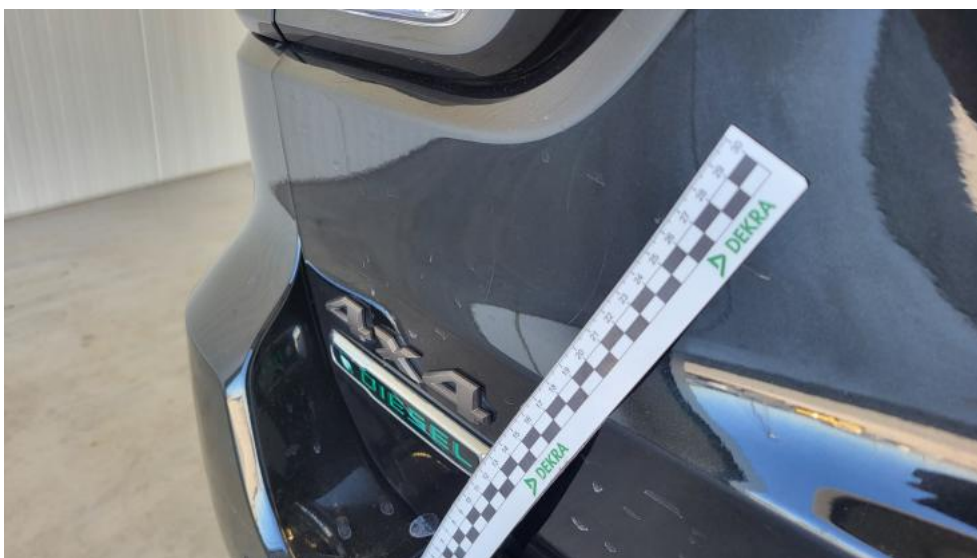
**Photo 52.**

Pokrywy bagażnika - Rysa/odprysk 2

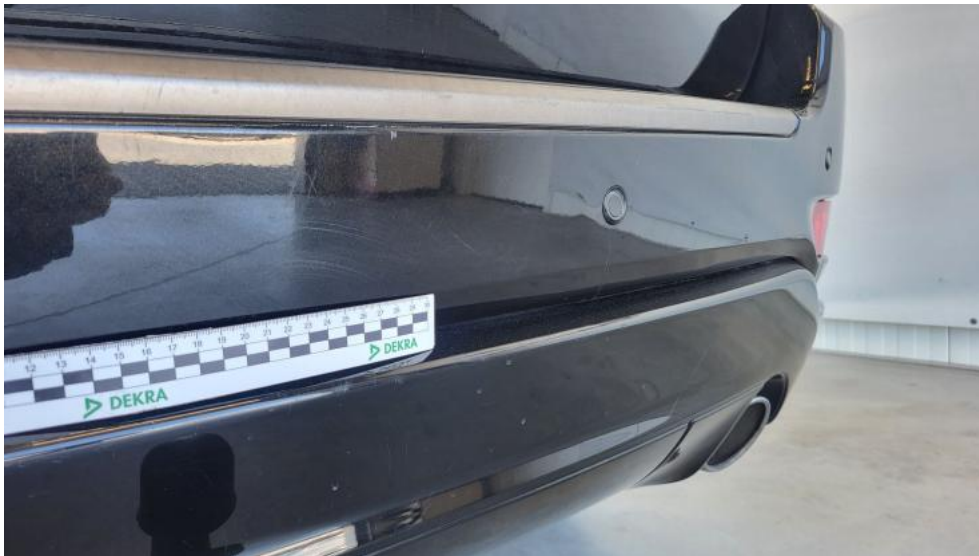
**Photo 53.**

Zderzak tylny - Rysa/odprysk 1

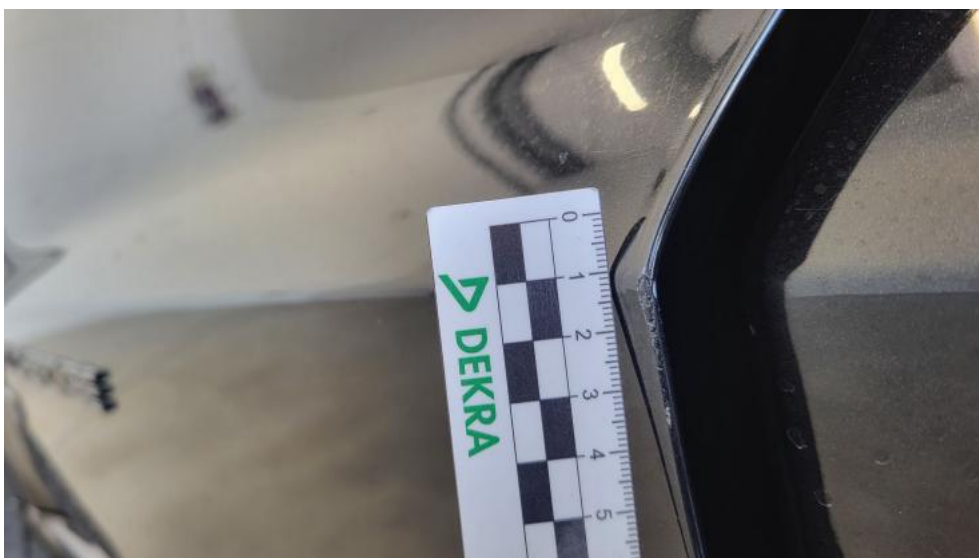
**Photo 54.**

Drzwi przed L - Rysa/odprysk 1

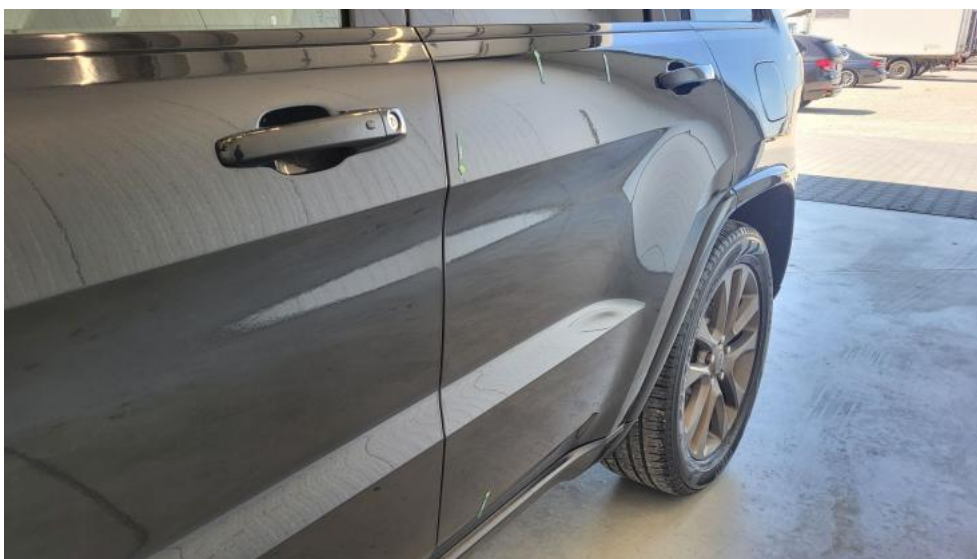
**Photo 55.**

Drzwi tylne L - Wgniecenie/odkształcenie 1

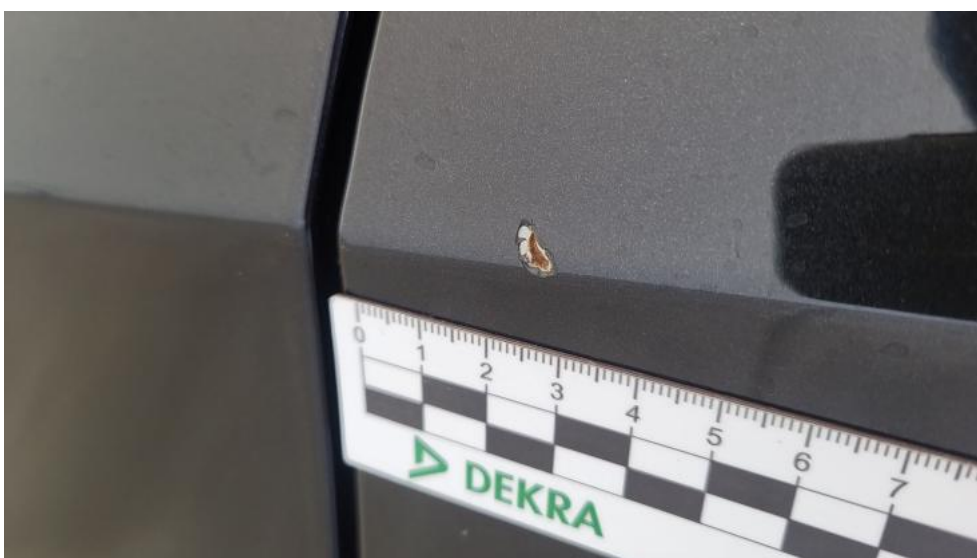
**Photo 56.**

Drzwi tylne L - Inne 1

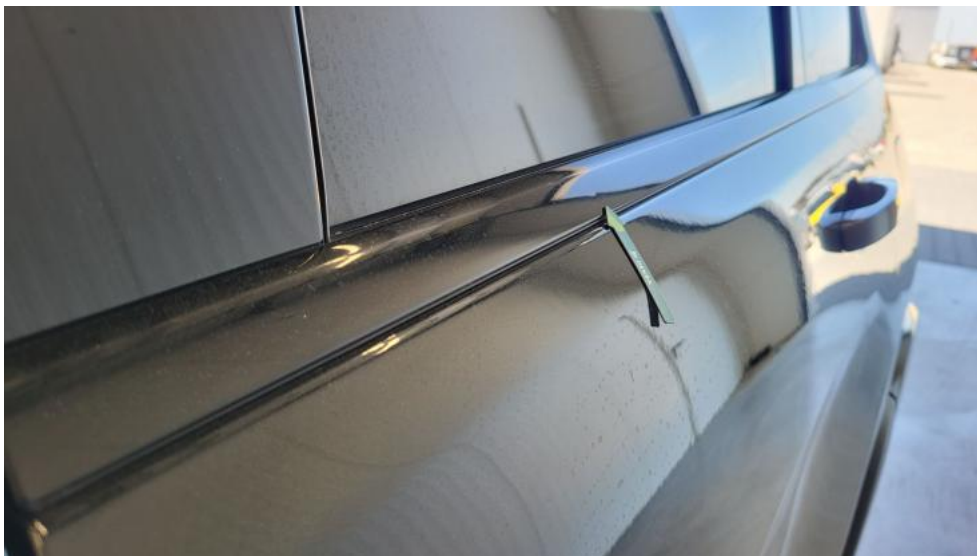
**Photo 57.**

Listwa drzwi tylnych L - Wgniecenie/odkształcenie 1

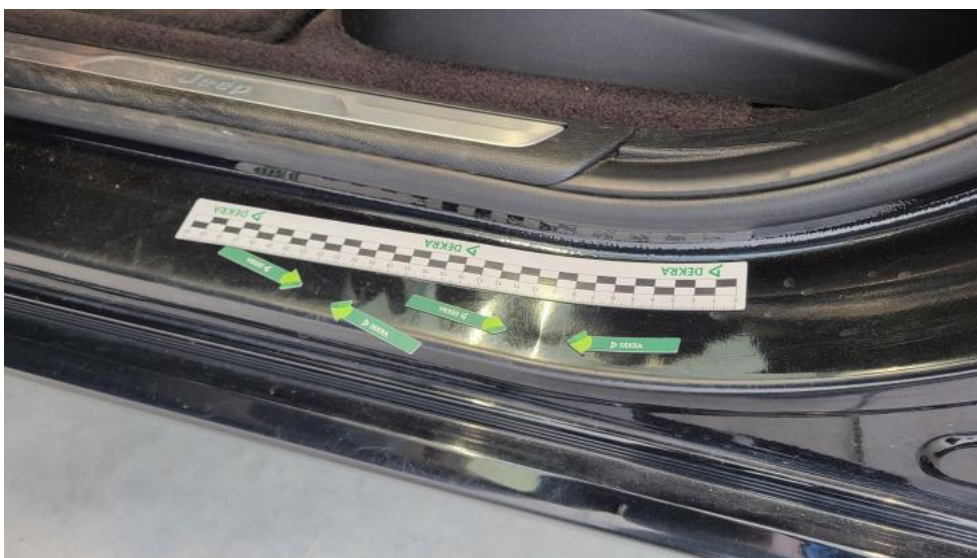
**Photo 58.**

Próg L - Wgniecenie/odkształcenie 1

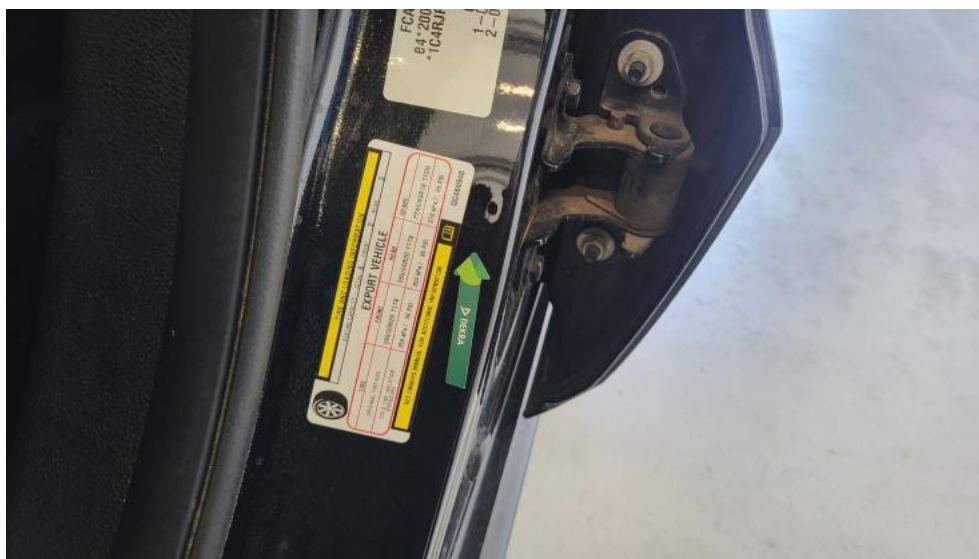
**Photo 59.**

Słupek środkowy L - Wgniecenie/odkształcenie 1

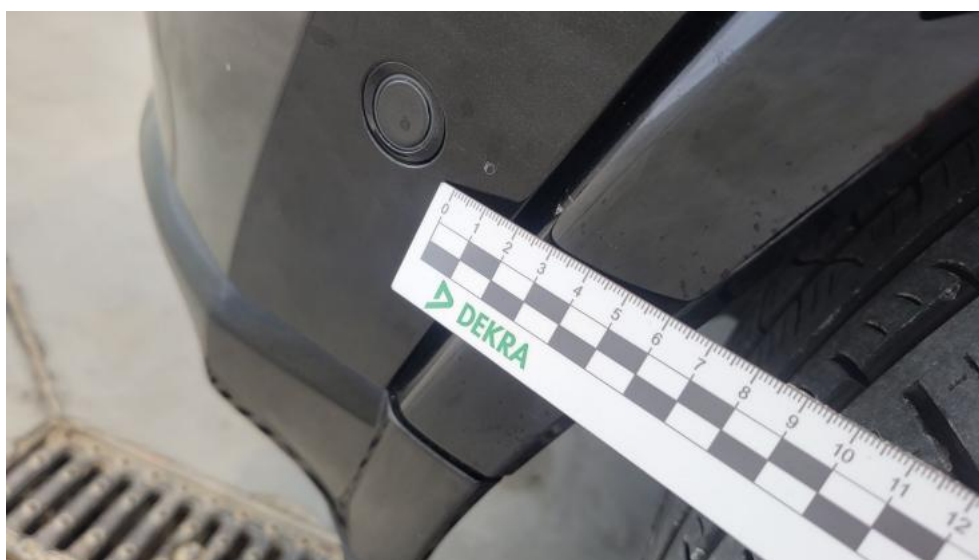
**Photo 60.**

Listwa błotnika przedniego L - Rysa/odprysk 1

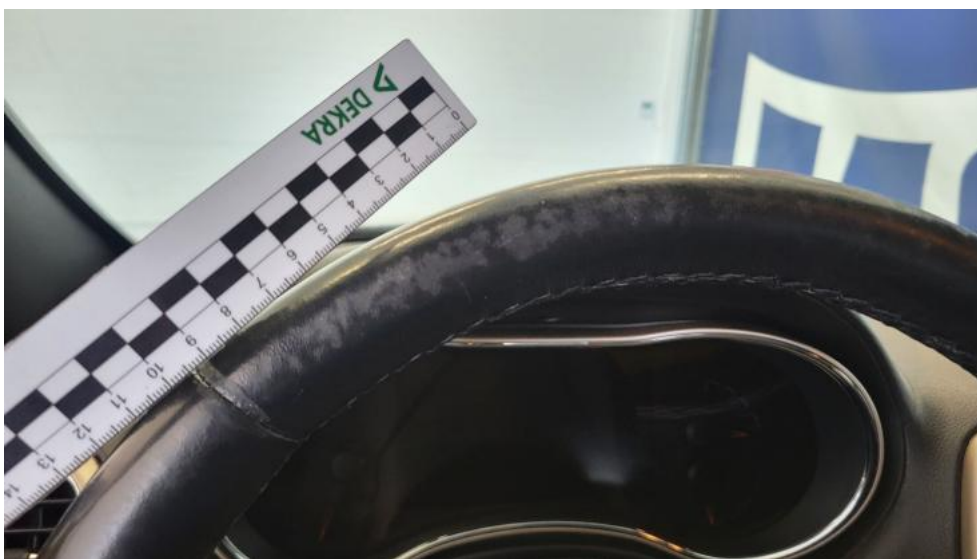
**Photo 61.**

Koło kierownicy - Inne 1

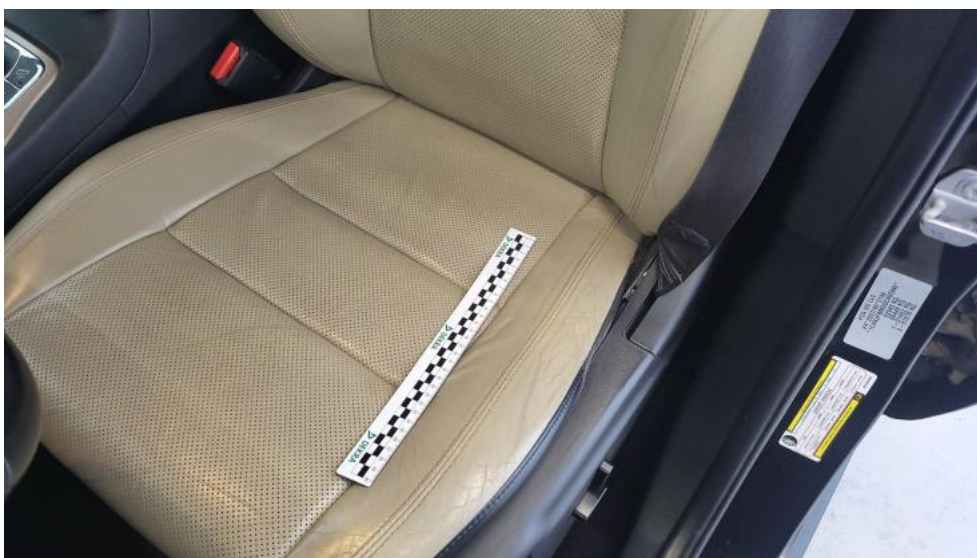
**Photo 64.**

Fotel prz. lew. - Inne 1

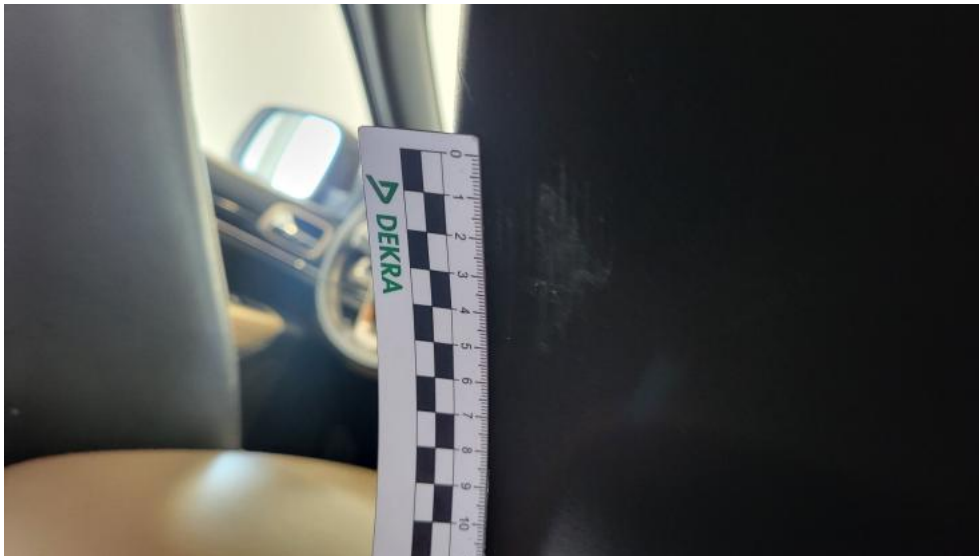
**Photo 65.**

Fotel prz. praw. - Rysa/odprysk 1

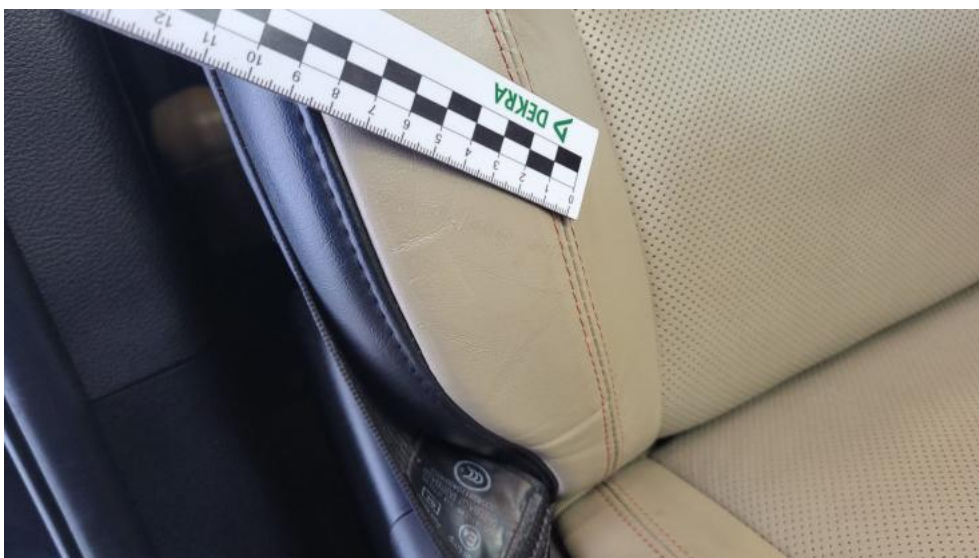
**Photo 66.**

Fotel prz. praw. - Inne 1

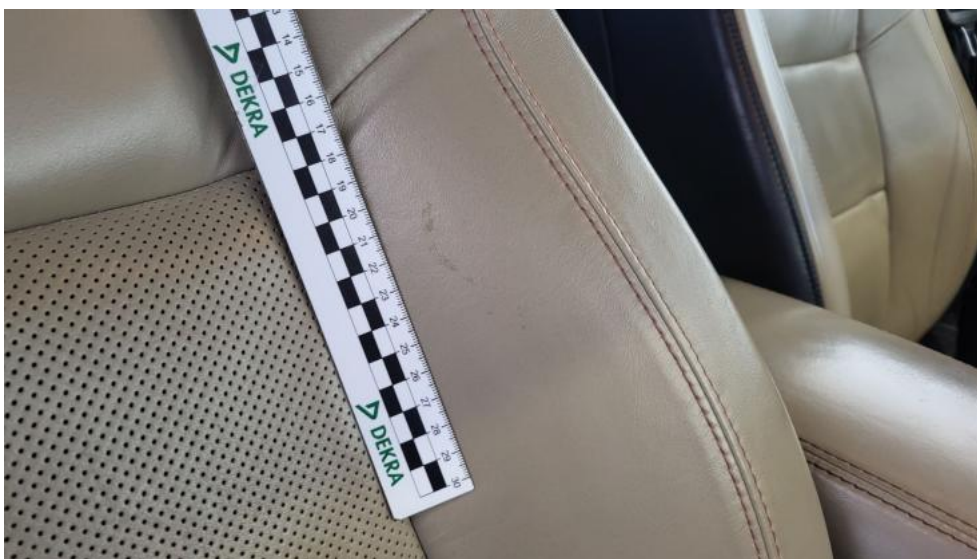
**Photo 67.**

Fotel prz. praw. - Inne 2

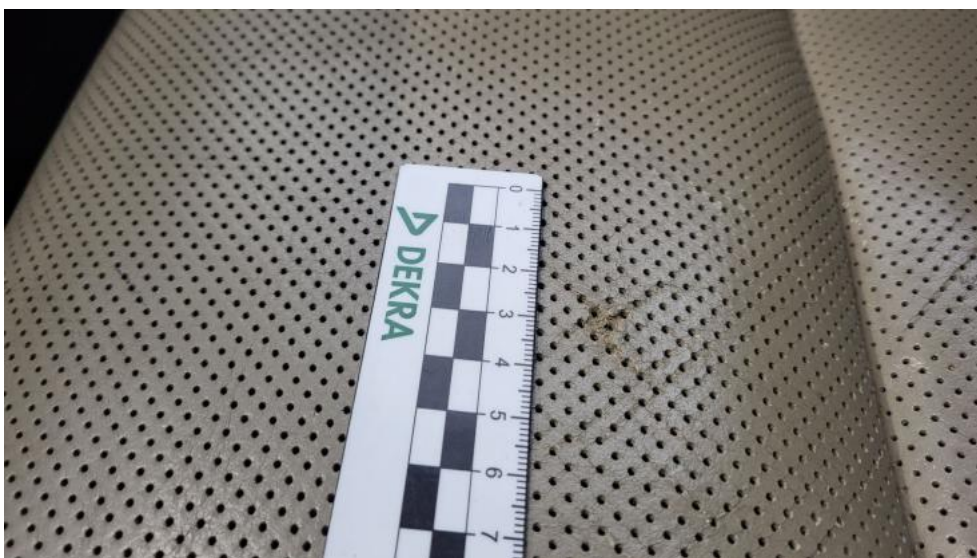
**Photo 68.**

Fotel prz. praw.() - Inne 3

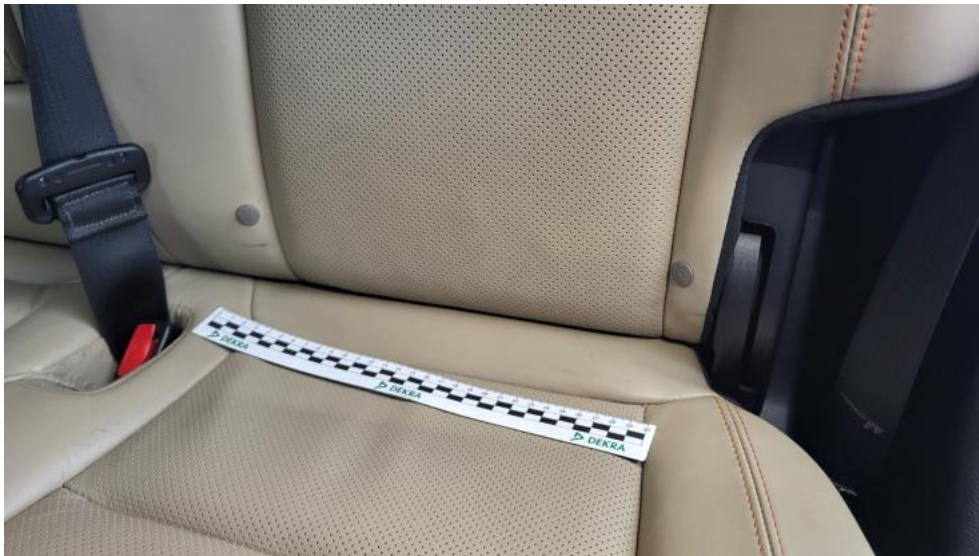
**Photo 69.**

Kanapa tyl. - Inne 1

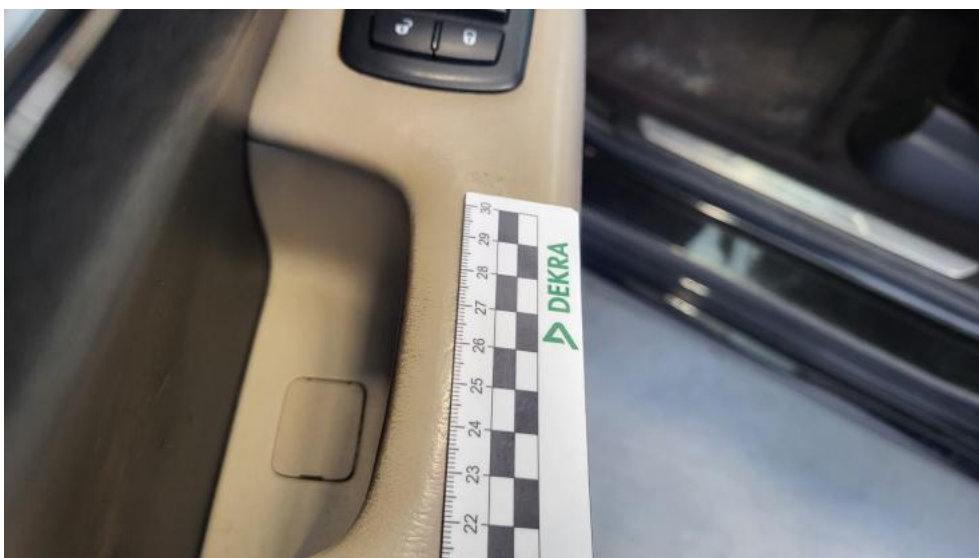
**Photo 70.**

Tapicerka drzwi przednich L - Inne 1

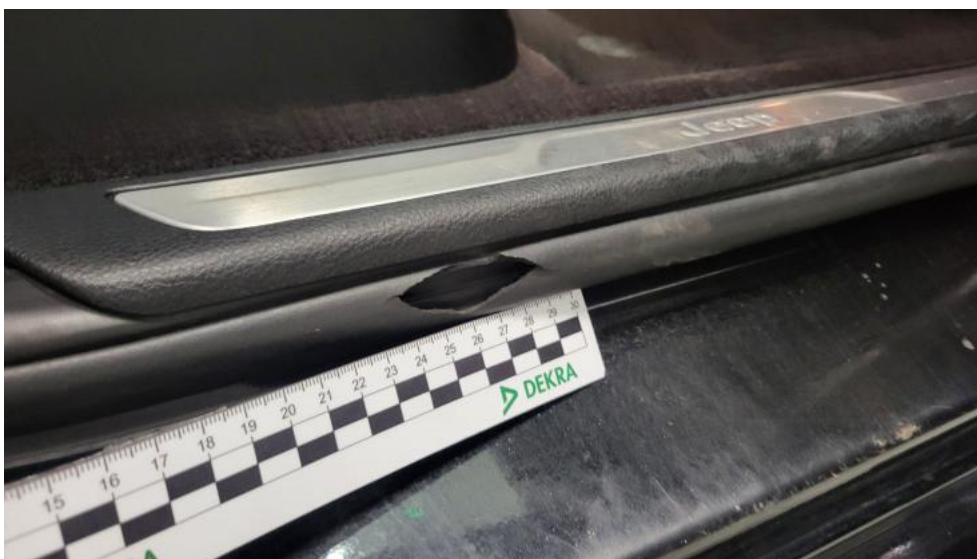
**Photo 71.**

Uszczelka drzwi przednich P - Pęknięcie/rozerwanie 1
