DEKRA's commission No. : PKOL(W)/LODZ/38889/25/05/29  
commission/ damage No. : 24/031168  
Date of commission: 29-05-2025

**DEKRA Poland - Headquarters**  
02-673 Warszawa, ul. Konstruktorska 12A

| Model | A7 Sportback 17-23 |
| Registration /record No. | WGM2993L |

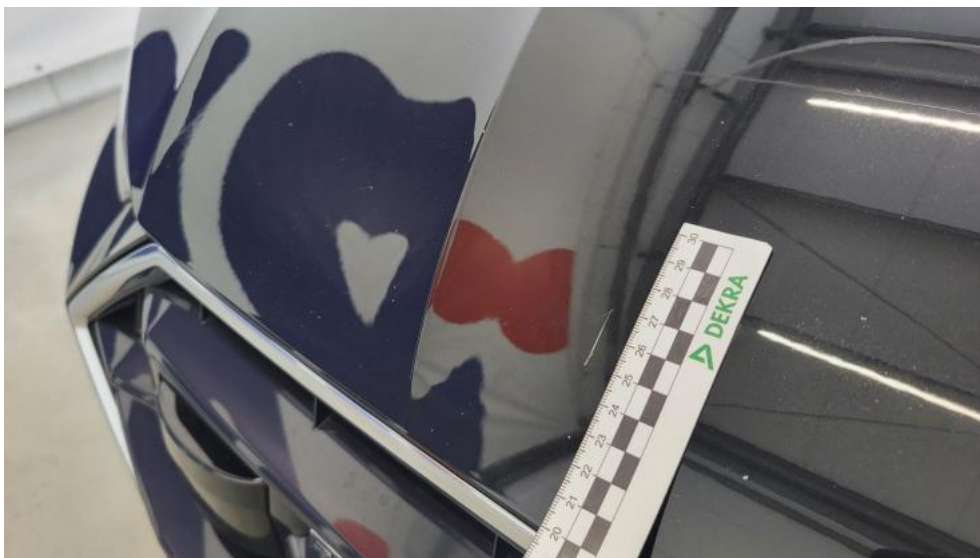
**Photo 44.**

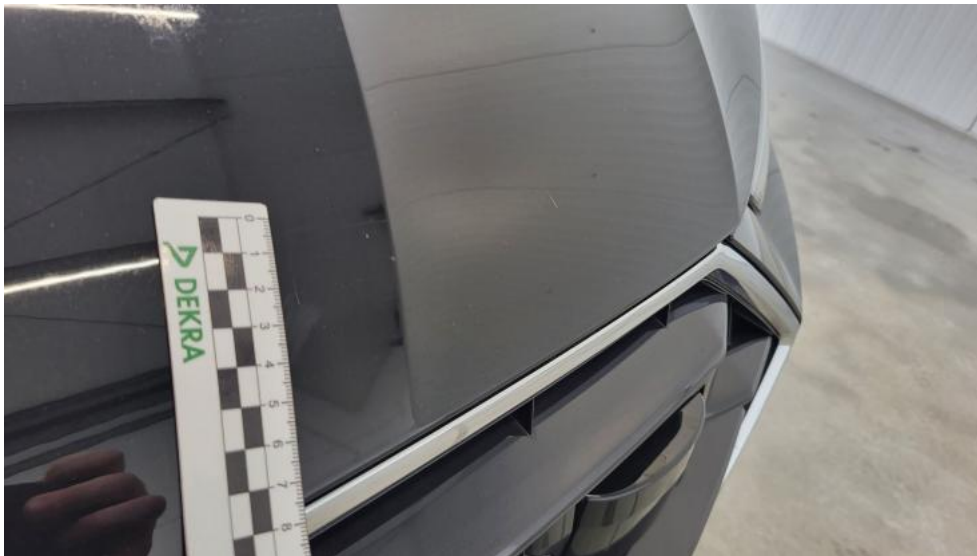
**Photo 45.**

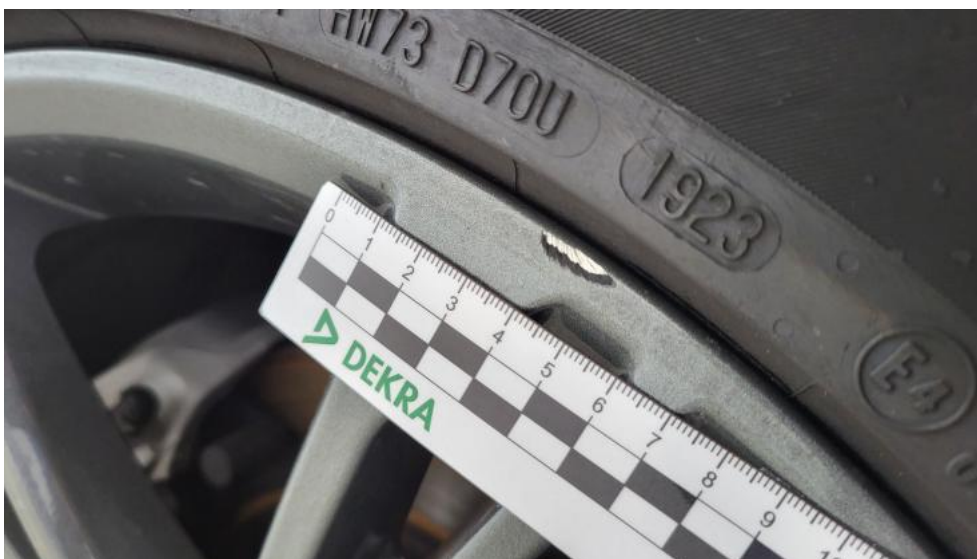
**Photo 47.**

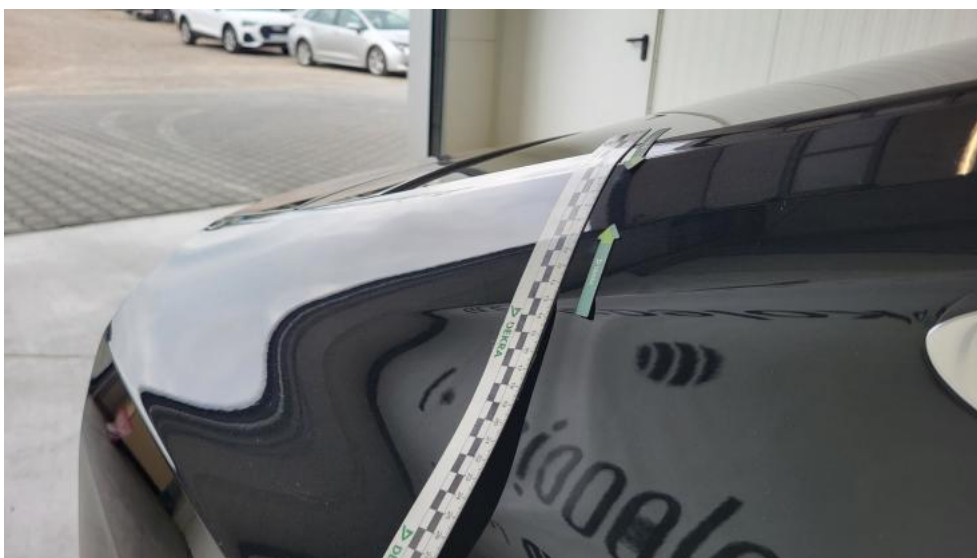
**Photo 48.**

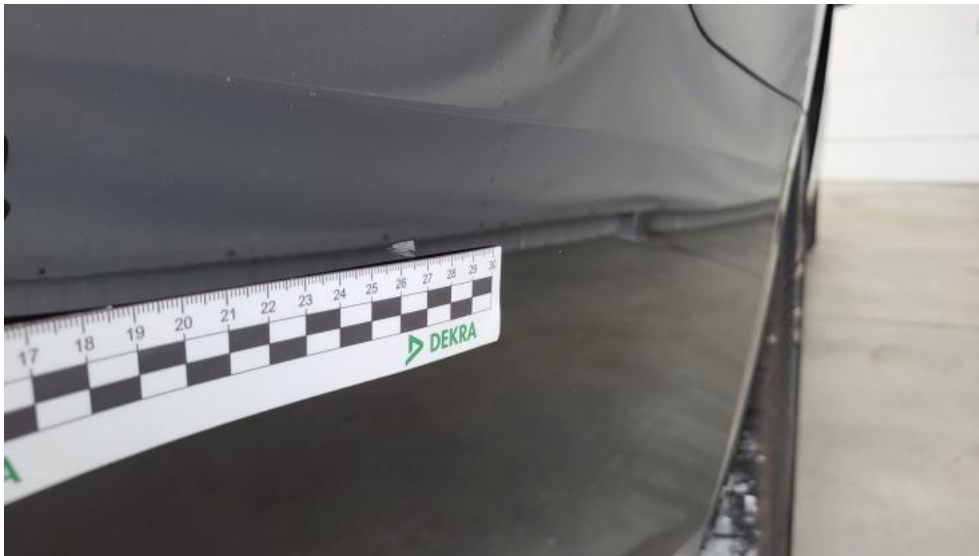
**Photo 49.**
