DEKRA's commission No. : PKOL(W)/LODZ/36359/25/05/20  
commission/ damage No. : 23/016289  
Date of commission: 20-05-2025

| Manufacturer | LAND ROVER |
| Type / version | Range Rover S 5.0 V8 S/C AB Dynamic |
| Registration /record No. | NO709AP |

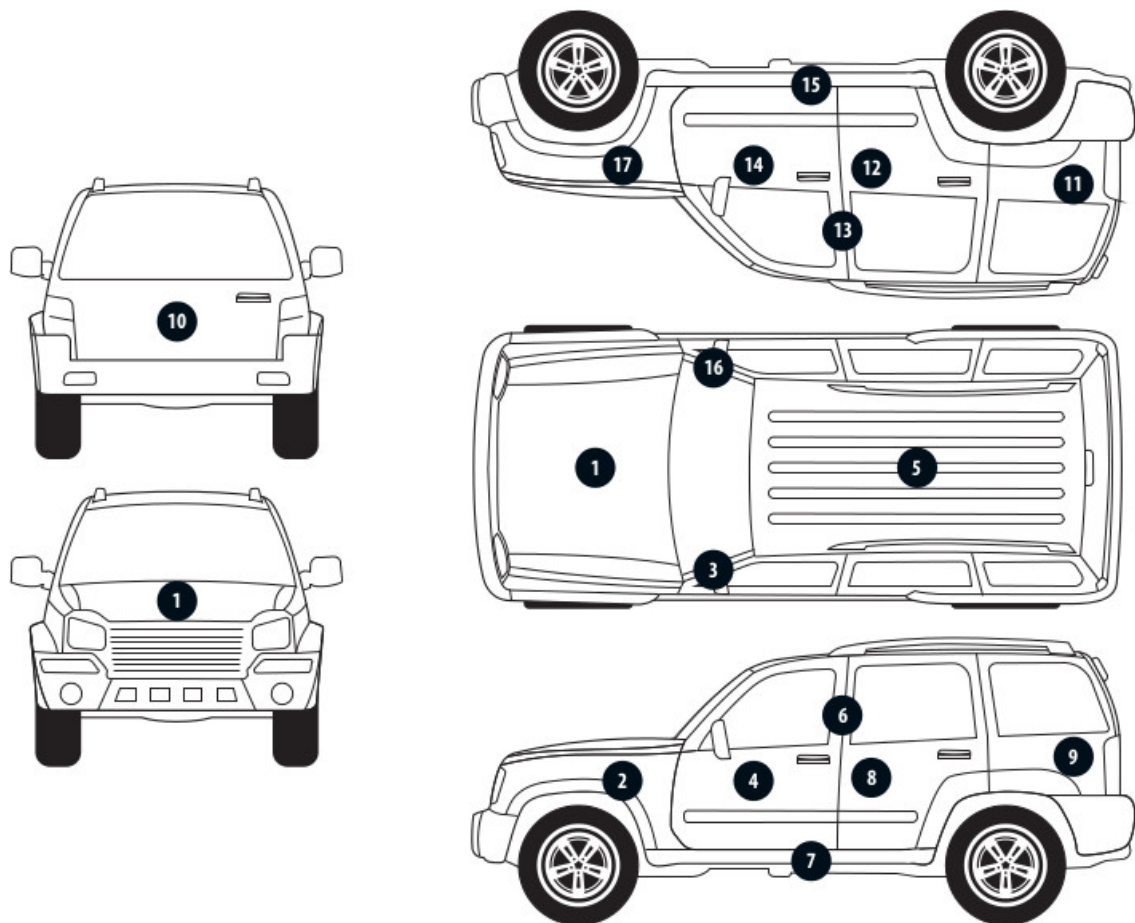
Measurement of thickness of the vehicle lacquer coating

| No. of controlled item | Controlled item | Measured range of thickness of the lacquer coat [µm] |
|---|---|---|
| 1 | Front cover | 150 - 300 |
| 2 | Left front fender | 150 - 300 |
| 3 | Left front pillar | to 150 |
| 4 | Left front wall | 150 - 300 |
| 5 | Roof | to 150 |
| 6 | Left middle pillar | 150 - 200 |
| 7 | Left side sill | 150 - 200 |
| 8 | Left rear wall | 150 - 300 |
| 9 | Left side wall | 150 - 300 |
| 11 | Side right wall | 150 - 300 |
| 12 | Rear right door | 150 - 300 |
| 13 | Middle right pillar | 150 - 200 |
| 14 | Front right door | 150 - 300 |
| 15 | Right side sill | 150 - 200 |
| 16 | Right front pillar | to 150 |
| 17 | Right front fender | 150 - 300 |

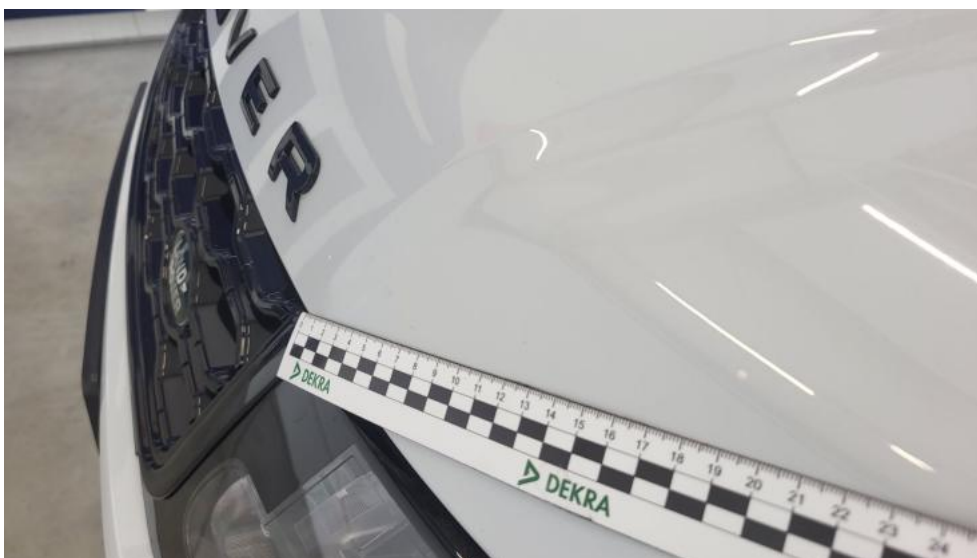
**Photo 46.**

Pokrywa komory silnika - Rysa/odprysk 1

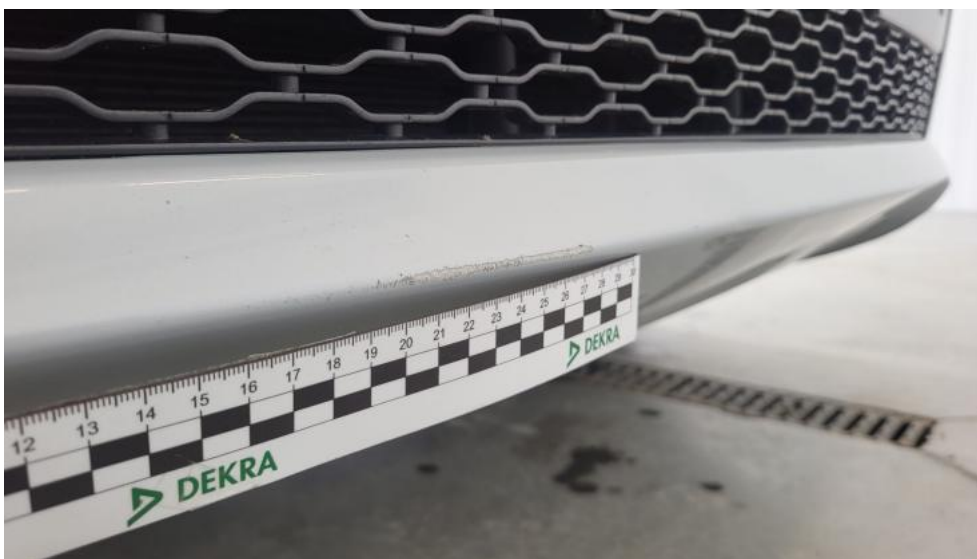
**Photo 47.**

Spoiler zderzaka przedniego - Rysa/odprysk 1

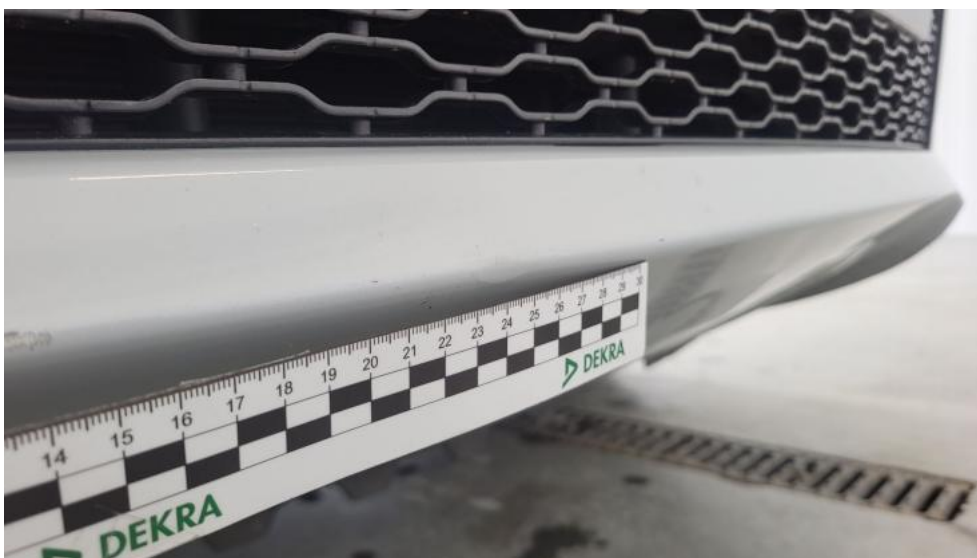
**Photo 48.**

Spoiler zderzaka przedniego - Wgniecenie/odkształcenie 1

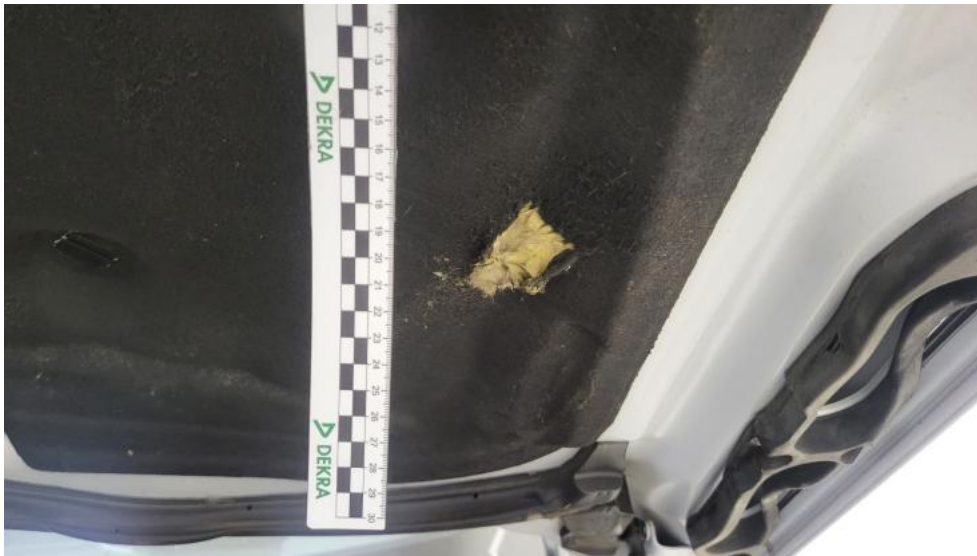
**Photo 49.**

Wykładzina pokrywy komory silnika - Pęknięcie/rozerwanie 1

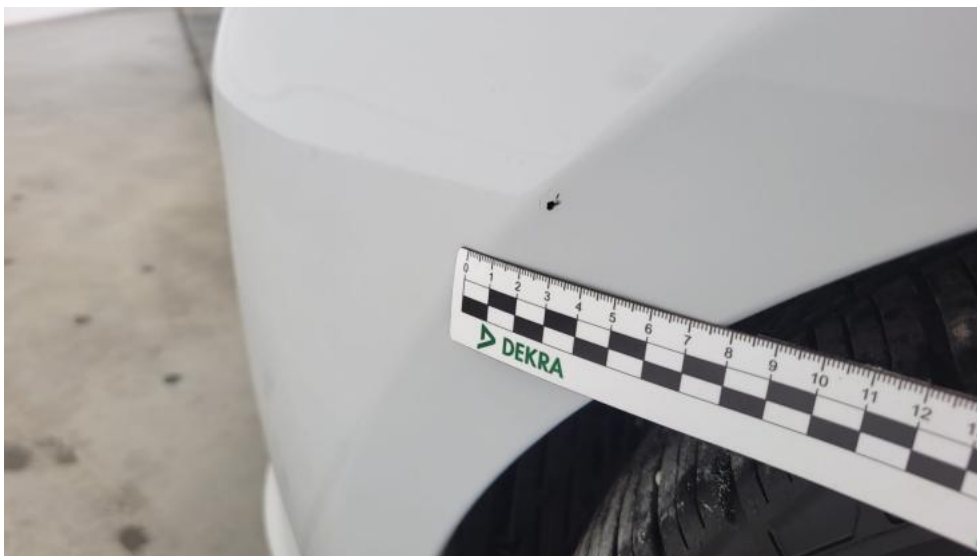
**Photo 50.**

Zderzak - Rysa/odprysk 1

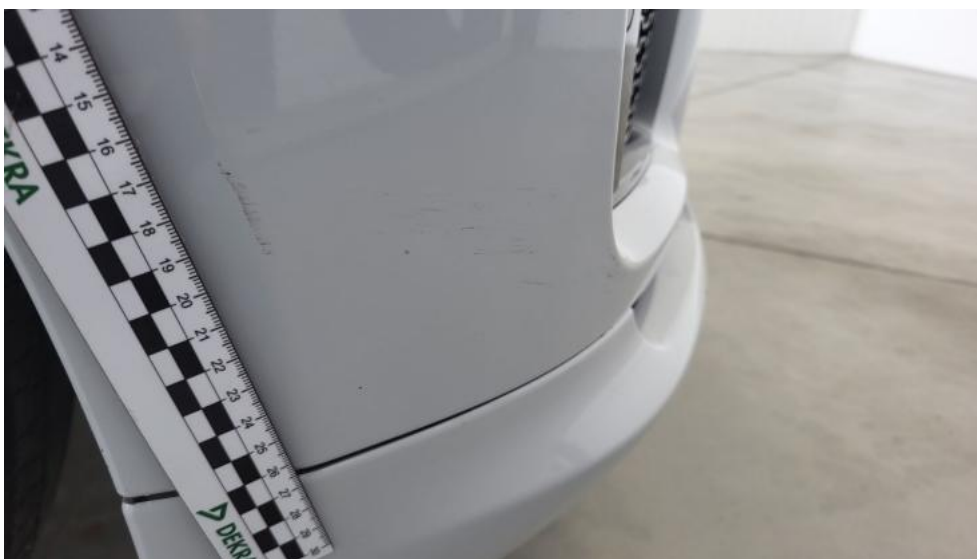
**Photo 51.**

Zderzak - Rysa/odprysk 2

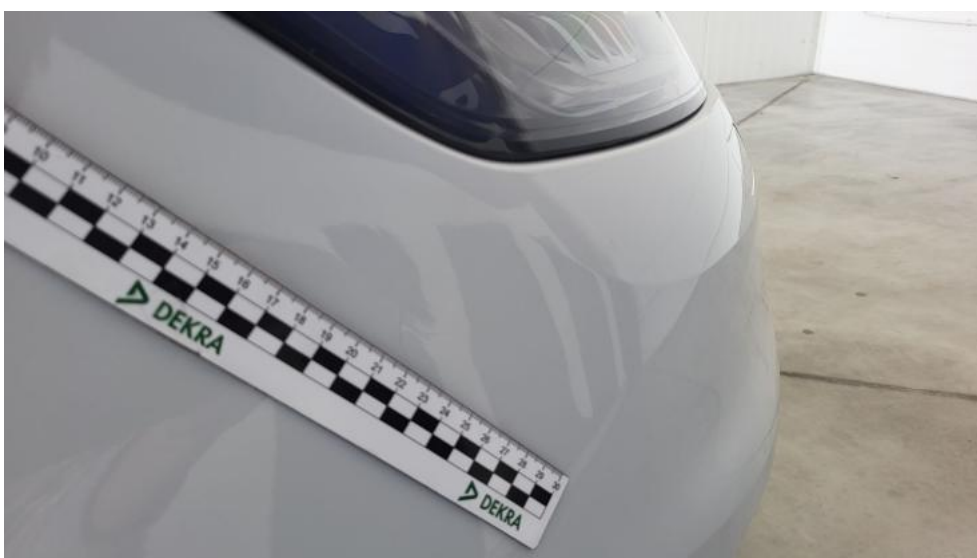
**Photo 52.**

Zderzak - Wgniecenie/odkształcenie 1

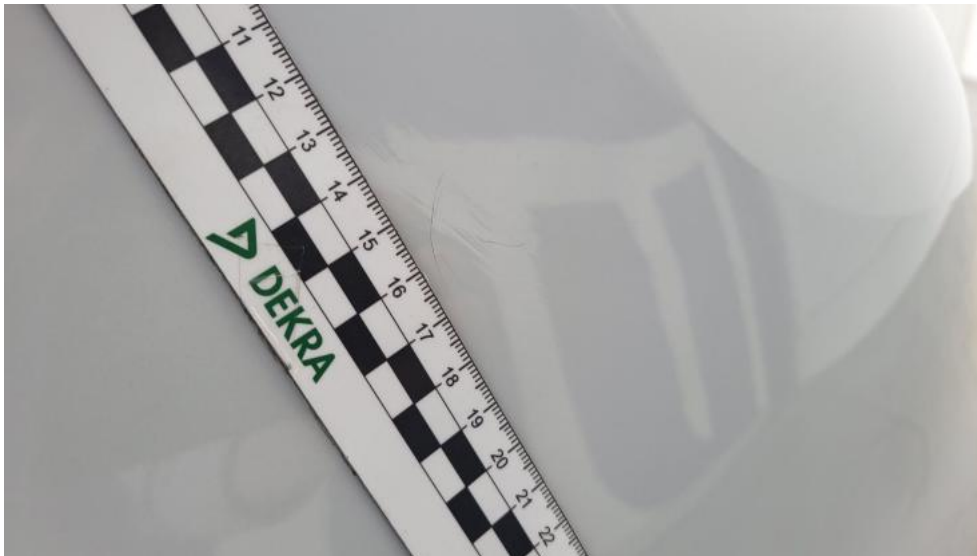
**Photo 53.**

Zderzak - Pęknięcie/rozerwanie 1

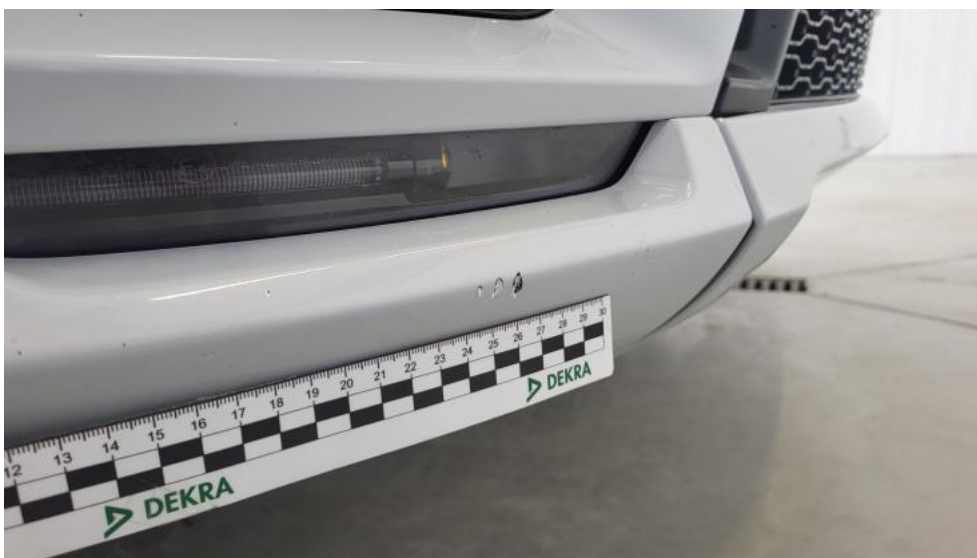
**Photo 54.**

Zderzak przedni cz P - Rysa/odprysk 1

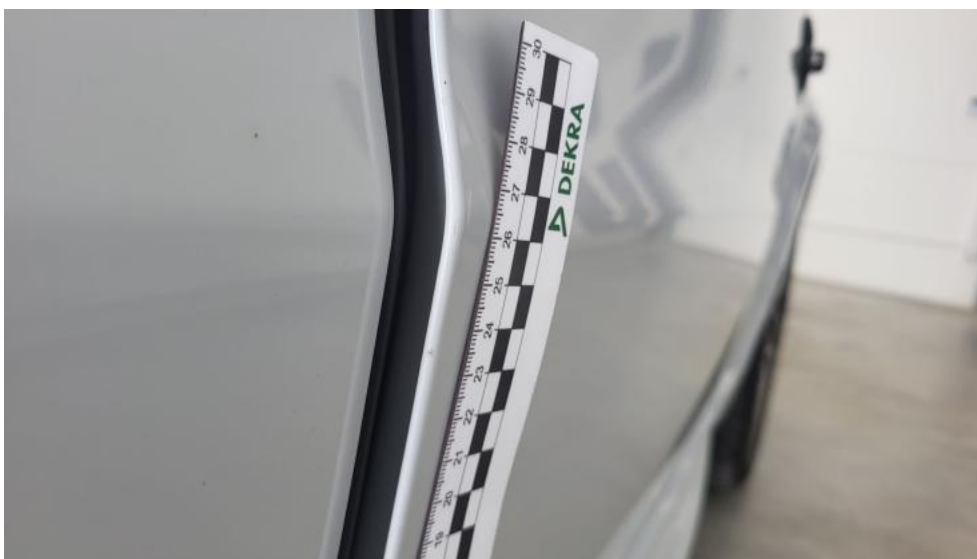
**Photo 55.**

Drzwi przednie P - Rysa/odprysk 1

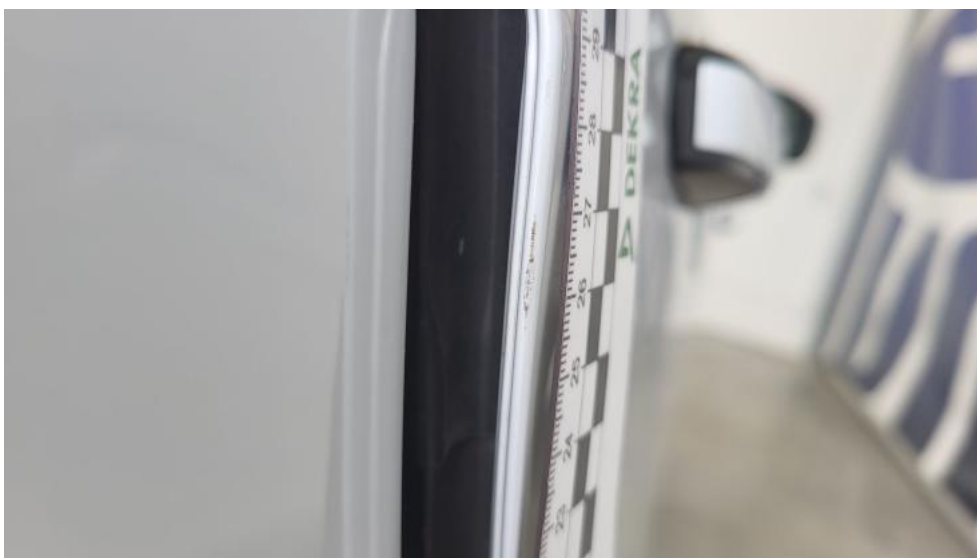
**Photo 56.**

Drzwi tylne P - Rysa/odprysk 1

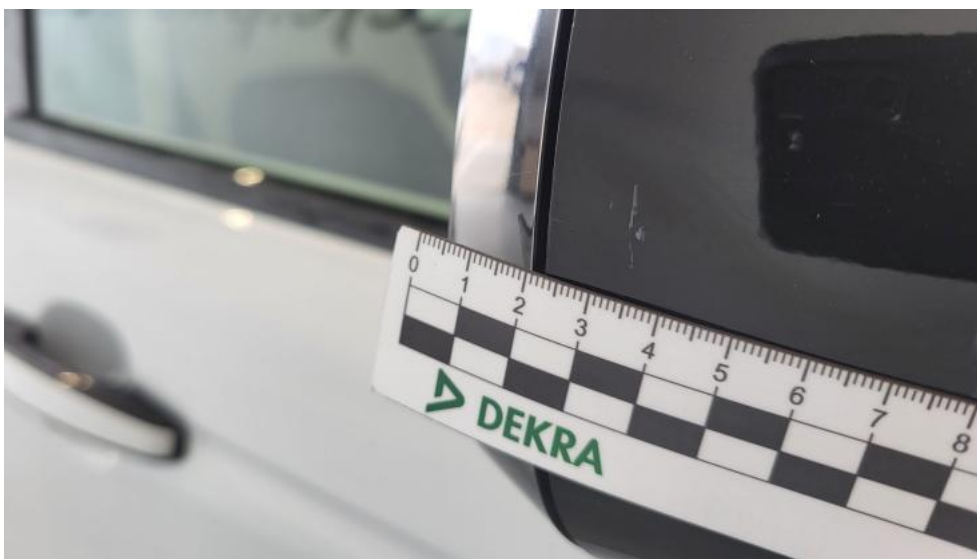
**Photo 57.**

Lusterko zew P - Rysa/odprysk 1

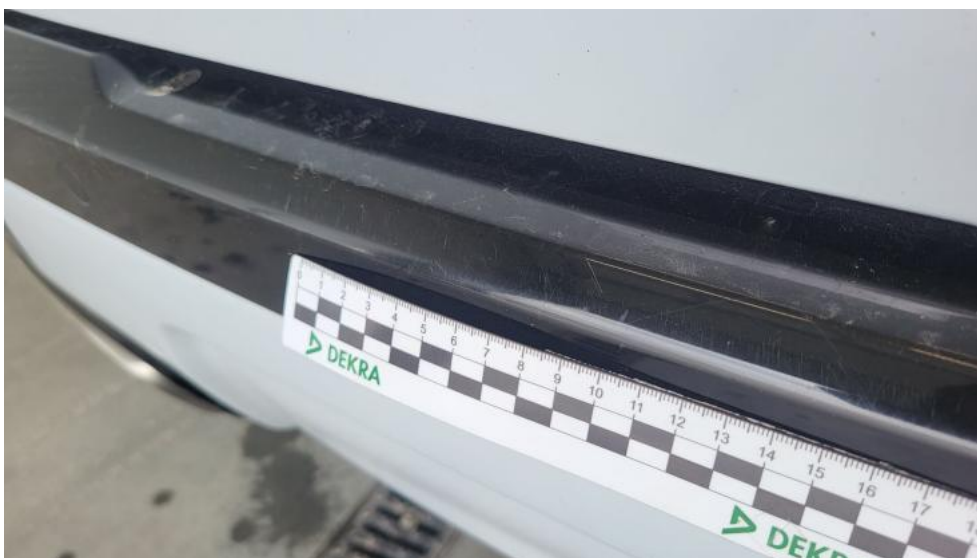
**Photo 58.**

Zderzak tylny - Rysa/odprysk 1

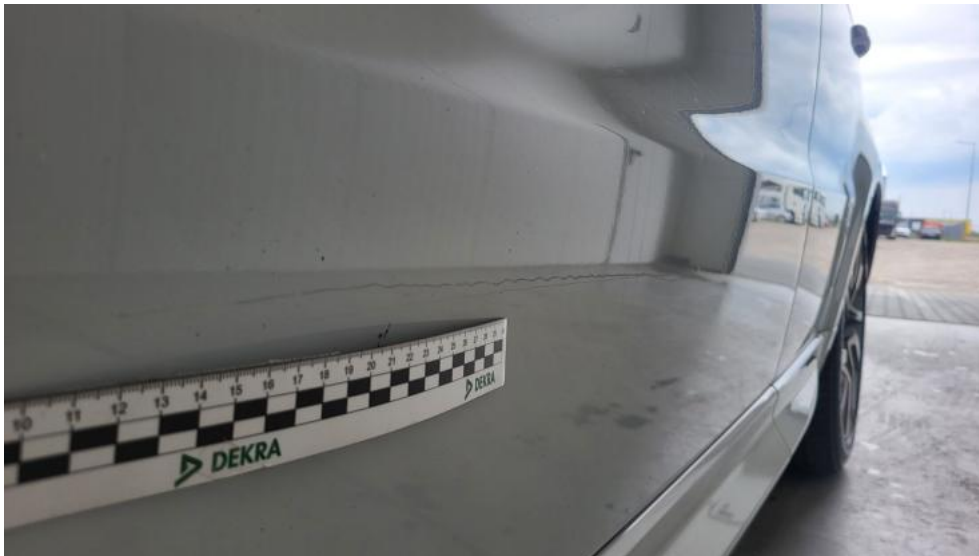
**Photo 59.**

Drzwi przed L - Rysa/odprysk 1

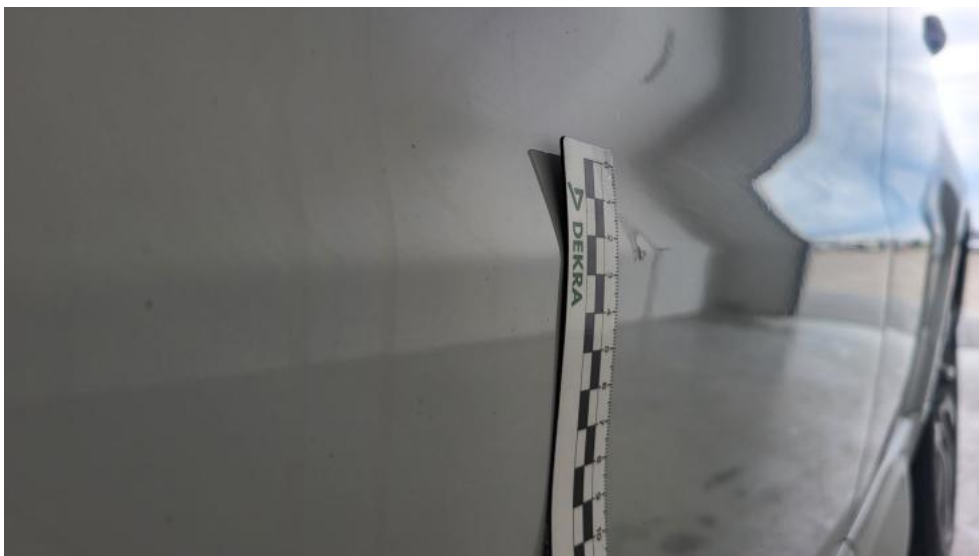
**Photo 60.**

Drzwi przed L - Wgniecenie/odkształcenie 1

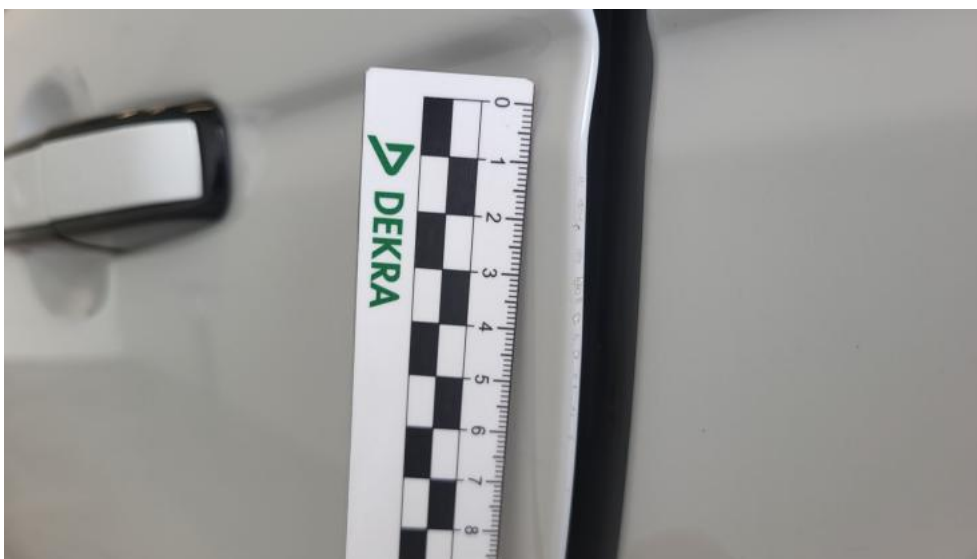
**Photo 61.**

Drzwi tylne L - Rysa/odprysk 1

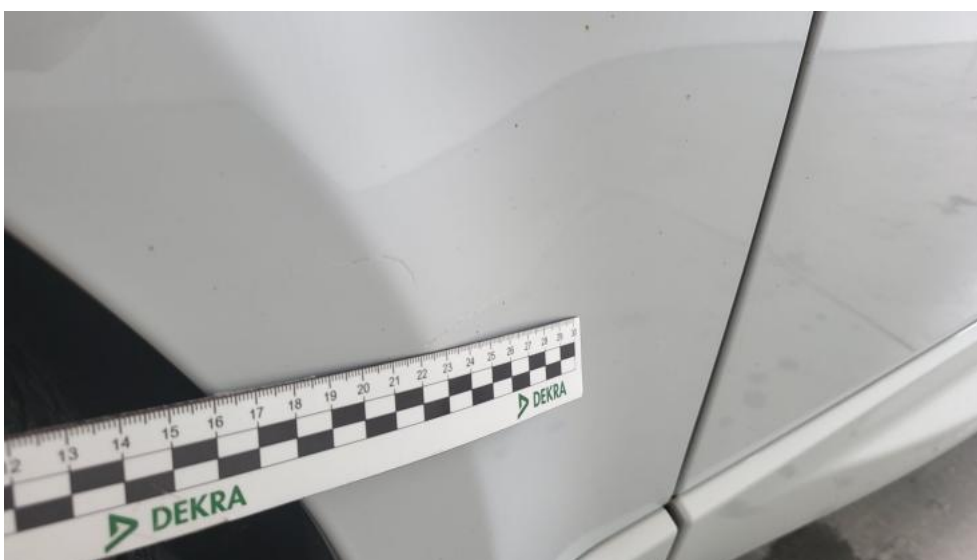
**Photo 62.**

Łotnik przedni L - Rysa/odprysk 1

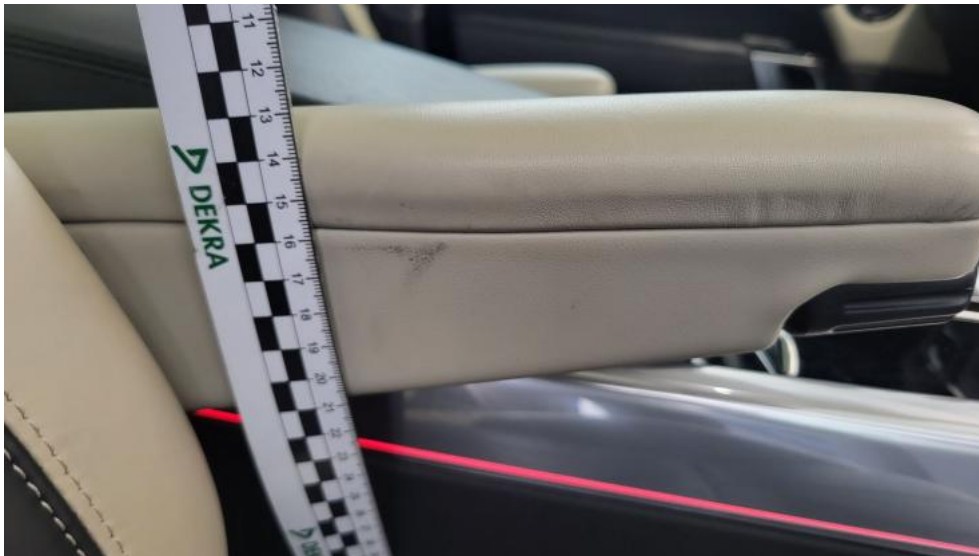
**Photo 63.**

Podłokietnik środkowy przedni - Inne 1

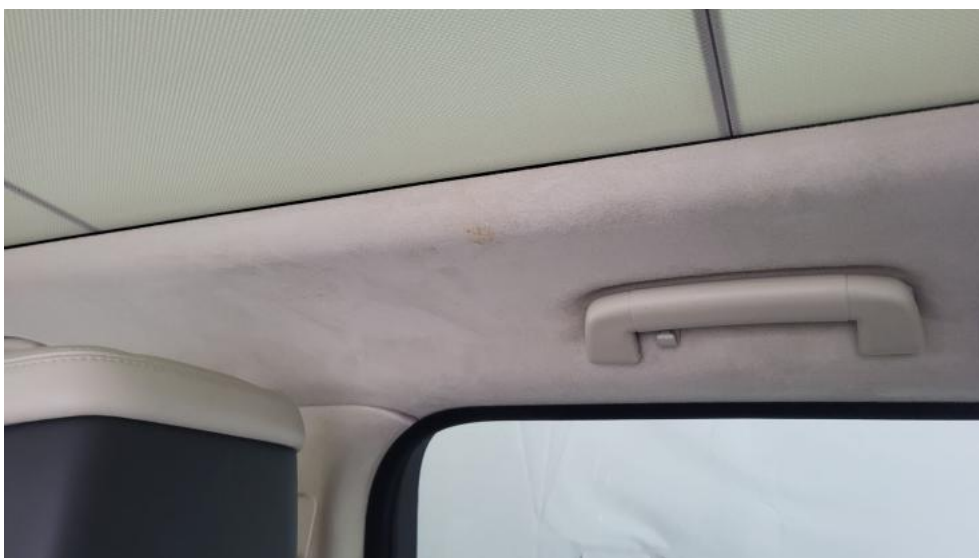
**Photo 64.**

Podsufitka - Inne 1

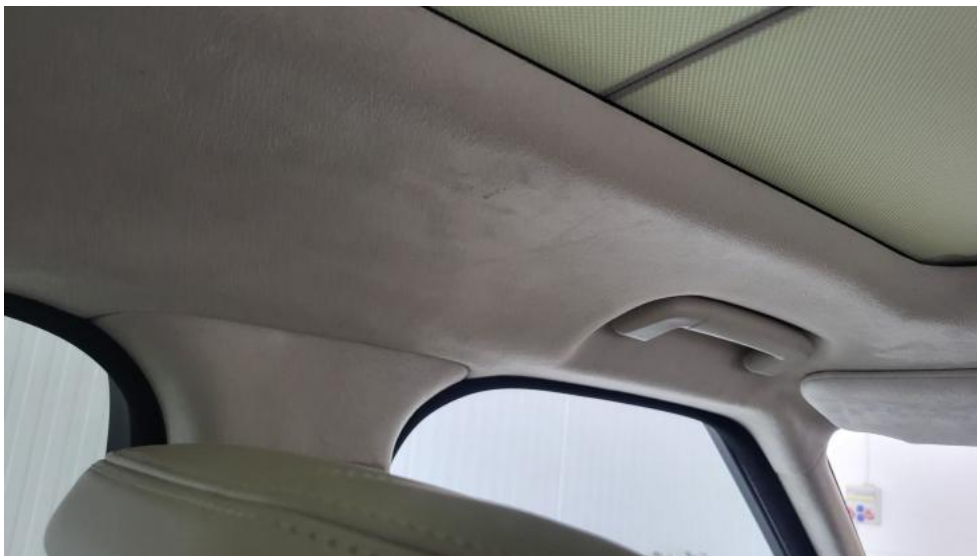
**Photo 65.**

Podsufitka - Inne 2
