DEKRA's commission No. : PKOL(W)/LODZ/19387/25/03/17
 commission/ damage No. : FUTURA
 Date of commission: 17-03-2025

Vehicle data

Group of objects (Eurotax)	cars
EC code (Eurotax)	0150122
Manufacturer	RENAULT
Model	Arkana 21-23
Type / version	Arkana 1.3 TCe mHEV R.S. Line EDC
Body type	hatchback
Number of doors / seats	5/5
Curb weight [kg]	1347
Gross vehicle weight [kg]	1876
Wheelbase 1/2	2720
Engine type	spark ignition
Pollution reduction system	GPF
Emission standard	EURO 6
Engine capacity [ccm]	1332
Engine Power [hp/kW]	158/116
Gearbox	automatic 7- gear
Registration /record No.	EL7FN53
VIN / serial number	VF1RJL004UC324187
Date of first registration	30-06-2022
Date of next. tech. test	30-06-2025
Year of manufacture	2022 (year has been verified with the manufacturer's base)
Readout [km]	34 768 (read)
Body color / type of coating	white/2-warstwowy metalik

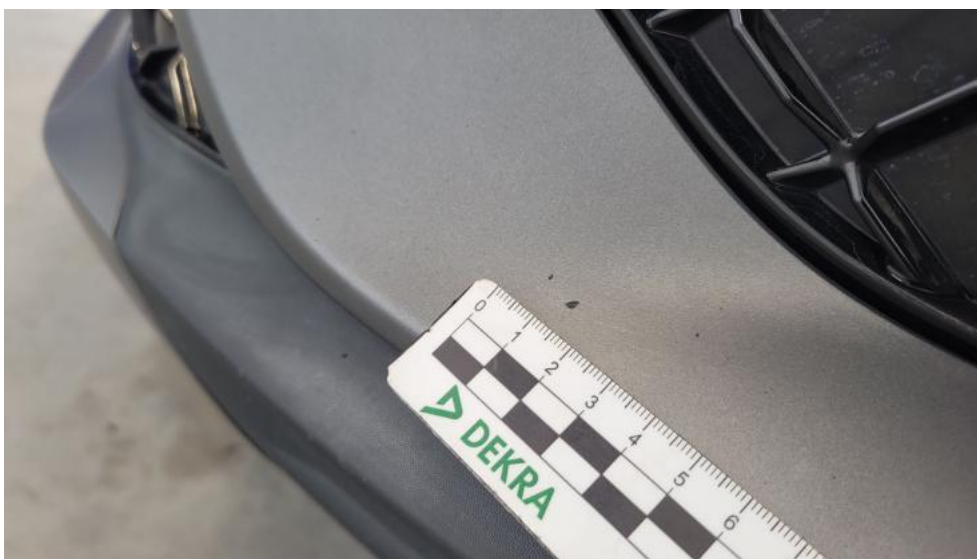
Photo 39.
Kratka/zaślepka halogenu L - Rysa/odprysk 1

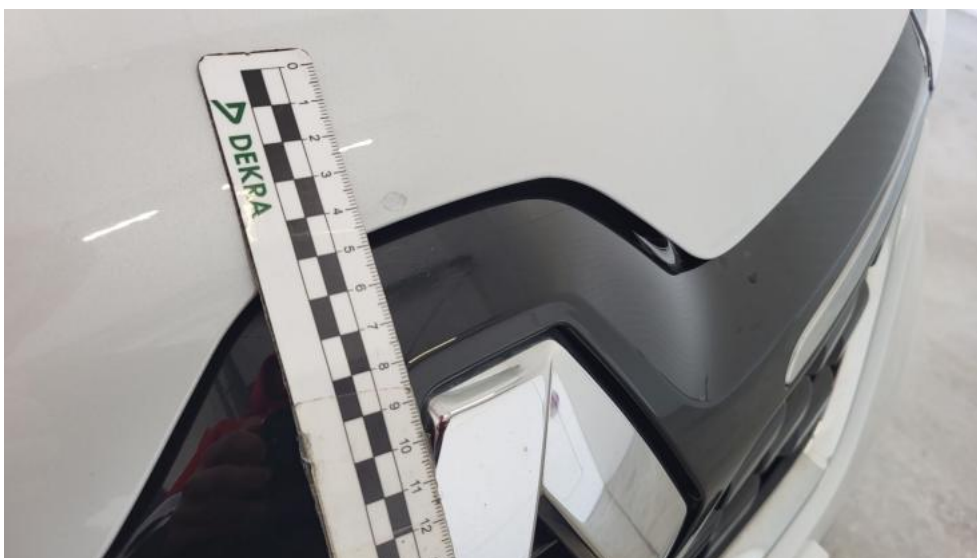
Photo 40.
Pokrywa komory silnika - Rysa/odprysk 1

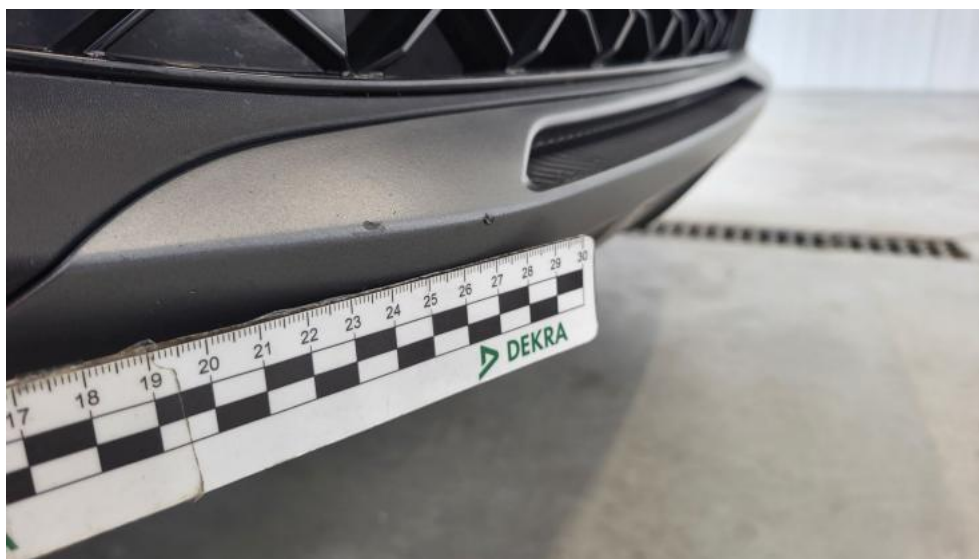
Photo 41.

Spoiler zderzaka przedniego - Rysa/odprysk 1

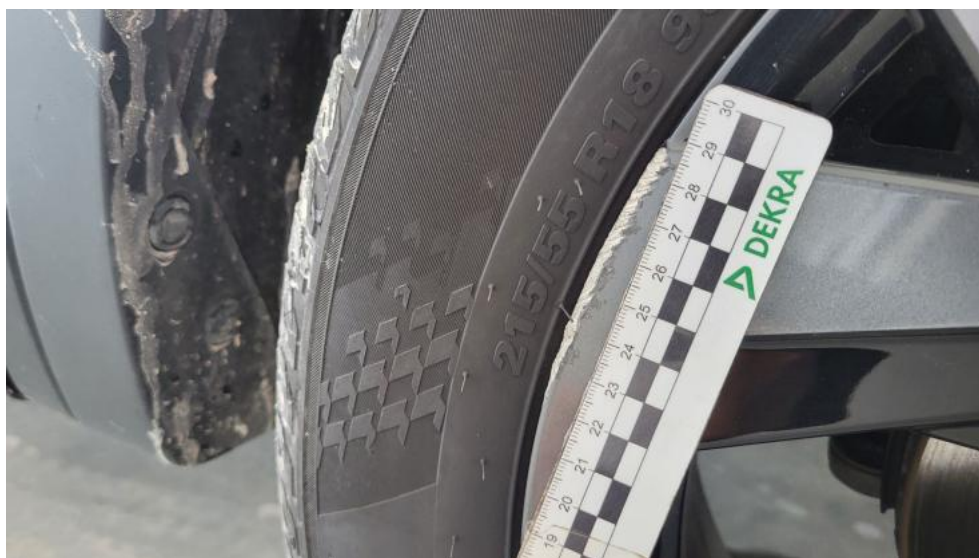
Photo 42.

Felga aluminiowa przednia P - Rysa/odprysk 1

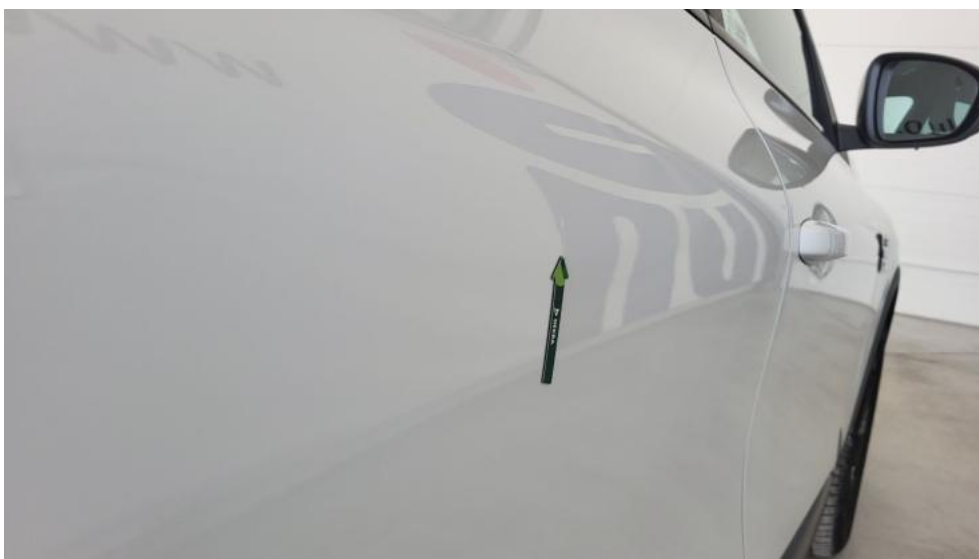
Photo 43.
Drzwi tylne P - Wgniecenie/odkształcenie 1

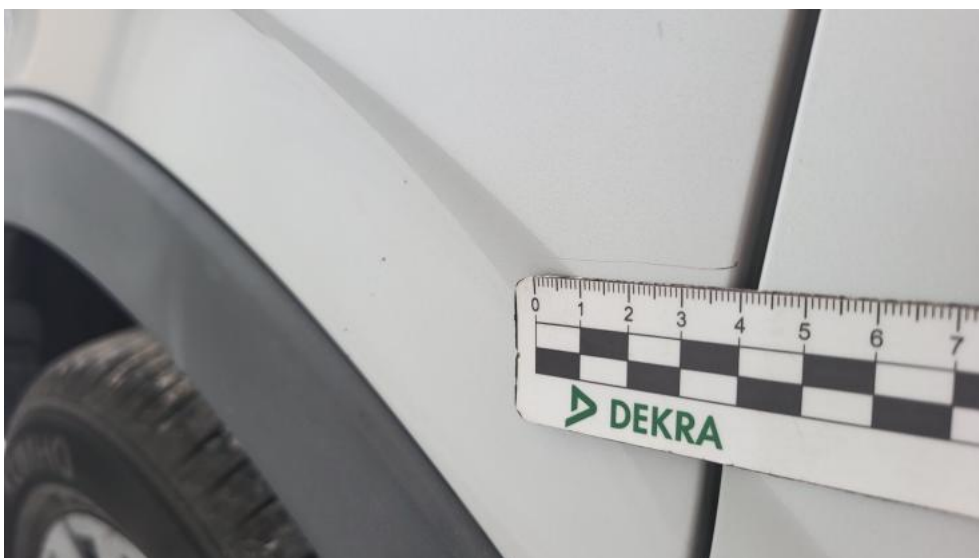
Photo 44.
Błotnik tylny P / Ściana boczna P - Rysa/odprysk 1

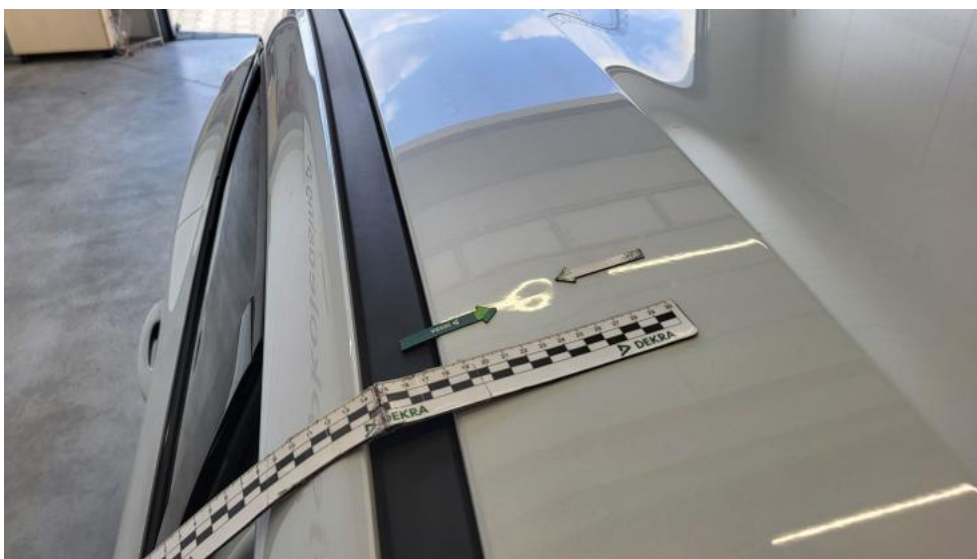
Photo 45.
Dach - Wgniecenie/odkształcenie 1

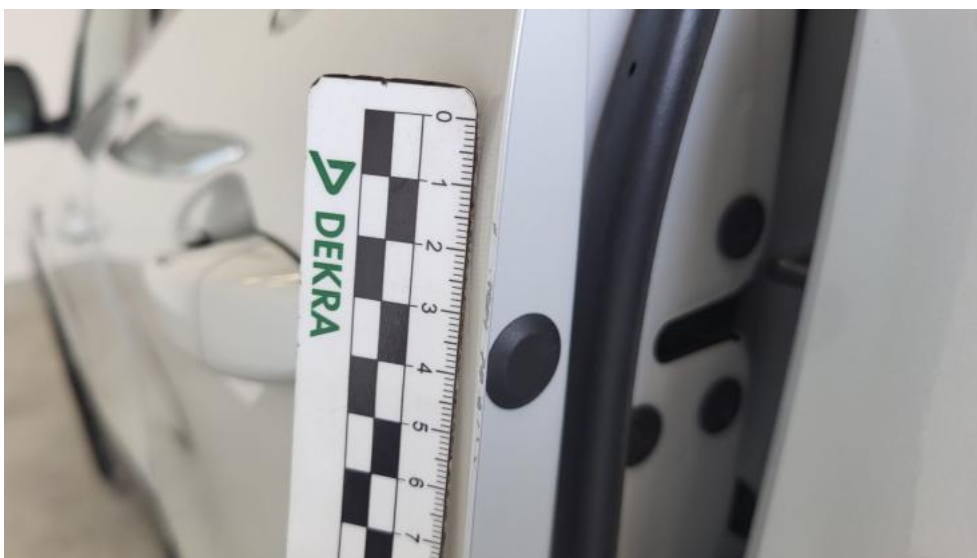
Photo 50.

Drzwi tylne L - Rysa/odprysk 1

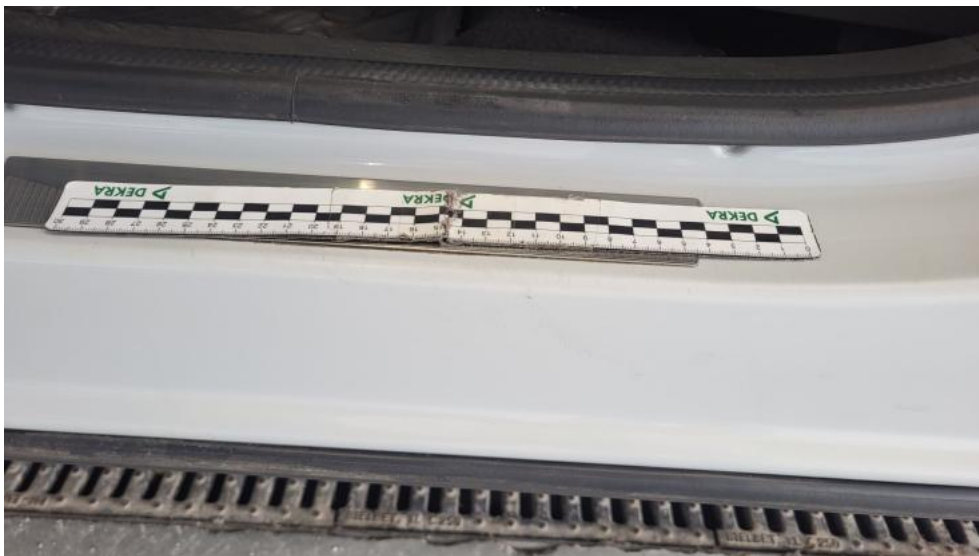
Photo 51.
Próg L - Rysa/odprysk 1

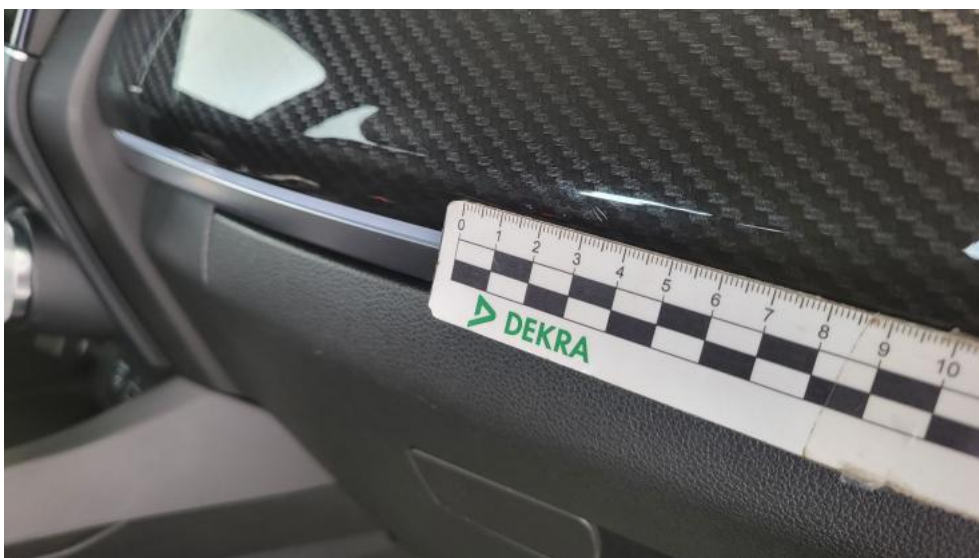
Photo 52.
Deska rozdzielcza - Rysa/odprysk 1

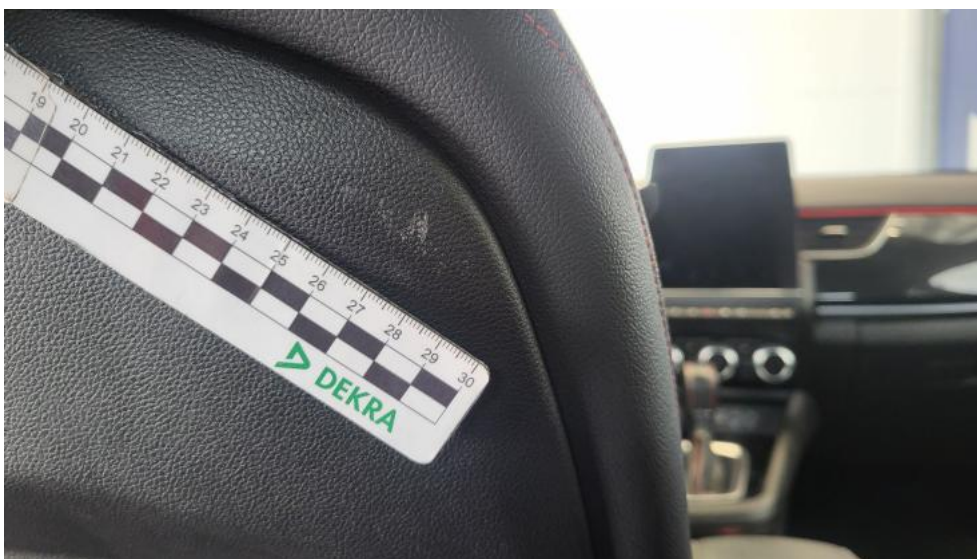
Photo 53.

Fotel prz. lew. - Rysa/odprysk 1

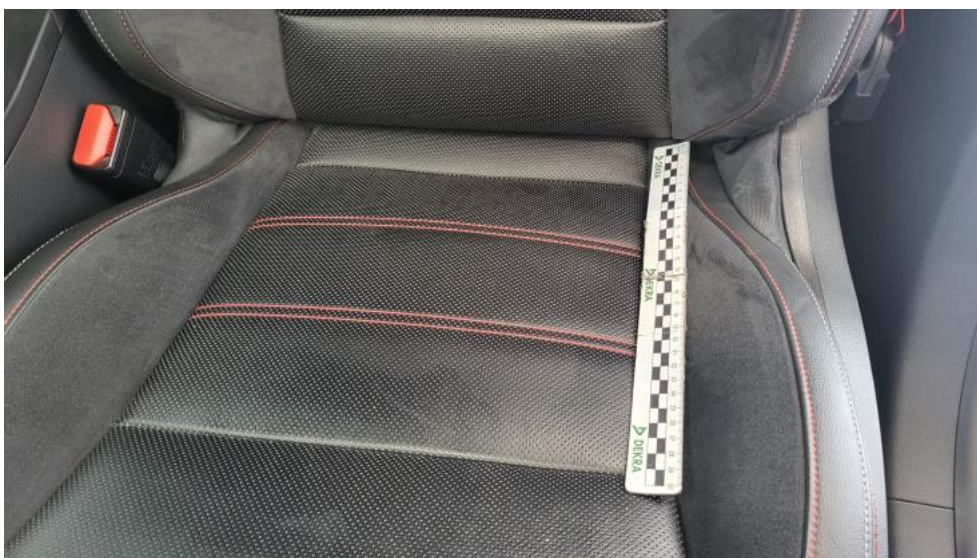
Photo 54.

Fotel prz. lew. - Inne 1

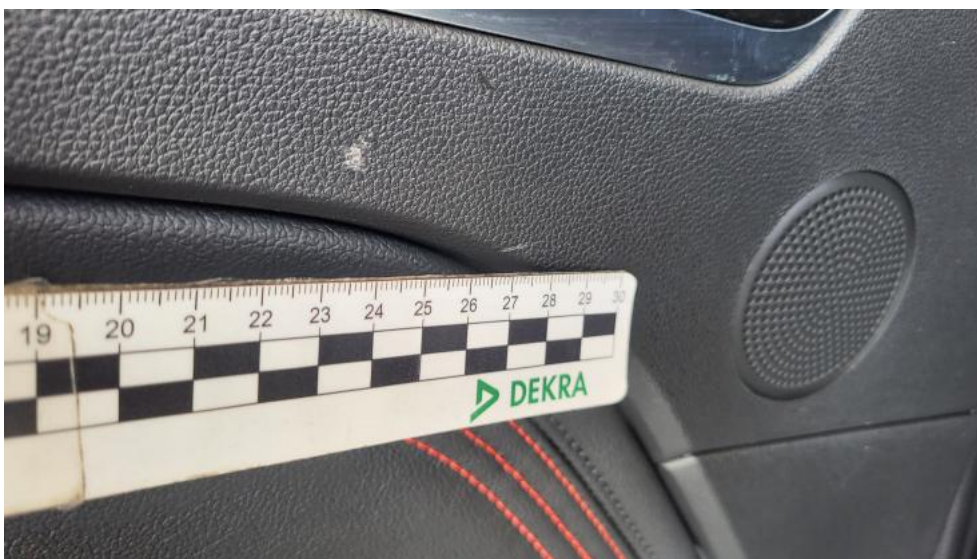
Photo 55.

Tapicerka drzwi tylnych L - Rysa/odprysk 1
