DEKRA's commission No. : PKOL(W)/LODZ/19292/25/03/17
 commission/ damage No. : Futura
 Date of commission: 17-03-2025

Vehicle data

Group of objects (Eurotax)	cars
EC code (Eurotax)	0108839
Manufacturer	OPEL
Model	Corsa E Hatchback 14-19
Type / version	Corsa 1.4 Enjoy
Body type	hatchback
Number of doors / seats	5/5
Curb weight [kg]	1134
Gross vehicle weight [kg]	1620
Wheelbase 1/2	2510
Engine type	spark ignition
Pollution reduction system	three-way catalytic converter
Engine capacity [ccm]	1398
Engine Power [hp/kW]	75/55
Gearbox	manual 5- gear
Registration /record No.	WX8298A
VIN / serial number	W0V0XEP68K4354880
Date of first registration	30-05-2019
Date of next. tech. test	10-06-2025
Year of manufacture	2019 (year has been verified with the manufacturer's base)
Readout [km]	64 008 (read)
Body color / type of coating	silver/double-layered, metallized

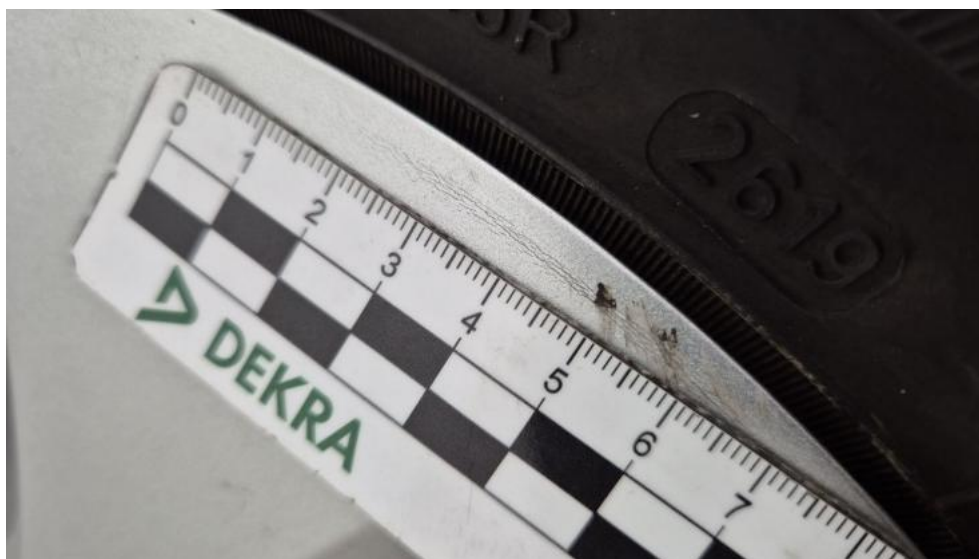
Photo 37.
Kołpak przedni P - Pęknięcie/rozerwanie 1

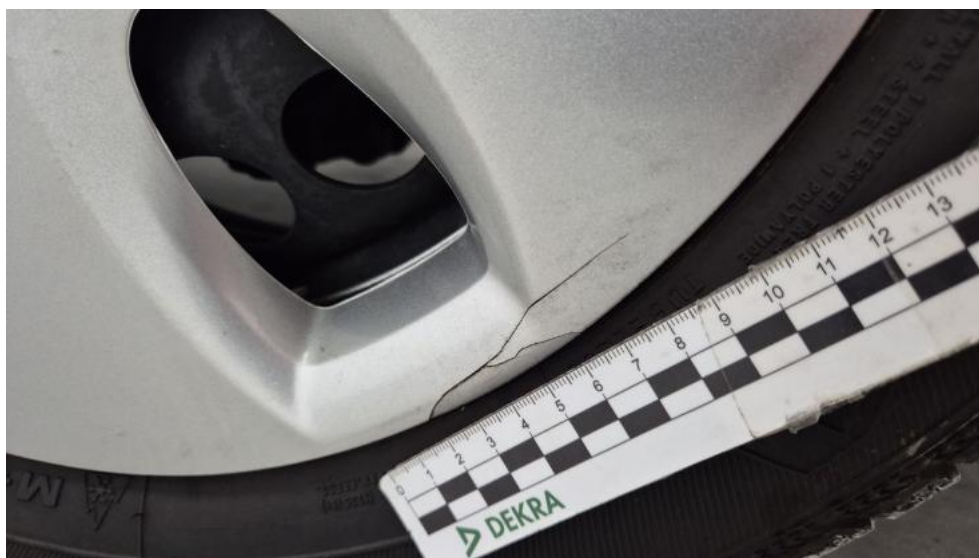
Photo 38.
Kołpak przedni P - Pęknięcie/rozerwanie 2

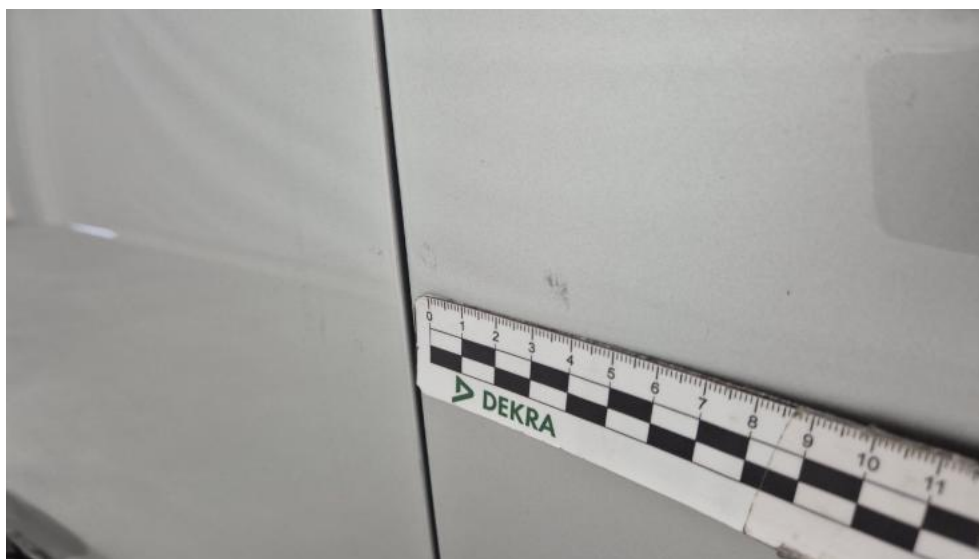
Photo 39.

Drzwi przednie P - Rysa/odprysk 1

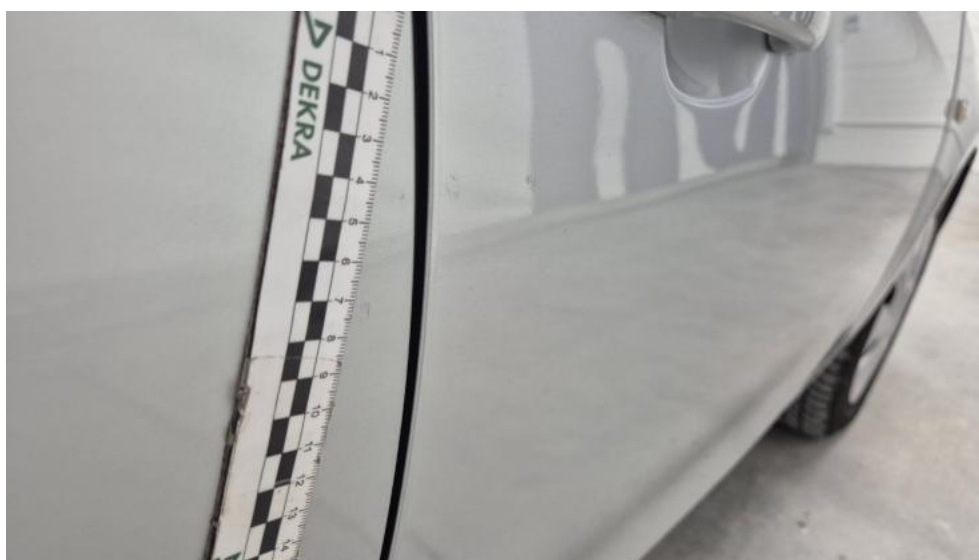
Photo 40.

Drzwi tylne P - Rysa/odprysk 1

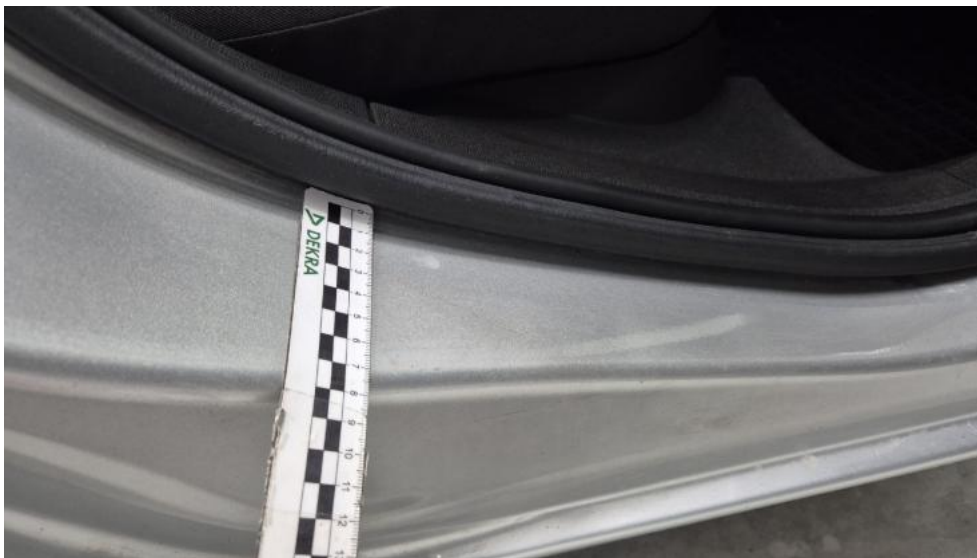
Photo 41.
Próg P - Rysa/odprysk 1

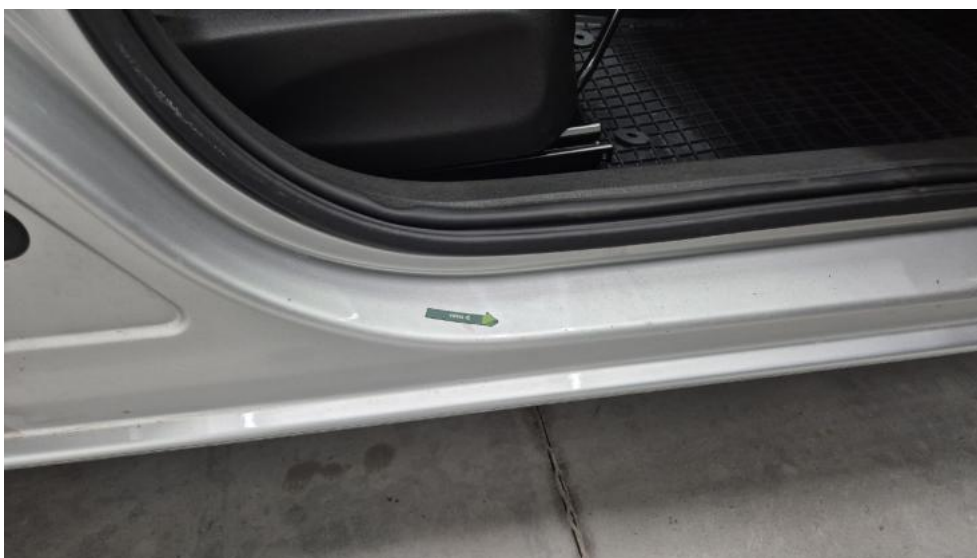
Photo 42.
Próg P - Wgniecenie/odkształcenie 1

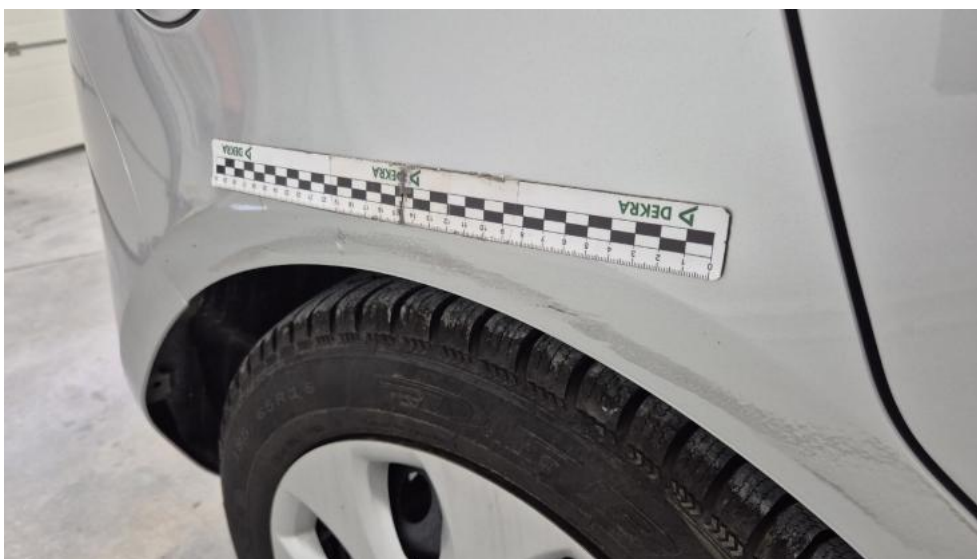
Photo 43.

Błotnik tylny P / Ściana boczna P - Rysa/odprysk 1

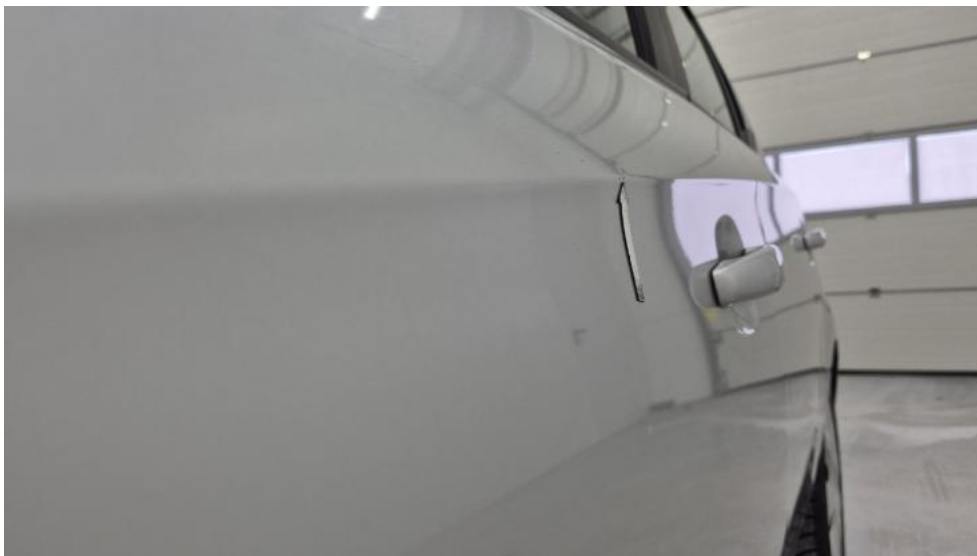
Photo 53.
Drzwi przed L - Wgniecenie/odkształcenie 1

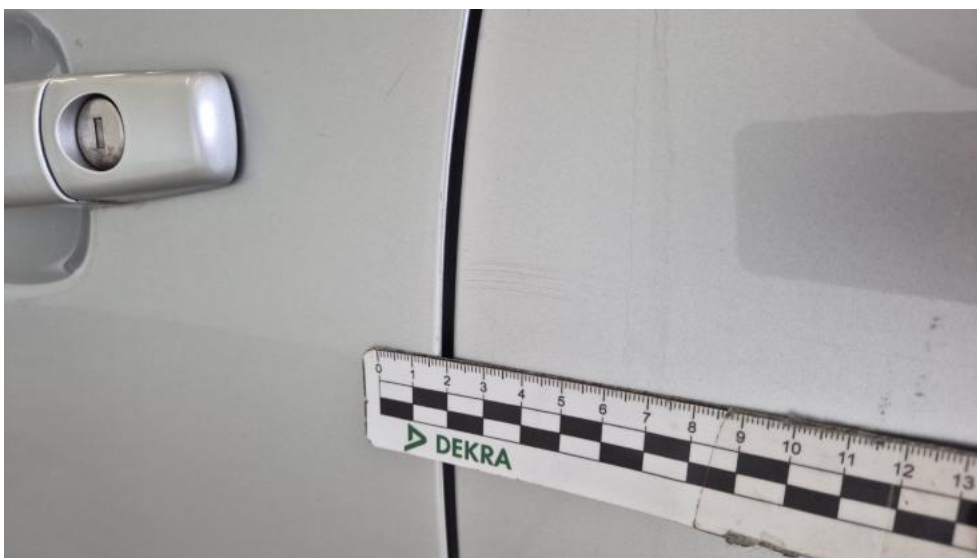
Photo 54.
Drzwi tylne L - Rysa/odprysk 1
