DEKRA's commission No. : PKOL(W)/LODZ/20104/25/03/19  
commission/ damage No. : 19/048005  
Date of commission: 19-03-2025

**Vehicle data**

Group of objects (Eurotax)	jeeps
EC code (Eurotax)	0133279
Manufacturer	LAND ROVER
Model	Range Rover Sport 17-22
Type / version	Range Rover S 2.0Si4 GPF S
Body type	KOM
Number of doors / seats	5/5
Curb weight [kg]	2205
Gross vehicle weight [kg]	2900
Wheelbase 1/2	2923
Engine type	spark ignition
Pollution reduction system	GPF
Engine capacity [ccm]	1997
Engine Power [hp/kW]	300/221
Gearbox	automatic 8- gear
Registration /record No.	WZ2935Y
VIN / serial number	SALWA2BXXLA895047
Date of first registration	14-11-2019
Date of next. tech. test	04-07-2025
Year of manufacture	2019
Readout [km]	237 560 (read)
Body color / type of coating	white/UNI

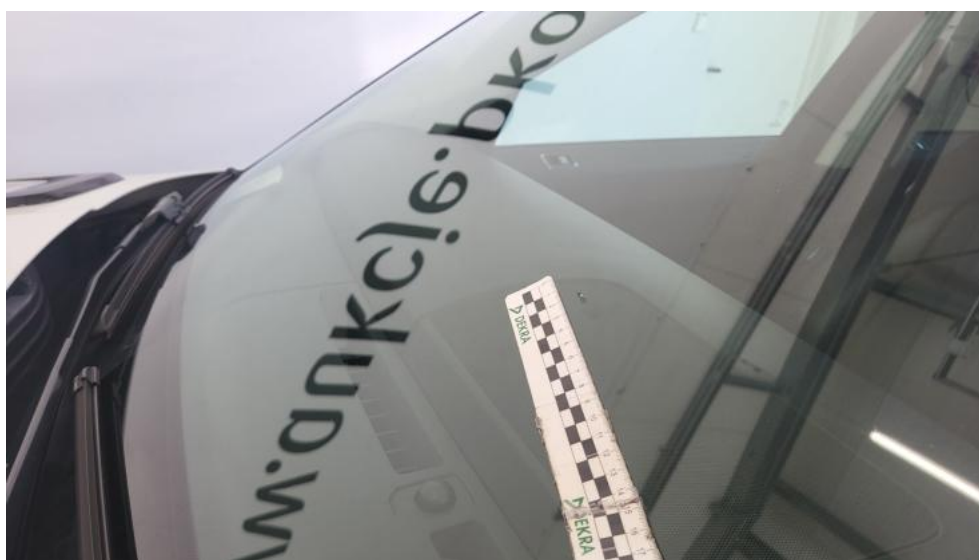
**Photo 38.**

Szyba czołowa - zdjęcie poglądowe 1

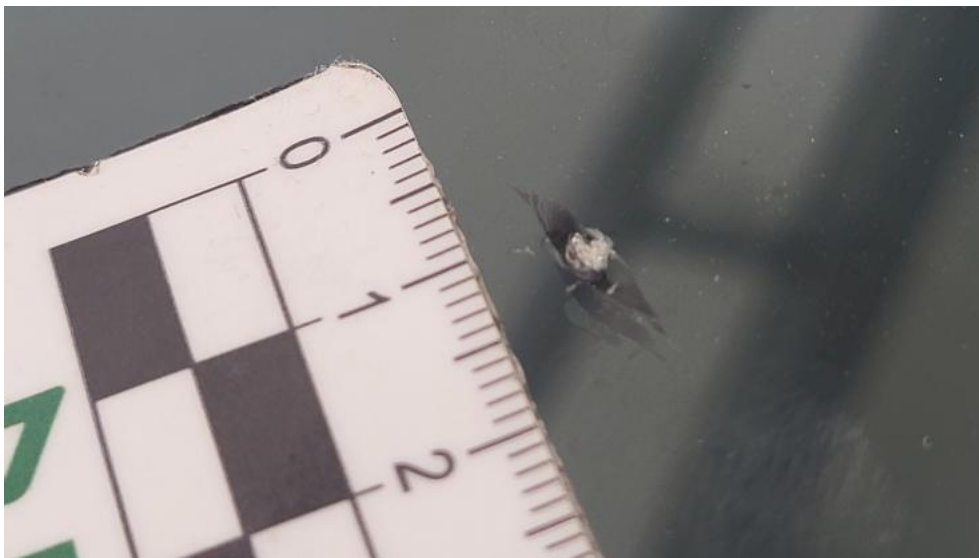
**Photo 39.**  
Szyba czołowa - Pęknięcie/rozerwanie 1

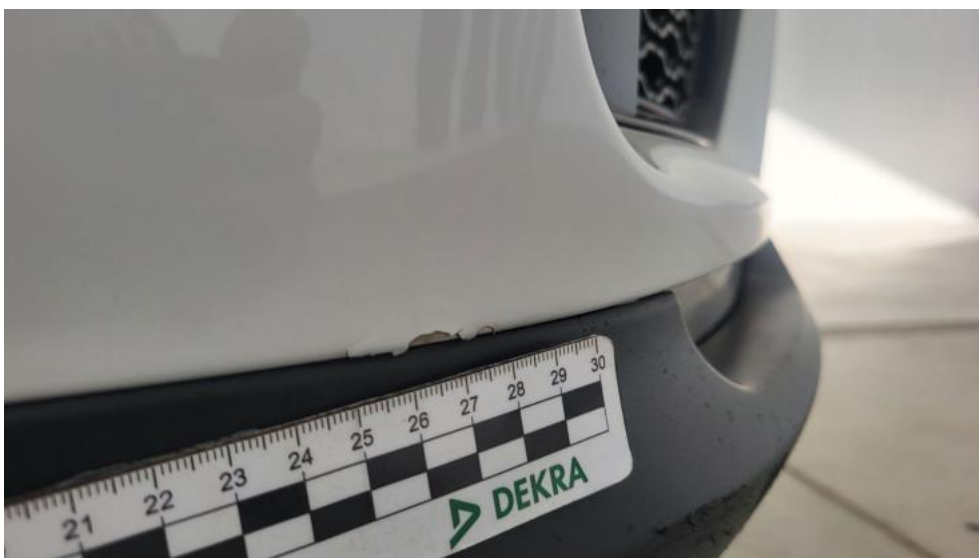
**Photo 40.**  
Zderzak - Rysa/odprysk 1

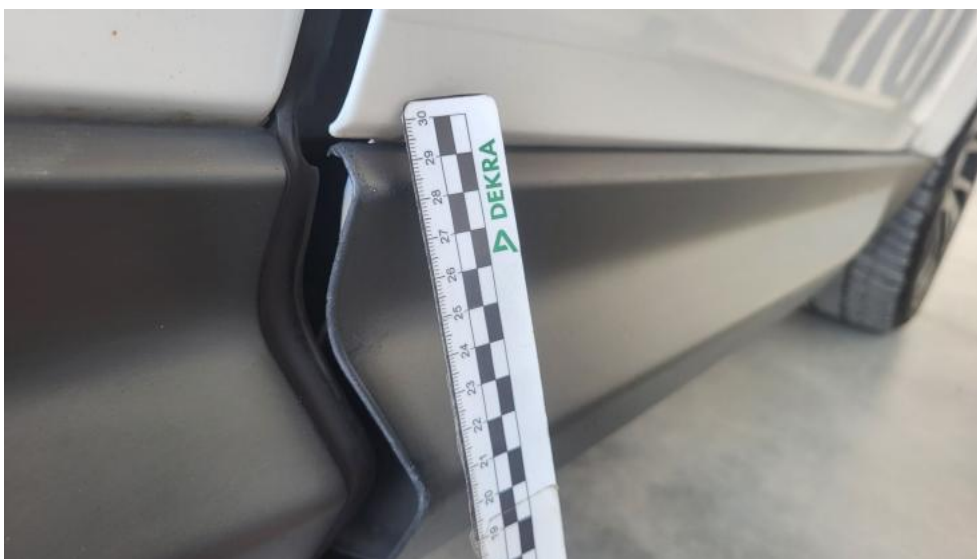
**Photo 53.**

Listwa drzwi przednich P - Rysa/odprysk 1

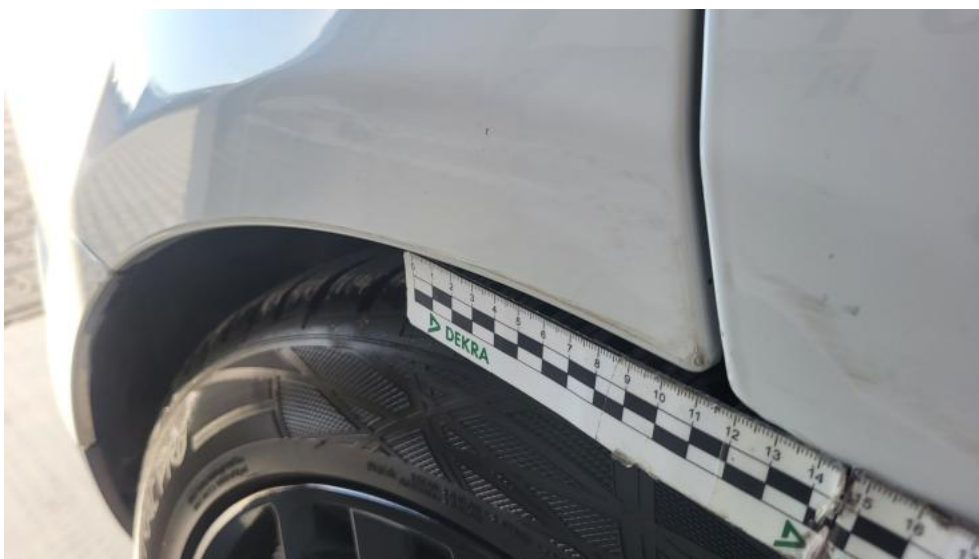
Błotnik tylny P / Ściana boczna P - Rysa/odprysk 1

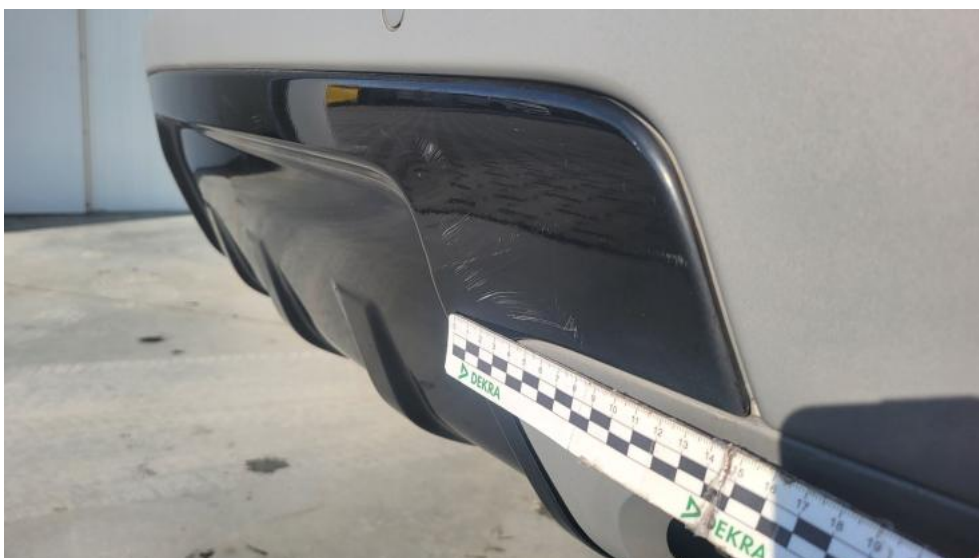
**Photo 56.**

Zderzak tylny cz dolna - Rysa/odprysk 1

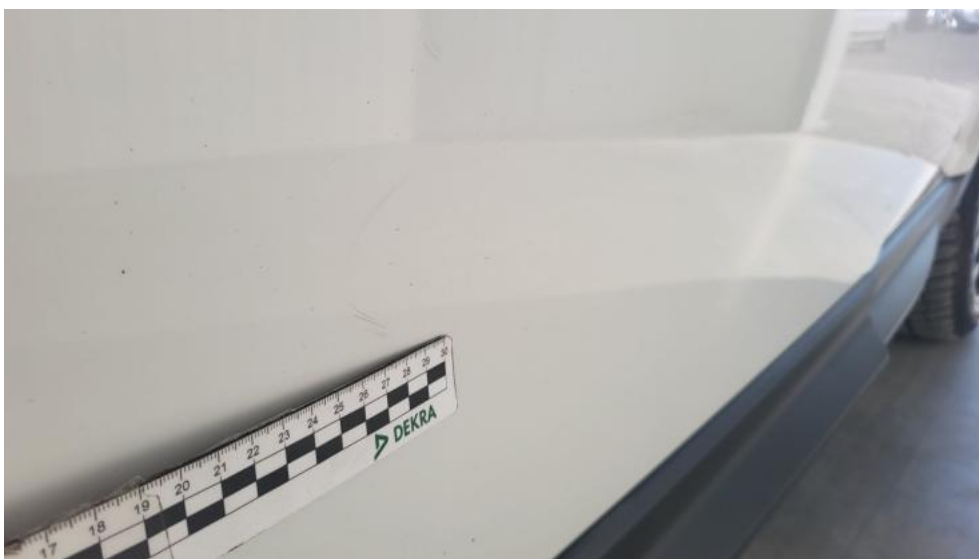
**Photo 59.**

Drzwi przed L - Rysa/odprysk 2

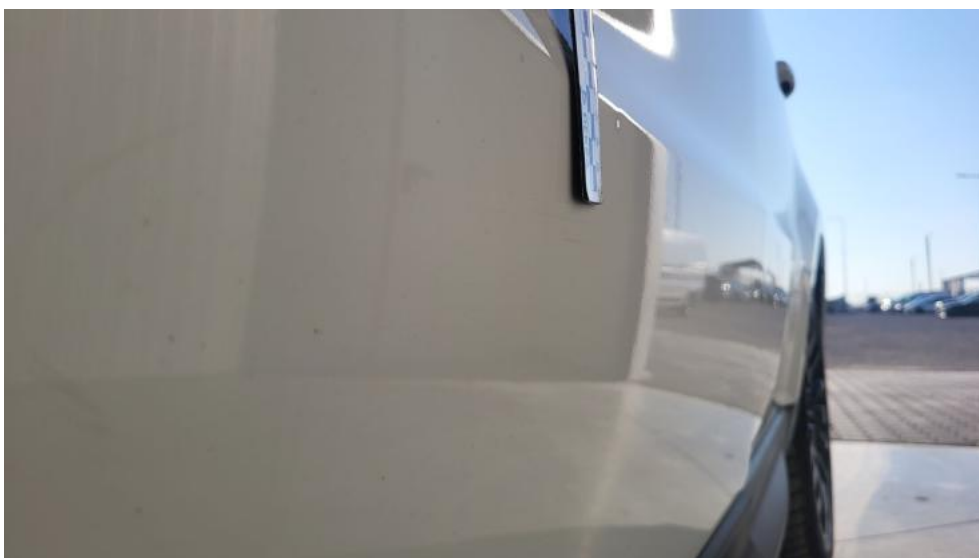
**Photo 60.**

Drzwi przed L - Wgniecenie/odkształcenie 1

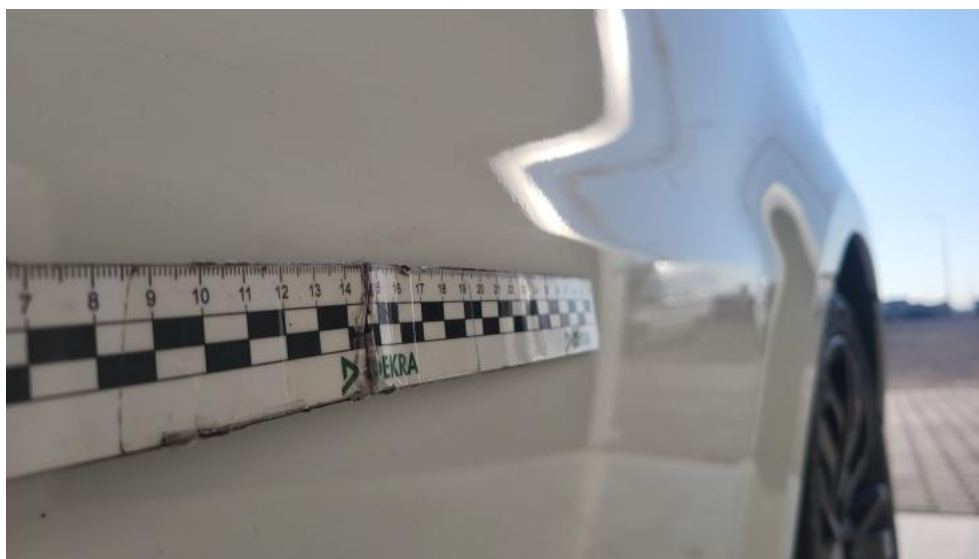
**Photo 63.**  
Drzwi tylne L - Wgniecenie/odkształcenie 1

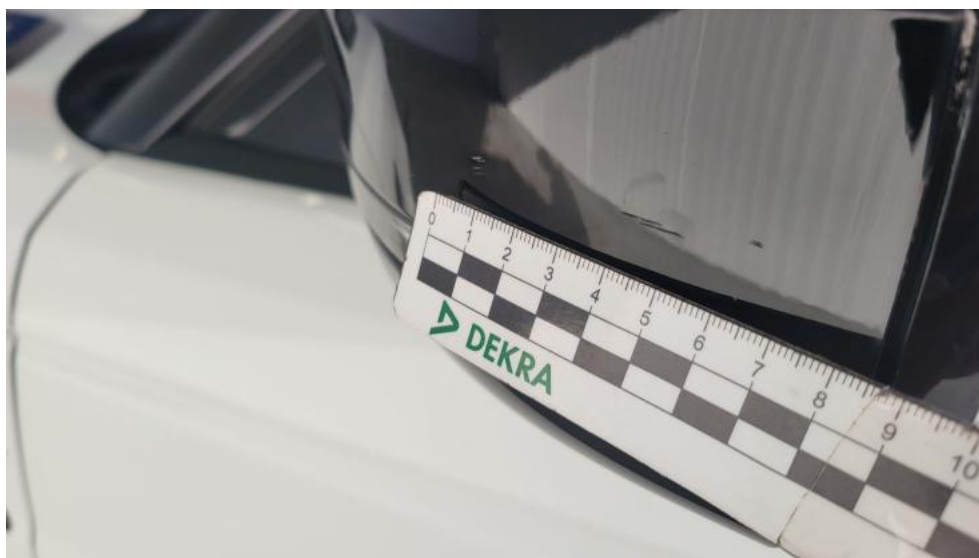
**Photo 64.**  
Lusterko zew L - Rysa/odprysk 1

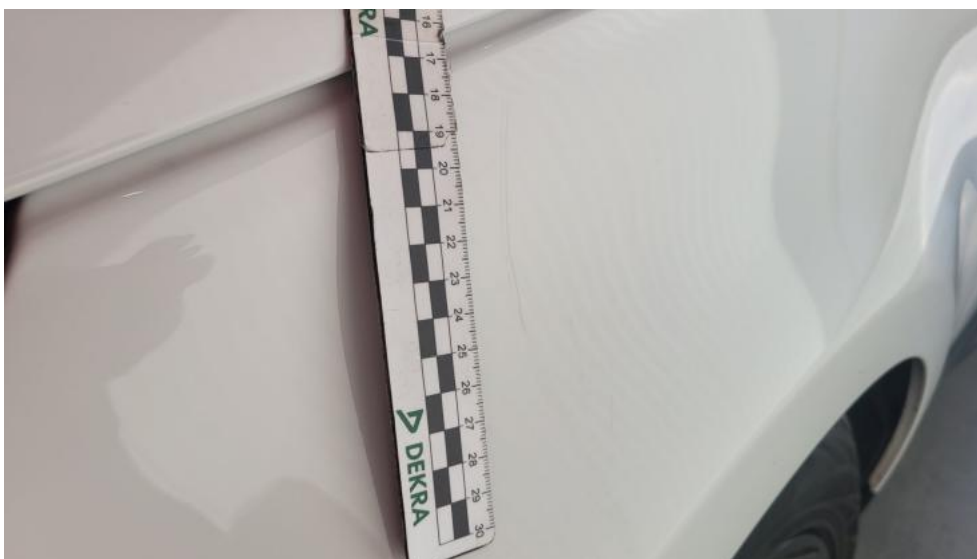
**Photo 65.**

Błotnik przedni L - Rysa/odprysk 1

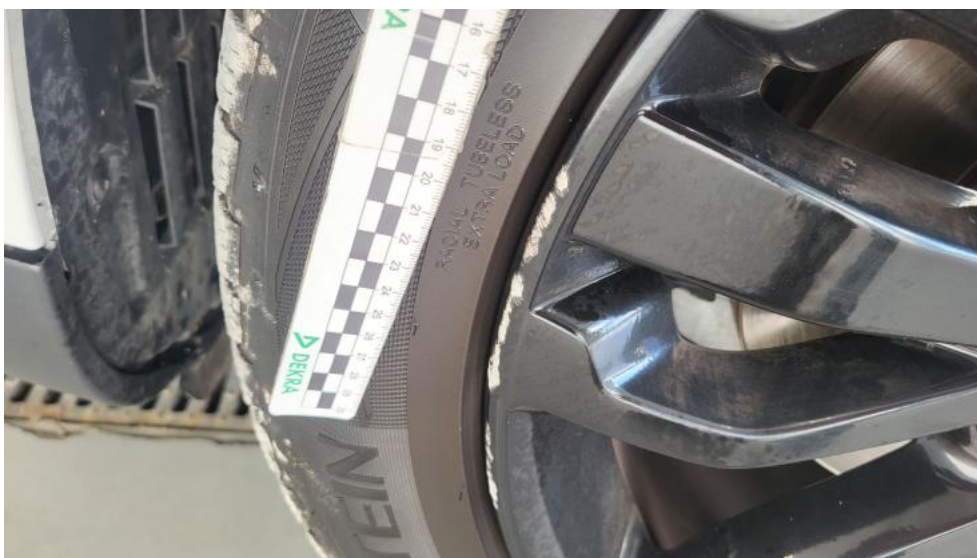
**Photo 66.**

Felga Aluminiowa przednia L - Rysa/odprysk 1

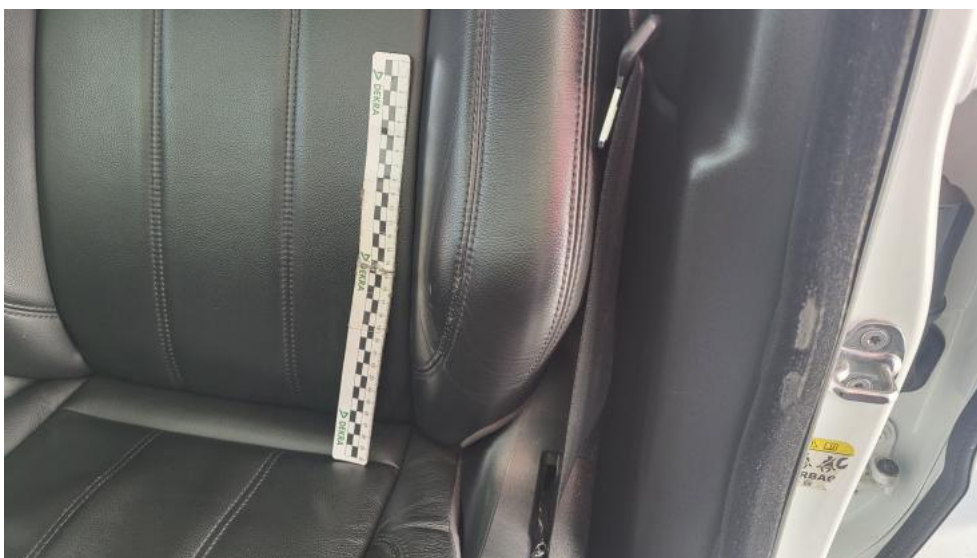
**Photo 68.**  
Fotel prz. lew. - Inne 1

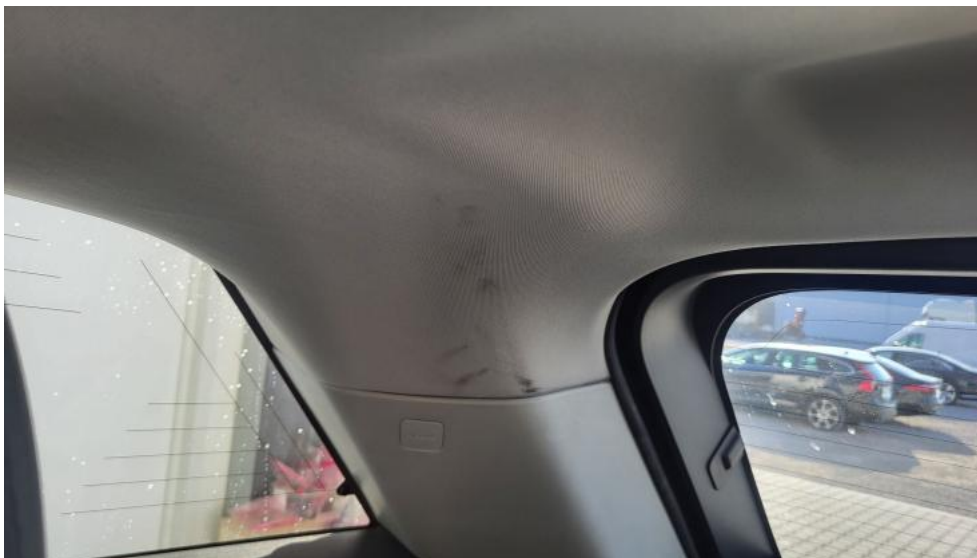
**Photo 71.**  
Podsufitka - Inne 1

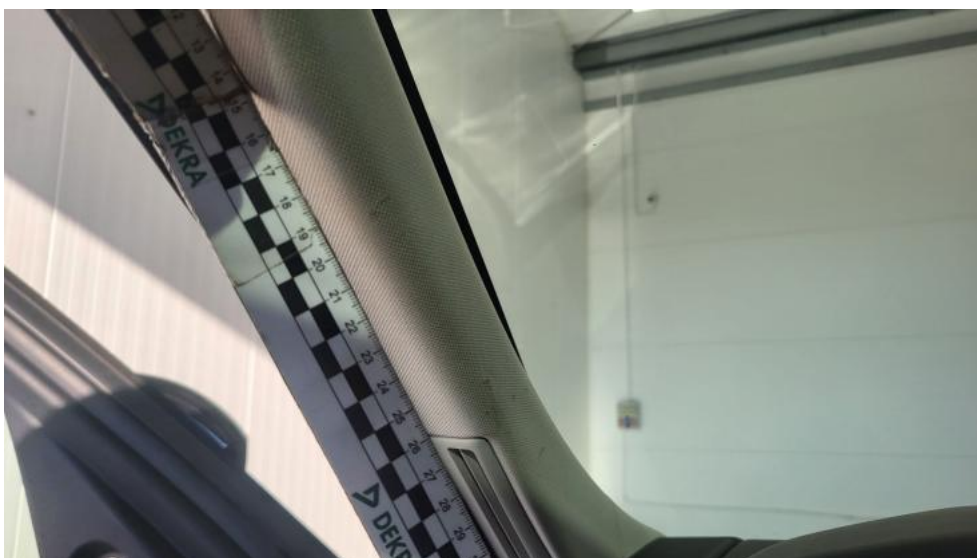
**Photo 72.**  
Wykładzina(y) słupka przedniego L - Inne 1

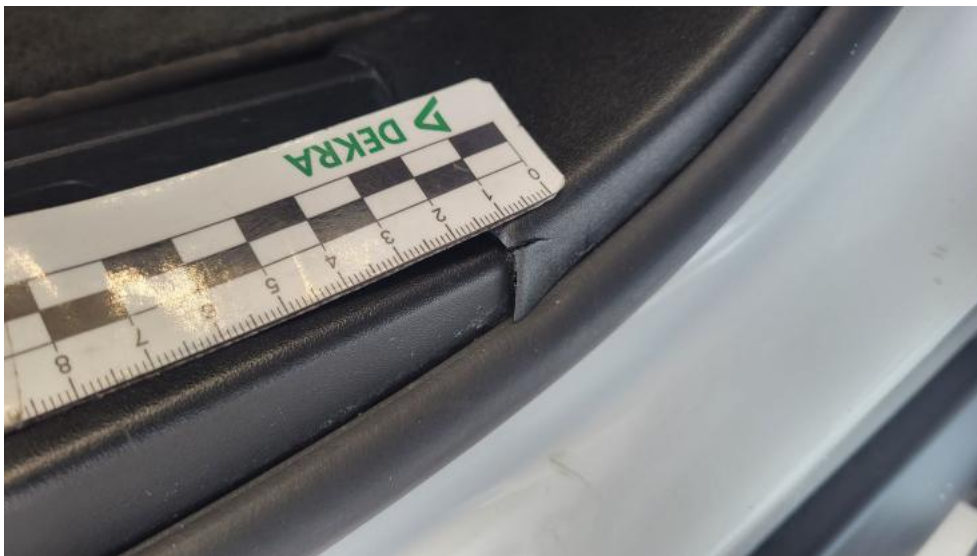
**Photo 75.**

Listwy progowe praw. - Pęknięcie/rozerwanie 1
