DEKRA's commission No. : PKOL(W)/LODZ/01243/26/01/08  
commission/ damage No. : 24/005231  
Date of commission: 08-01-2026

**DEKRA Poland - Headquarters**  
02-673 Warszawa, ul. Konstruktorska 12A

| Manufacturer | TOYOTA |
| Type / version | Corolla 1.8 Hybrid GPF Comfort |

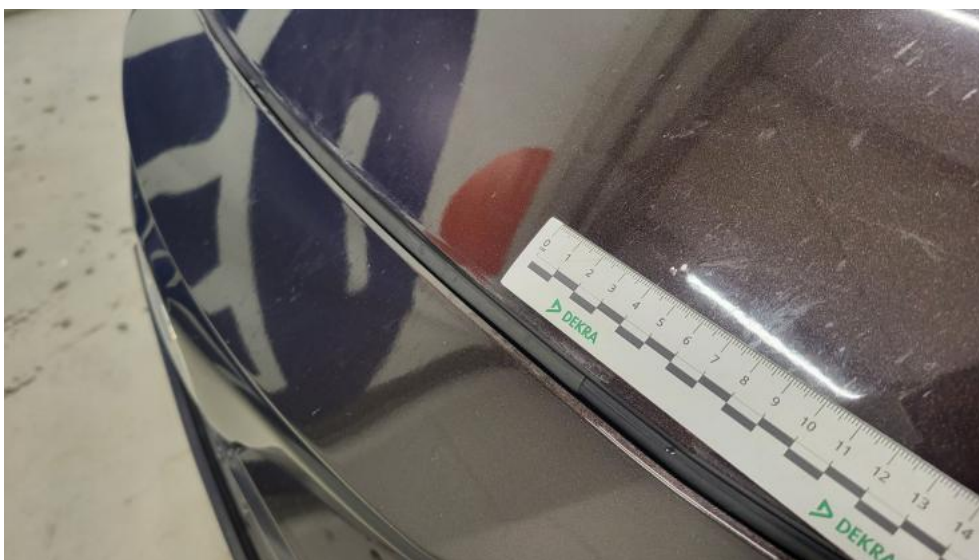
**Photo 36.**  
Pokrywa komory silnika - Rysa/odprysk 1

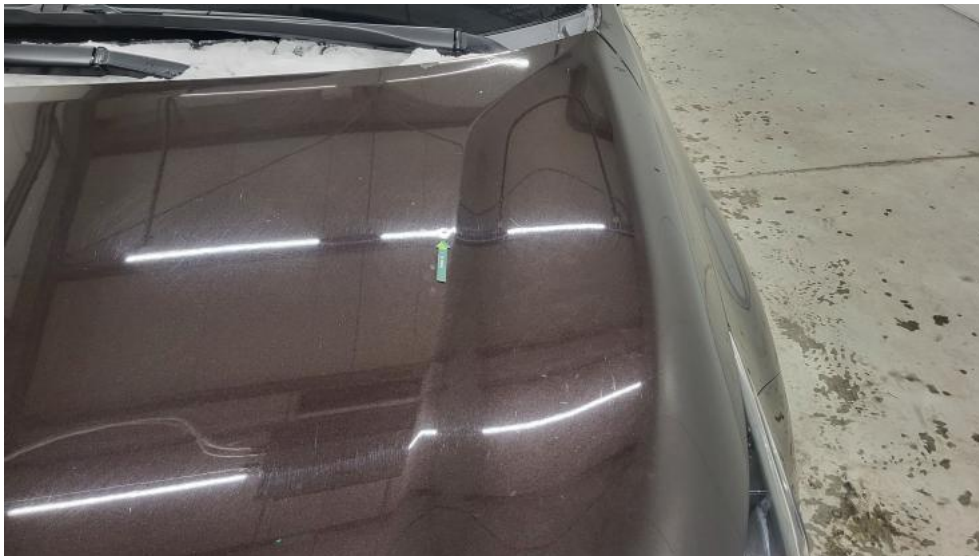
**Photo 37.**

Pokrywa komory silnika - Wgniecenie/odkształcenie 1

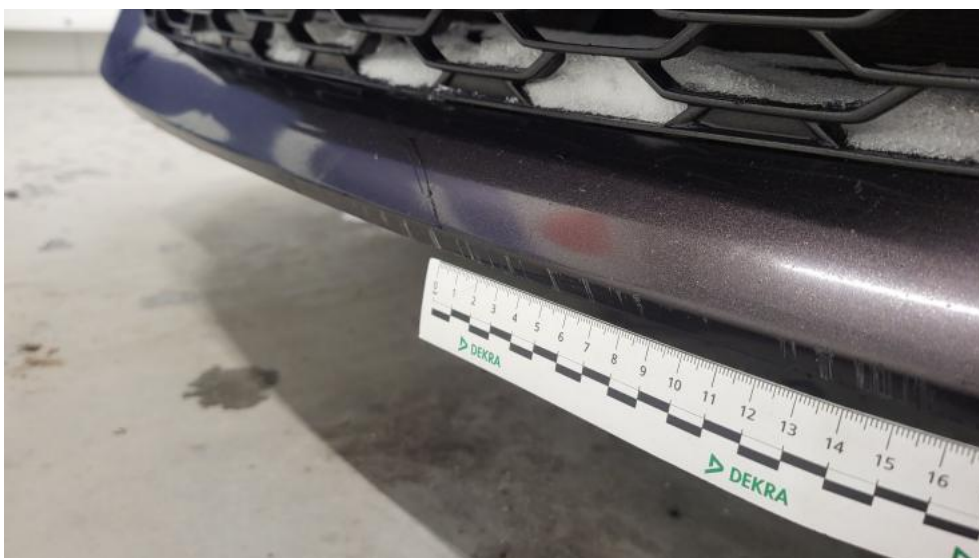
**Photo 38.**

Spoiler zderzaka przedniego - Rysa/odprysk 1

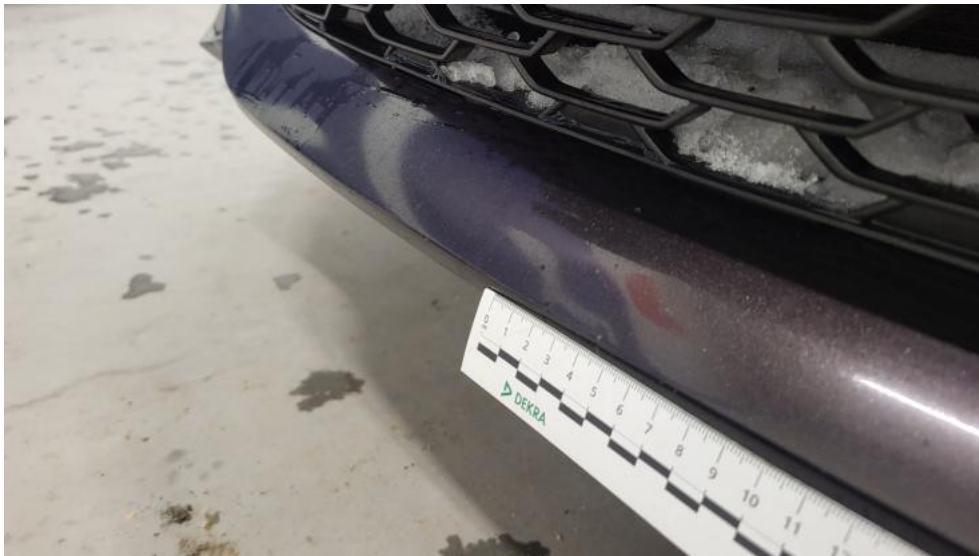
**Photo 39.**

Spoiler zderzaka przedniego - Wgniecenie/odkształcenie 1

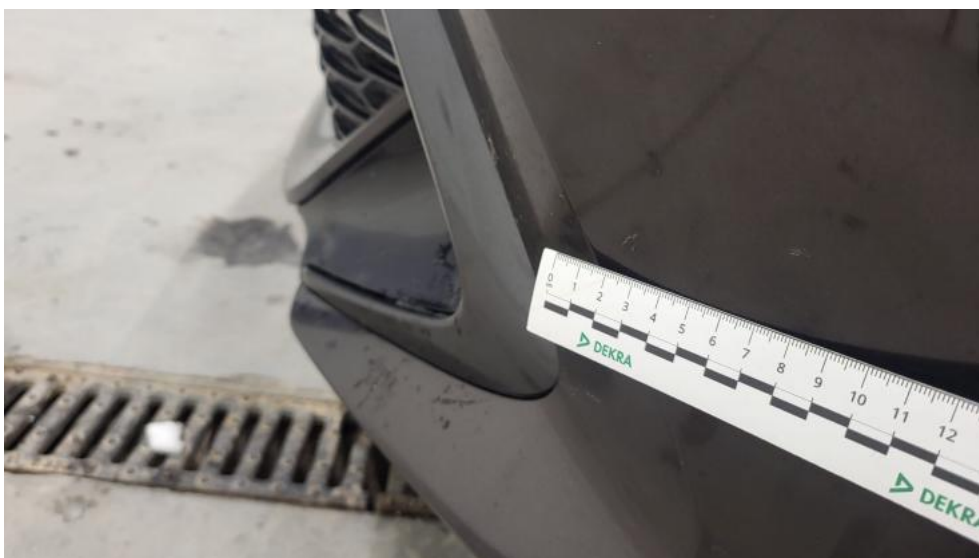
**Photo 40.**

Zderzak - Rysa/odprysk 1

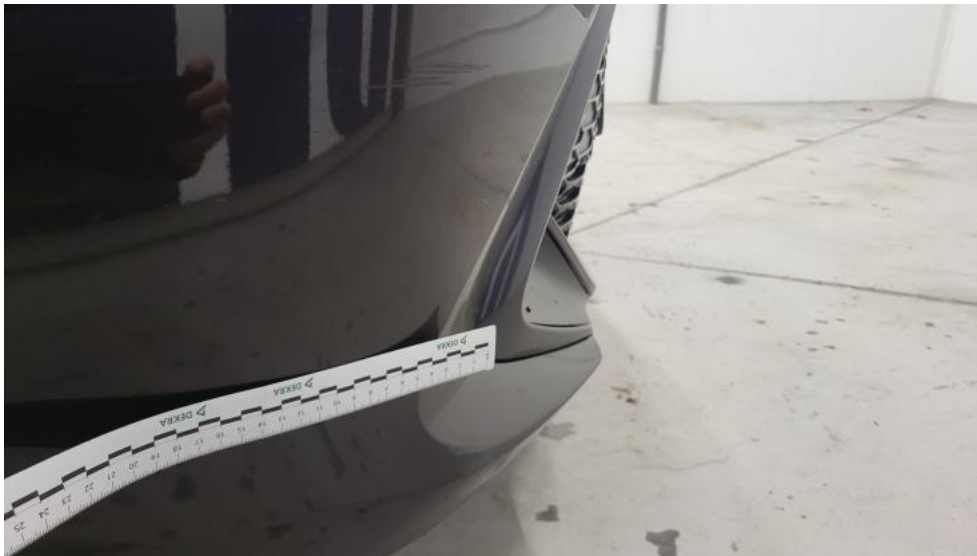
**Photo 41.**

Zderzak - Rysa/odprysk 2

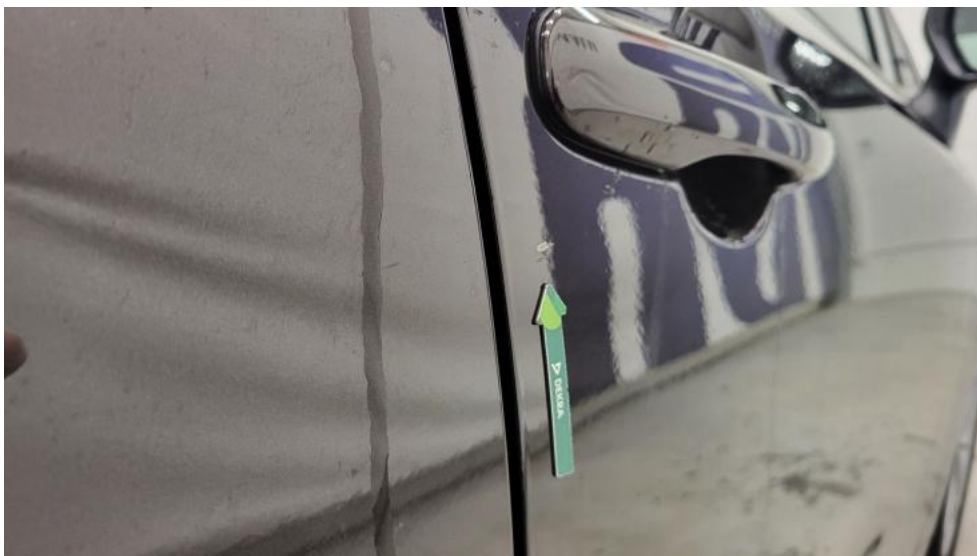
**Photo 42.**

Drzwi przednie P - Wgniecenie/odkształcenie 1

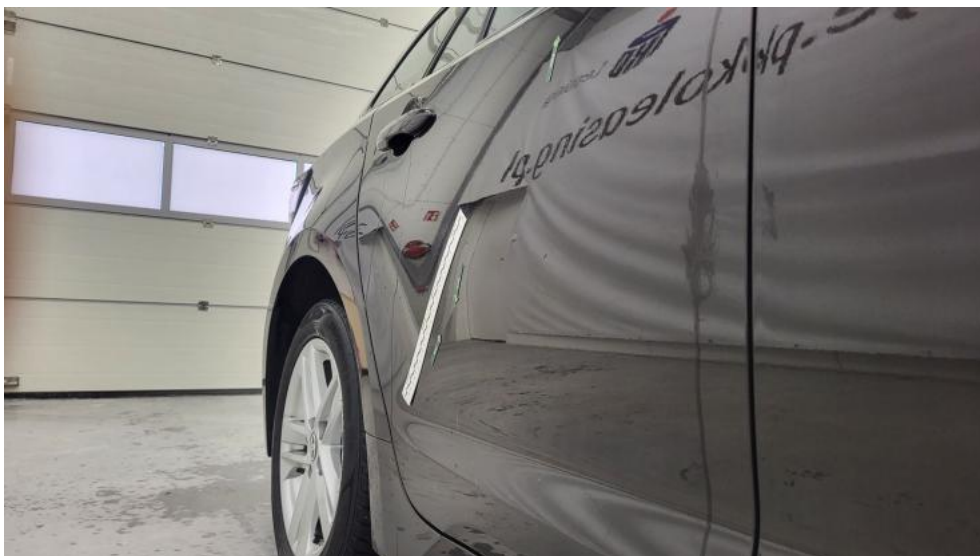
**Photo 44.**

Drzwi tylne P - Wgniecenie/odkształcenie 1

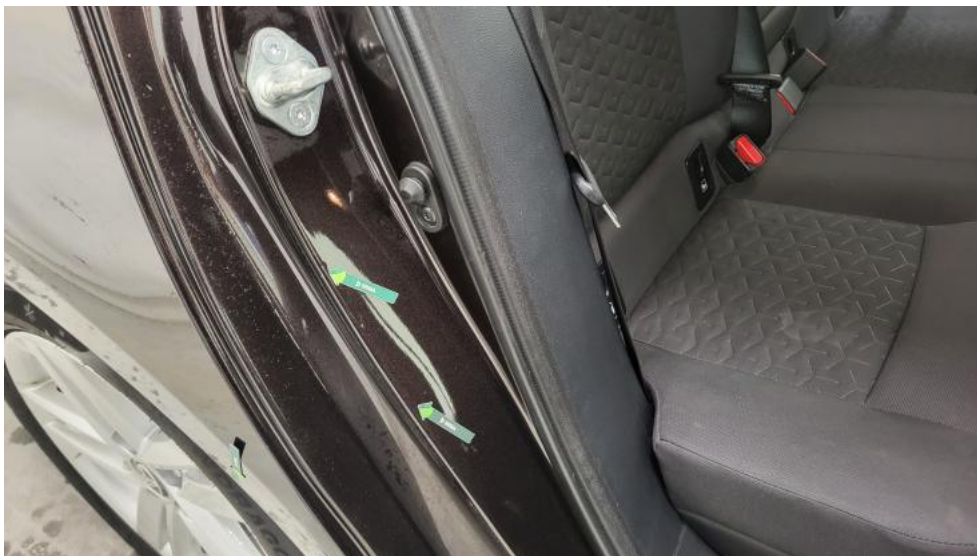
**Photo 45.**

Błotnik tylny P / Ściana boczna P - Wgniecenie/odkształcenie 1

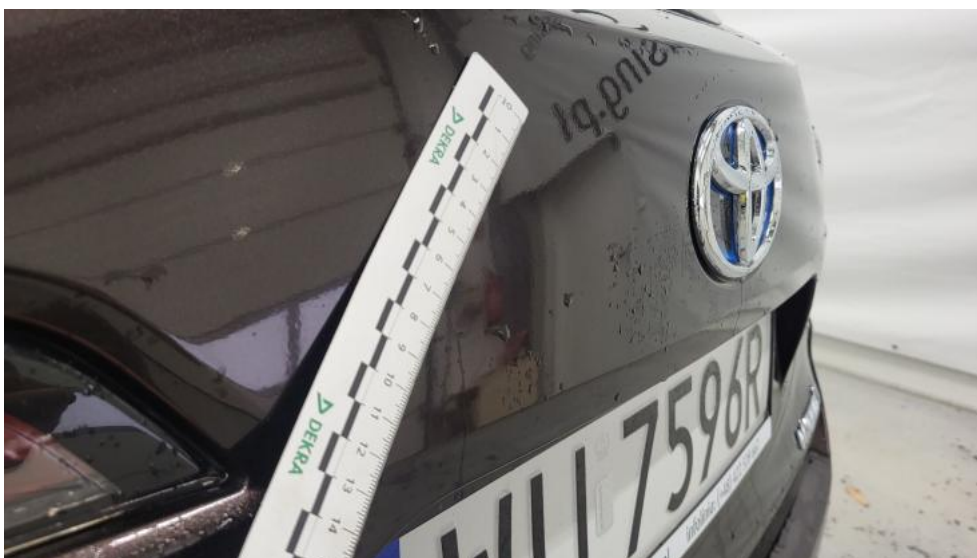
**Photo 46.**

Pokrywy bagażnika - Wgniecenie/odkształcenie 1

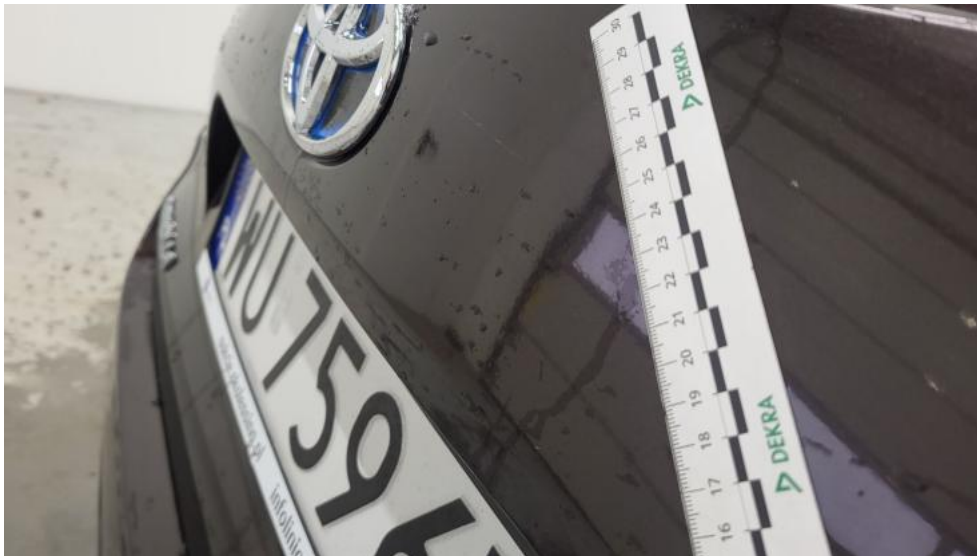
**Photo 47.**

Pokrywy bagażnika - Wgniecenie/odkształcenie 2

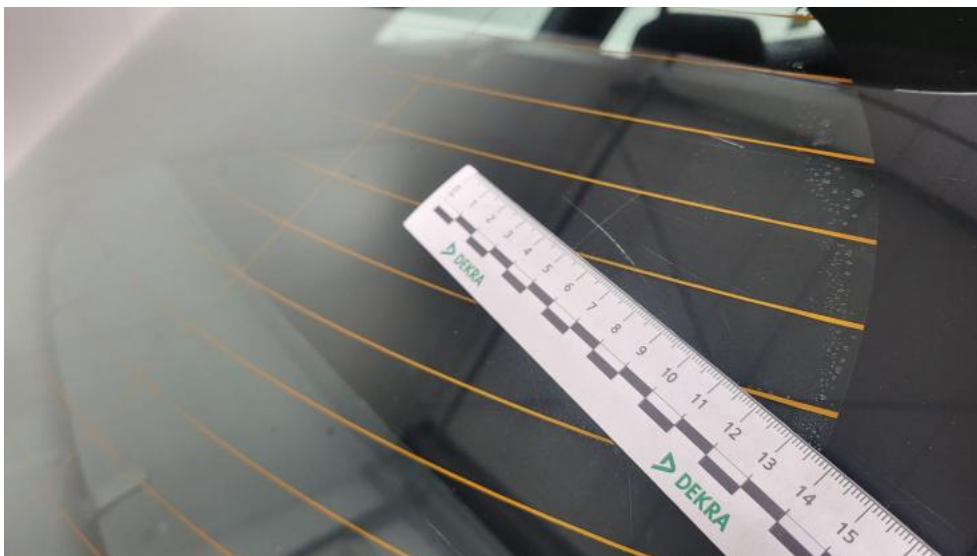
**Photo 48.**

Szyba tylna - Rysa/odprysk 1

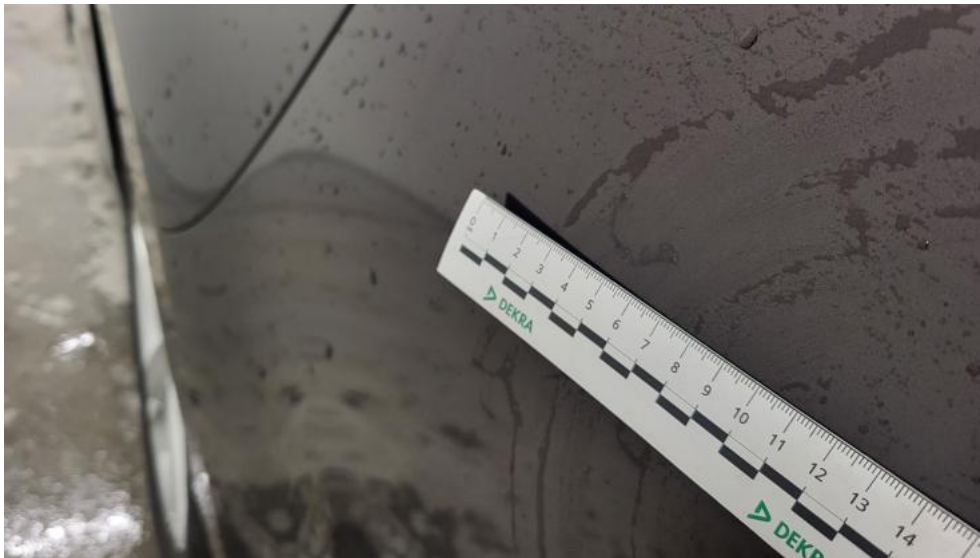
**Photo 49.**

Zderzak tylny - Rysa/odprysk 1

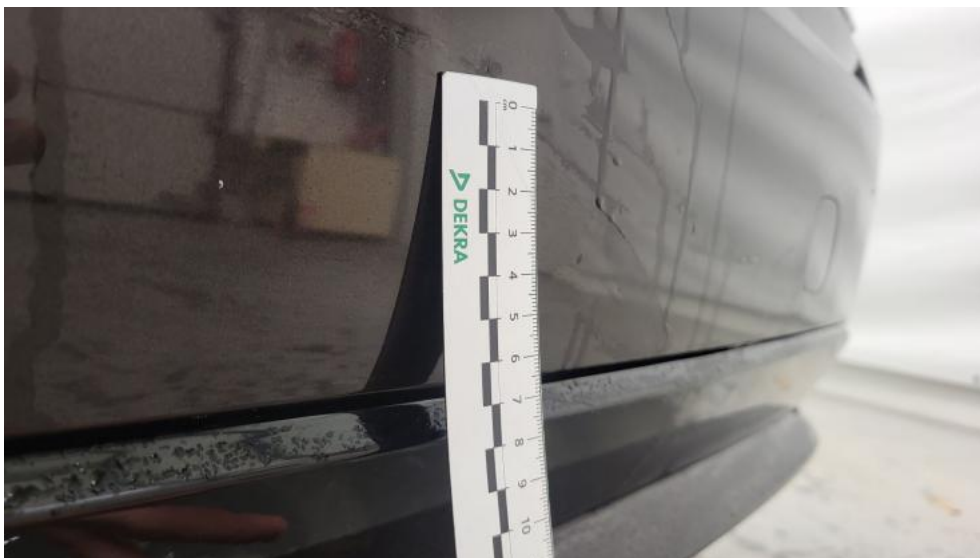
**Photo 50.**

Zderzak tylny - Wgniecenie/odkształcenie 1

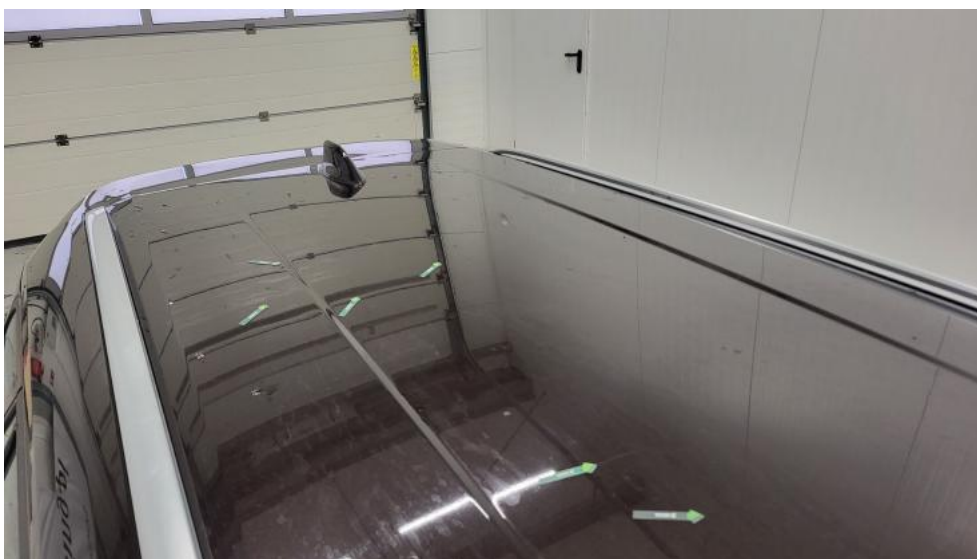
**Photo 51.**

Dach - Wgniecenie/odkształcenie 1

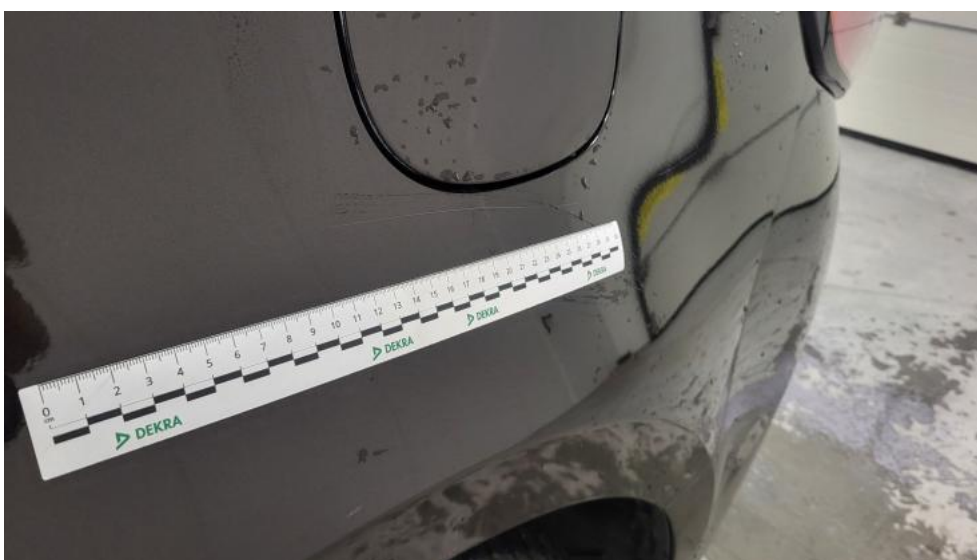
**Photo 52.**

Ścianka tylna L / Ścianka boczna L - Rysa/odprysk 1

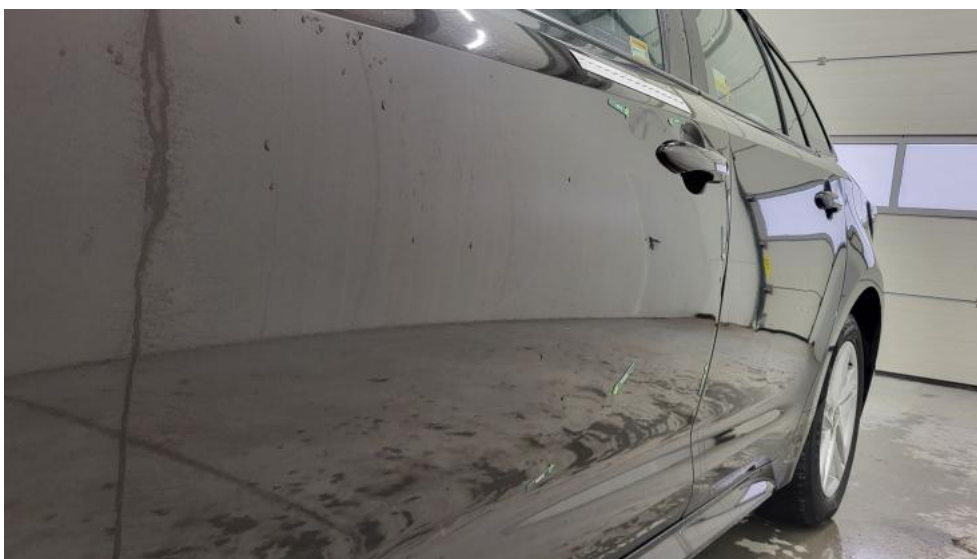
**Photo 53.**

Drzwi przed L - Wgniecenie/odkształcenie 1

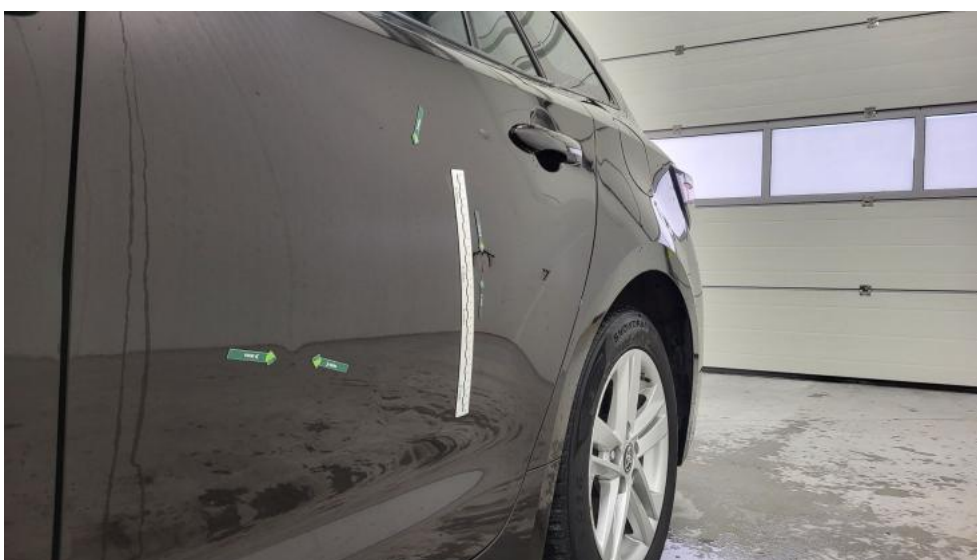
**Photo 54.**

Drzwi tylne L - Wgniecenie/odkształcenie 1

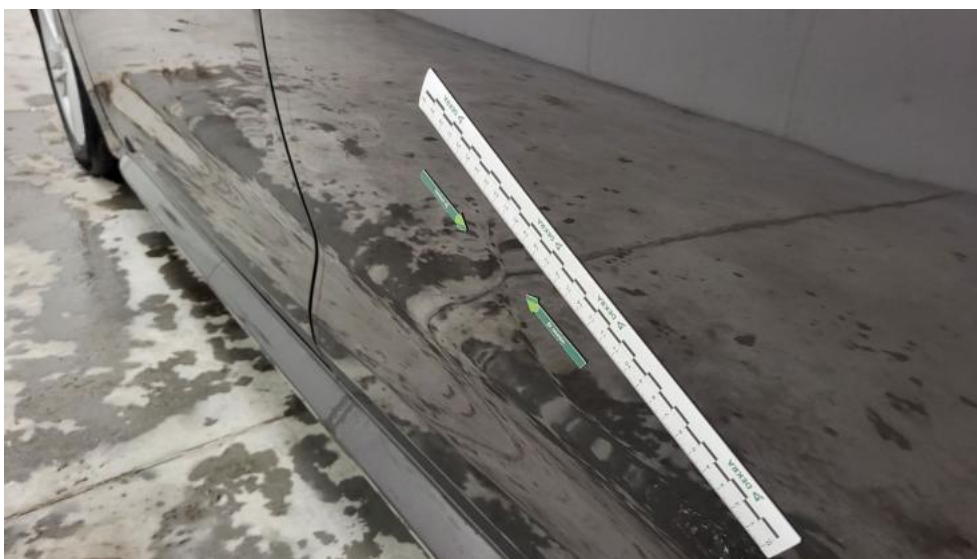
**Photo 55.**

Drzwi tylne L - Wgniecenie/odkształcenie 2
