DEKRA's commission No. : PKOL(W)/LODZ/95213/26/10/12  
commission/ damage No. : 22/038660  
Date of commission: 12-10-2026

**DEKRA Poland - Headquarters**  
02-673 Warszawa, ul. Konstruktorska 12A

| Model | Musso Grand 19-23 |
| Type / version | Musso Grand 2.2 e-XDi Sapphire 4WD aut |

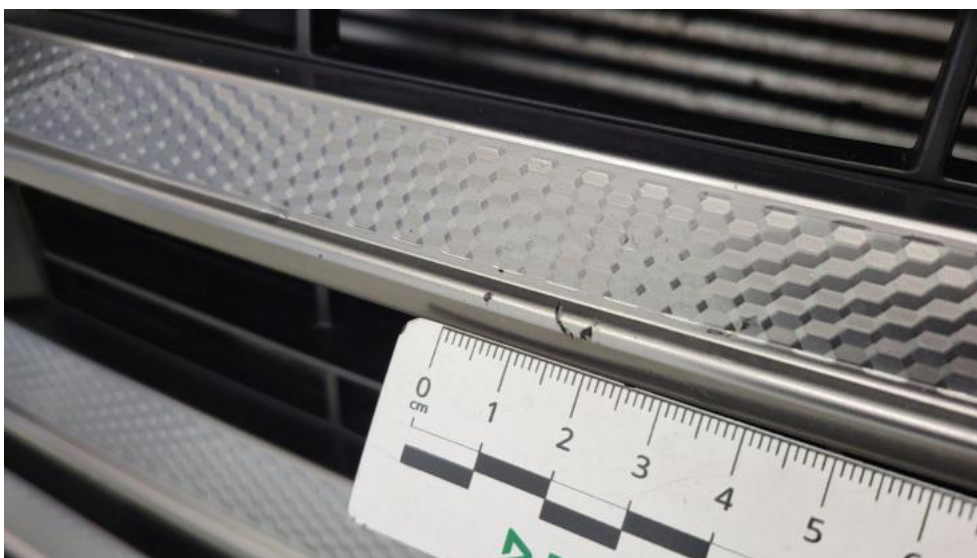
**Photo 42.**

Atrapa przednia - Rysa/odprysk 1

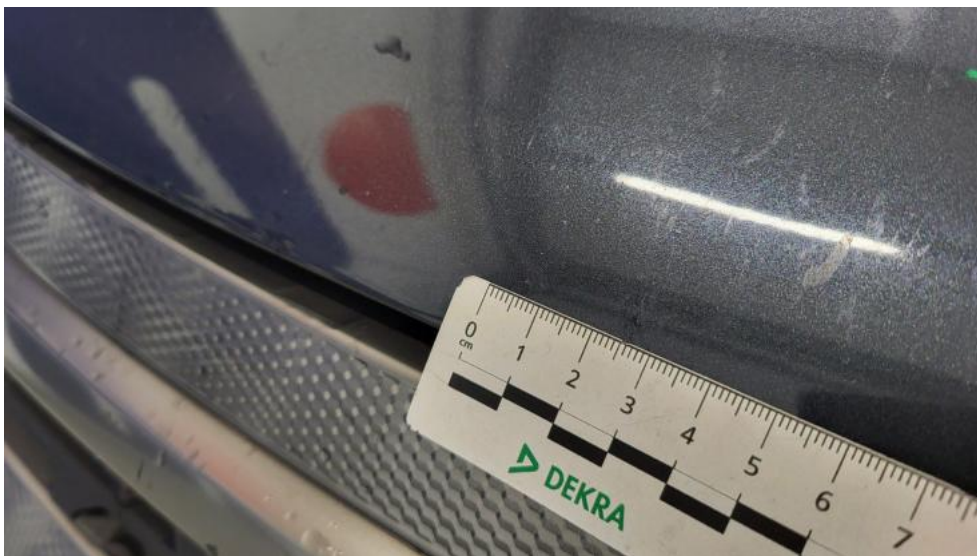
**Photo 43.**

Pokrywa komory silnika - Rysa/odprysk 1

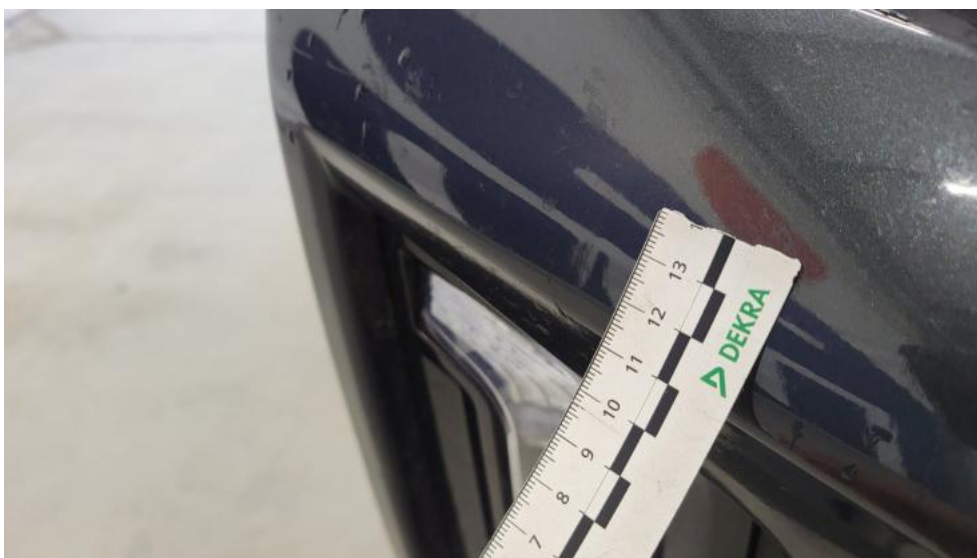
**Photo 44.**

Zderzak - Wgniecenie/odkształcenie 1

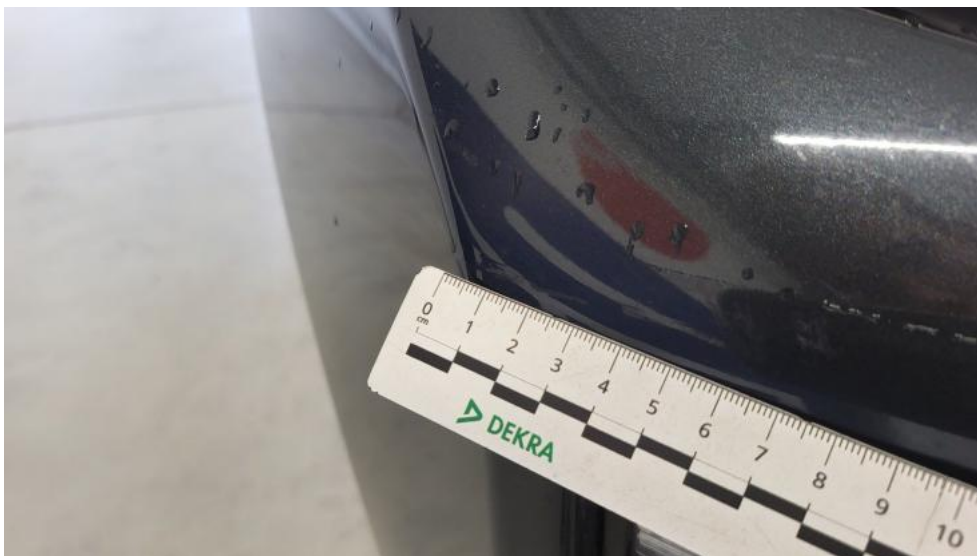
**Photo 45.**

Zderzak - Wgniecenie/odkształcenie 2

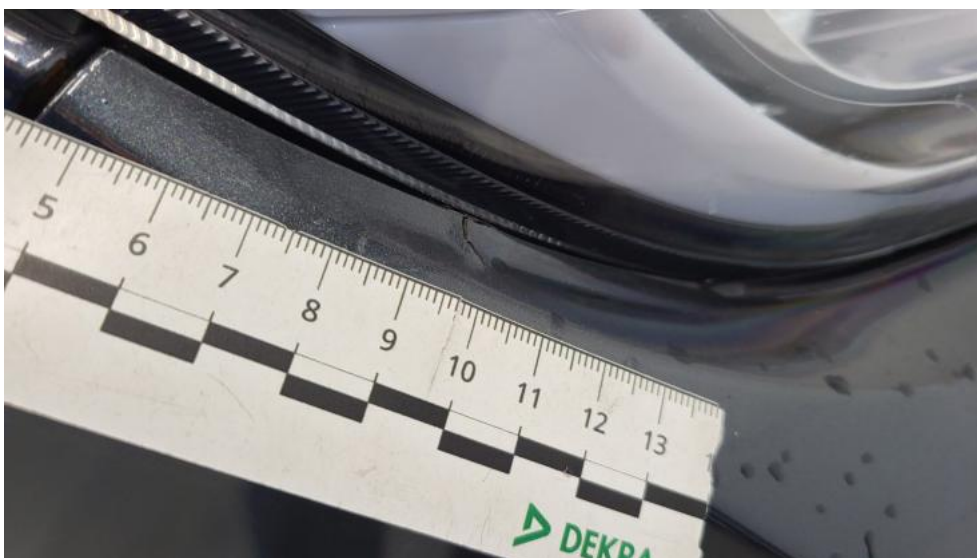
**Photo 46.**

Zderzak - Pęknięcie/rozerwanie 1

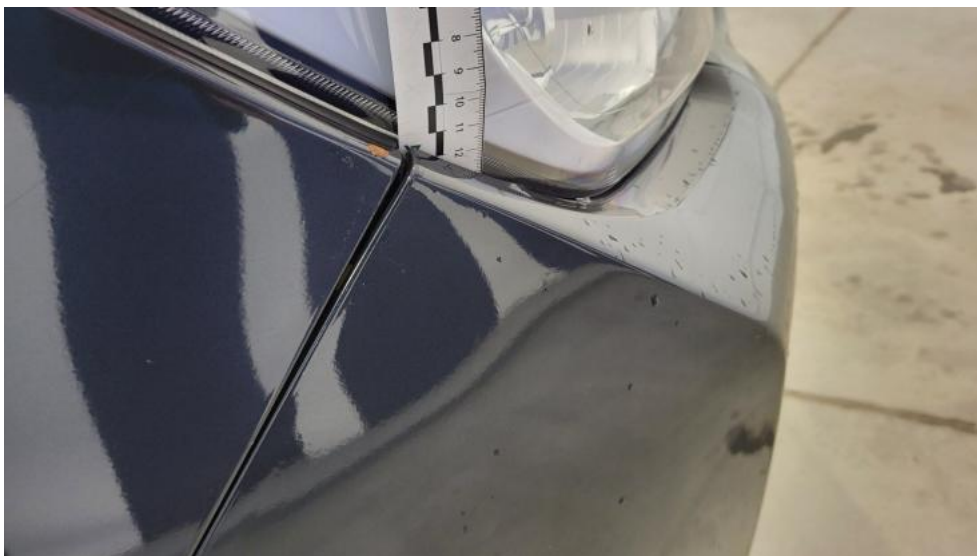
**Photo 47.**

Zderzak - Inne 1

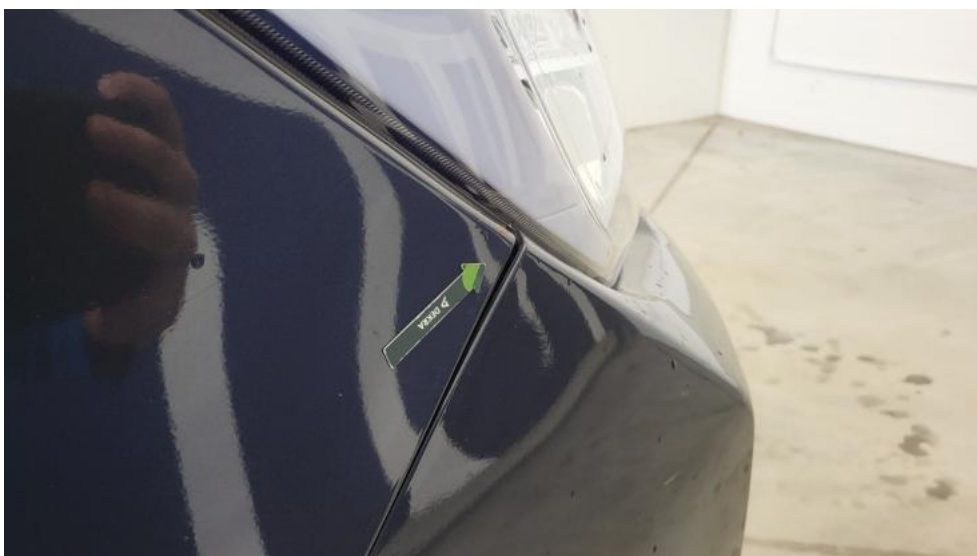
**Photo 48.**

Ślotnik przedni P - Wgniecenie/odkształcenie 1

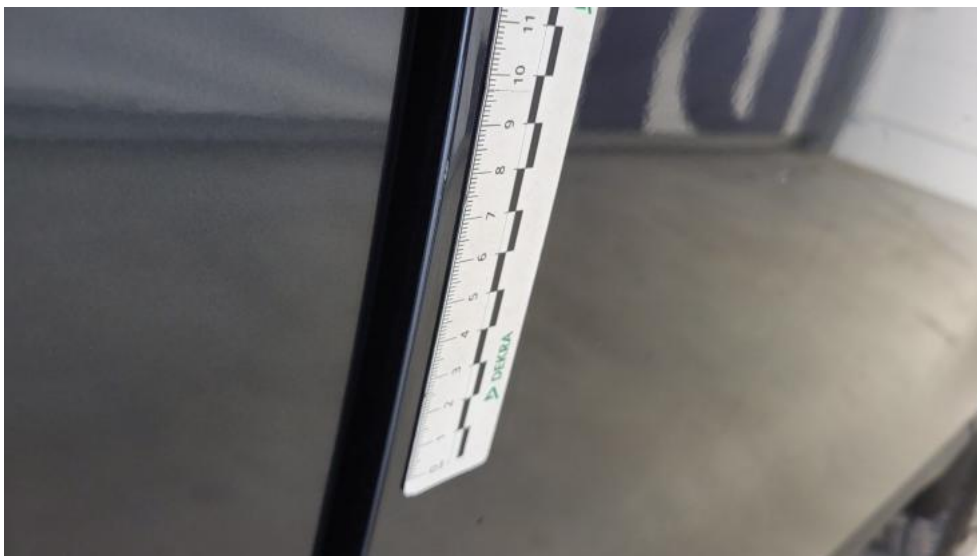
**Photo 51.**

Drzwi przednie P - Rysa/odprysk 1

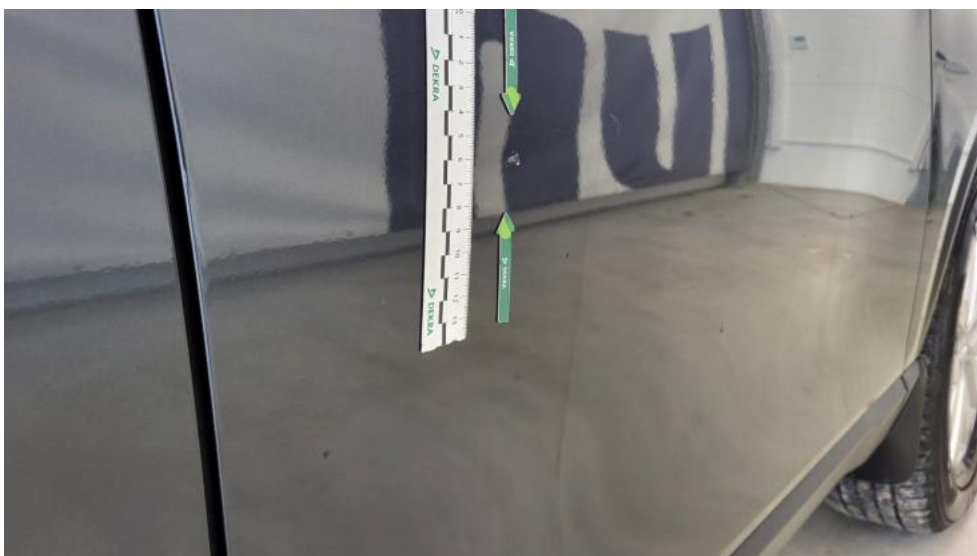
**Photo 52.**

Drzwi przednie P - Wgniecenie/odkształcenie 1

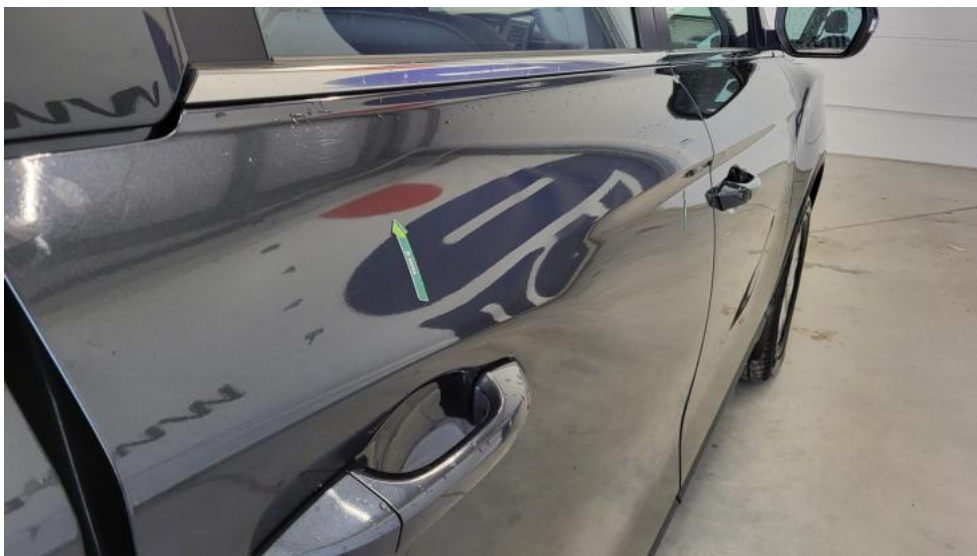
**Photo 53.**

Drzwi tylne P - Wgniecenie/odkształcenie 1

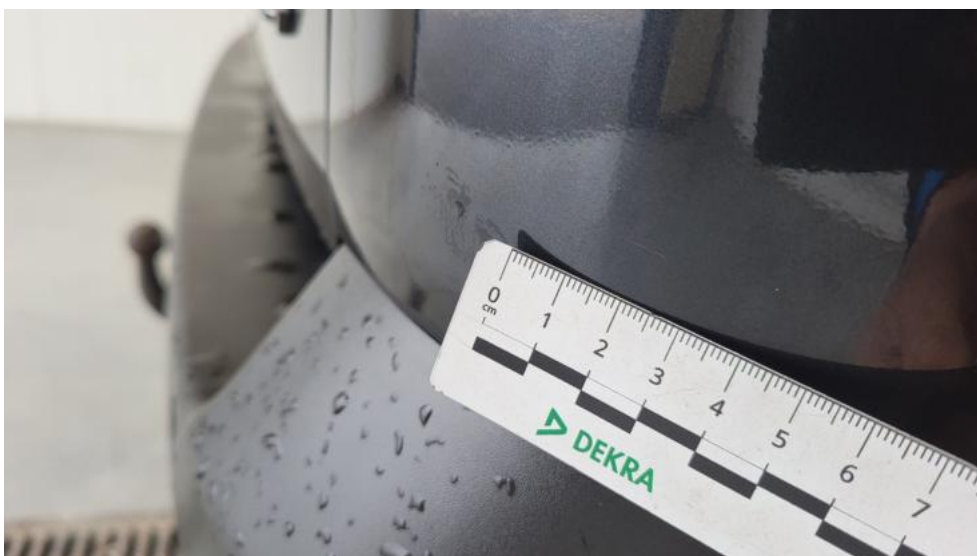
**Photo 54.**

Ścianka tylna P / Ścianka boczna P - Rysa/odprysk 1

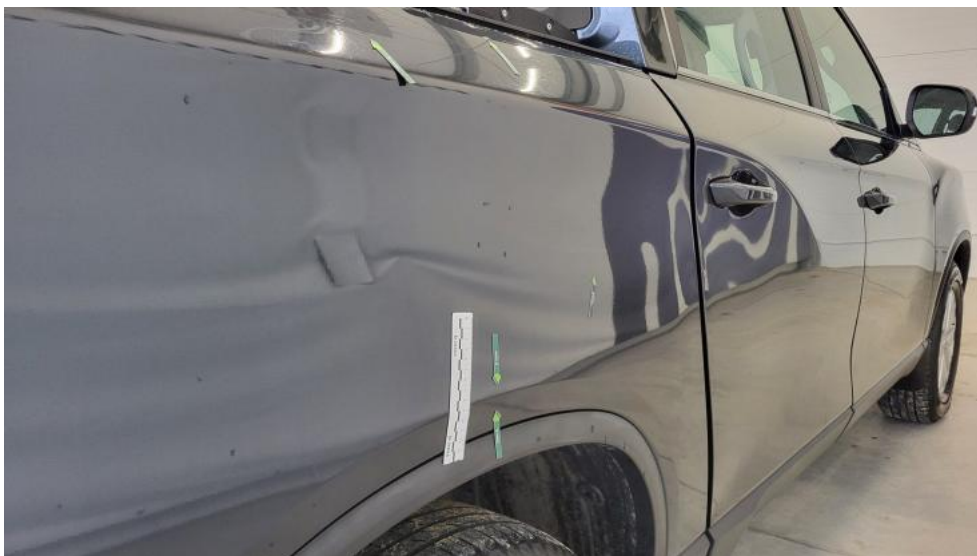
**Photo 55.**

Błotnik tylny P / Ściana boczna P - Wgniecenie/odkształcenie 1

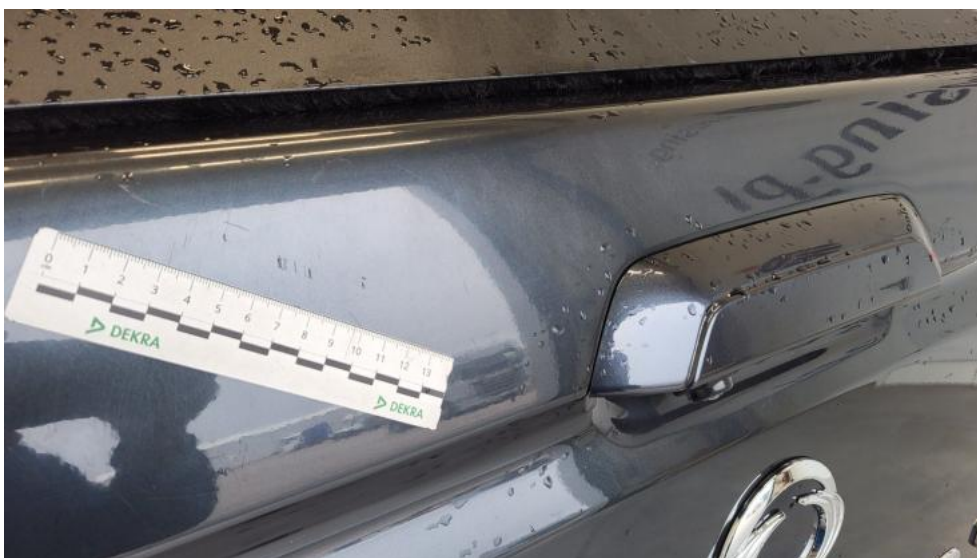
**Photo 56.**

Pokrywy bagażnika - Rysa/odprysk 1

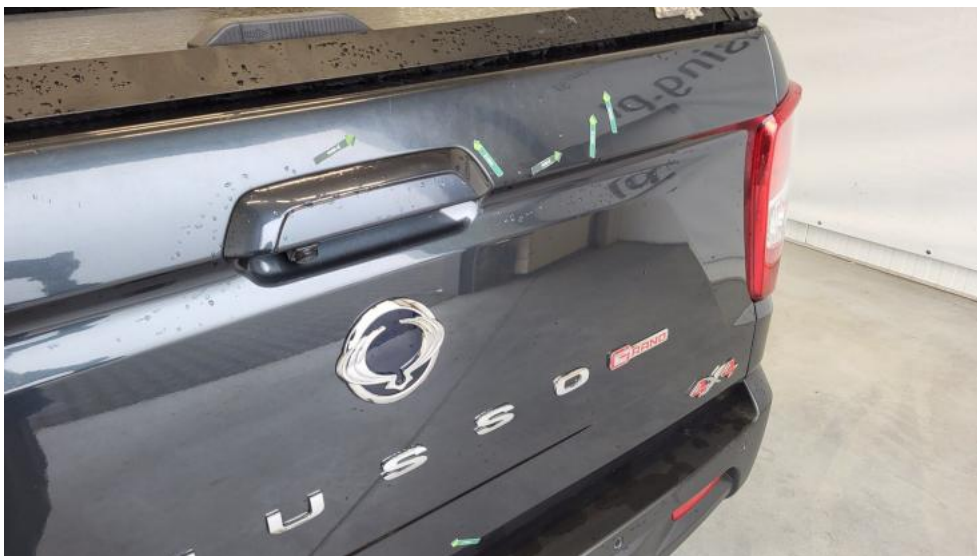
**Photo 57.**

Pokrywy bagażnika - Wgniecenie/odkształcenie 1

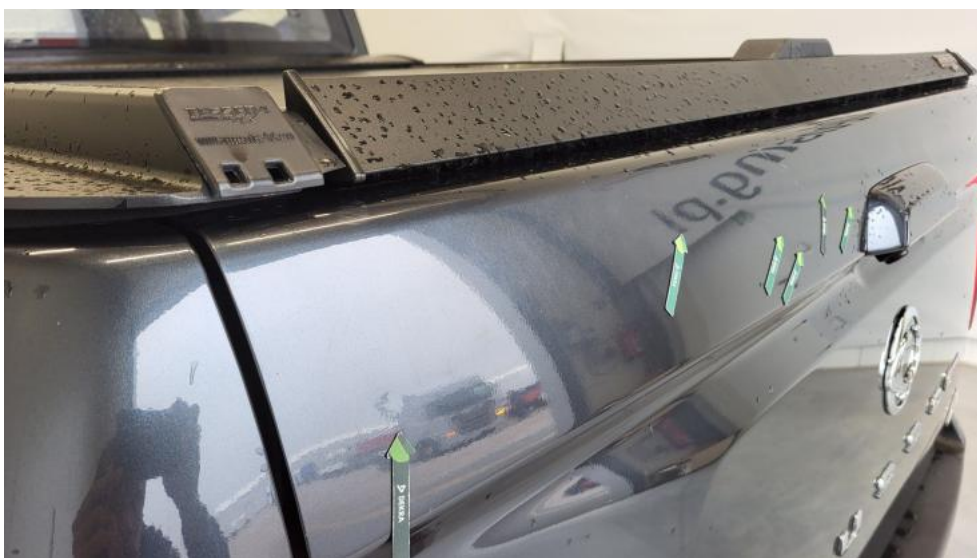
**Photo 58.**

Pokrywy bagażnika - Wgniecenie/odkształcenie 2

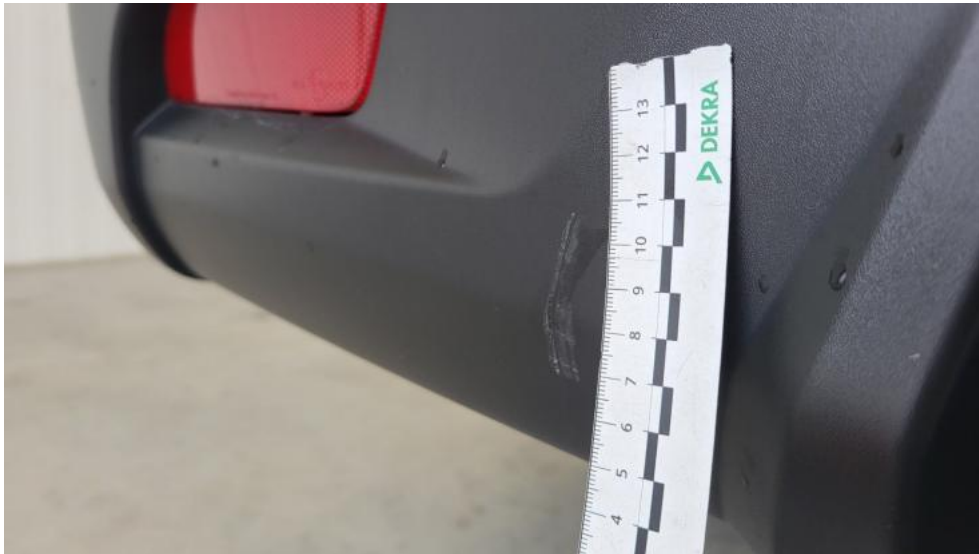
**Photo 59.**

Zderzak tylny - Rysa/odprysk 1

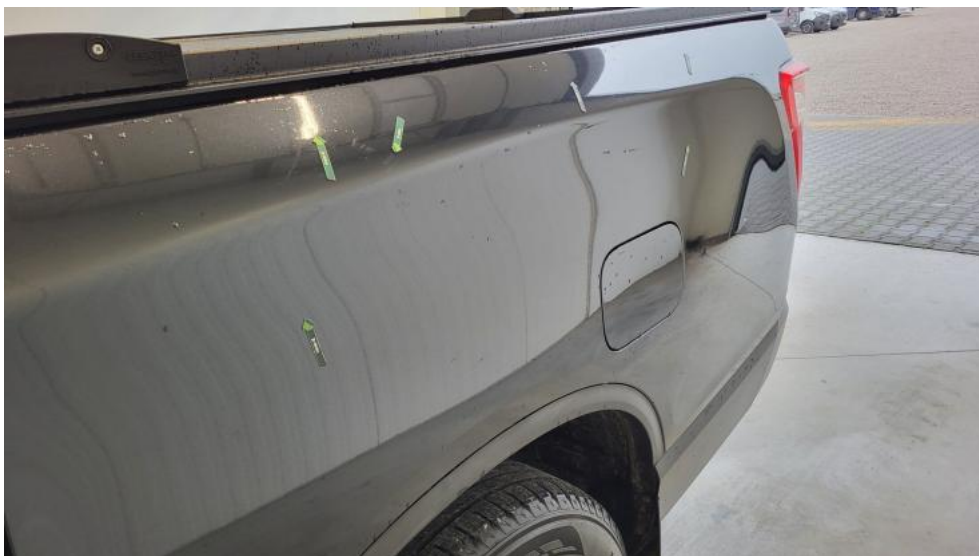
**Photo 60.**

Błotnik tylny L / Ściana boczna L - Wgniecenie/odkształcenie 1

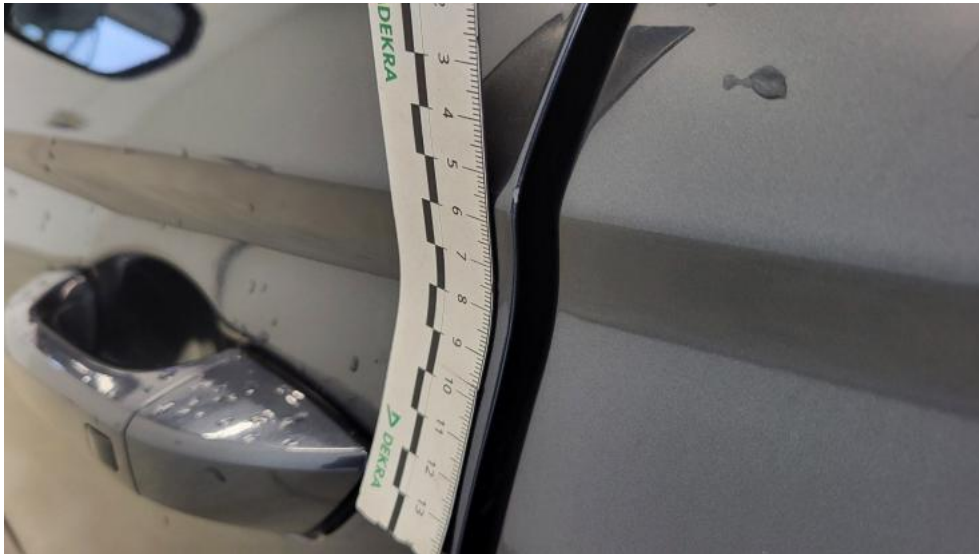
**Photo 61.**

Drzwi przed L - Rysa/odprysk 1

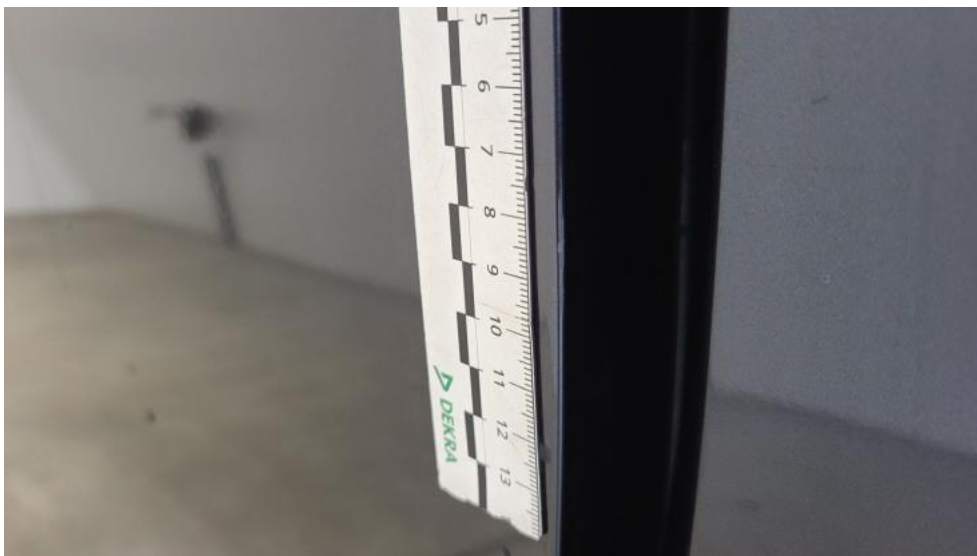
**Photo 63.**

Drzwi tylne L - Rysa/odprysk 1

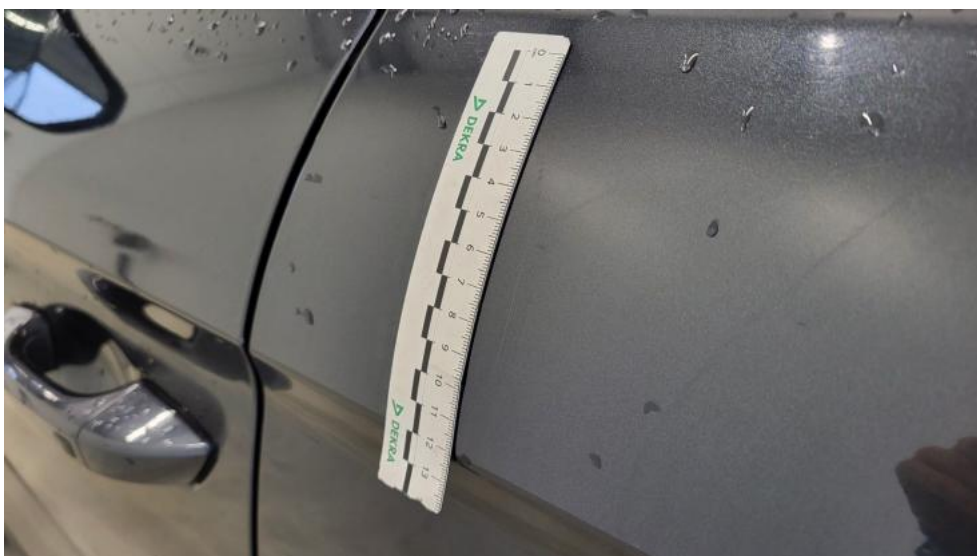
**Photo 64.**

Drzwi tylne L - Rysa/odprysk 2

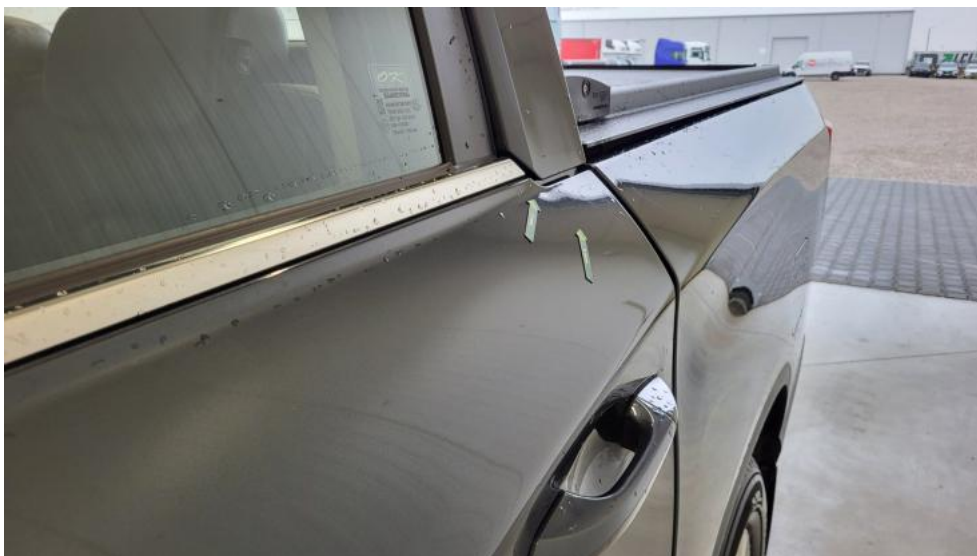
**Photo 65.**

Drzwi tylne L - Wgniecenie/odkształcenie 1

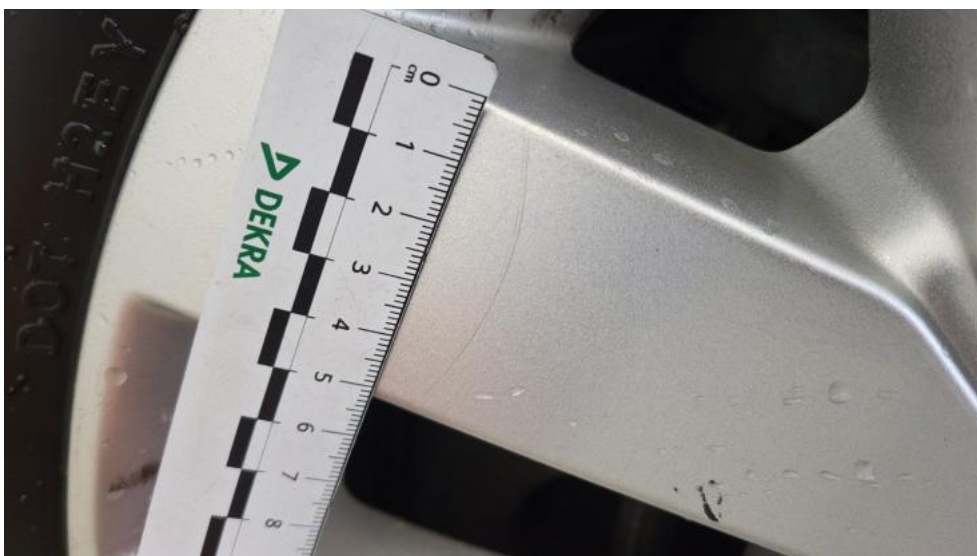
**Photo 66.**

Felga Aluminiowa przednia L - Rysa/odprysk 1

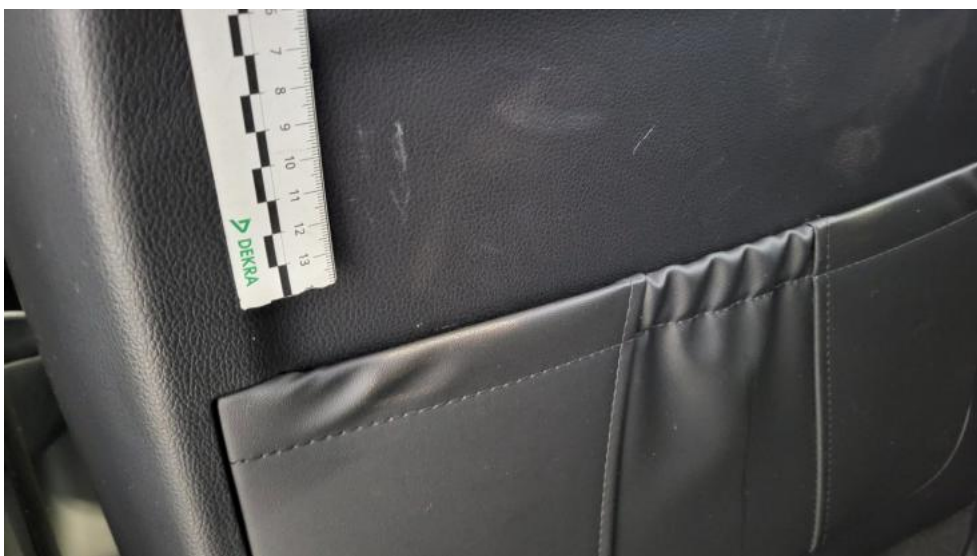
**Photo 68.**

Fotel prz. lew. - Rysa/odprysk 1

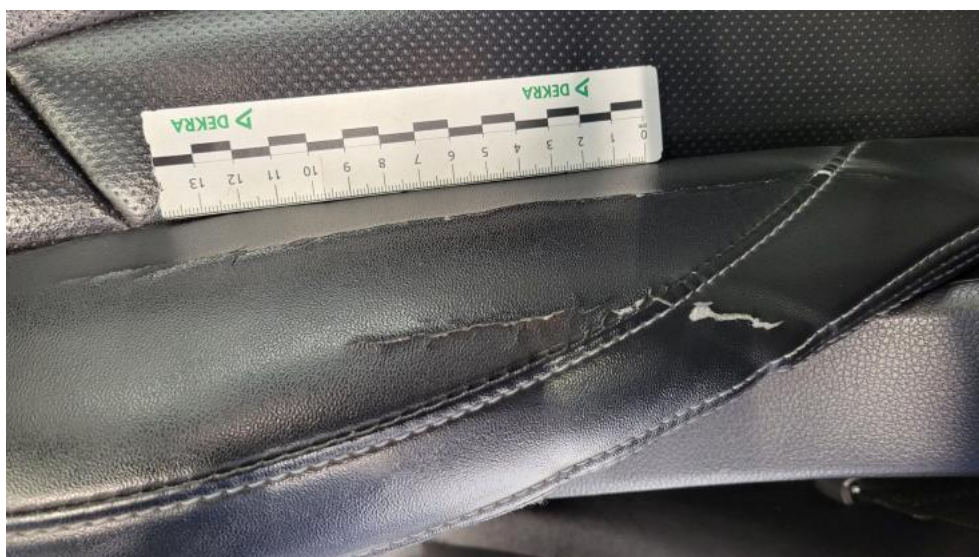
**Photo 69.**

Fotel prz. lew. - Pęknięcie/rozerwanie 1

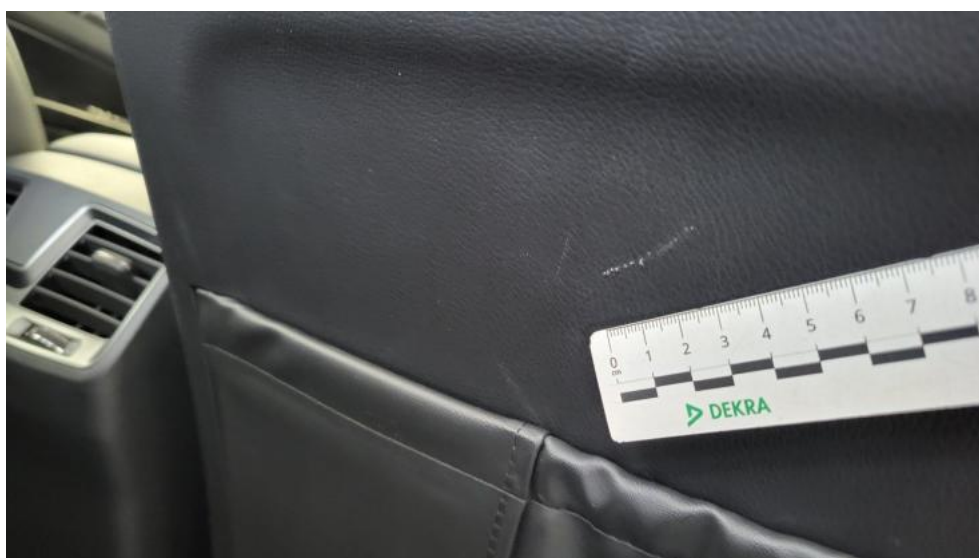
**Photo 70.**

Fotel prz. praw. - Rysa/odprysk 1

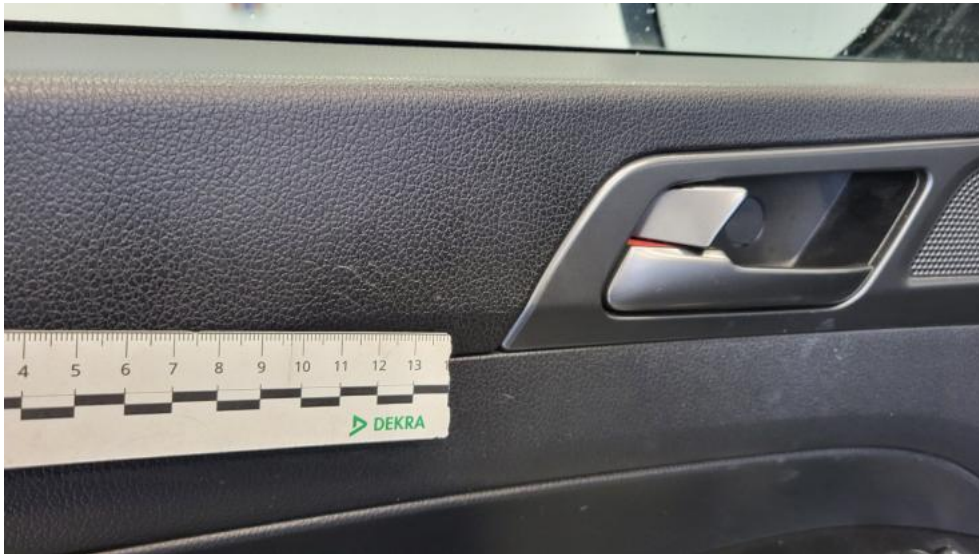
**Photo 71.**

Tapicerka drzwi przednich L - Rysa/odprysk 1

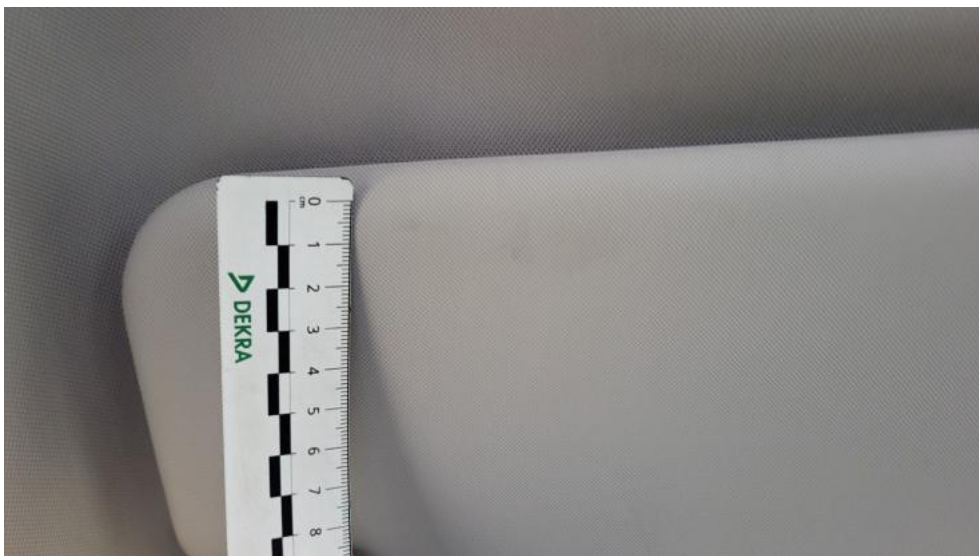
**Photo 72.**

Osłona p/słoneczna lewa - Inne 1

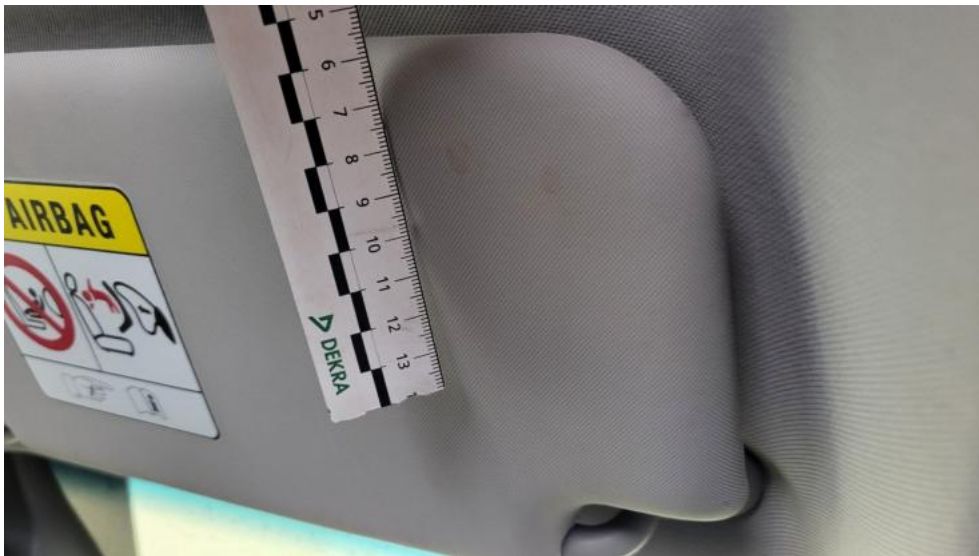
**Photo 73.**

Osłona p/słoneczna prawa - Inne 1

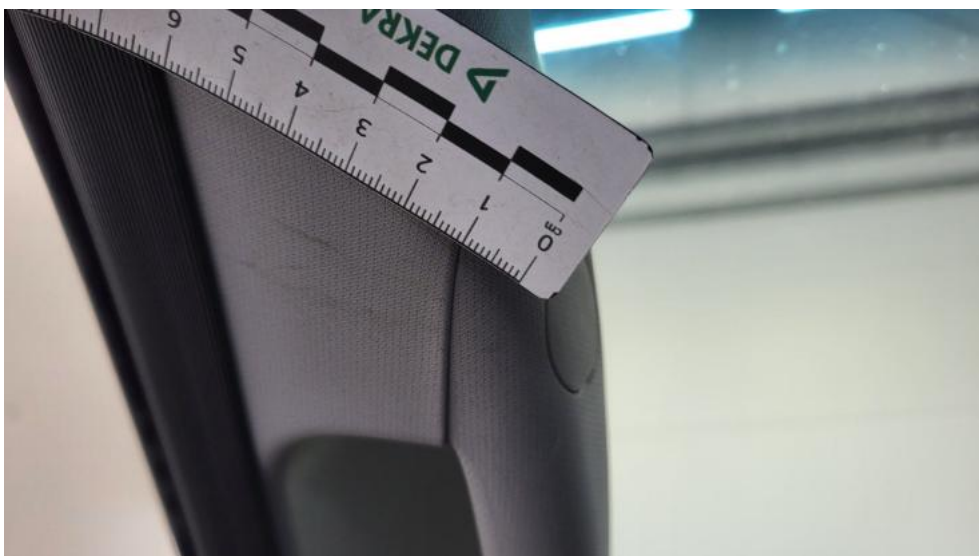
**Photo 74.**

Wykładzina(y) słupka przedniego L - Inne 1

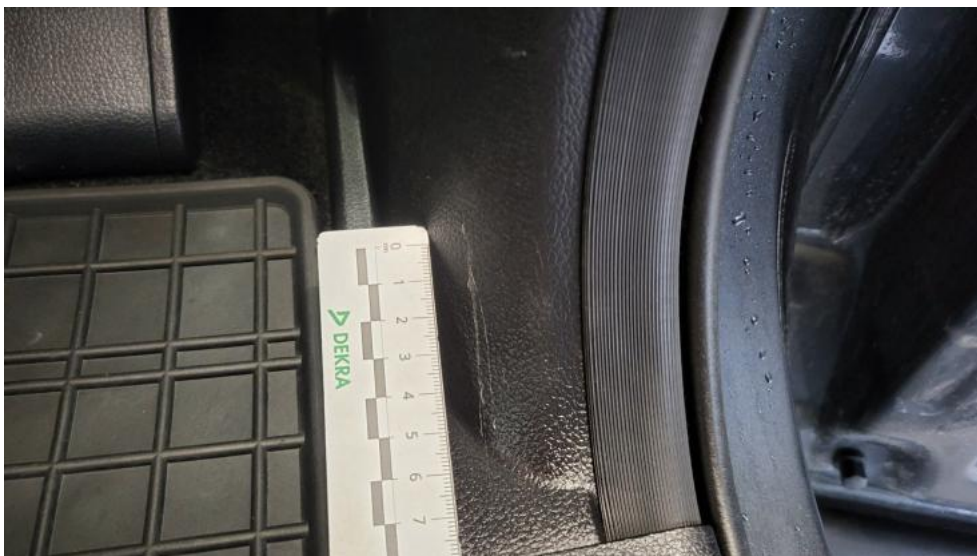
**Photo 75.**

Wykładzina(y) słupka środkowego P - Rysa/odprysk 1
