DEKRA's commission No. : PKOL(W)/LODZ/14695/25/02/26
 commission/ damage No. : 24/009168
 Date of commission: 26-02-2025

PKO Leasing SA
 Świętokrzyska 36
 00-116 Warszawa

Vehicle data

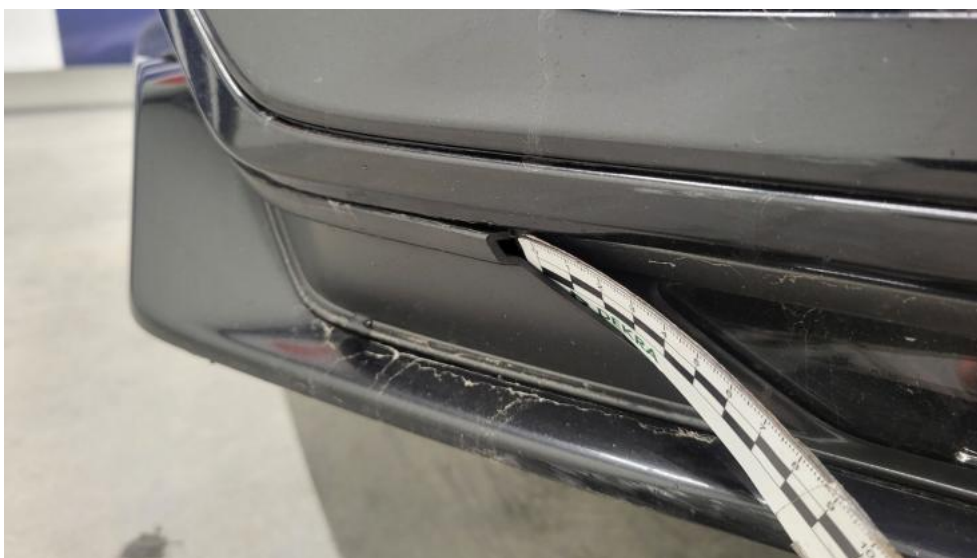
Photo 42.
Krata zderzaka prz. - Inne 1

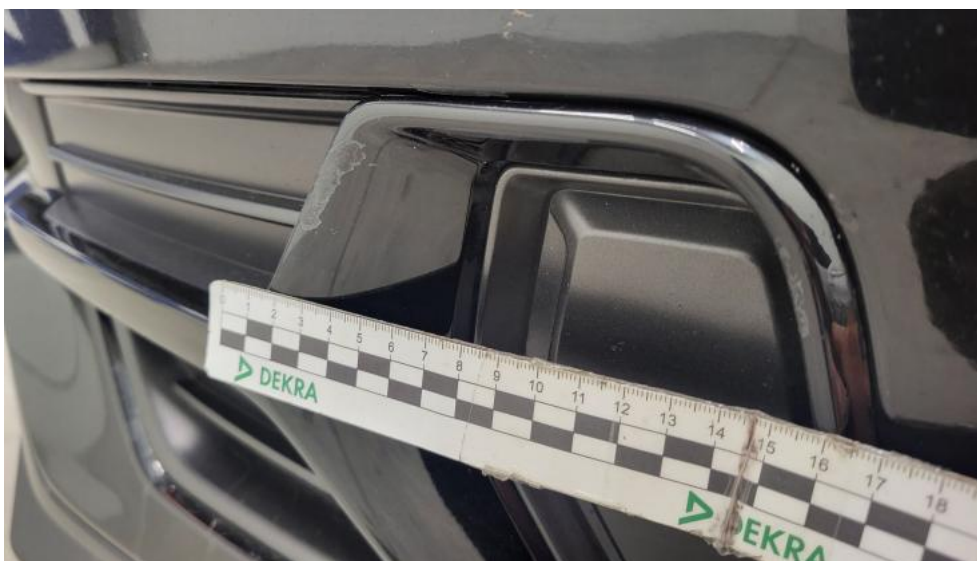
Photo 43.
Kratka/zaślepka halogenu L - Rysa/odprysk 1

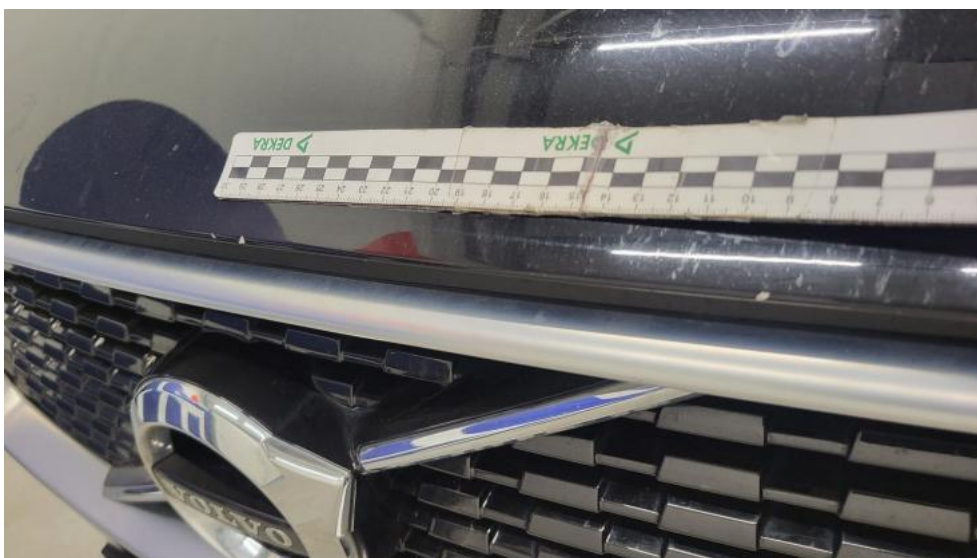
Photo 44.
Pokrywa komory silnika - Rysa/odprysk 1

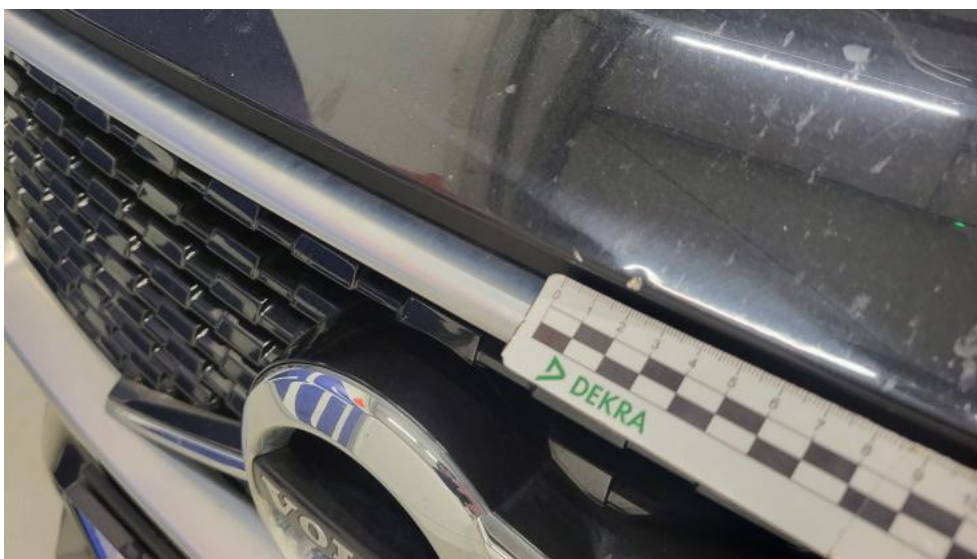
Photo 45.
Pokrywa komory silnika - Wgniecenie/odkształcenie 1

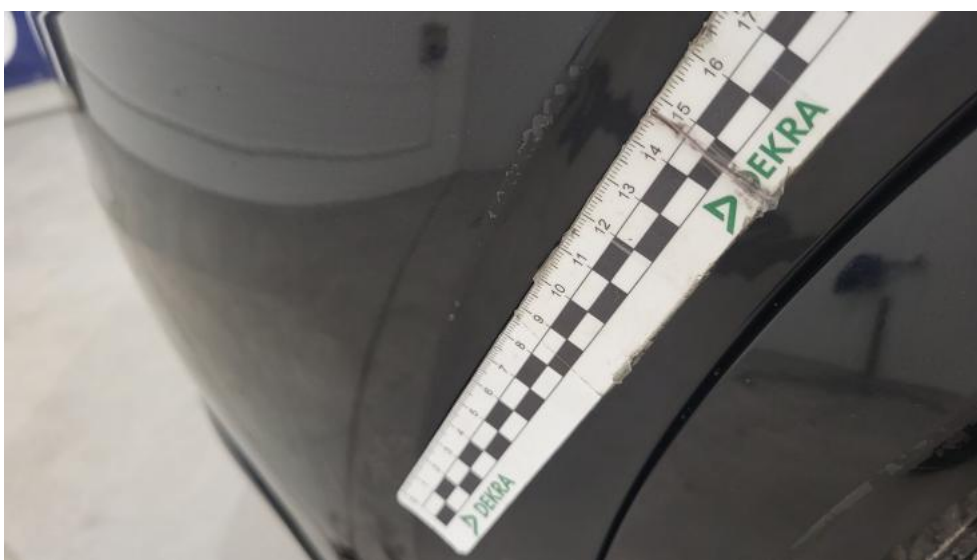
Photo 46.
Zderzak - Rysa/odprysk 1

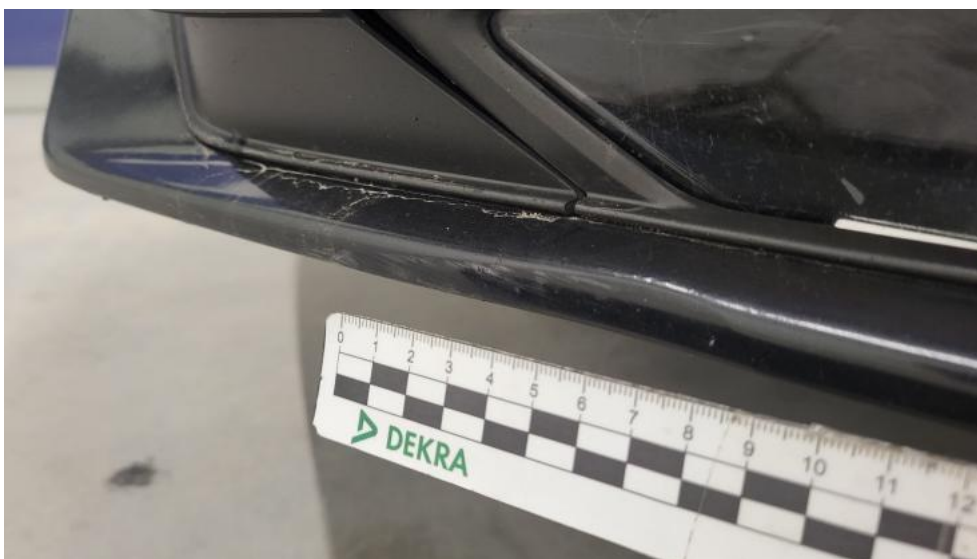
Photo 47.

Zderzak przedni cz dolna - Rysa/odprysk 1

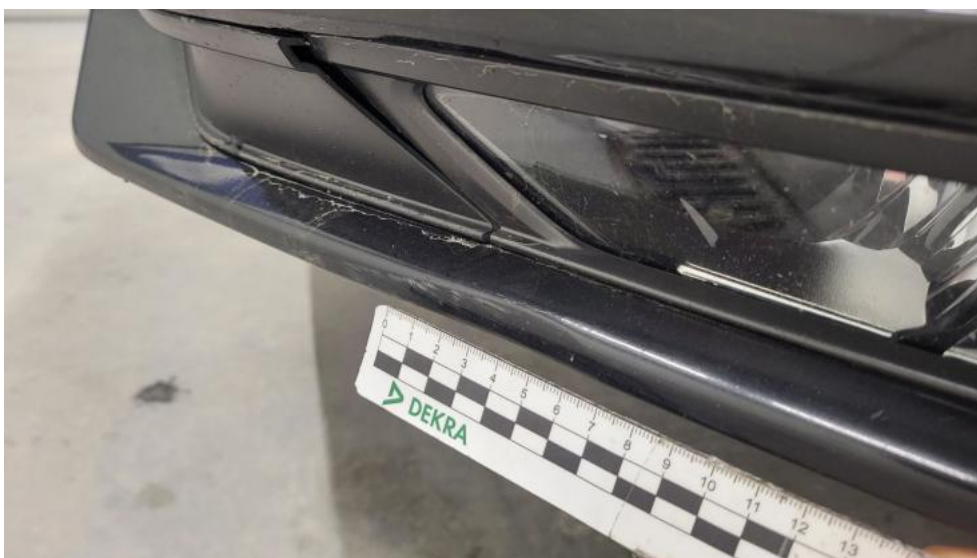
Photo 48.

Zderzak przedni cz dolna - Wgniecenie/odkształcenie 1

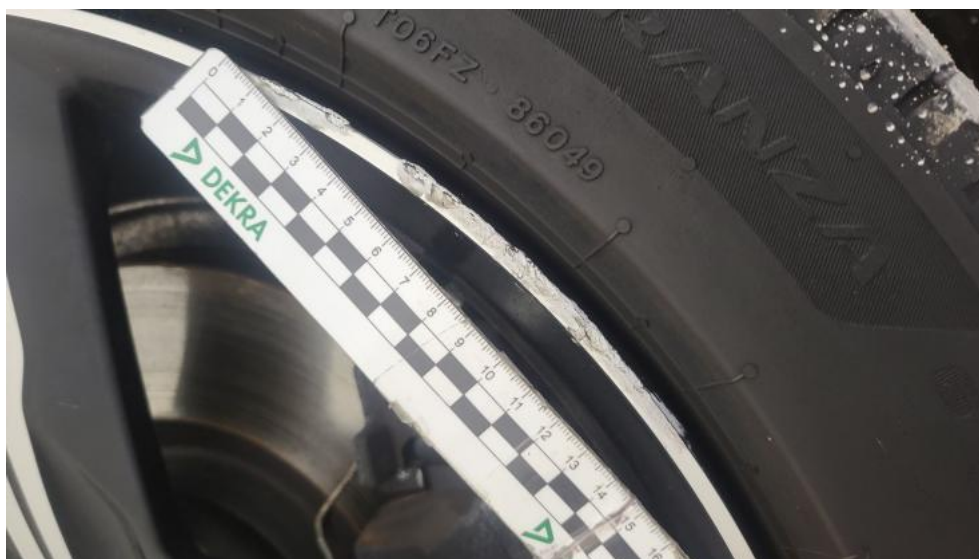
Photo 49.
Felga aluminiowa przednia P - Rysa/odprysk 1

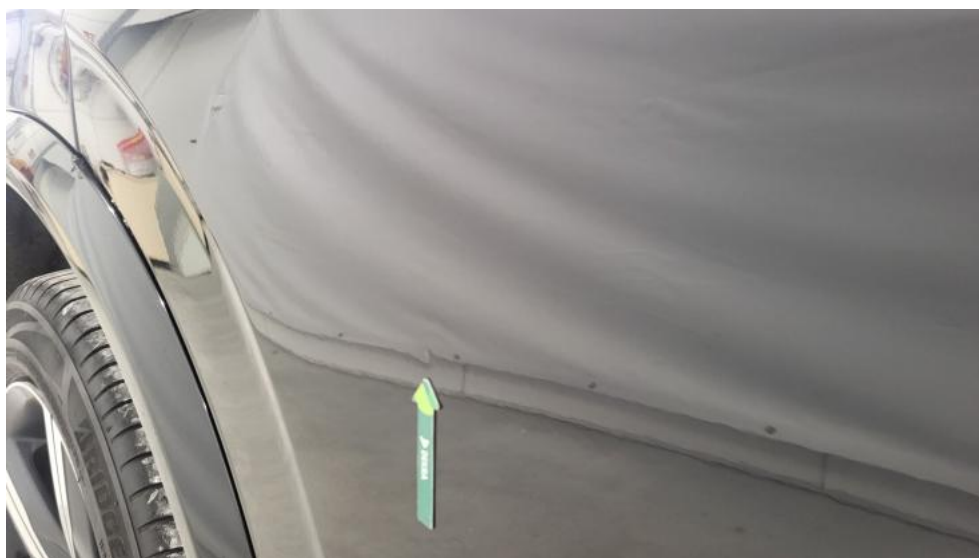
Photo 50.
Drzwi tylne P - Wgniecenie/odkształcenie 1

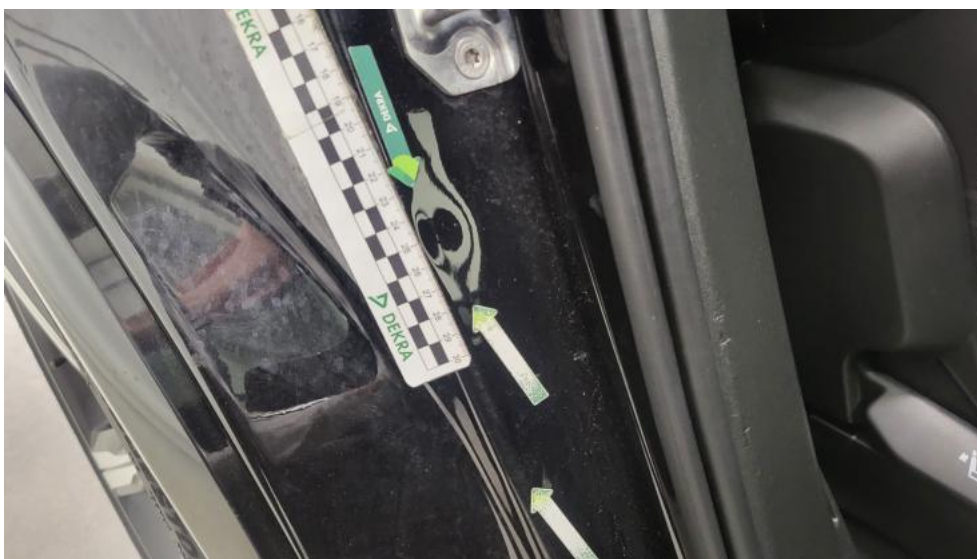
Photo 51.
Błotnik tylny P / Ściana boczna P - Wgniecenie/odkształcenie 1

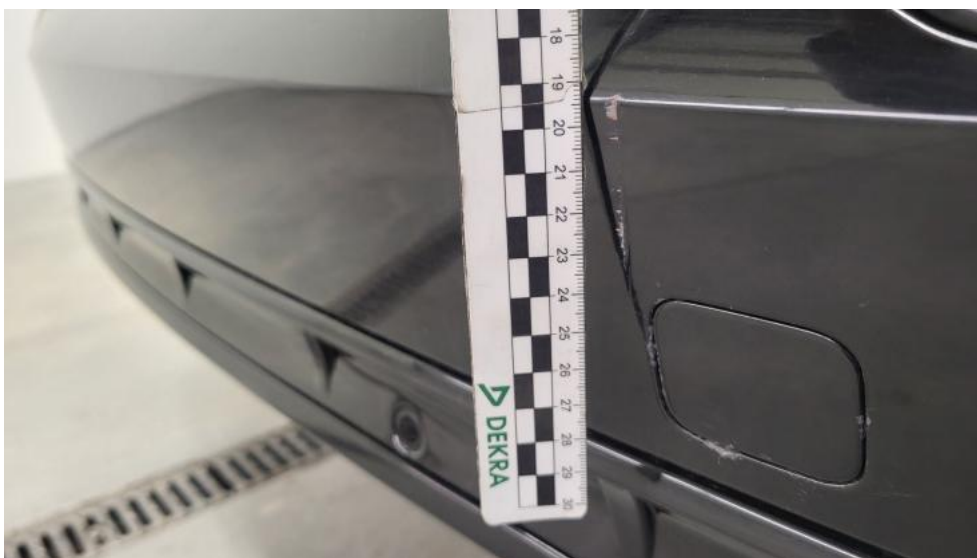
Photo 52.
Zderzak tylny - Rysa/odprysk 1

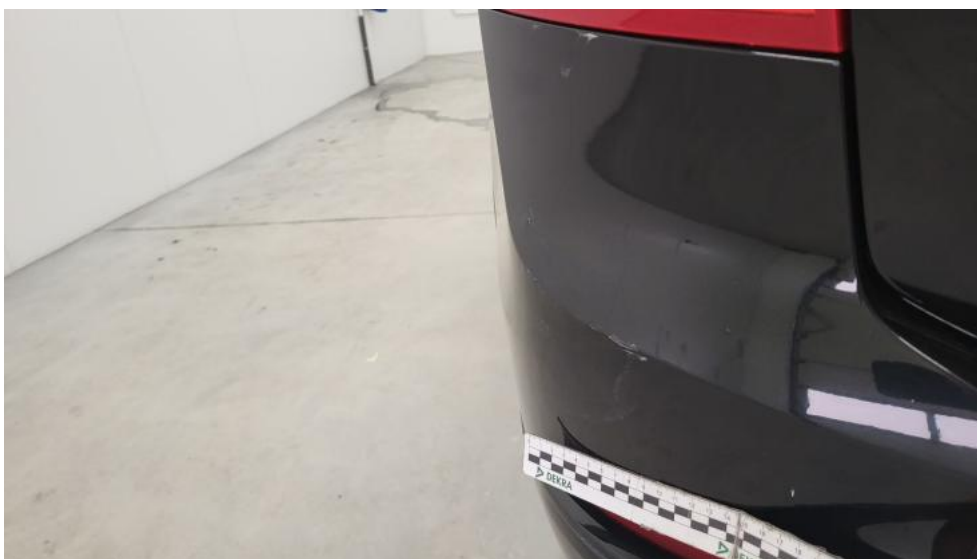
Photo 53.
Zderzak tylny - Rysa/odprysk 2

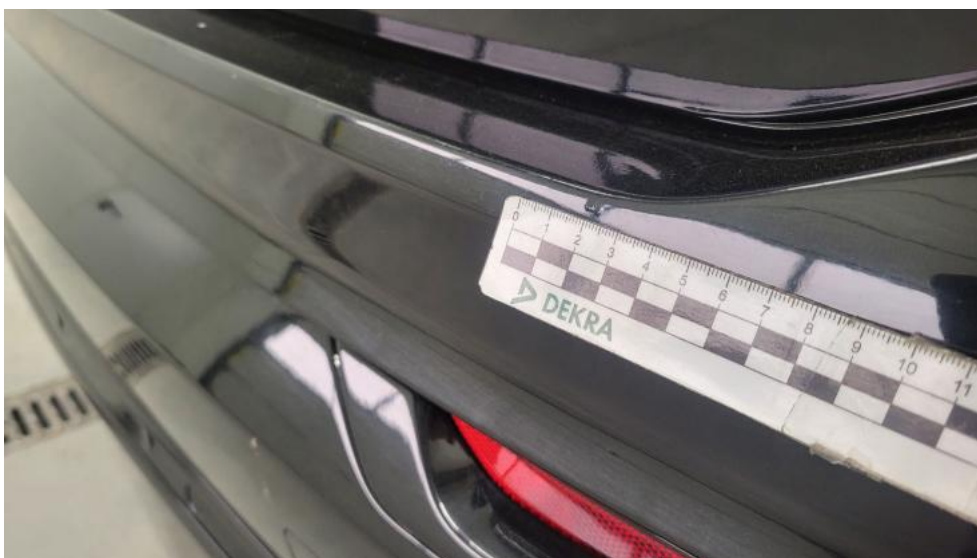
Photo 54.
Zderzak tylny - Wgniecenie/odkształcenie 1

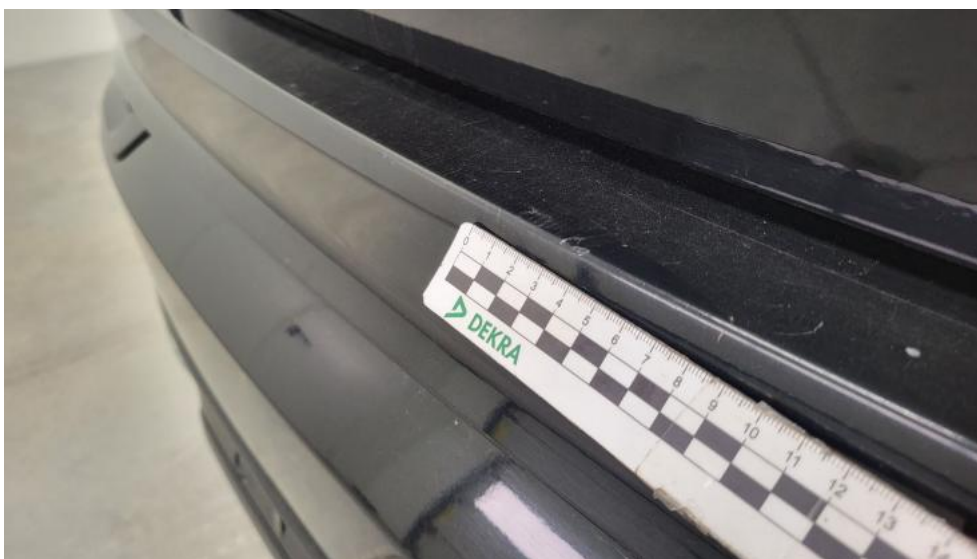
Photo 55.
Zderzak tylny - Wgniecenie/odkształcenie 2

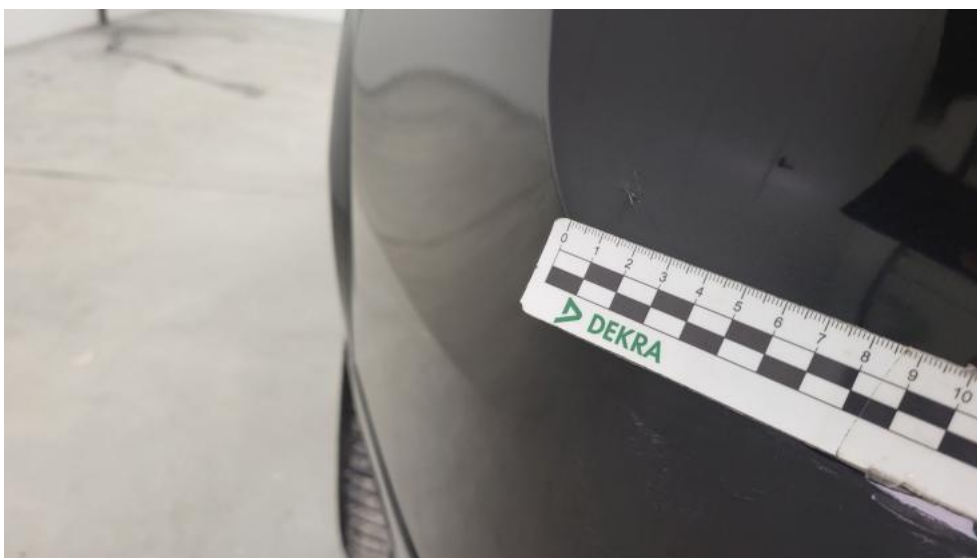
Photo 56.
Zderzak tylny() - Wgniecenie/odkształcenie 3

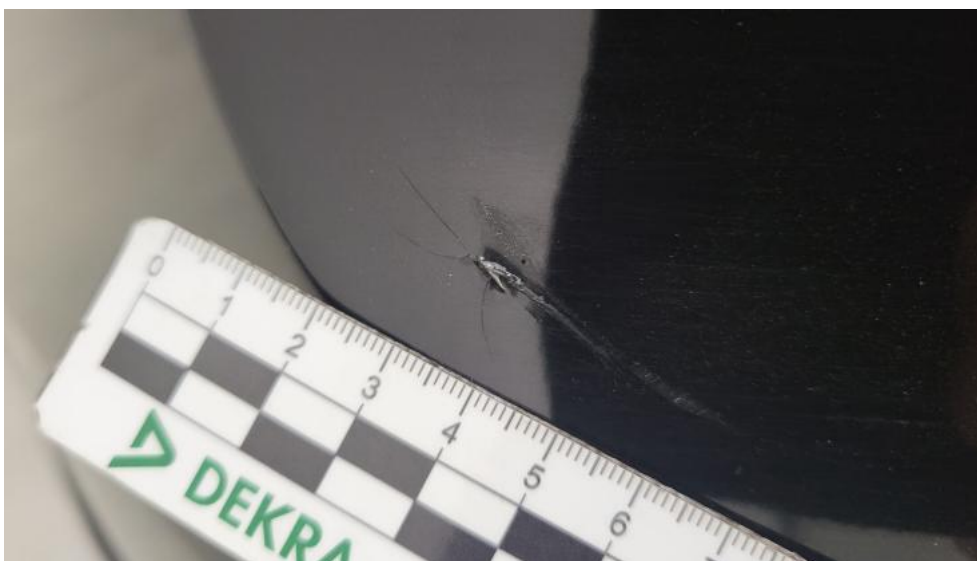
Photo 57.
Zderzak tylny - Pęknięcie/rozerwanie 1

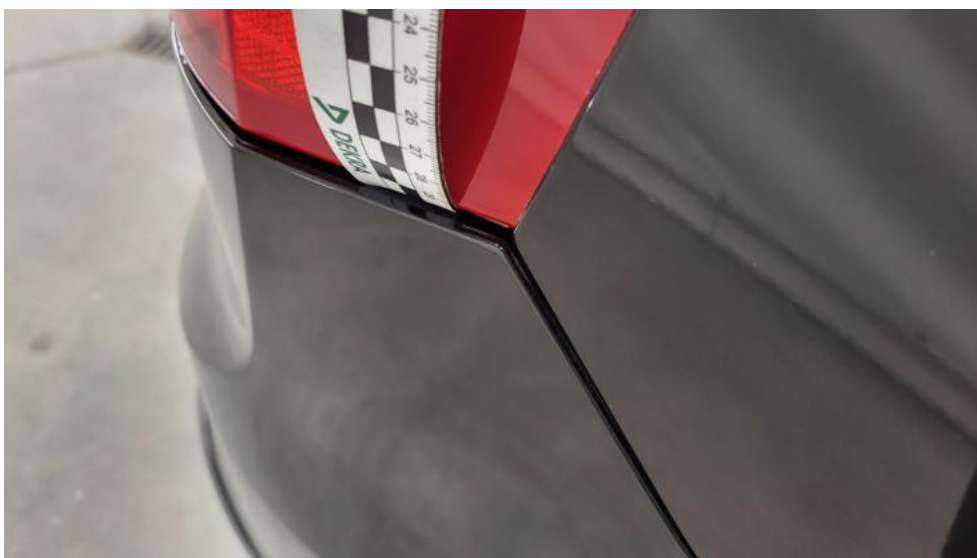
Photo 58.
Zderzak tylny - Inne 1

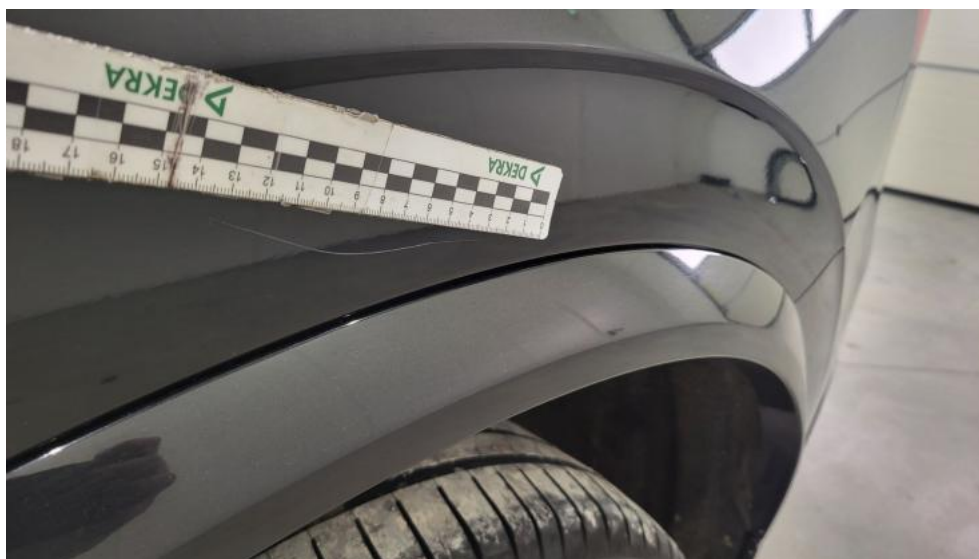
Photo 59.
Błotnik tylny L / Ściana boczna L - Rysa/odprysk 1

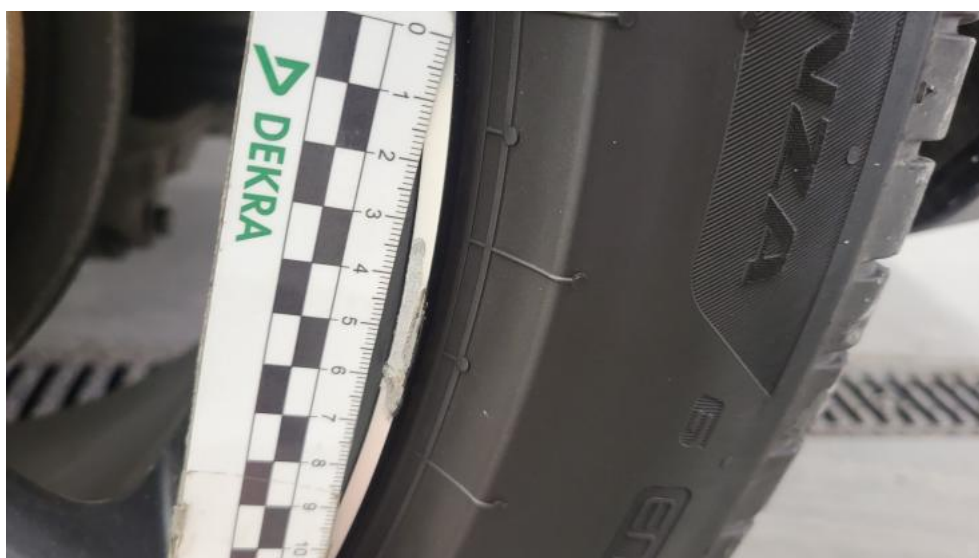
Photo 60.
Felga aluminiowa tylna L - Rysa/odprysk 1

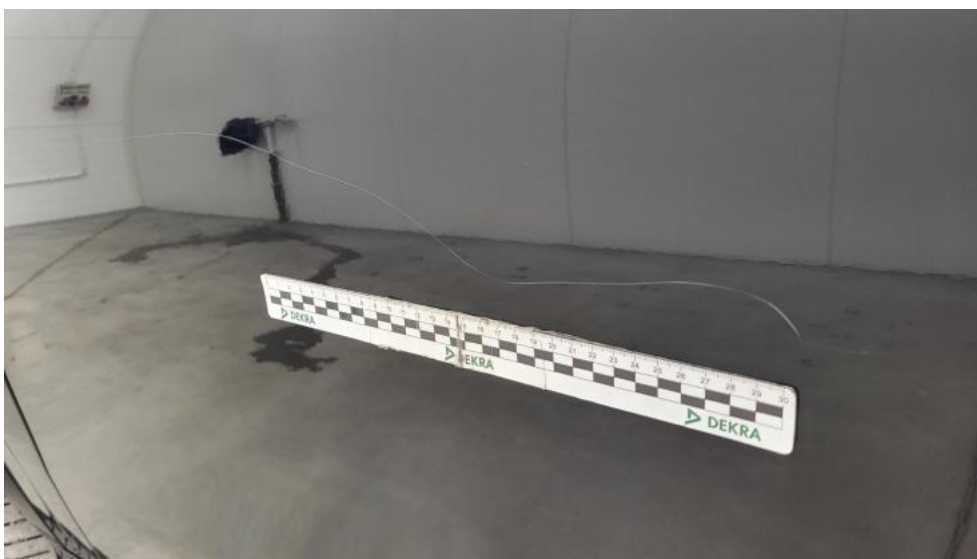
Photo 61.

Drzwi przed L - Rysa/odprysk 1

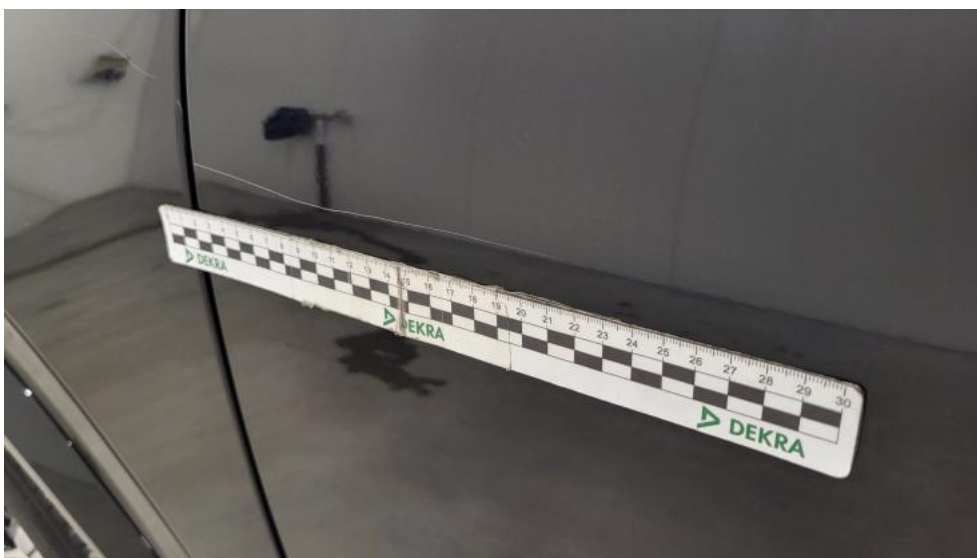
Photo 62.

Drzwi przed L - Rysa/odprysk 2

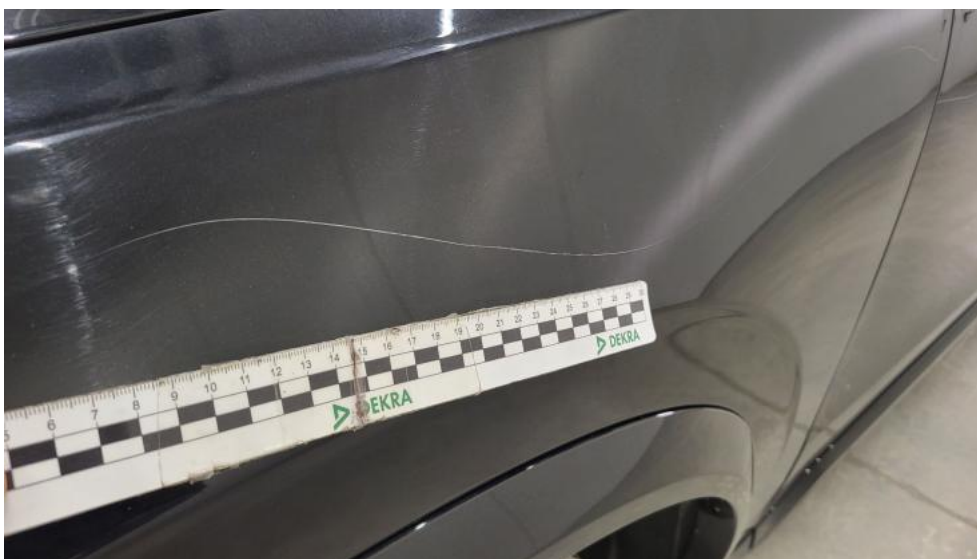
Photo 63.
Błotnik przedni L - Rysa/odprysk 1

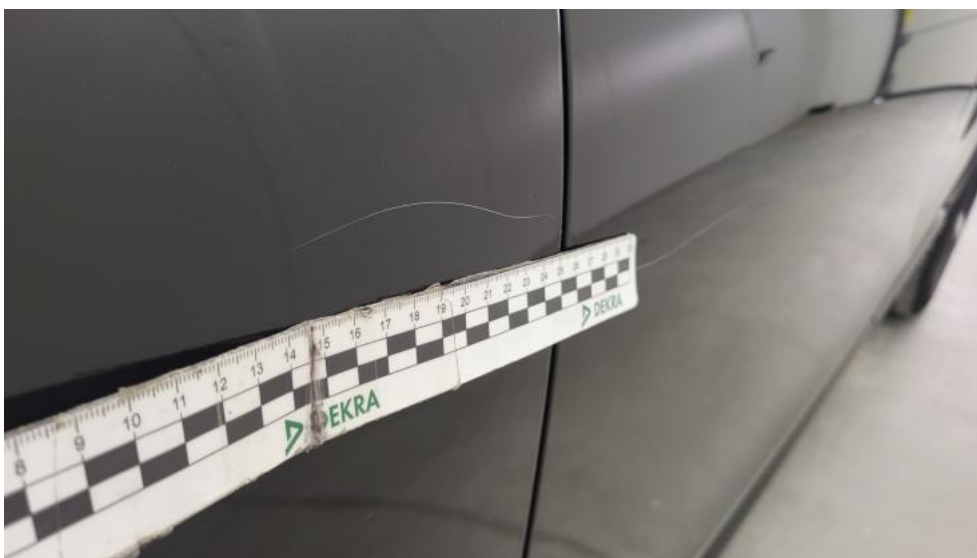
Photo 64.
Błotnik przedni L - Rysa/odprysk 2

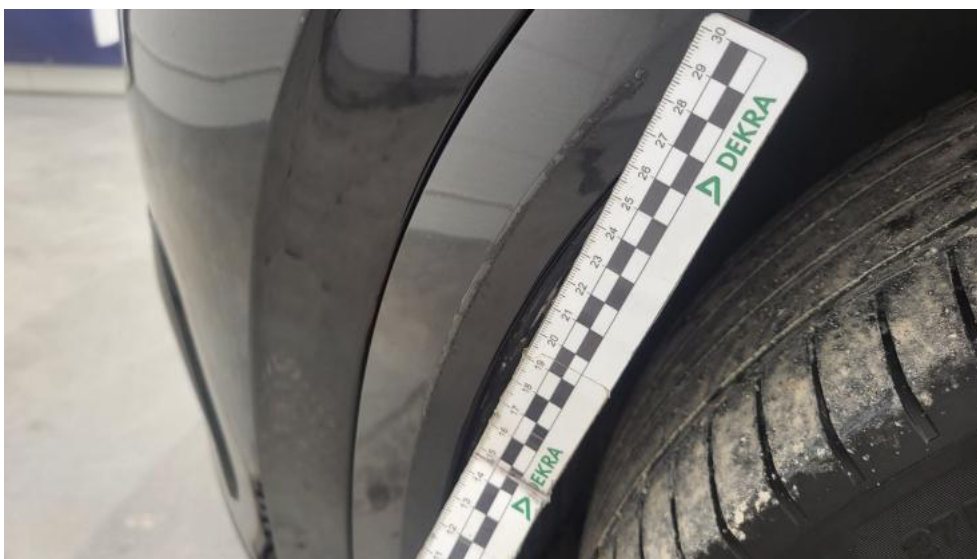
Photo 65.

Listwa błotnika przedniego L - Rysa/odprysk 1

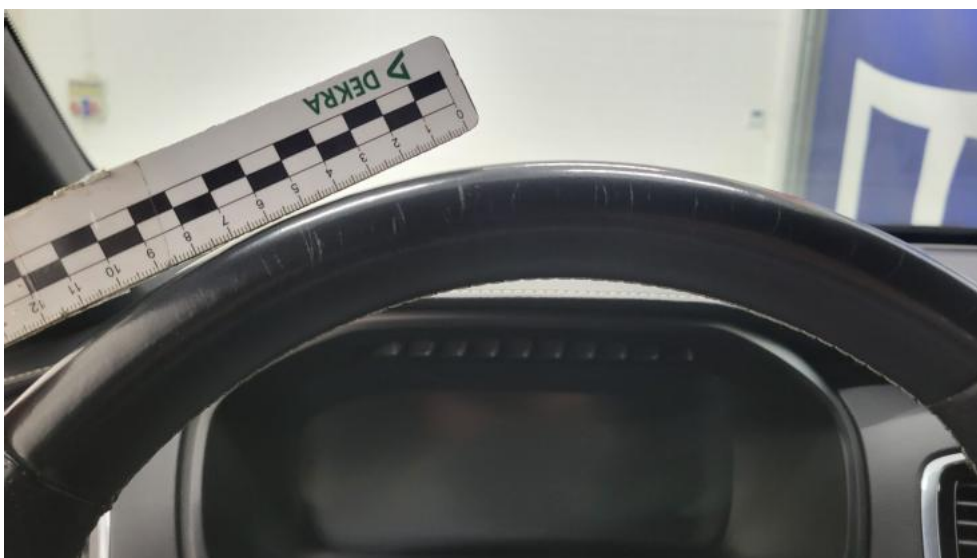
Photo 66.

Koło kierownicy - Rysa/odprysk 1

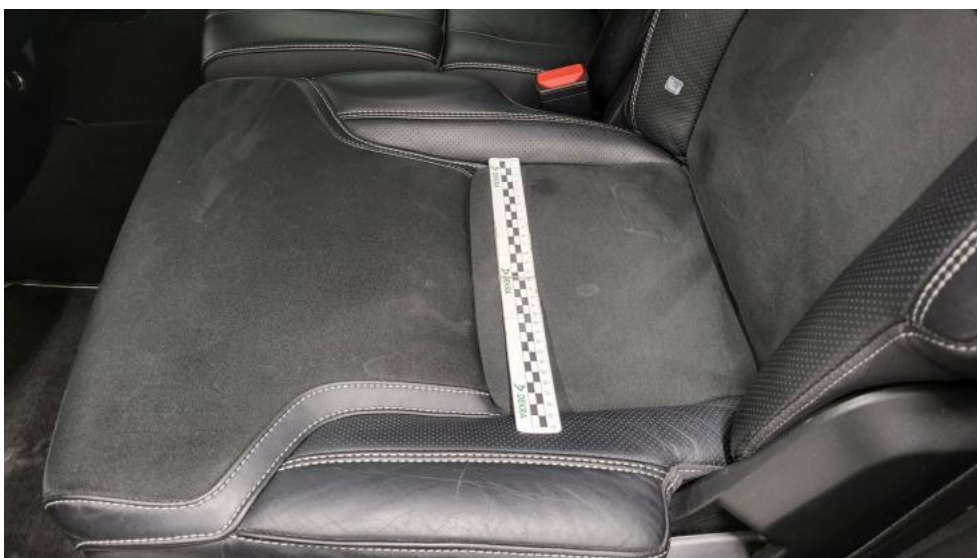
Photo 68.
Kanapa tyl. - Inne 1

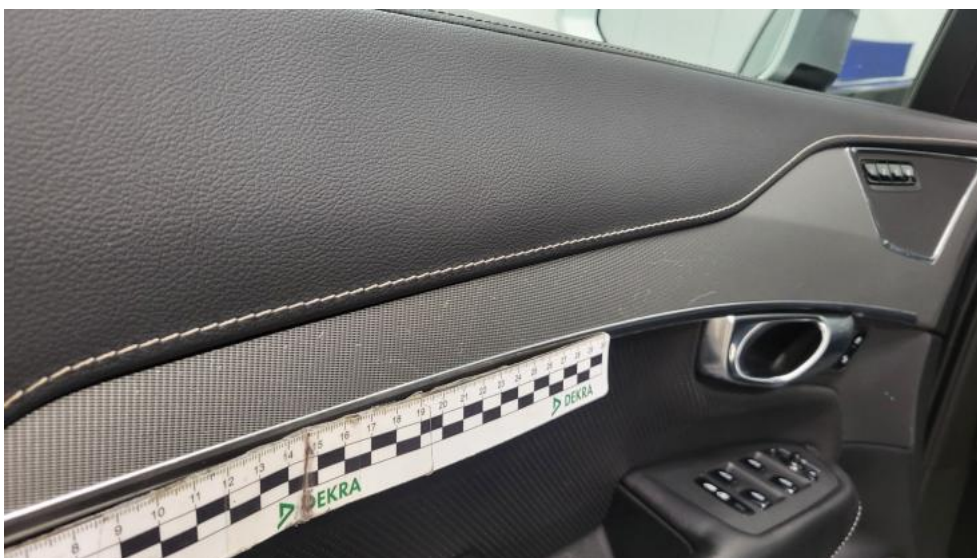
Photo 70.
Tapicerka drzwi przednich L - Rysa/odprysk 1

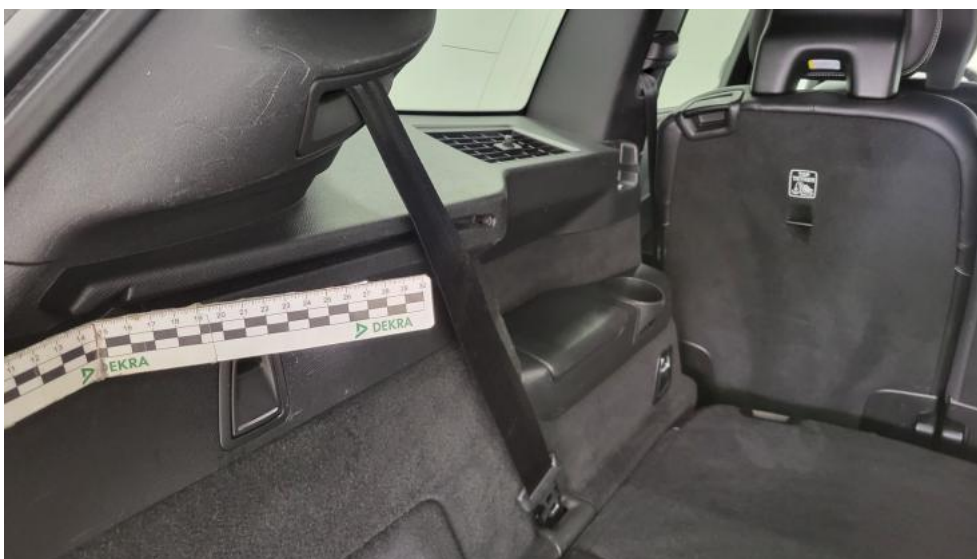
Photo 71.

Rysy na samochodzie. Dostarczone ksero pozwolenia czasowego. Niesprawne przyciski funkcyjne w jednym z kluczyków, grot prawidłowy. Ślady polerowania. Brak półki bagażnika. Odpryski na szybie czołowej.

Półka/roleta tylna - Inne 1
