DEKRA's commission No. : PKOL(W)/LODZ/17176/25/03/07
 commission/ damage No. : 23/004173
 Date of commission: 07-03-2025

Vehicle data

Description of the technical condition

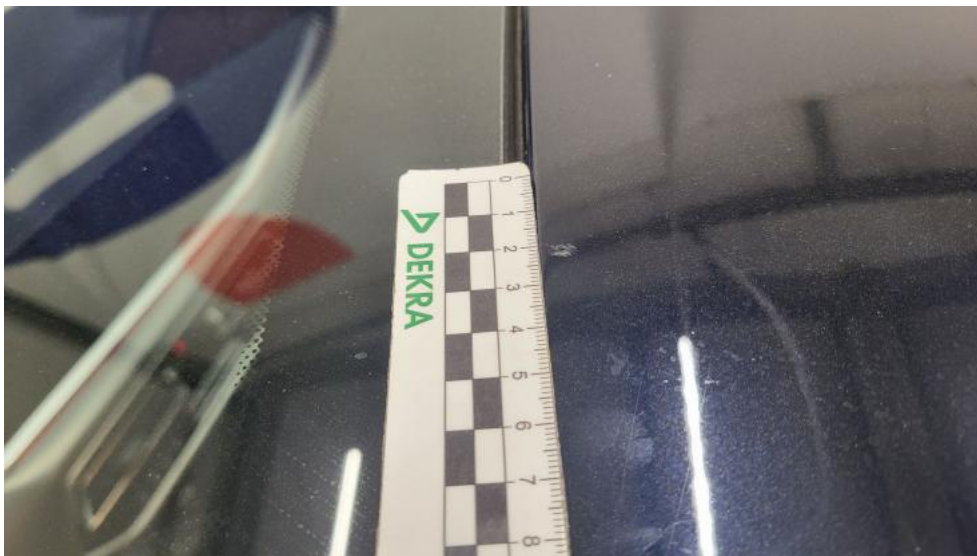
Photo 43.
Dach - Rysa/odprysk 1

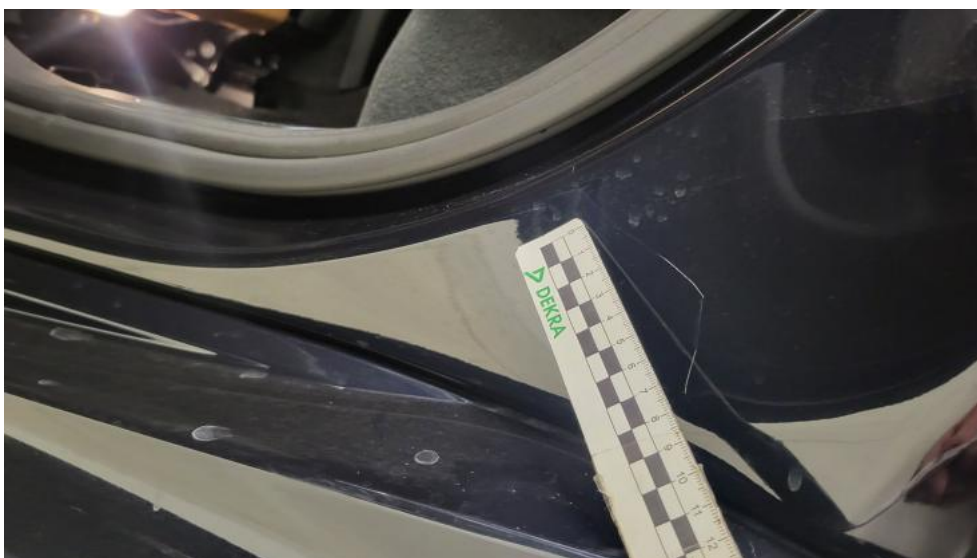
Photo 44.
Próg L - Rysa/odprysk 1
