DEKRA's commission No. : PKOL(W)/LODZ/84505/24/10/31
commission/ damage No. : 22/033947
Date of commission: 31-10-2024

Vehicle data

Measurement of thickness of the vehicle lacquer coating

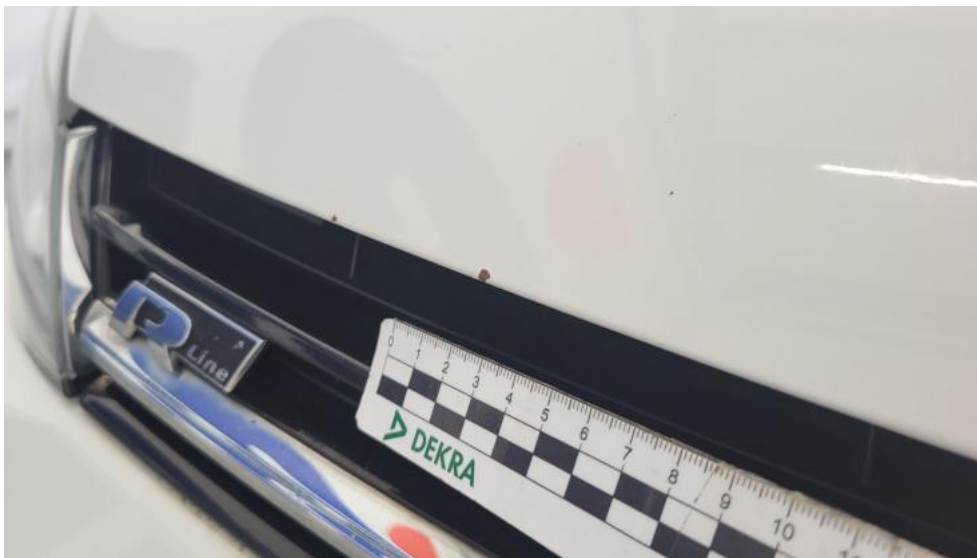
Pokrywa komory silnika - Rysa/odprysk 1

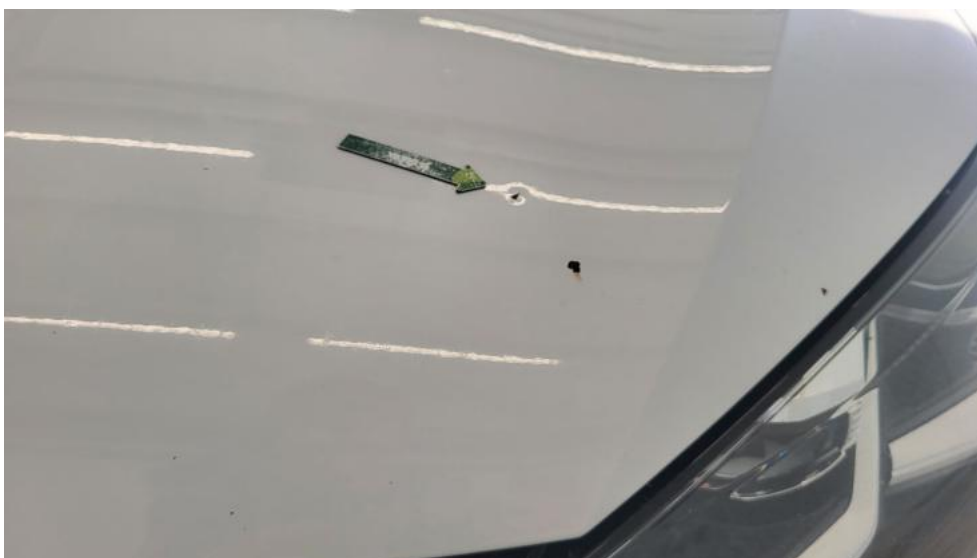
Pokrywa komory silnika - Wgniecenie/odkształcenie 1

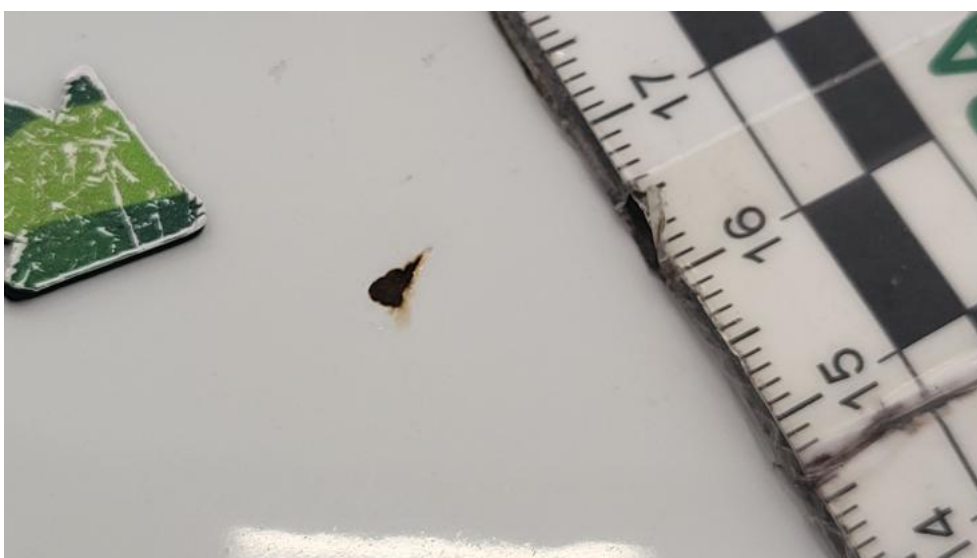
Pokrywa komory silnika - Inne 2

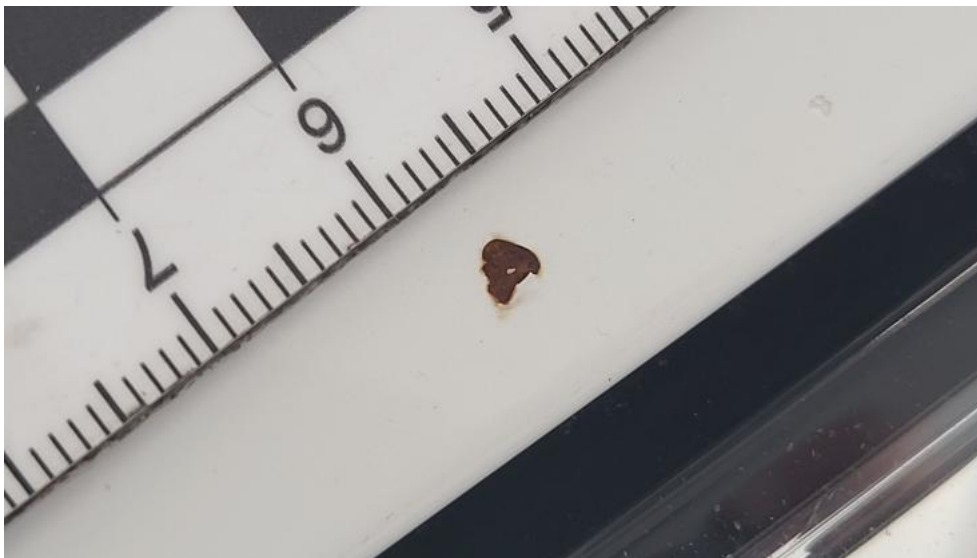
Pokrywa komory silnika() - Inne 3

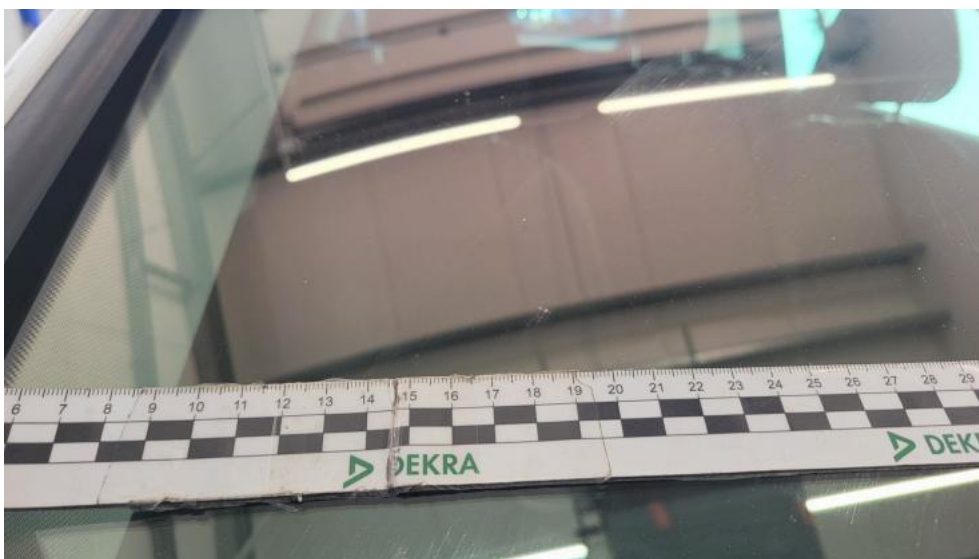
Photo 53.
Szyba czołowa - Rysa/odprysk 1

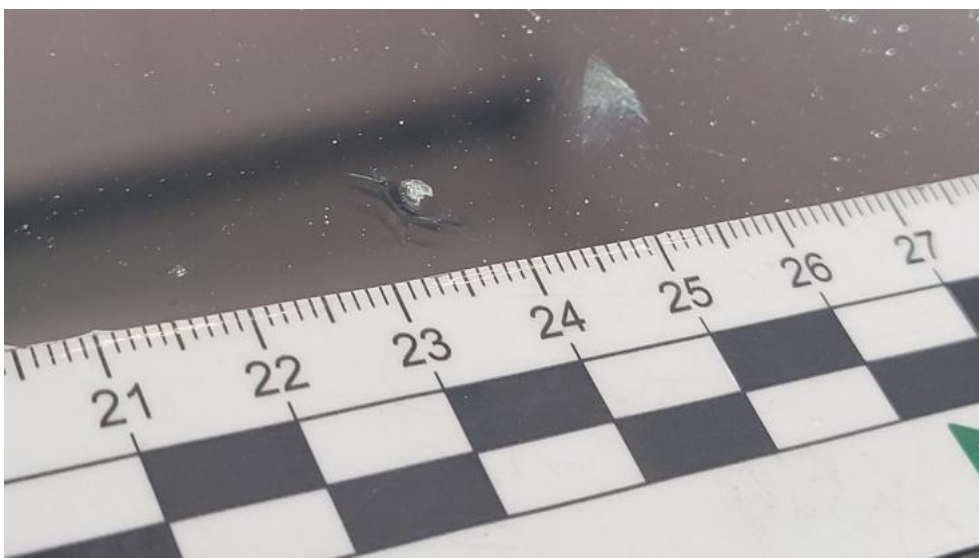
Photo 54.
Szyba czołowa - Pęknięcie/rozerwanie 1

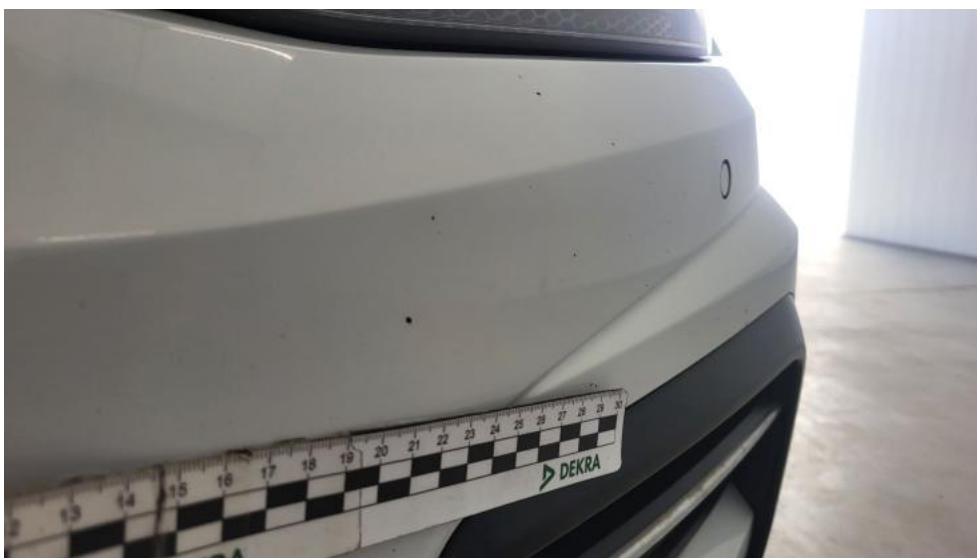
Zderzak - Rysa/odprysk 1

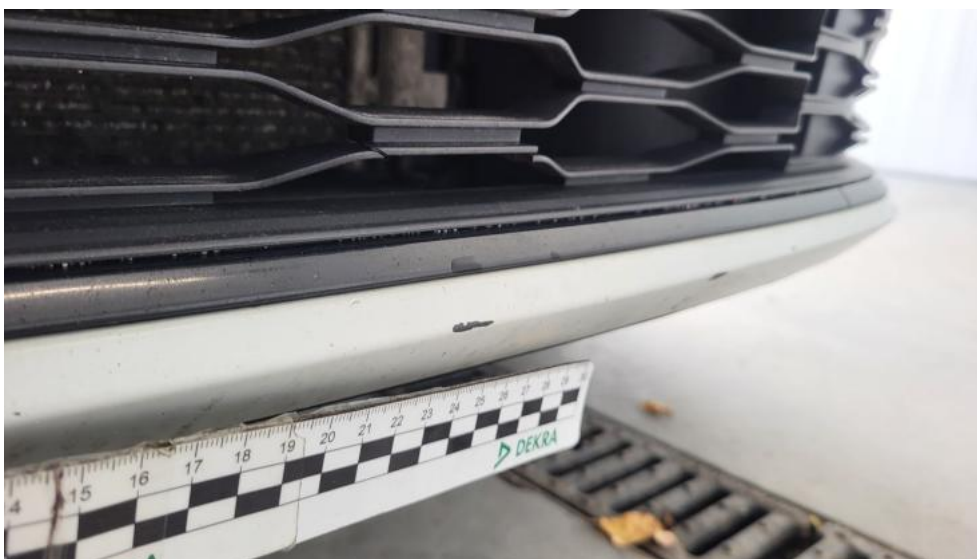
Zderzak - Rysa/odprysk 2

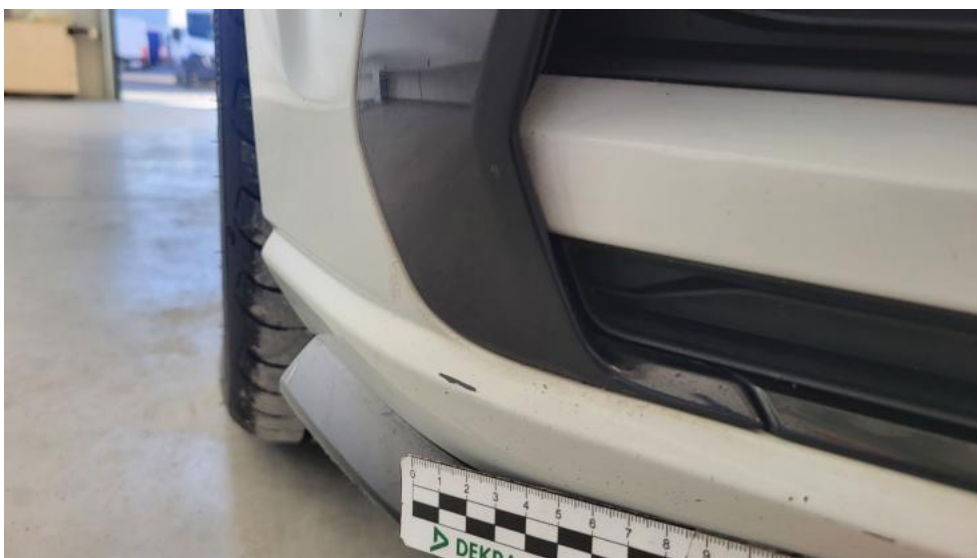
Zderzak() - Rysa/odprysk 3

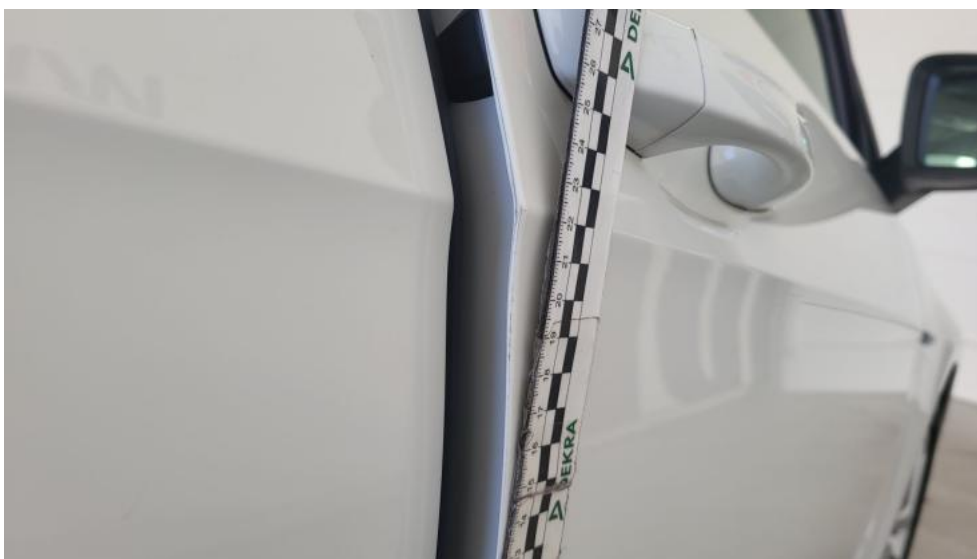
Drzwi przednie P - Rysa/odprysk 1

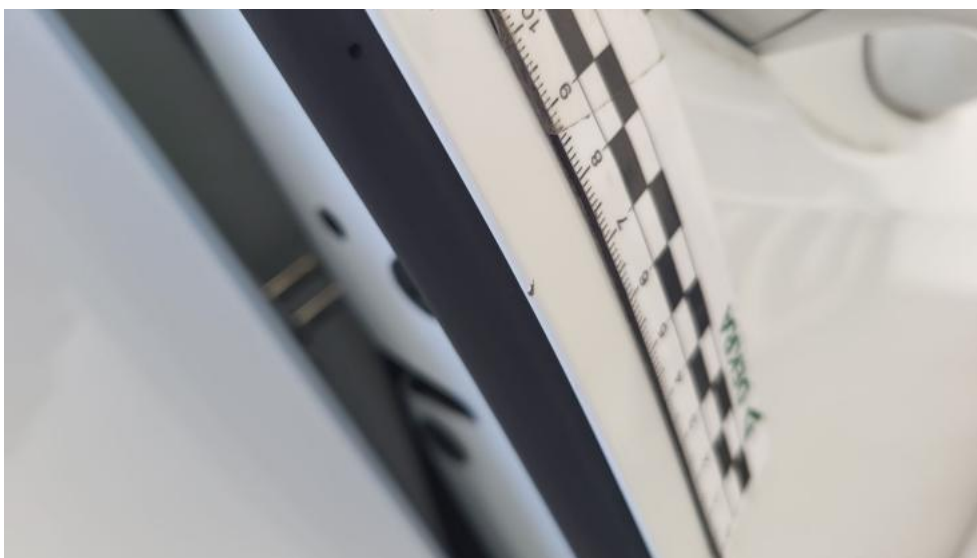
Drzwi tylne P - Rysa/odprysk 1

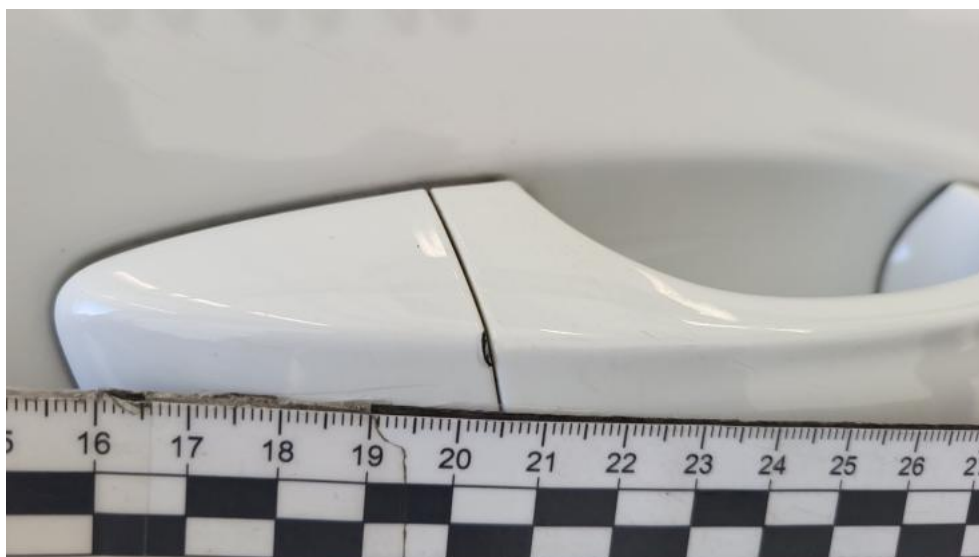
Photo 61.
Klamka drzwi prz P - Rysa/odprysk 1

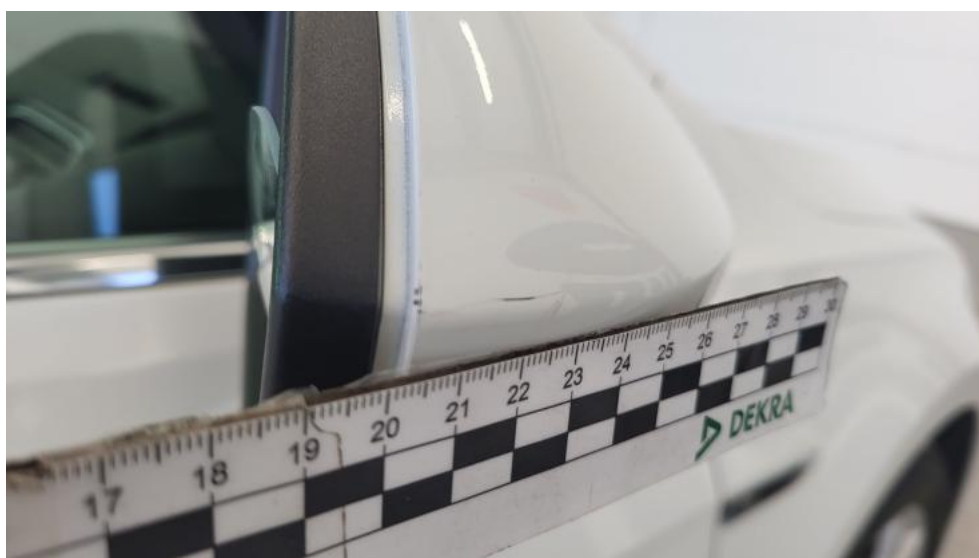
Photo 62.
Lusterko zew P - Rysa/odprysk 1

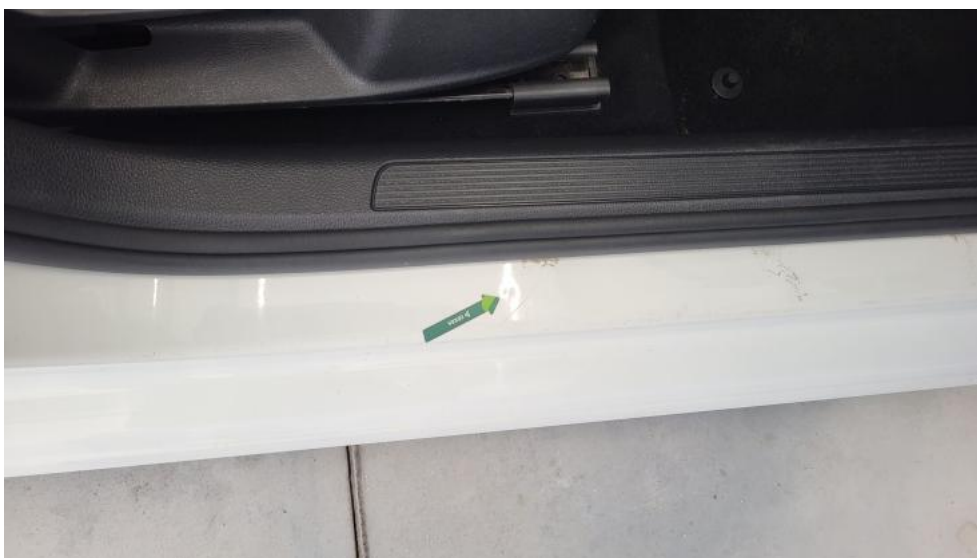
Photo 64.
Próg P - Wgniecenie/odkształcenie 1

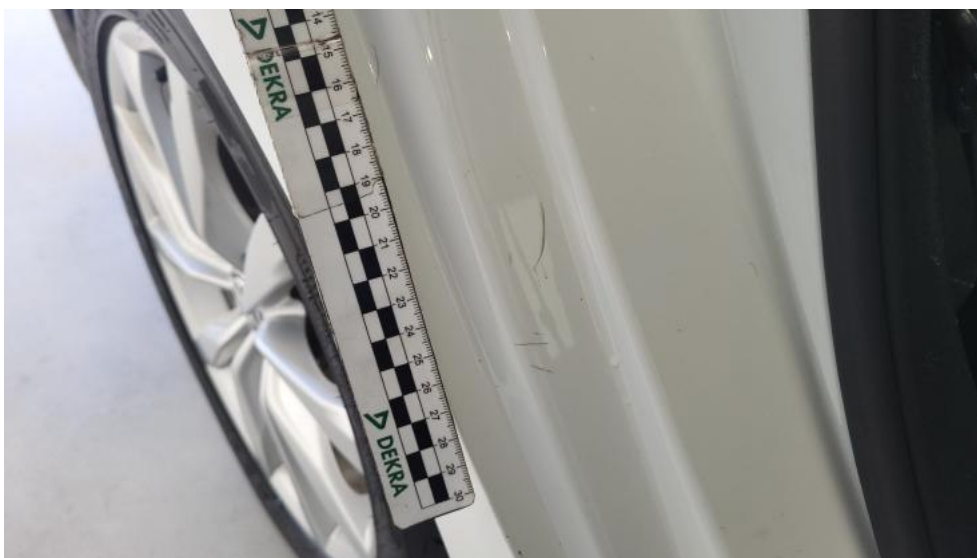
Błotnik tylny P / Ściana boczna P - Rysa/odprysk 1

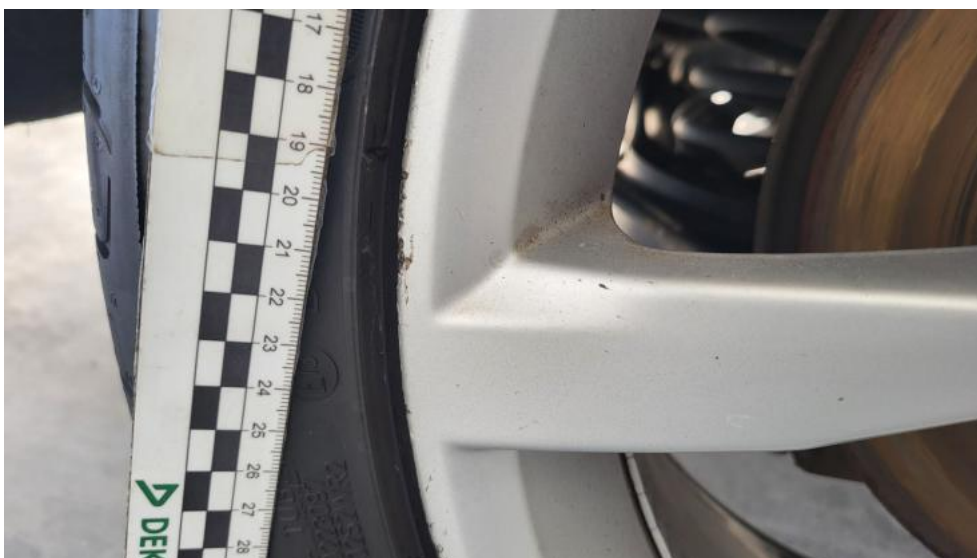
Felga aluminiowa tylna P - Rysa/odprysk 1

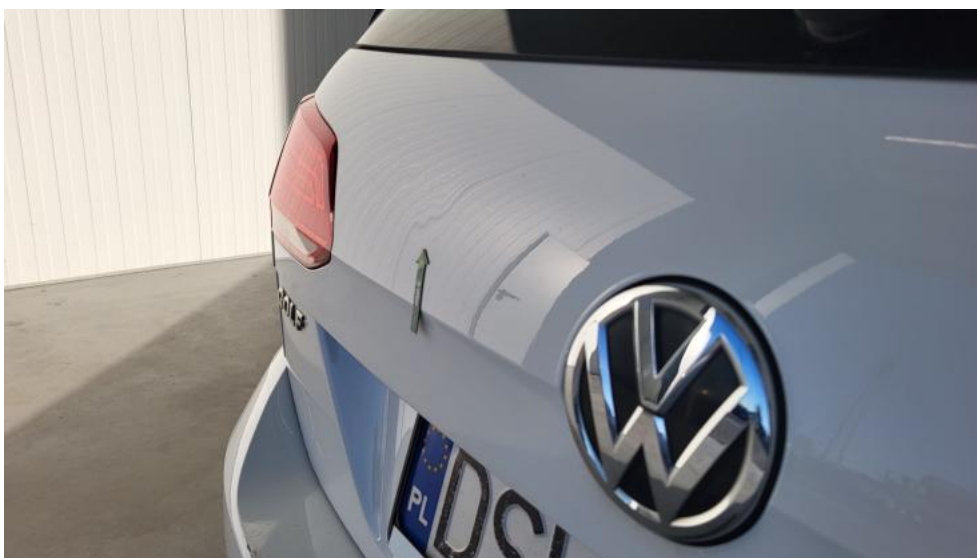
Pokrywy bagażnika - Wgniecenie/odkształcenie 2

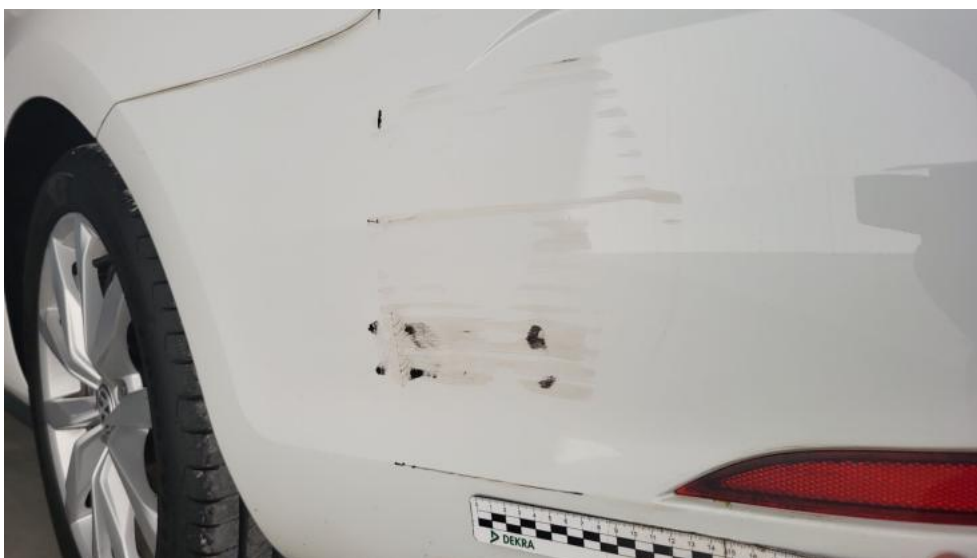
Zderzak tylny() - Rysa/odprysk 3

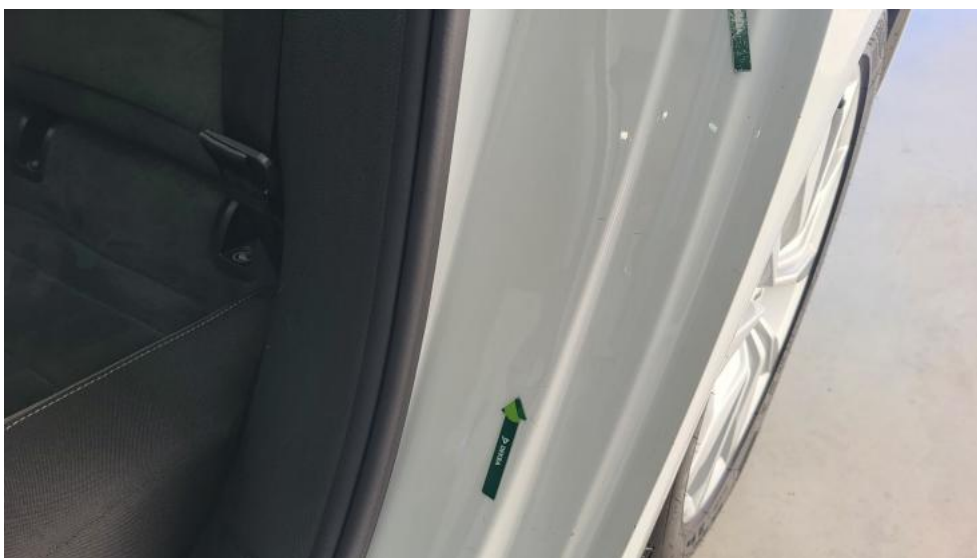
Błotnik tylny L / Ściana boczna L - Wgniecenie/odkształcenie 2

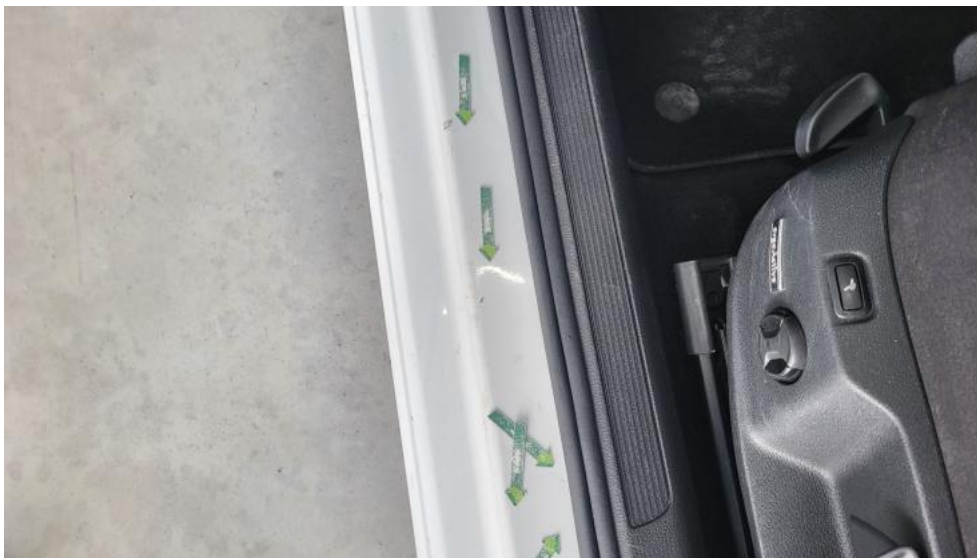
Próg L - Wgniecenie/odkształcenie 2

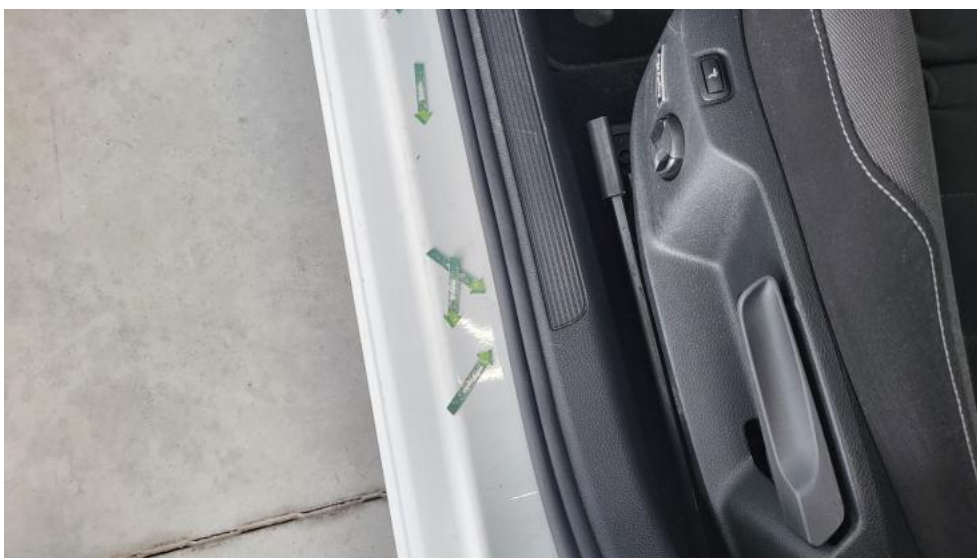
Próg L() - Wgniecenie/odkształcenie 3

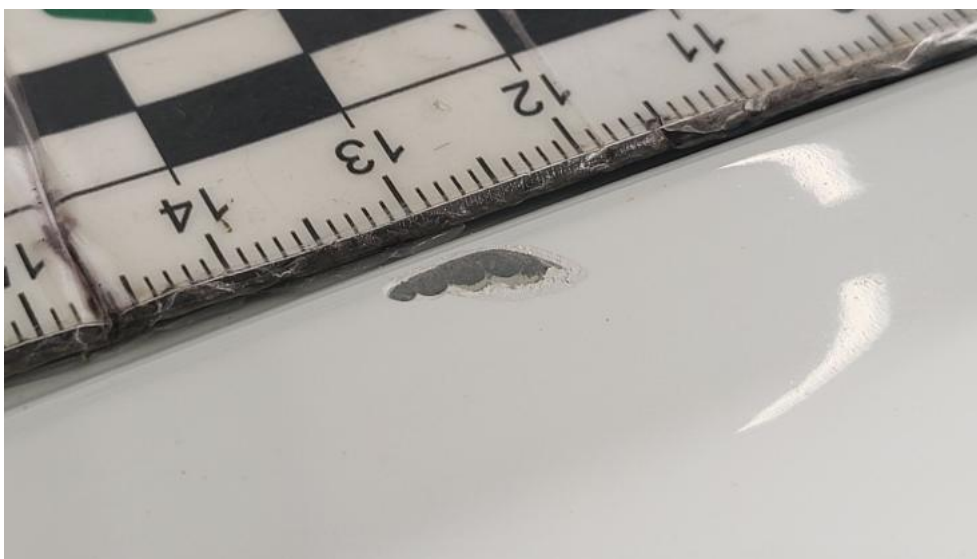
Photo 87.
Stupek przedni L - Rysa/odprysk 2

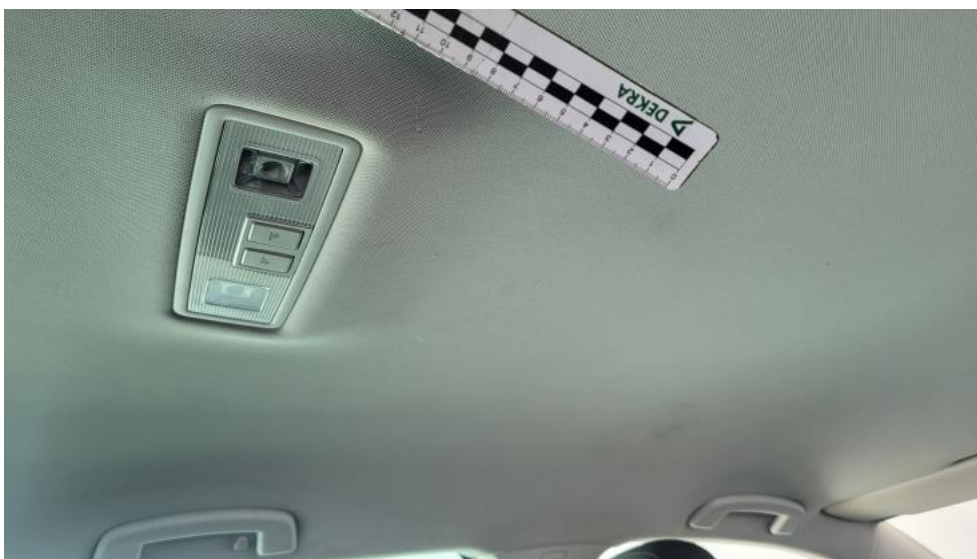
Photo 95.
Podsufitka - Inne 1
