DEKRA's commission No. : PKOL(W)/LODZ/93766/25/12/01  
commission/ damage No. : 22/032363  
Date of commission: 01-12-2025

| Manufacturer | BMW |
| Model | Seria 4 Coupe [G22/G82] 20-24 |
| Registration /record No. | WU0435R |

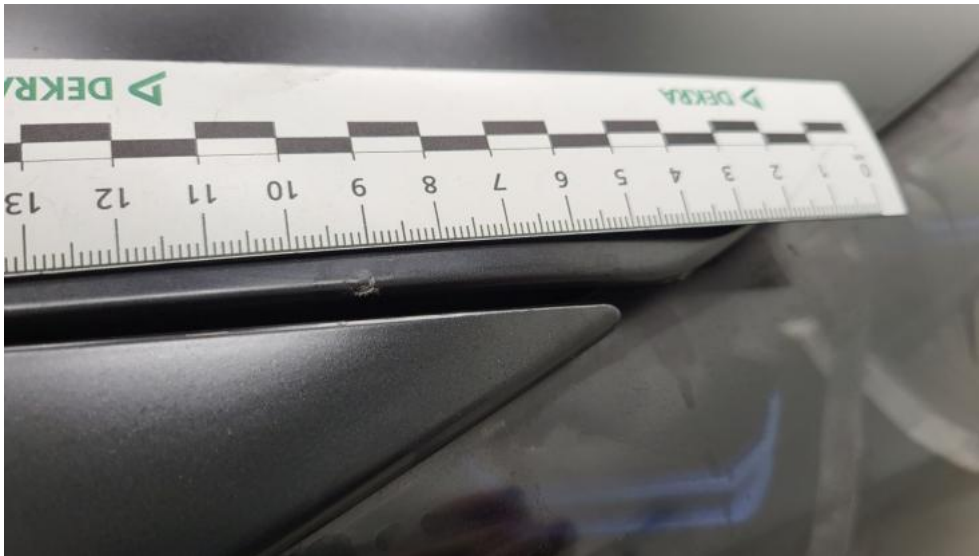
**Photo 47.**

Pokrywa komory silnika - Rysa/odprysk 1

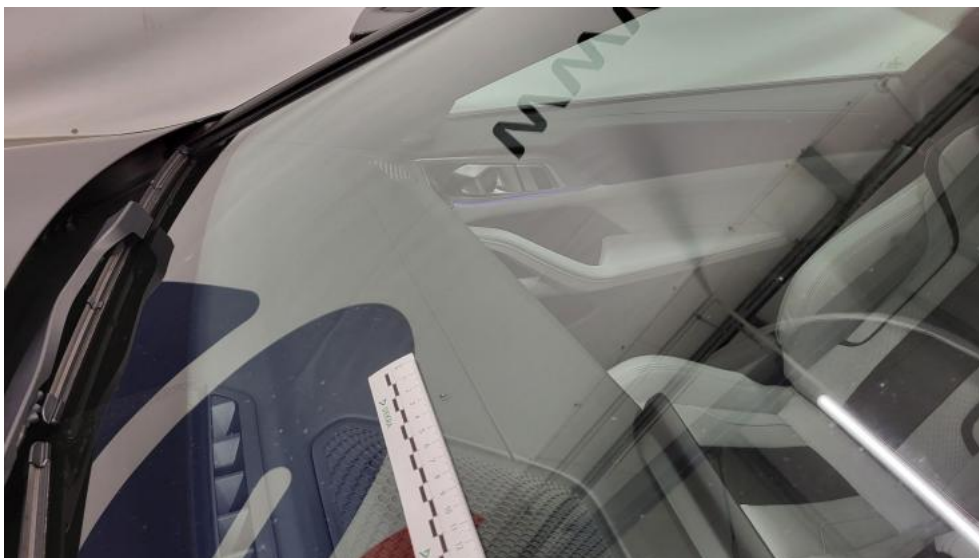
**Photo 48.**

Niesprawne przyciski funkcyjne w jednym z kluczyków, grot prawidłowy. Pojazd oklejony folią. Pomiar lakieru wykonany na folii, elementy: pokrywa przednia, dach, słupki przedni lewy/prawy, błotnik przedni lewy/prawy. Rysy na samochodzie. Odpryski na szybie czołowej. Reflektory oklejone folią. Lampy tylne oklejone folią.

Szyba czołowa - zdjęcie poglądowe 1

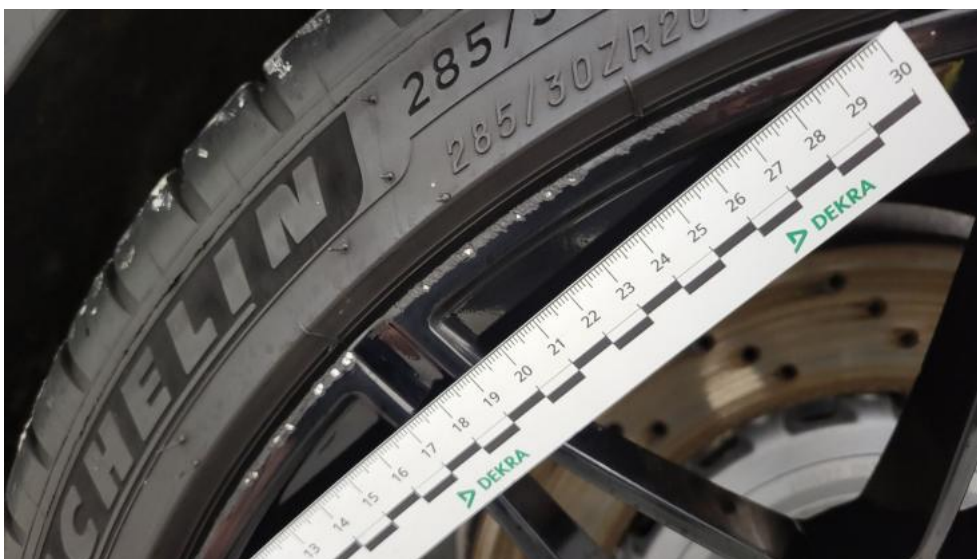
**Photo 53.**

Felga aluminiowa tylna P - Rysa/odprysk 1

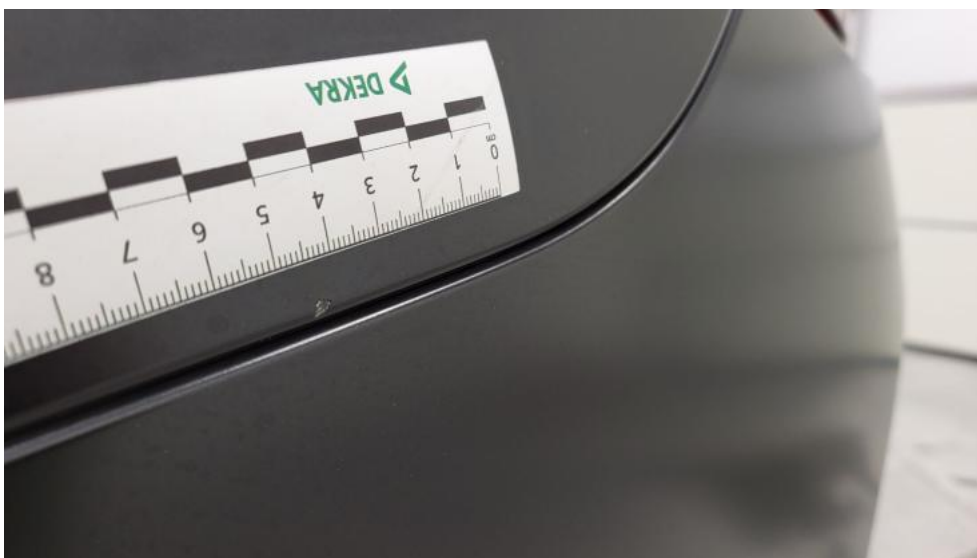
**Photo 54.**

Ścianka tylna L / Ścianka boczna L - Rysa/odprysk 1

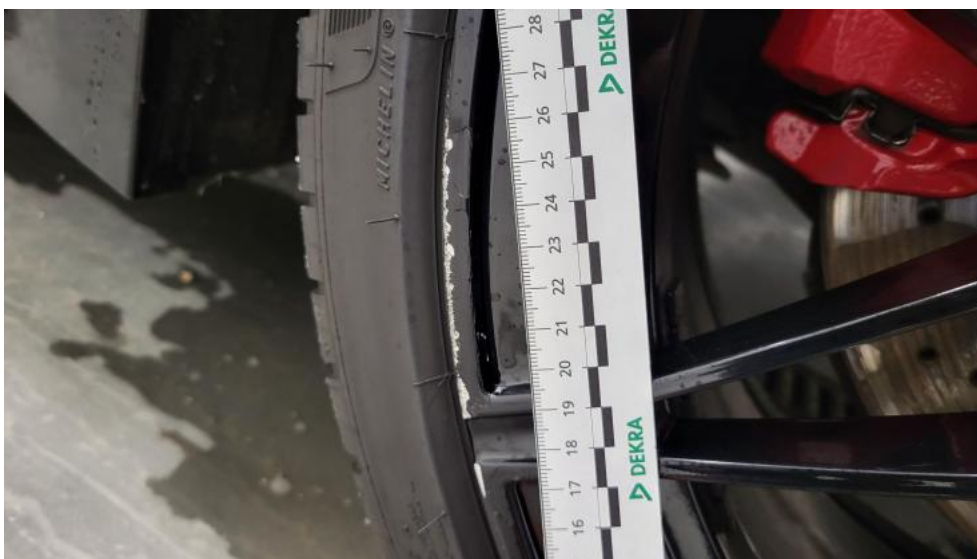
**Photo 57.**

Felga aluminiowa tylna L - Rysa/odprysk 1

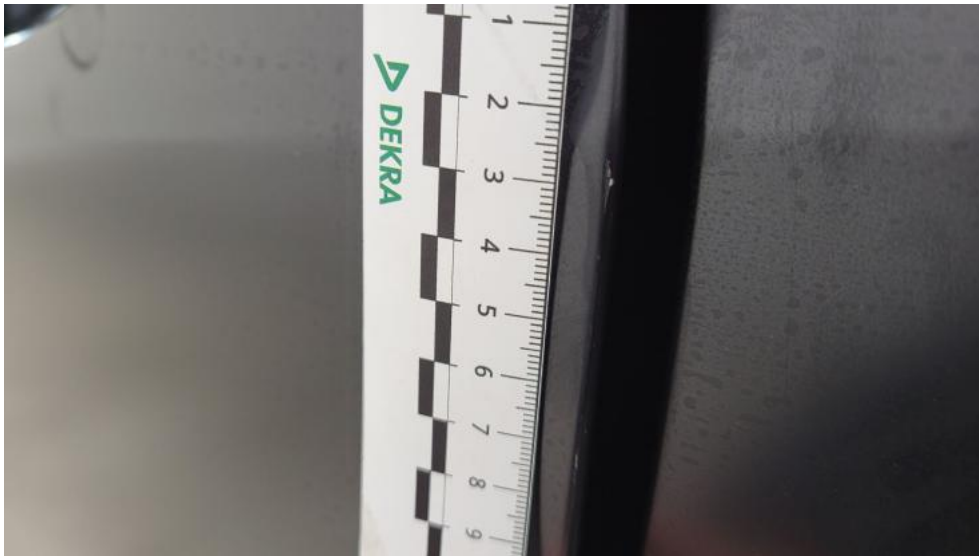
**Photo 59.**

Drzwi przed L - Rysa/odprysk 2

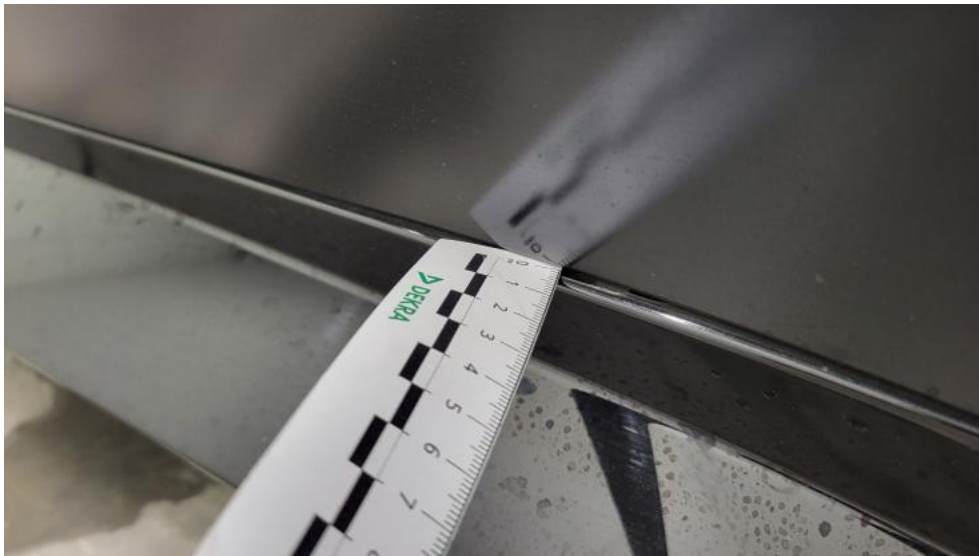
**Photo 61.**  
Próg L - Inne 1

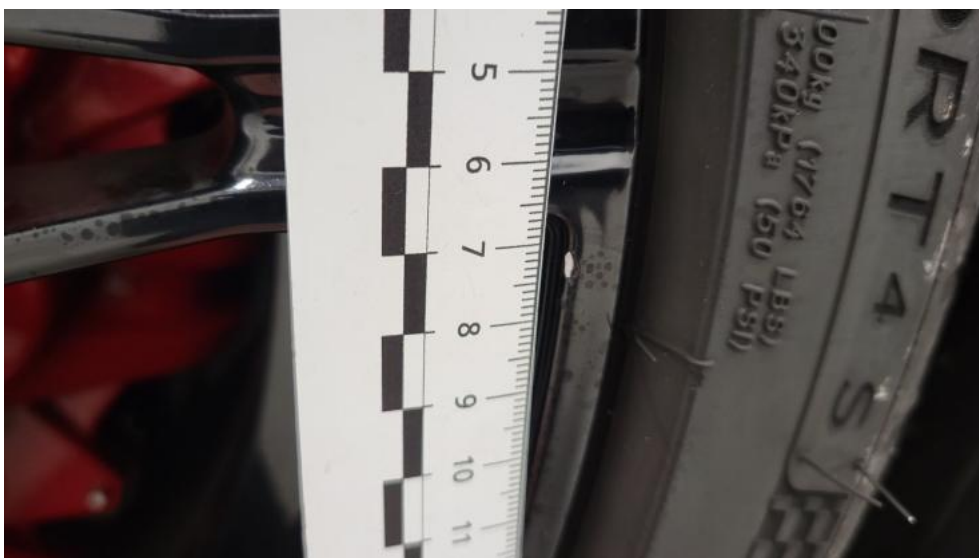
**Photo 62.**  
Felga Aluminiowa przednia L - Rysa/odprysk 1
