DEKRA's commission No. : PKOL(W)/LODZ/04313/26/01/19  
commission/ damage No. : 23/001634  
Date of commission: 19-01-2026

**DEKRA Poland - Headquarters**  
02-673 Warszawa, ul. Konstruktorska 12A

| Manufacturer | BMW |
| Model | Seria 5 [G30/F90] 20-23 |

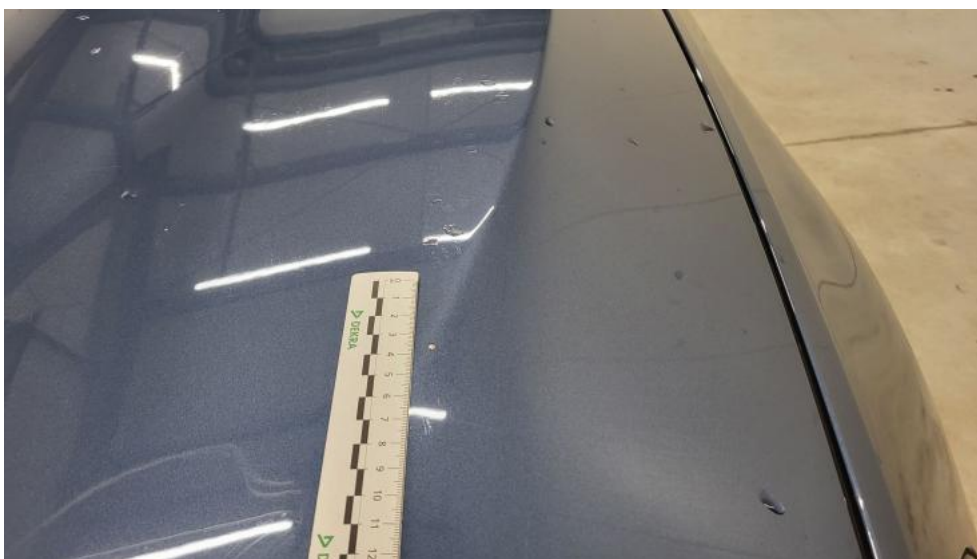
**Photo 41.**

Pokrywa komory silnika - Rysa/odprysk 1

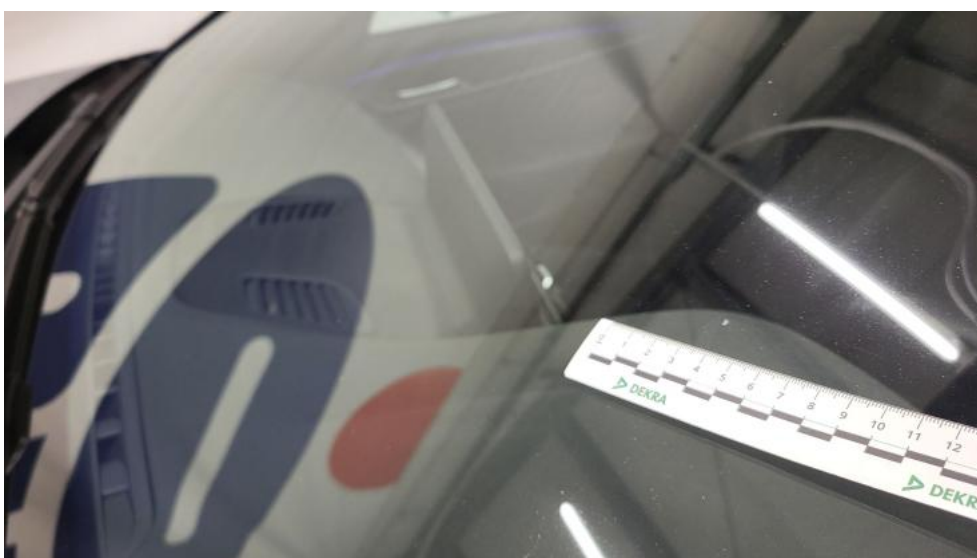
**Photo 42.**

Brak aktualnych badań technicznych. Aktywna kontrolka ciśnienia w kołach. Aktywna kontrolka serwisu. Informacja o wymianie okładzin hamulcowych od 3000km. Wymagany serwis oleju silnikowego i kontrola wzrokowa od 1900km. Odpryski na szybie czołowej. Rysy na samochodzie.

Szyba czołowa - zdjęcie poglądowe 1

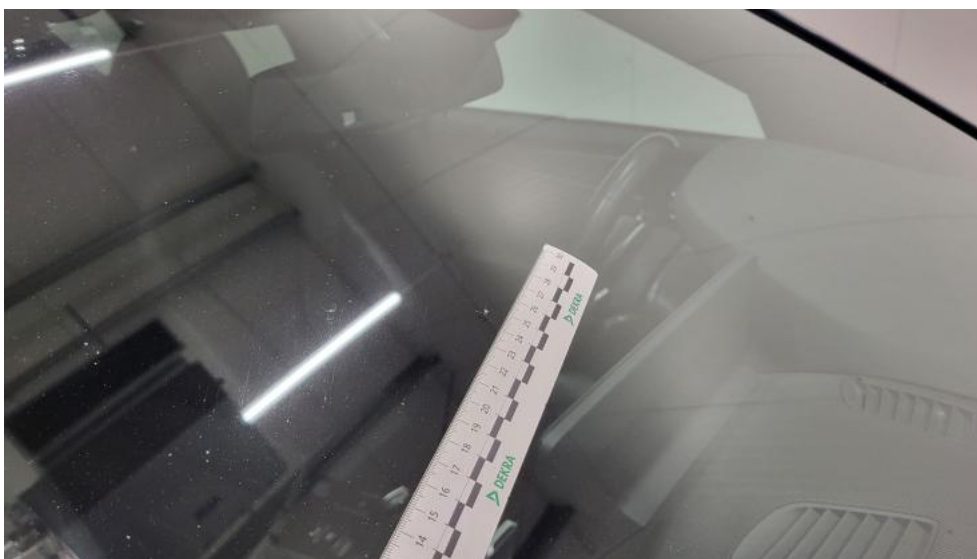
**Photo 43.**

Szyba czołowa - zdjęcie poglądowe 2

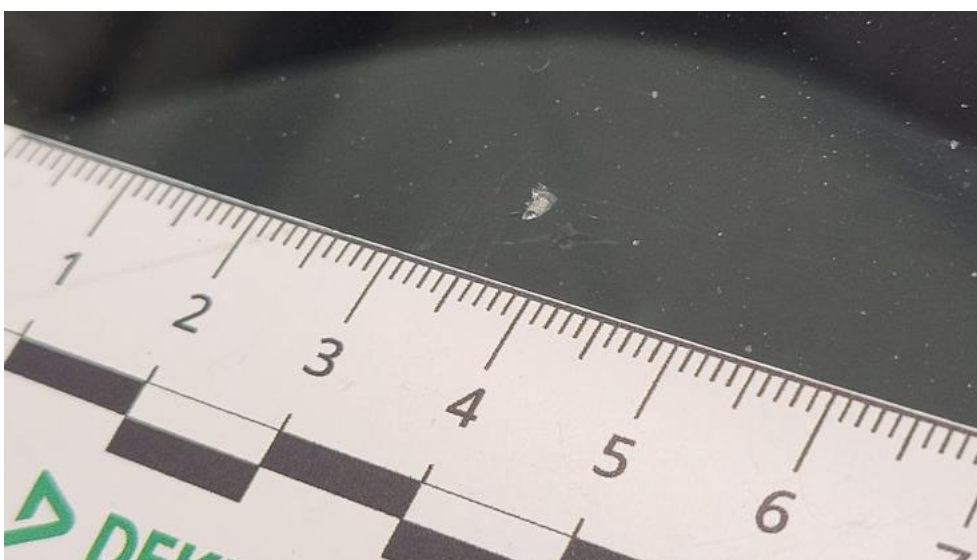
**Photo 44.**

Szyba czołowa - Pęknięcie/rozerwanie 1

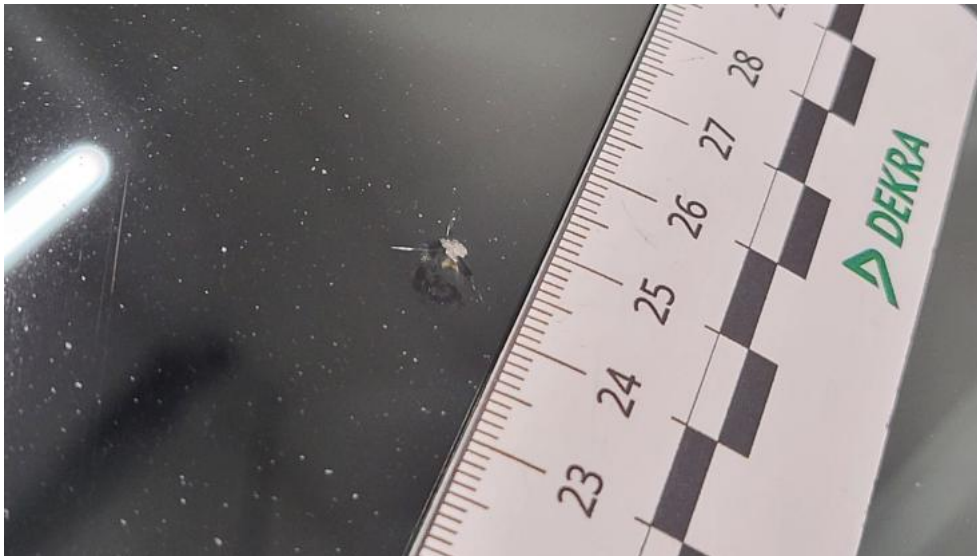
**Photo 45.**

Szyba czołowa - Pęknięcie/rozerwanie 2

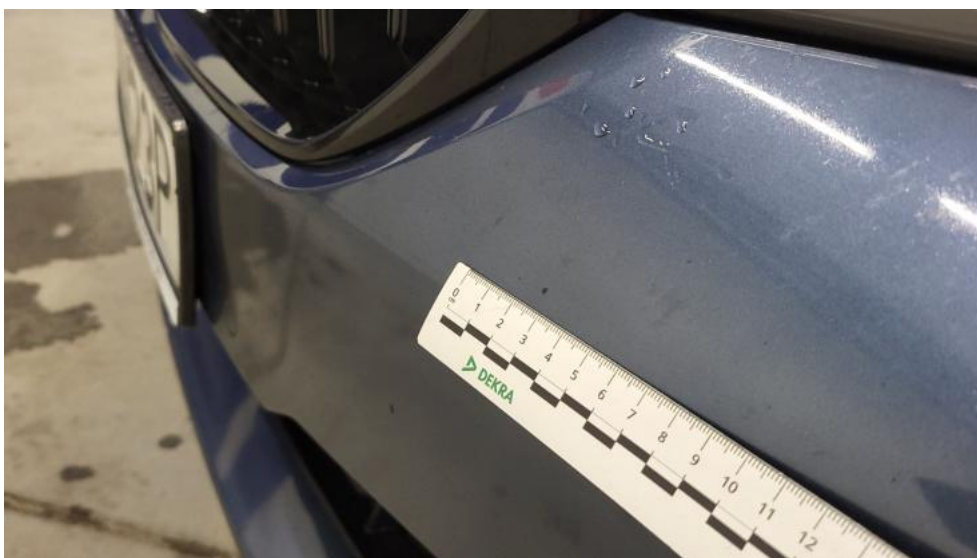
**Photo 46.**

Zderzak - Rysa/odprysk 1

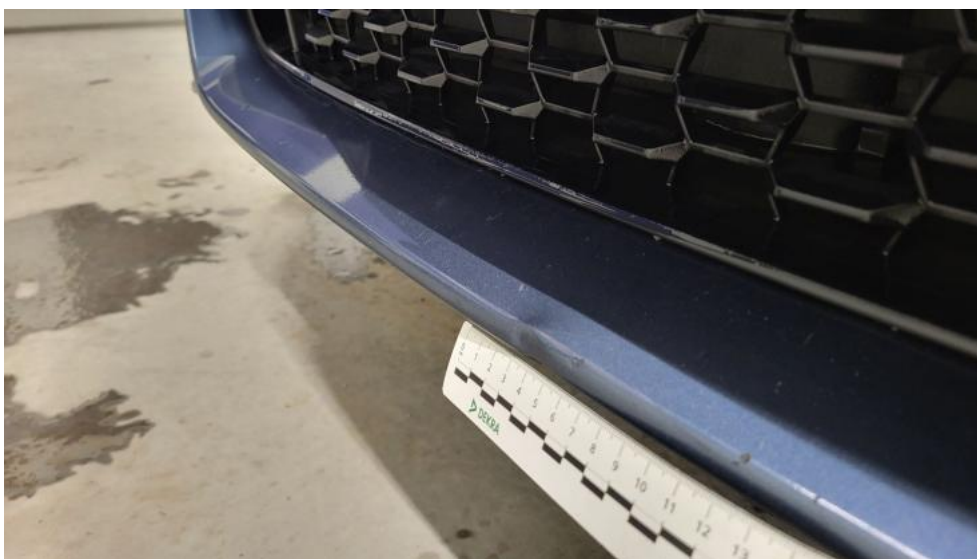
**Photo 47.**

Zderzak - Wgniecenie/odkształcenie 1

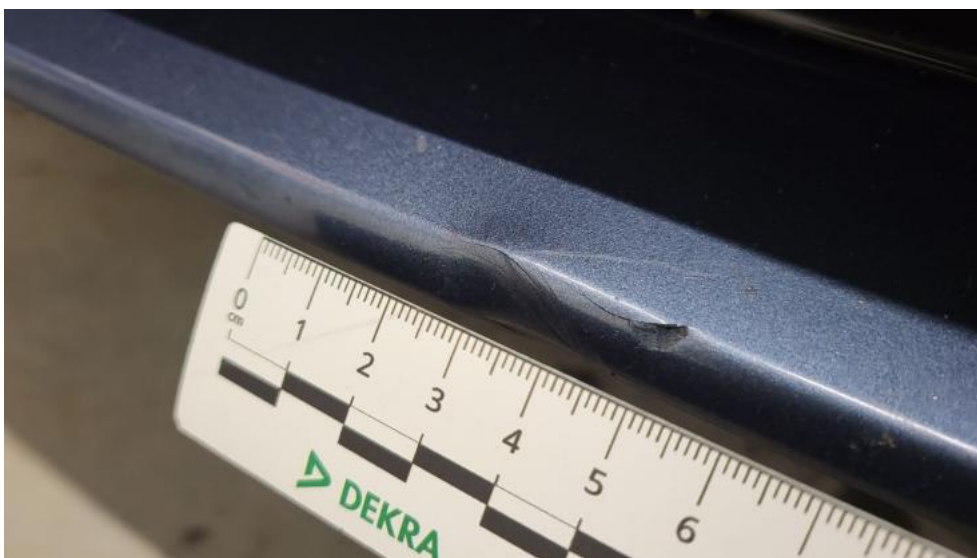
**Photo 48.**

Zderzak - Pęknięcie/rozerwanie 1

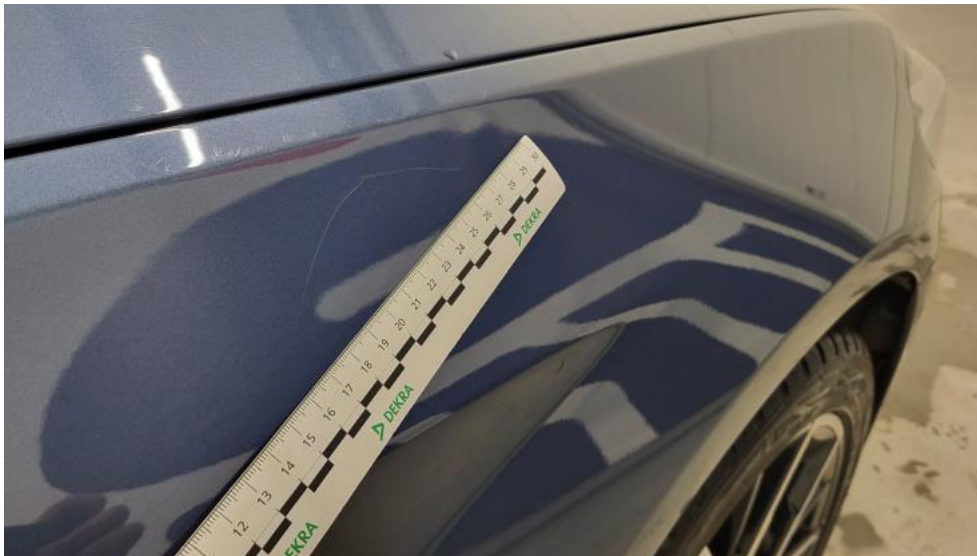
**Photo 49.**

Błotnik przedni P - Rysa/odprysk 1

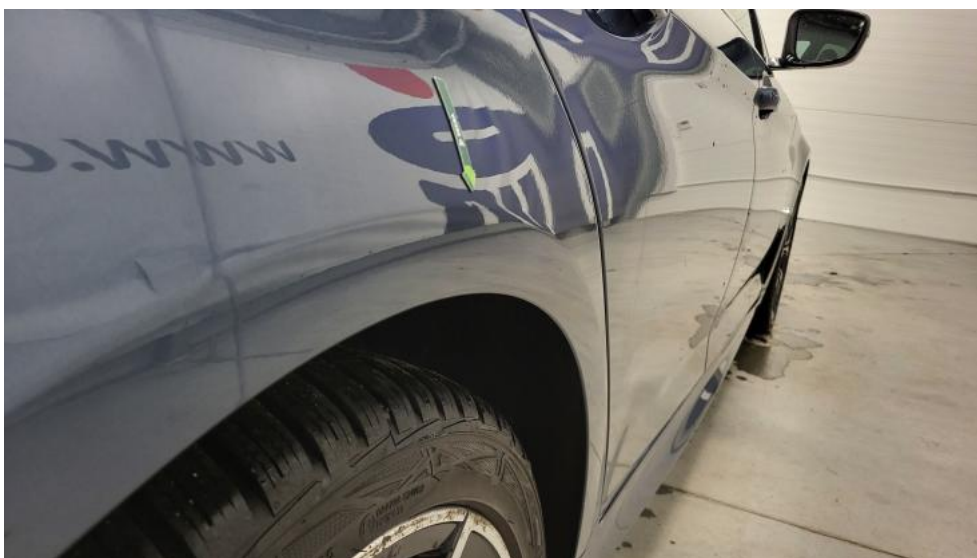
**Photo 50.**

Błotnik tylny P / Ściana boczna P - Wgniecenie/odkształcenie 1

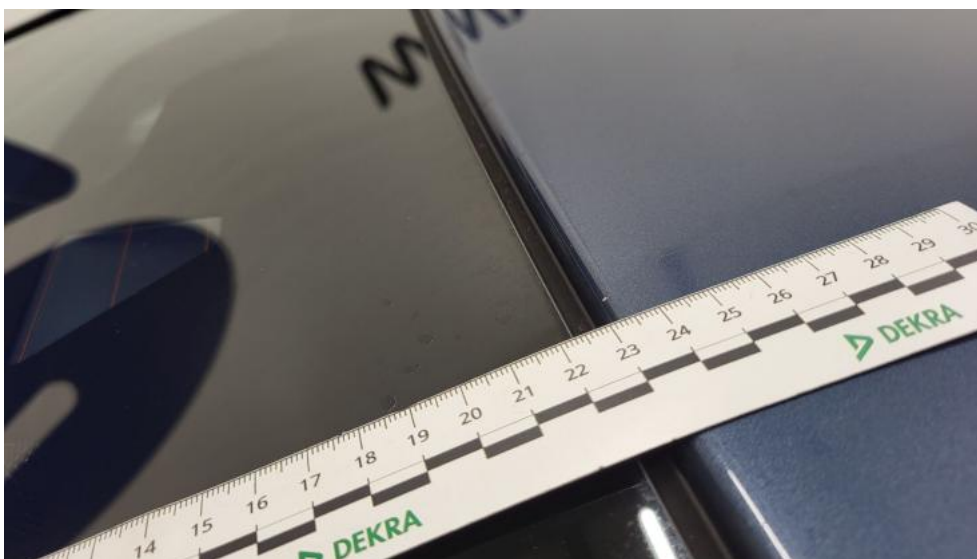
**Photo 51.**

Dach - Rysa/odprysk 1

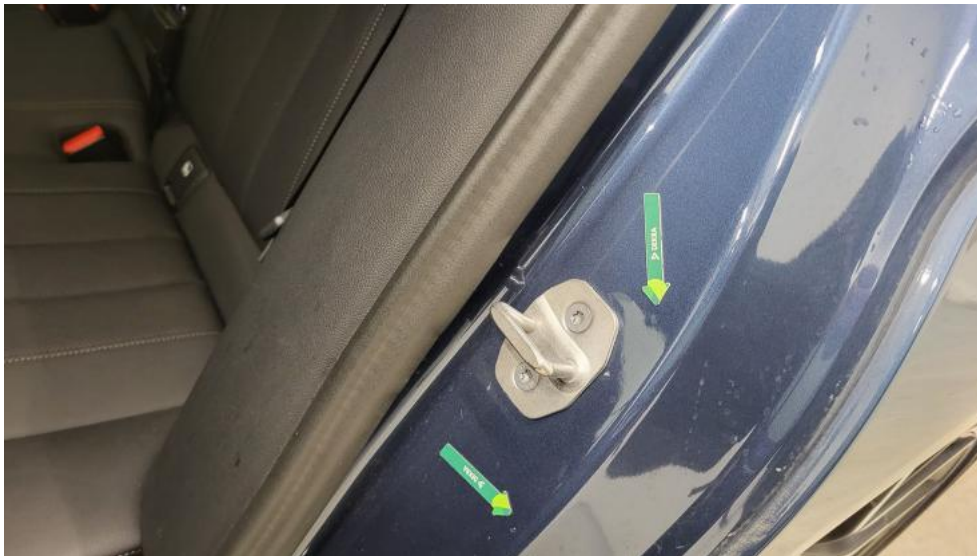
**Photo 53.**

Błotnik tylny L / Ściana boczna L - Wgniecenie/odkształcenie 1

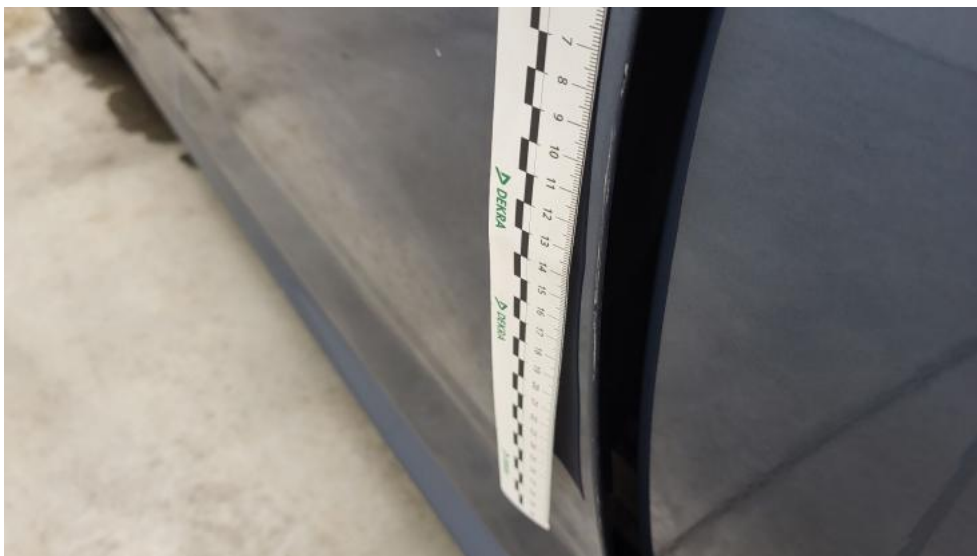
**Photo 54.**

Drzwi przed L - Rysa/odprysk 1

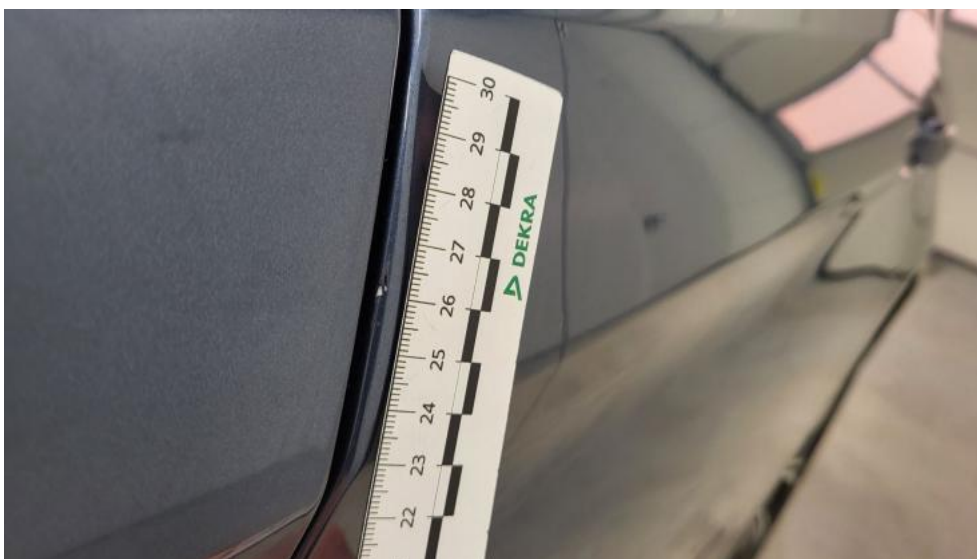
**Photo 55.**

Drzwi tylne L - Rysa/odprysk 1

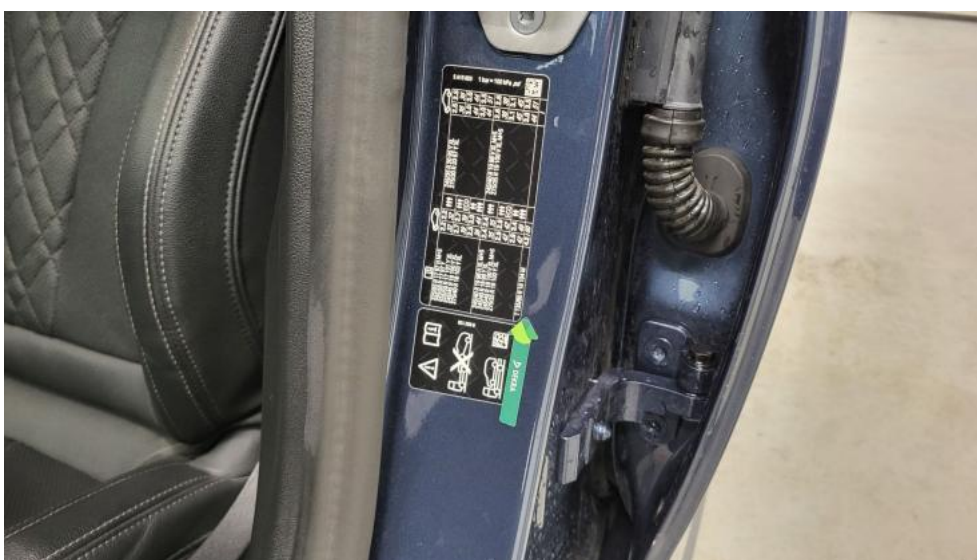
**Photo 56.**

Słupki środkowy L - Wgniecenie/odkształcenie 1

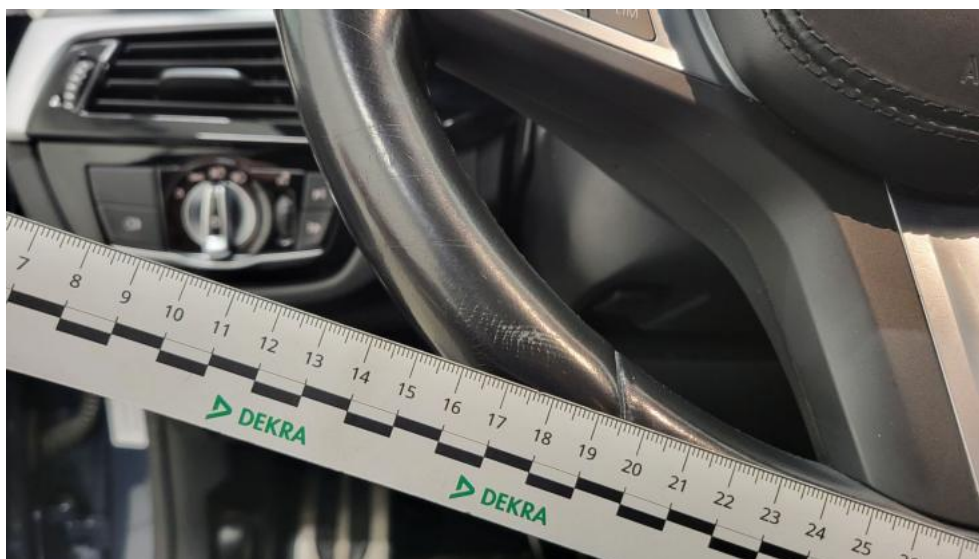
**Photo 57.**

Koło kierownicy - Rysa/odprysk 1

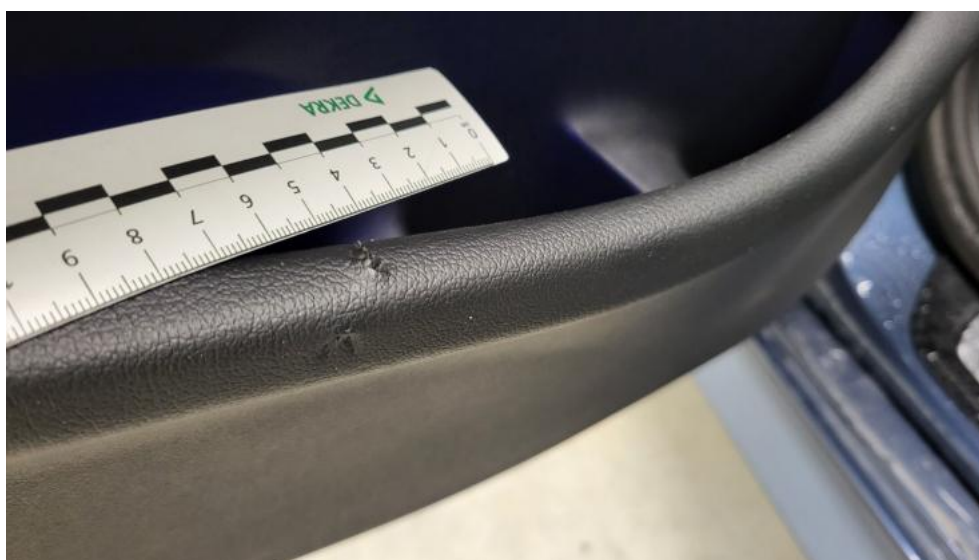
**Photo 58.**

Tapicerka drzwi przednich L - Pęknięcie/rozerwanie 1
