DEKRA's commission No. : PKOL(W)/LODZ/84092/25/10/31  
commission/ damage No. : 23/010216  
Date of commission: 31-10-2025

| Model | X6 [G06] 19-23 |
| Type / version | X6 M Competition |
| Registration /record No. | KK80767 |

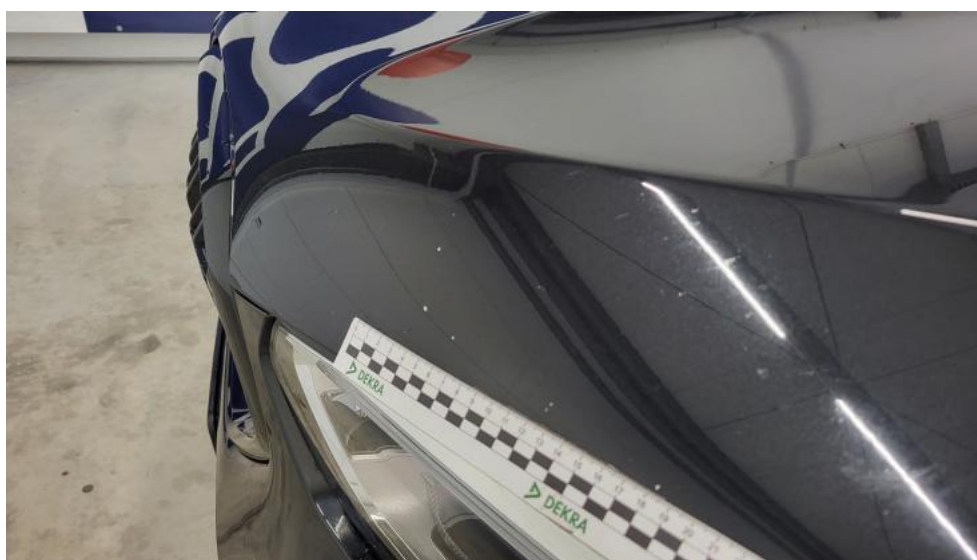
**Photo 48.**

Pokrywa komory silnika - Rysa/odprysk 1

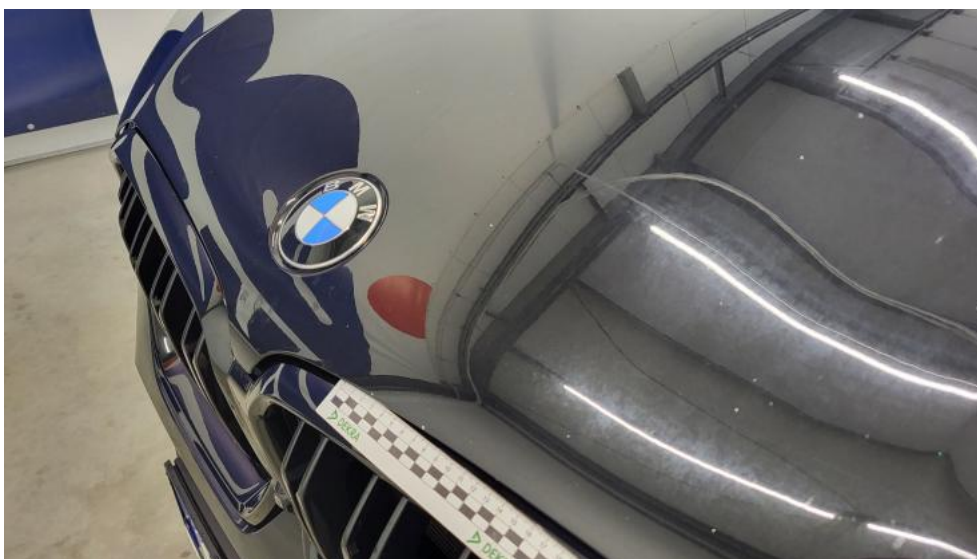
**Photo 49.**

Pokrywa komory silnika - Rysa/odprysk 2

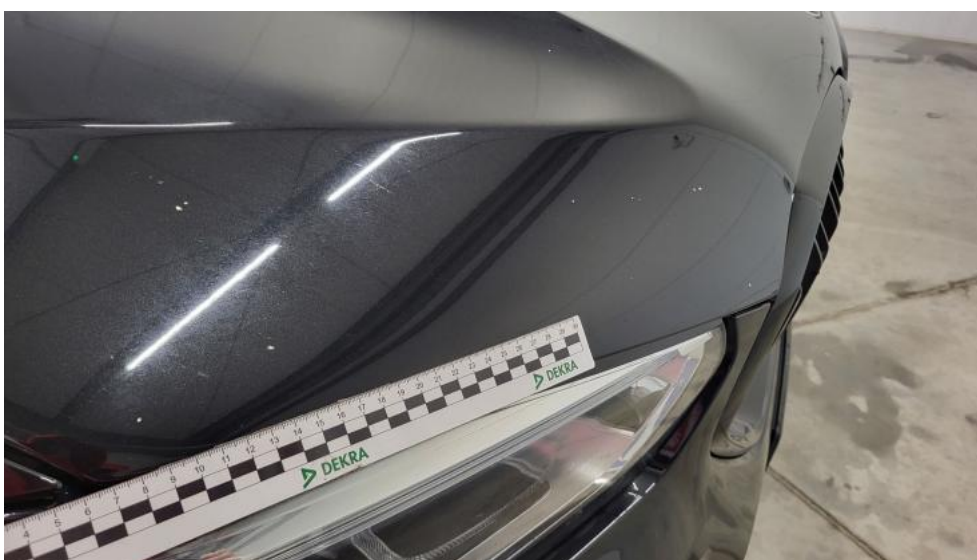
**Photo 50.**

Pokrywa komory silnika() - Rysa/odprysk 3

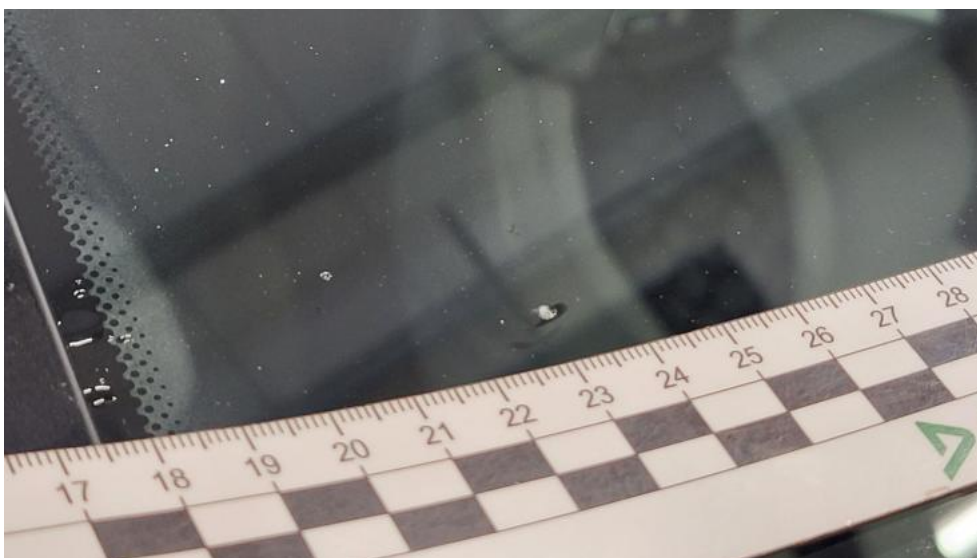
**Photo 52.**

Niesprawne elektryczne domykanie drzwi przednich lewych. Brak czterech dywaników. Odpryski na szybie czołowej. Rysy na samochodzie.

Szyba czołowa - Pęknięcie/rozerwanie 1

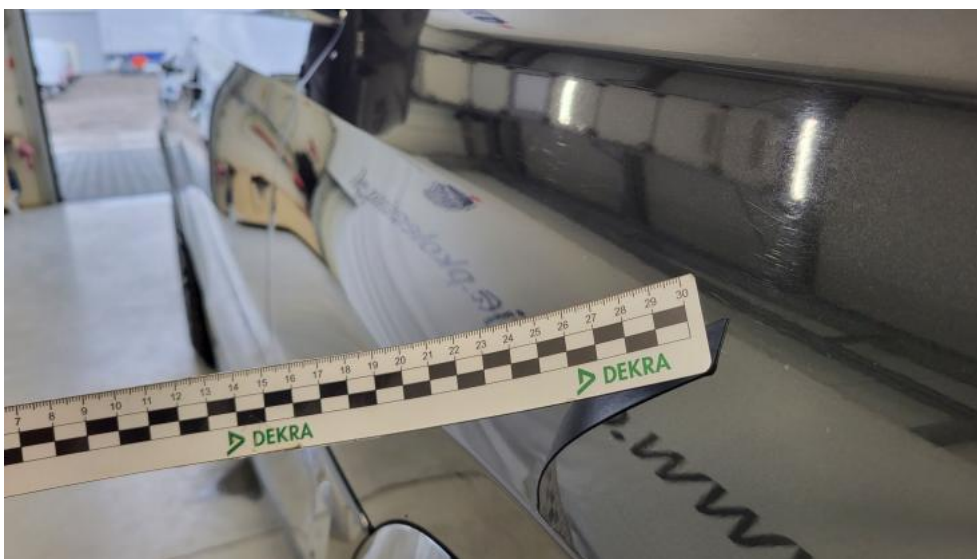
**Photo 53.**

Błotnik przedni P - Wgniecenie/odkształcenie 1

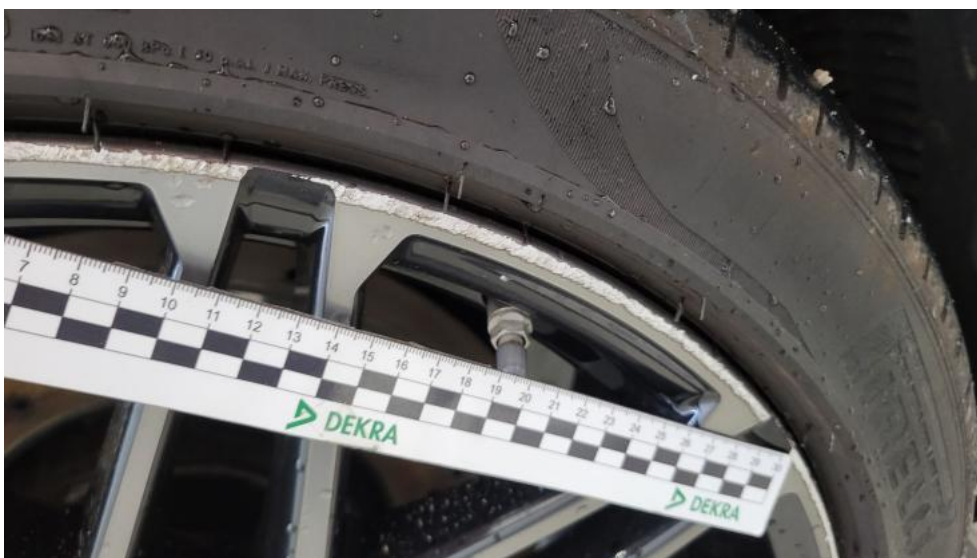
**Photo 54.**

Felga aluminiowa przednia P - Rysa/odprysk 1

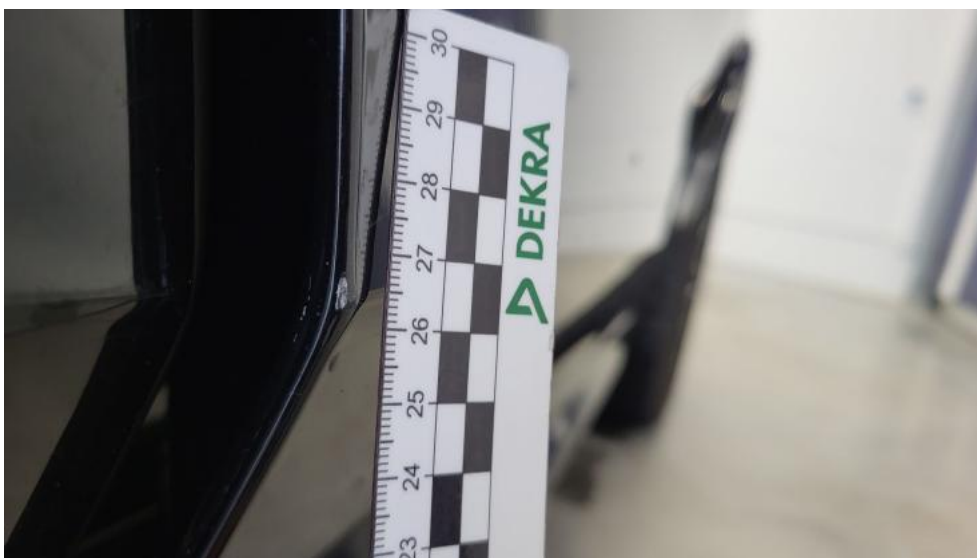
**Photo 56.**

Drzwi przednie P - Rysa/odprysk 1

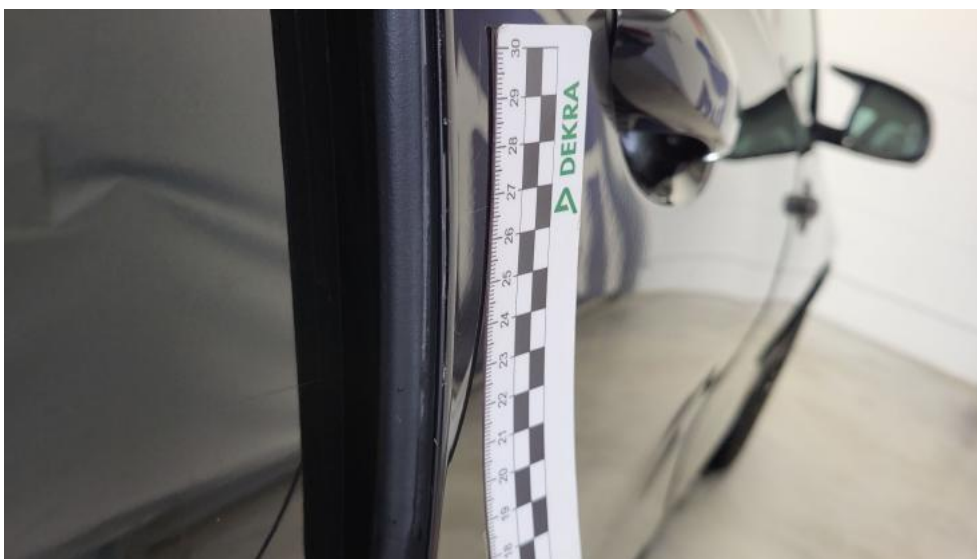
**Photo 57.**

Drzwi tylne P - Rysa/odprysk 1

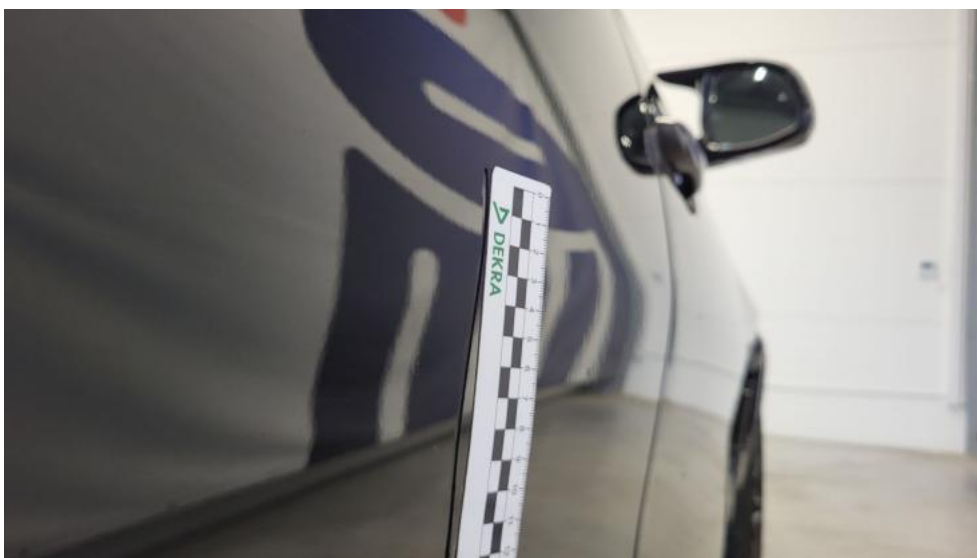
**Photo 58.**

Drzwi tylne P - Wgniecenie/odkształcenie 1

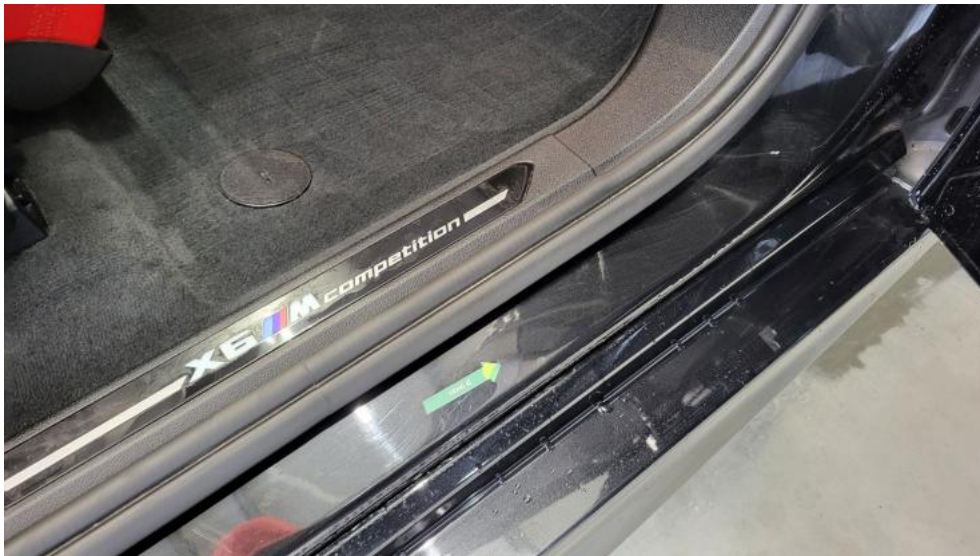
**Photo 59.**

Próg P - Wgniecenie/odkształcenie 1

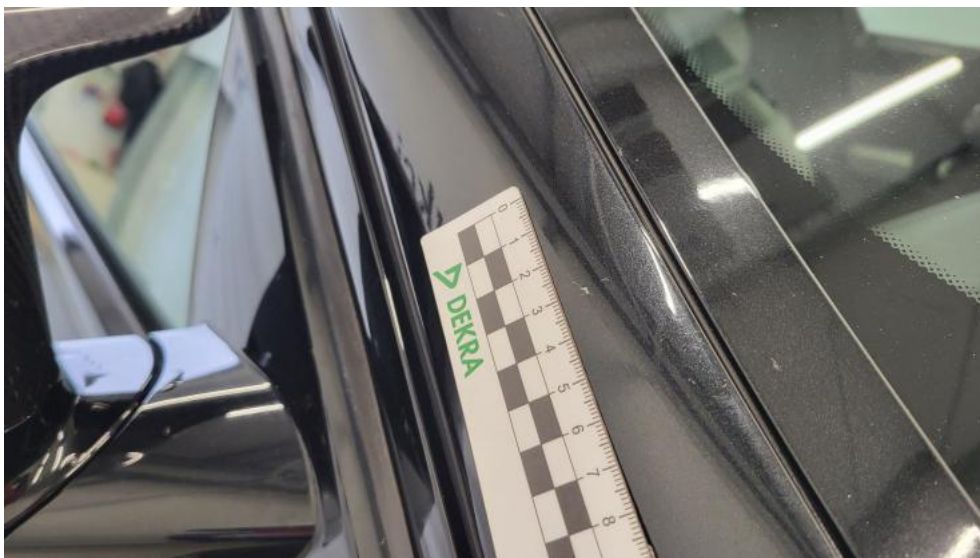
**Photo 60.**

Słupek przedni P - Rysa/odprysk 1

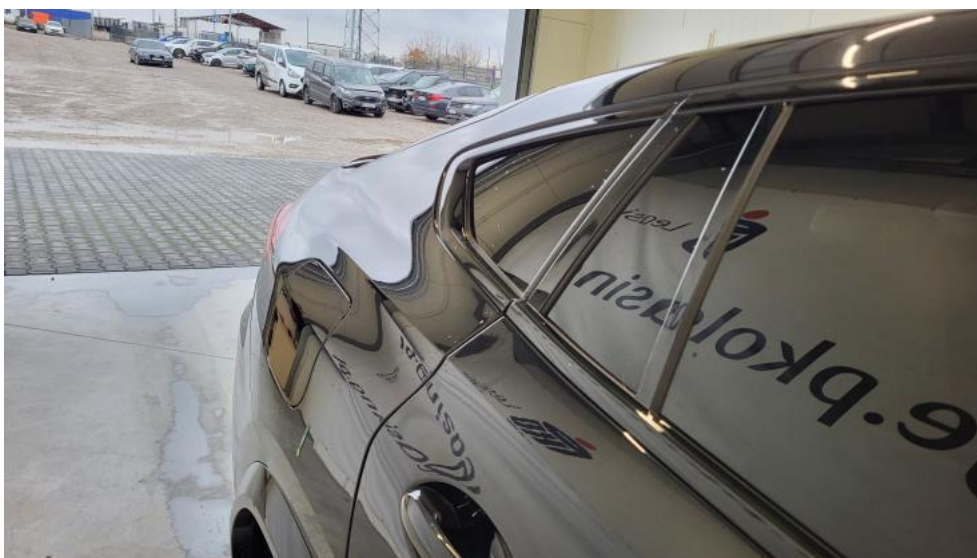
**Photo 62.**

Ścianka tylna P / Ścianka boczna P - Wgniecenie/odkształcenie 1

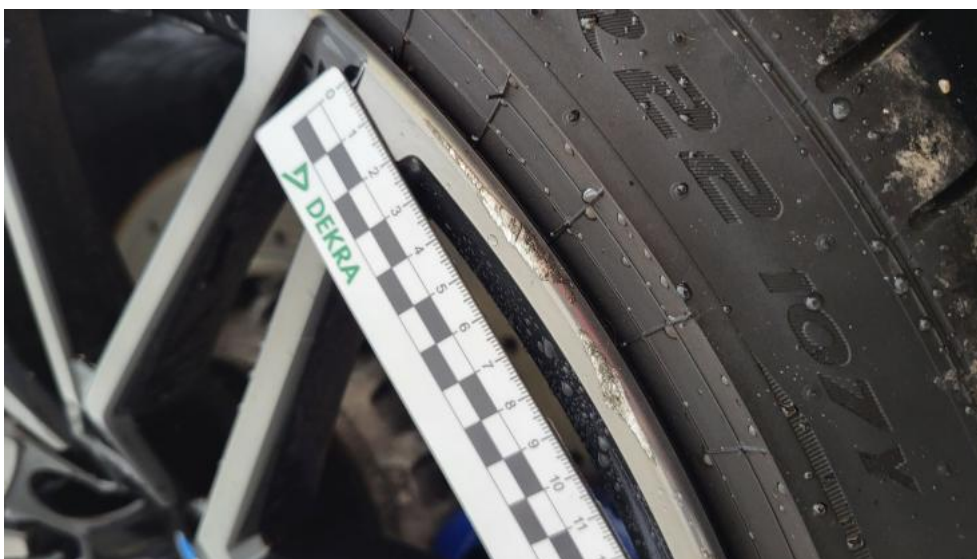
**Photo 63.**

Felga aluminiowa tylna P - Rysa/odprysk 1

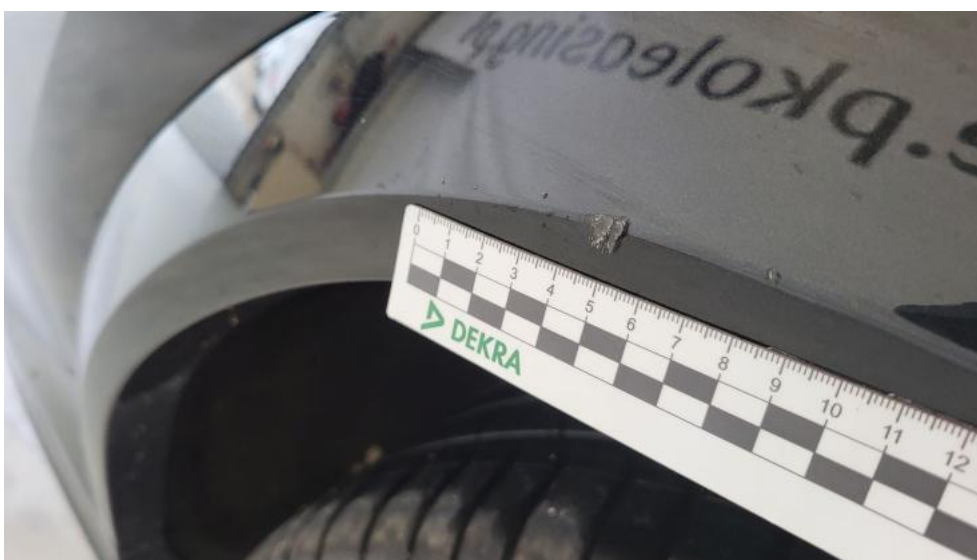
**Photo 64.**

Listwa krawędzi błotnika tyl P - Rysa/odprysk 1

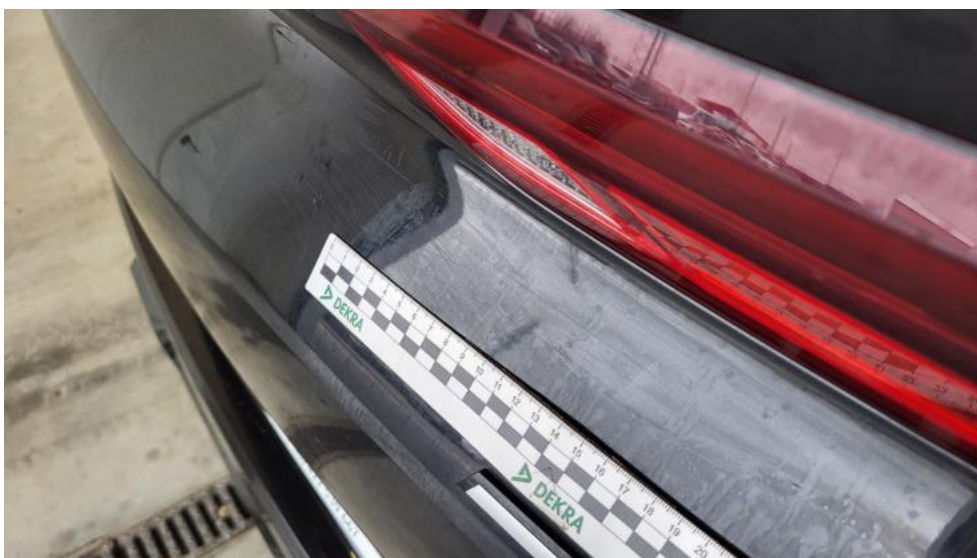
**Photo 66.**

Pokrywy bagażnika - Rysa/odprysk 1

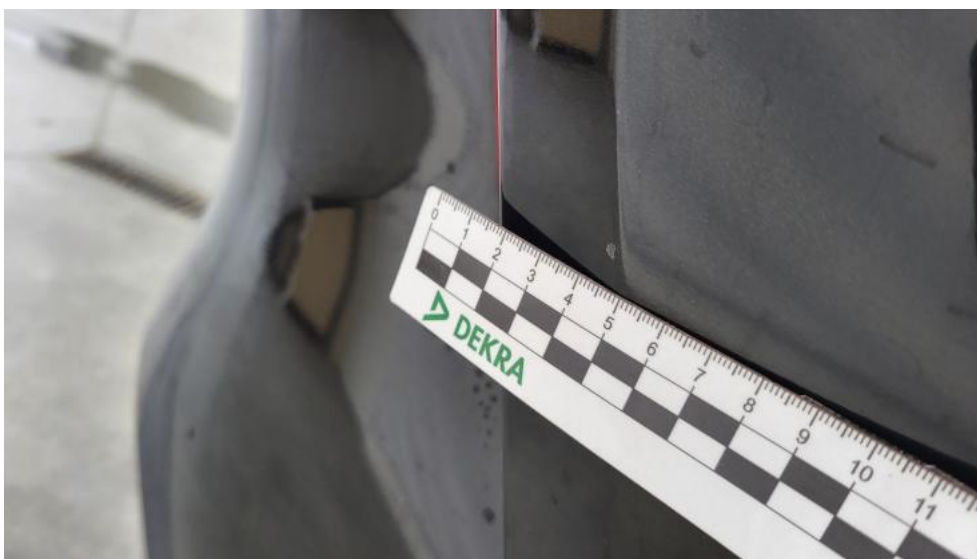
**Photo 67.**

Zderzak tylny - Rysa/odprysk 1

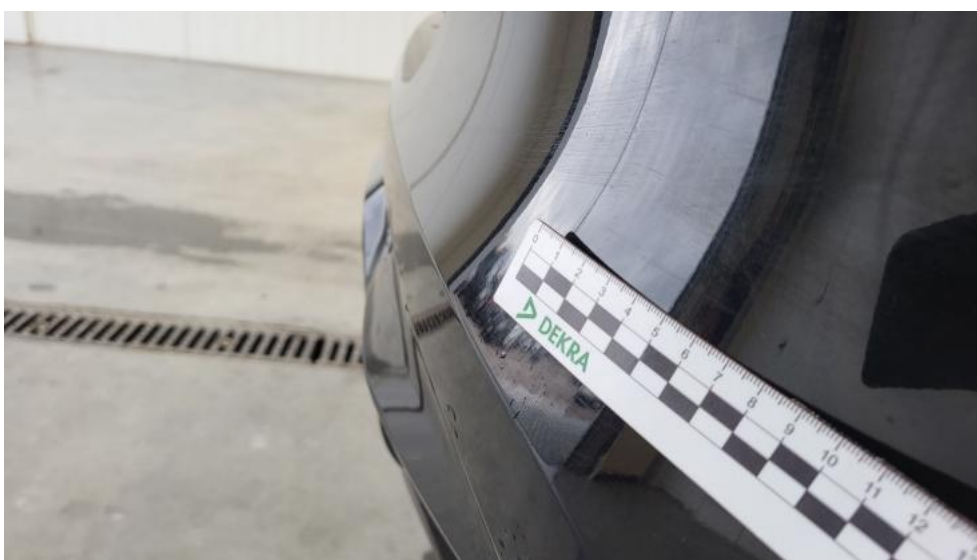
**Photo 68.**

Zderzak tylny - Rysa/odprysk 2

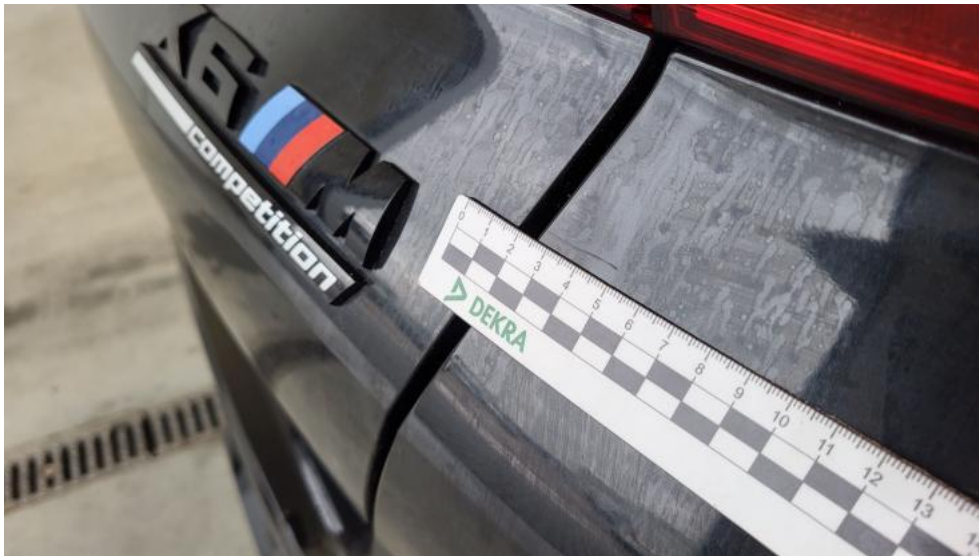
**Photo 69.**

Zderzak tylny() - Rysa/odprysk 3

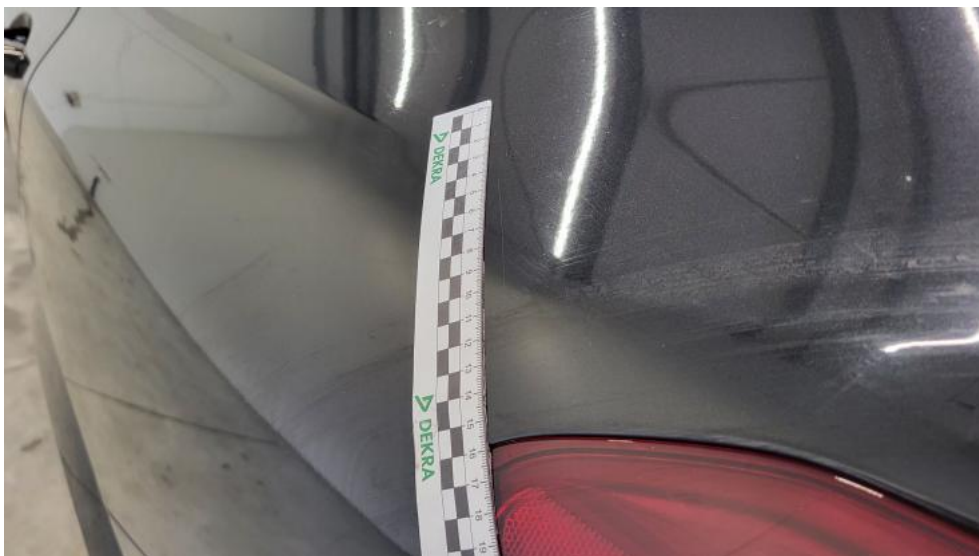
**Photo 70.**

Błotnik tylny L / Ściana boczna L - Rysa/odprysk 1

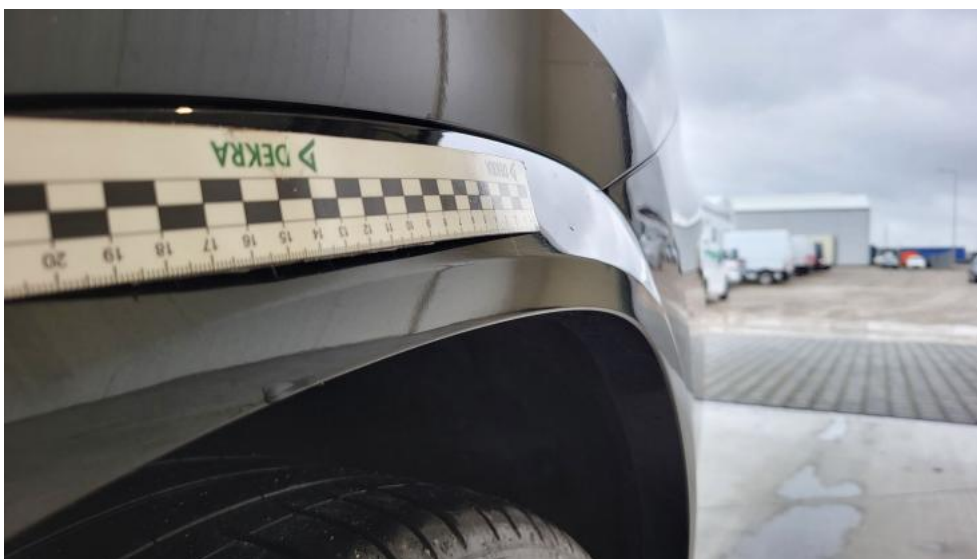
**Photo 71.**

Listwa krawędzi błotnika tyl L - Wgniecenie/odkształcenie 1

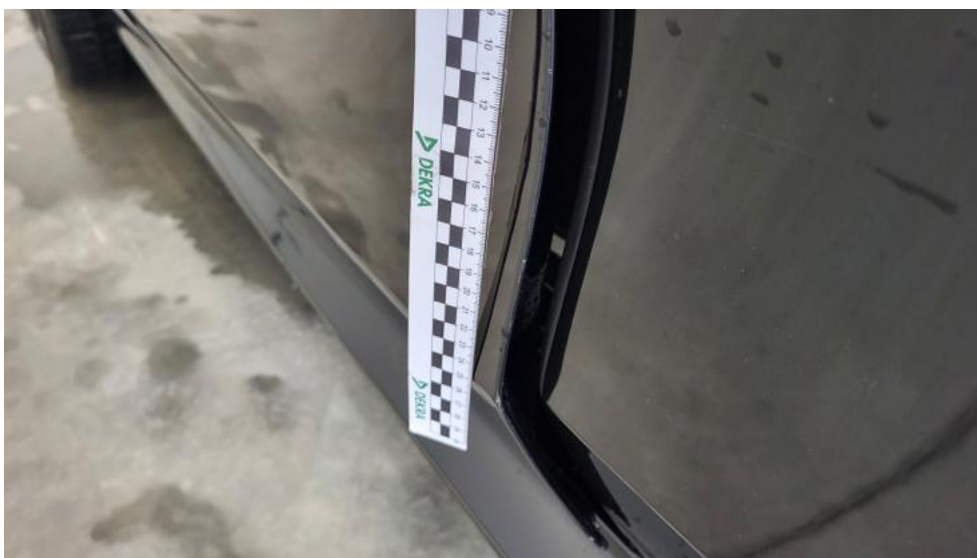
**Photo 72.**

Drzwi przed L - Rysa/odprysk 1

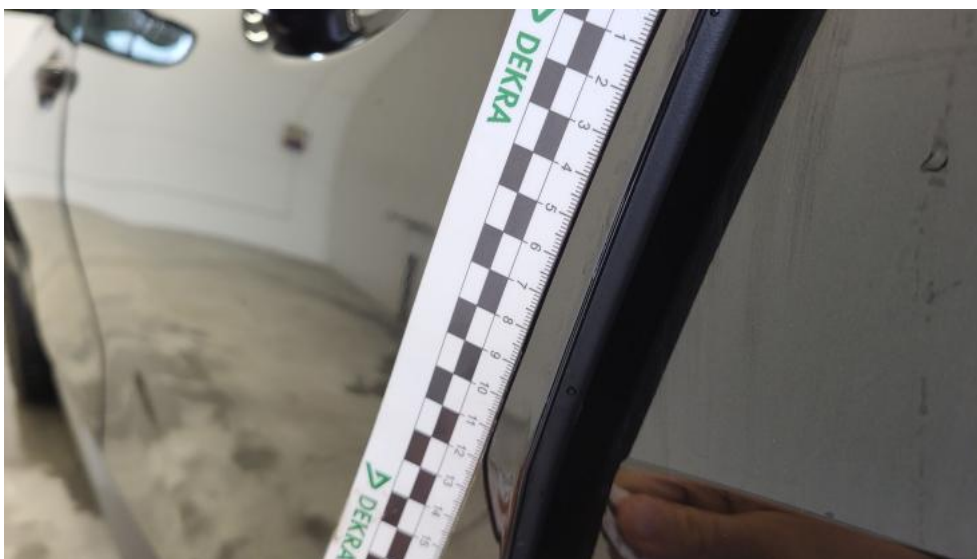
**Photo 73.**

Drzwi tylne L - Rysa/odprysk 1

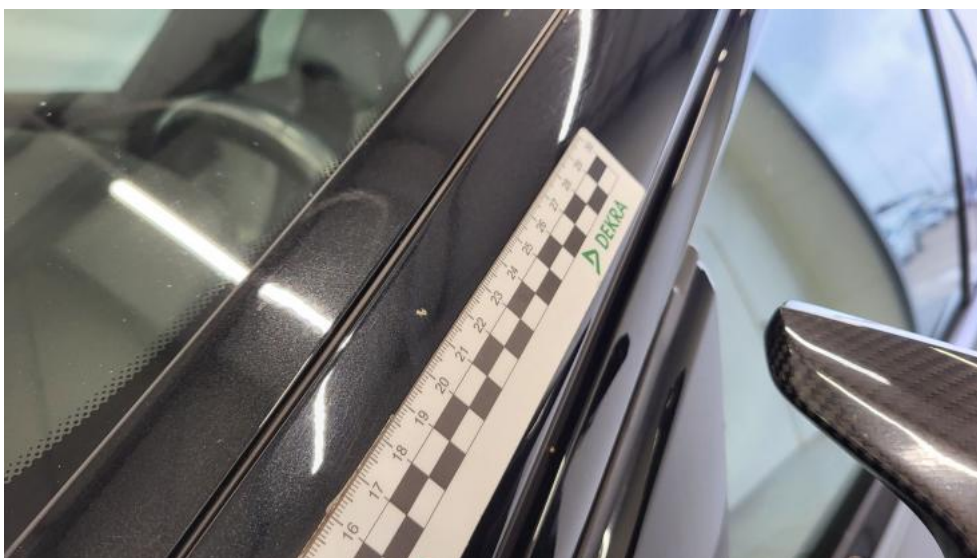
**Photo 74.**

Słupki przedni L - Rysa/odprysk 1

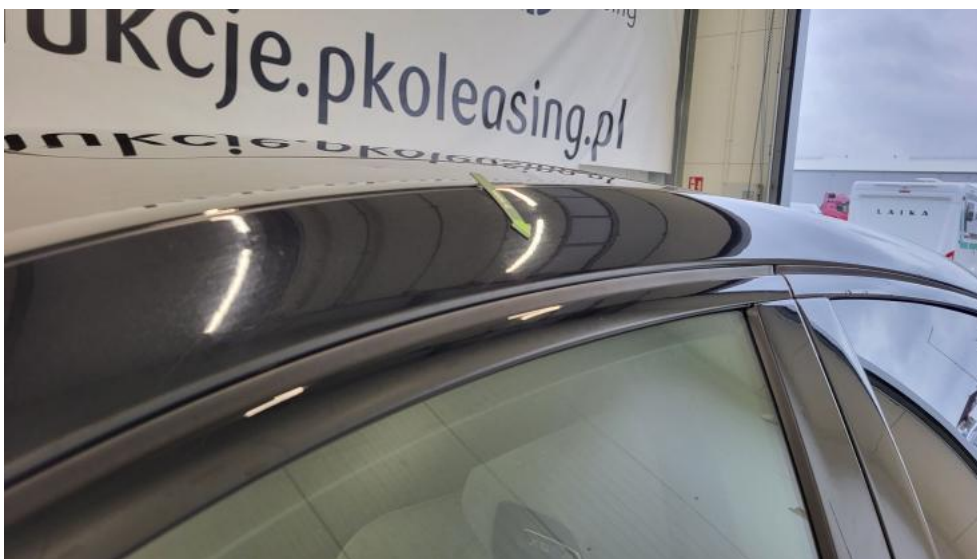
**Photo 75.**

Słupek przedni L - Wgniecenie/odkształcenie 1

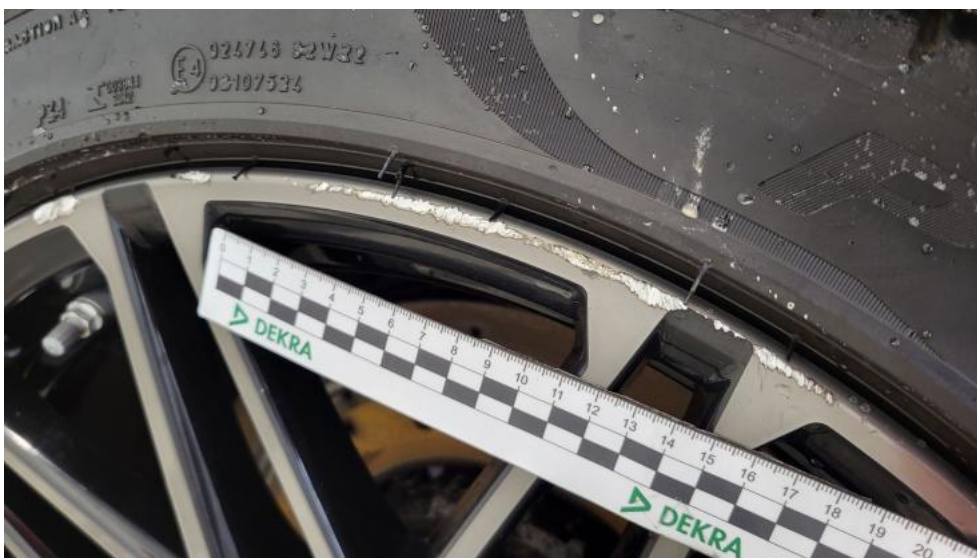
**Photo 76.**

Felga Aluminiowa przednia L - Rysa/odprysk 1

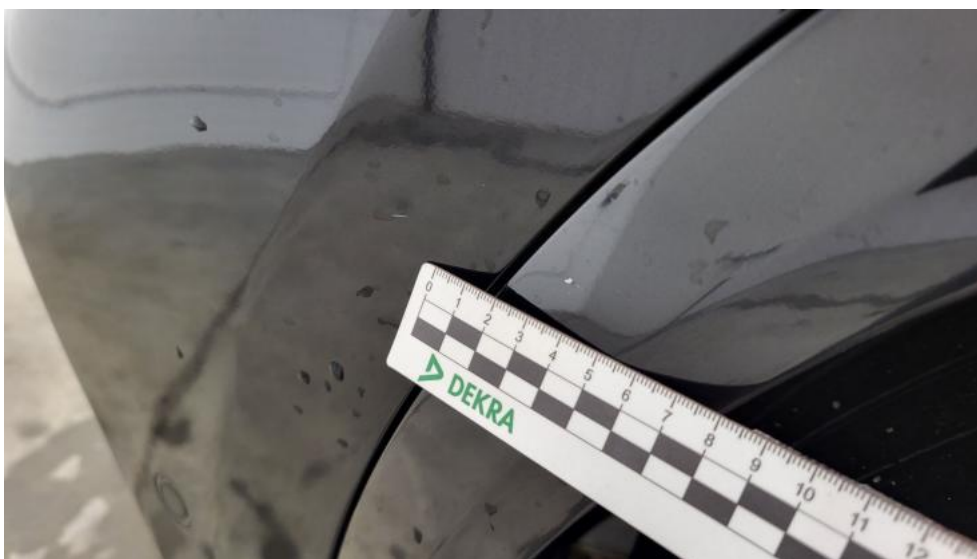
**Photo 77.**

Listwa błotnika przedniego L - Rysa/odprysk 1

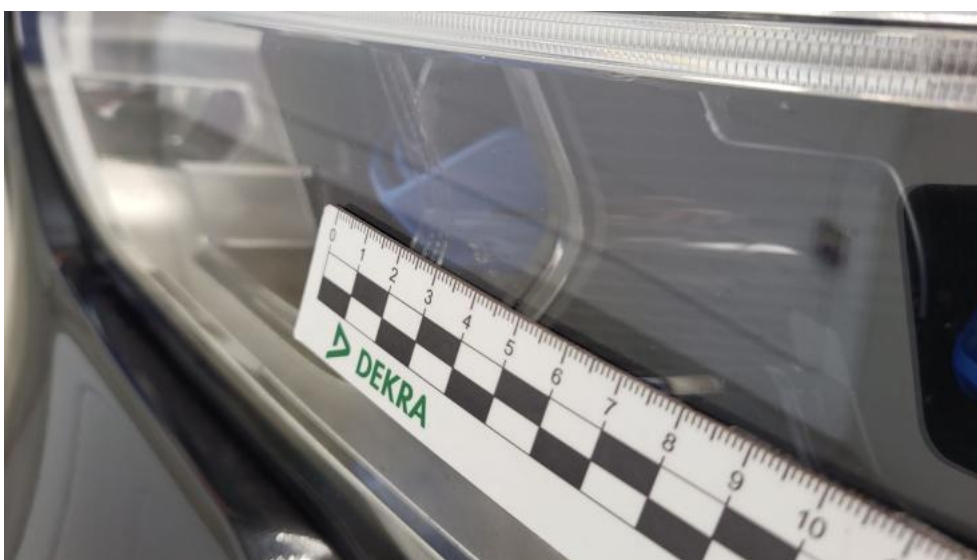
**Photo 78.**

Reflektor L - Rysa/odprysk 1

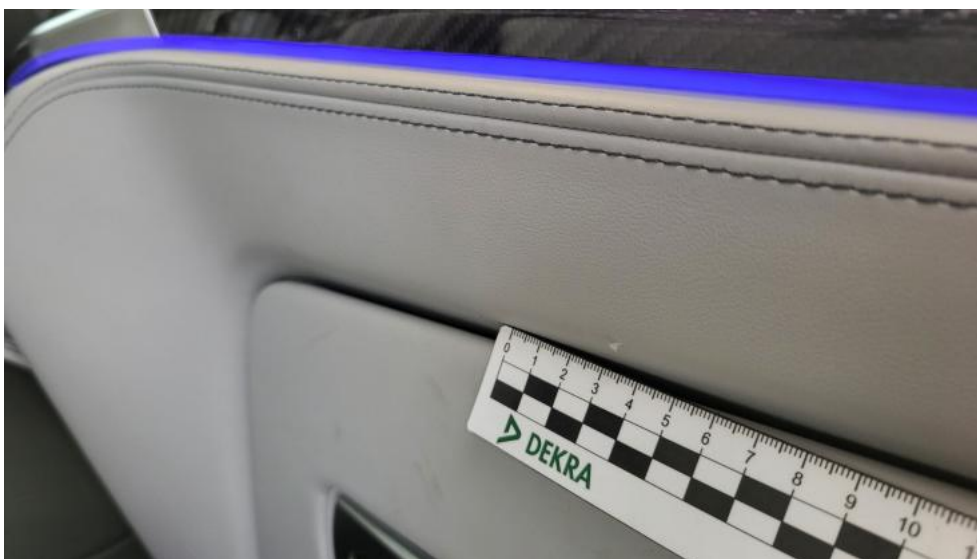
**Photo 79.**

Deska rozdzielcza - Pęknięcie/rozerwanie 1

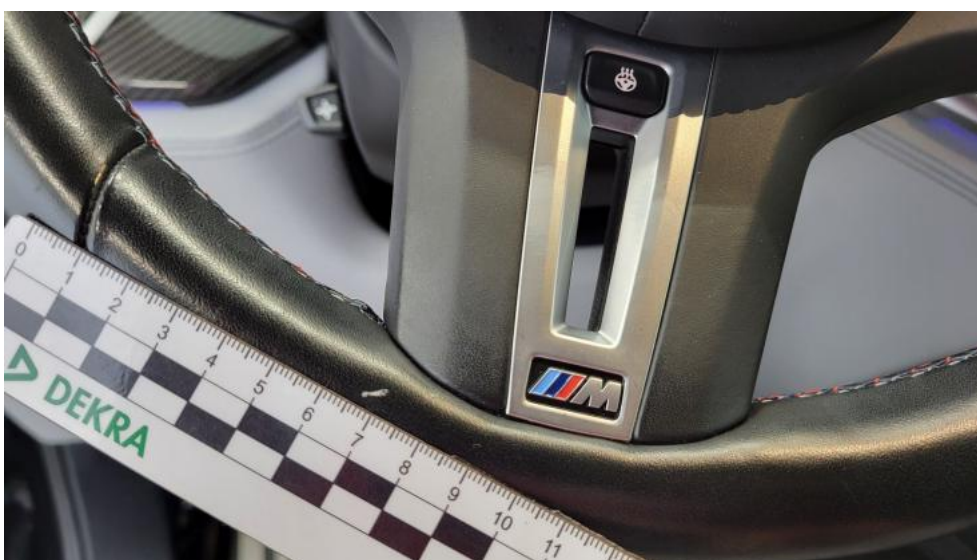
**Photo 80.**

Koło kierownicy - Inne 1

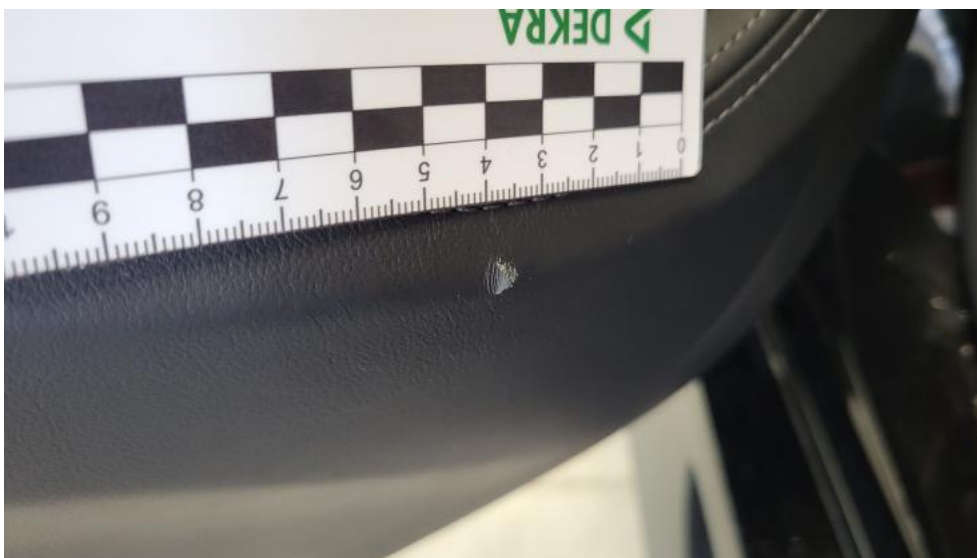
**Photo 82.**

Tapicerka drzwi tylnych L - Pęknięcie/rozerwanie 1

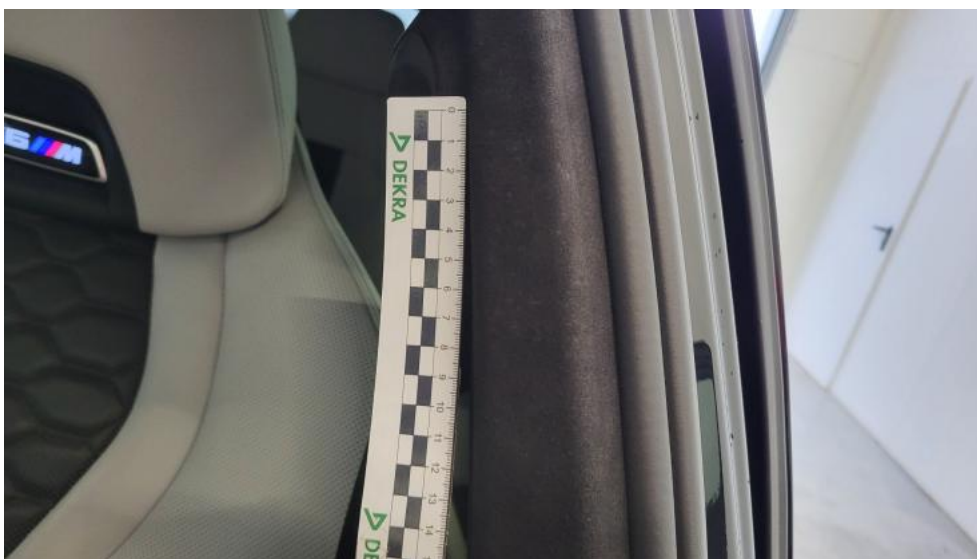
**Photo 83.**

Wykładzina(y) słupka środkowego L - Inne 1
