DEKRA's commission No. : PKOL(W)/LODZ/77426/25/10/09  
commission/ damage No. : 21/035102  
Date of commission: 09-10-2025

| Manufacturer | FORD |
| Model | Mondeo Kombi 14-19 |
| Type / version | Mondeo 2.0 TDCi Titanium |

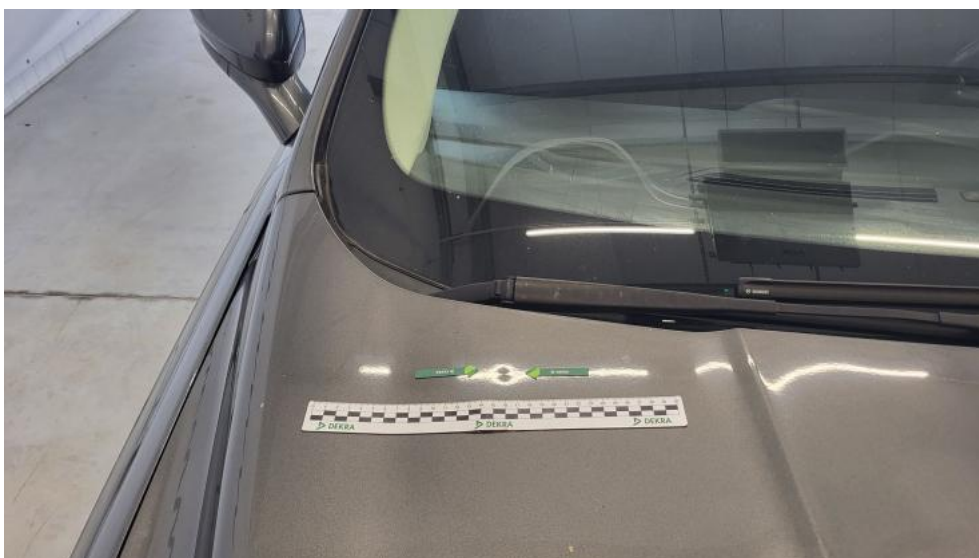
**Photo 36.**

Pokrywa komory silnika - Wgniecenie/odkształcenie 1

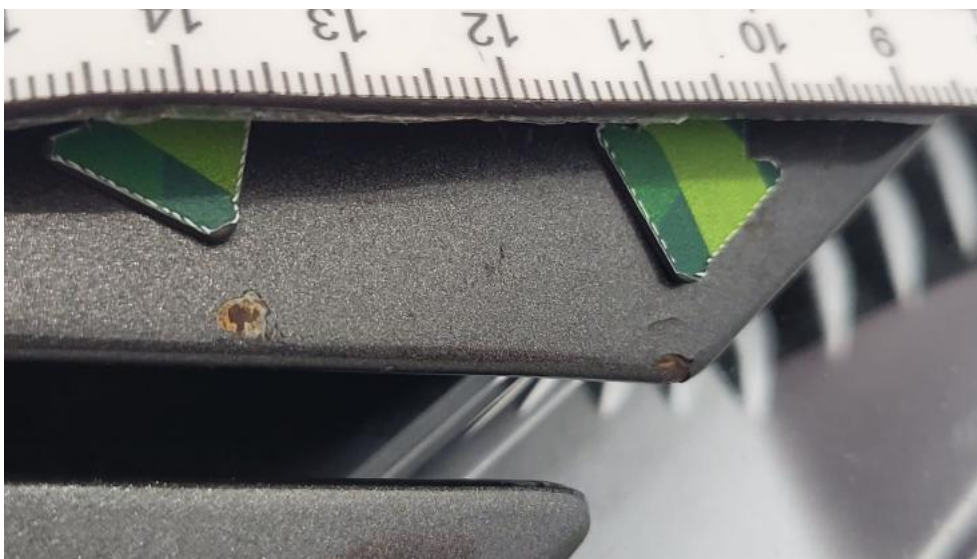
**Photo 37.**

Pokrywa komory silnika - Inne 1

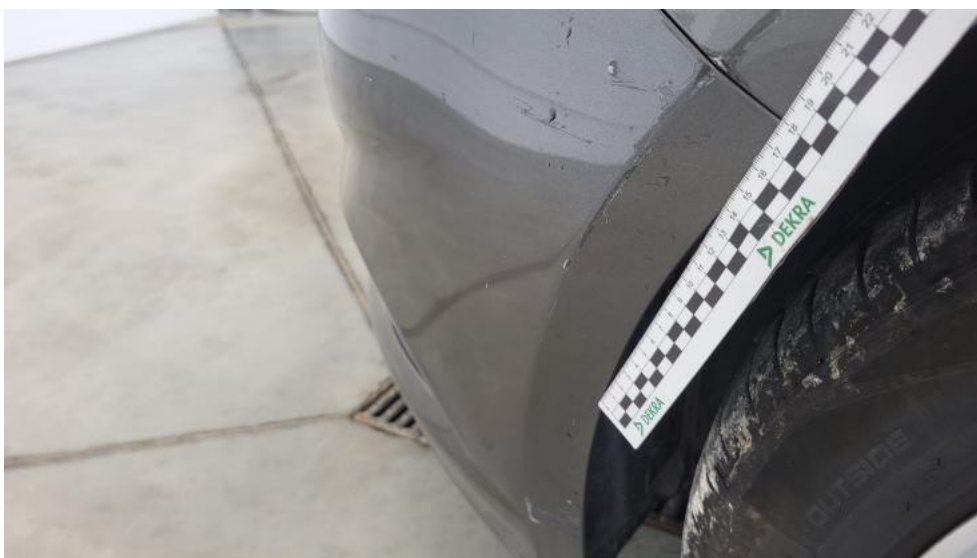
**Photo 38.**

Zderzak - Rysa/odprysk 1

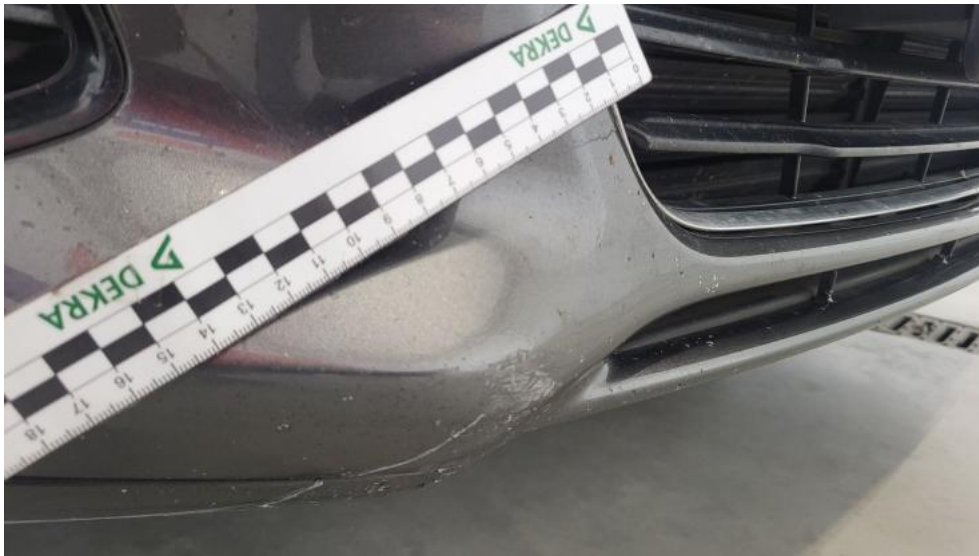
**Photo 39.**

Zderzak - Pęknięcie/rozerwanie 1

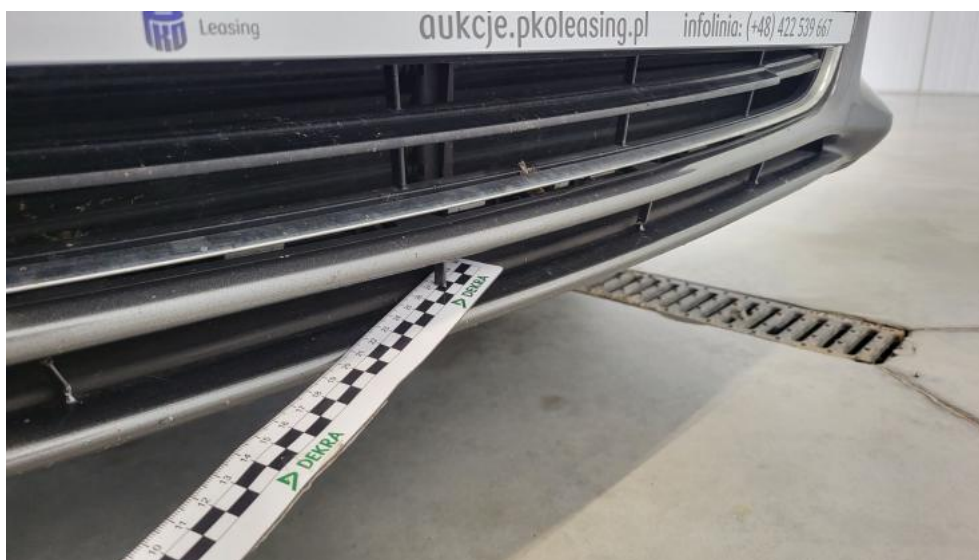
**Photo 40.**

Zderzak - Pęknięcie/rozerwanie 2

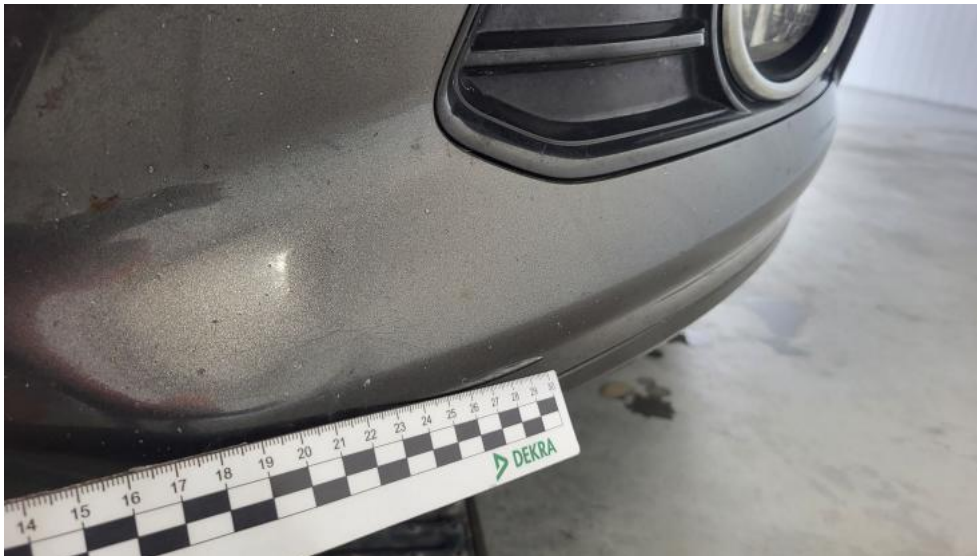
**Photo 41.**

Zderzak() - Pęknięcie/rozerwanie 3

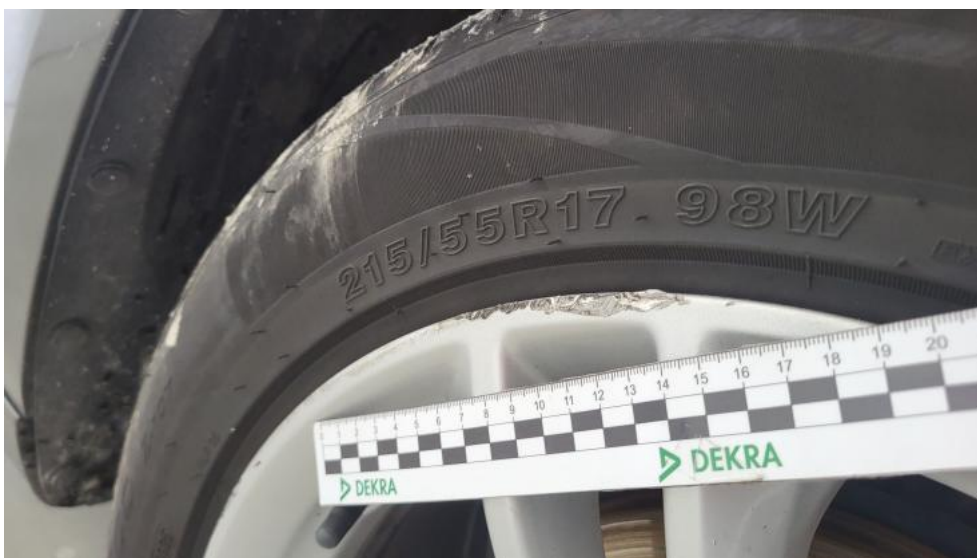
**Photo 42.**

Felga aluminiowa przednia P - Rysa/odprysk 1

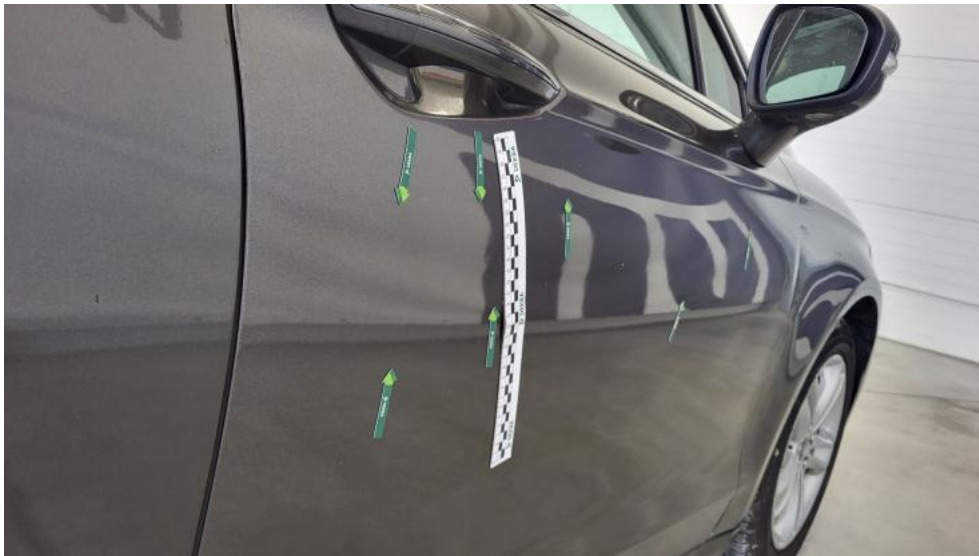
**Photo 43.**

Drzwi przednie P - Wgniecenie/odkształcenie 1

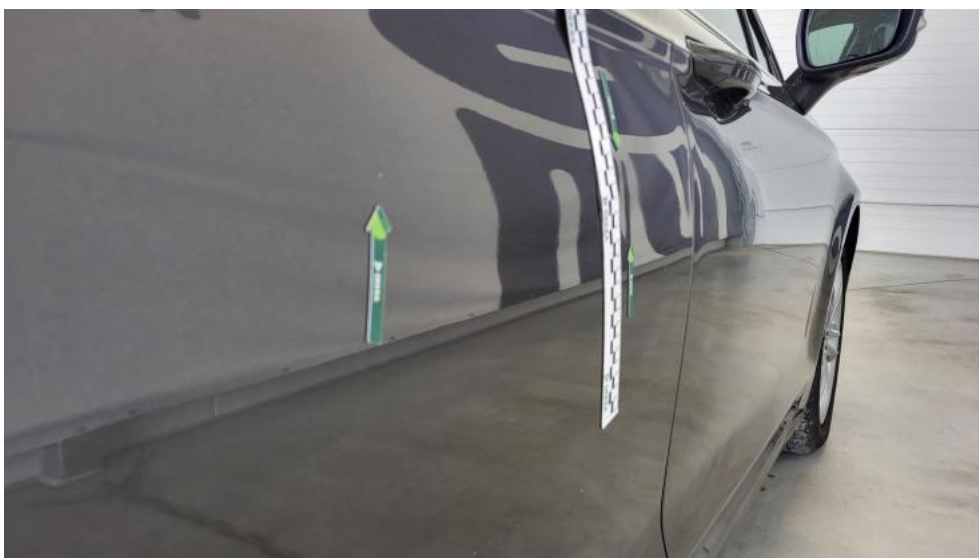
**Photo 44.**

Drzwi tylne P - Wgniecenie/odkształcenie 1

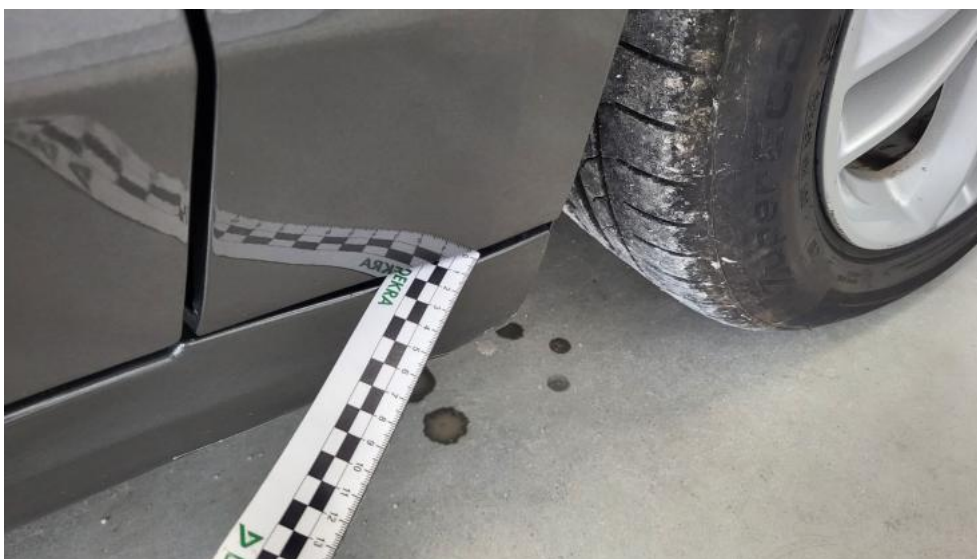
**Photo 47.**

Próg P - Inne 1

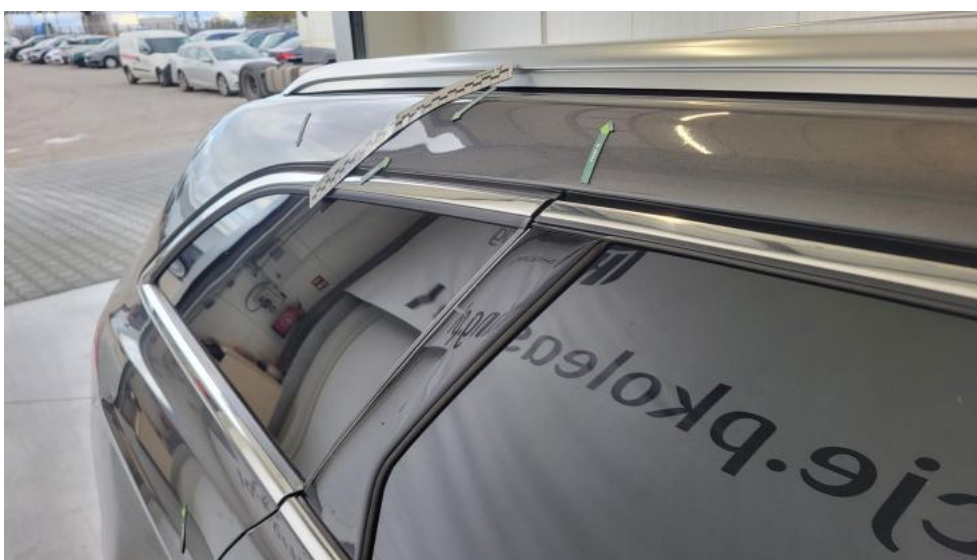
**Photo 48.**

Ścianka tylna P / Ścianka boczna P - Wgniecenie/odkształcenie 1

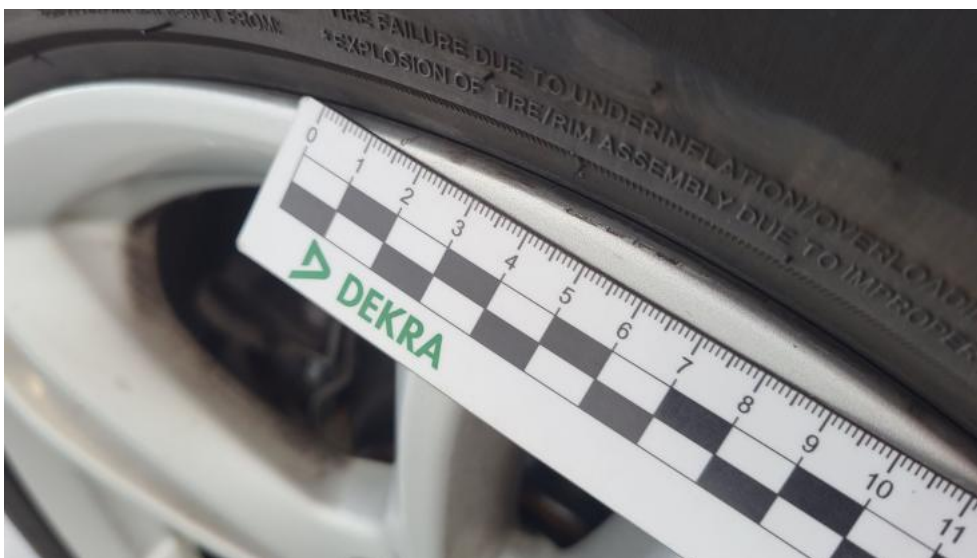
**Photo 50.**

Felga aluminiowa tylna P - Rysa/odprysk 1

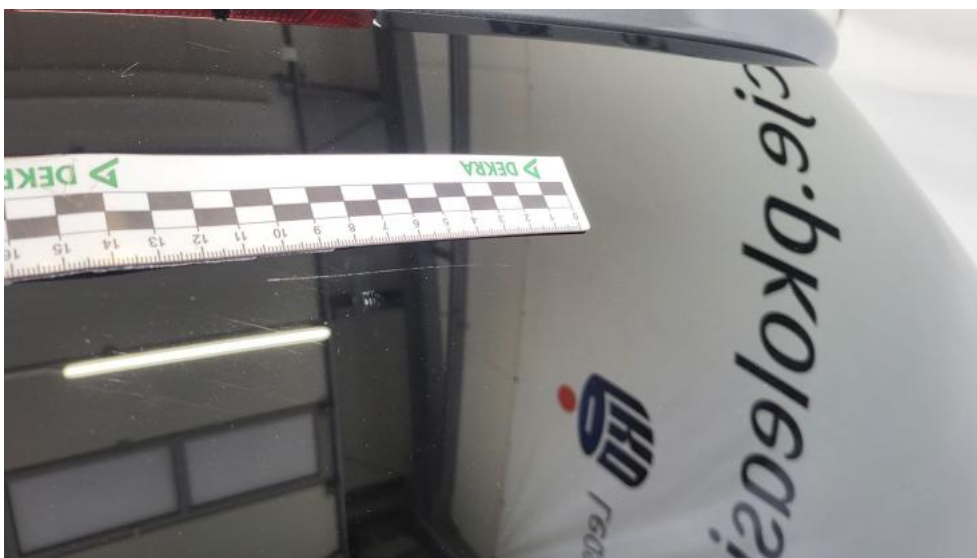
**Photo 52.**

Szyba tylna - Rysa/odprysk 1

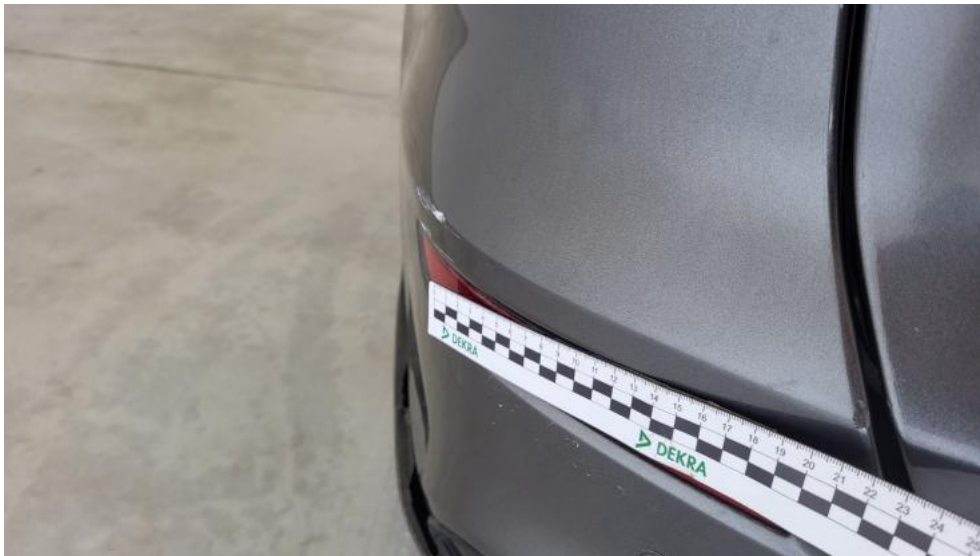
**Photo 53.**

Zderzak tylny - Rysa/odprysk 1

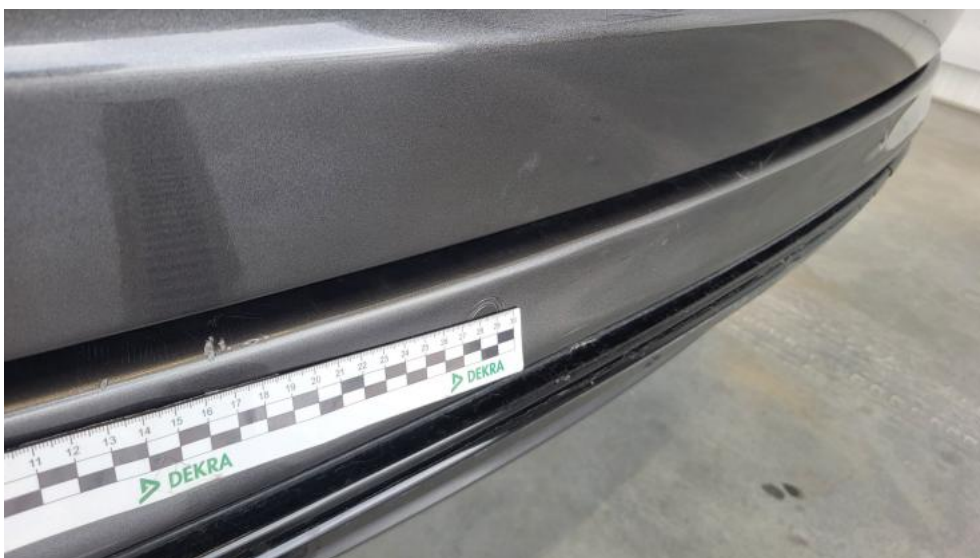
**Photo 54.**

Zderzak tylny - Rysa/odprysk 2

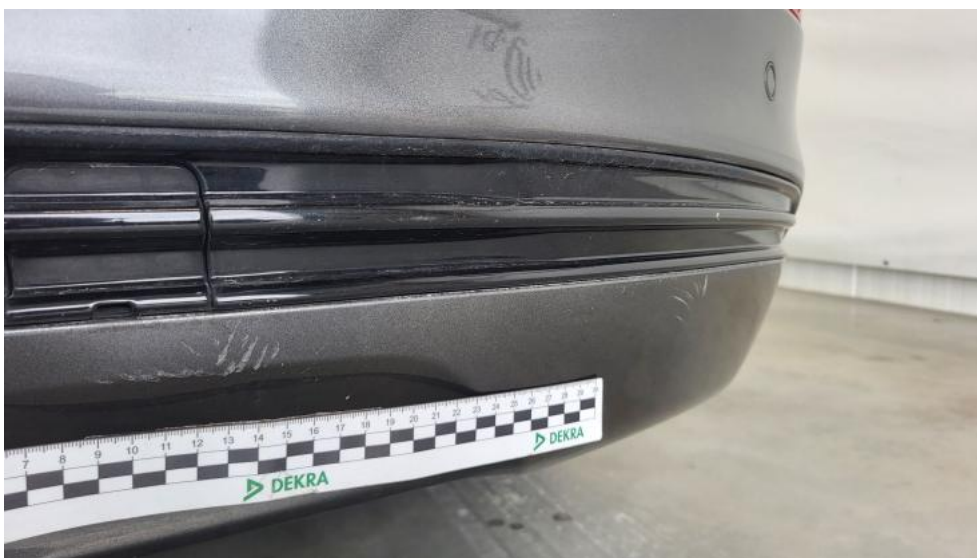
**Photo 56.**

Zderzak tylny cz dolna - Rysa/odprysk 1

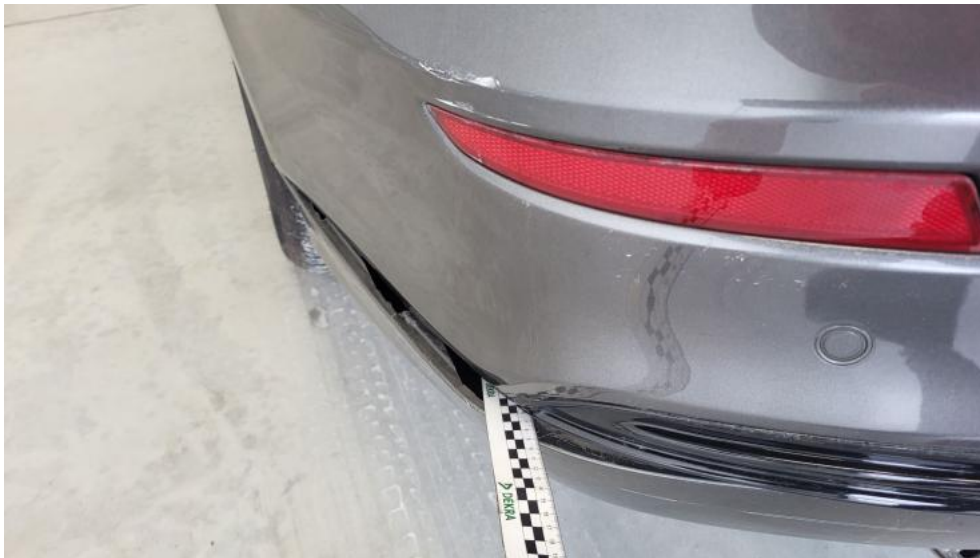
**Photo 57.**

Zderzak tylny cz dolna - Inne 1

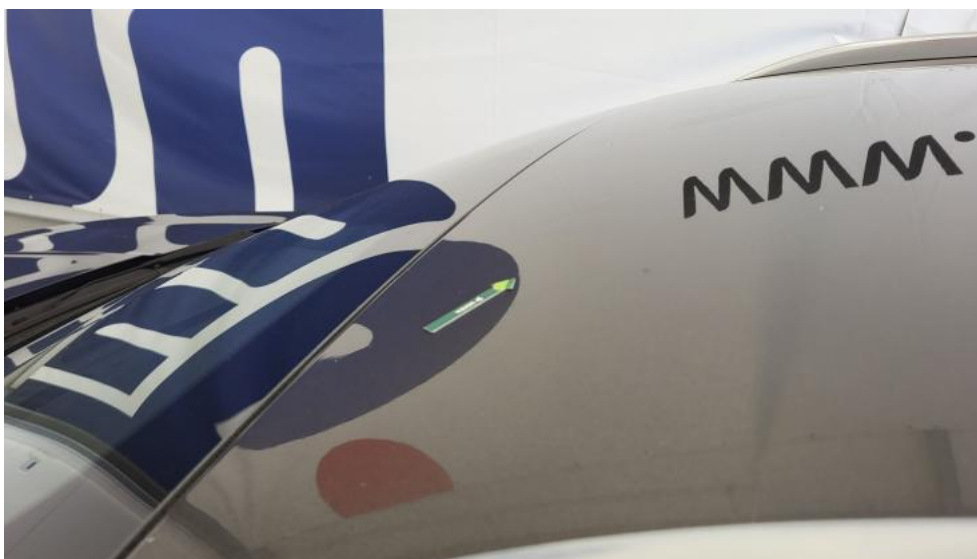
**Photo 59.**

Dach - Wgniecenie/odkształcenie 1

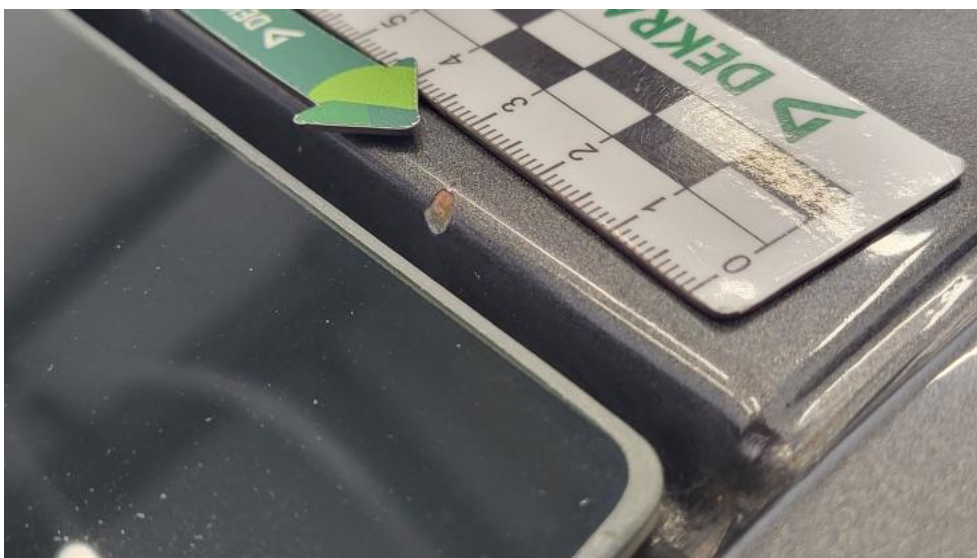
**Photo 60.**

Dach - Inne 1

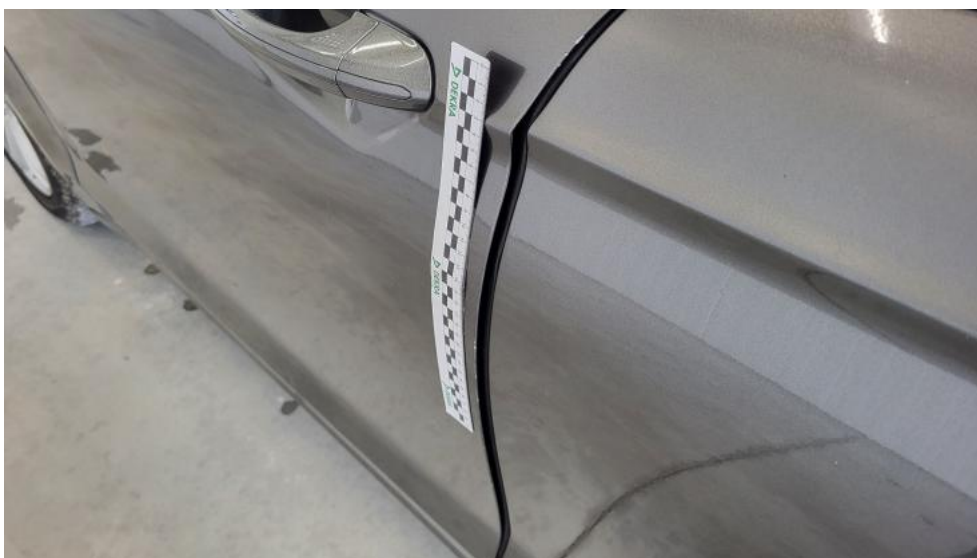
**Photo 62.**

Drzwi przed L - Rysa/odprysk 1

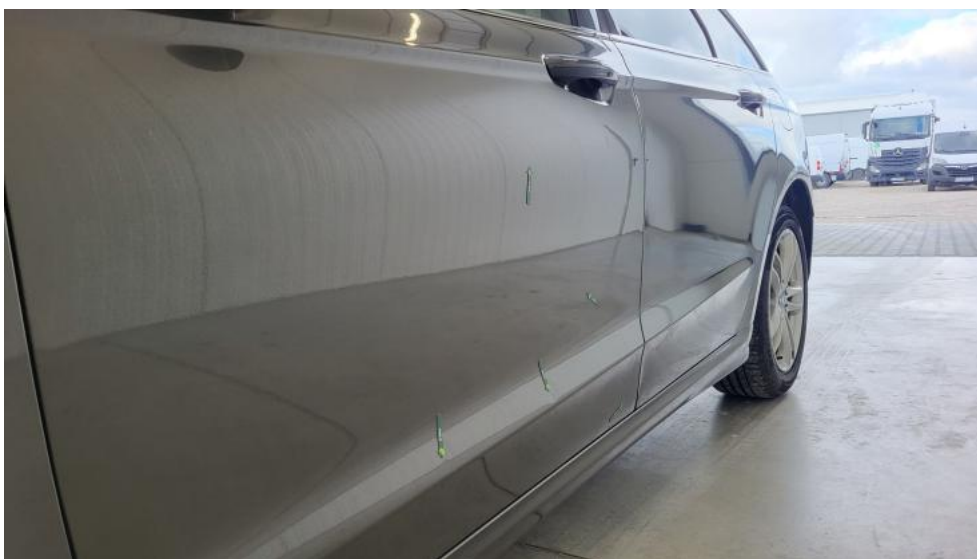
**Photo 63.**

Drzwi przed L - Wgniecenie/odkształcenie 1

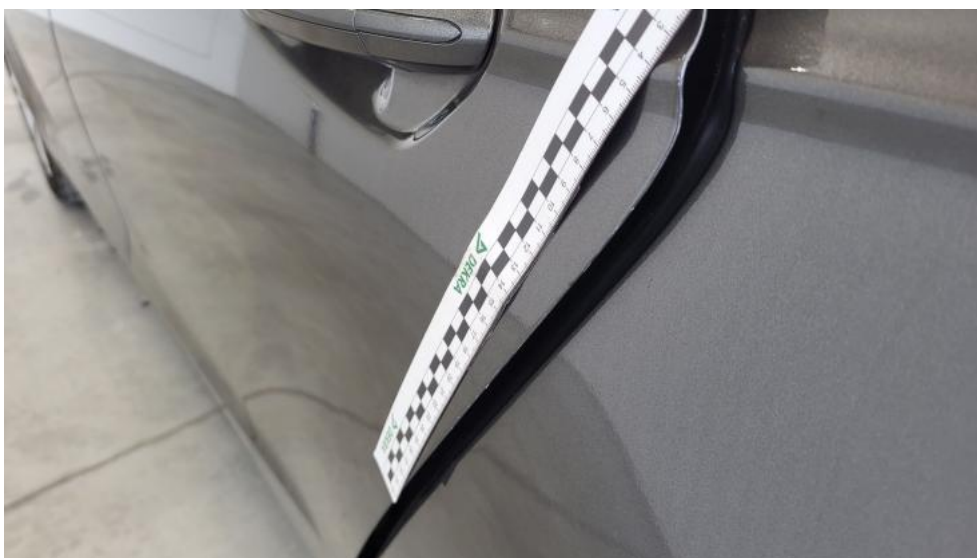
**Photo 64.**

Drzwi tylne L - Rysa/odprysk 1

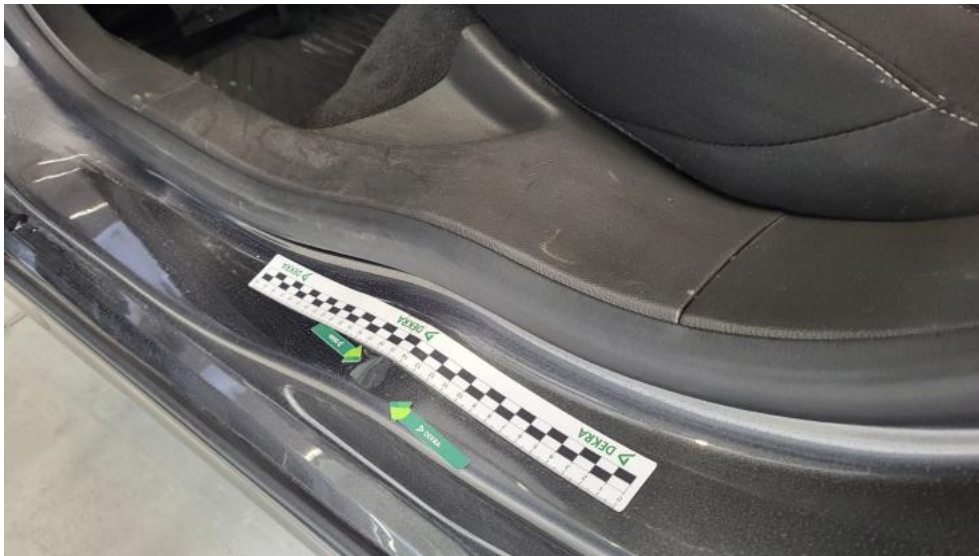
**Photo 65.**

Próg L - Wgniecenie/odkształcenie 1

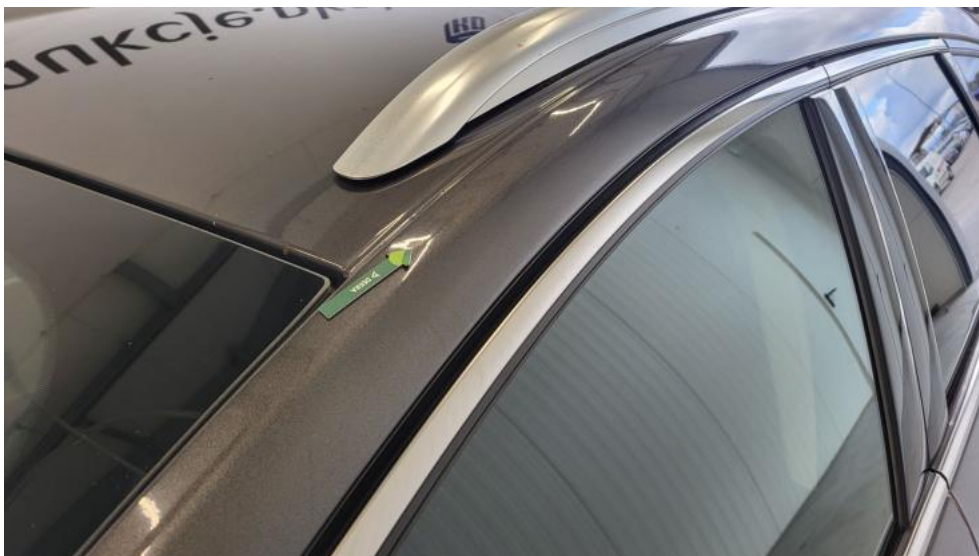
**Photo 66.**

Słupek przedni L - Wgniecenie/odkształcenie 1

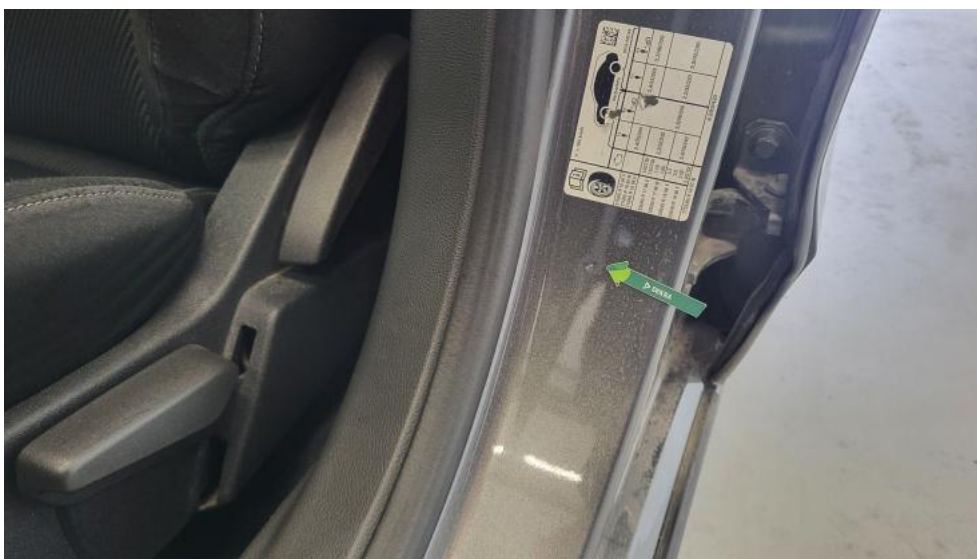
**Photo 67.**

Słupiek środkowy L - Wgniecenie/odkształcenie 1

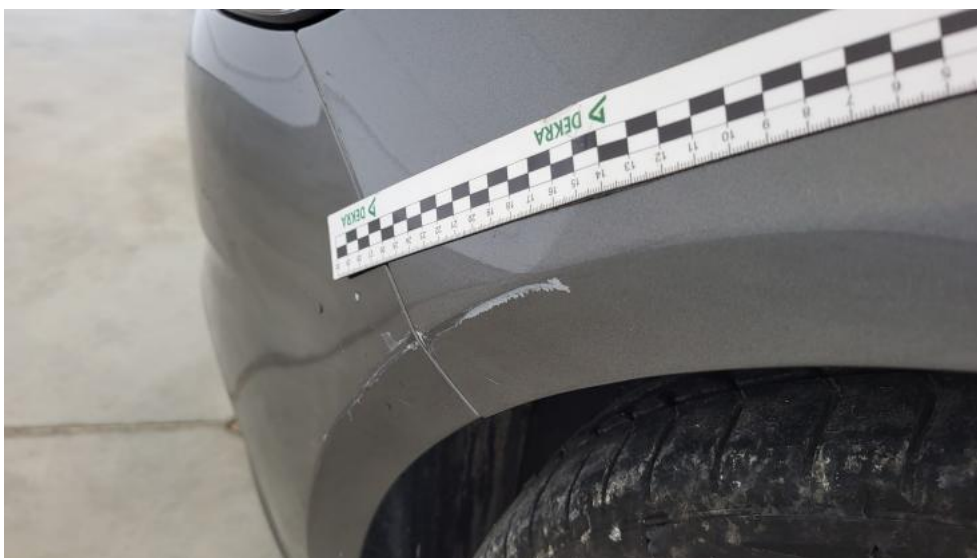
**Photo 68.**

Łotnik przedni L - Rysa/odprysk 1

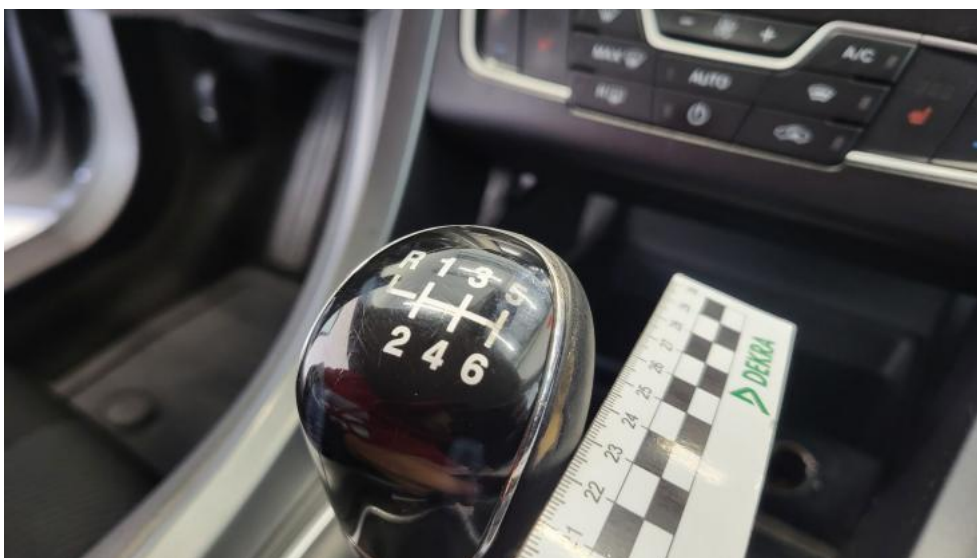
**Photo 70.**

Gałka dźwigni zmiany biegów - Inne 1

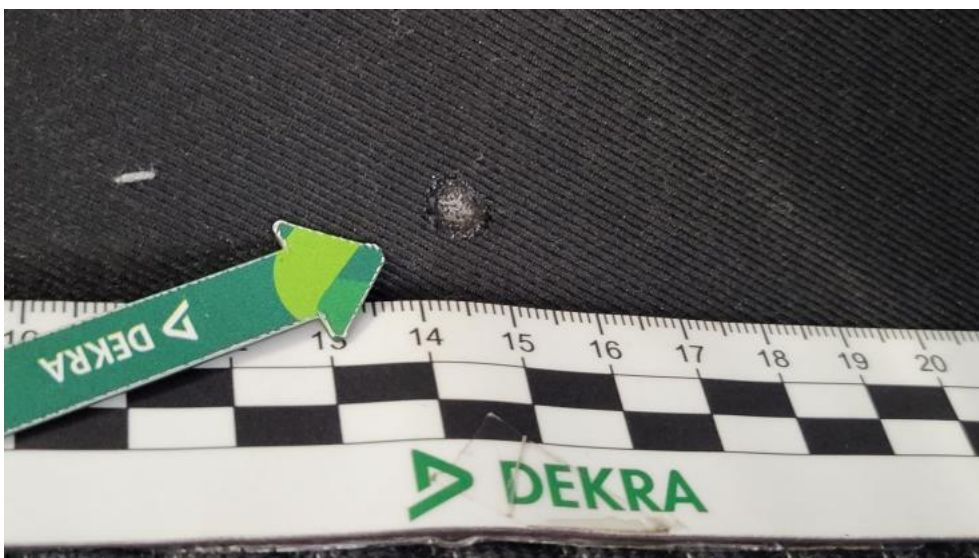
**Photo 72.**

Fotel prz. lew. - Inne 1

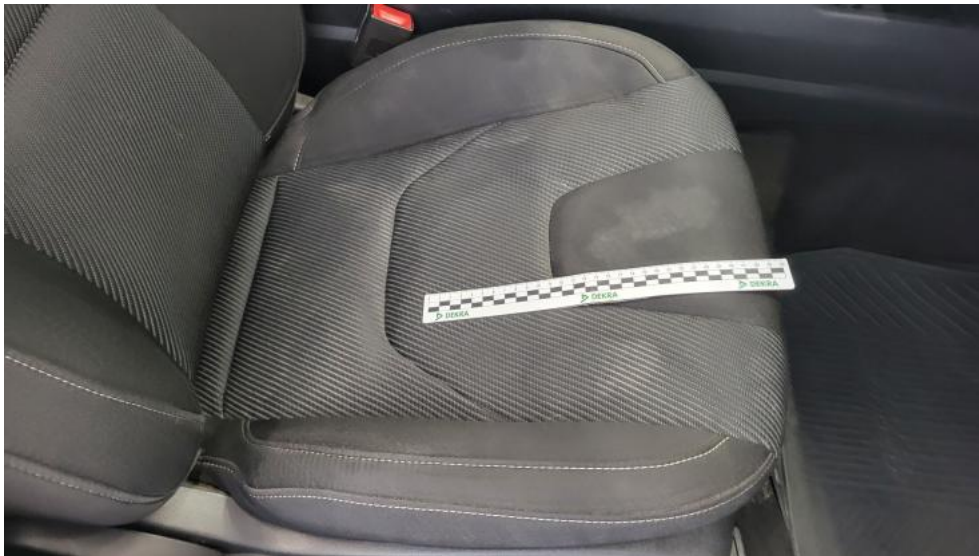
**Photo 73.**

Fotel prz. praw. - Inne 1

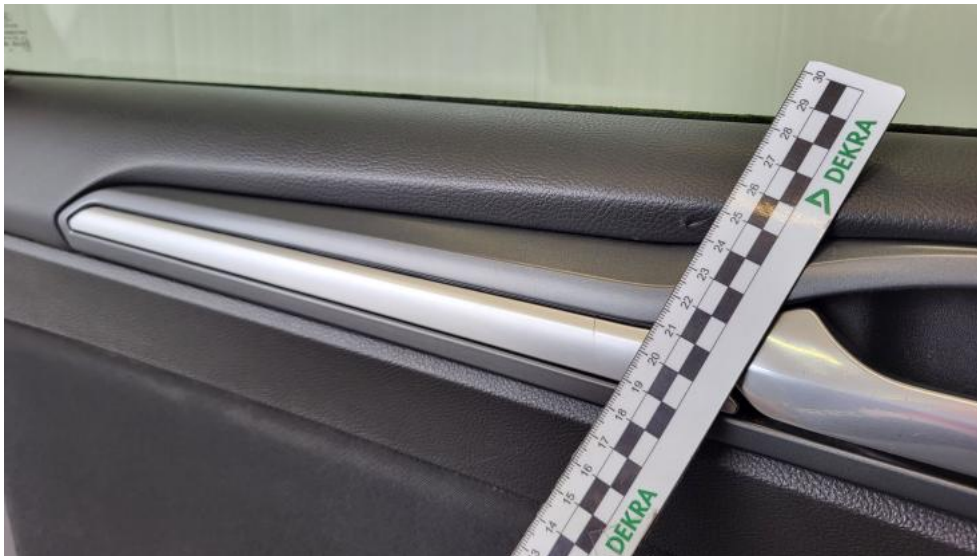
**Photo 77.**

Tapicerka drzwi przednich L - Pęknięcie/rozerwanie 1

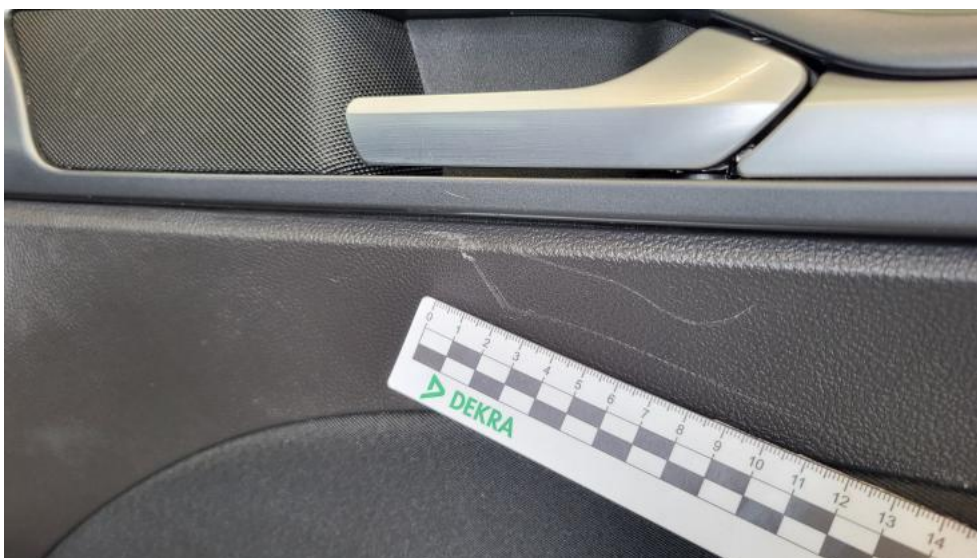
**Photo 78.**

Tapicerka drzwi przednich P - Rysa/odprysk 1

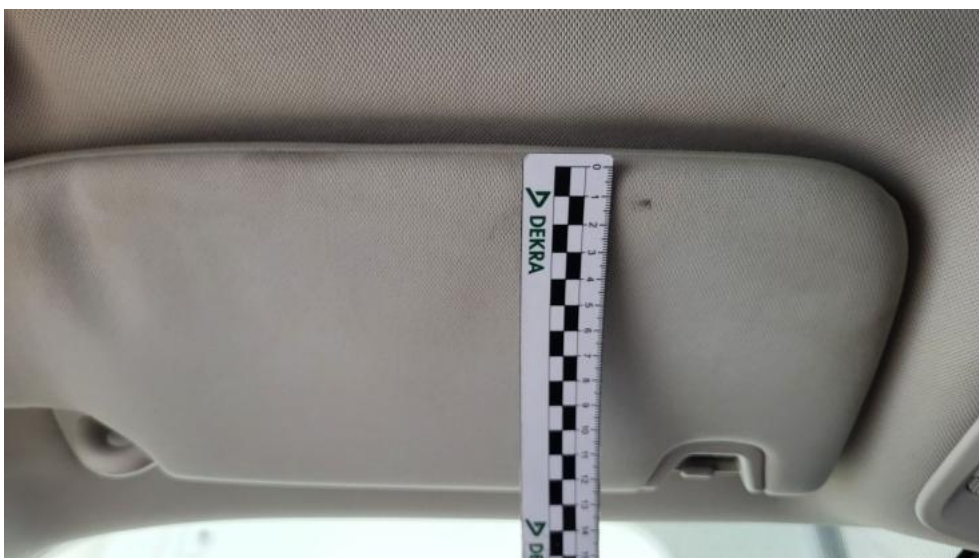
**Photo 80.**

Osłona p/słoneczna lewa - Inne 1

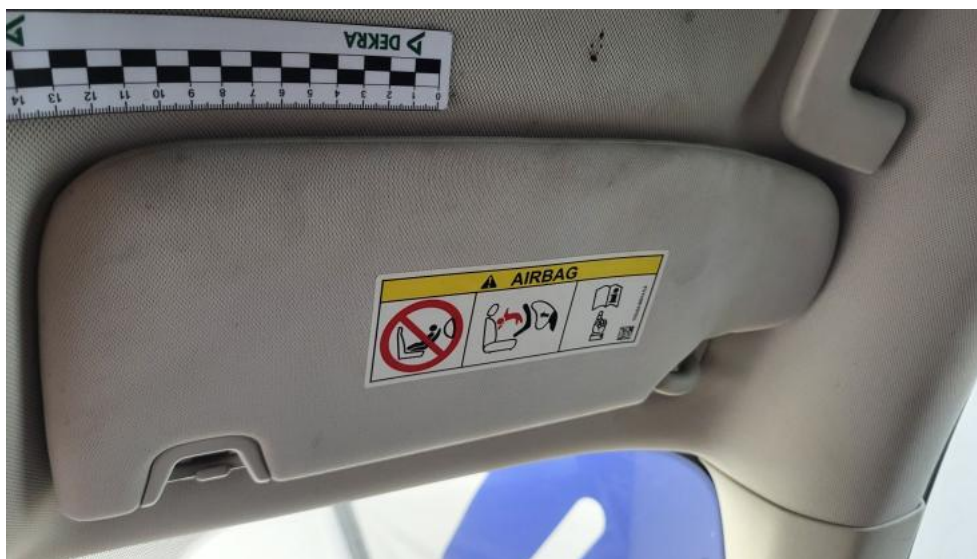
**Photo 81.**

Osłona p/słoneczna prawa - Inne 1

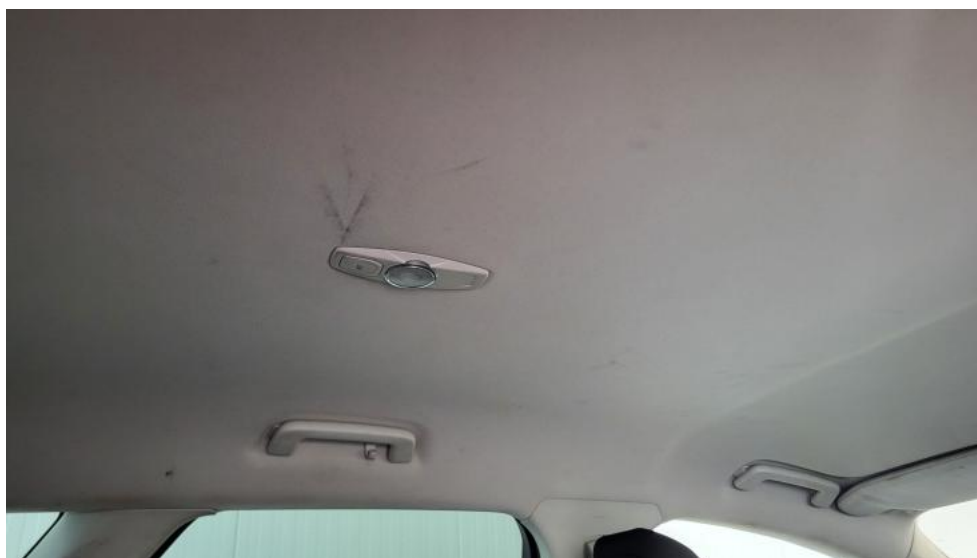
**Photo 82.**

Podsufitka - Inne 1

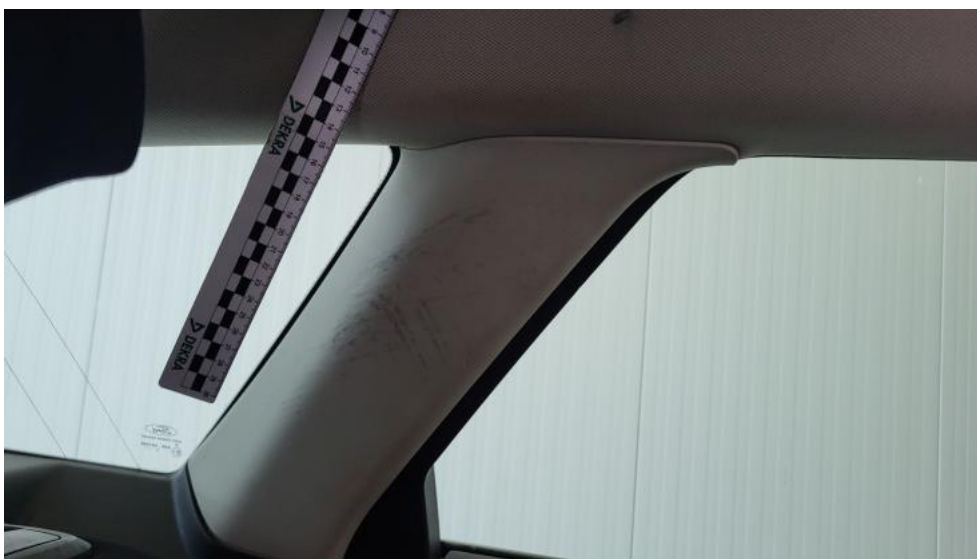
**Photo 85.**

Wykładzina(y) słupka tylnego L - Inne 1

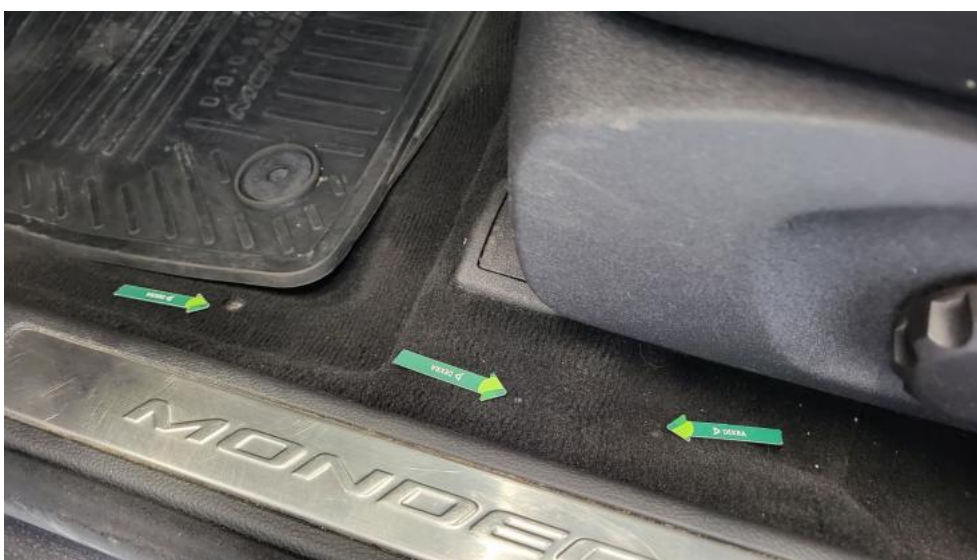
**Photo 86.**

Wykładzina podłogi - Inne 1

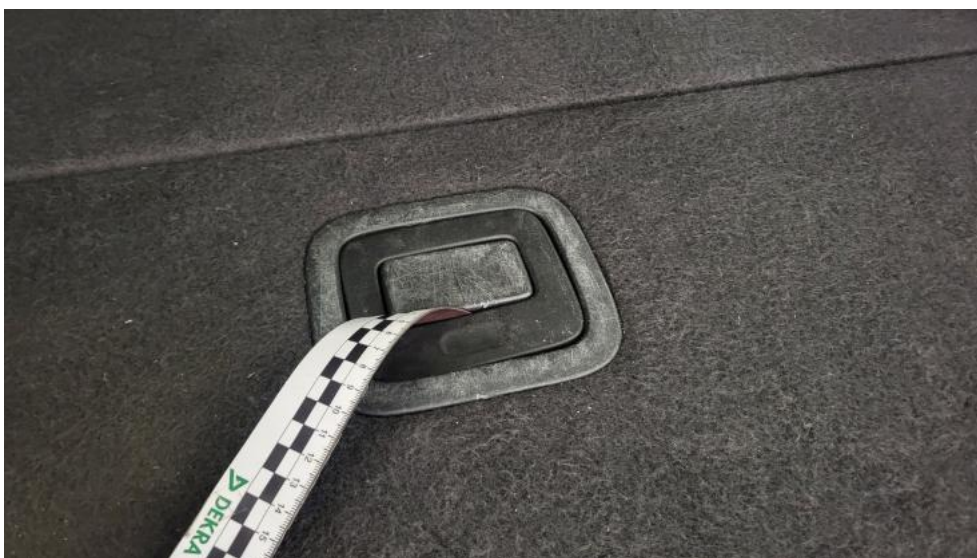
**Photo 88.**

Wykładzina podłogi bagażnika - Inne 1

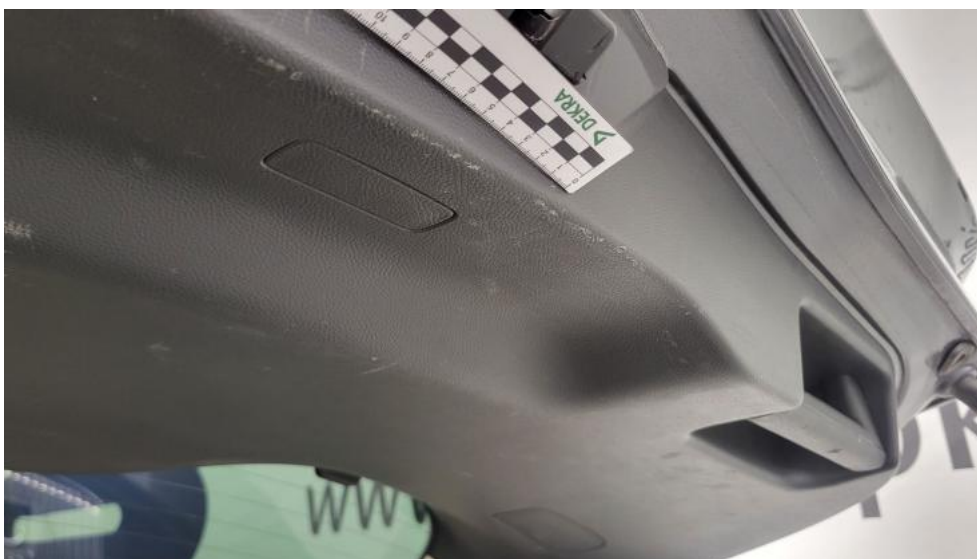
**Photo 89.**

Wykładzina pokrywy tylnej - Rysa/odprysk 1
