DEKRA's commission No. : PKOL(W)/LODZ/30803/26/04/09
commission/ damage No. : 22/020681
Date of commission: 09-04-2026

Vehicle data

Description of the technical condition

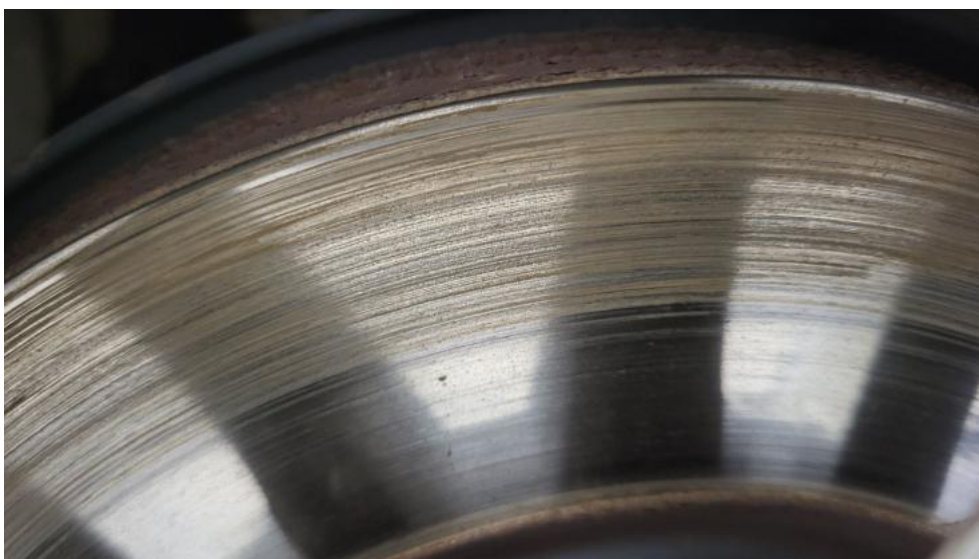
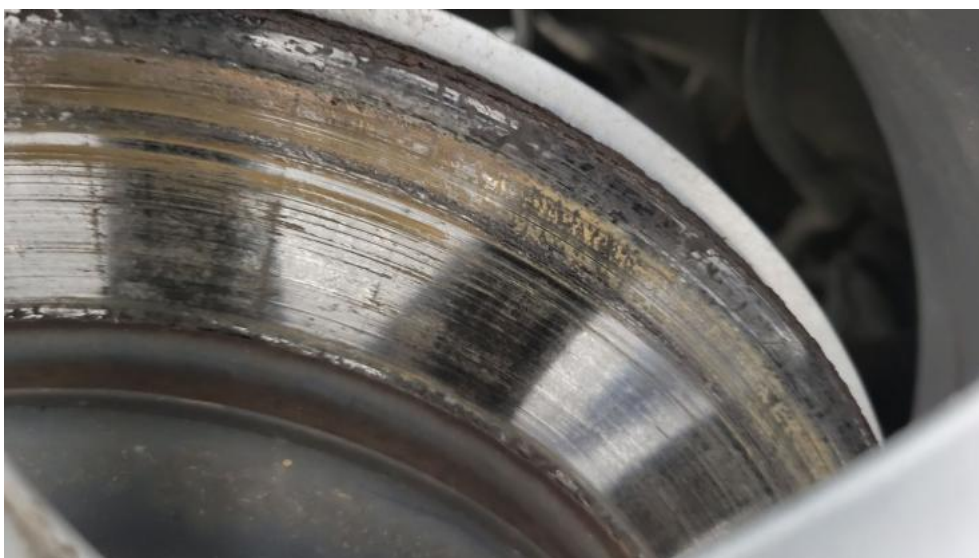
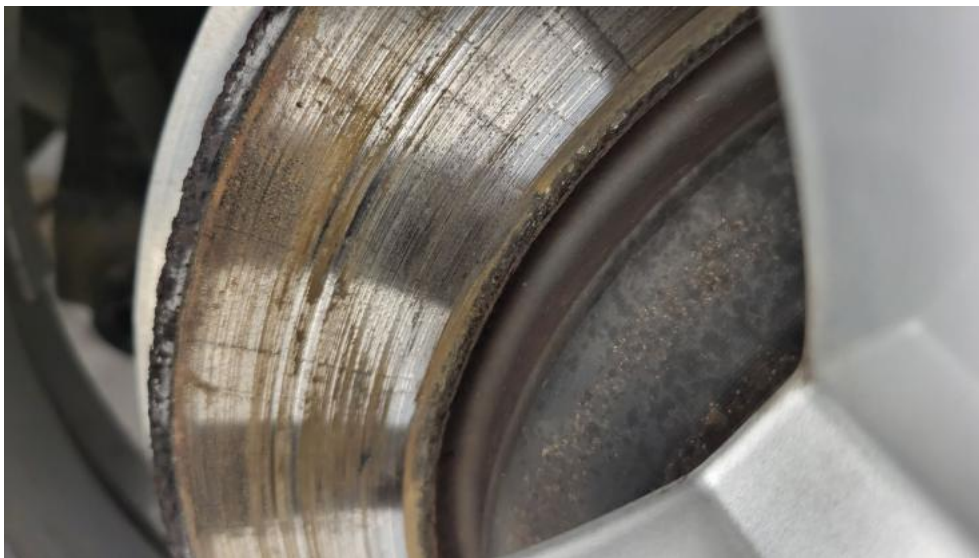
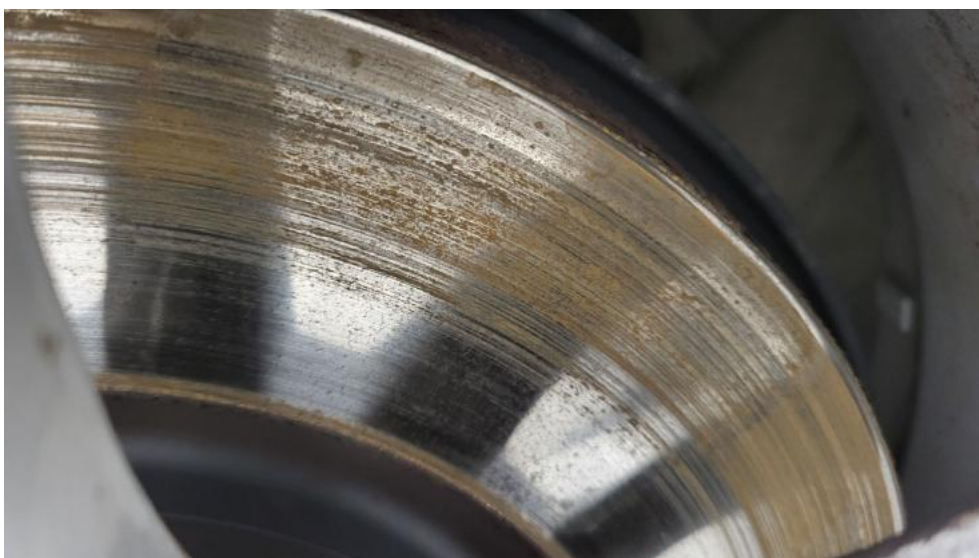
Item name	Description of item	Damage type	Location / Size	Comments
Tarcze hamulcowe		traces of corrosion		- zarysowania,

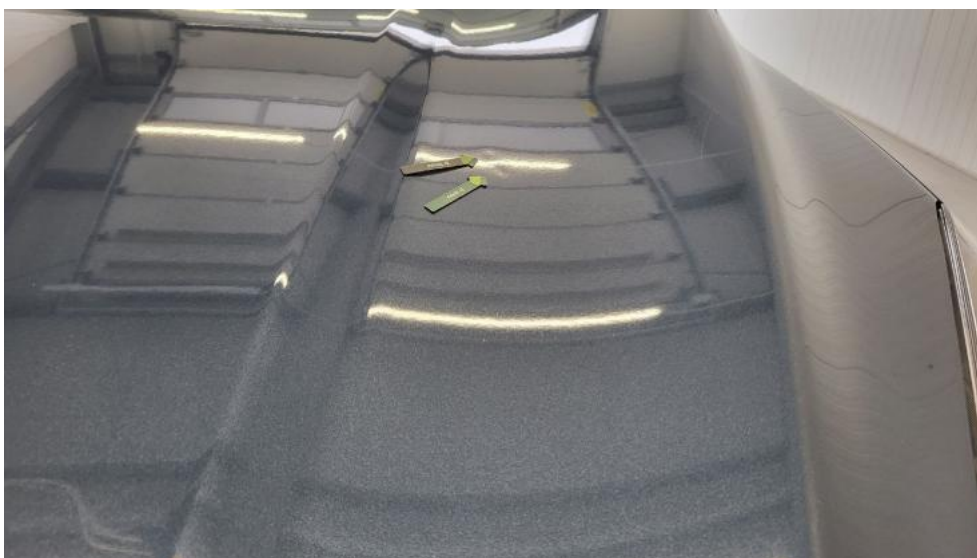
Item name	Description of item	Damage type	Location / Size	Comments
Engine bonnet		wgniecenie/nia	in the left part	
Fender	front r.	wgniecenie/nia	in the right part	
Door	front r.	wgniecenie/nia	in the right part	- odpryski lakieru na krawędzi,
Cover of the luggage comp. /rear door		wgniecenie/nia	in the right part	
Roof		wgniecenie/nia		- w części przedniej i środkowej,
Fender	rear l.	scratch	in the right part	- odkształcenie w części górnej tył,
Side sill	left	deformation	in the right part	
Fender	front r.	scratch	in the middle part	
Fender	front l.	deformation	in the rear part

Photo 36.
Pokrywa komory silnika - Wgniecenie/odkształcenie 1

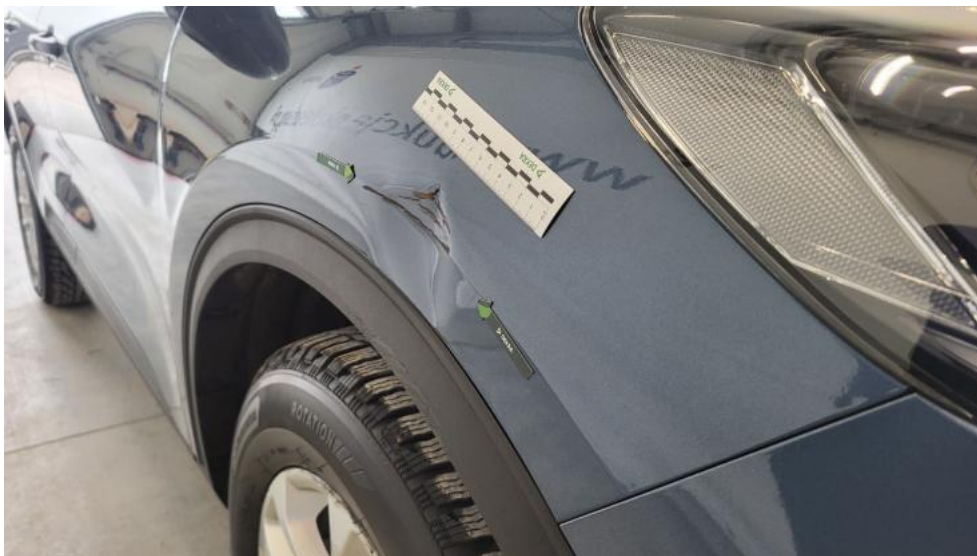
Photo 37.
Błotnik przedni P - Wgniecenie/odkształcenie 1

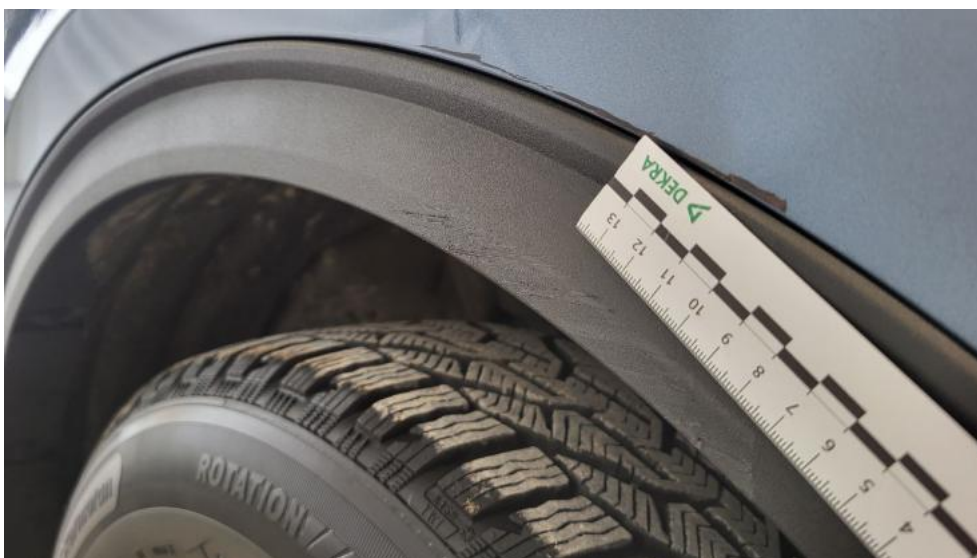
Item name	Description of item	Damage type	Location / Size	Comments
Listwa błotnika	front r.	scratch	in the right part	
Compoud lamp	rear r.	broken		- nieszczelna,
Bumper	rear	scratch		- w części środkowej i prawej,
Glass	front	loss of material, spot

Photo 38.
Listwa krawędzi błotnika prz P - Rysa/odprysk 1

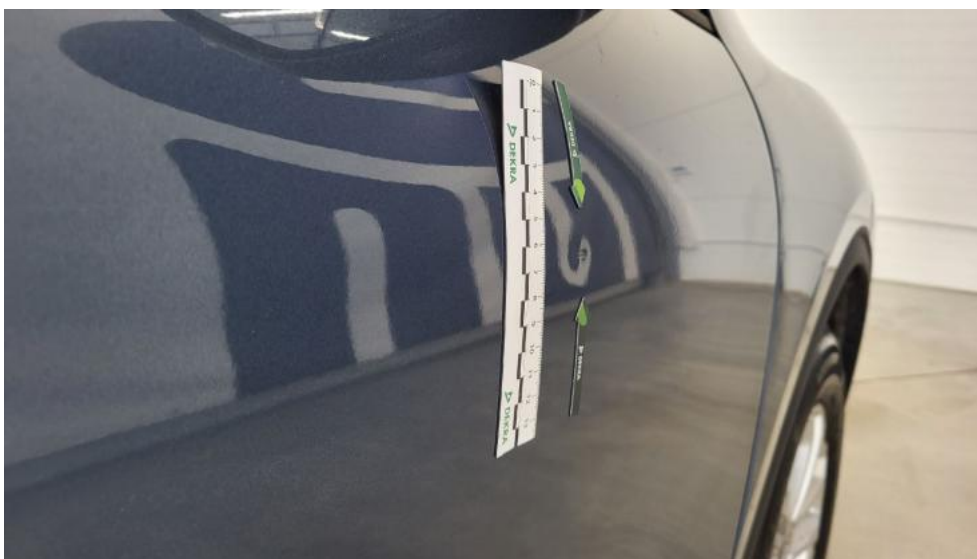
Photo 39.
Drzwi przednie P - Wgniecenie/odkształcenie 1

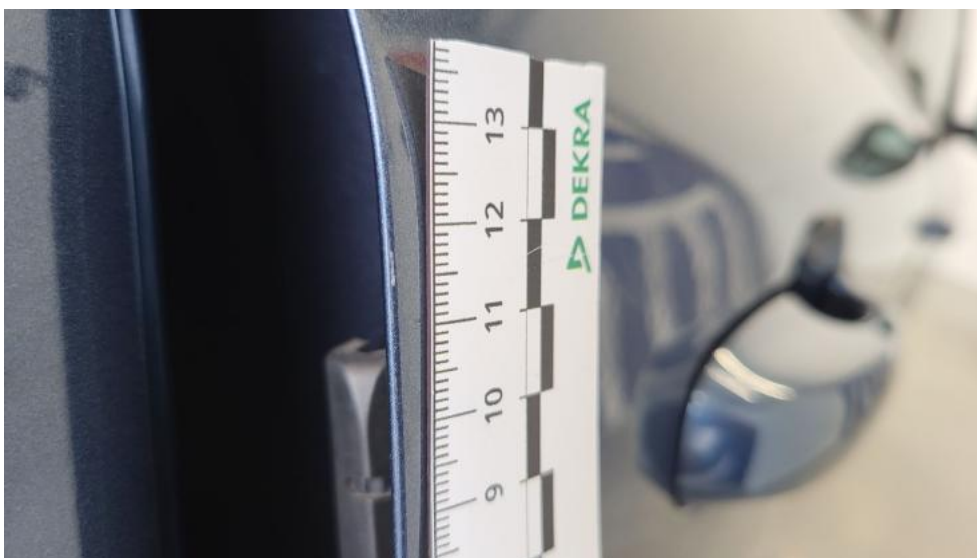
Photo 40.
Drzwi tylne P - Rysa/odprysk 1

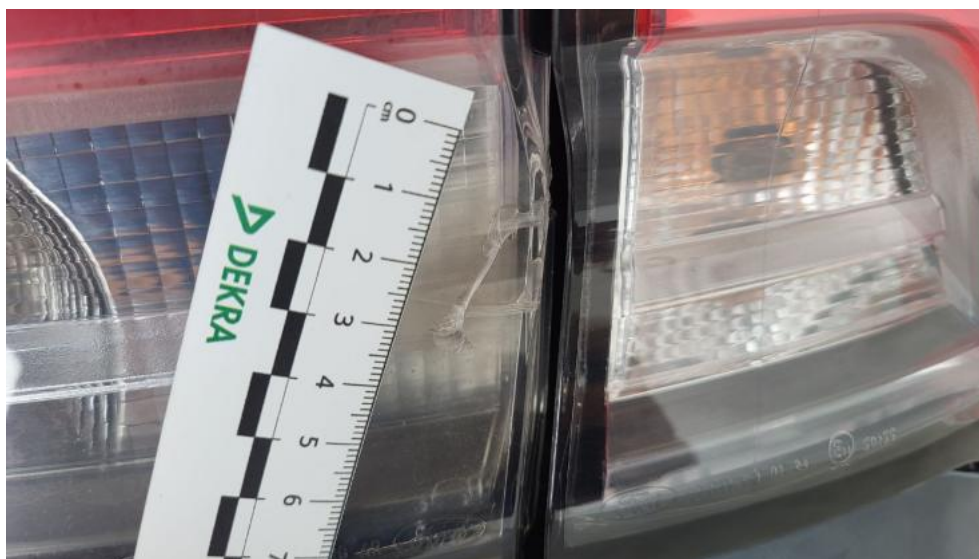
Photo 41.
Lampa tylna wew P - Pęknięcie/rozerwanie 1

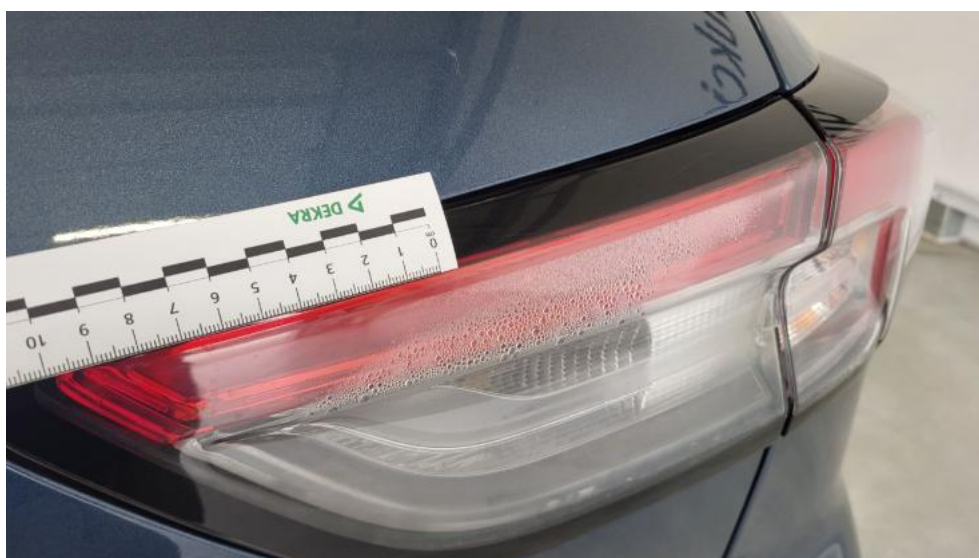
Photo 42.
Lampa tylna wew P - Inne 1

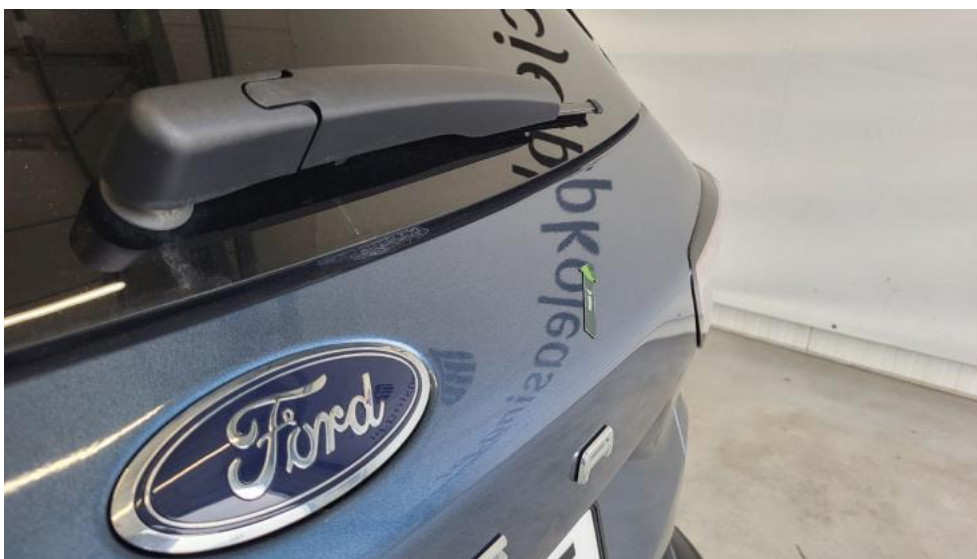
Photo 43.
Pokrywy bagażnika - Wgniecenie/odkształcenie 1

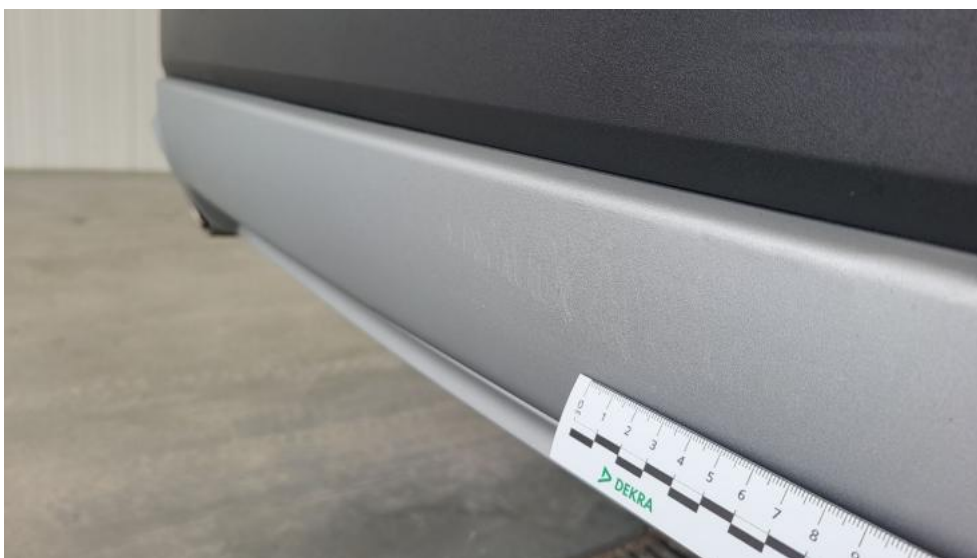
Photo 44.
Spojler zderzaka tylnego - Rysa/odprysk 1

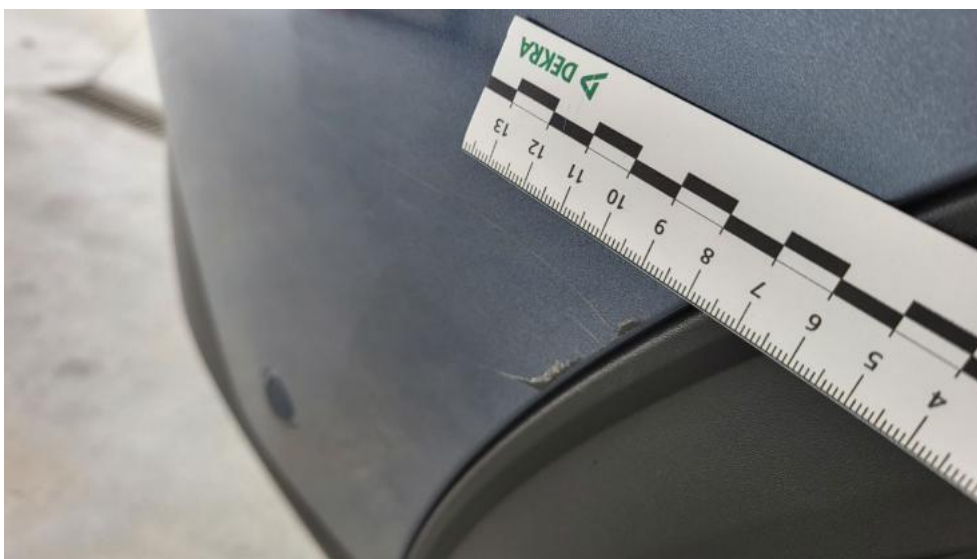
Photo 45.
Zderzak tylny - Rysa/odprysk 1

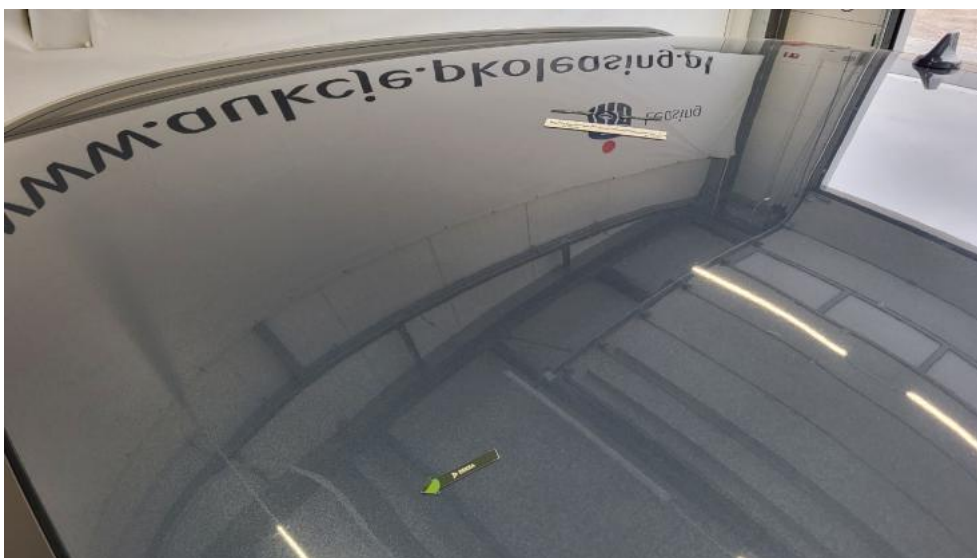
Photo 46.
Dach - Wgniecenie/odkształcenie 1

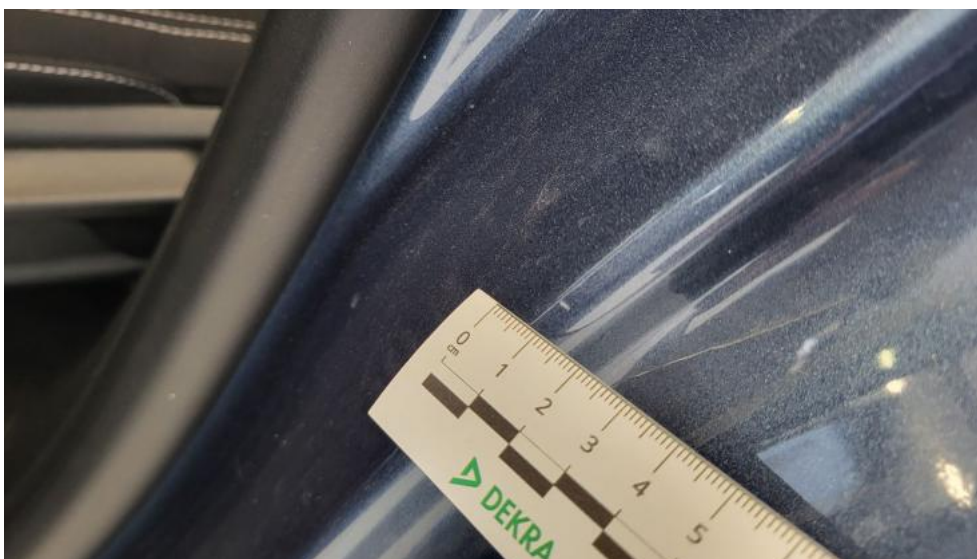
Photo 47.
Błotnik tylny L / Ściana boczna L - Rysa/odprysk 1

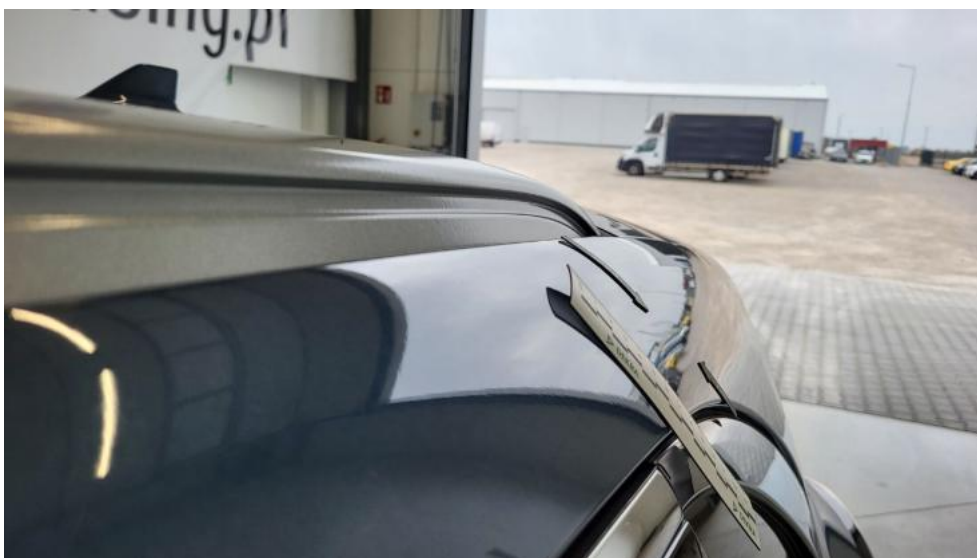
Photo 48.
Błotnik tylny L / Ściana boczna L - Wgniecenie/odkształcenie 1

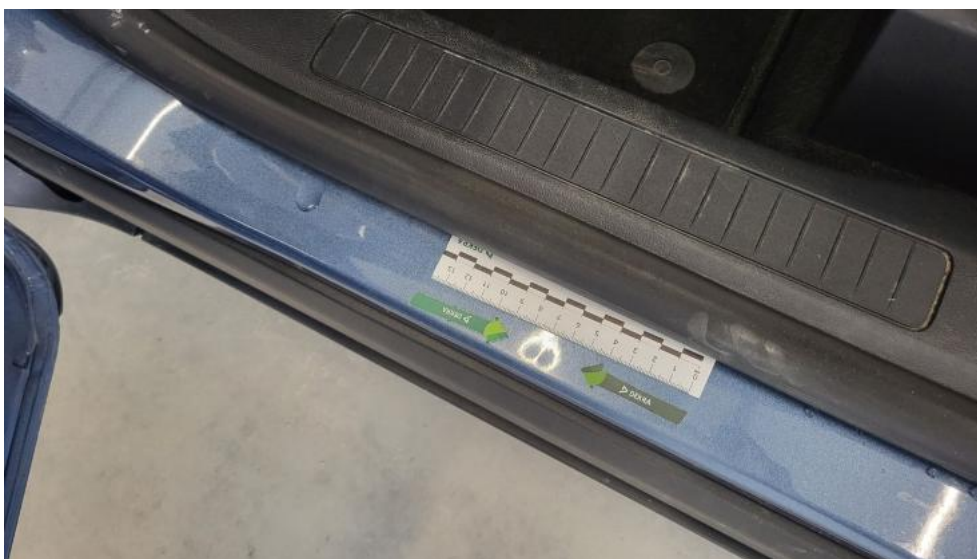
Photo 49.
Próg L - Wgniecenie/odkształcenie 1

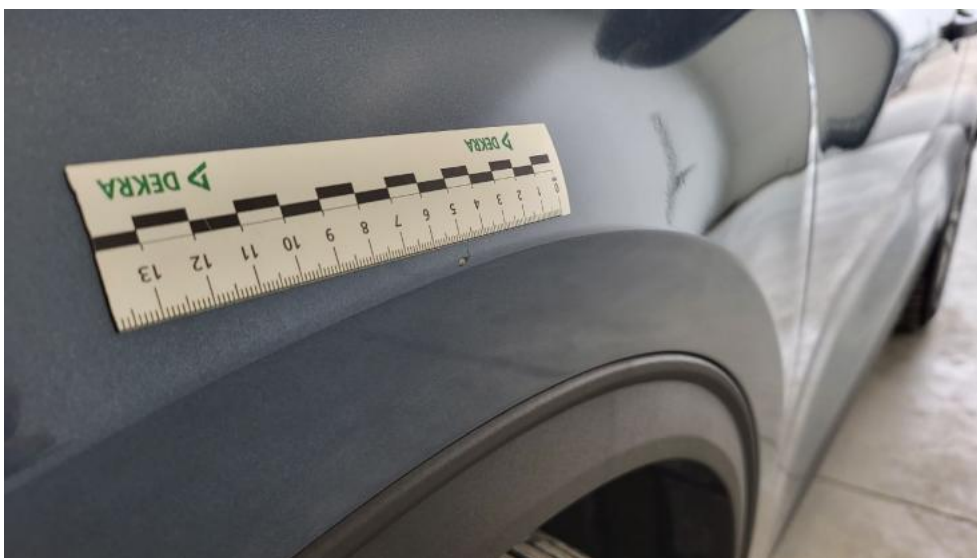
Photo 50.
Błotnik przedni L - Rysa/odprysk 1

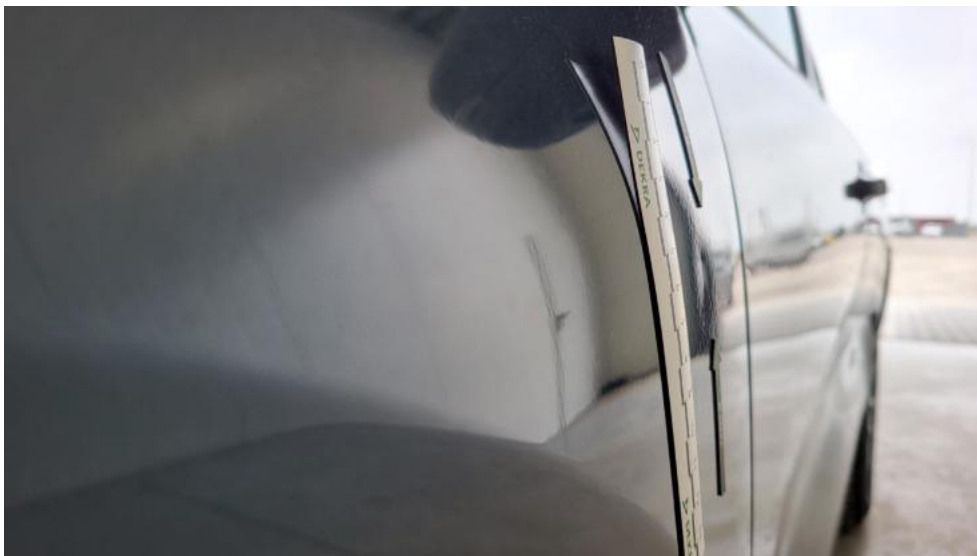
Photo 51.
Błotnik przedni L - Wgniecenie/odkształcenie 1

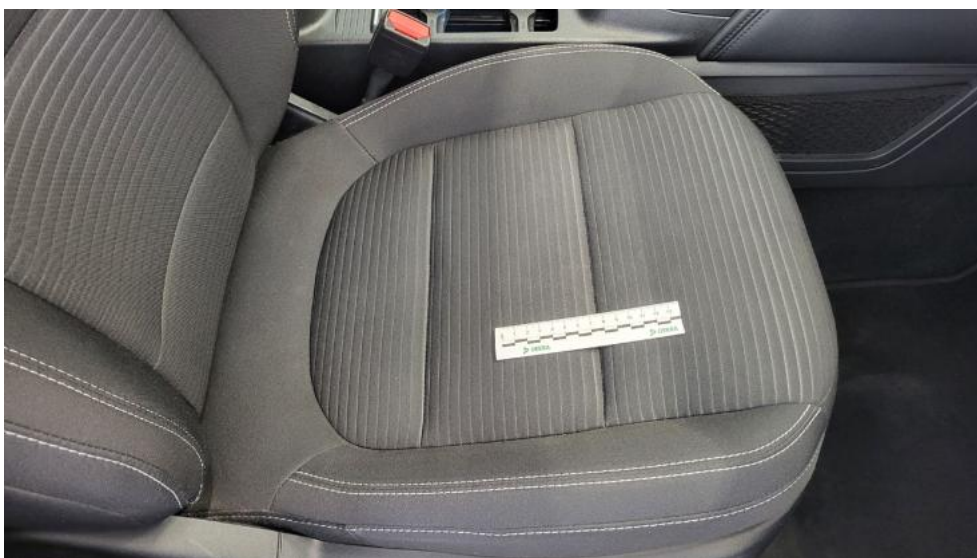
Photo 52.
Fotel prz. praw. - Inne 1

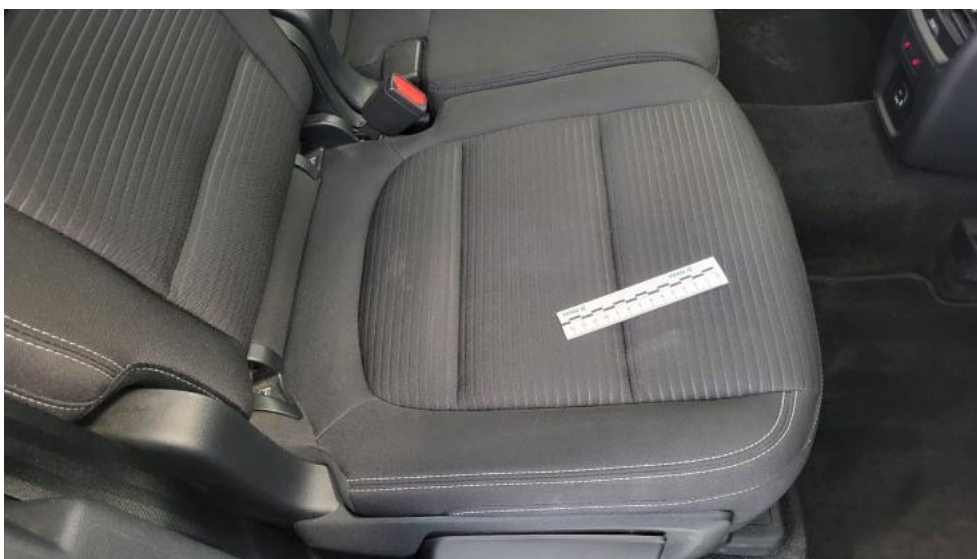
Item name	Description of item	Damage type	Location / Size	Comments
Upcholstery with shields				- zabrudzone , poplamione,
Oslona przeciwsłoneczna	right			- zabrudzona,
Bench				- brak zaślepki,

Photo 53.
Kanapa tyl. - Inne 1

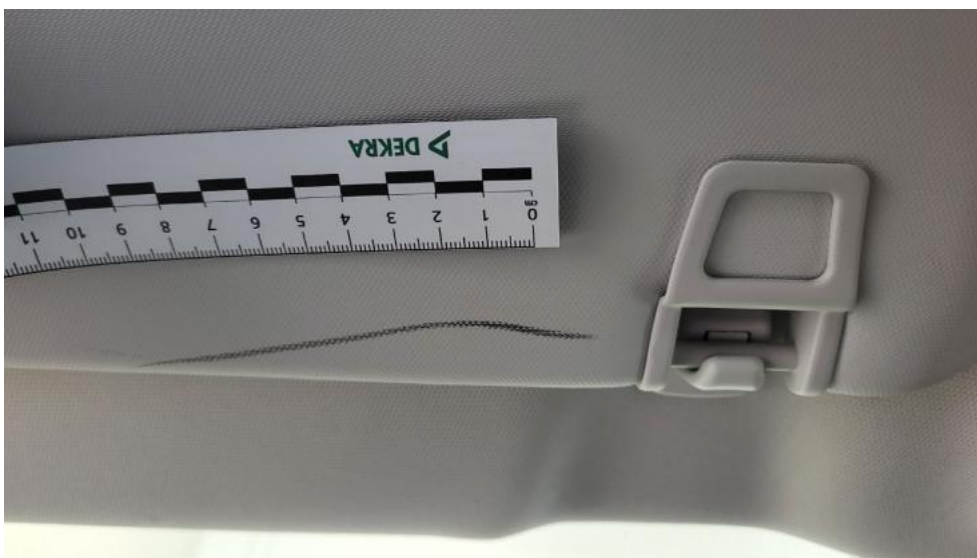
Photo 54.
Osłona p/słoneczna lewa - Inne 1

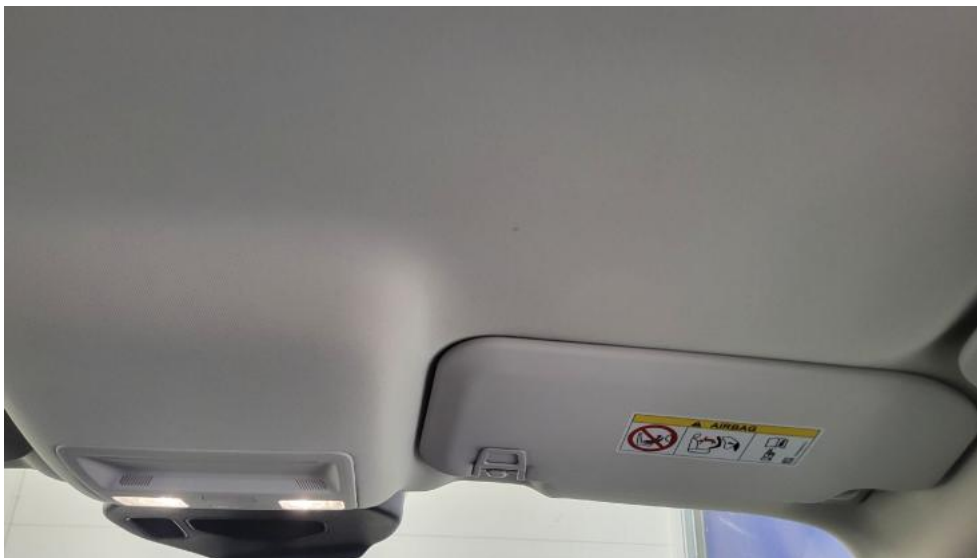
Photo 55.
Podsufitka - Inne 1
