DEKRA's commission No. : PKOL(W)/LODZ/22884/25/03/28  
commission/ damage No. : Futura  
Date of commission: 28-03-2025

**DEKRA Poland - Headquarters**  
02-673 Warszawa, ul. Konstruktorska 12A

PKO Leasing SA  
Świętokrzyska 36  
00-116 Warszawa

| Manufacturer | OPEL |

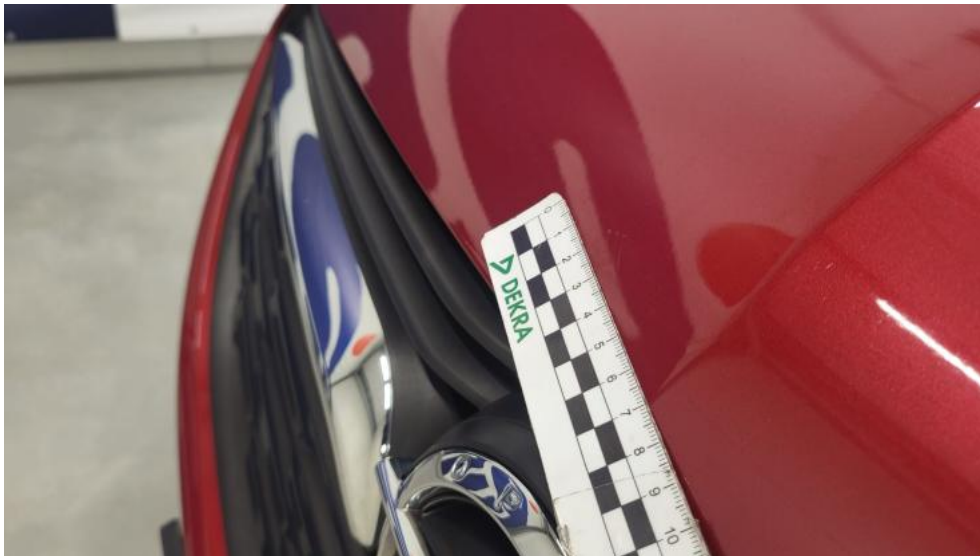
**Photo 39.**

Pokrywa komory silnika - Rysa/odprysk 1

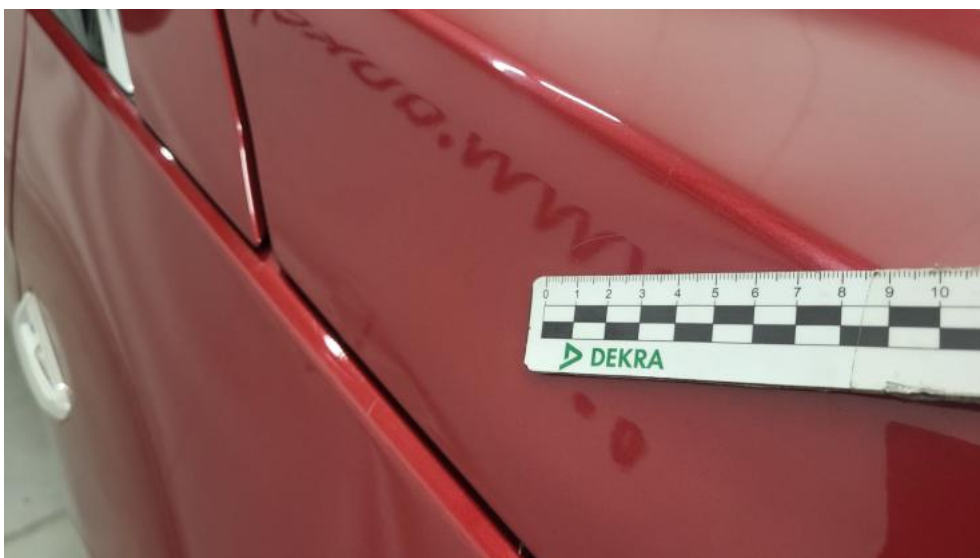
**Photo 40.**

Pokrywa komory silnika - Rysa/odprysk 2

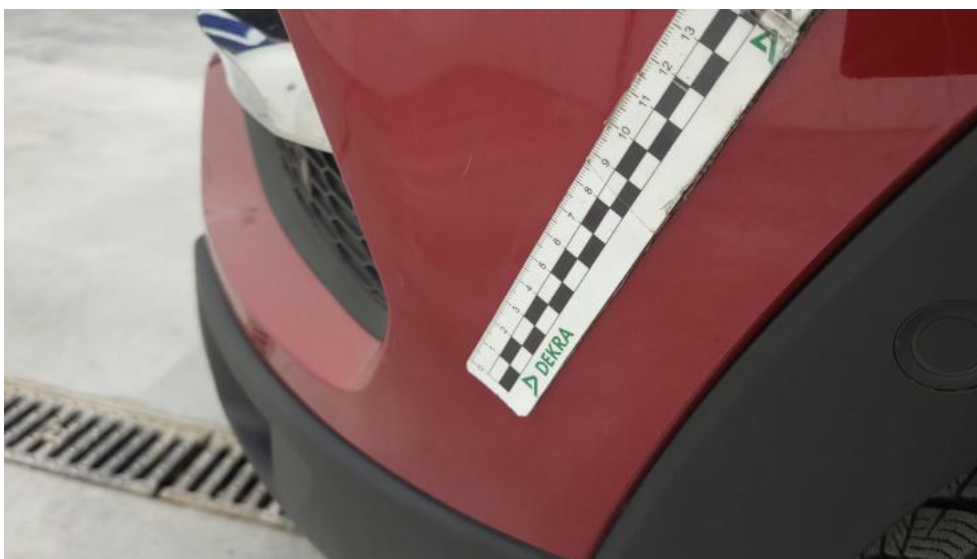
**Photo 41.**

Zderzak - Rysa/odprysk 1

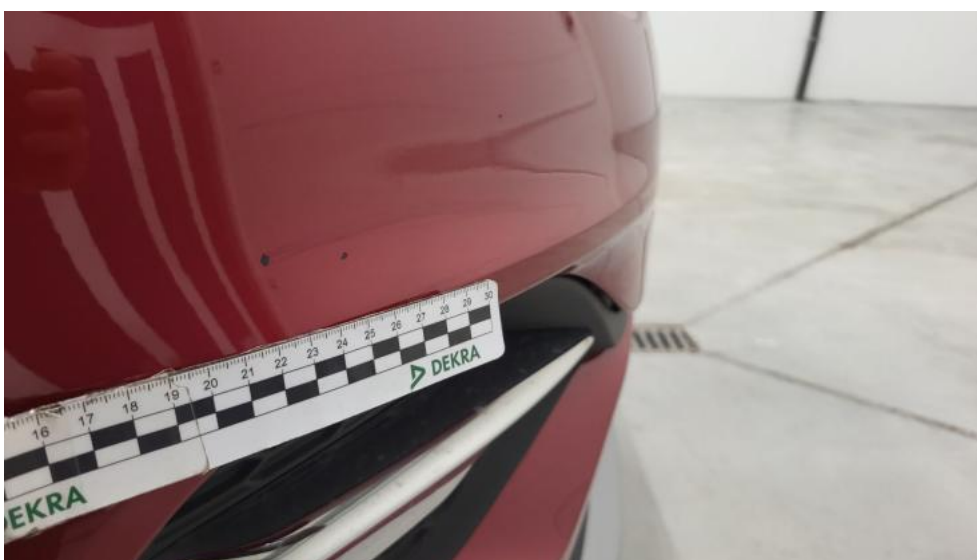
**Photo 42.**

Zderzak - Rysa/odprysk 2

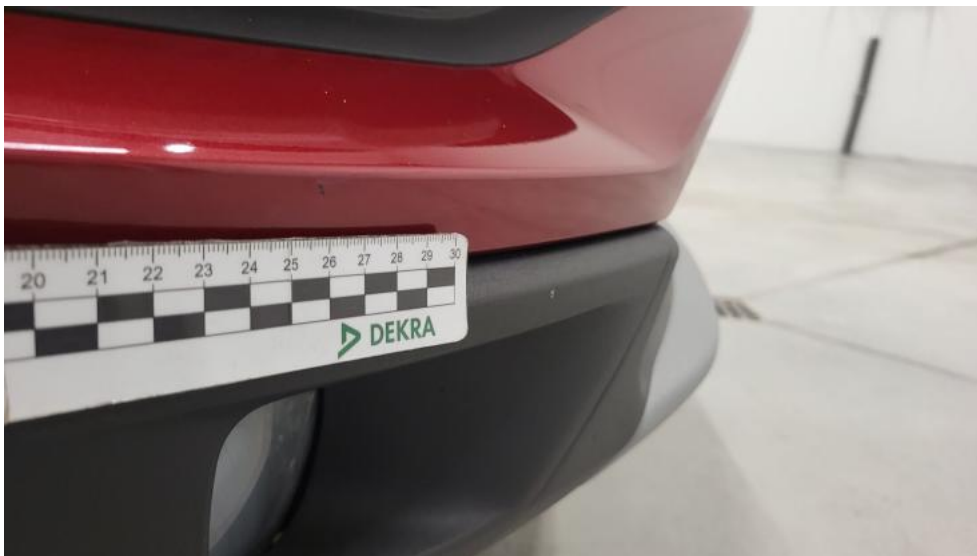
**Photo 43.**

Zderzak() - Rysa/odprysk 3

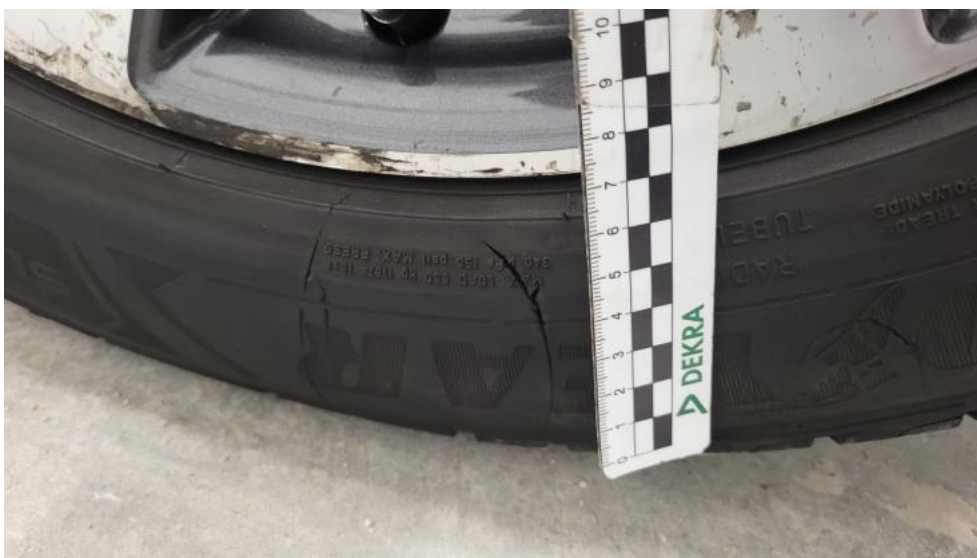
**Photo 44.**

Opona przednia P - Pęknięcie/rozerwanie 1

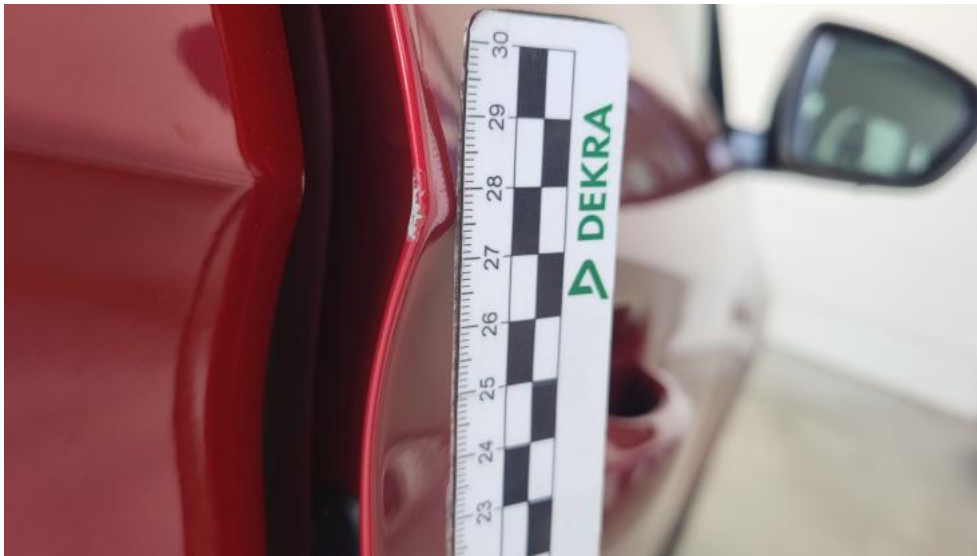
**Photo 45.**

Drzwi przednie P - Rysa/odprysk 1

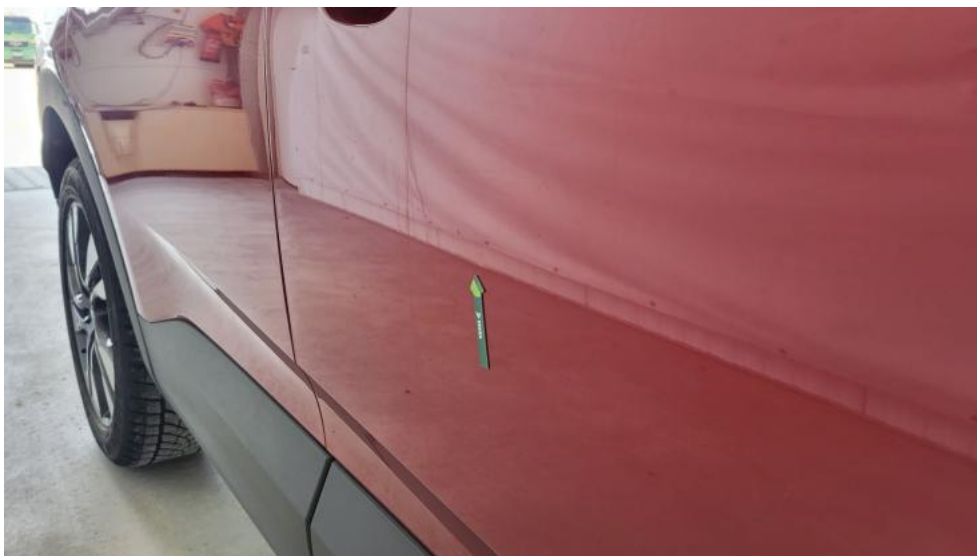
**Photo 46.**

Drzwi przednie P - Wgniecenie/odkształcenie 1

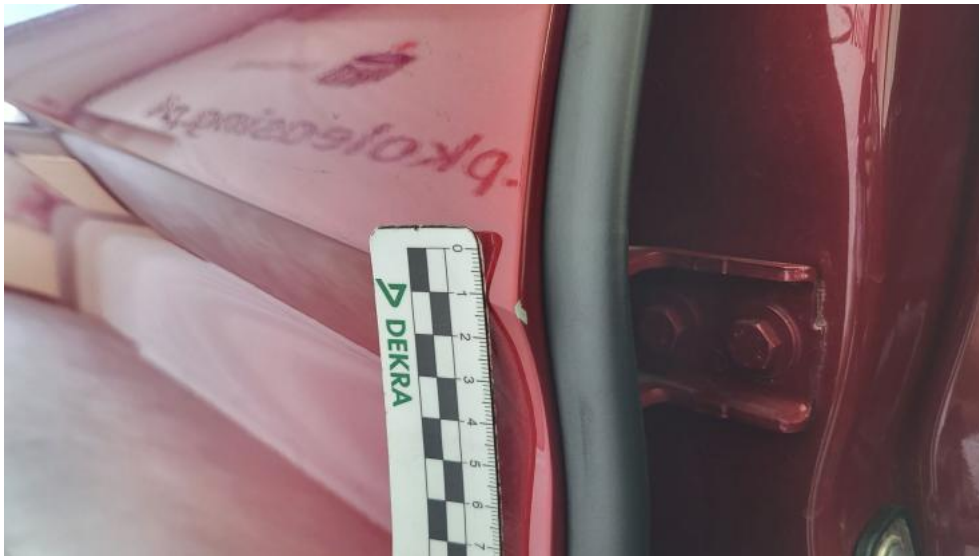
**Photo 47.**

Drzwi tylne P - Rysa/odprysk 1

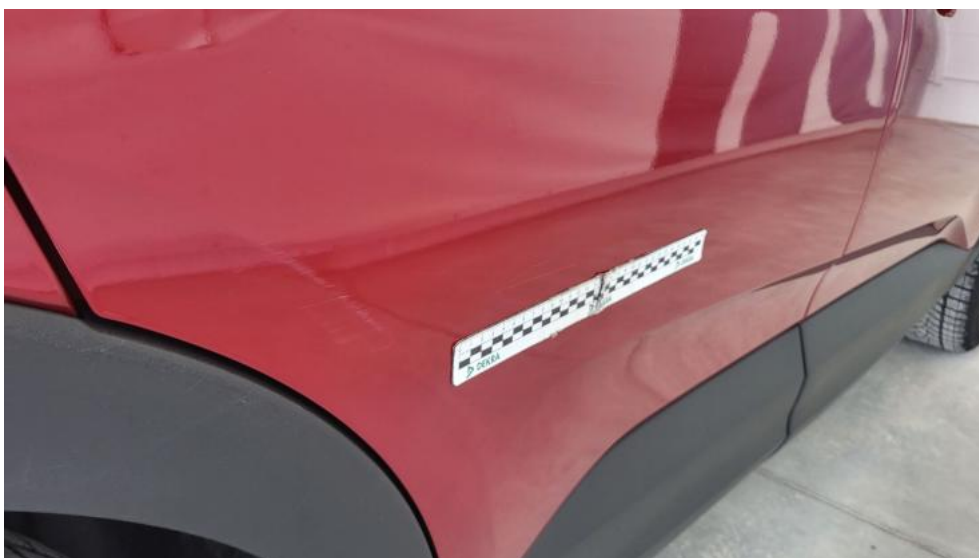
**Photo 48.**

Drzwi tylne P - Rysa/odprysk 2

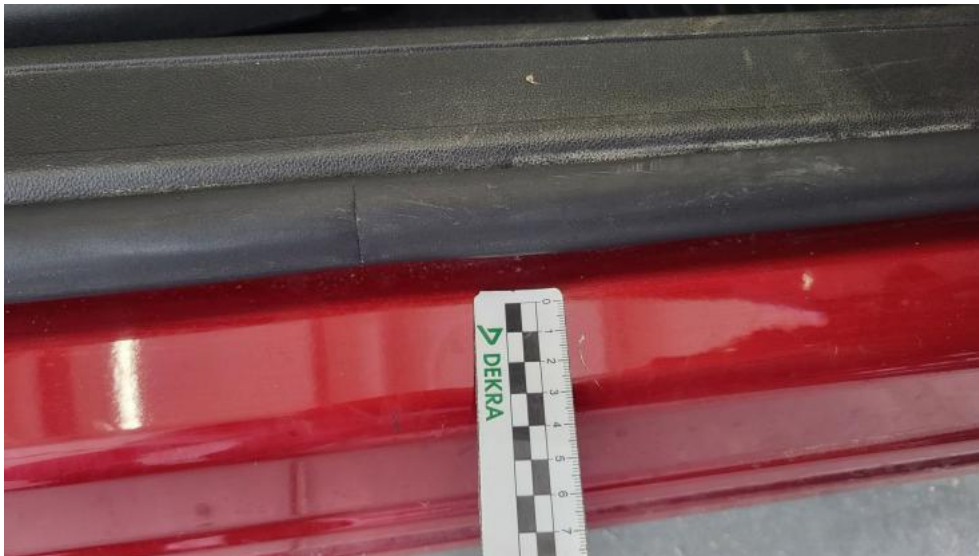
**Photo 49.**

Próg P - Rysa/odprysk 1

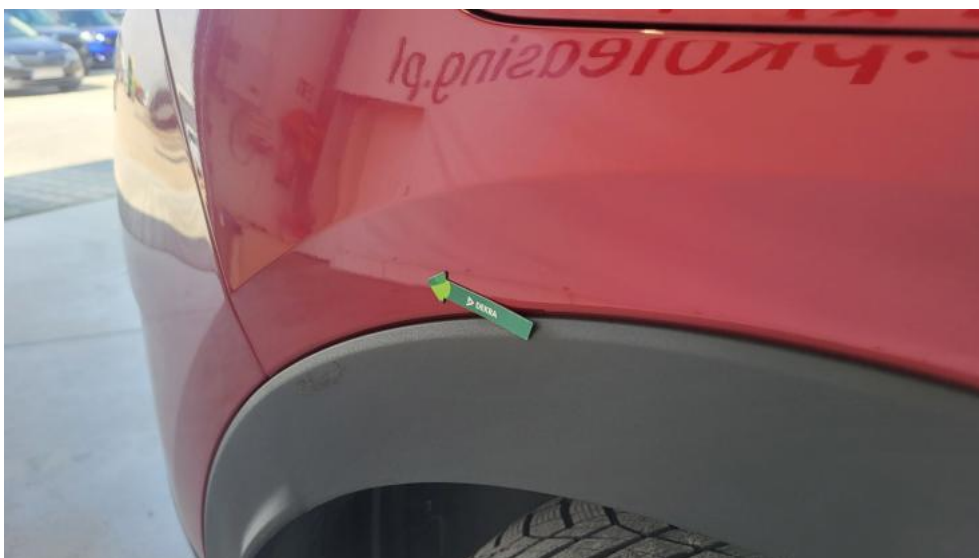
**Photo 50.**

Ścianka tylna P / Ścianka boczna P - Wgniecenie/odkształcenie 1

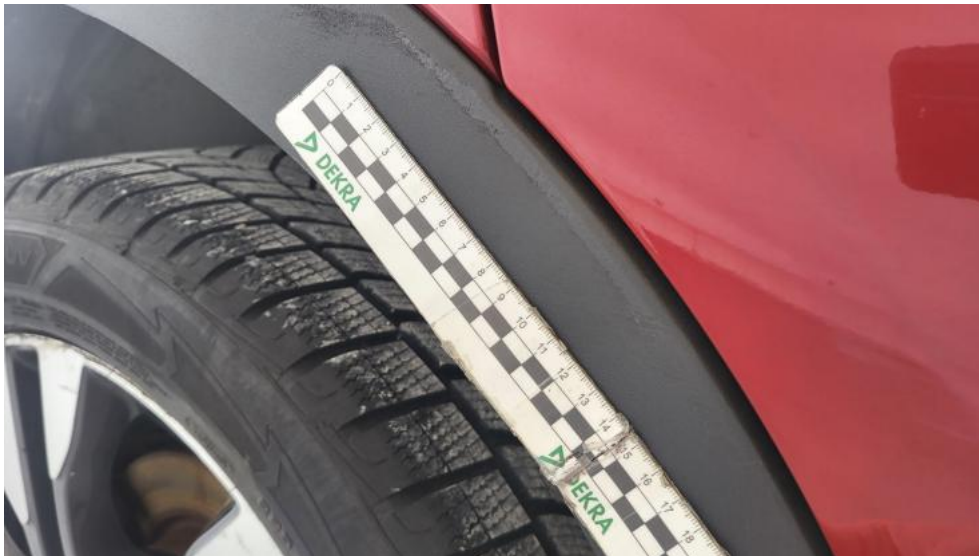
**Photo 51.**

Listwa krawędzi błotnika tyl P - Rysa/odprysk 1

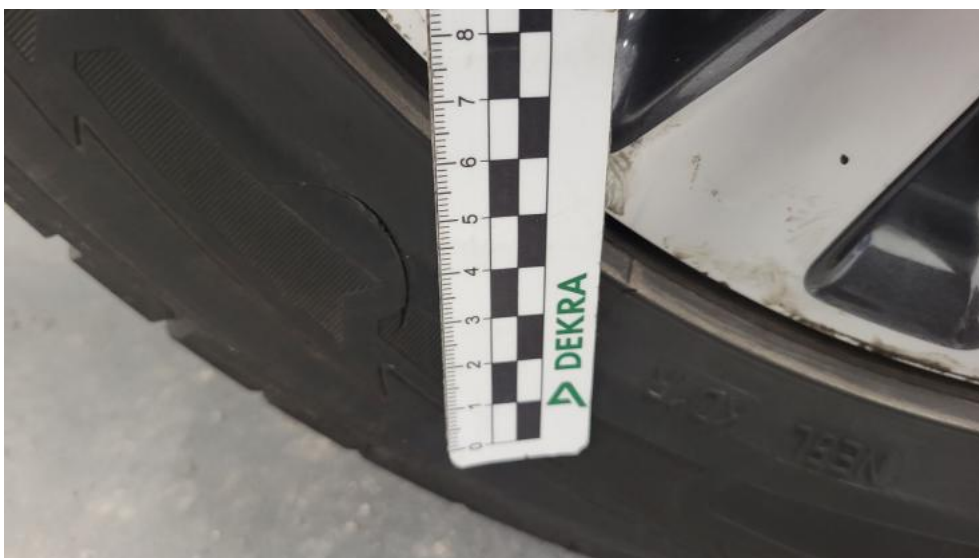
**Photo 52.**

Opona tylna P - Pęknięcie/rozerwanie 1

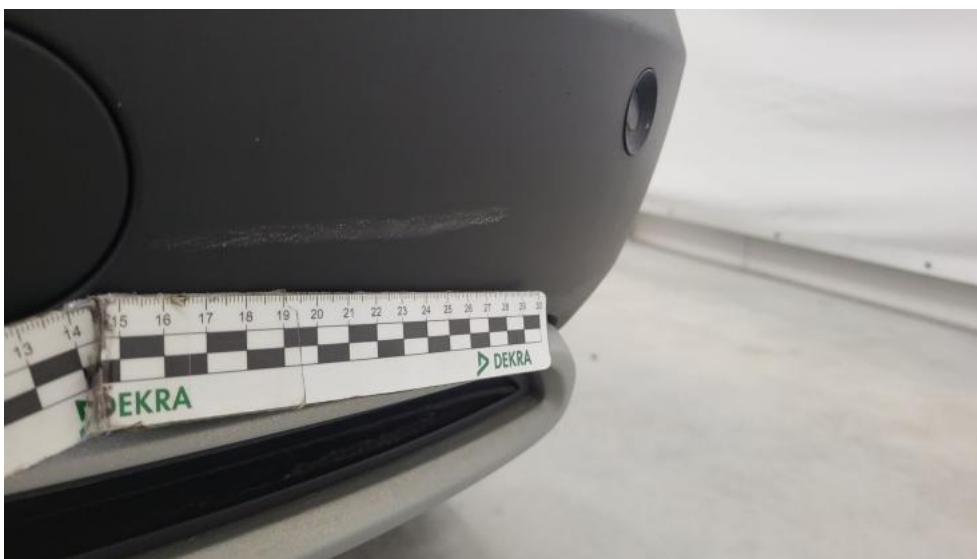
**Photo 53.**

Zderzak tylny - Rysa/odprysk 1

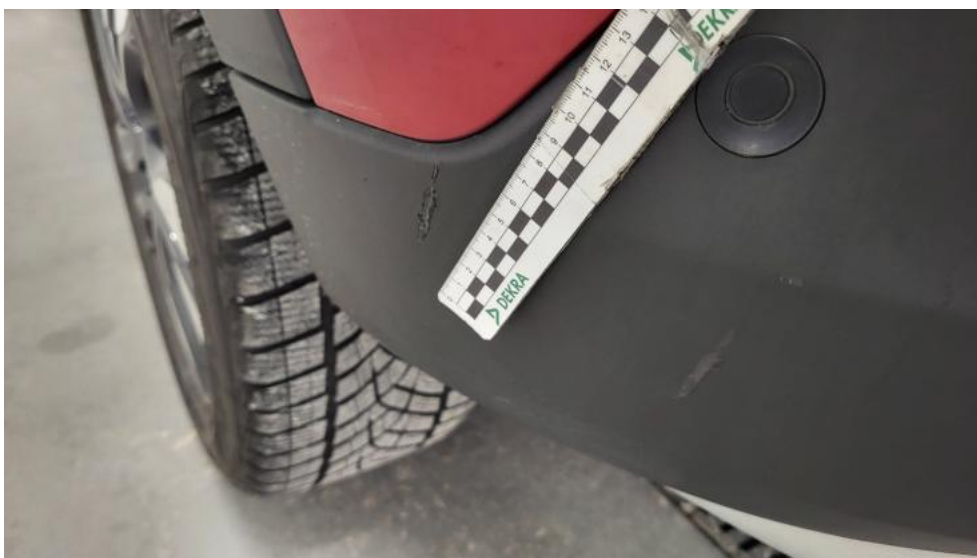
**Photo 54.**

Zderzak tylny - Rysa/odprysk 2

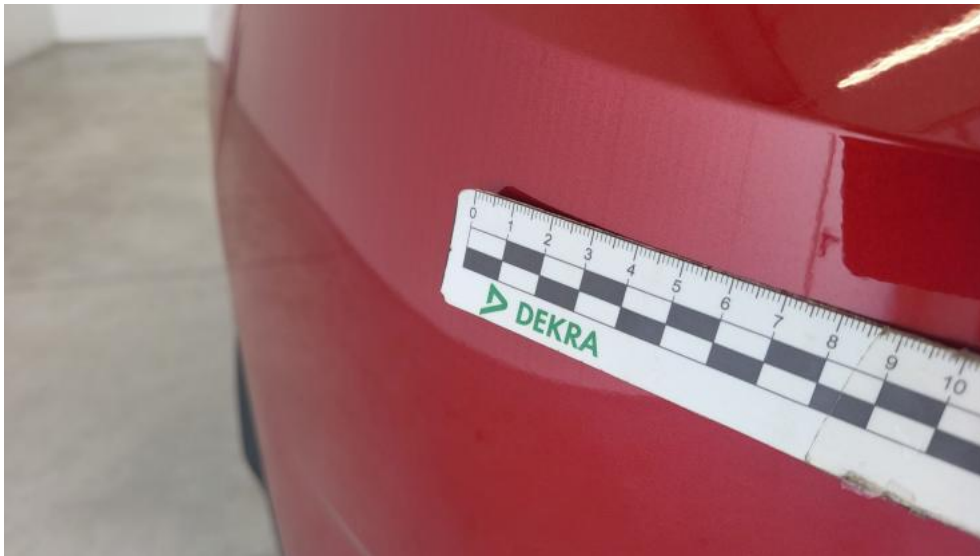
**Photo 55.**

Zderzak tylny cz L - Rysa/odprysk 1

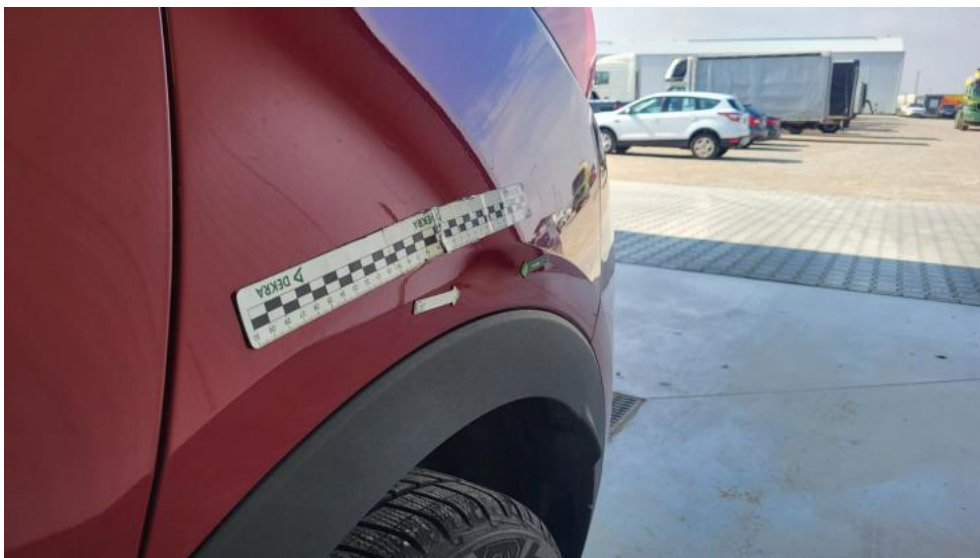
**Photo 56.**

Ścianka tylna L / Ścianka boczna L - Wgniecenie/odkształcenie 1

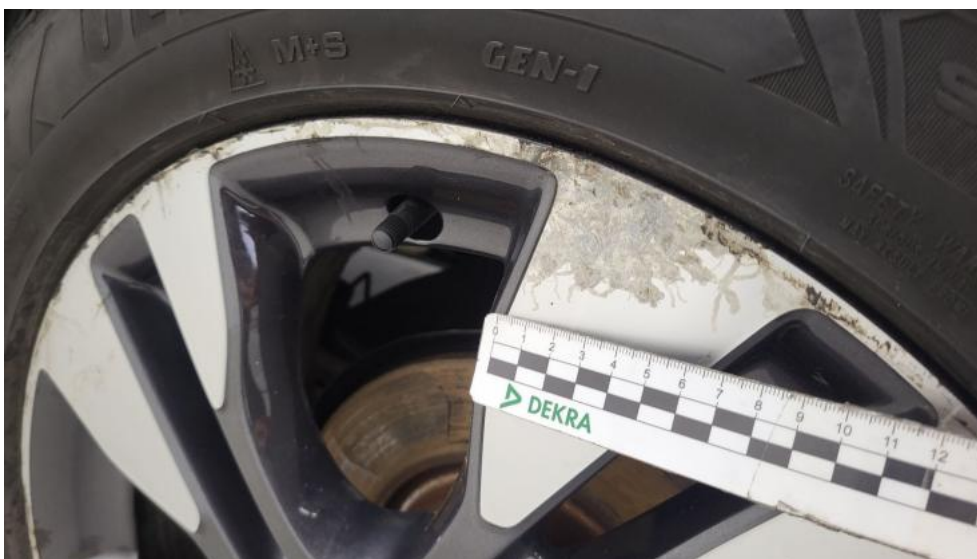
**Photo 57.**

Felga aluminiowa tylna L - Rysa/odprysk 1

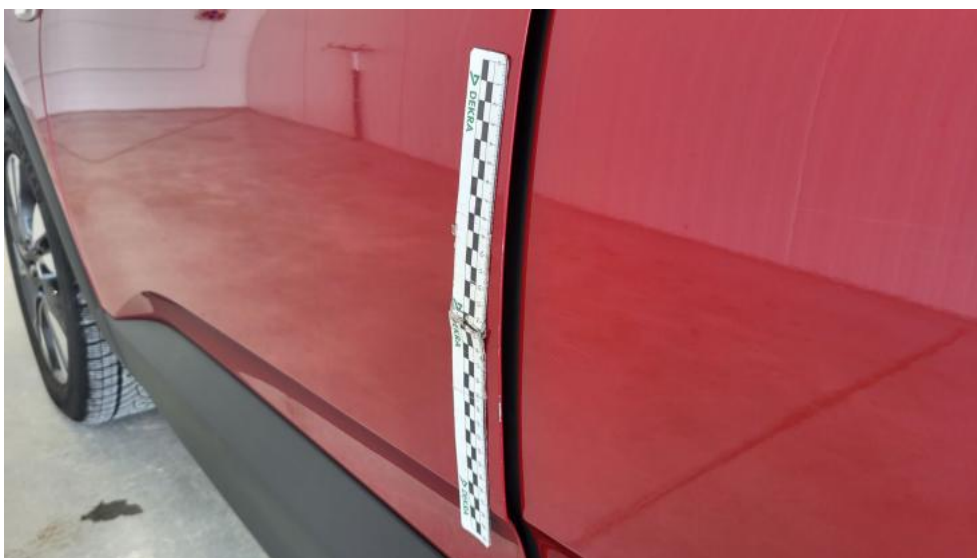
**Photo 58.**

Drzwi przed L - Rysa/odprysk 1

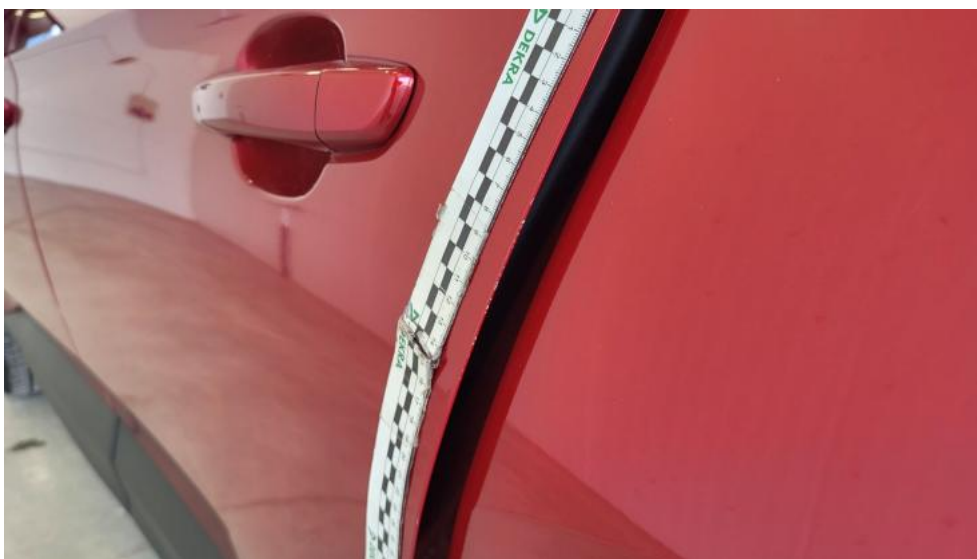
**Photo 59.**

Drzwi tylne L - Rysa/odprysk 1

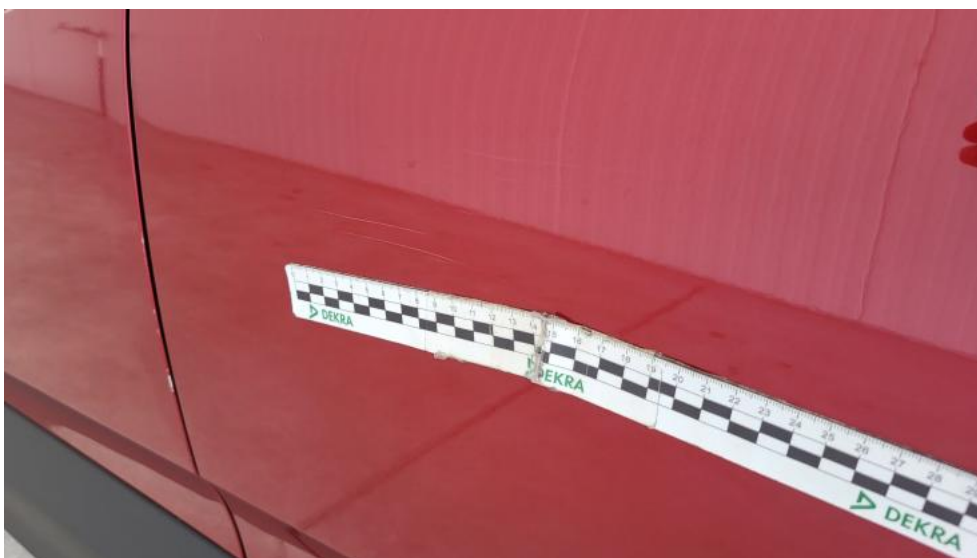
**Photo 60.**

Drzwi tylne L - Rysa/odprysk 2

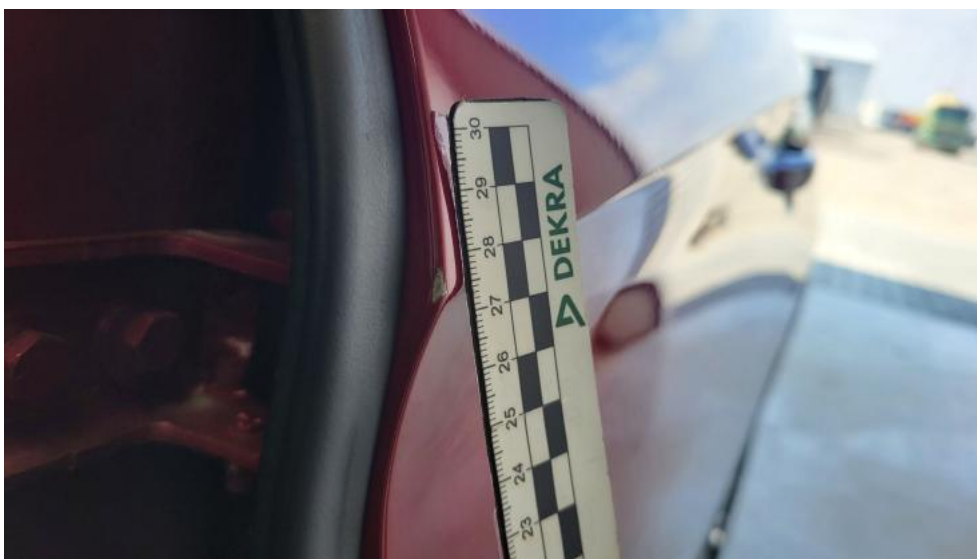
**Photo 61.**

Drzwi tylne L() - Rysa/odprysk 3

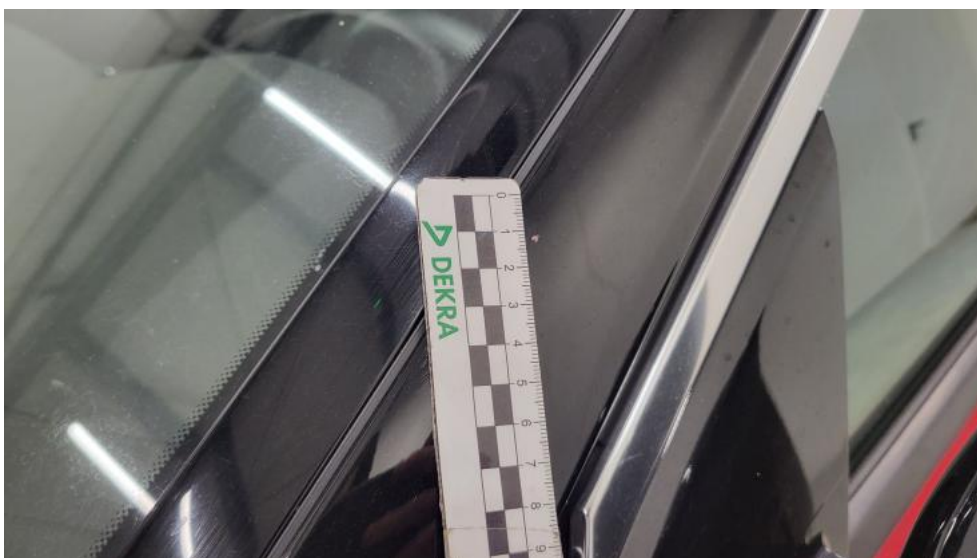
**Photo 62.**

Słupek przedni L - Rysa/odprysk 1

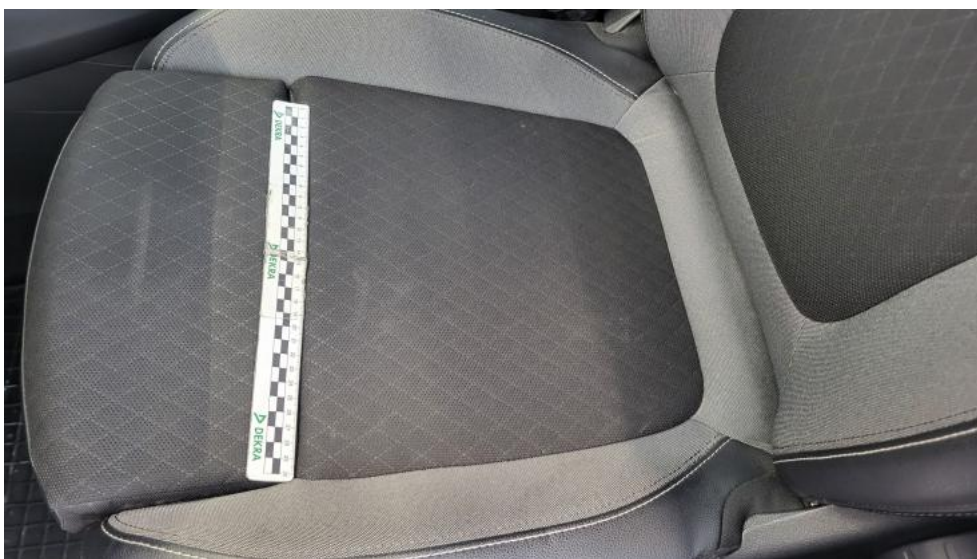
**Photo 63.**

Fotel prz. lew. - Inne 1

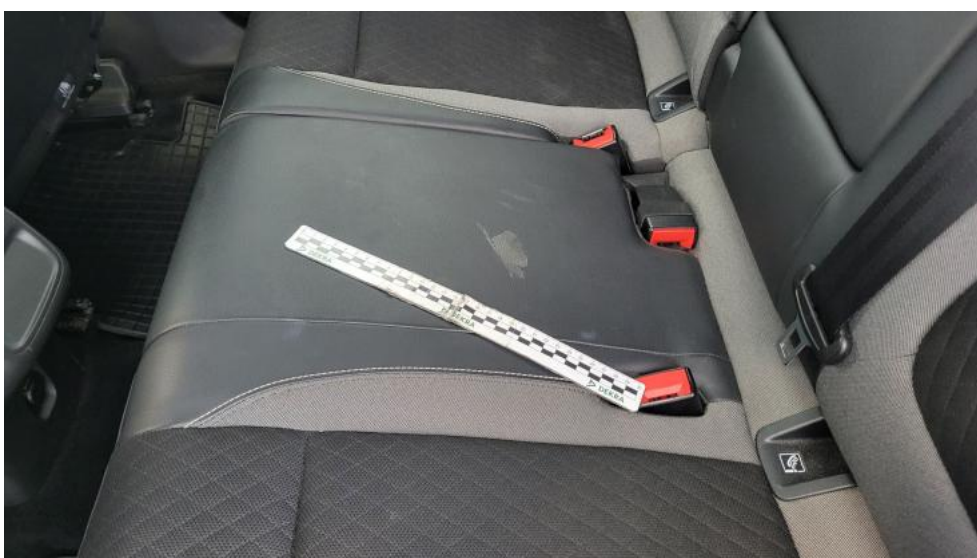
**Photo 64.**

Kanapa tyl. - Inne 1

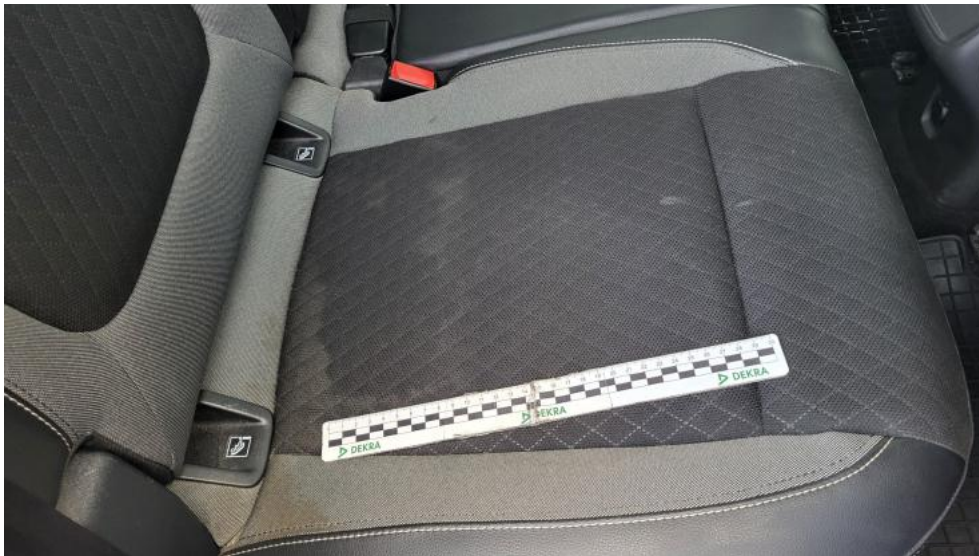
**Photo 65.**  
Kanapa tyl. - Inne 2

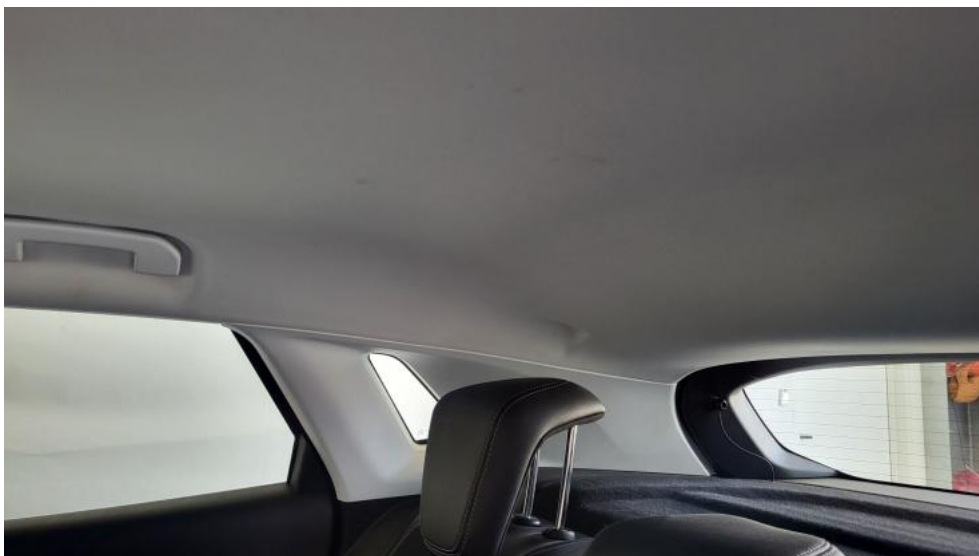
**Photo 66.**  
Podsufitka - Inne 1

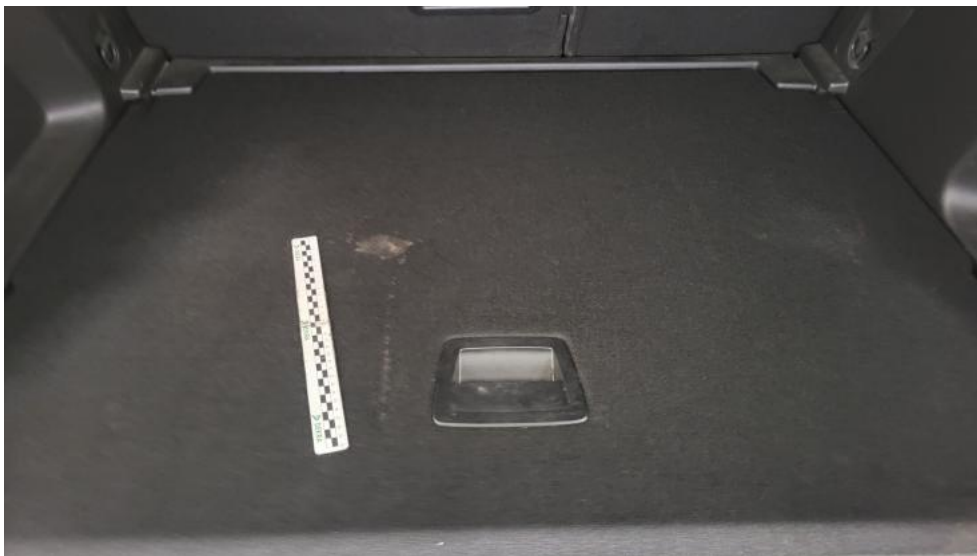
**Photo 67.**

Wykładzina podłogi bagażnika - Inne 1
