DEKRA's commission No. : PKOL(W)/LODZ/36435/25/05/20  
commission/ damage No. : FUTURA  
Date of commission: 20-05-2025

| Manufacturer | NISSAN |
| Model | Leaf 17-22 |
| Registration /record No. | WD2015R |

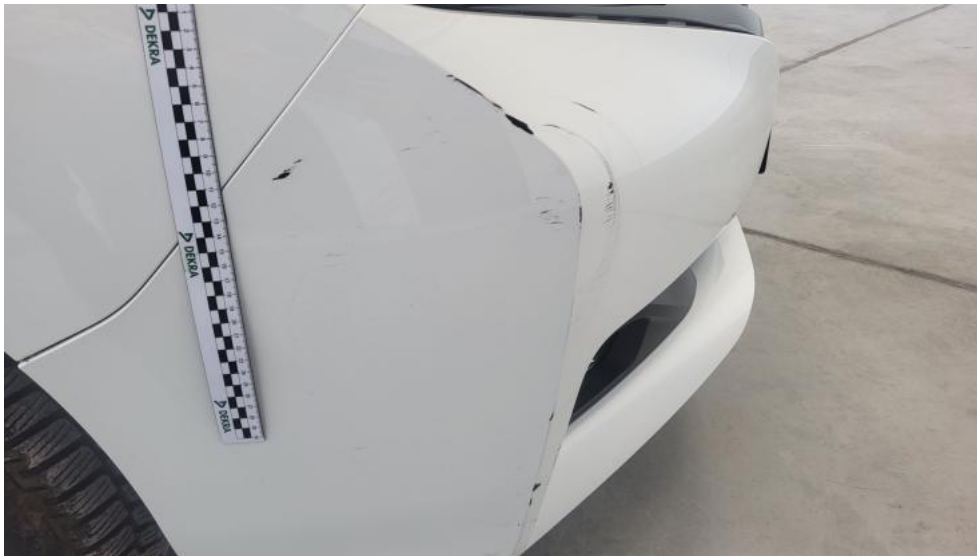
**Photo 45.**

Zderzak - Rysa/odprysk 1

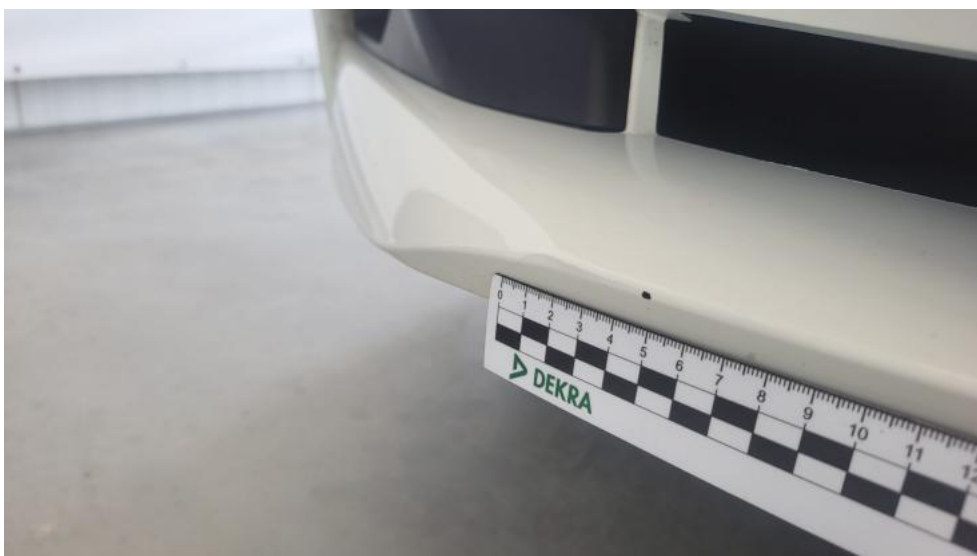
**Photo 46.**

Zderzak - Wgniecenie/odkształcenie 1

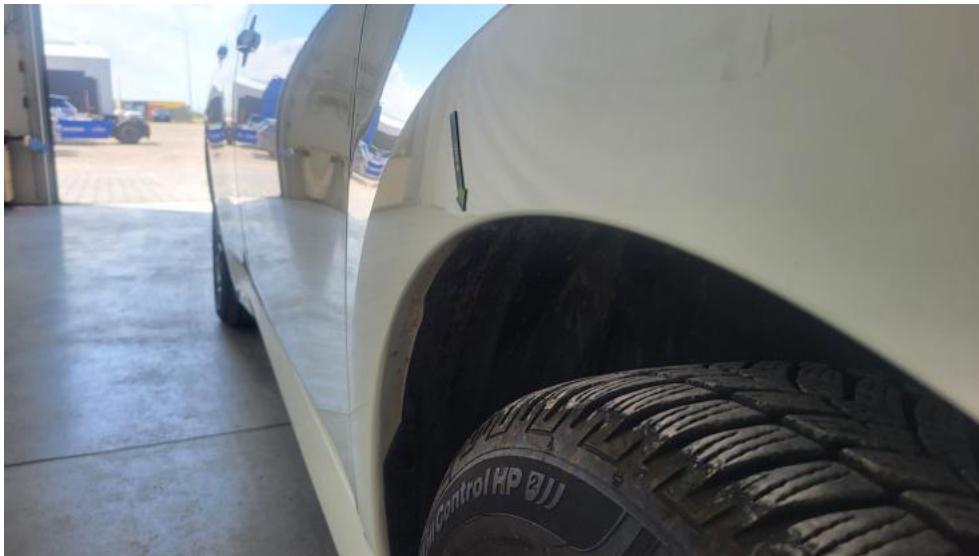
**Photo 47.**

Błotnik przedni P - Wgniecenie/odkształcenie 1

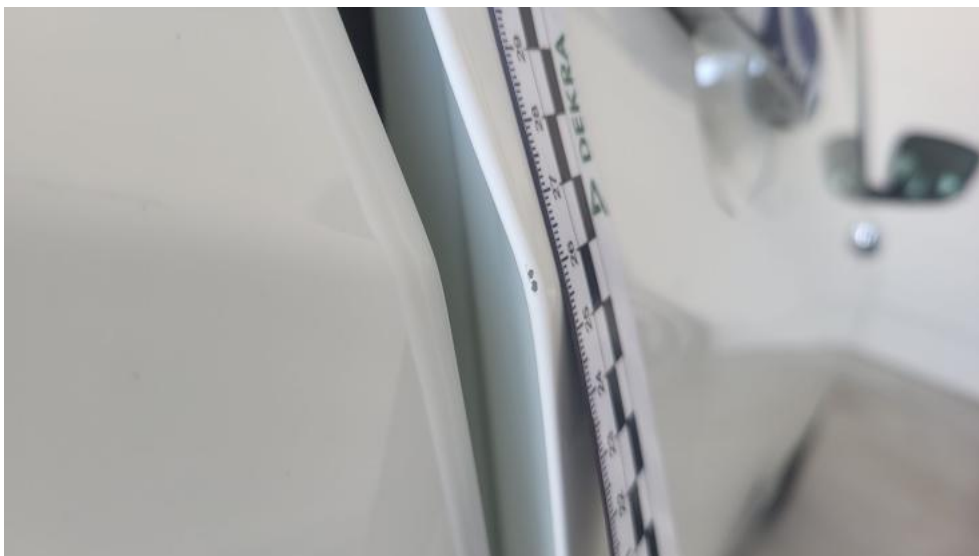
**Photo 48.**

Drzwi tylne P - Rysa/odprysk 1

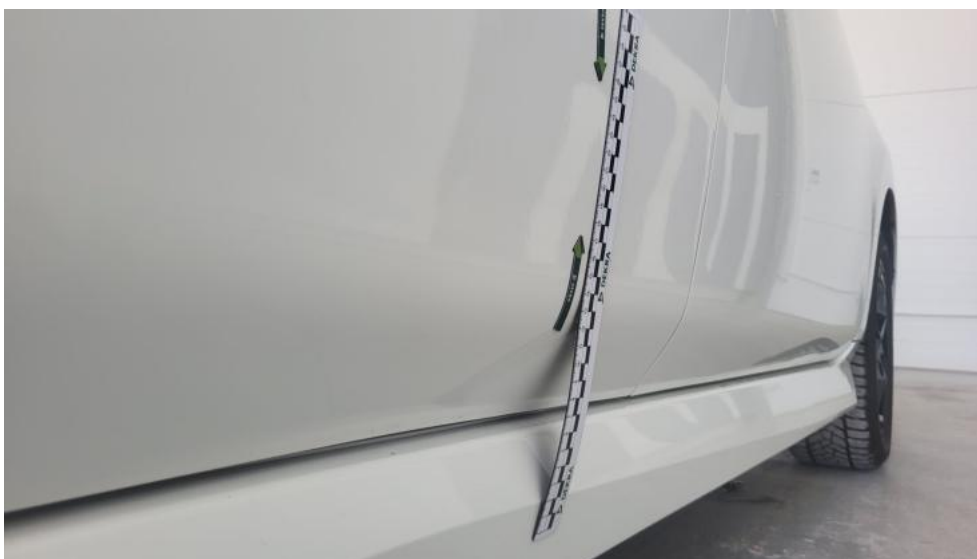
**Photo 49.**

Drzwi tylne P - Wgniecenie/odkształcenie 1

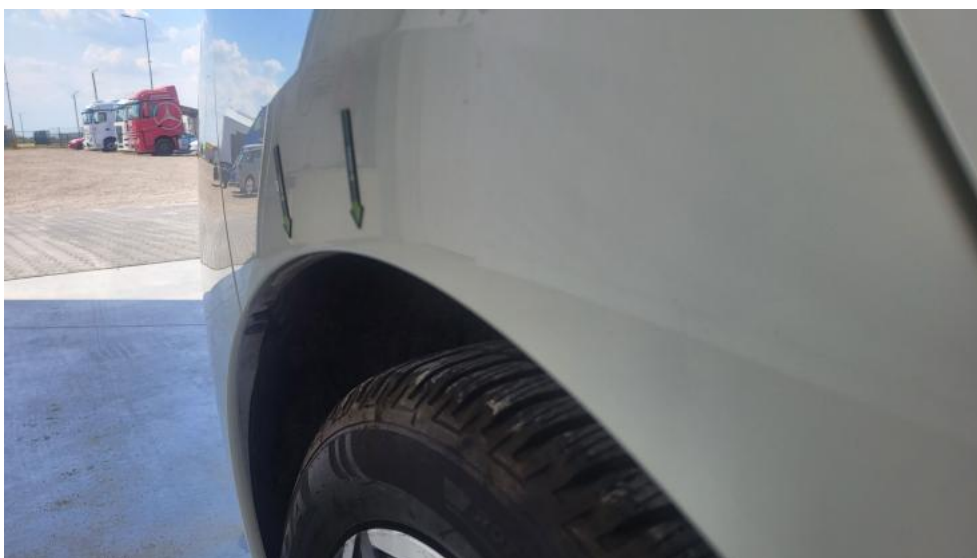
**Photo 50.**

Ścianka tylna P / Ścianka boczna P - Wgniecenie/odkształcenie 1

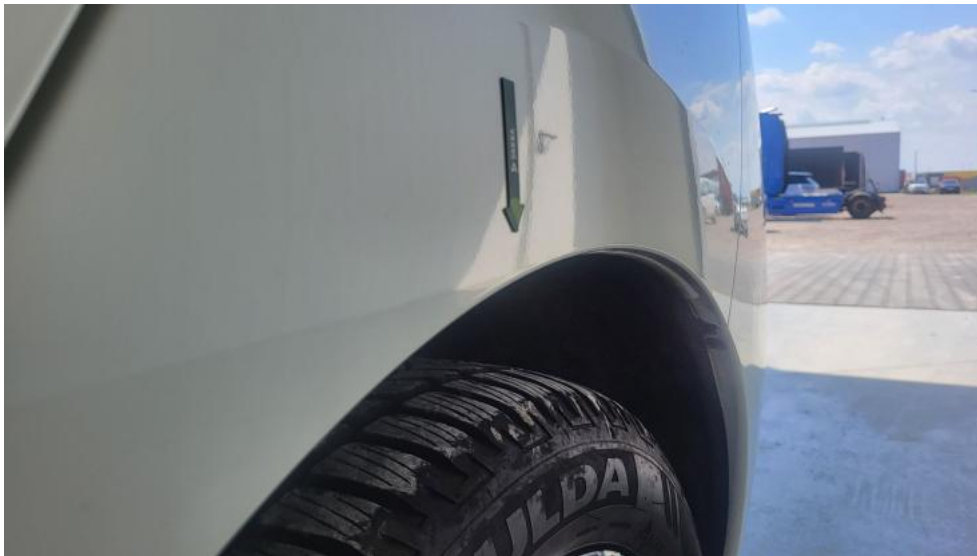
**Photo 51.**

Błotnik tylny L / Ściana boczna L - Wgniecenie/odkształcenie 1

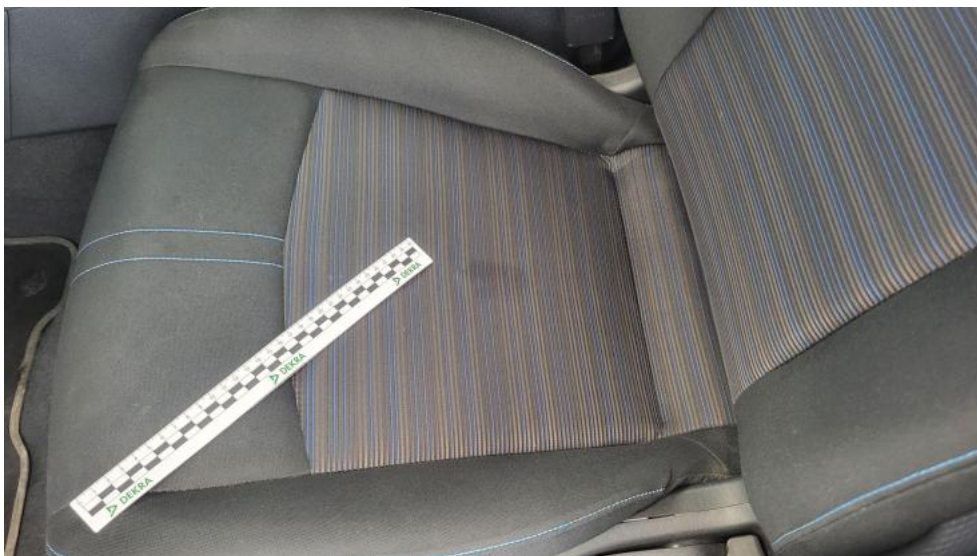
**Photo 52.**

Fotel prz. lew. - Inne 1

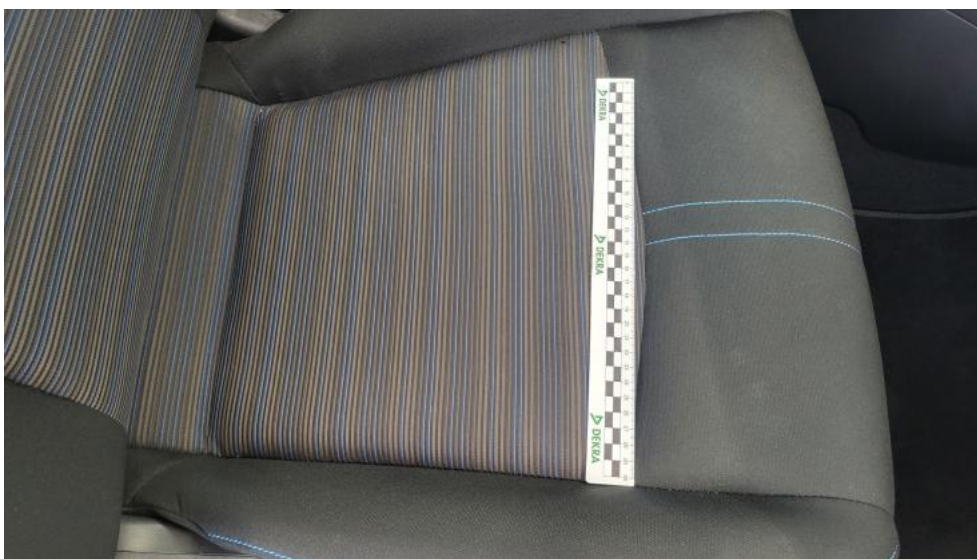
**Photo 53.**

Fotel prz. praw. - Inne 1

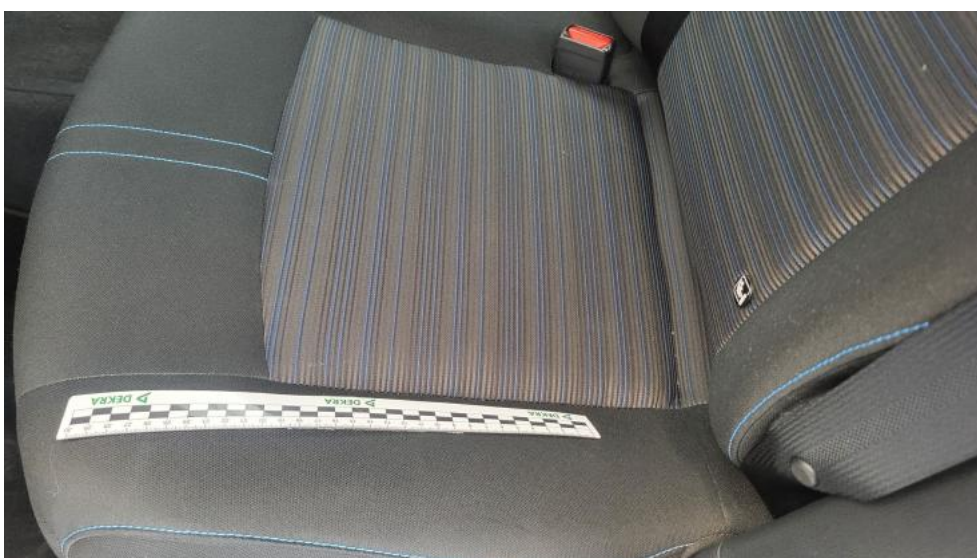
**Photo 54.**

Kanapa tyl. - Inne 1
