DEKRA's commission No. : PKOL(W)/LODZ/30364/25/04/28  
commission/ damage No. : 23/033529  
Date of commission: 28-04-2025

PKO Leasing SA  
Świętokrzyska 36  
00-116 Warszawa

| Manufacturer | CITROEN |
| Model | Berlingo Van 1.5 BlueHDI Euro 6 1499ccm - 102KM |

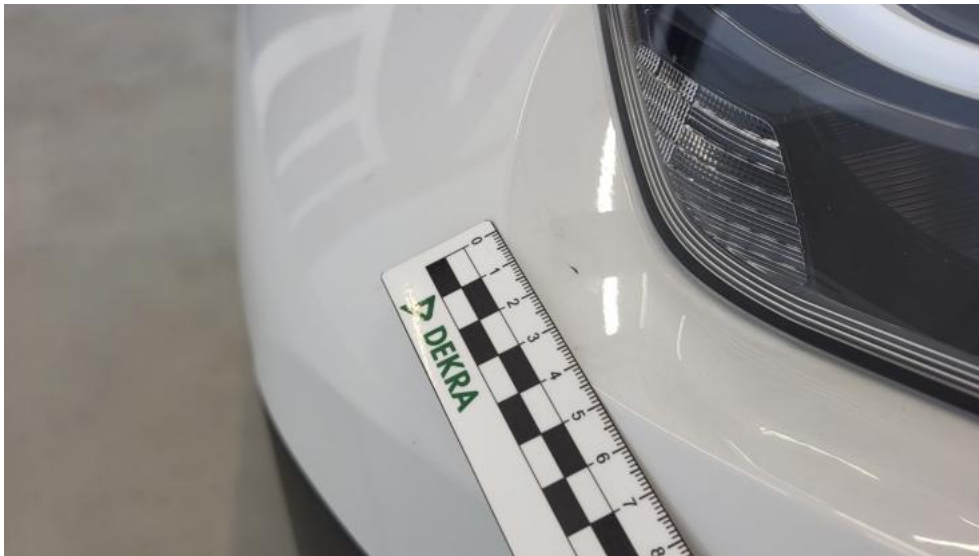
**Photo 31.**

Zderzak - Rysa/odprysk 1

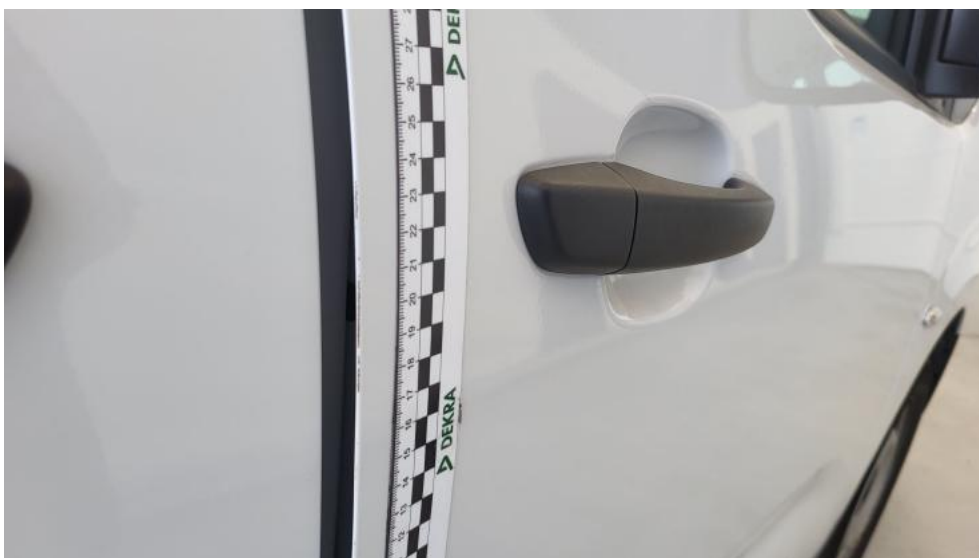
**Photo 32.**

Drzwi przednie P - Rysa/odprysk 1

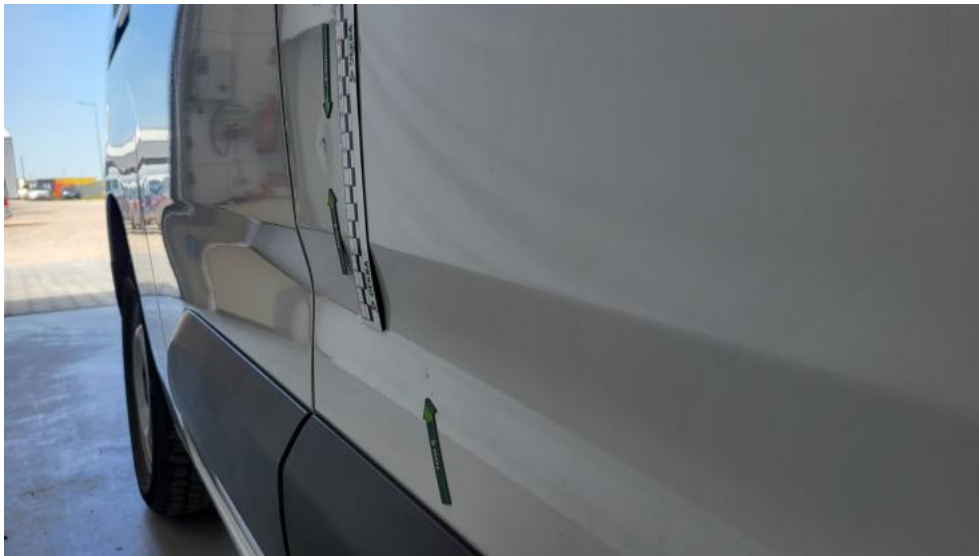
**Photo 33.**

Drzwi przednie P - Wgniecenie/odkształcenie 1

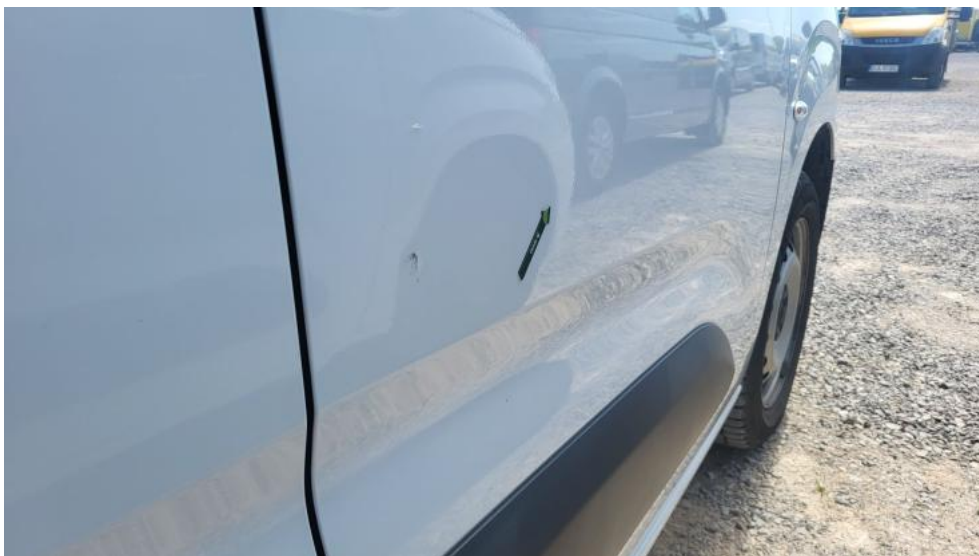
**Photo 34.**

Drzwi przednie P - Wgniecenie/odkształcenie 2

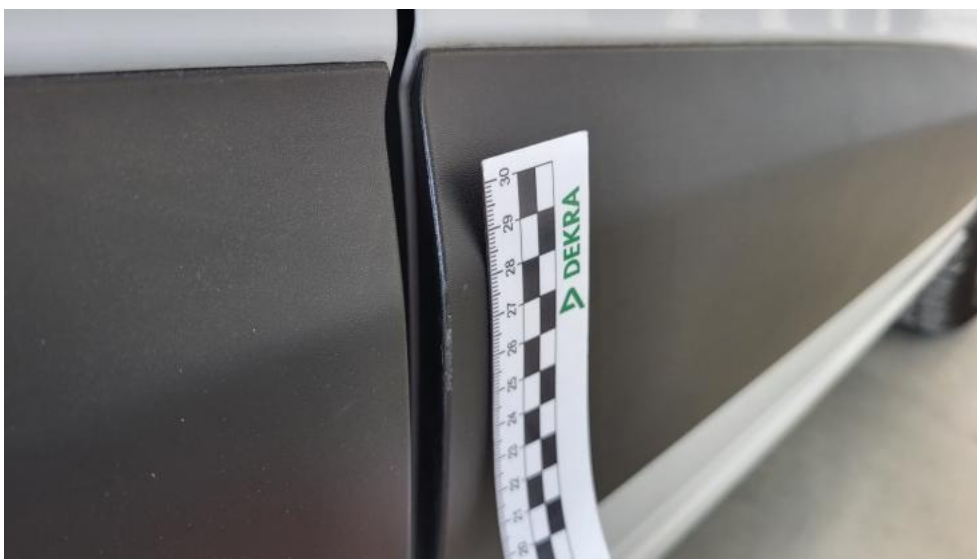
**Photo 35.**

Listwa drzwi przednich P - Rysa/odprysk 1

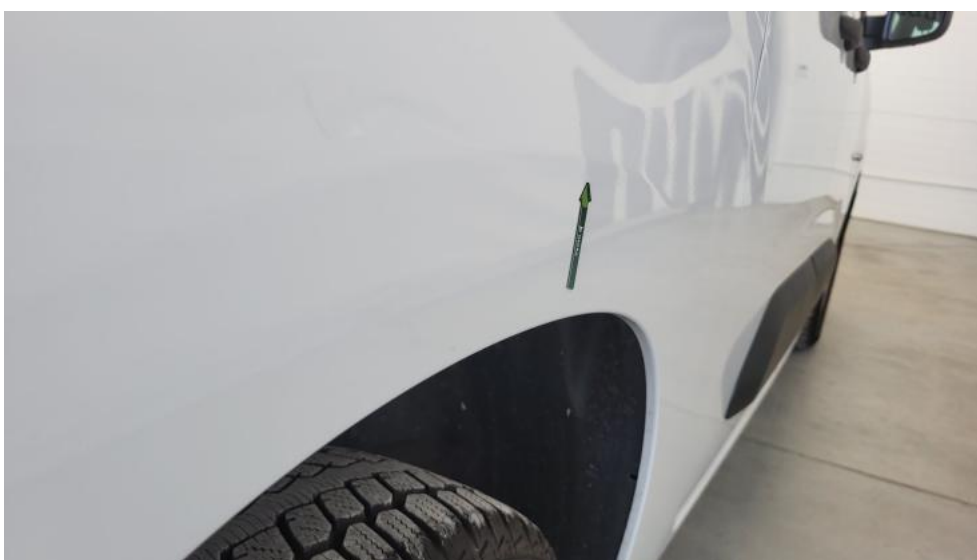
**Photo 36.**

Łotnik tylny P / Ściana boczna P - Wgniecenie/odkształcenie 1

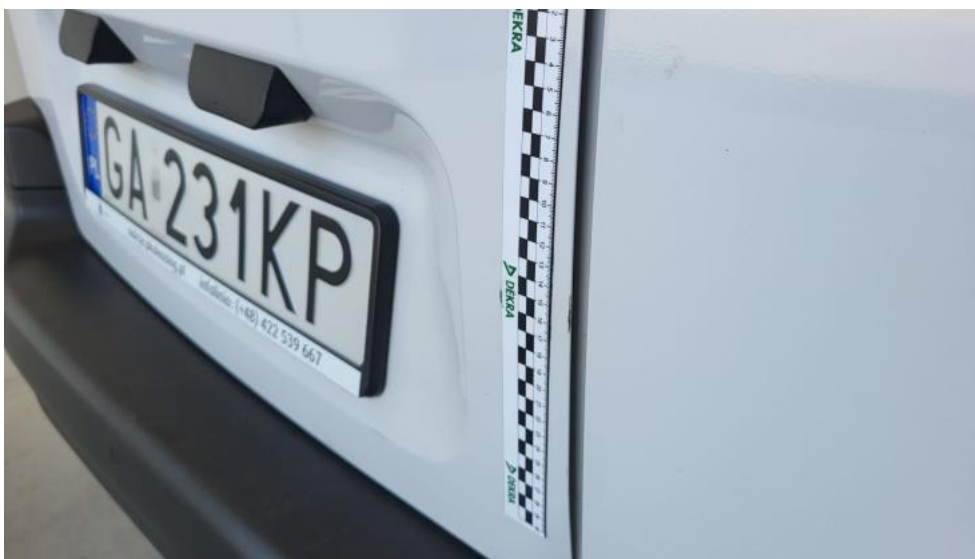
**Photo 37.**

Pokrywy bagażnika - Rysa/odprysk 1

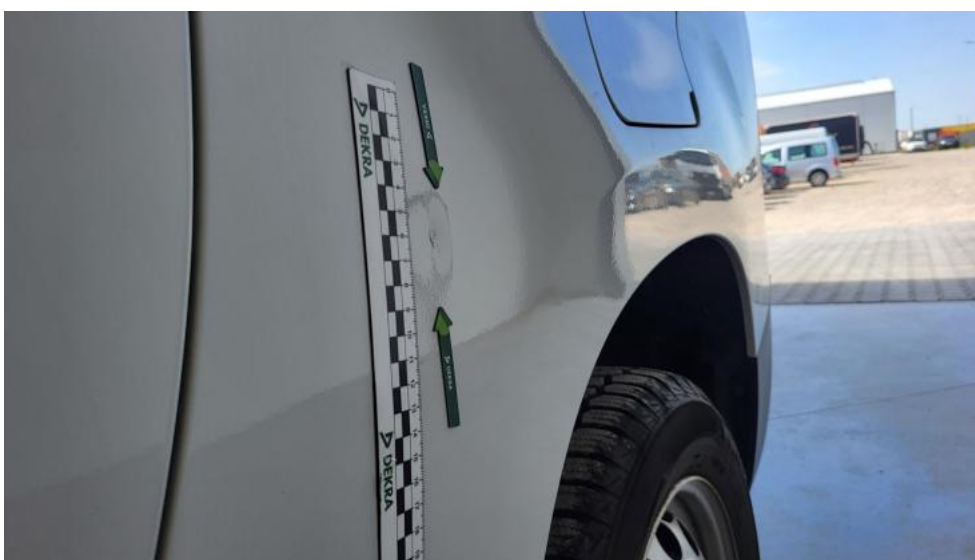
**Photo 38.**

Łotnik tylny L / Ściana boczna L - Wgniecenie/odkształcenie 1

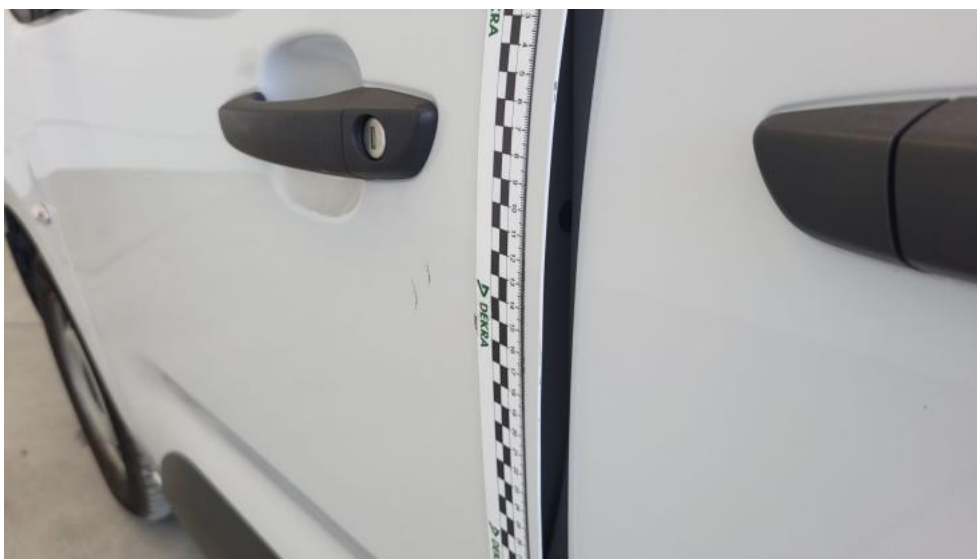
**Photo 39.**

Drzwi przed L - Rysa/odprysk 1

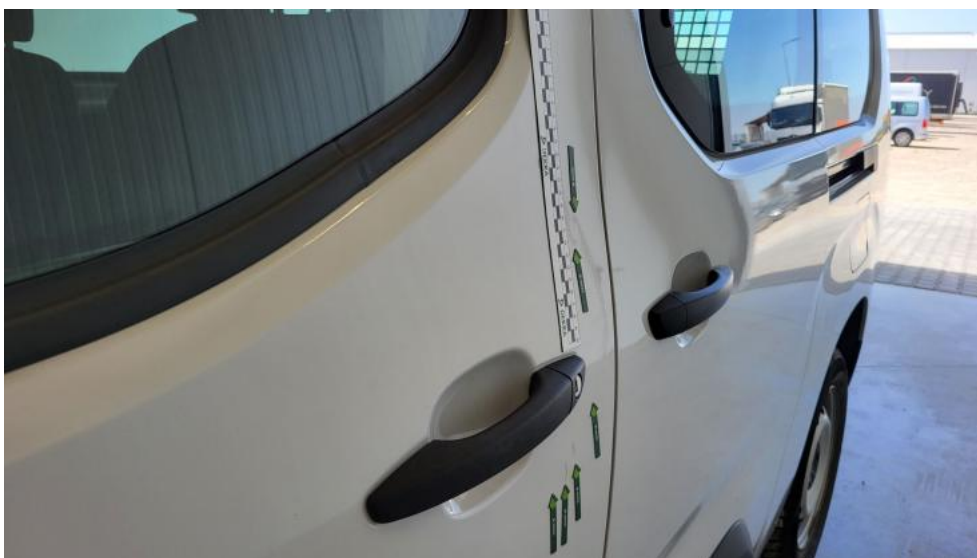
**Photo 40.**

Drzwi przed L - Wgniecenie/odkształcenie 1

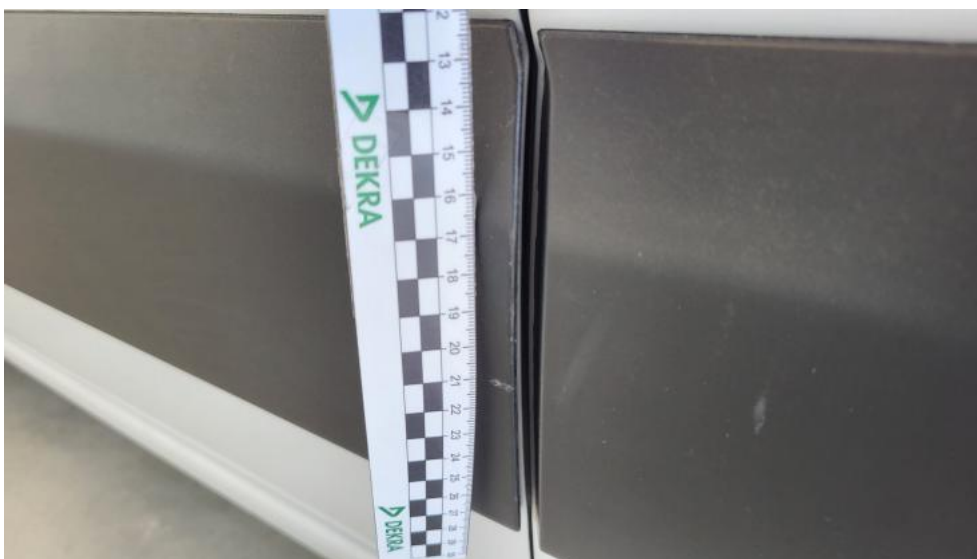
**Photo 41.**

Listwa drzwi przednich L - Rysa/odprysk 1

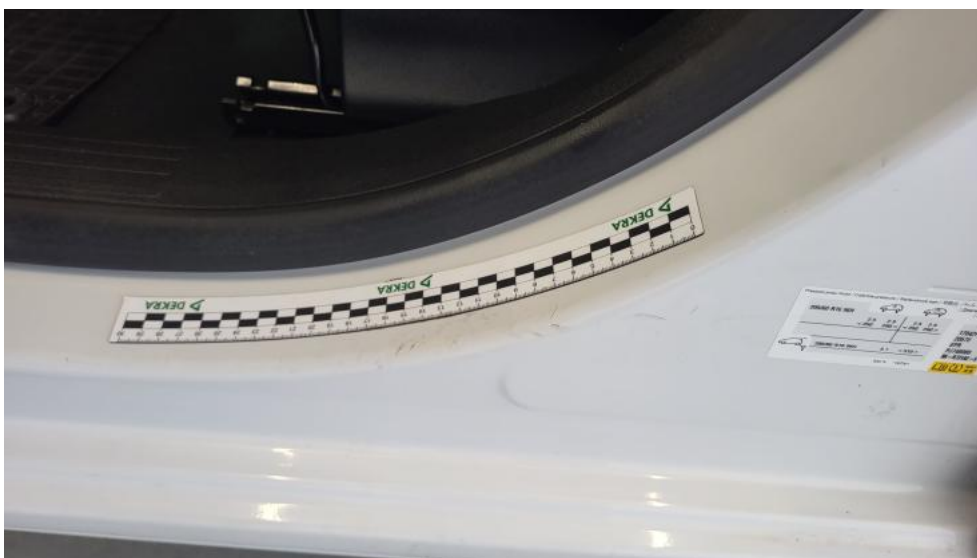
**Photo 42.**

Próg L - Rysa/odprysk 1

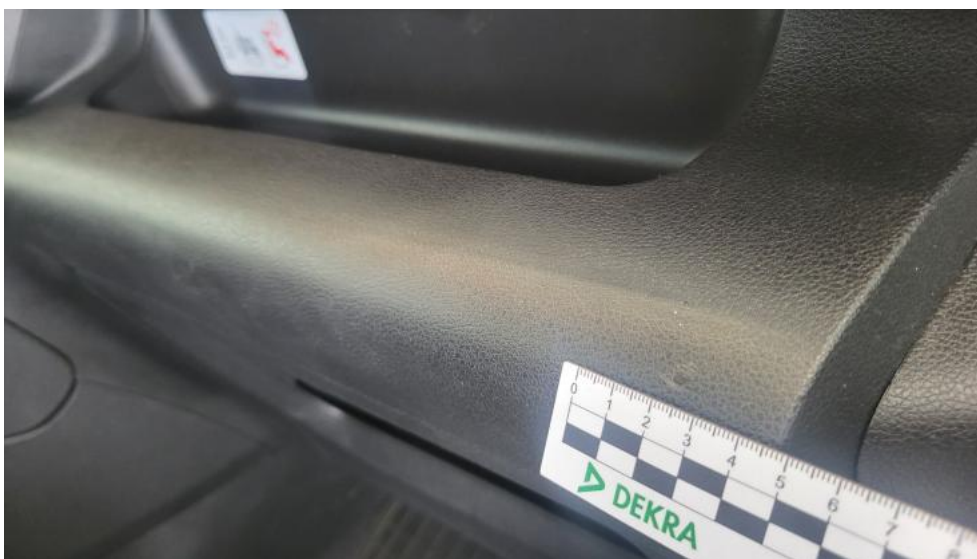
**Photo 43.**

Deska rozdzielcza - Rysa/odprysk 1

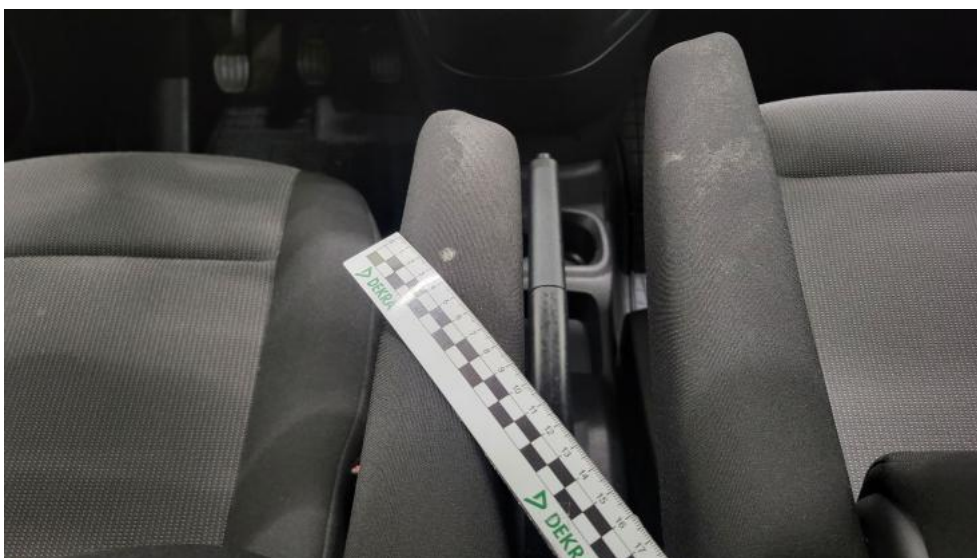
**Photo 44.**

Podłokietnik środkowy przedni - Inne 1

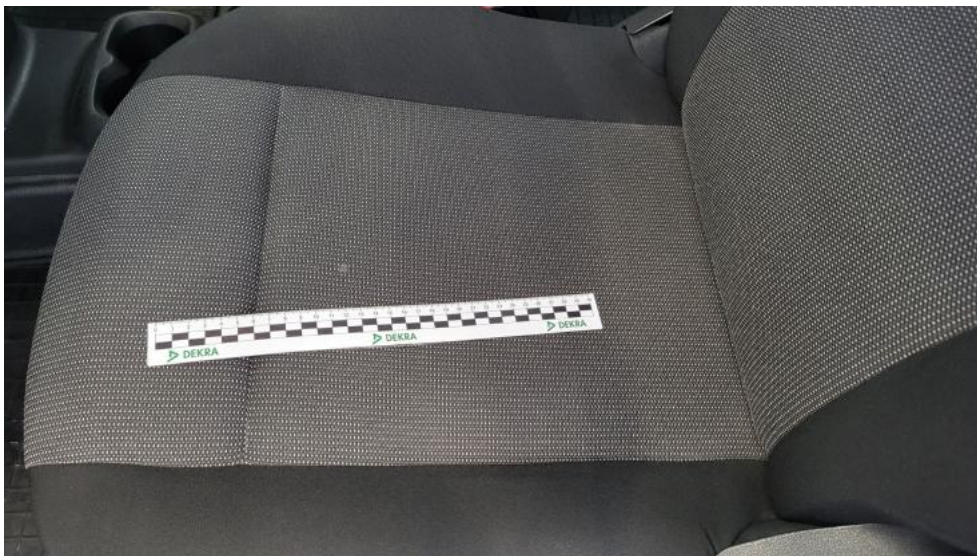
**Photo 45.**

Fotel prz. lew. - Inne 1

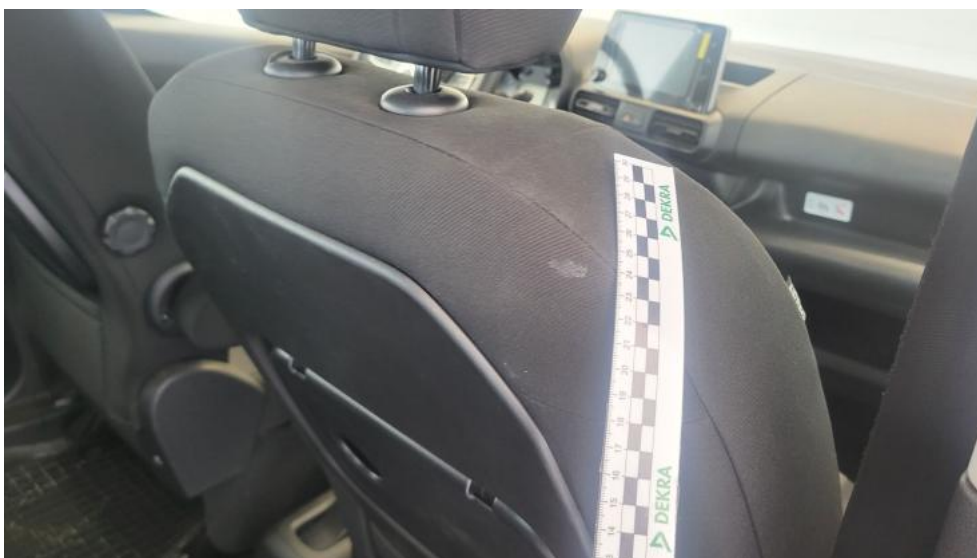
**Photo 46.**

Fotel prz. praw. - Inne 1

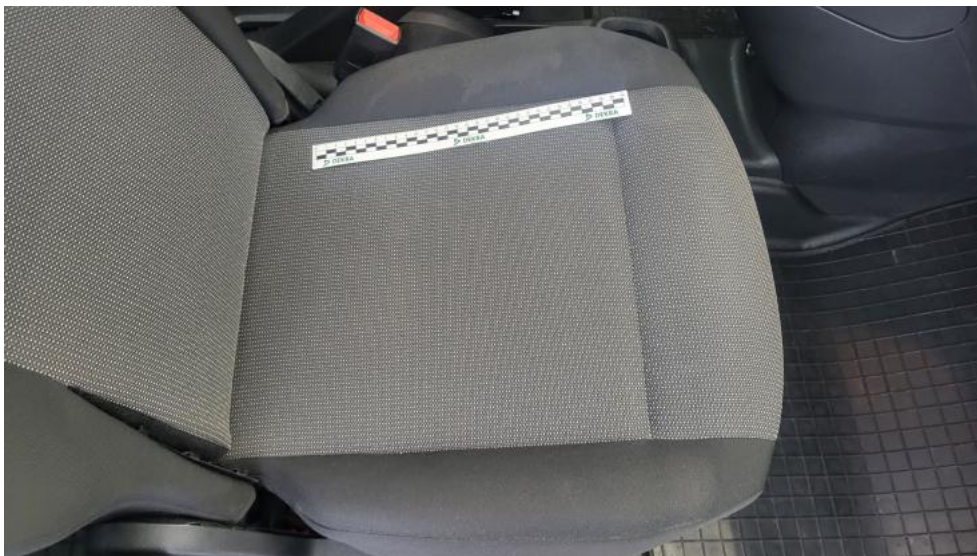
**Photo 47.**  
Fotel prz. praw. - Inne 2

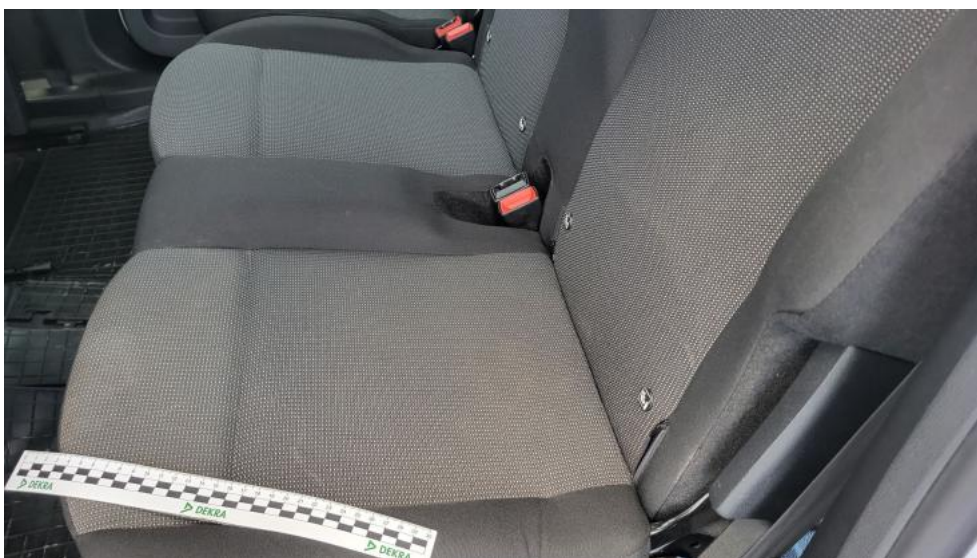
**Photo 48.**  
Kanapa tyl. - Inne 1

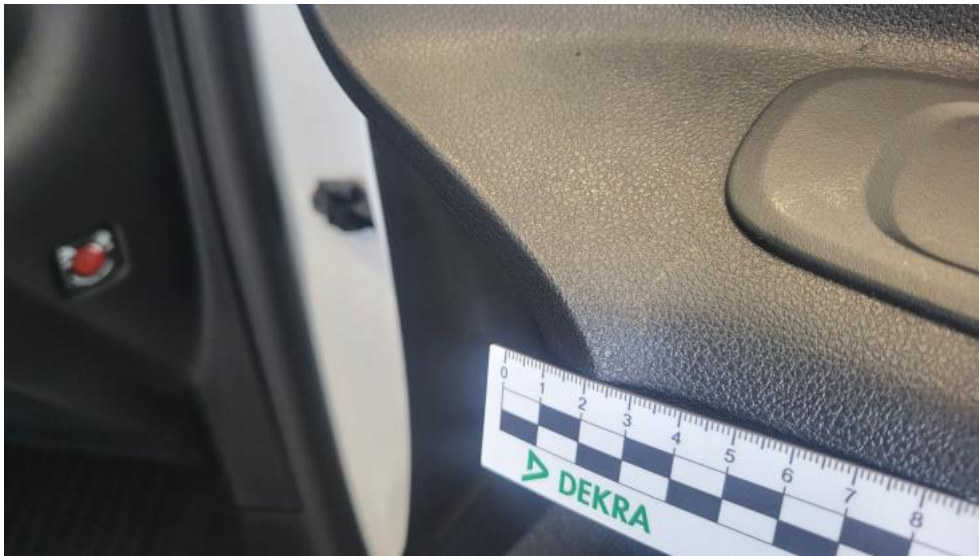
**Photo 49.**

Tapicerka drzwi przednich P - Rysa/odprysk 1

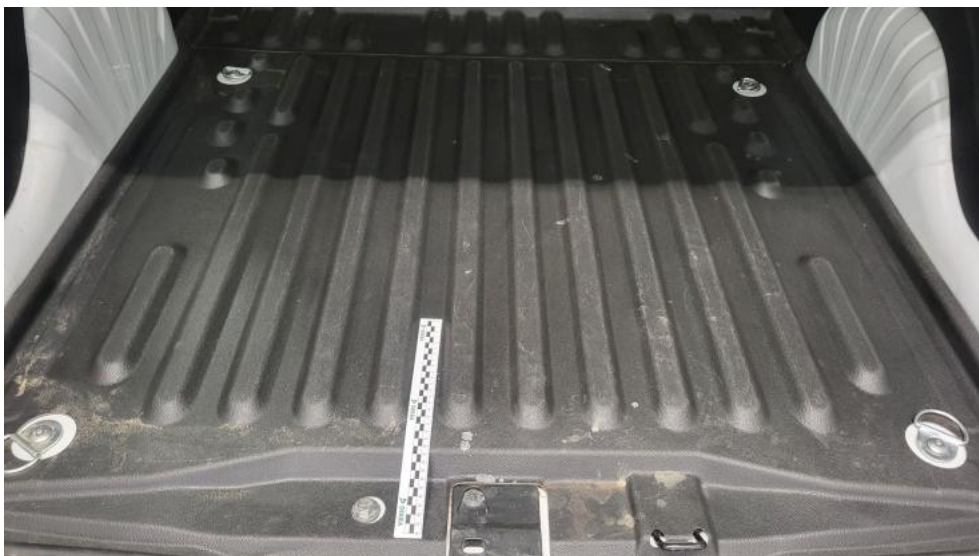
**Photo 50.**

Wykładzina podłogi bagażnika - Inne 1

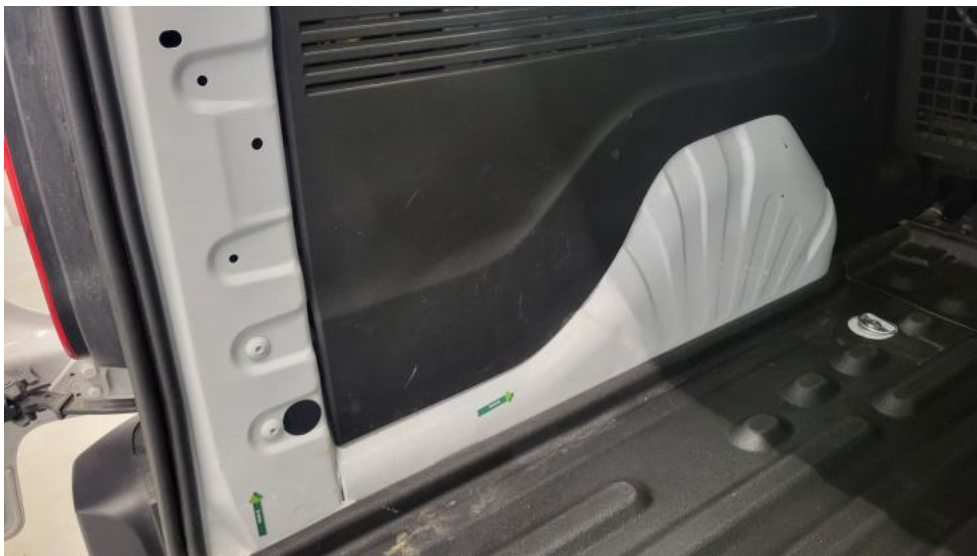
**Photo 51.**

Ściana lewa - Wgniecenie/odkształcenie 1

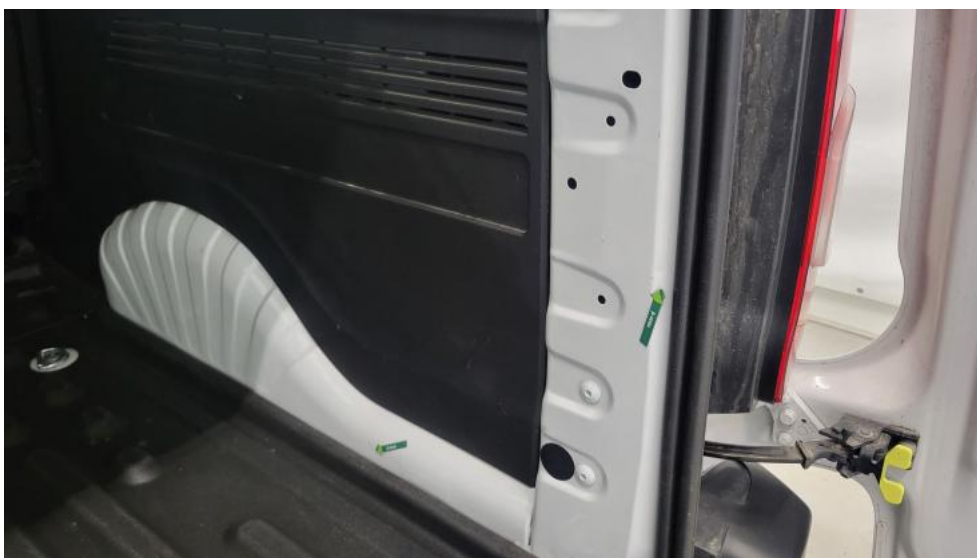
**Photo 52.**

Ściana prawa - Wgniecenie/odkształcenie 1
