DEKRA's commission No. : PKOL(W)/LODZ/14018/25/02/24
commission/ damage No. : 22/032333
Date of commission: 24-02-2025

Vehicle data

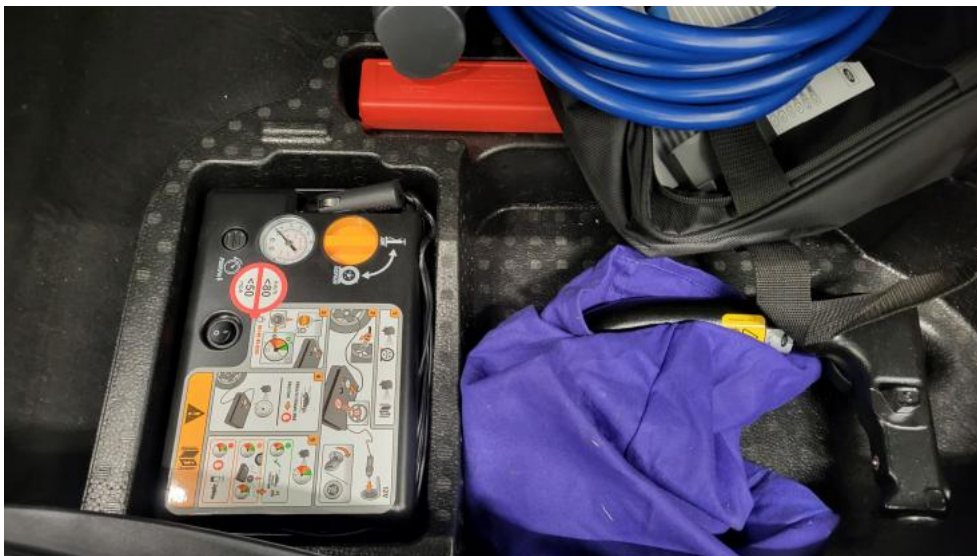
Rysy na samochodzie. Pojazd posiada hak. Brak płynu zestawu naprawczego. Moc silnika potwierdzona w ASO Gołębiewski.

Photo 35.
Zestaw naprawczy koła

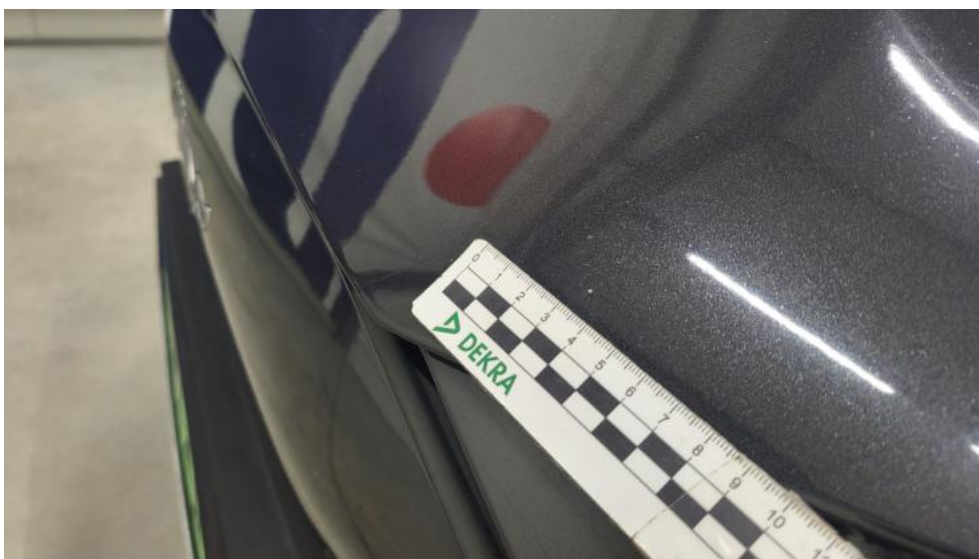
Photo 49.

Pokrywa komory silnika - Rysa/odprysk 1

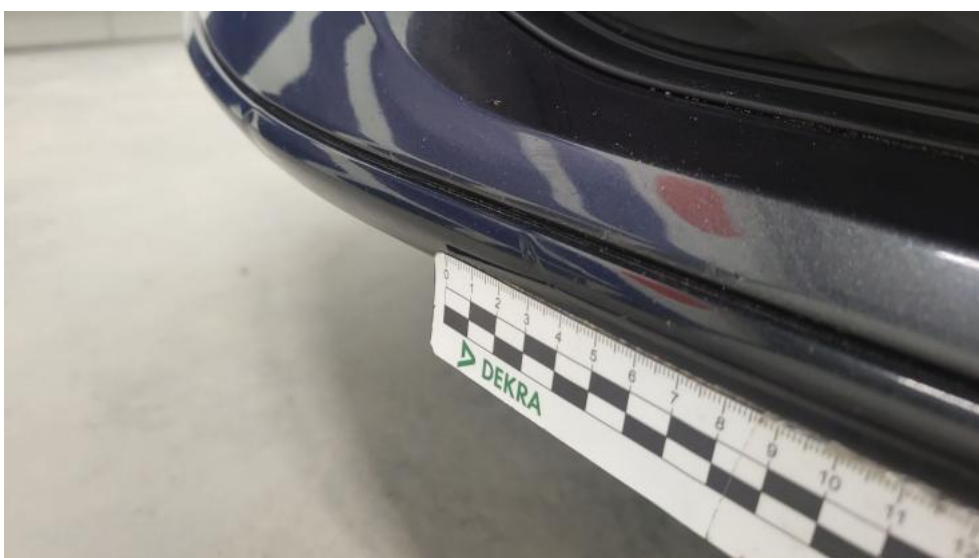
Photo 50.

Spoiler zderzaka przedniego - Wgniecenie/odkształcenie 1

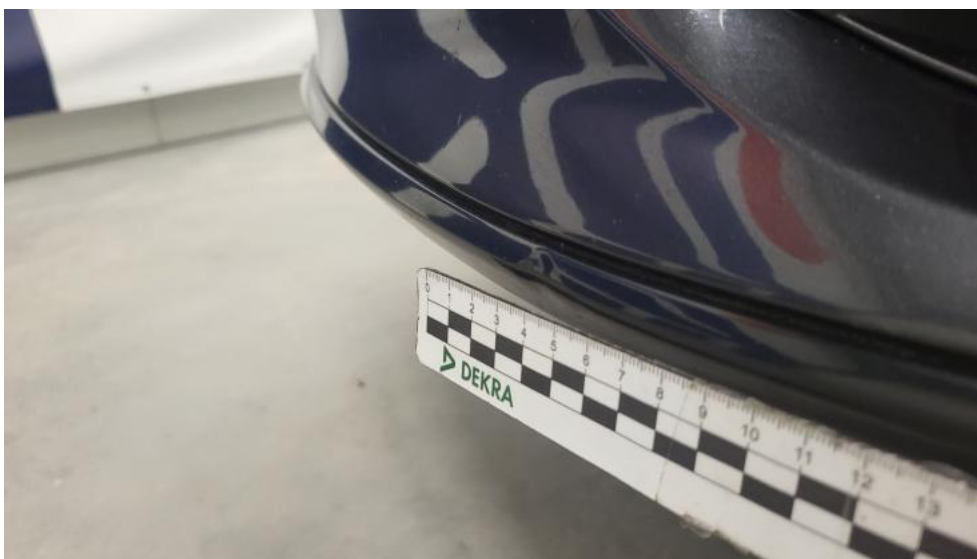
Photo 51.

Spoiler zderzaka przedniego - Wgniecenie/odkształcenie 2

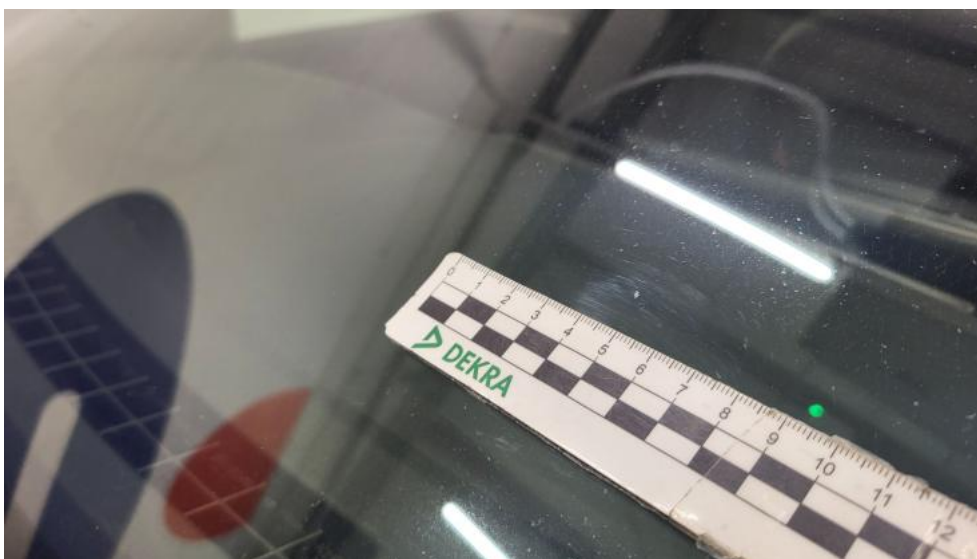
Photo 53.
Szyba czołowa ogrzewana - Rysa/odprysk 1

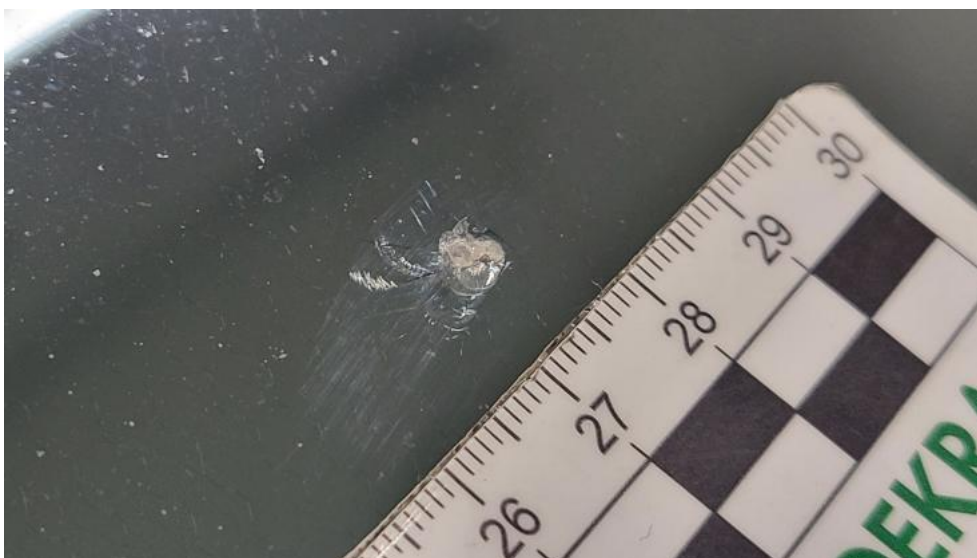
Photo 54.
Szyba czołowa ogrzewana - Pęknięcie/rozerwanie 1

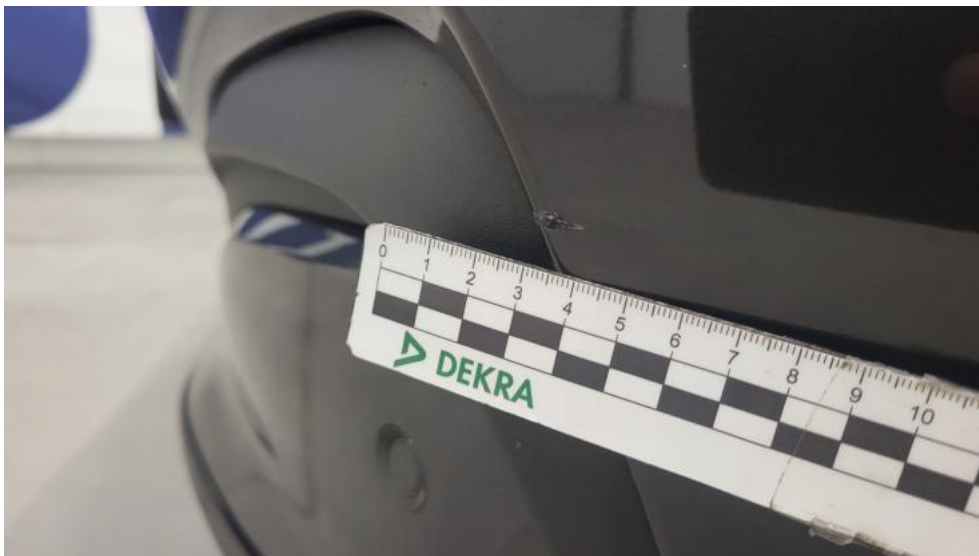
Photo 55.
Zderzak - Rysa/odprysk 1

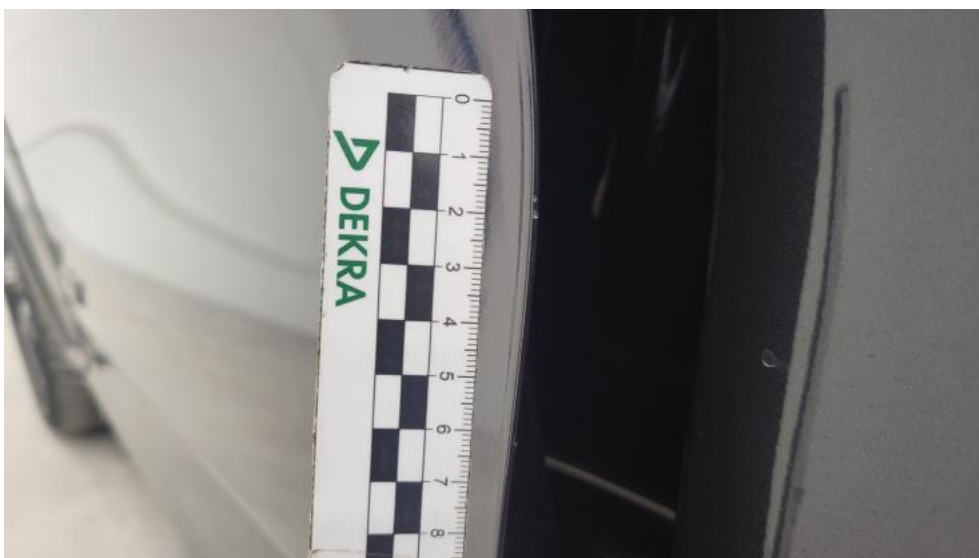
Photo 56.
Drzwi przed L - Rysa/odprysk 1

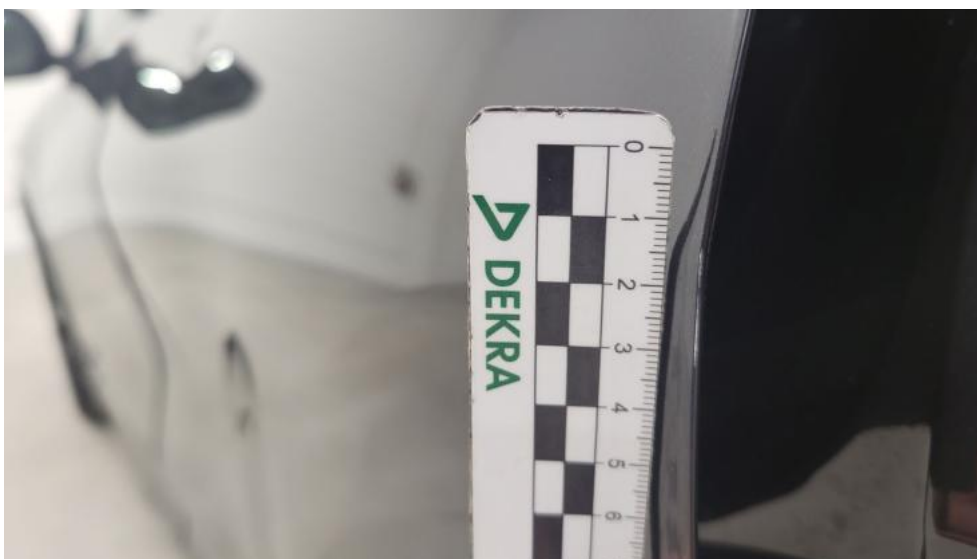
Photo 57.

Drzwi tylne L - Rysa/odprysk 1
