DEKRA's commission No. : PKOL(W)/LODZ/10501/25/02/11
 commission/ damage No. : 21/059066
 Date of commission: 11-02-2025

PKO Leasing SA
 Świętokrzyska 36
 00-116 Warszawa

Group of objects (Eurotax)	cars
EC code (Eurotax)	0152522
Manufacturer	VOLKSWAGEN
Model	ID.4 20-
Type / version	ID.4 77kWh 4Mot. GTX
Body type	hatchback
Number of doors / seats	5/5
Curb weight [kg]	2209
Gross vehicle weight [kg]	2750
Wheelbase 1/2	2769
Engine type	elektryczny
Pollution reduction system	-
Engine capacity [ccm]	0
Engine Power [hp/kW]	299/220
Gearbox	automatic 1- gear
Registration /record No.	GA244FY
VIN / serial number	WVGZZZE2ZNP017201
Date of first registration	15-12-2021
Date of next. tech. test	15-12-2026
Year of manufacture	2021 (year has been verified with the manufacturer's base)
Readout [km]	129 901 (read)
Body color / type of coating	white/UNI

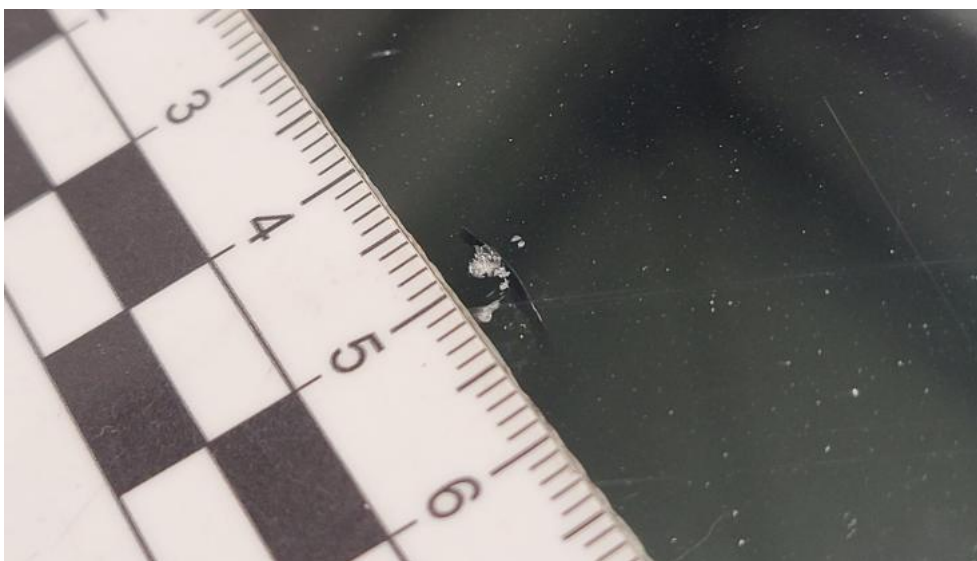
Photo 45.
Szyba czołowa - Pęknięcie/rozerwanie 1

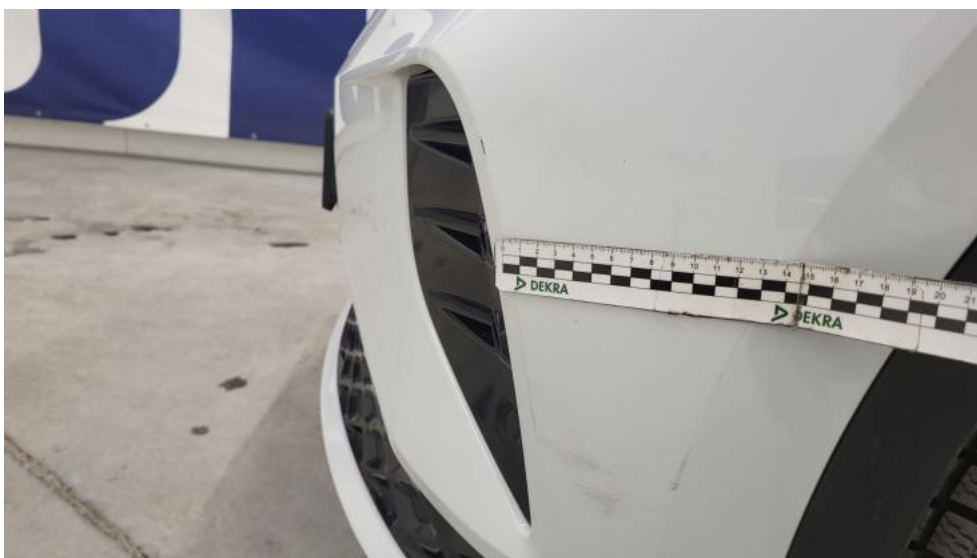
Photo 46.
Zderzak - Rysa/odprysk 1

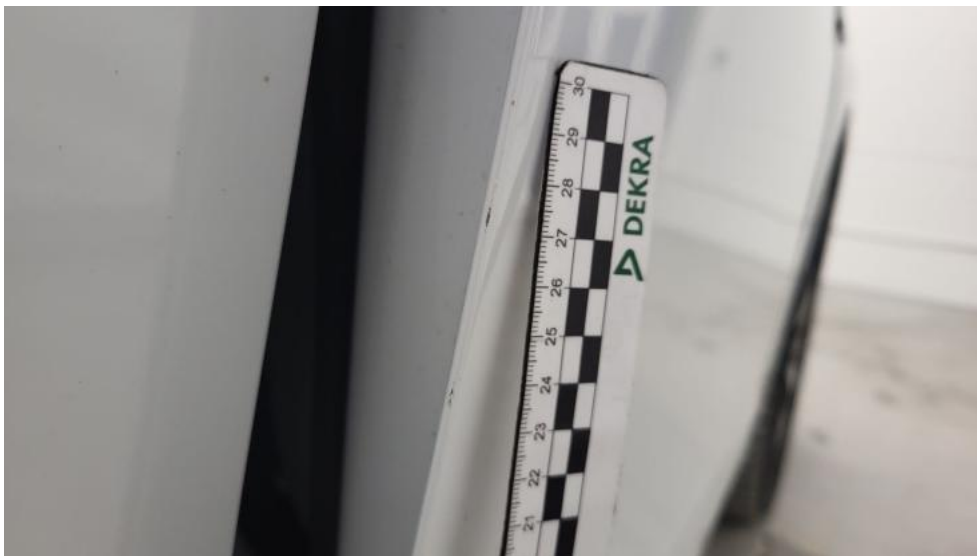
Photo 47.

Drzwi przednie P - Rysa/odprysk 1

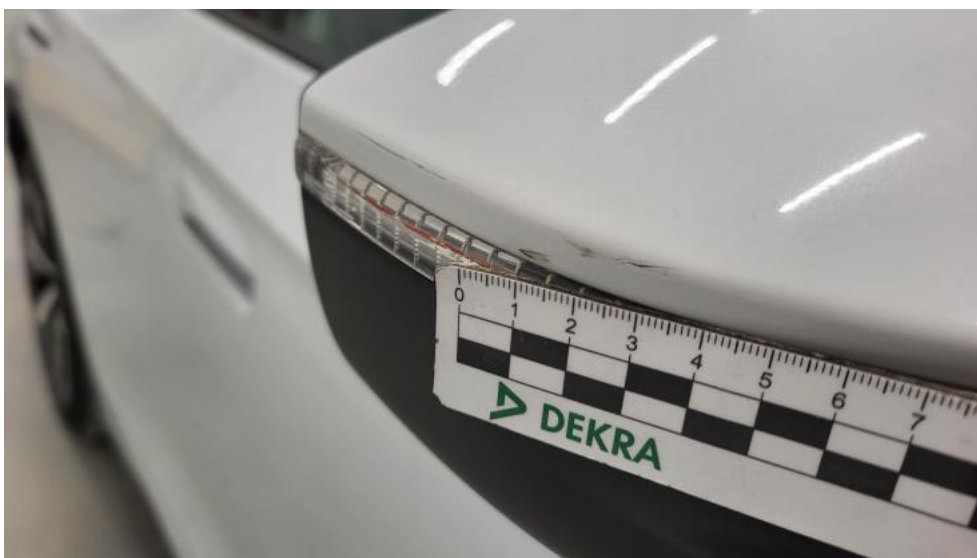
Photo 50.
Lusterko zew P - Rysa/odprysk 1

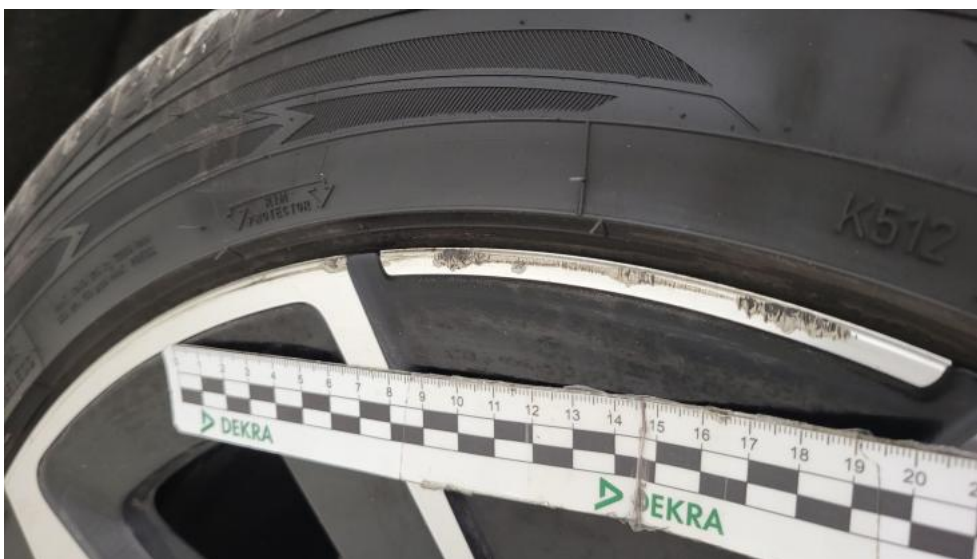
Photo 51.
Felga aluminiowa tylna P - Rysa/odprysk 1

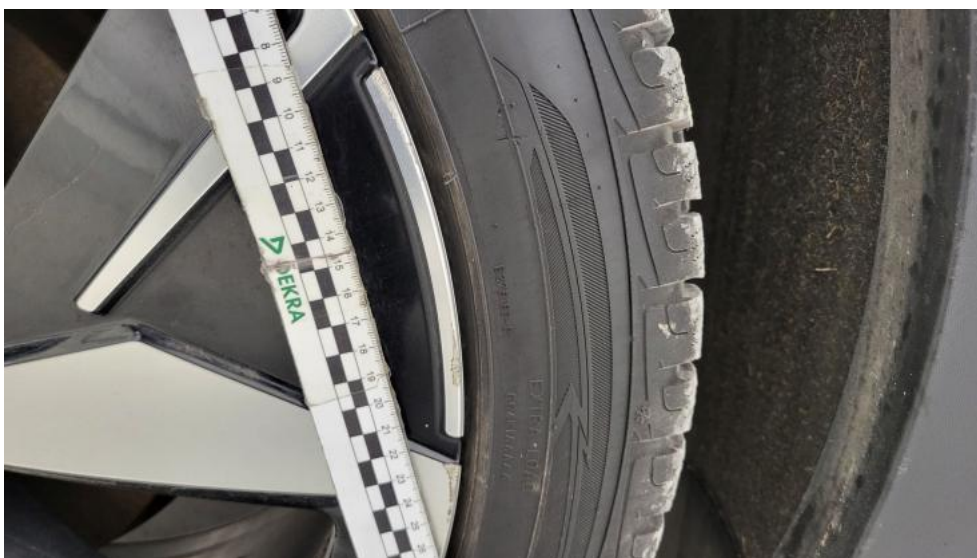
Photo 52.
Felga aluminiowa tylna P - Rysa/odprysk 2

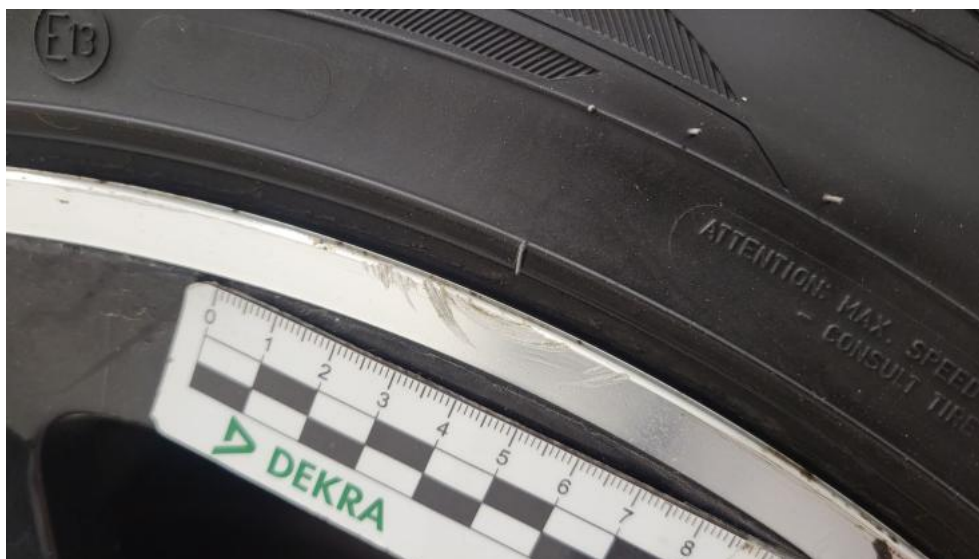
Photo 55.
Felga aluminiowa tylna L - Rysa/odprysk 1

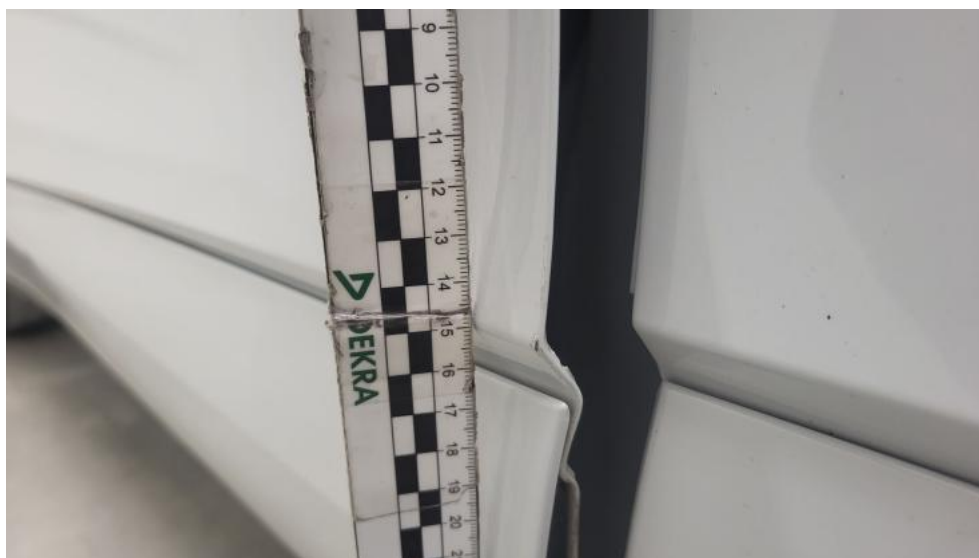
Photo 56.
Drzwi przed L - Rysa/odprysk 1

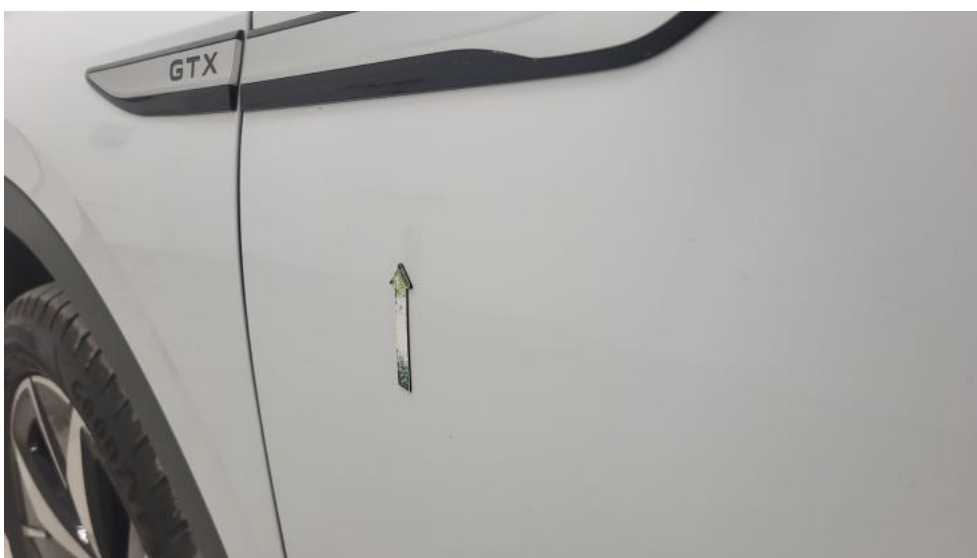
Photo 58.

Drzwi przed L - Wgniecenie/odkształcenie 1

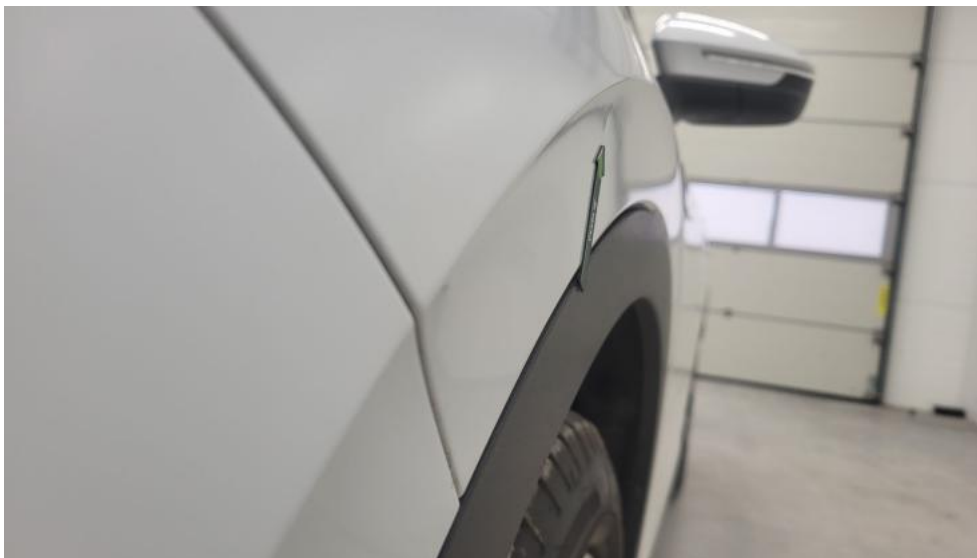
Photo 61.
Błotnik przedni L - Wgniecenie/odkształcenie 1

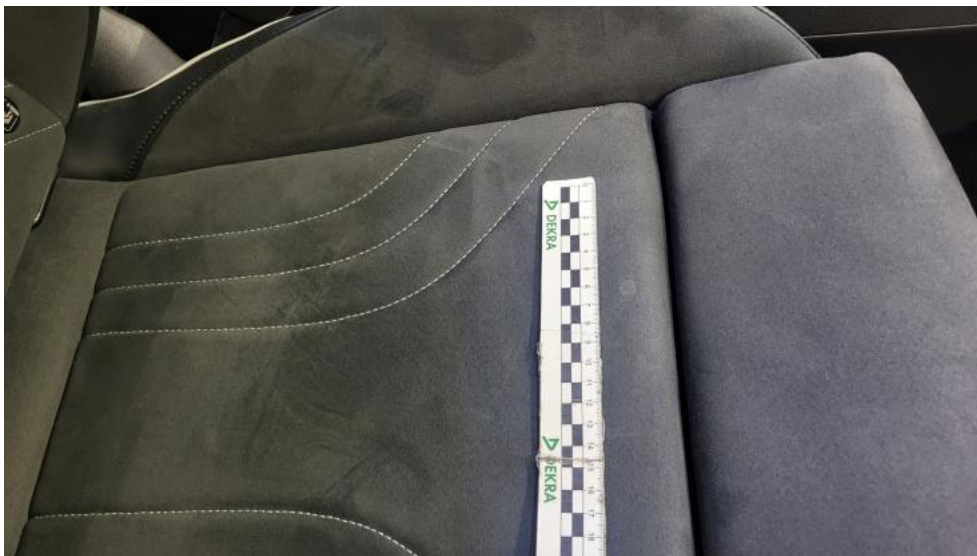
Photo 63.
Fotel prz. praw. - Inne 1

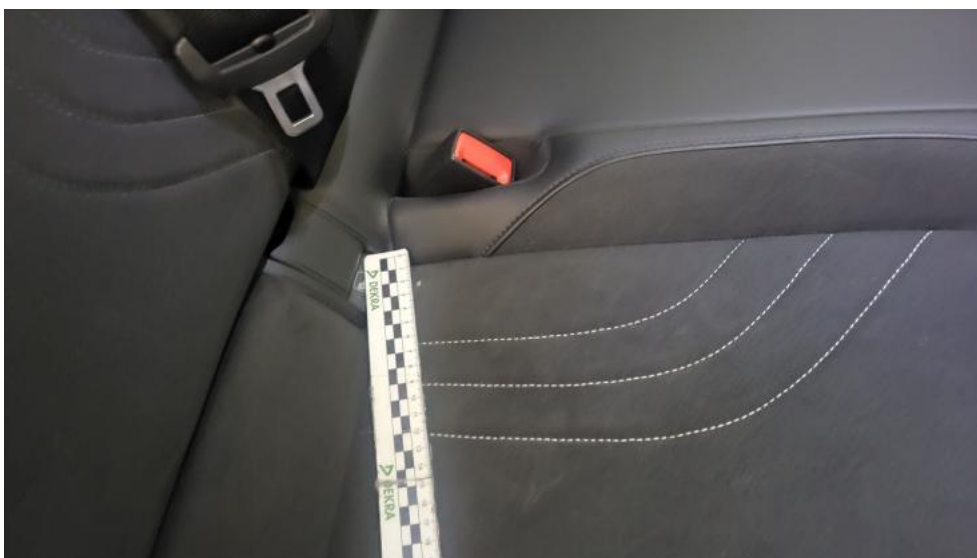
Photo 64.
Kanapa tyl. - Inne 1
