DEKRA's commission No. : PKOL(W)/LODZ/04398/25/01/20
commission/ damage No. : 20/055859
Date of commission: 20-01-2025

Vehicle data

Group of objects (Eurotax)	jeeps
EC code (Eurotax)	0134506
Manufacturer	VOLVO
Model	XC60 17-21
Type / version	XC60 T4 Momentum aut
Body type	KOM
Number of doors / seats	5/5
Curb weight [kg]	1804
Gross vehicle weight [kg]	2390
Wheelbase 1/2	2865
Engine type	spark ignition
Pollution reduction system	three-way catalytic converter
Engine capacity [ccm]	1969
Engine Power [hp/kW]	190/140
Gearbox	automatic 8- gear
Registration /record No.	PO5SM79
VIN / serial number	LYVUZAKVDLB607362
Date of first registration	29-12-2020
Date of next. tech. test	29-12-2025
Year of manufacture	2020 (year has been verified with the manufacturer's base)
Readout [km]	105 257 (read)
Body color / type of coating	grafitowy/METALIK

Measurement of thickness of the vehicle lacquer coating

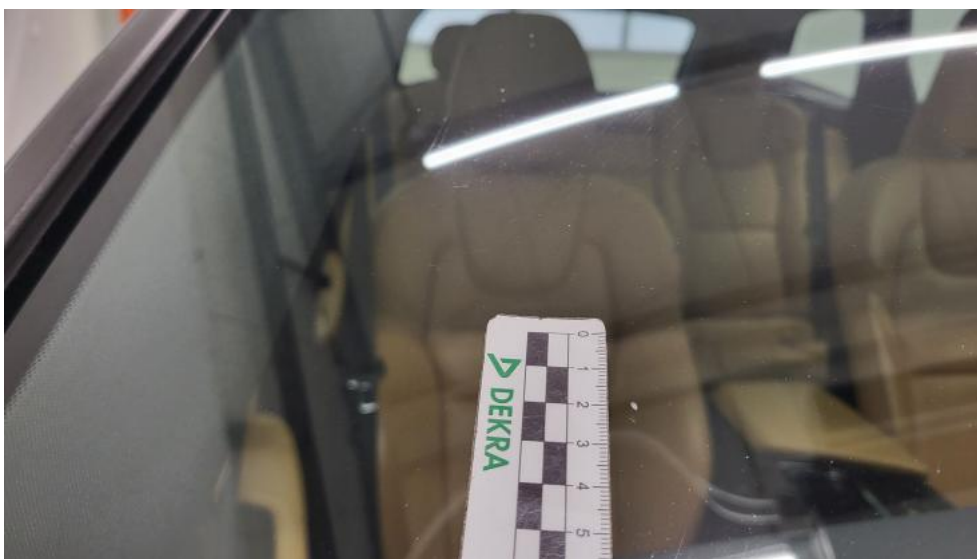
Photo 43.
Szyba czołowa - Rysa/odprysk 1

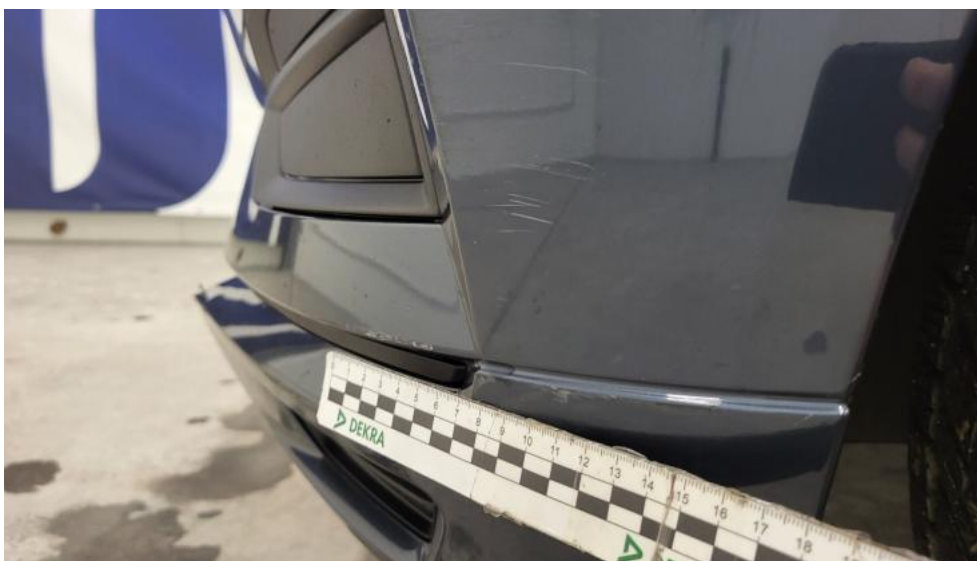
Photo 45.
Zderzak - Rysa/odprysk 1

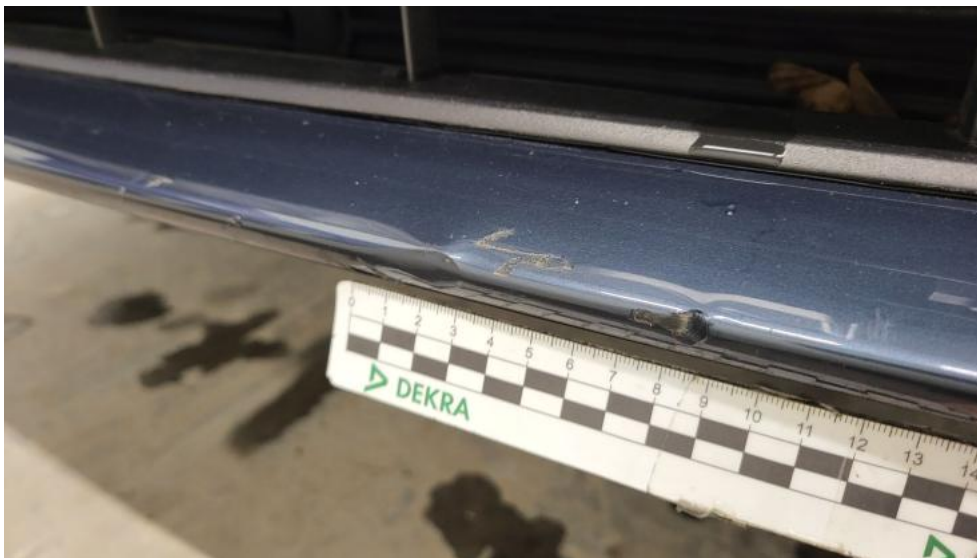
Photo 49.
Zderzak przedni cz dolna - Rysa/odprysk 2

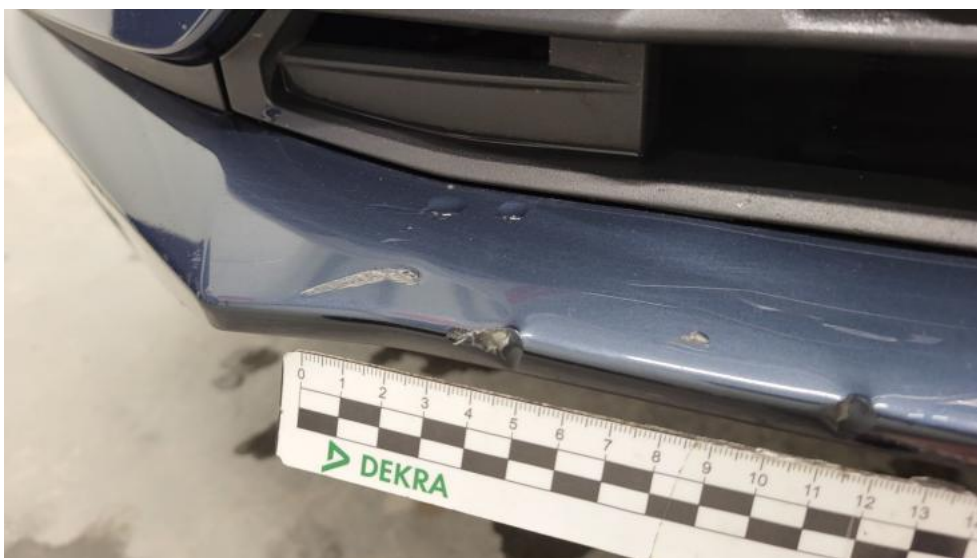
Photo 50.
Zderzak przedni cz dolna() - Rysa/odprysk 3

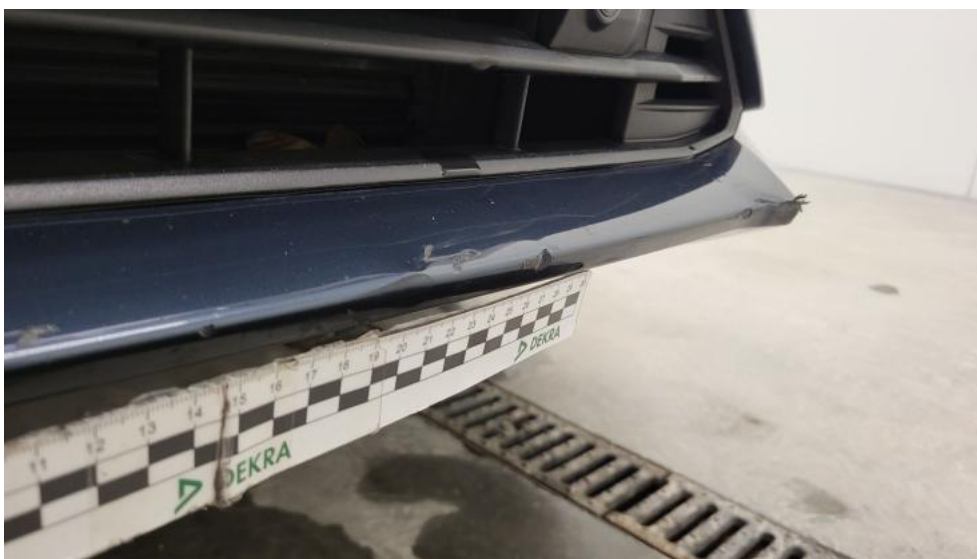
Photo 51.
Zderzak przedni cz dolna - Wgniecenie/odkształcenie 1

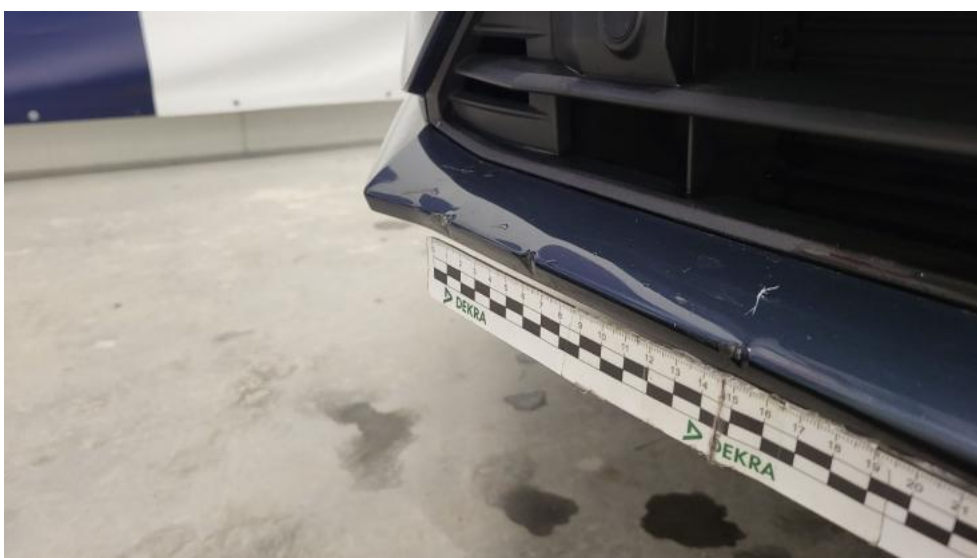
Photo 52.
Zderzak przedni cz dolna - Wgniecenie/odkształcenie 2

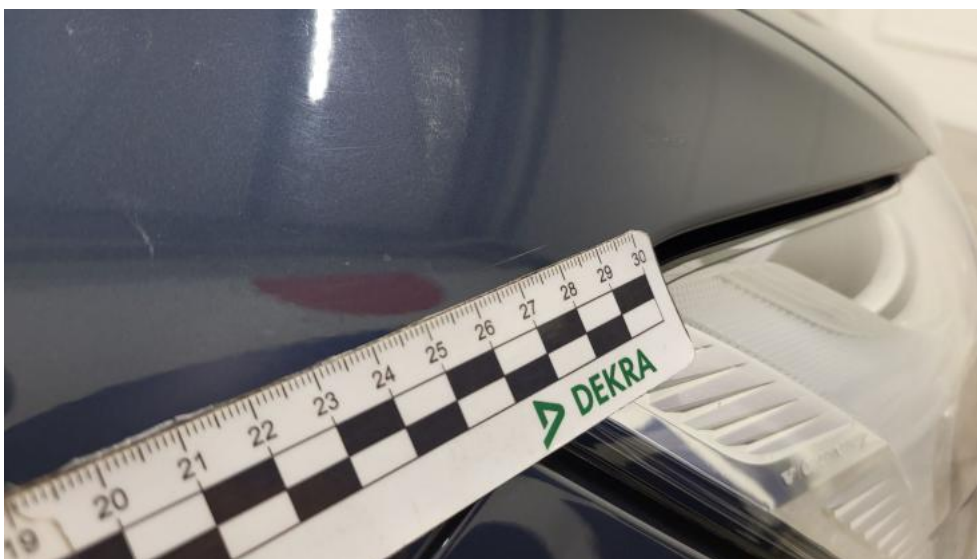
Photo 55.
Błotnik przedni P - Rysa/odprysk 1

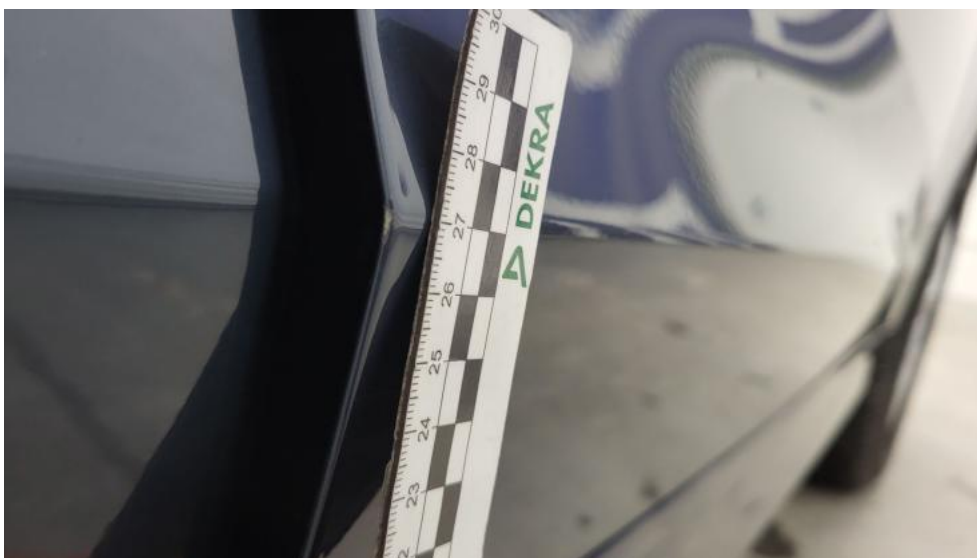
Photo 56.
Drzwi przednie P - Rysa/odprysk 1

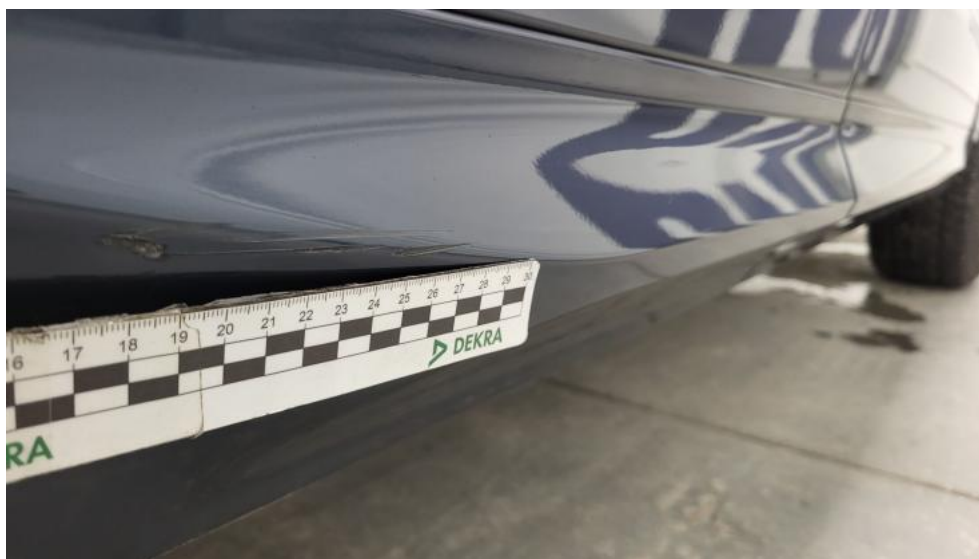
Photo 59.
Próg P - Rysa/odprysk 1

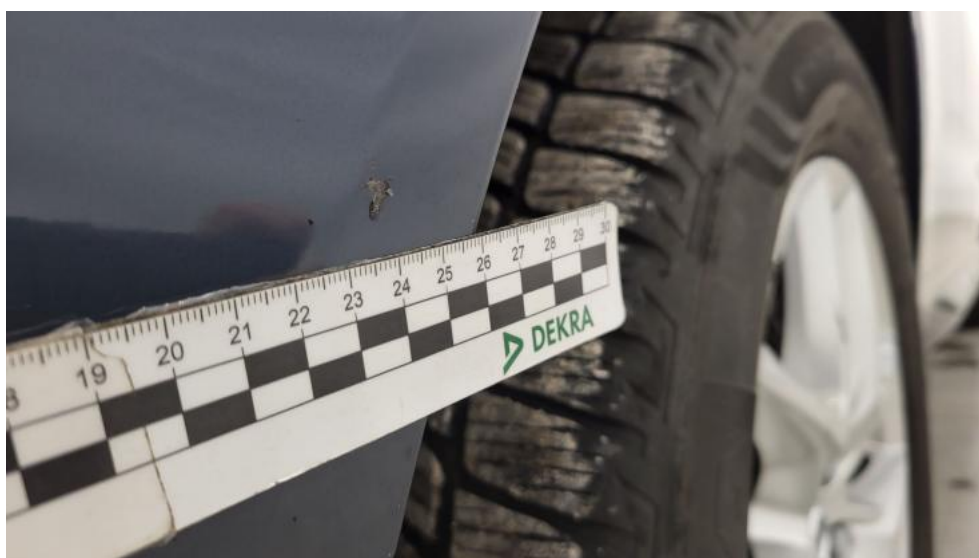
Photo 60.
Zderzak tylny - Rysa/odprysk 1

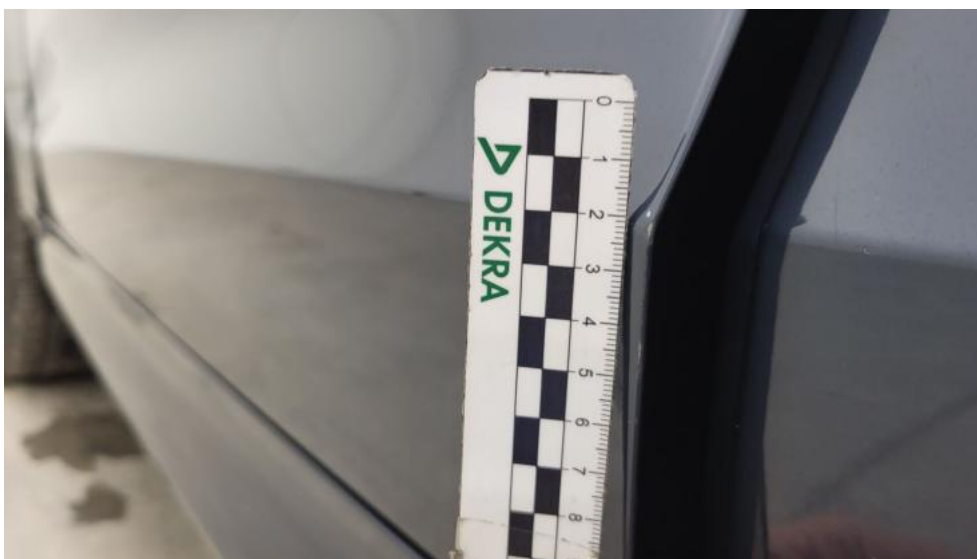
Photo 61.

Drzwi przed L - Rysa/odprysk 1

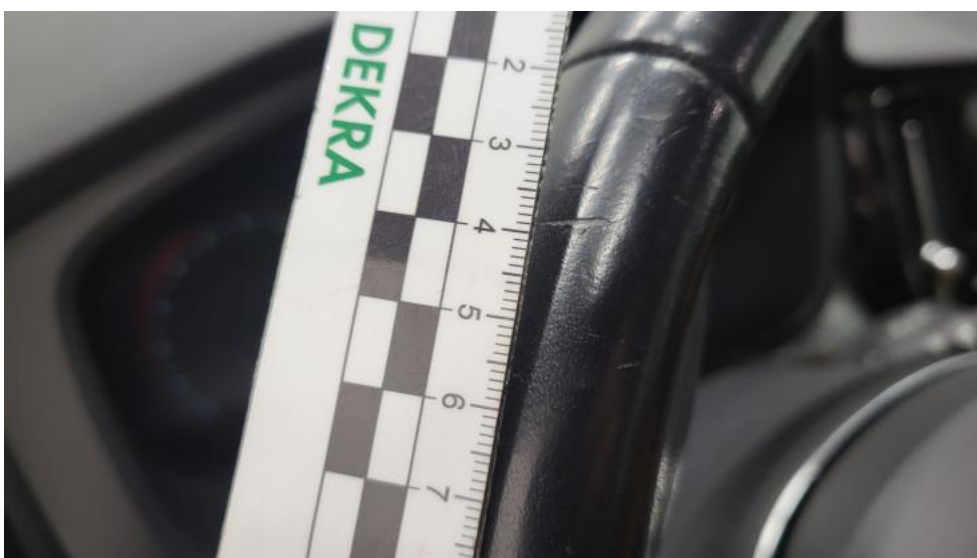
Photo 64.
Koło kierownicy - Rysa/odprysk 1

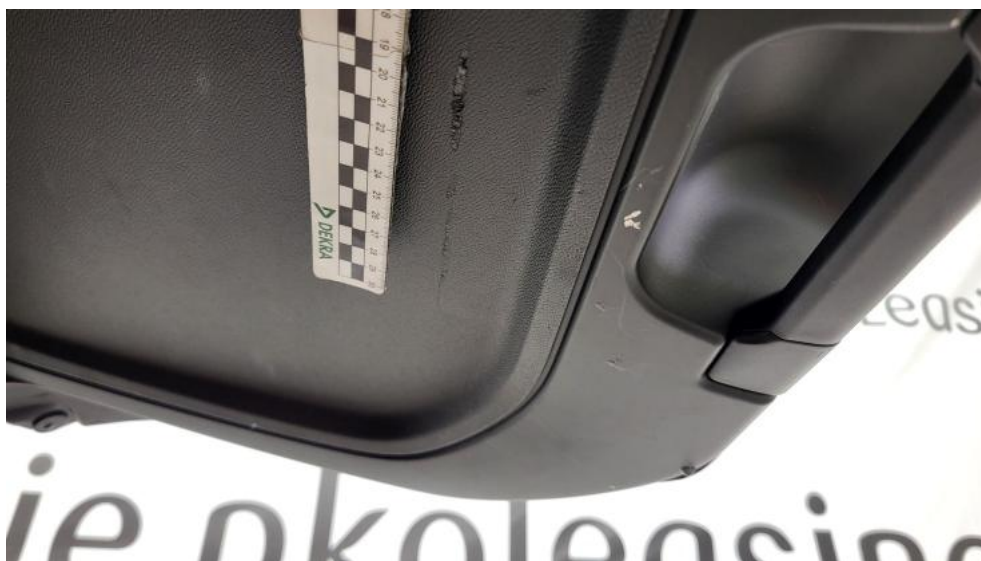
Photo 69.

Wykładzina pokrywy tylnej - Rysa/odprysk 1

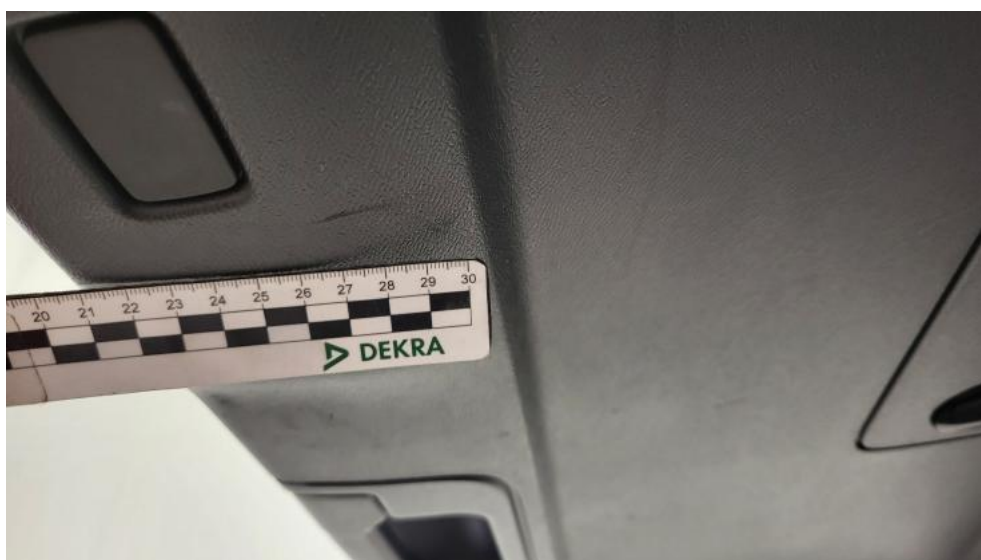
Photo 70.

Wykładzina pokrywy tylnej - Rysa/odprysk 2
