DEKRA's commission No. : PKOL(W)/LODZ/95753/25/12/05  
commission/ damage No. : 01726/LF/24  
Date of commission: 05-12-2025

**DEKRA Poland - Headquarters**  
02-673 Warszawa, ul. Konstruktorska 12A

| Manufacturer | JAGUAR |
| Type / version | I-Pace EV400 AWD S |

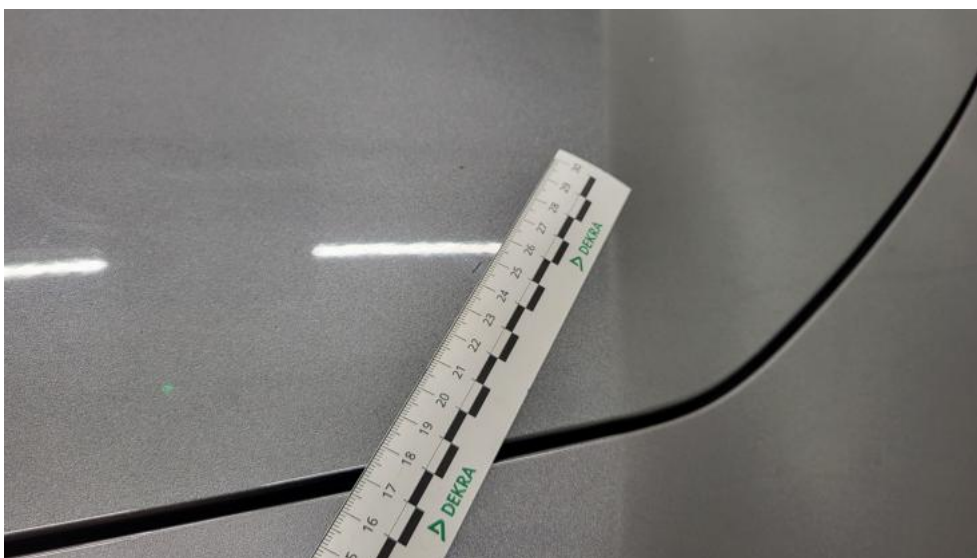
**Photo 46.**

Pokrywa komory silnika - Rysa/odprysk 1

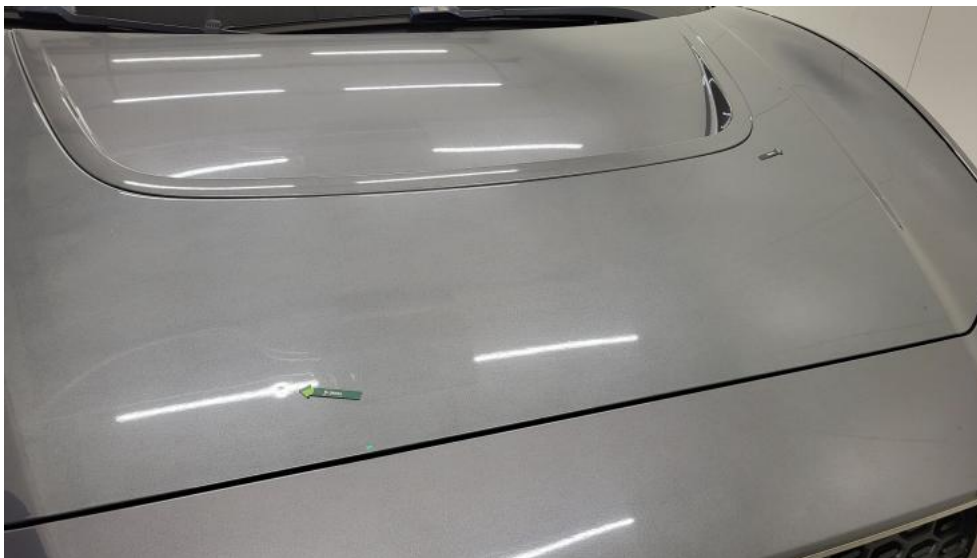
**Photo 47.**

Pokrywa komory silnika - Wgniecenie/odkształcenie 1

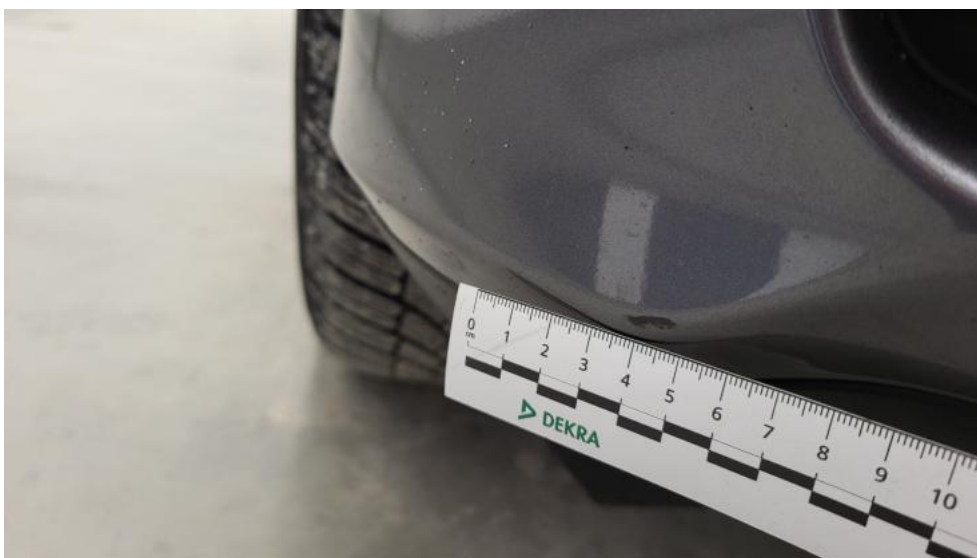
**Photo 48.**

Spoiler zderzaka przedniego - Rysa/odprysk 1

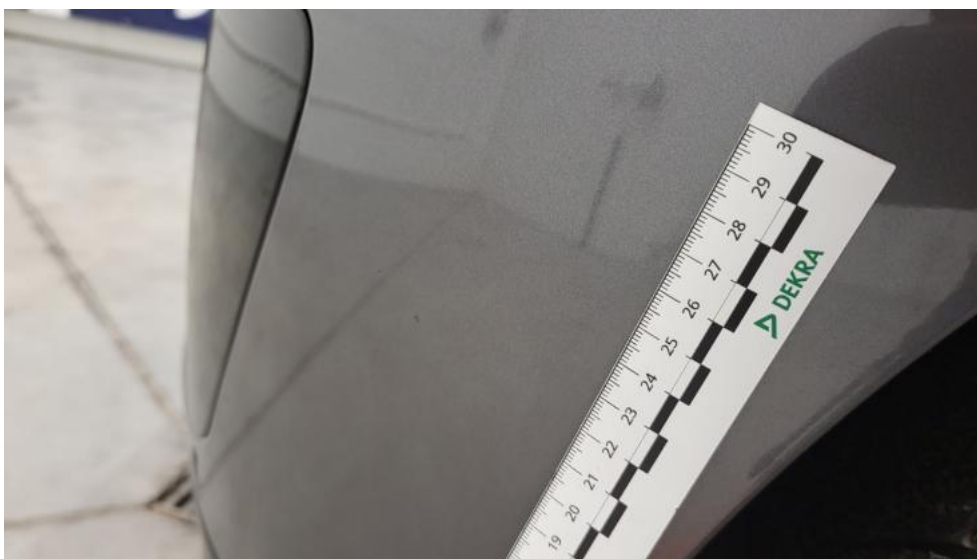
**Photo 49.**

Zderzak - Rysa/odprysk 1

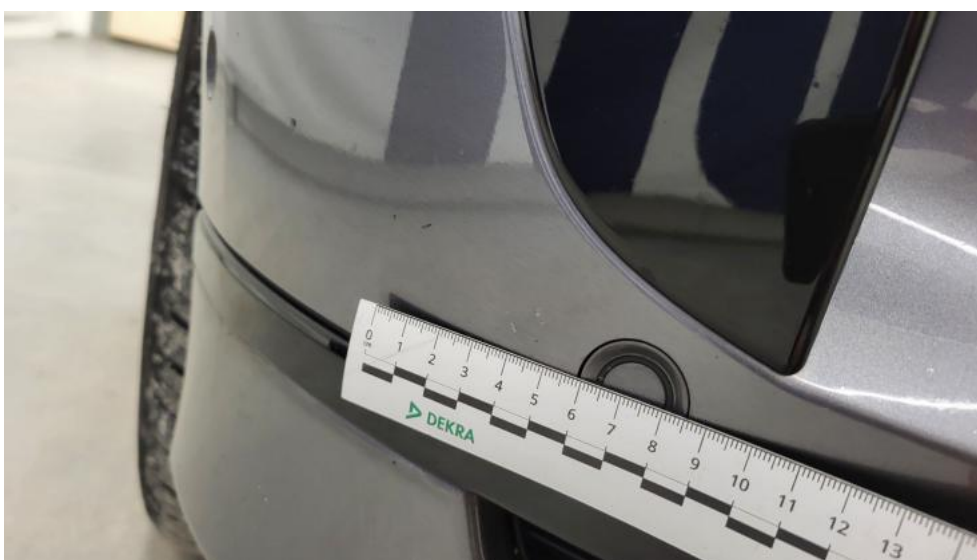
**Photo 50.**

Zderzak - Rysa/odprysk 2

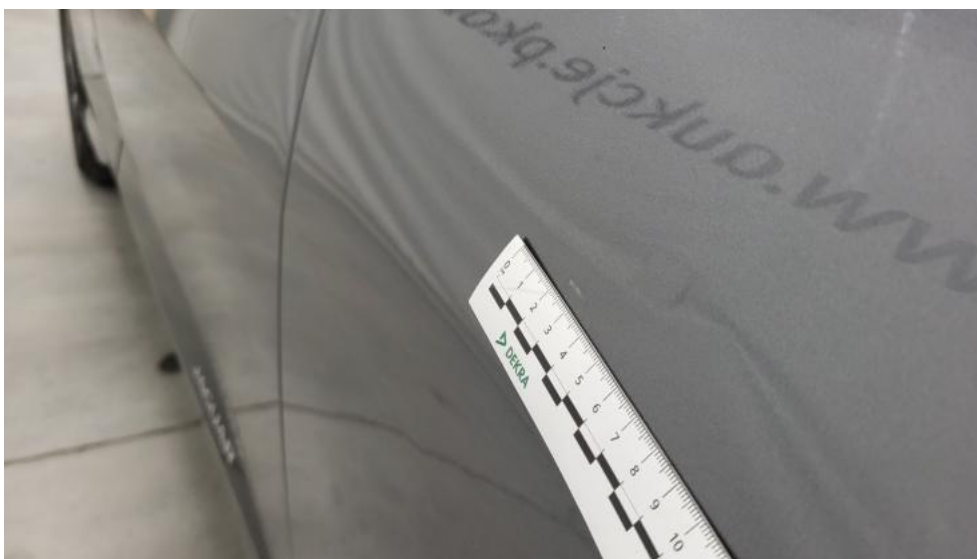
**Photo 51.**

Błotnik przedni P - Rysa/odprysk 1

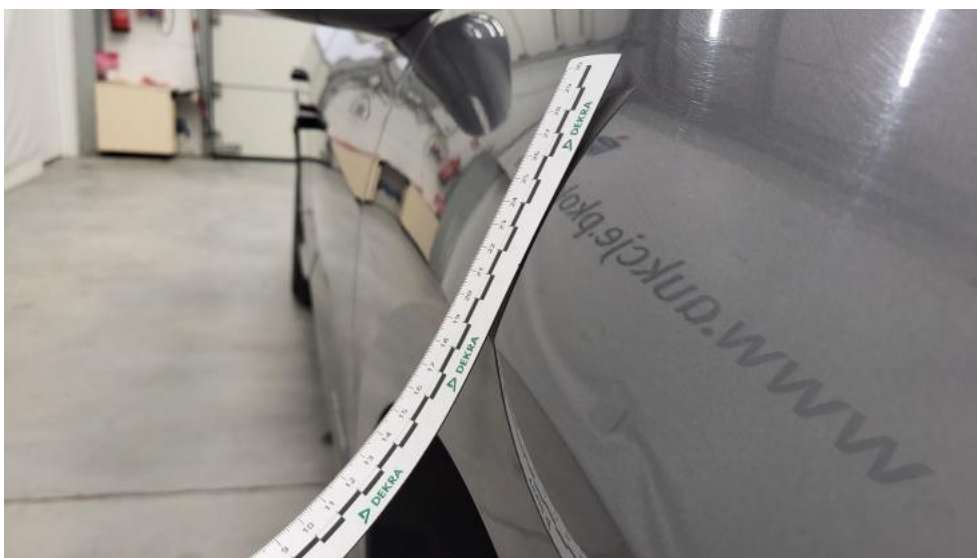
**Photo 52.**

Błotnik przedni P - Wgniecenie/odkształcenie 1

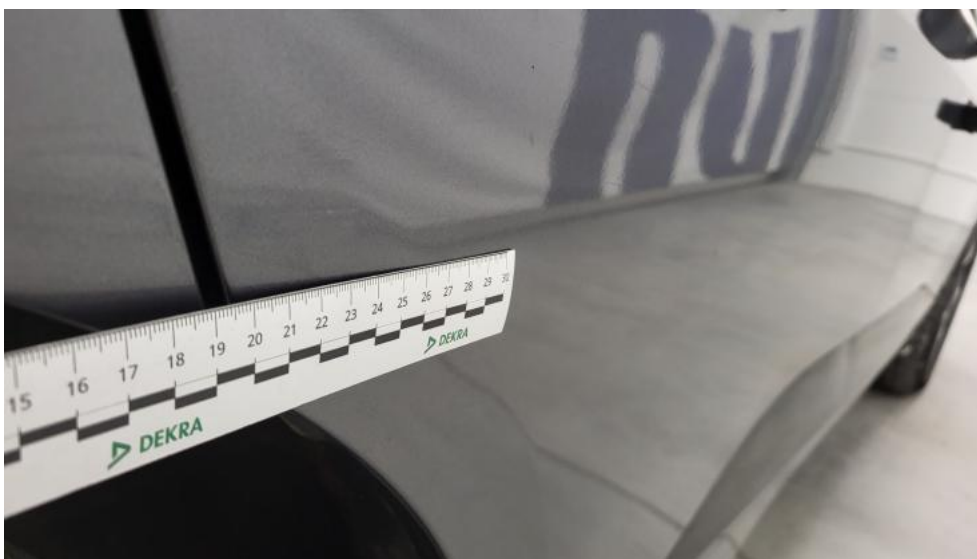
**Photo 53.**

Drzwi przednie P - Rysa/odprysk 1

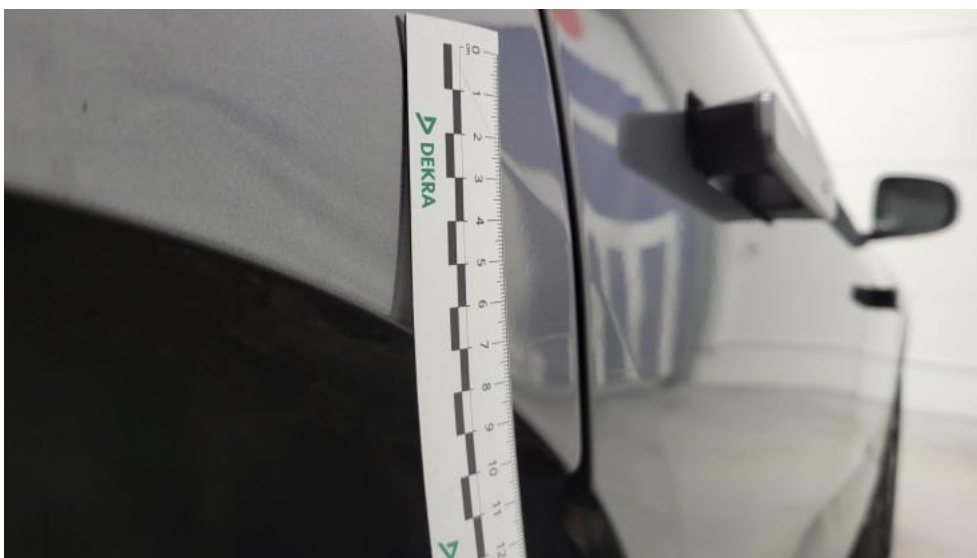
**Photo 54.**

Łotnik tylny P / Ściana boczna P - Wgniecenie/odkształcenie 1

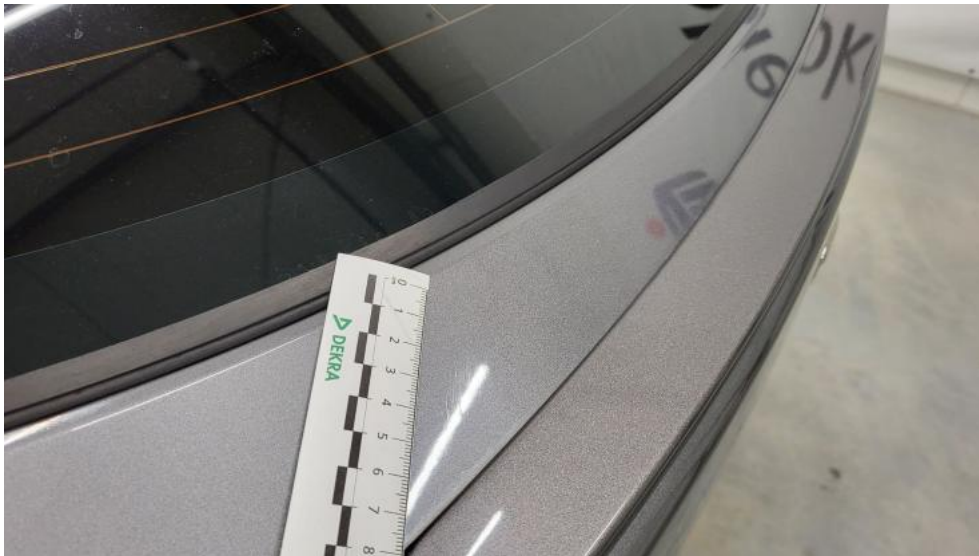
**Photo 55.**

Pierwsza rejestracja w kraju 30-01-2024. Pojazd elektryczny. Dostarczono pozwolenie czasowe. Rysy na samochodzie. Pokrywa bagażnika otwiera się i opada do połowy. Brak zaślepek w tylnej kanapie. Brak półki bagażnika. Odpryski na szybie czołowej.

Pokrywy bagażnika - Rysa/odprysk 1

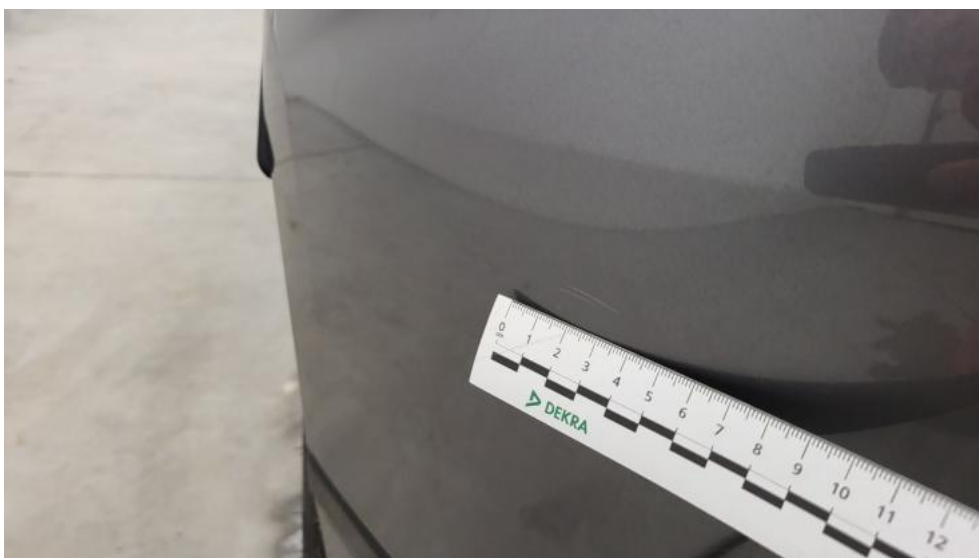
**Photo 56.**

Zderzak tylny cz L - Rysa/odprysk 1

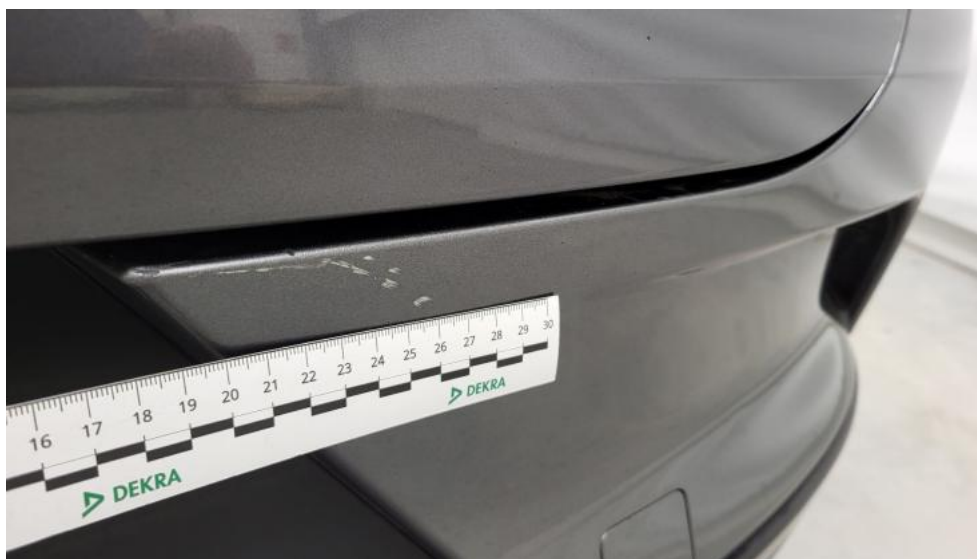
**Photo 57.**

Zderzak tylny cz P - Rysa/odprysk 1

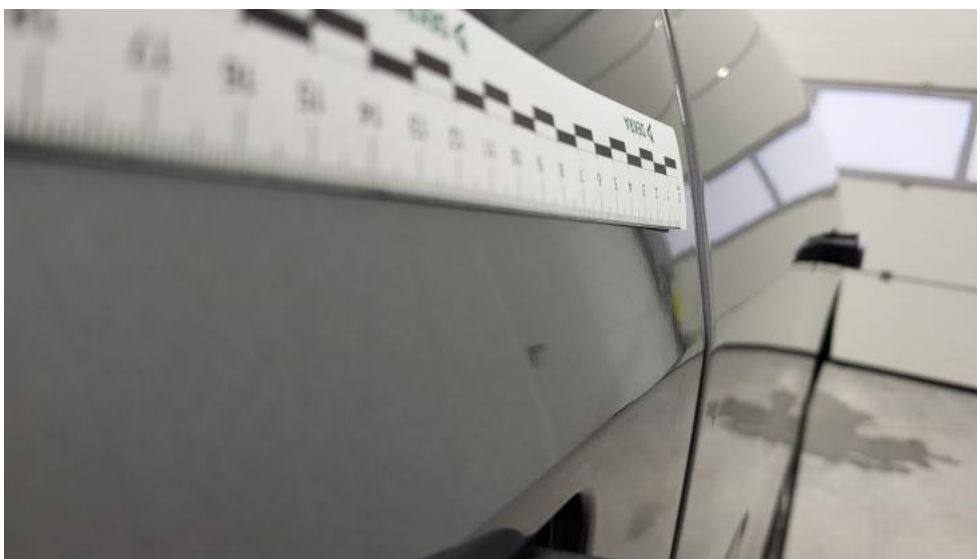
**Photo 59.**

Drzwi przed L - Wgniecenie/odkształcenie 1

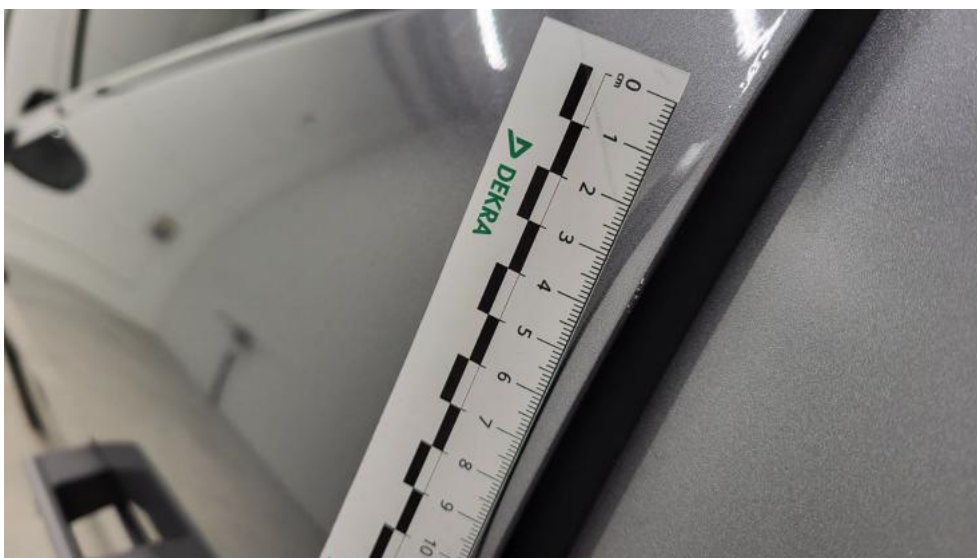
**Photo 60.**

Drzwi tylne L - Rysa/odprysk 1

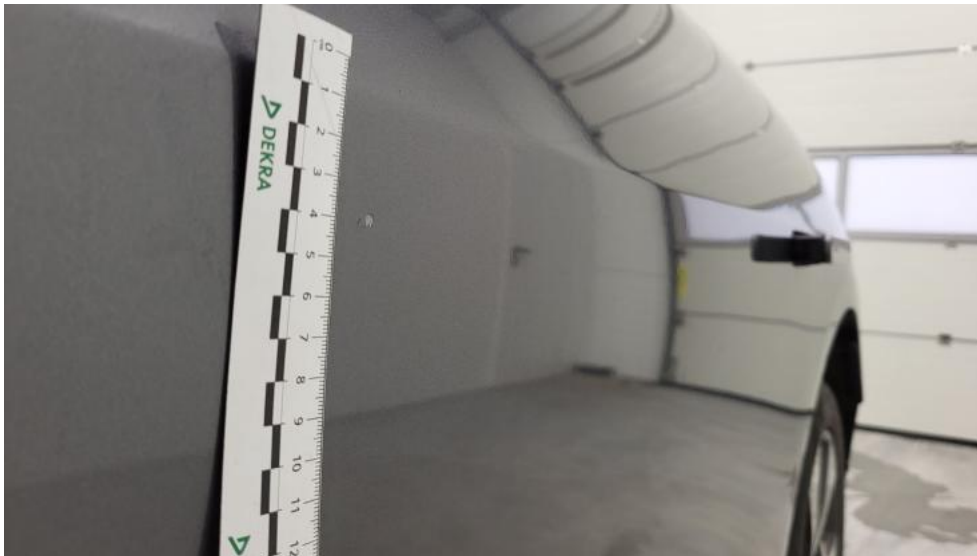
**Photo 61.**

Drzwi tylne L - Rysa/odprysk 2

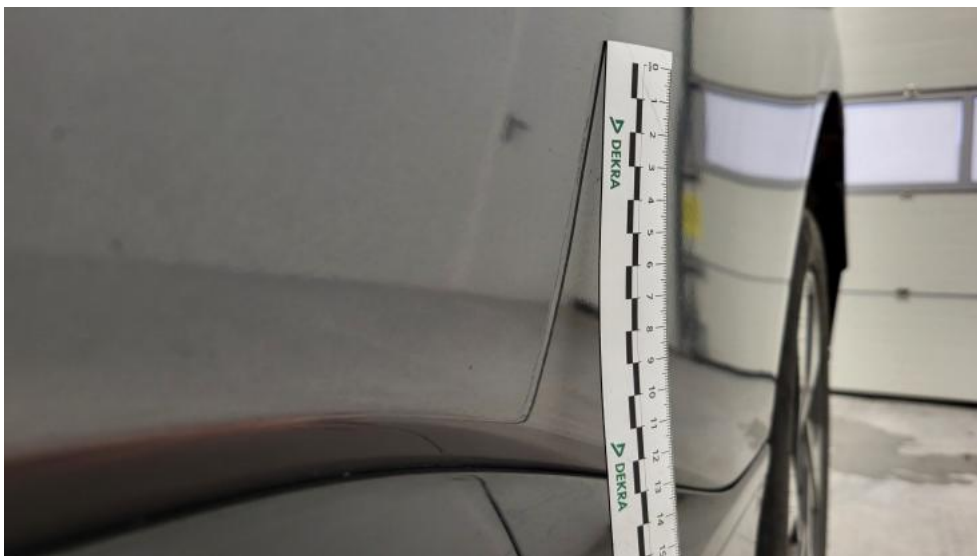
**Photo 62.**

Drzwi tylne L - Wgniecenie/odkształcenie 1

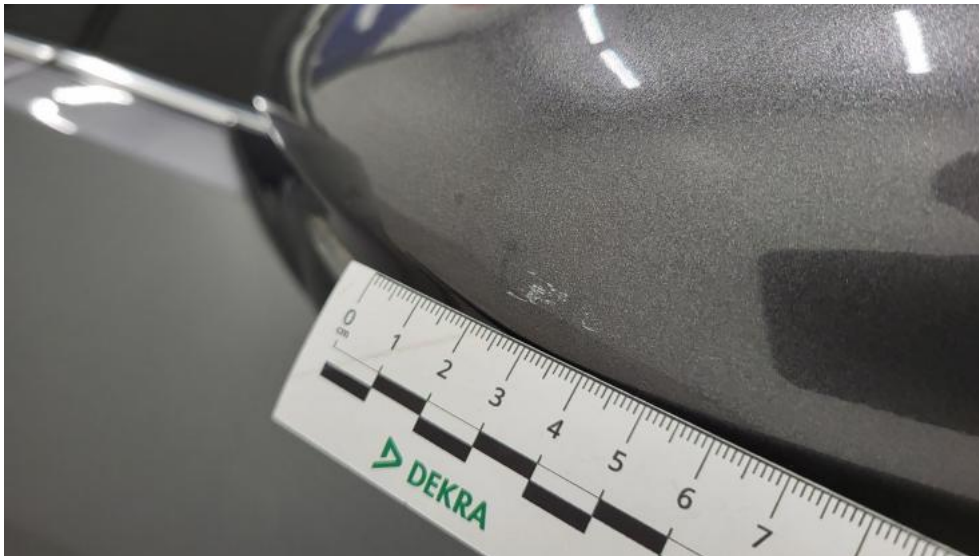
**Photo 63.**

Lusterko zew L - Rysa/odprysk 1

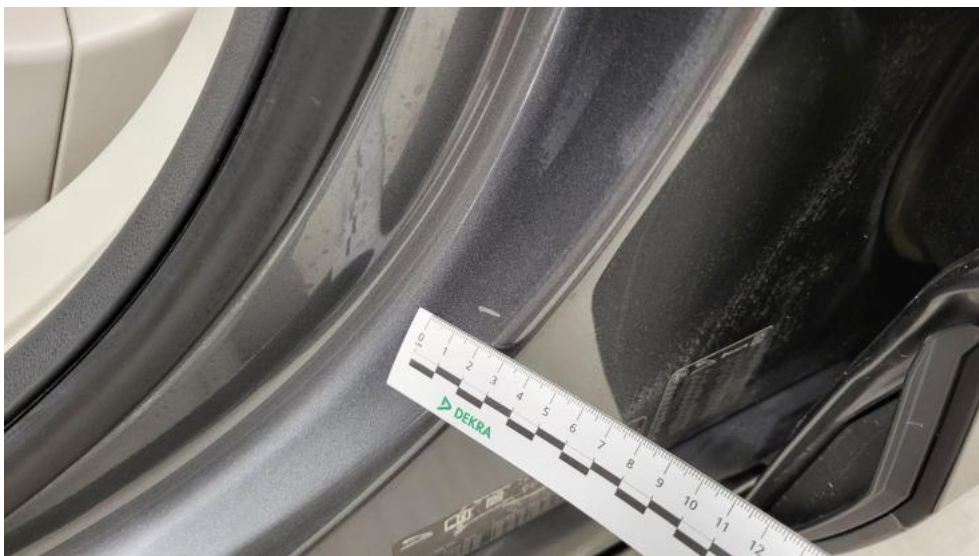
**Photo 64.**

Słupek środkowy L - Rysa/odprysk 1

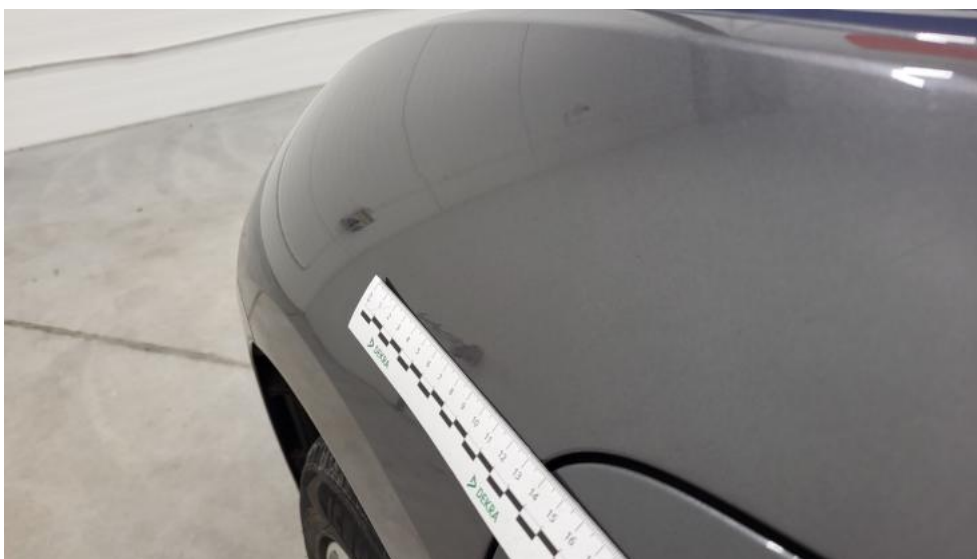
**Photo 65.**

Błotnik przedni L - Wgniecenie/odkształcenie 1

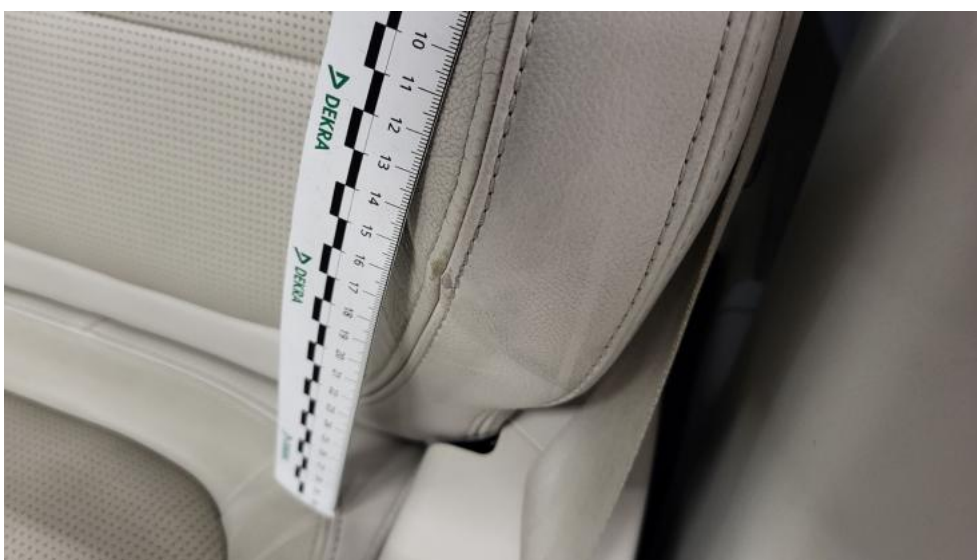
**Photo 66.**

Fotel prz. lew. - Inne 1

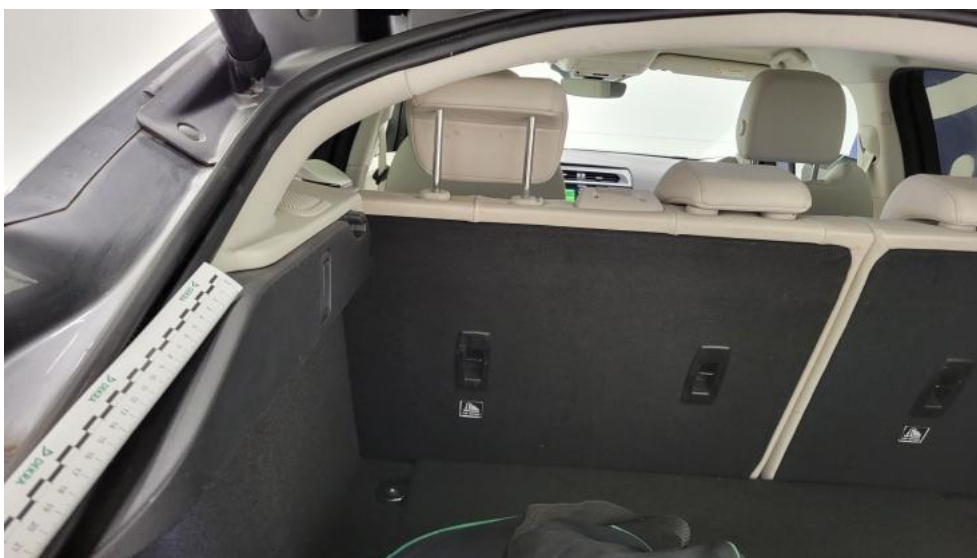
**Photo 68.**

Półka/roleta tylna - Inne 1
