DEKRA's commission No. : PKOL(W)/LODZ/91928/25/11/26  
commission/ damage No. : 24/025828  
Date of commission: 26-11-2025

| Manufacturer | BMW |
| Model | Seria 2 Cabrio [F23] 17-21 |
| Registration /record No. | TK632EM |

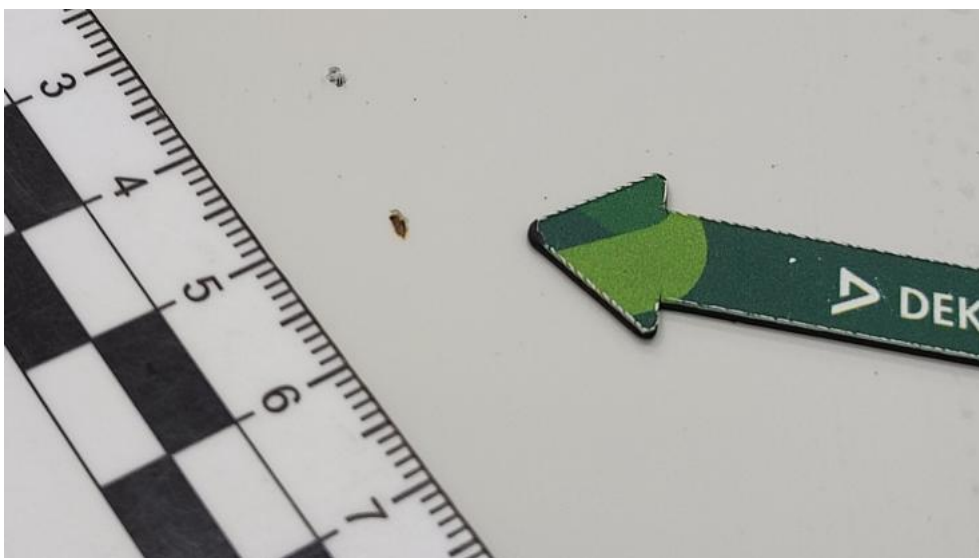
**Photo 38.**

Pokrywa komory silnika - Inne 1

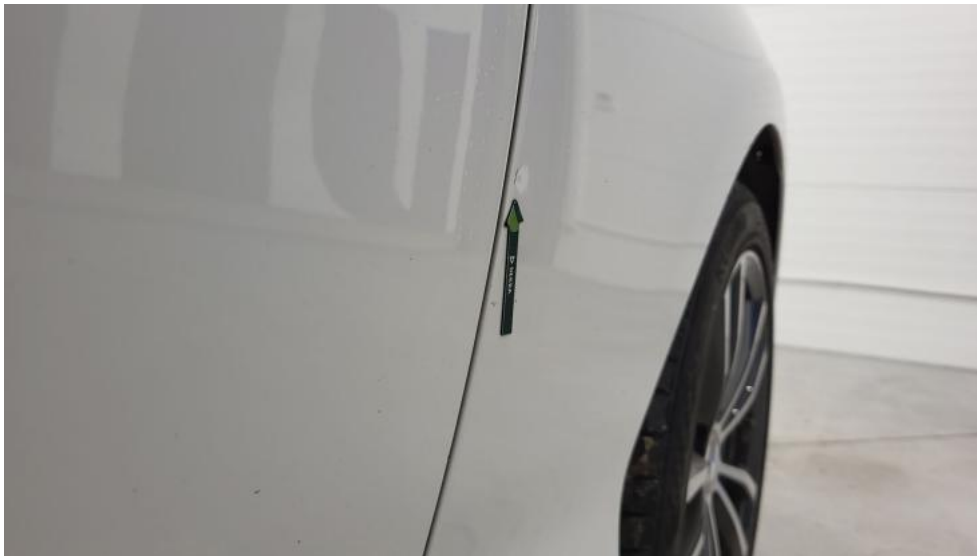
**Photo 39.**

Błotnik przedni P - Wgniecenie/odkształcenie 1

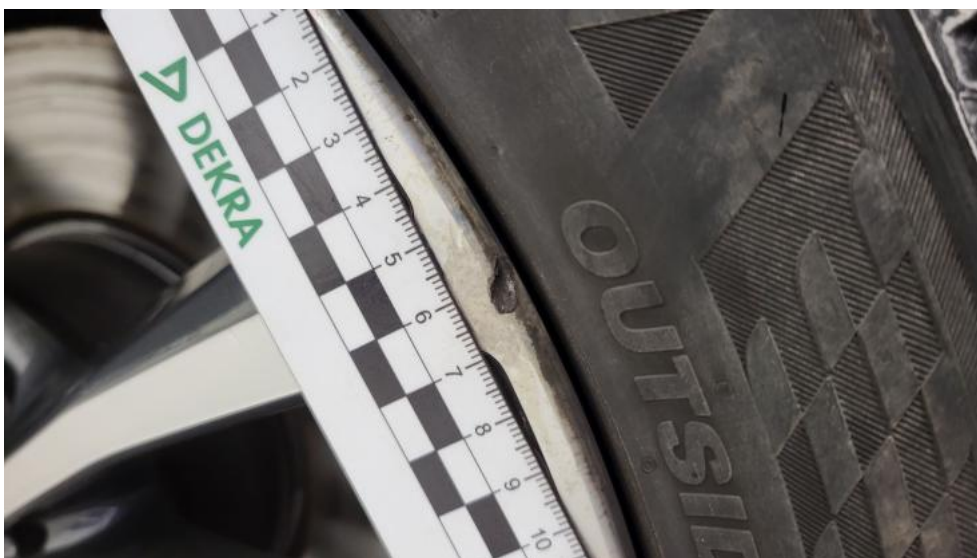
**Photo 40.**

Felga aluminiowa przednia P - Rysa/odprysk 1

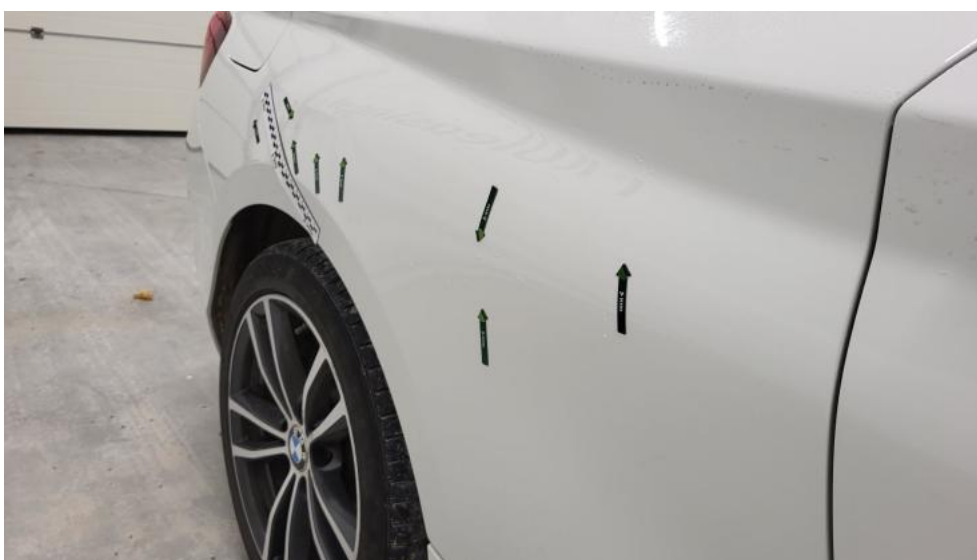
**Photo 42.**

Łotnik tylny P / Ściana boczna P - Wgniecenie/odkształcenie 1

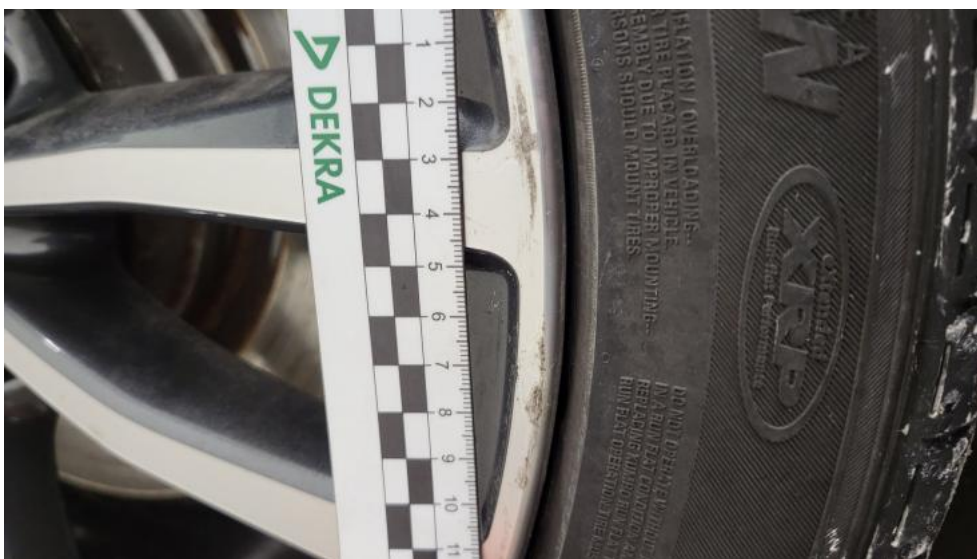
**Photo 45.**

Felga aluminiowa tylna L - Rysa/odprysk 1

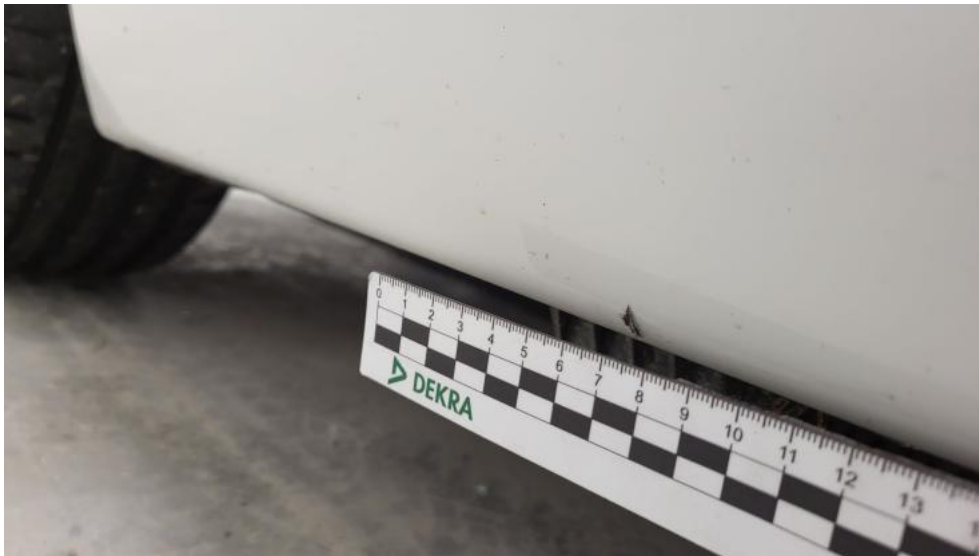
**Photo 49.**

Próg L - Rysa/odprysk 1

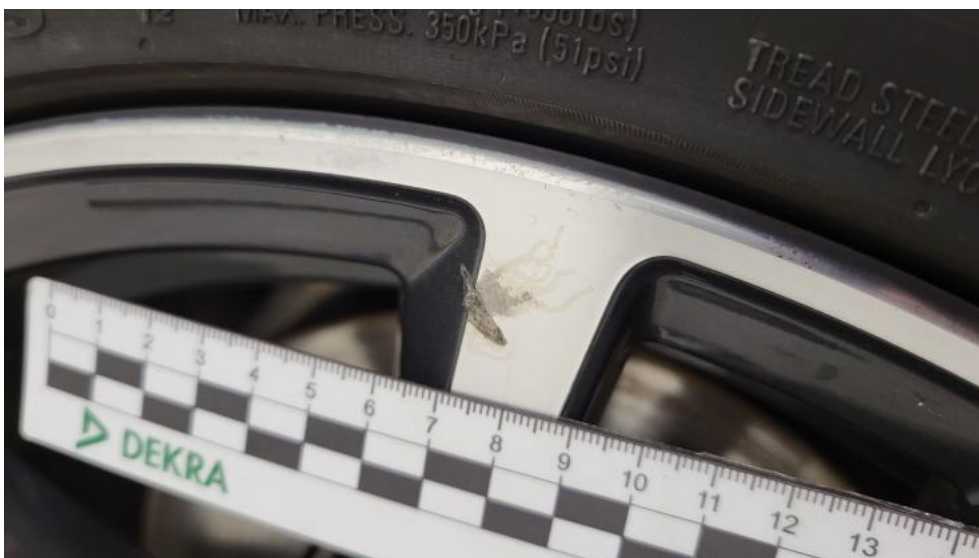
**Photo 50.**

Felga Aluminiowa przednia L - Rysa/odprysk 1
