DEKRA's commission No. : PKOL(W)/LODZ/07515/26/01/29  
commission/ damage No. : 23/034483  
Date of commission: 29-01-2026

**DEKRA Poland - Headquarters**  
02-673 Warszawa, ul. Konstruktorska 12A

| Manufacturer | BMW |
| Type / version | 730d xDrive mHEV sport-aut |

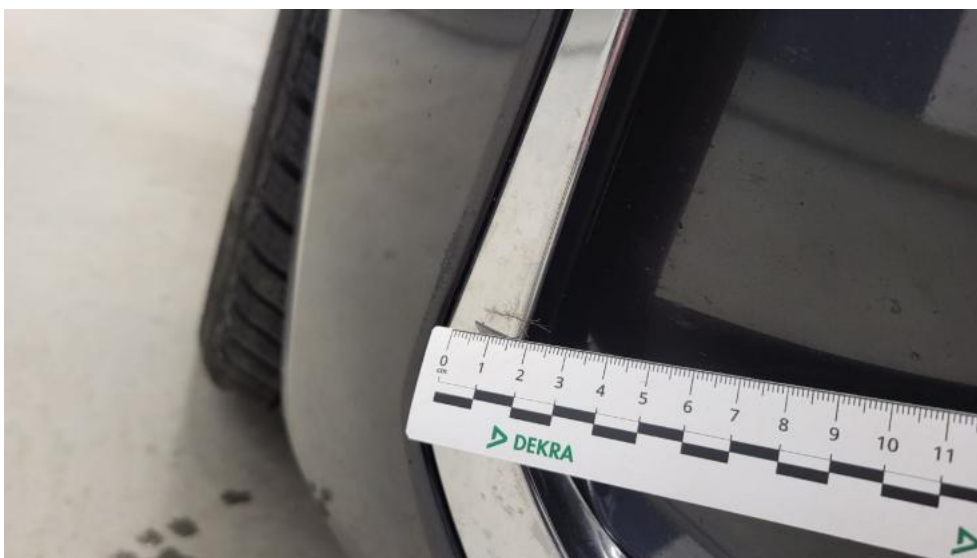
**Photo 52.**

Kratka/zaślepka halogenu P - Pęknięcie/rozerwanie 1

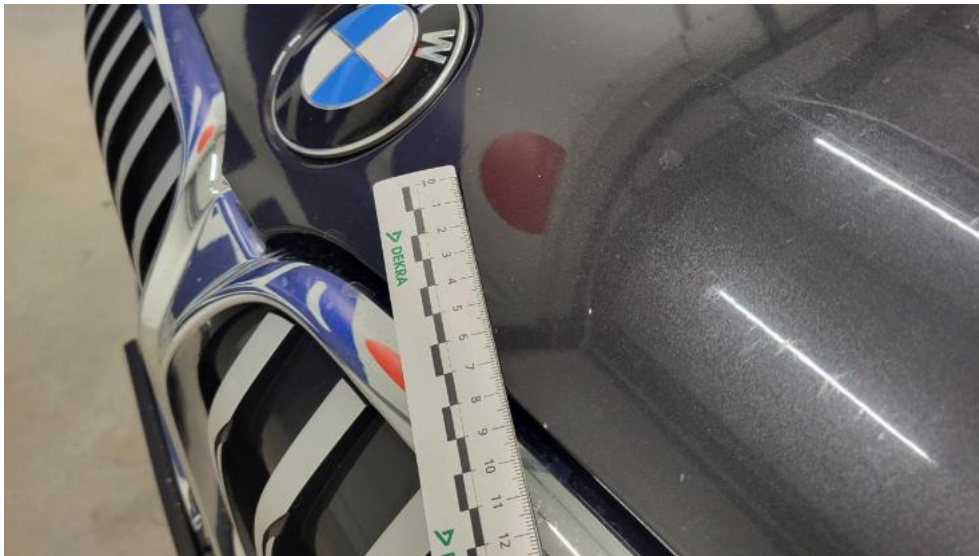
**Photo 53.**

Pokrywa komory silnika - Rysa/odprysk 1

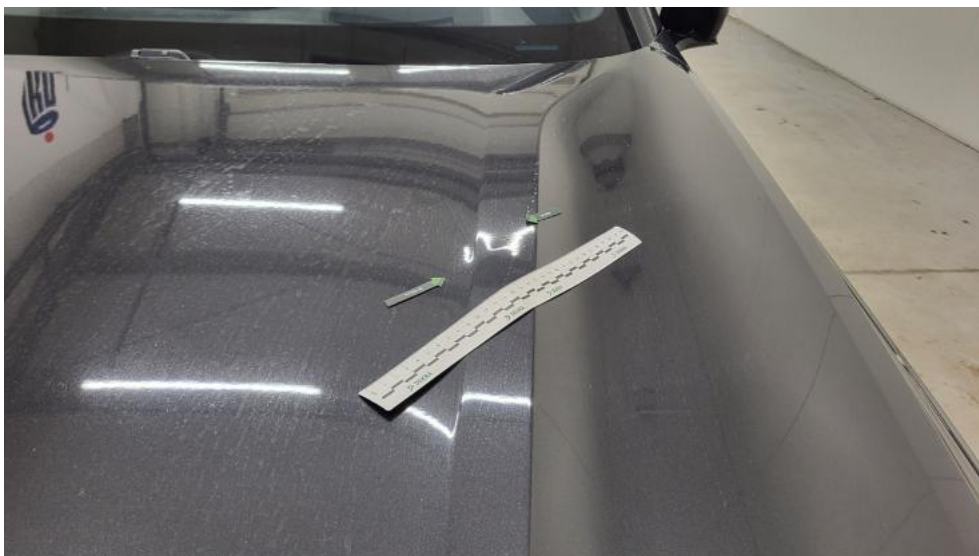
**Photo 54.**

Pokrywa komory silnika - Wgniecenie/odkształcenie 1

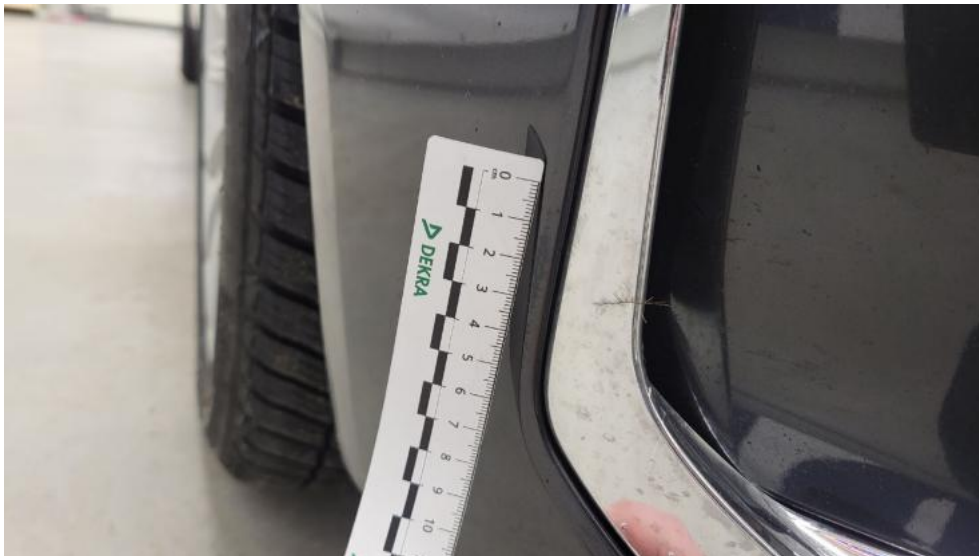
**Photo 55.**

Zderzak - Rysa/odprysk 1

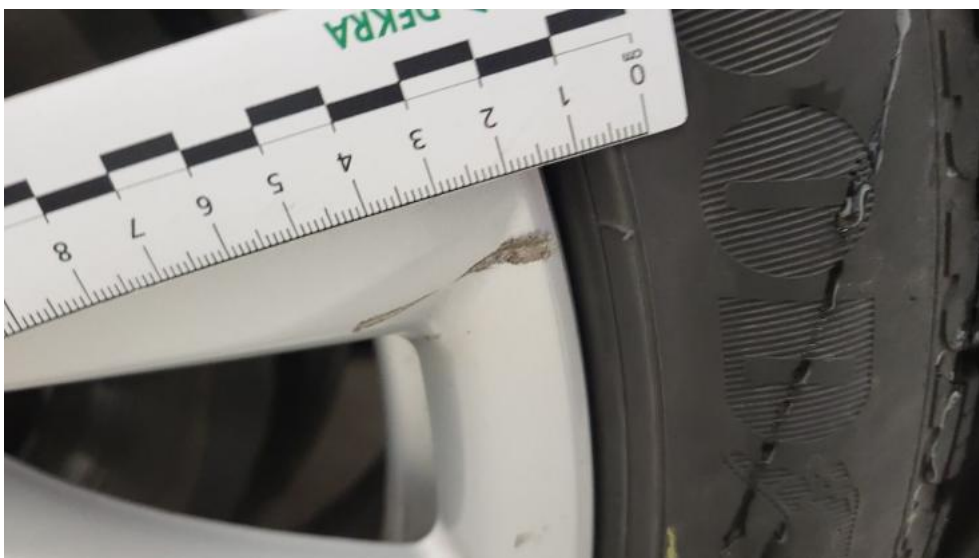
**Photo 56.**

Felga aluminiowa przednia P - Rysa/odprysk 1

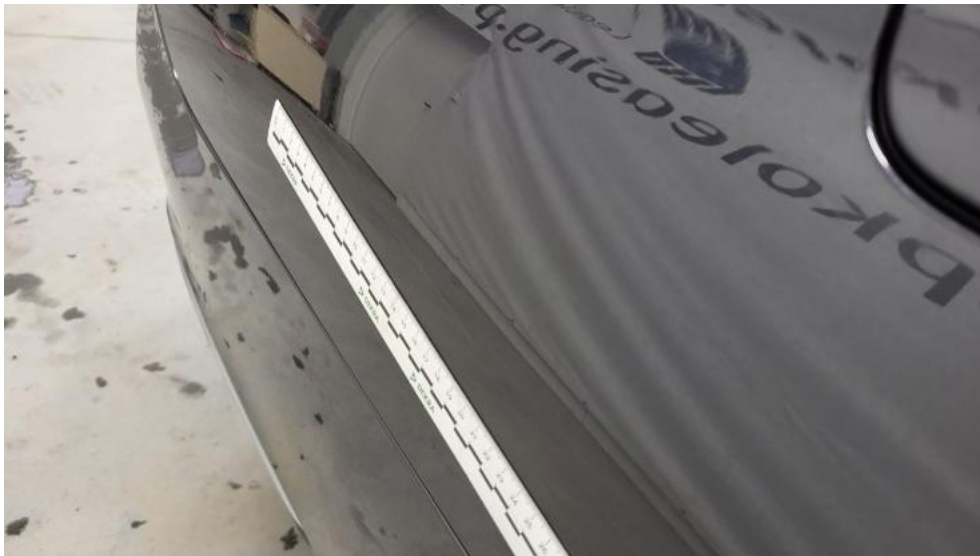
**Photo 57.**

Błotnik tylny P / Ściana boczna P - Rysa/odprysk 1

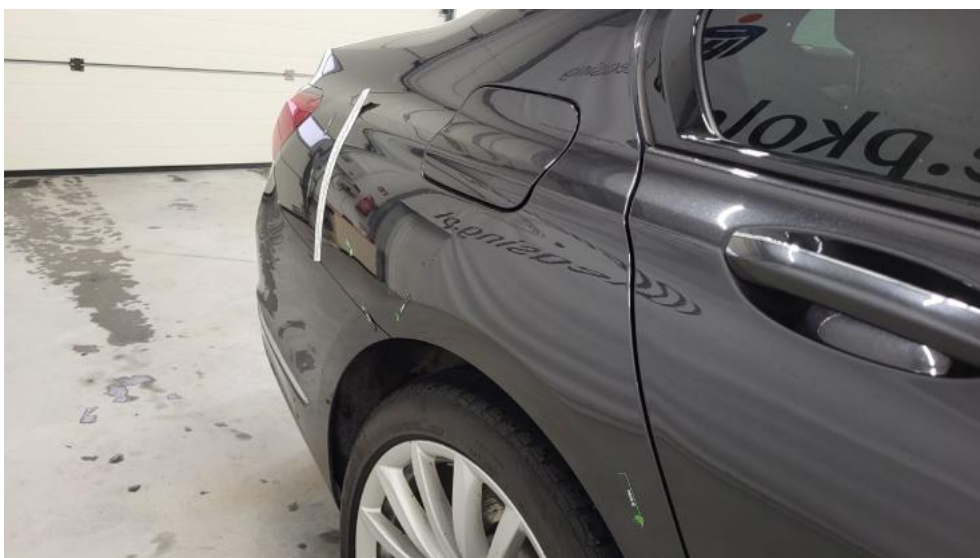
**Photo 58.**

Błotnik tylny P / Ściana boczna P - Wgniecenie/odkształcenie 1

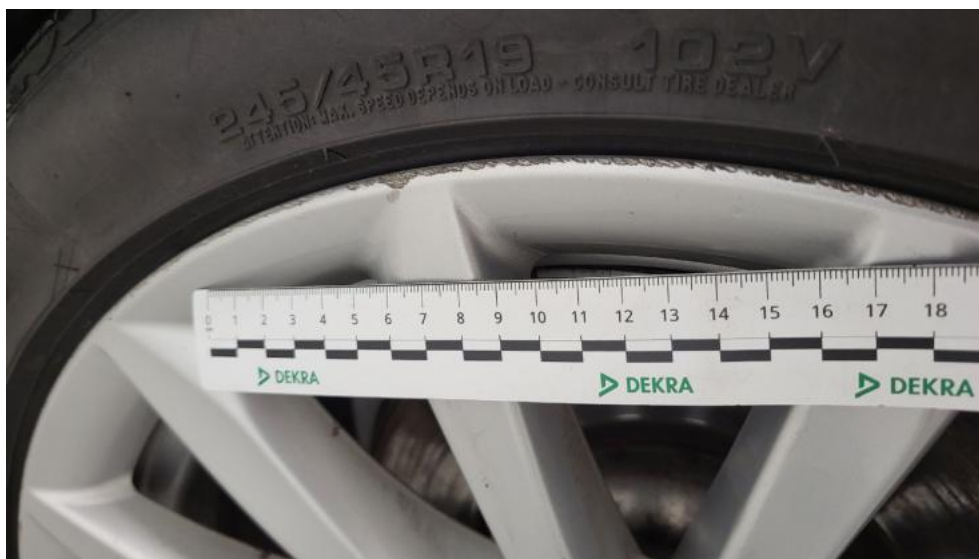
**Photo 59.**

Felga aluminiowa tylna P - Rysa/odprysk 1

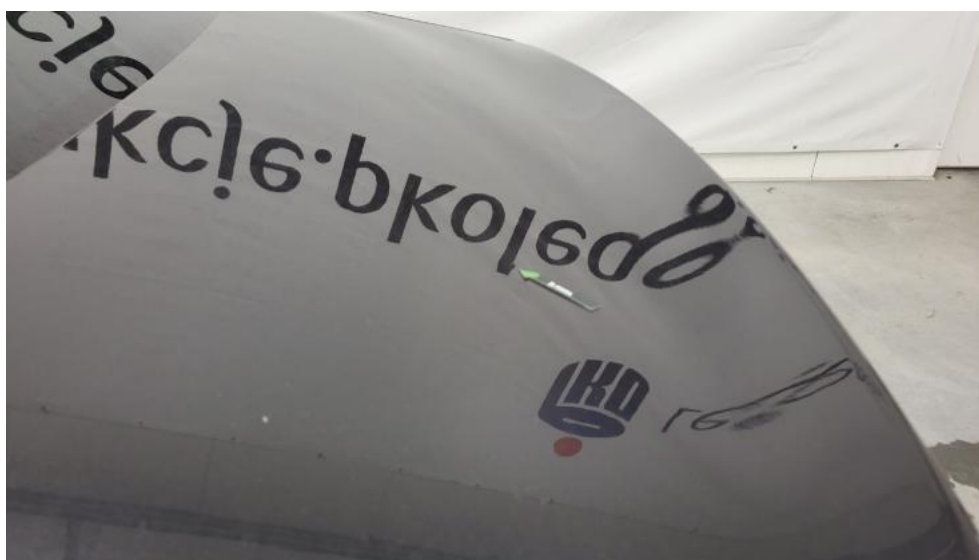
**Photo 60.**

Pokrywy bagażnika - Wgniecenie/odkształcenie 1

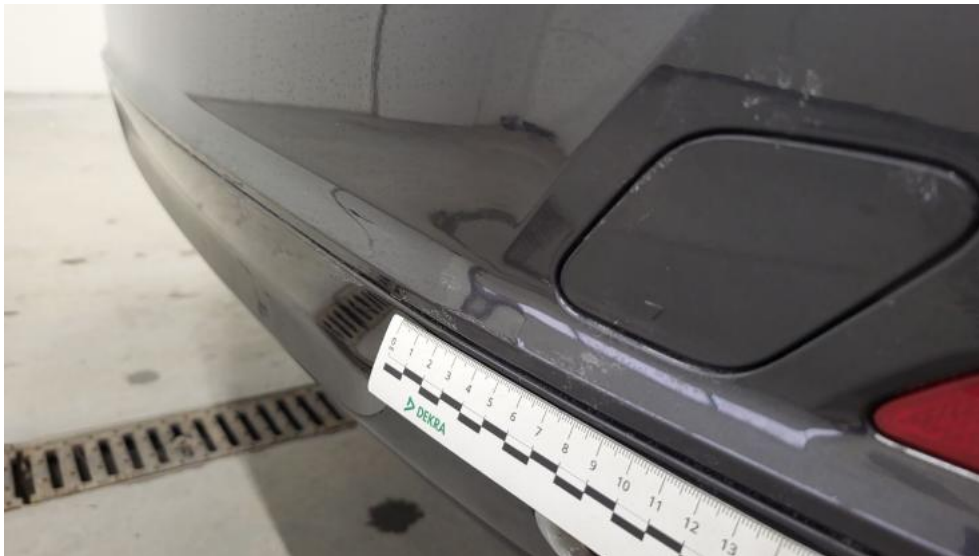
**Photo 61.**

Zderzak tylny - Wgniecenie/odkształcenie 1

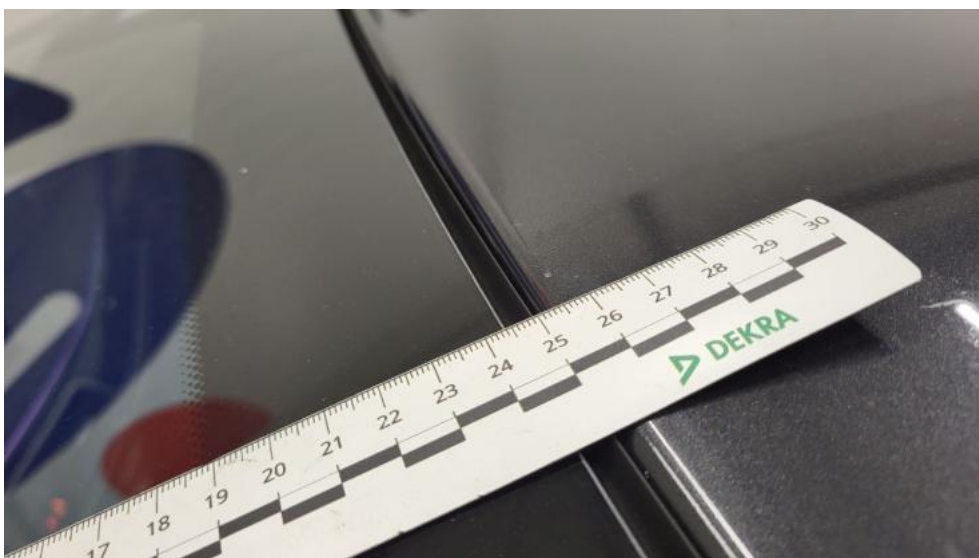
**Photo 62.**

Dach - Rysa/odprysk 1

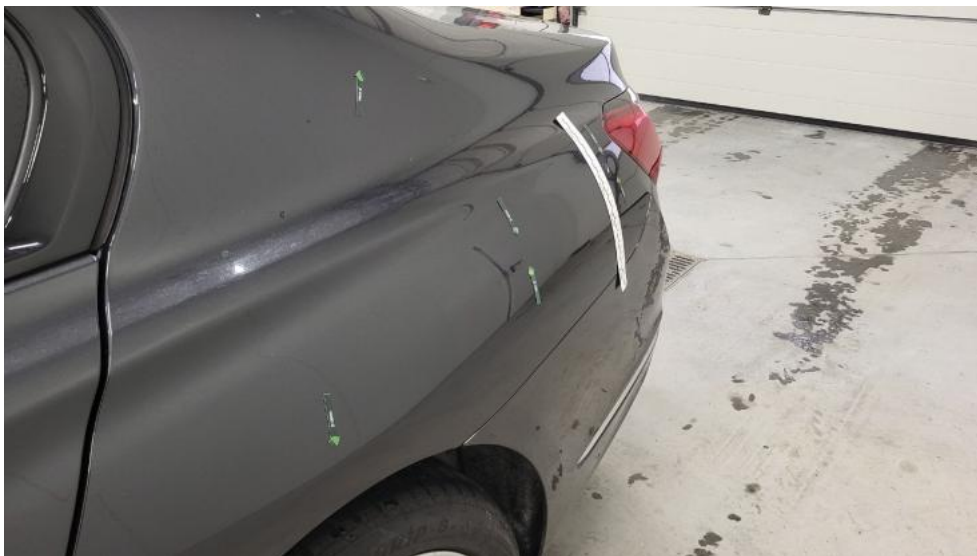
**Photo 63.**

Błotnik tylny L / Ściana boczna L - Wgniecenie/odkształcenie 1

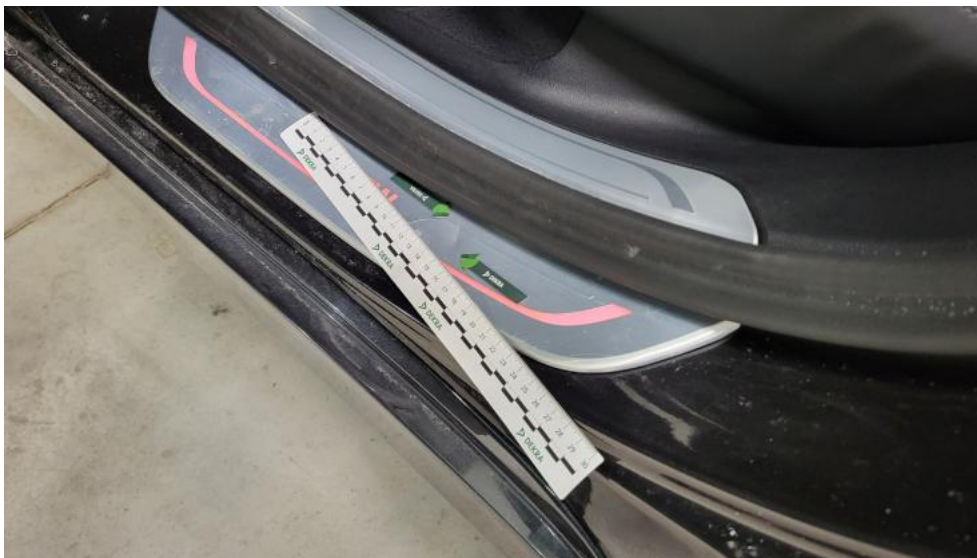
**Photo 67.**

Próg L - Wgniecenie/odkształcenie 1
