DEKRA's commission No. : PKOL(W)/LODZ/88562/26/09/21  
commission/ damage No. : 23/032489  
Date of commission: 21-09-2026

| Manufacturer | HYUNDAI |
| Model | Tucson 18-21 |
| Type / version | Tucson 1.6 T-GDi Premium 4WD DCT |

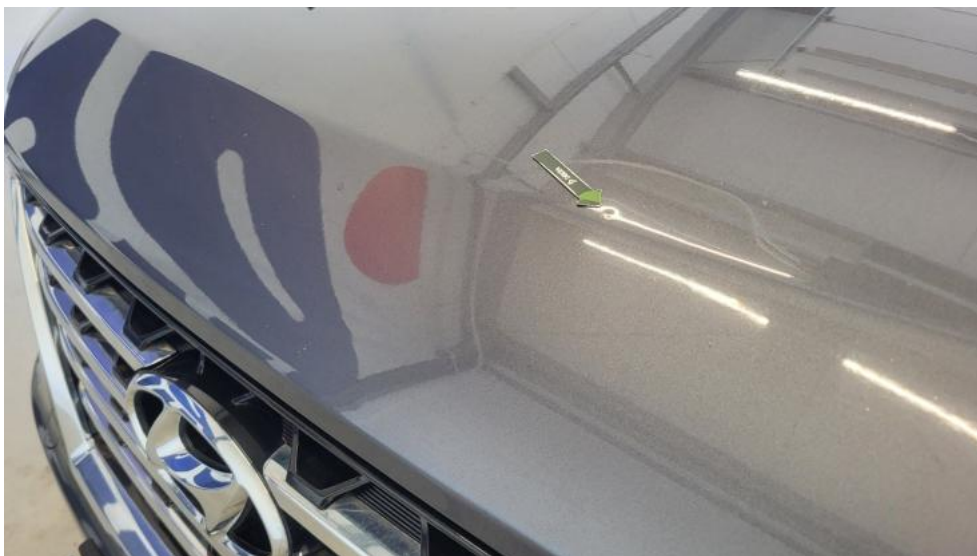
**Photo 44.**

Pokrywa komory silnika - Wgniecenie/odkształcenie 1

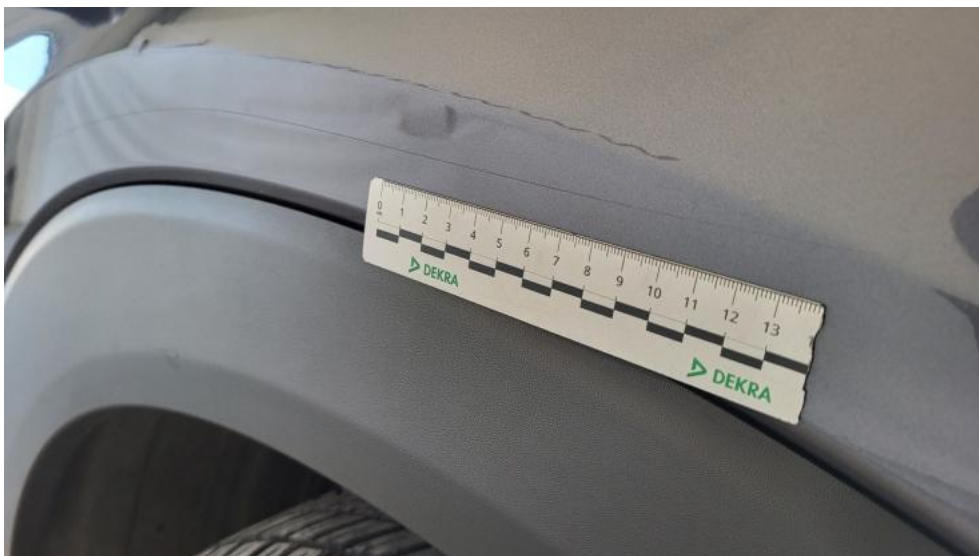
**Photo 46.**

Błotnik przedni P - Rysa/odprysk 1

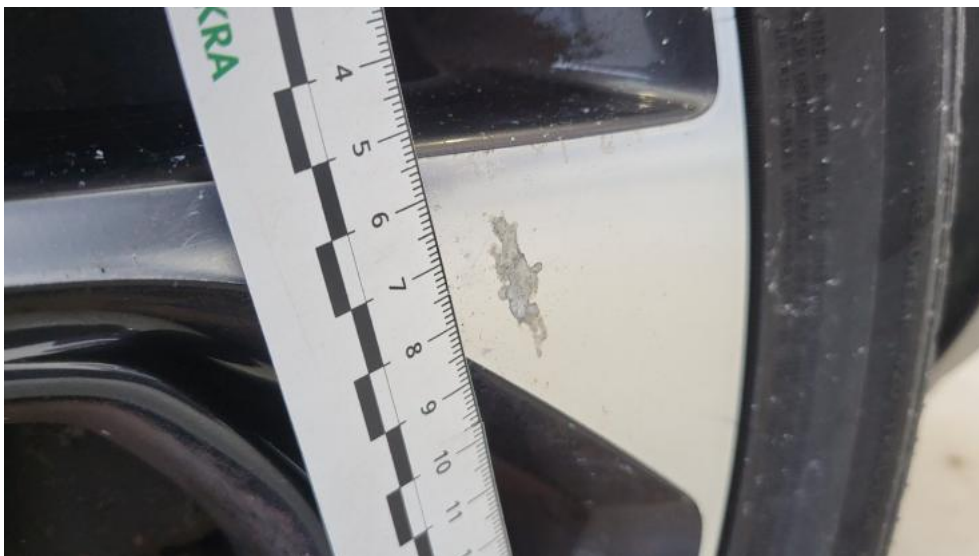
**Photo 48.**

Felga aluminiowa przednia P - Rysa/odprysk 1

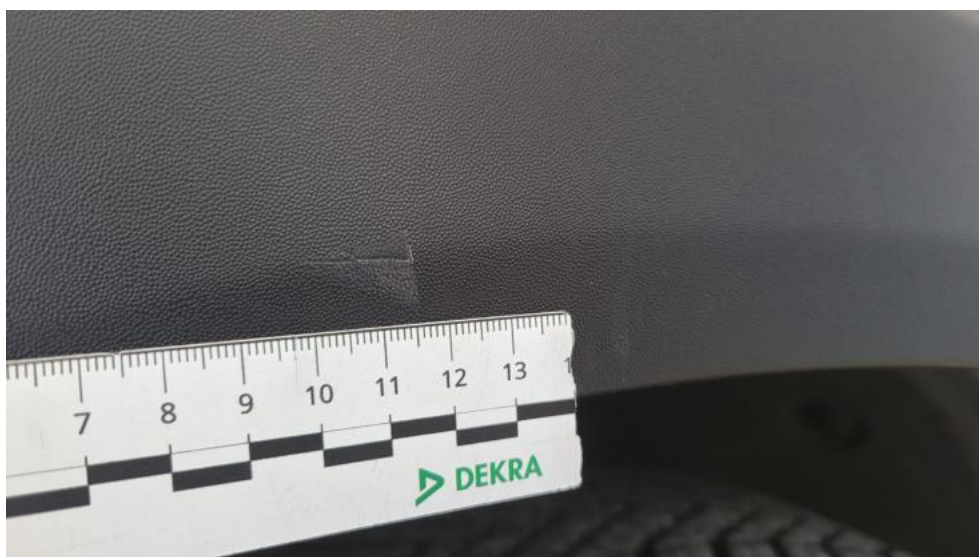
**Photo 49.**

Listwa krawędzi błotnika prz P - Rysa/odprysk 1

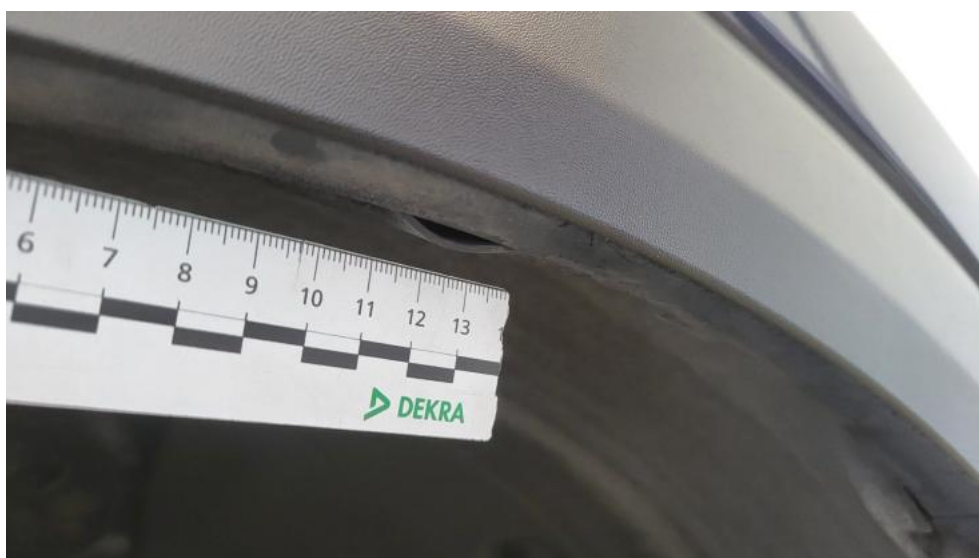
**Photo 50.**

Nadkole przednie P - Inne 1

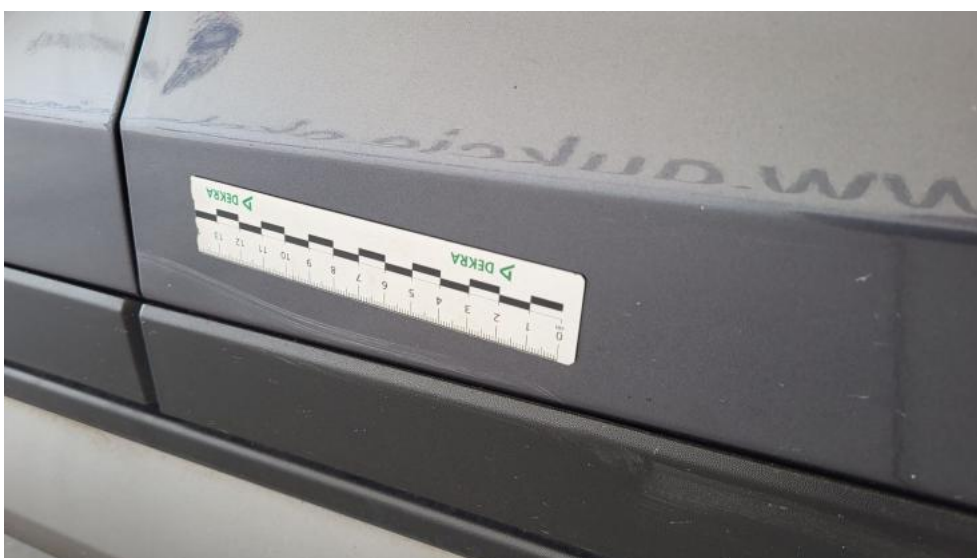
**Photo 52.**

Drzwi przednie P - Rysa/odprysk 2

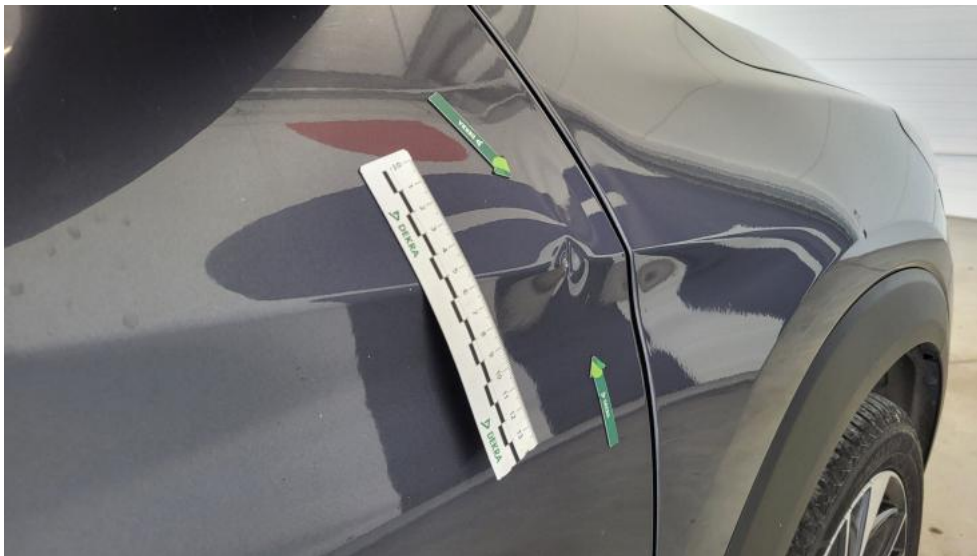
**Photo 53.**

Drzwi przednie P - Wgniecenie/odkształcenie 1

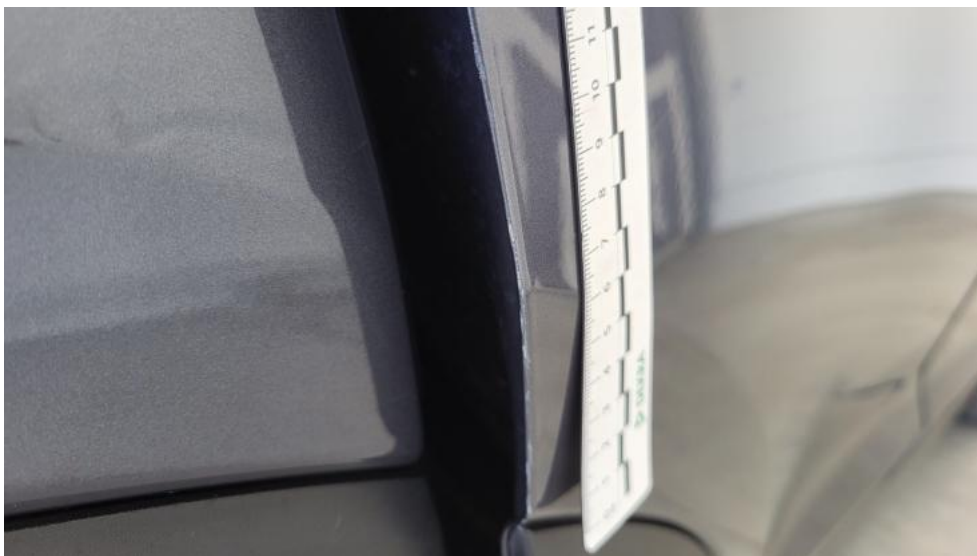
**Photo 54.**

Drzwi tylne P - Rysa/odprysk 1

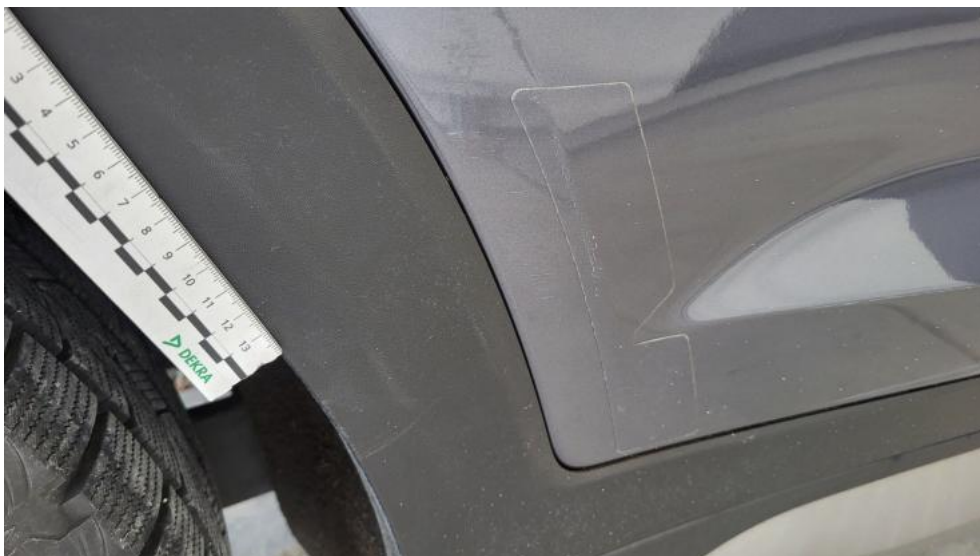
**Photo 58.**

Listwa drzwi tylnych P - Rysa/odprysk 1

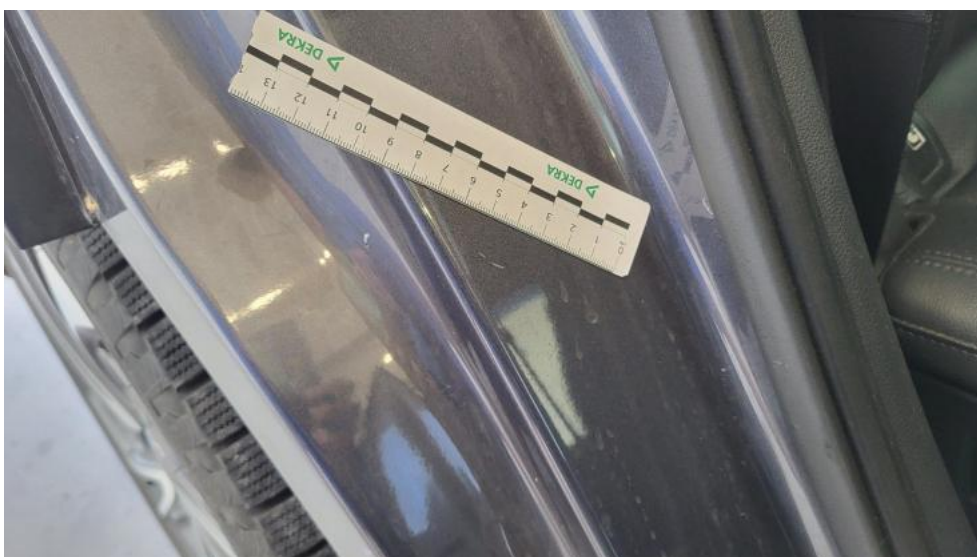
**Photo 63.**

Błotnik tylny P / Ściana boczna P - Rysa/odprysk 1

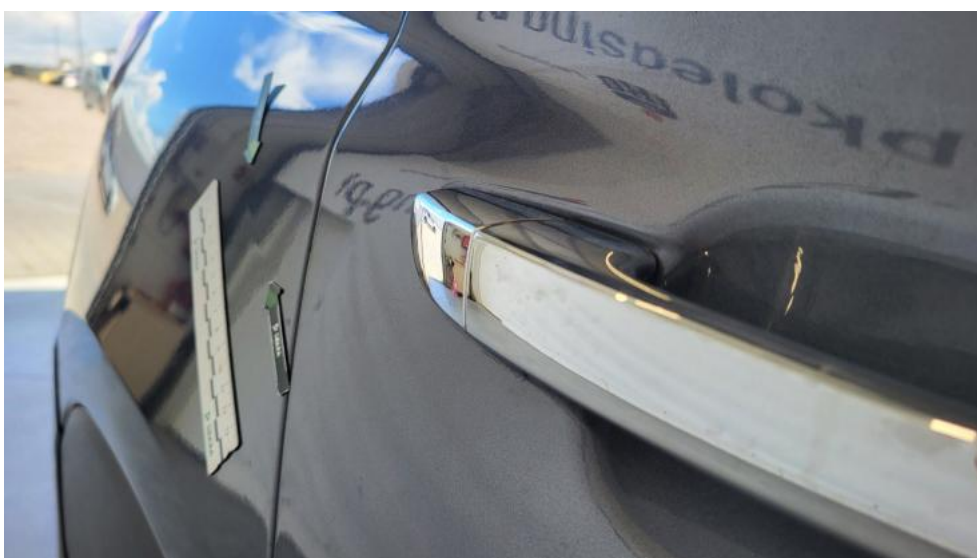
**Photo 64.**

Błotnik tylny P / Ściana boczna P - Wgniecenie/odkształcenie 1

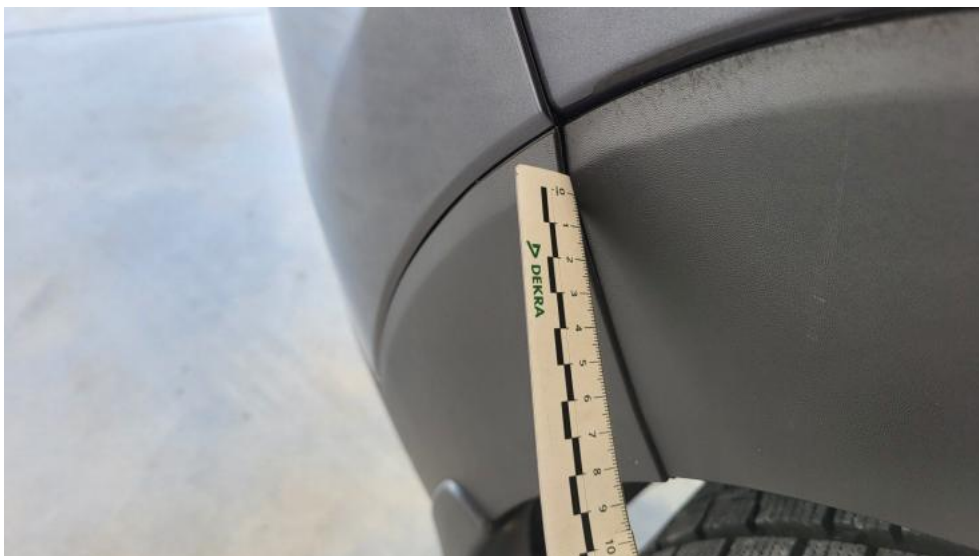
**Photo 66.**

Listwa zderzaka tylnego P - Inne 1

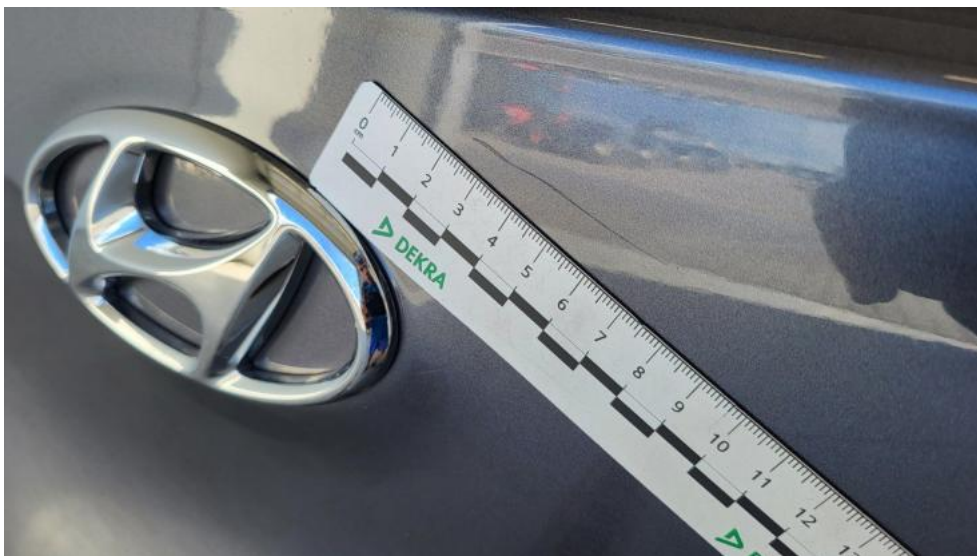
**Photo 67.**

Pokrywy bagażnika - Rysa/odprysk 1

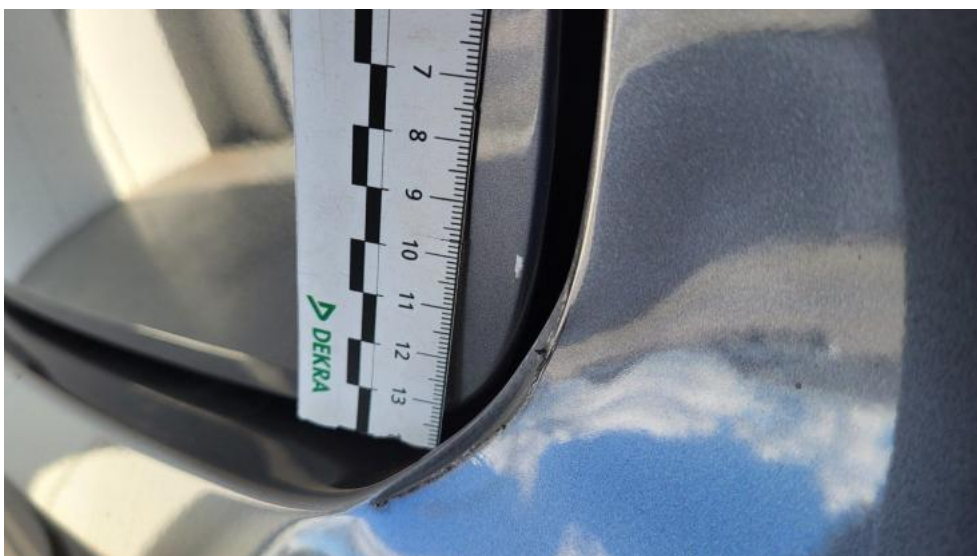
**Photo 68.**

Pokrywy bagażnika - Rysa/odprysk 2

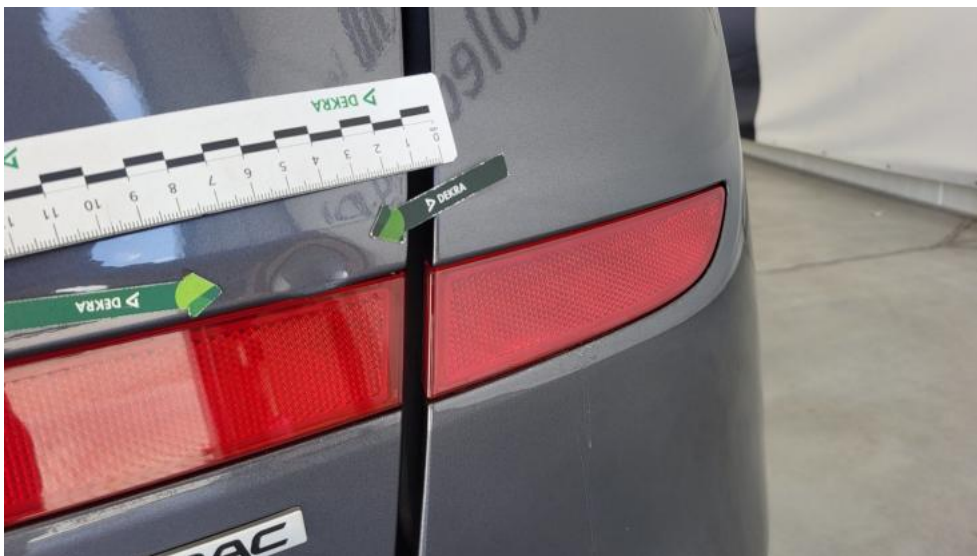
**Photo 69.**

Pokrywy bagażnika - Wgniecenie/odkształcenie 1

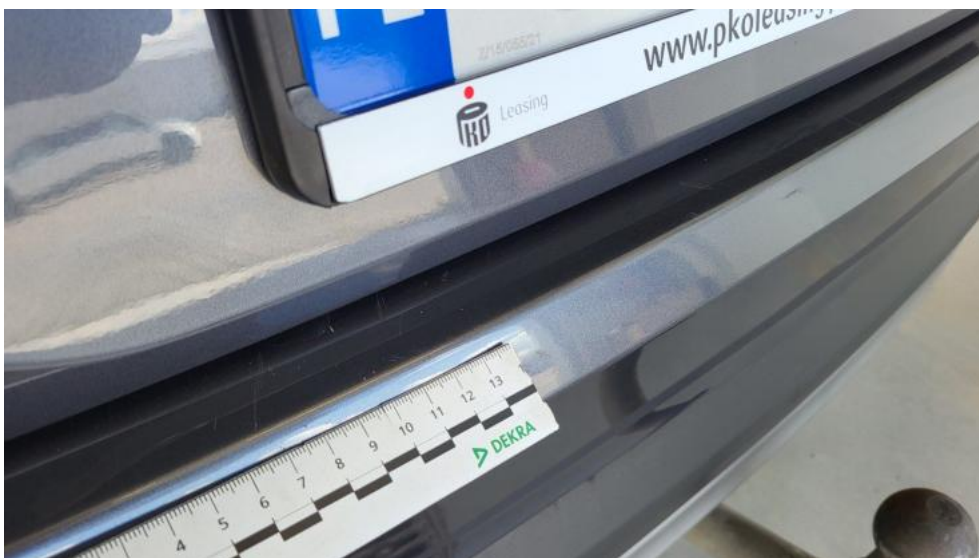
**Photo 72.**

Zderzak tylny - Rysa/odprysk 2

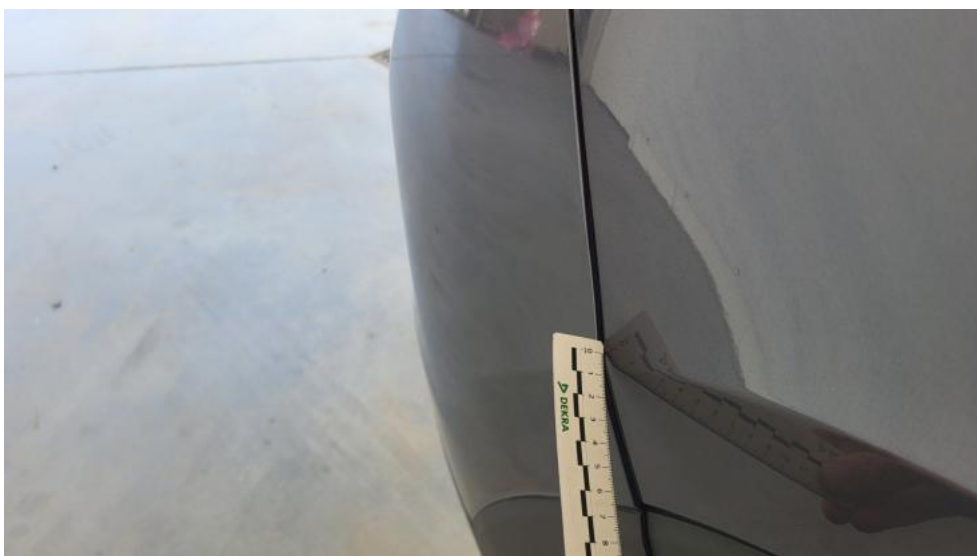
**Photo 74.**

Zderzak tylny - Inne 1

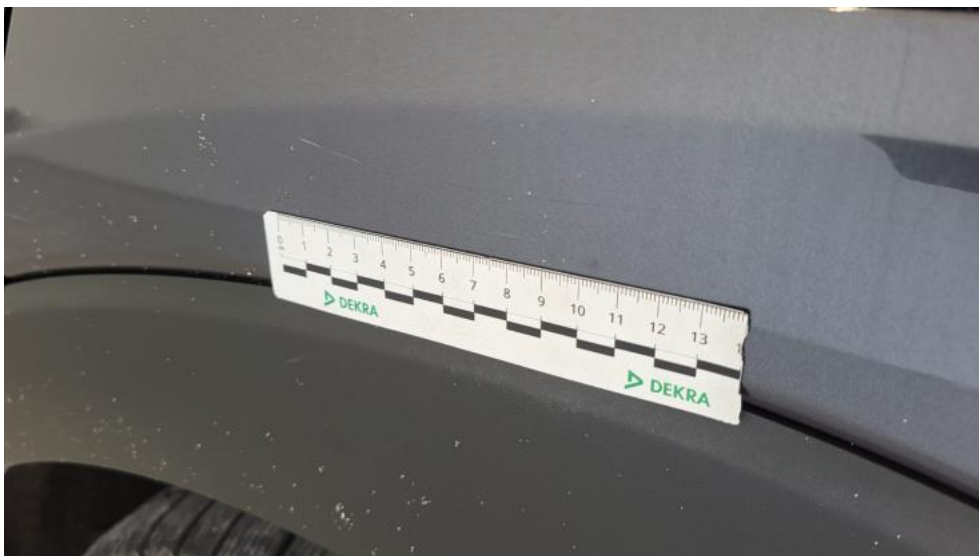
**Photo 76.**

Łotnik tylny L / Ściana boczna L - Rysa/odprysk 1

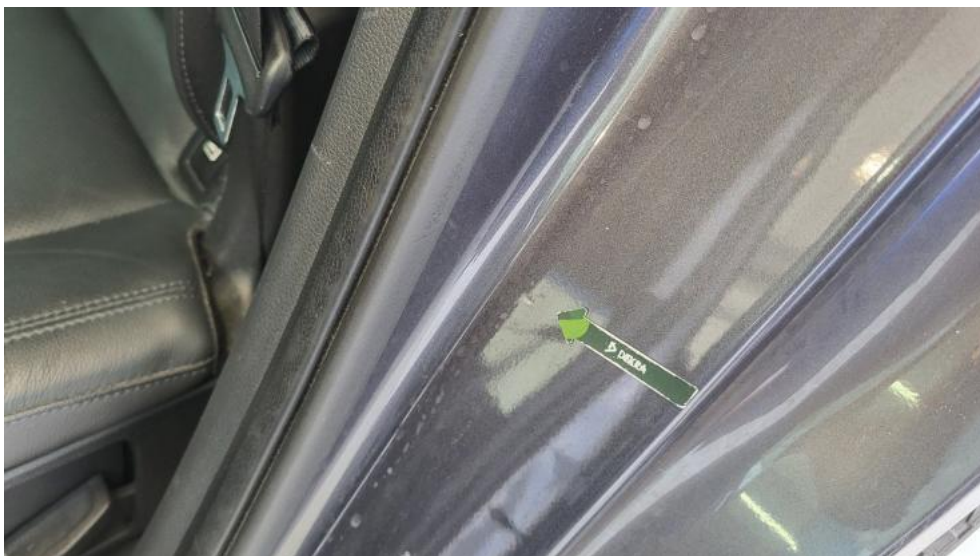
**Photo 78.**

Błotnik tylny L / Ściana boczna L - Wgniecenie/odkształcenie 2

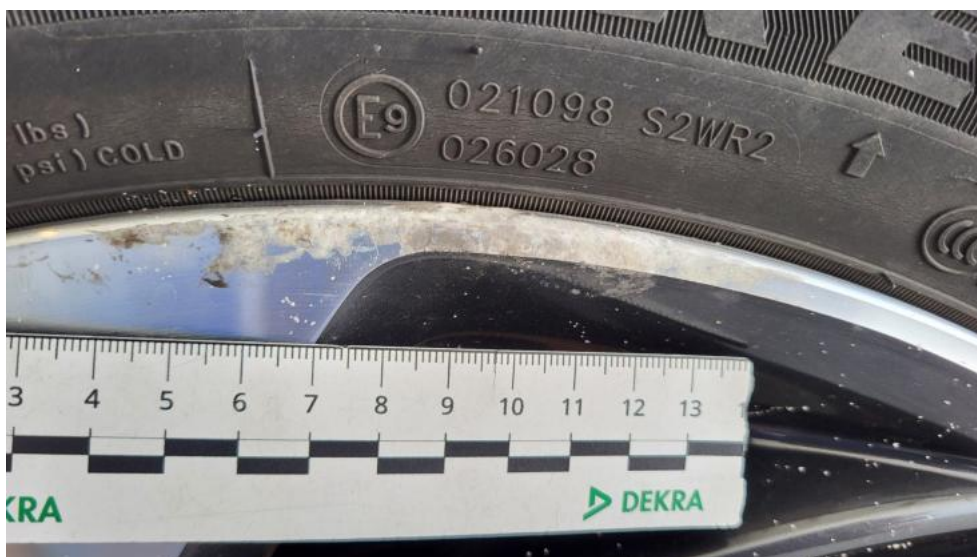
**Photo 79.**

Felga aluminiowa tylna L - Rysa/odprysk 1

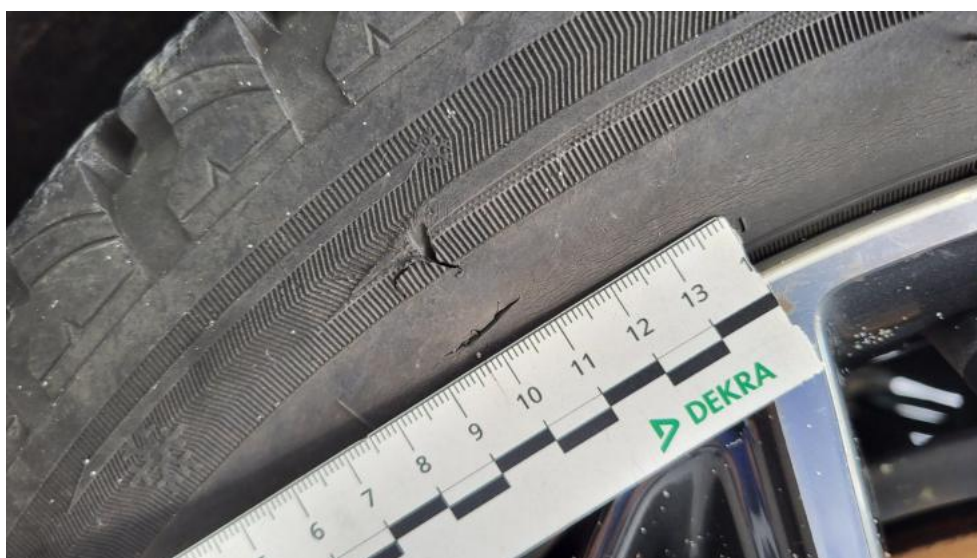
**Photo 80.**

Opona tylna L - Pęknięcie/rozerwanie 1

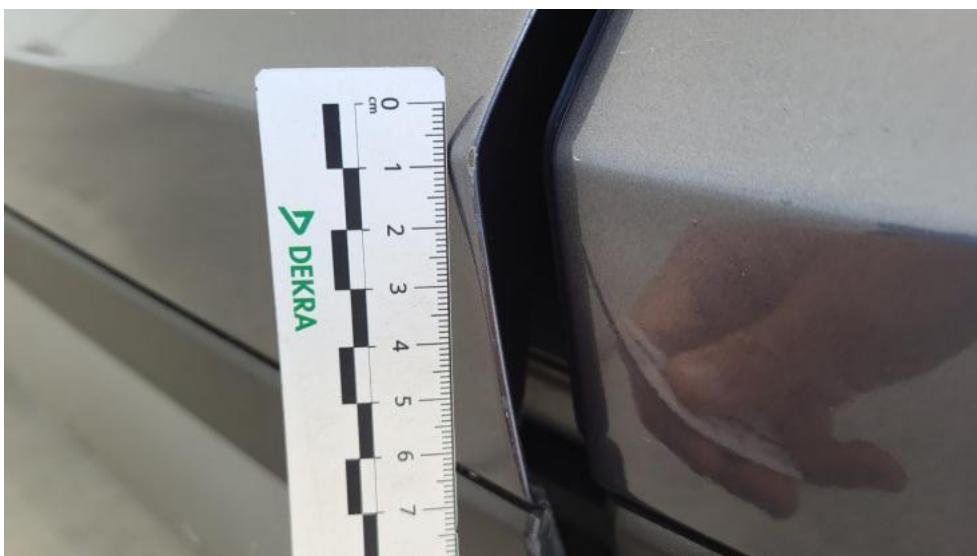
**Photo 82.**

Drzwi przed L - Rysa/odprysk 2

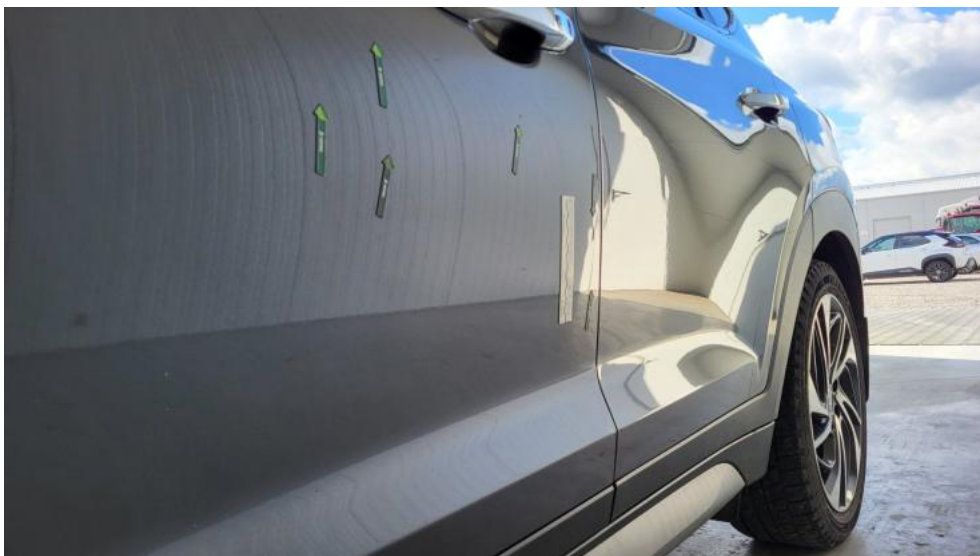
**Photo 84.**

Drzwi przed L - Wgniecenie/odkształcenie 1

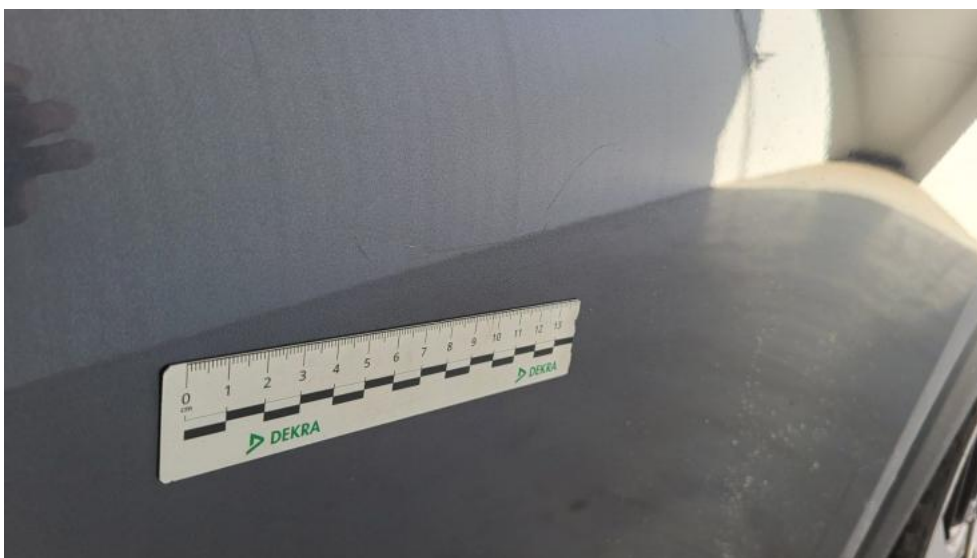
**Photo 86.**

Drzwi tylne L - Rysa/odprysk 2

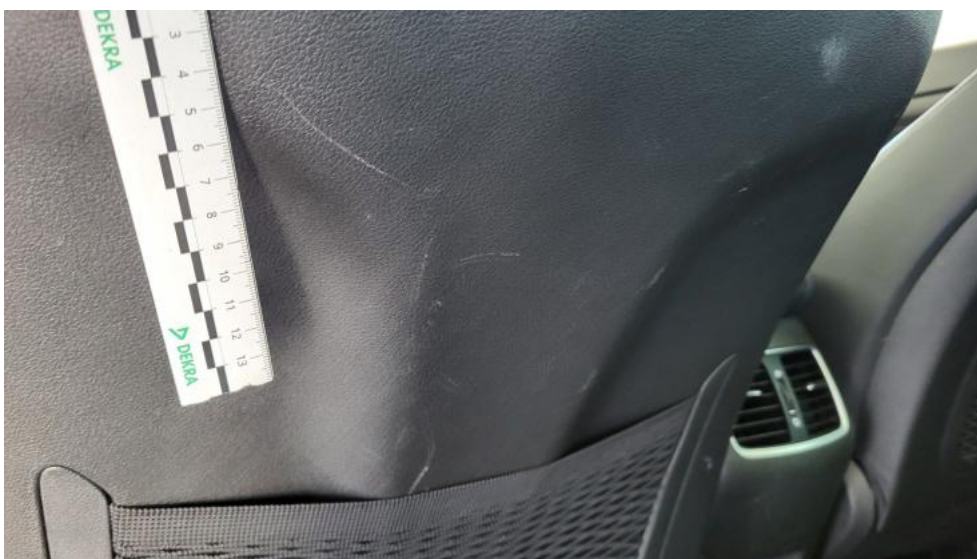
**Photo 93.**

Fotel prz. lew. - Rysa/odprysk 1

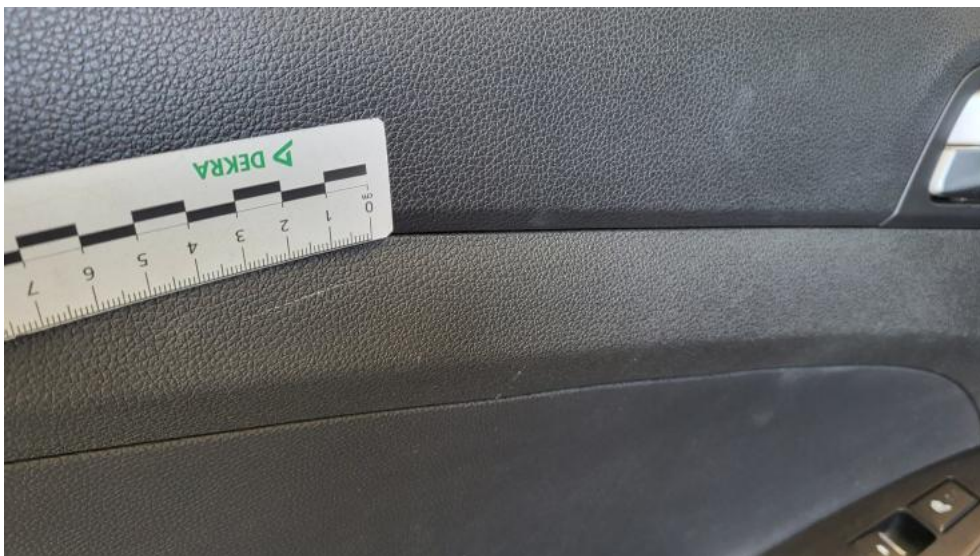
**Photo 96.**

Tapicerka drzwi tylnych L - Rysa/odprysk 1

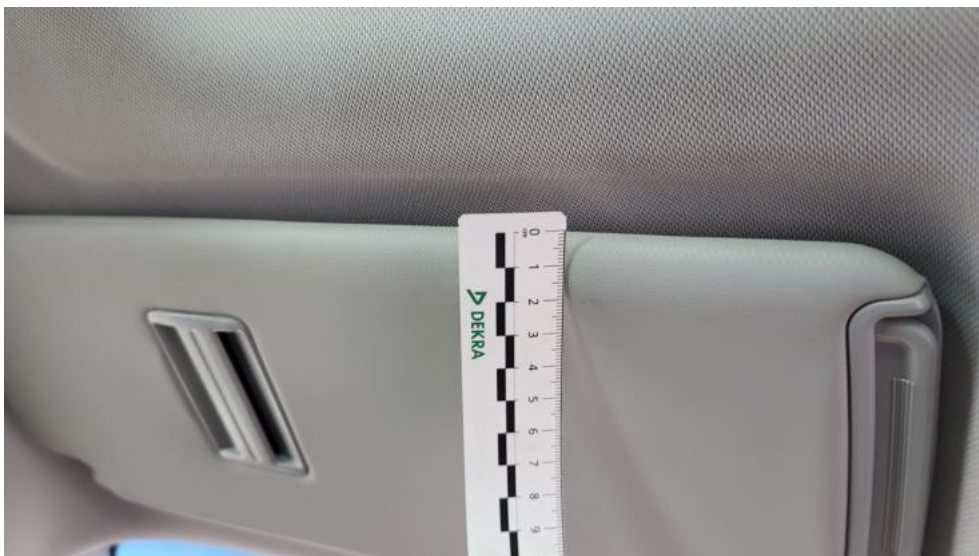
**Photo 98.**

Osłona p/słoneczna lewa - Inne 1
