DEKRA's commission No. : PKOL(W)/LODZ/40068/26/05/07  
 commission/ damage No. : 24/029865  
 Date of commission: 07-05-2026

**Vehicle data**

Group of objects (Eurotax)	cars
EC code (Eurotax)	0134478
Manufacturer	BMW
Model	Seria 8 Coupe [G15] 18-22
Type / version	M850i xDrive
Body type	CPE
Number of doors / seats	2/4
Curb weight [kg]	1890
Gross vehicle weight [kg]	2395
Wheelbase 1/2	2822
Engine type	spark ignition
Pollution reduction system	GPF
Engine capacity [ccm]	4395
Engine Power [hp/kW]	530/390
Gearbox	automatic 8- gear
Registration /record No.	GD3R179
VIN / serial number	WBABC41010CD03342
Date of first registration	09-10-2019
Year of manufacture	2019
Readout [km]	177 292 (read)
Body color / type of coating	black/METALIK

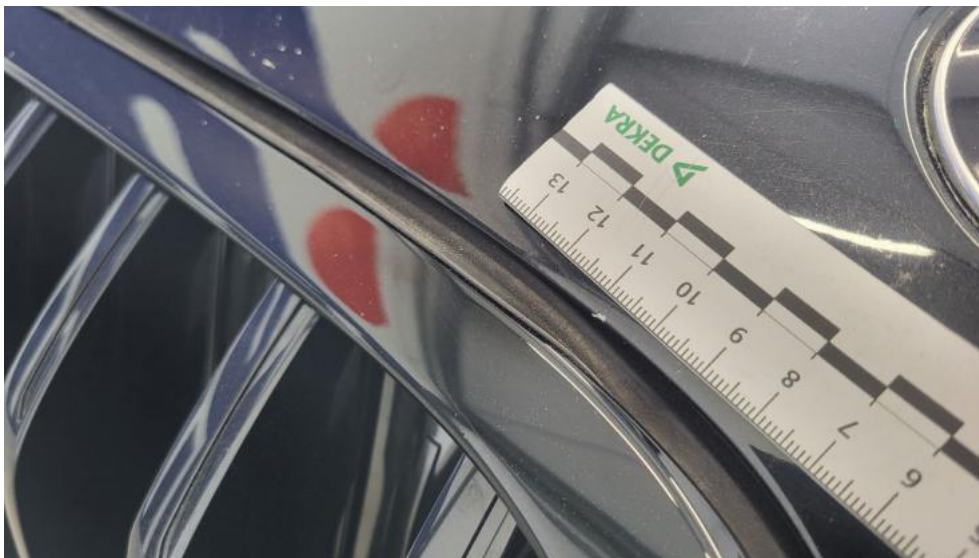
**Photo 47.**

Pokrywa komory silnika - Rysa/odprysk 1

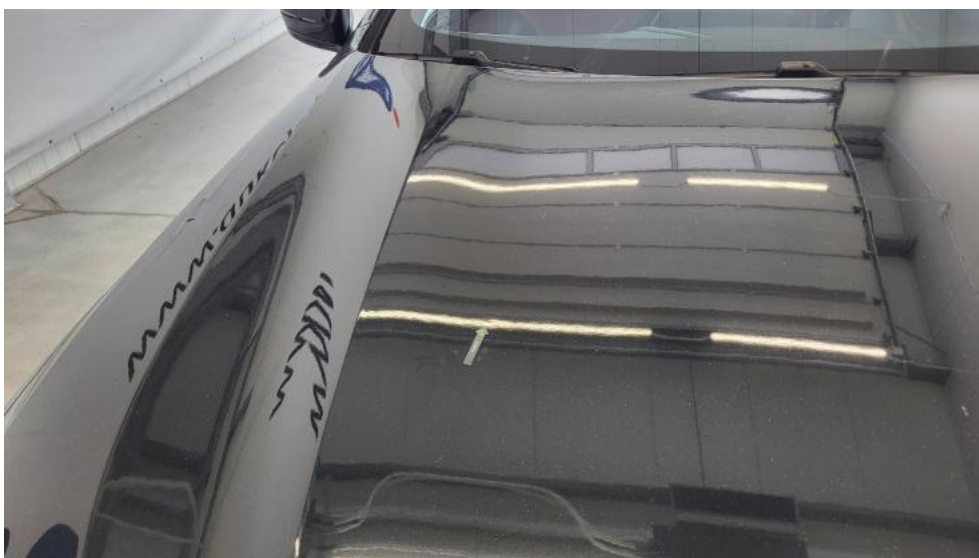
**Photo 48.**

Pokrywa komory silnika - Wgniecenie/odkształcenie 1

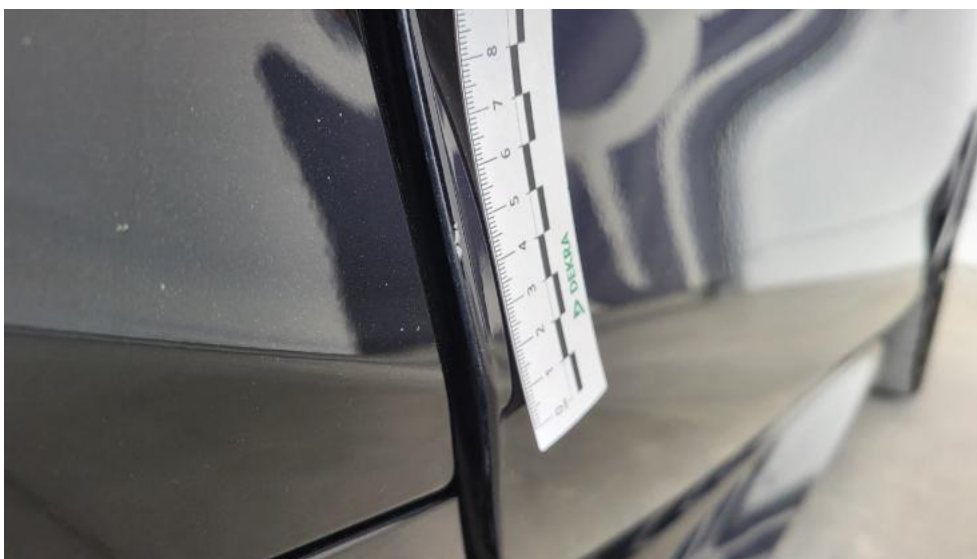
**Photo 53.**

Drzwi przednie P - Rysa/odprysk 1

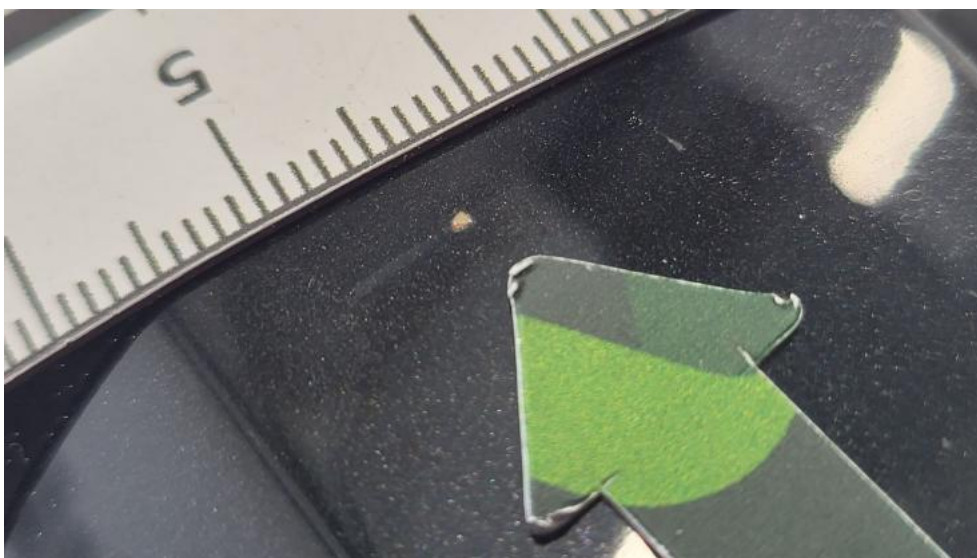
**Photo 56.**  
Stupek przedni P - Inne 1

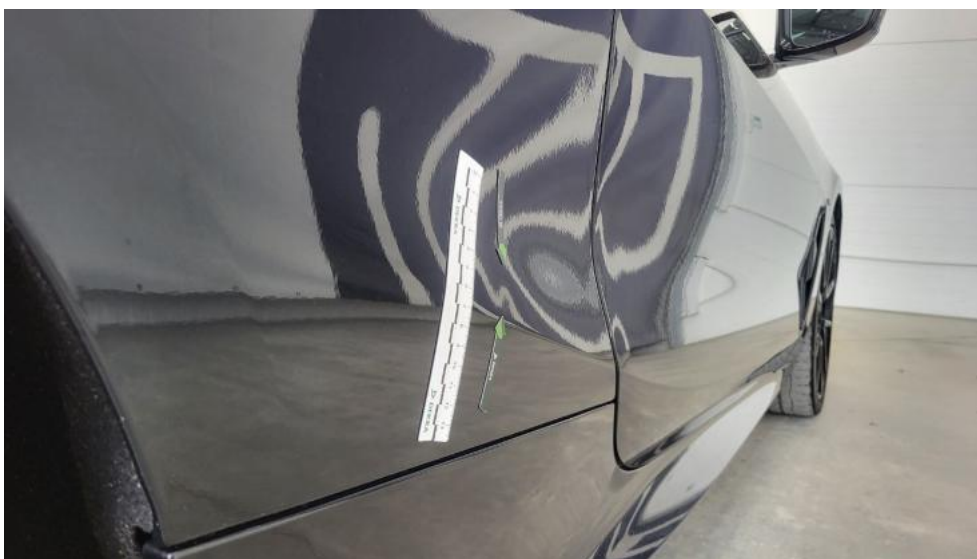
**Photo 57.**  
Błotnik tylny P / Ściana boczna P - Wgniecenie/odkształcenie 1

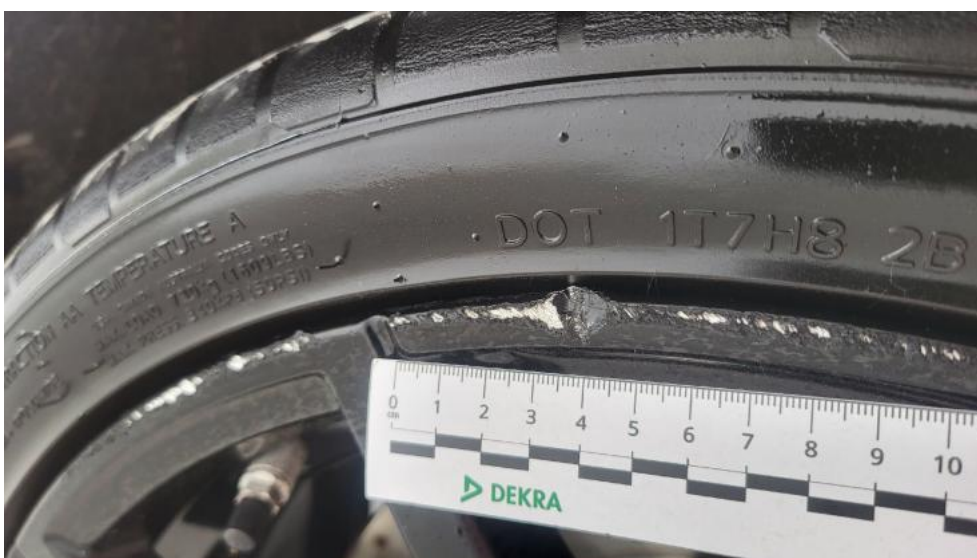
**Photo 58.**  
Felga aluminiowa tylna P - Rysa/odprysk 1

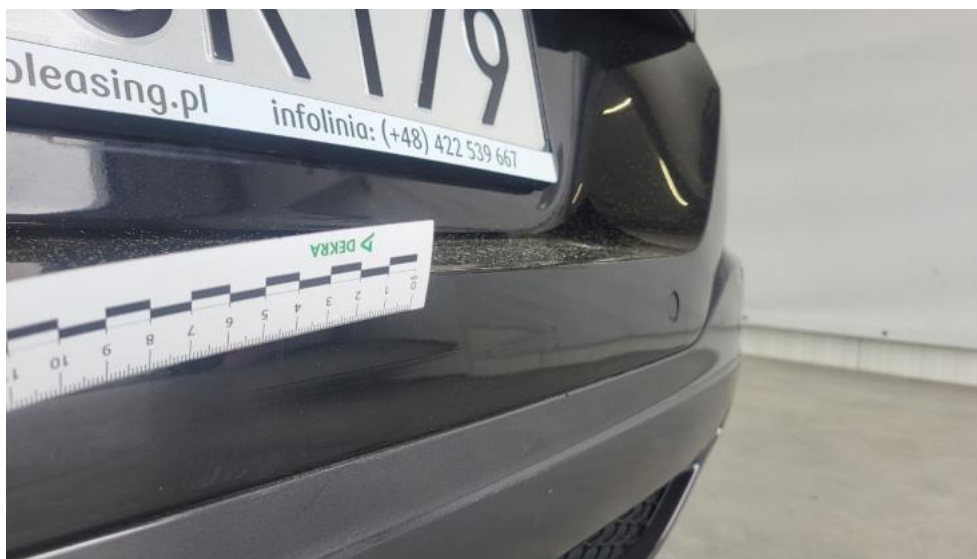
**Photo 59.**  
Zderzak tylny - Wgniecenie/odkształcenie 1

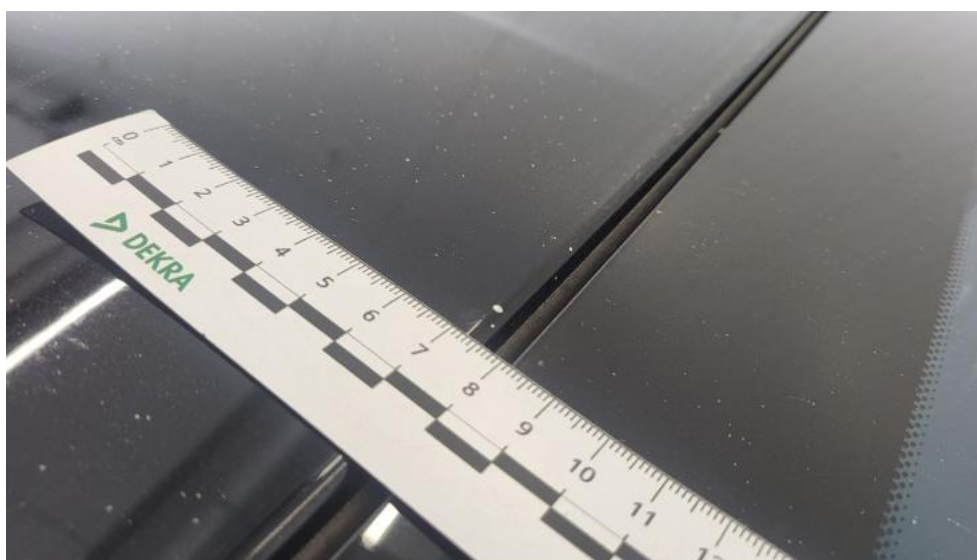
**Photo 60.**  
Dach - Rysa/odprysk 1

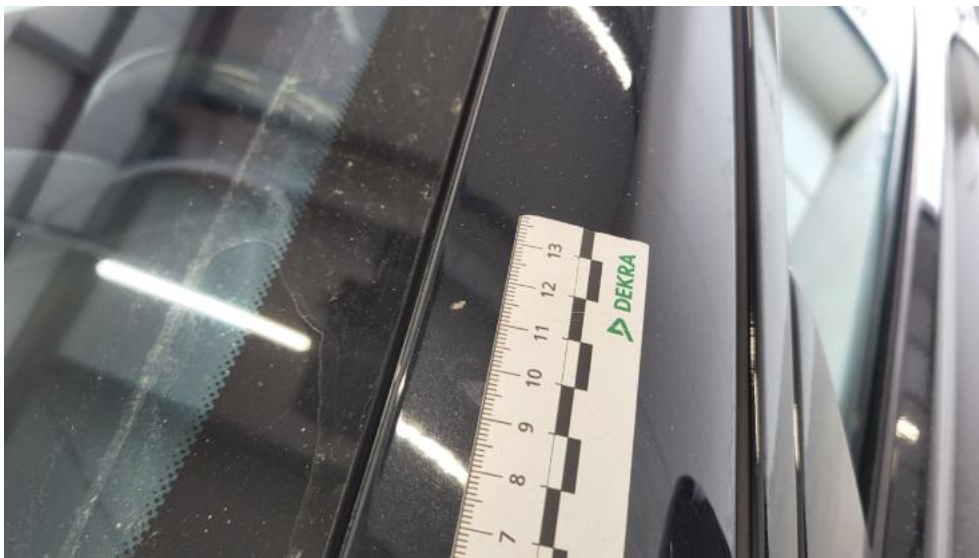
**Photo 65.**  
Stupek przedni L - Rysa/odprysk 1

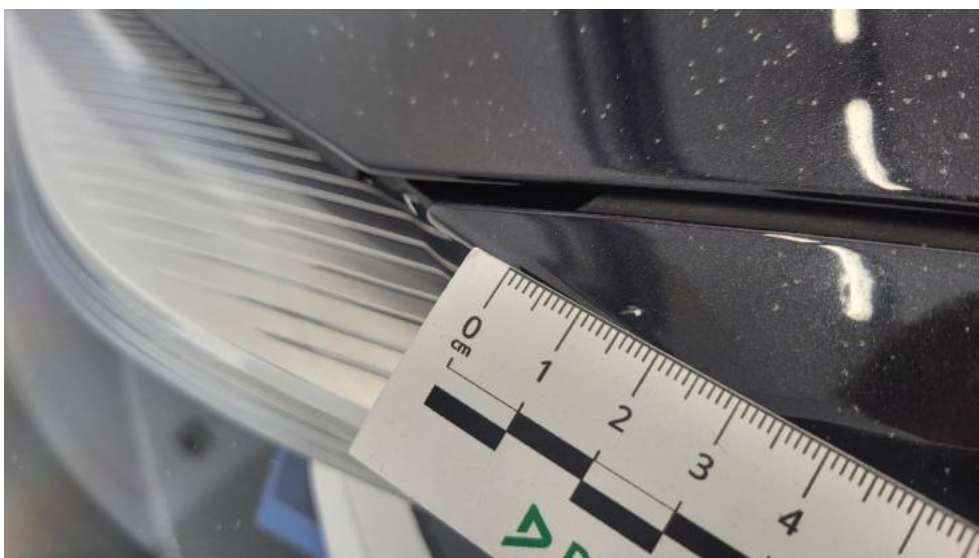
**Photo 66.**  
Błotnik przedni L - Rysa/odprysk 1

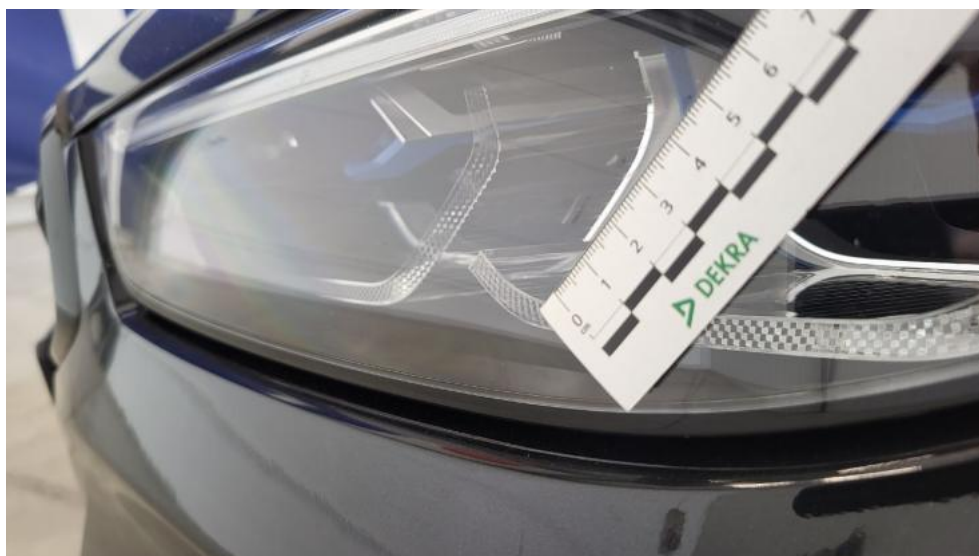
**Photo 68.**  
Reflektor L - Rysa/odprysk 1

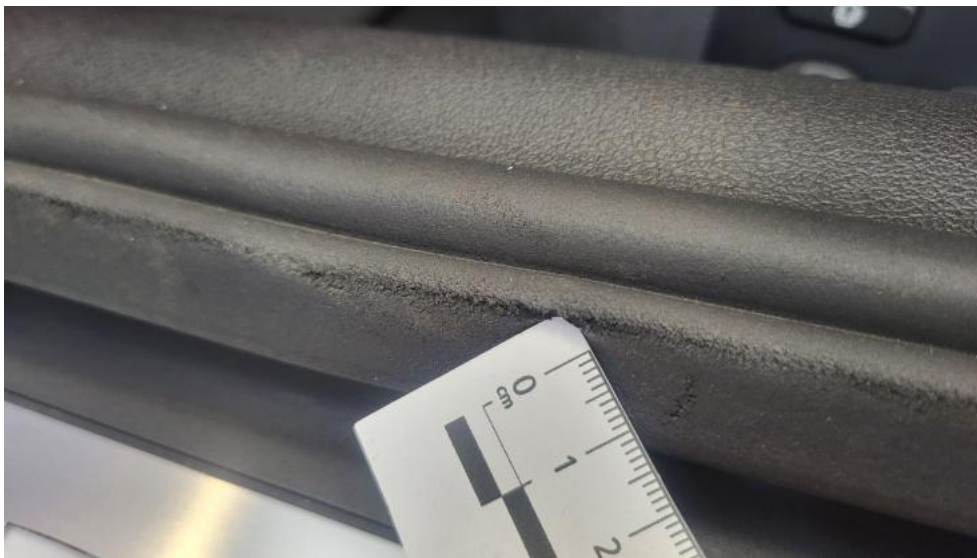
Rysy na samochodzie. Dostarczono ksero pozwolenia czasowego. Niesprawne elektryczne domykanie drzwi przednich lewych. Informacja poduszka powietrzna pasażera przód dezaktywowana. Odpryski na szybie czołowej. Odpryski na szybie czołowej. Widoczne wady lakiernicze. Informacja ograniczone działanie wspomaganie kierownicy. Informacja awaria ostrzegania przed ruchem poprzecznym.

**Photo 73.**  
Uszczelka drzwi przednich L - Pęknięcie/rozerwanie 1

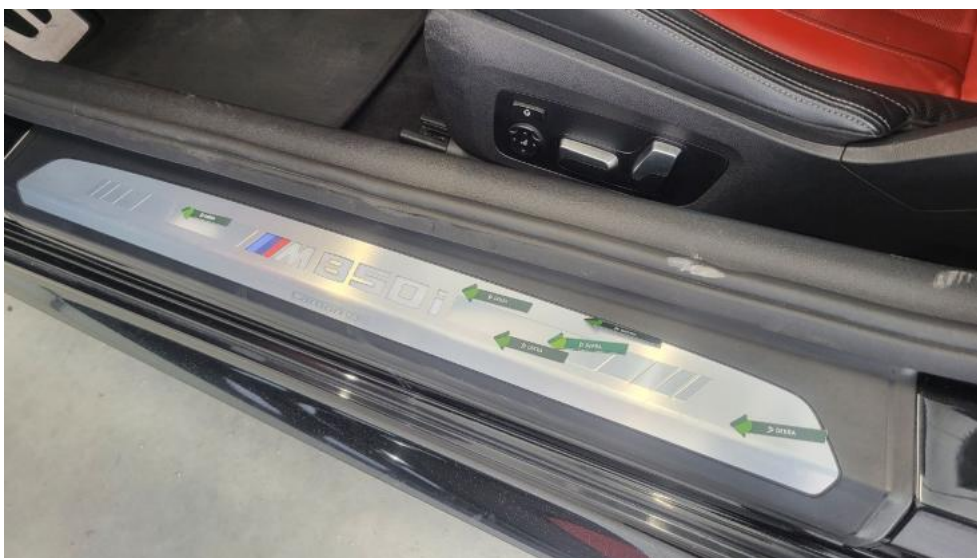
**Photo 74.**  
Listwy progowe lew. - Wgniecenie/odkształcenie 1
