DEKRA's commission No. : PKOL(W)/LODZ/56124/26/06/18  
commission/ damage No. : 24/000951  
Date of commission: 18-06-2026

**DEKRA Poland - Headquarters**  
02-673 Warszawa, ul. Konstruktorska 12A

PKO Leasing SA  
Świętokrzyska 36  
00-116 Warszawa

| Model | Seria 3 [G20] 18-22 |

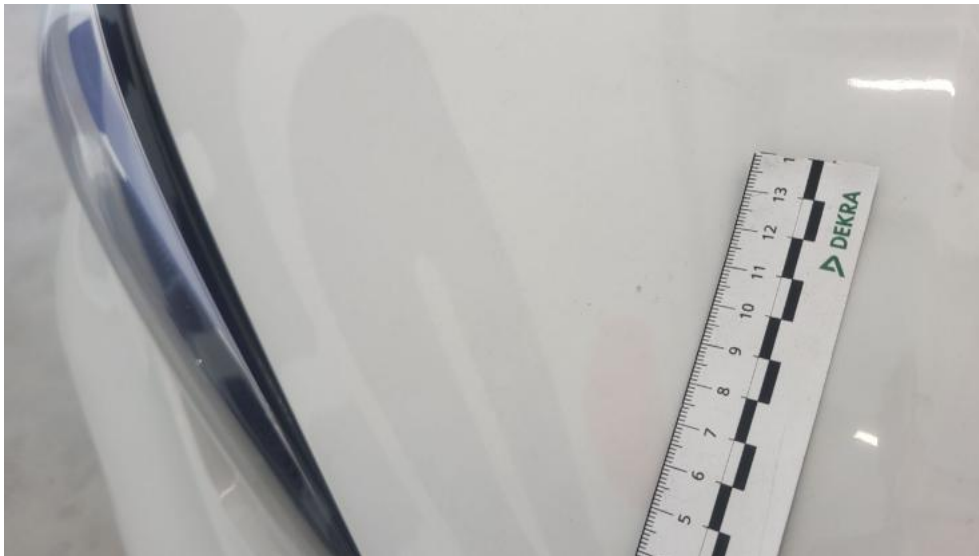
**Photo 41.**

Pokrywa komory silnika - Rysa/odprysk 1

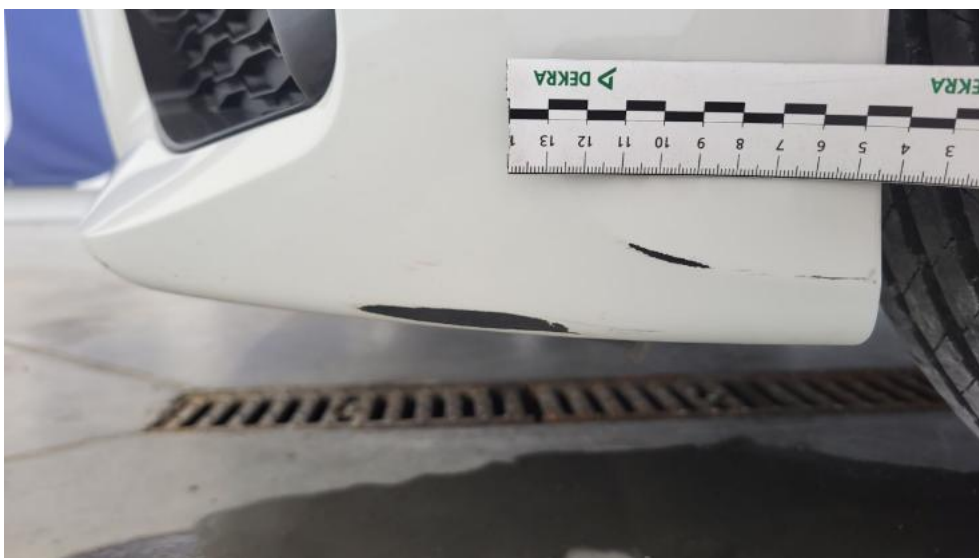
**Photo 42.**

Zderzak - Rysa/odprysk 1

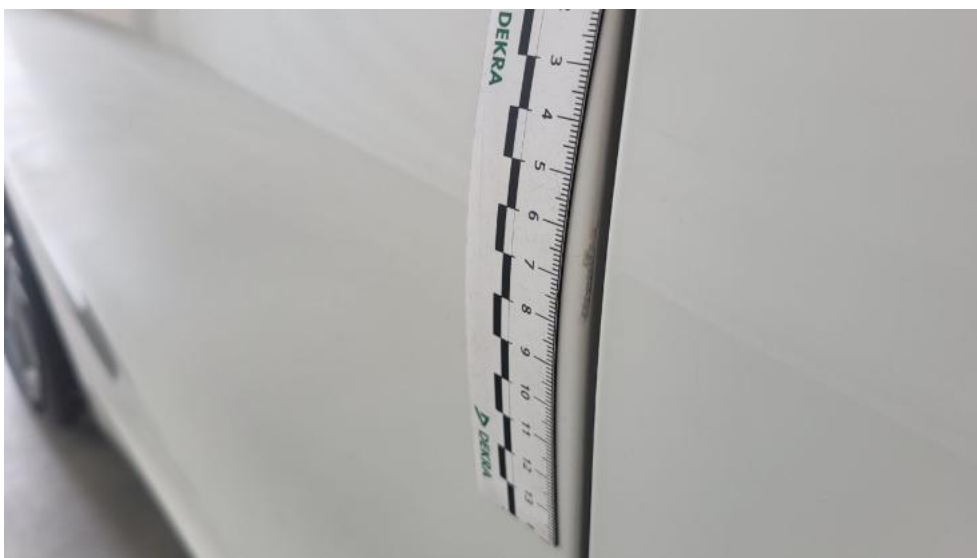
**Photo 46.**

Drzwi tylne P - Rysa/odprysk 1

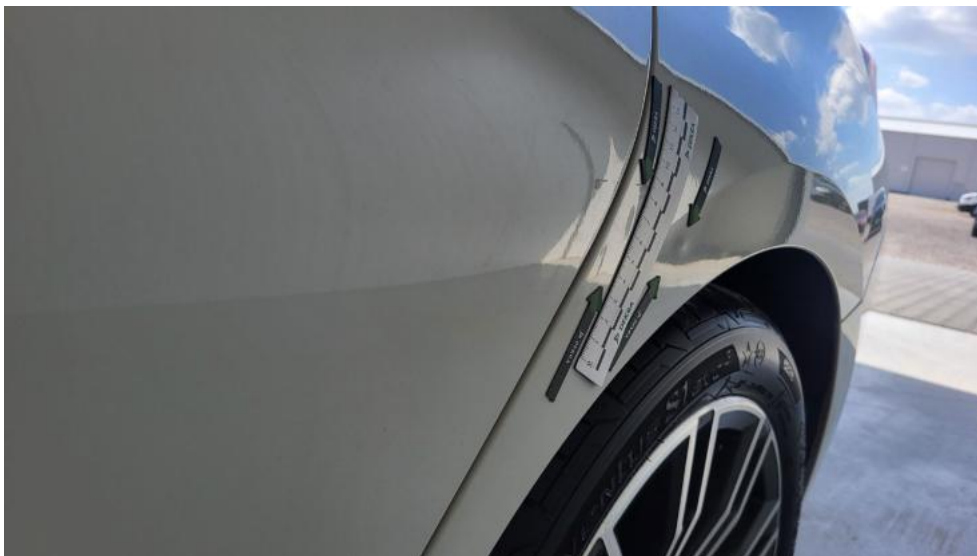
**Photo 49.**

Błotnik tylny L / Ściana boczna L - Wgniecenie/odkształcenie 1

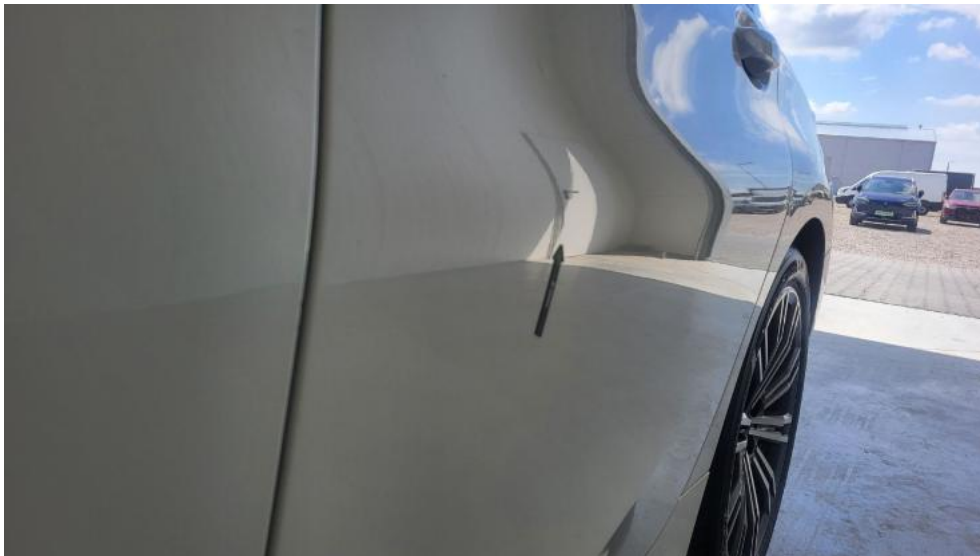
**Photo 53.**

Drzwi tylne L - Wgniecenie/odkształcenie 1

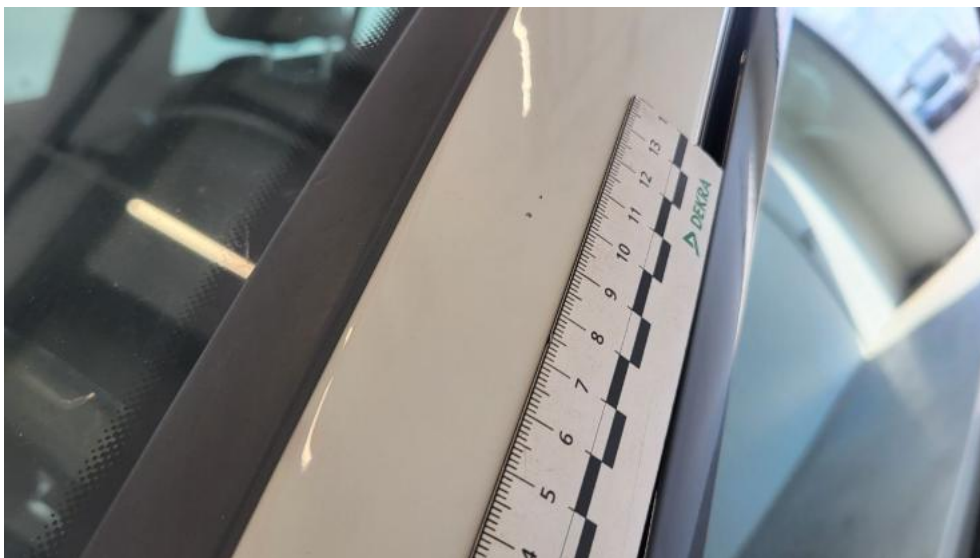
**Photo 54.**

Słupek przedni L - Rysa/odprysk 1

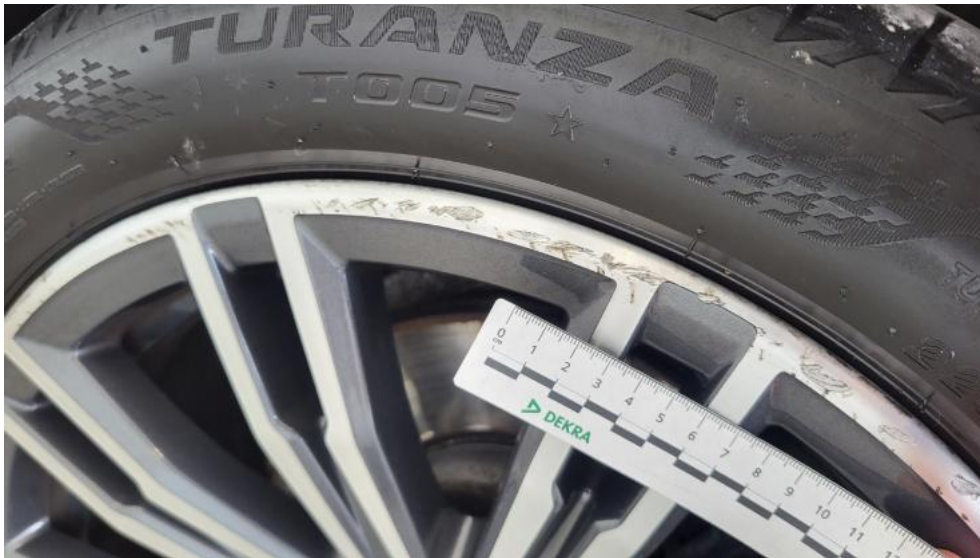
**Photo 55.**

Felga Aluminiowa przednia L - Rysa/odprysk 1

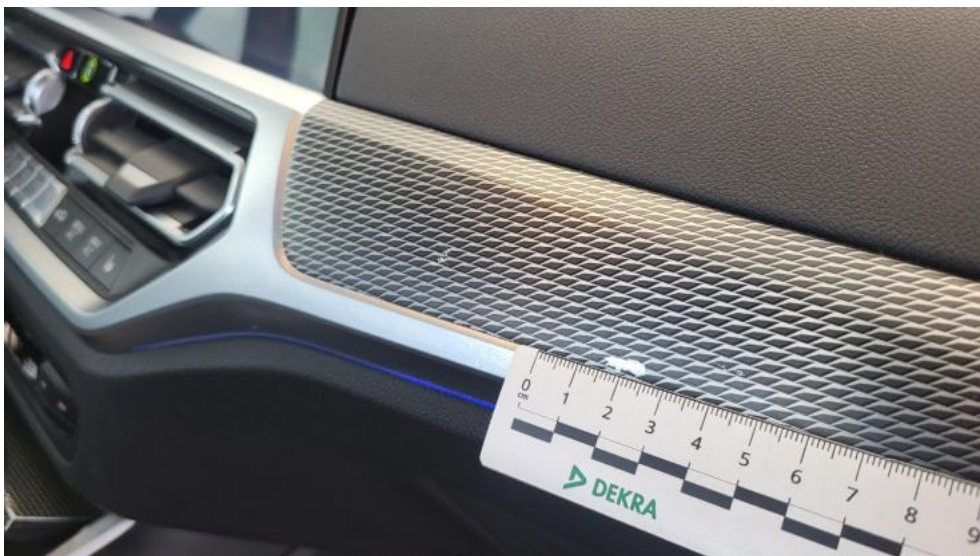
**Photo 56.**

Deska rozdzielcza - Rysa/odprysk 1

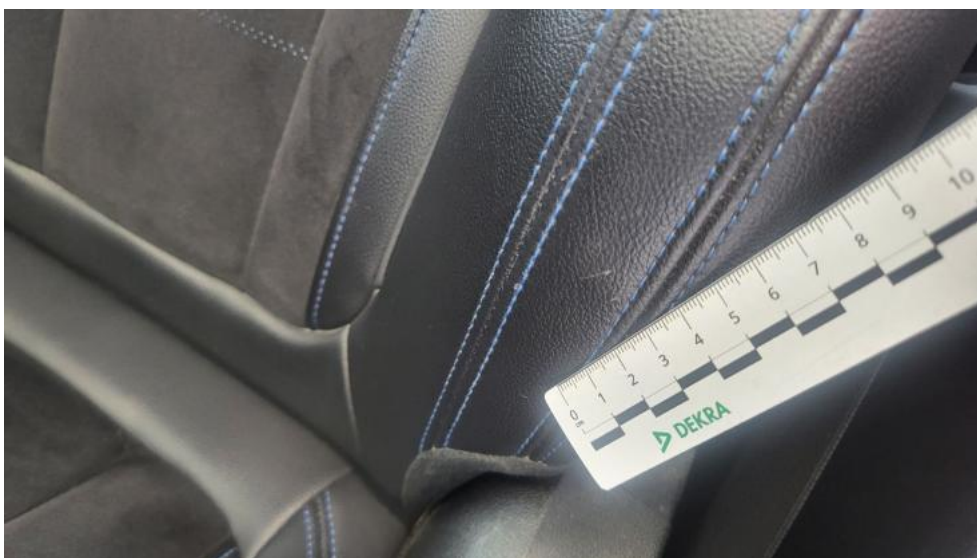
**Photo 58.**

Fotel prz. lew. - Rysa/odprysk 1

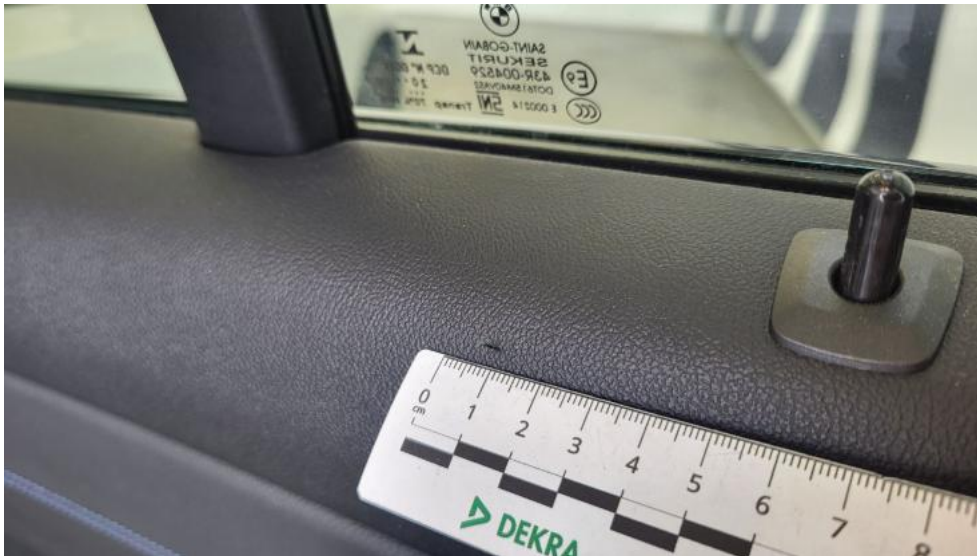
**Photo 59.**

Tapicerka drzwi tylnych P - Pęknięcie/rozerwanie 1

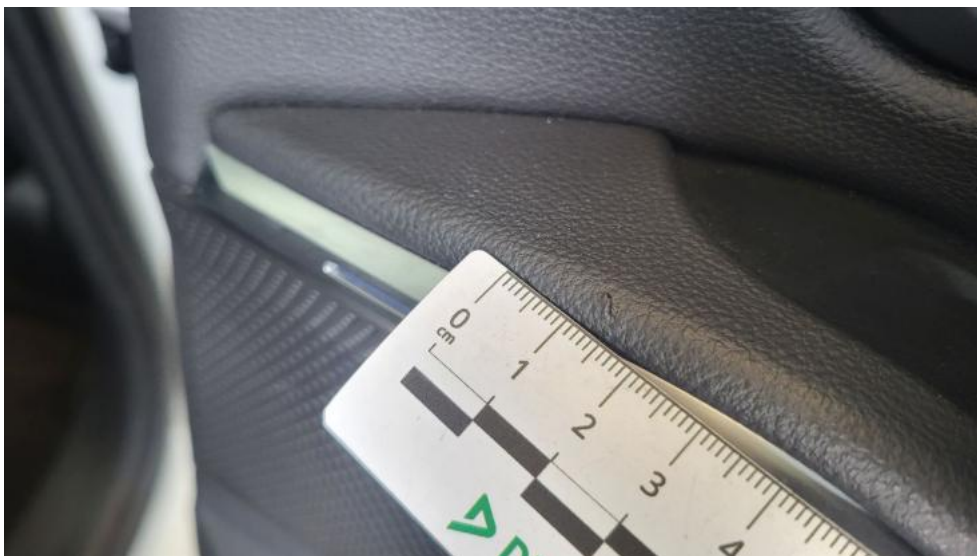
**Photo 60.**

Tapicerka drzwi tylnych P - Pęknięcie/rozerwanie 2

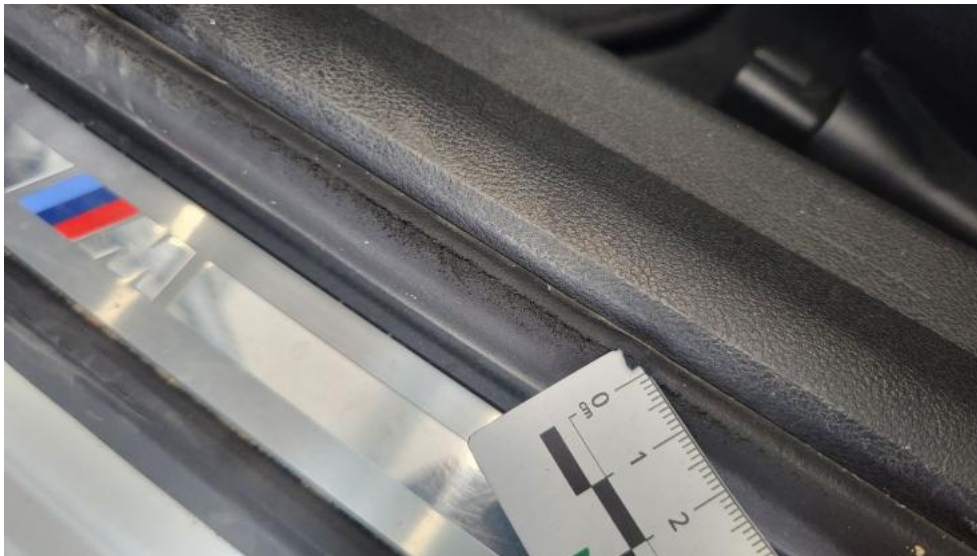
**Photo 61.**

Uszczelka drzwi przednich L - Pęknięcie/rozerwanie 1

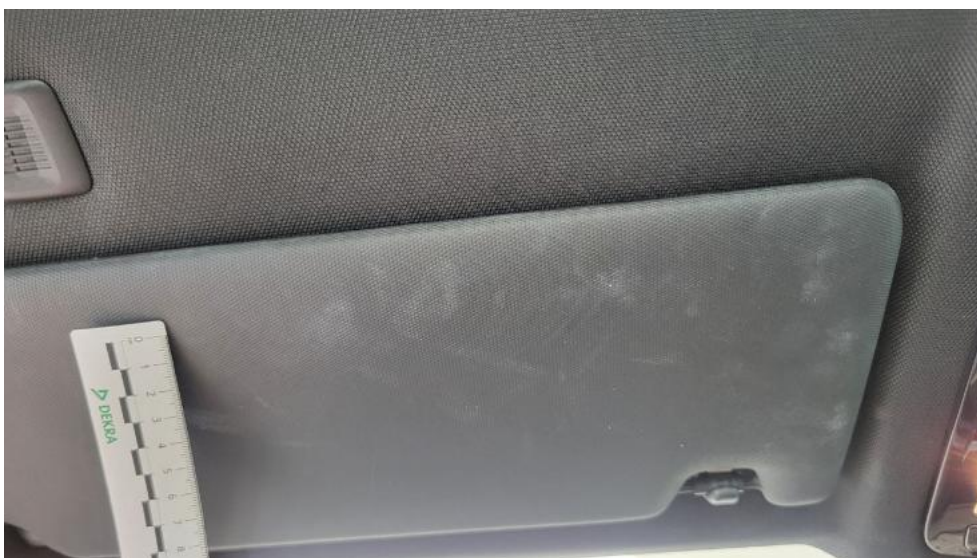
**Photo 62.**

Osłona p/słoneczna lewa - Inne 1
