DEKRA's commission No. : PKOL(W)/LODZ/33455/25/05/09  
 commission/ damage No. : 23/021318  
 Date of commission: 09-05-2025

| Manufacturer | JAGUAR |
| Model | XE 19-24 |
| Type / version | XE 2.0 D180 R-Dynamic SE aut |

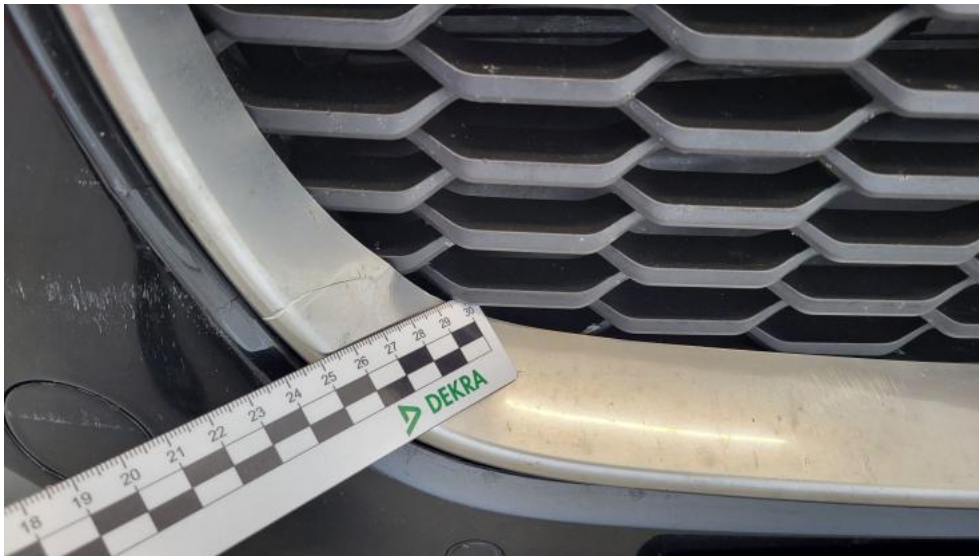
**Photo 39.**

Atrapa przednia - Pęknięcie/rozerwanie 1

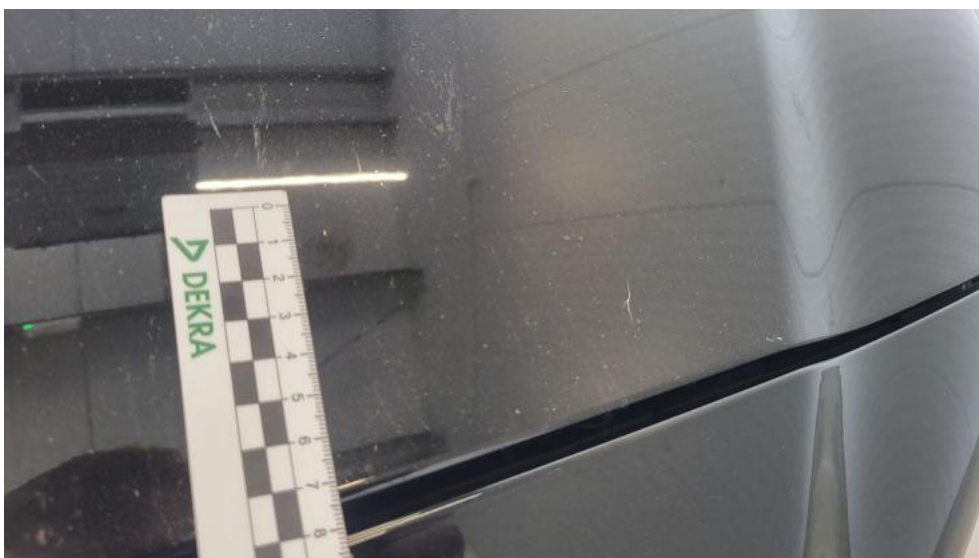
**Photo 40.**

Pokrywa komory silnika - Rysa/odprysk 1

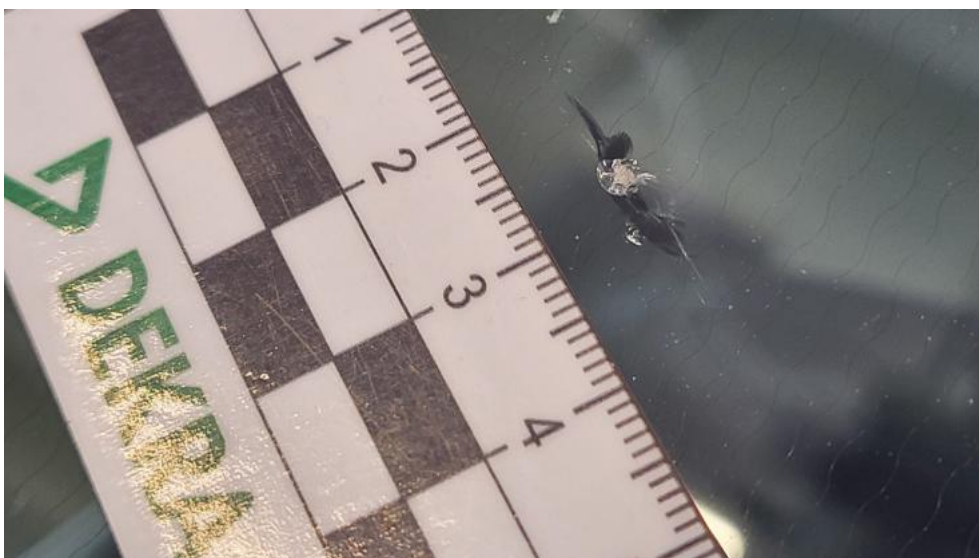
**Photo 42.**

Szyba czołowa - Pęknięcie/rozerwanie 1

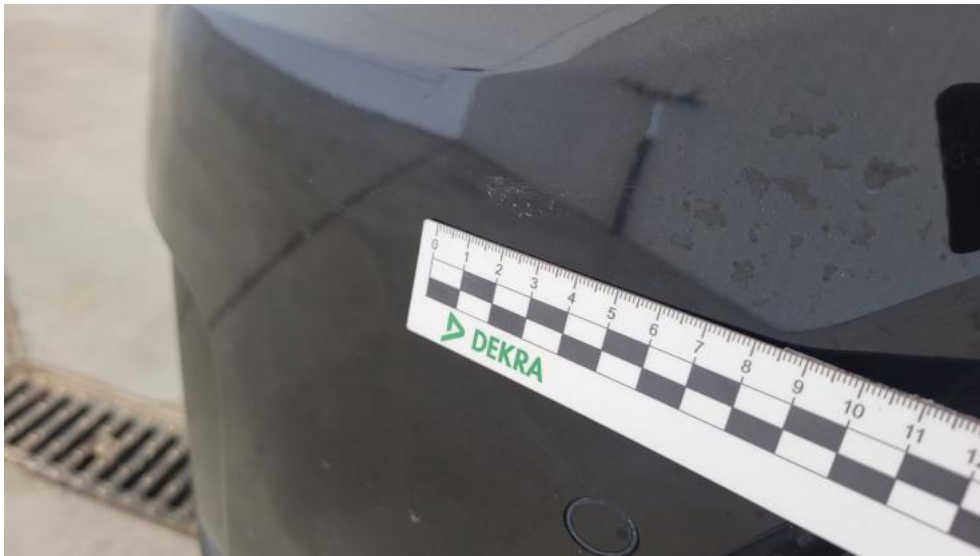
**Photo 43.**

Zderzak - Rysa/odprysk 1

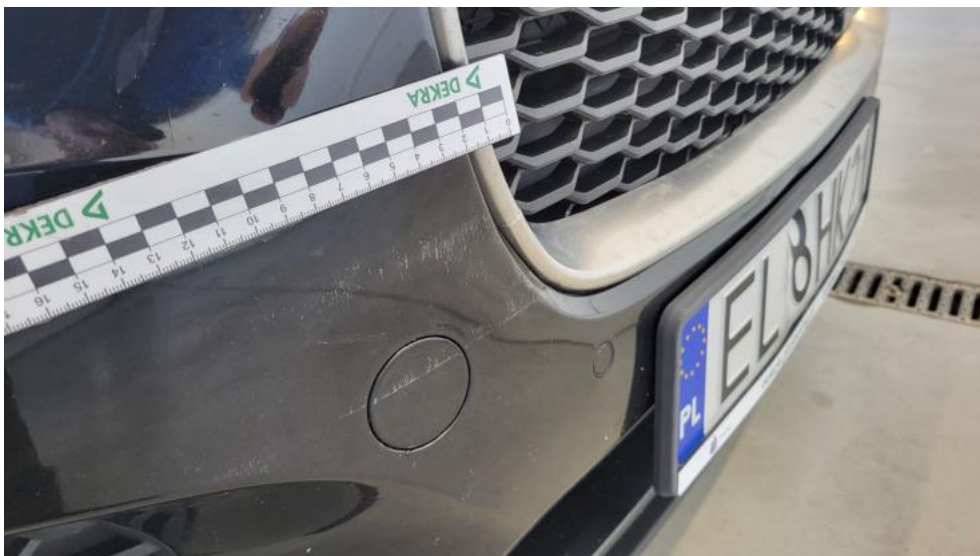
**Photo 44.**

Zderzak - Rysa/odprysk 2

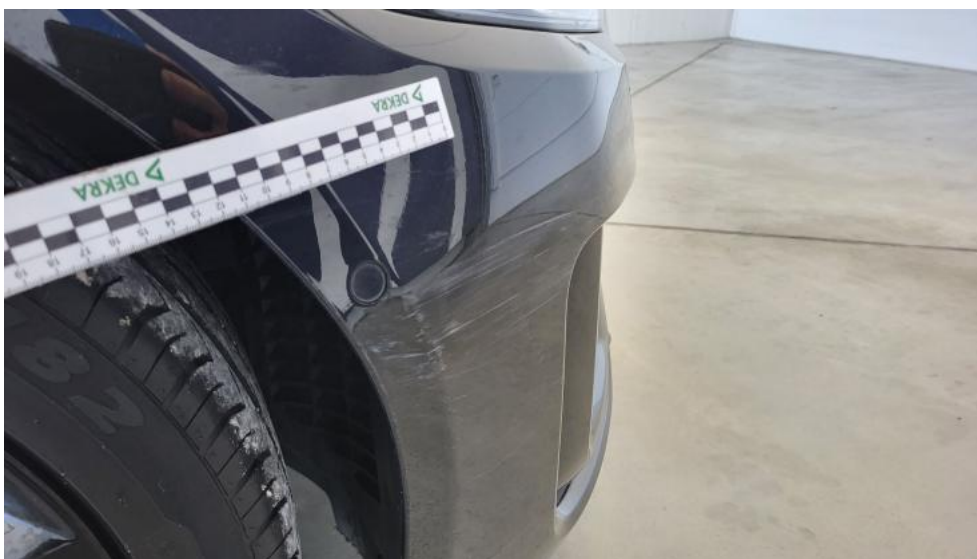
**Photo 45.**

Zderzak - Wgniecenie/odkształcenie 1

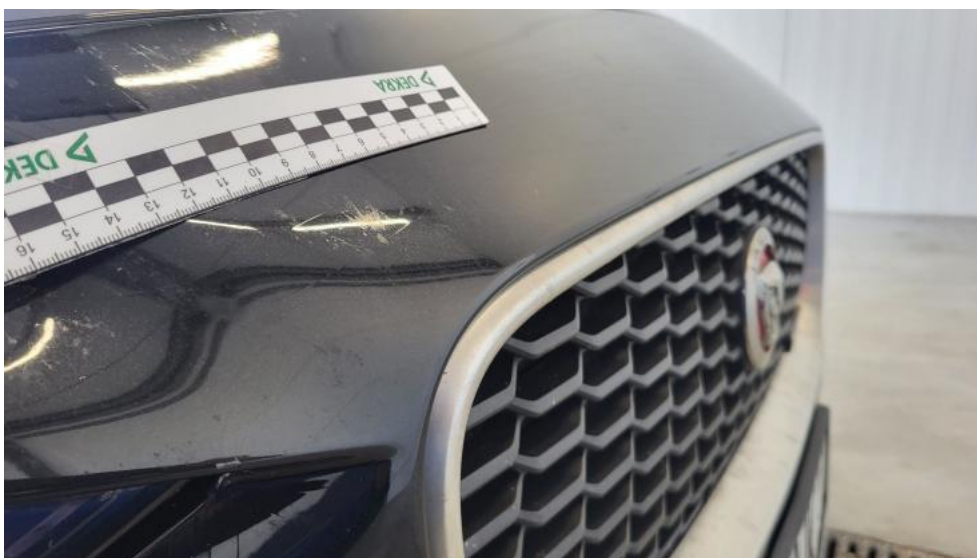
**Photo 46.**

Zderzak - Pęknięcie/rozerwanie 1

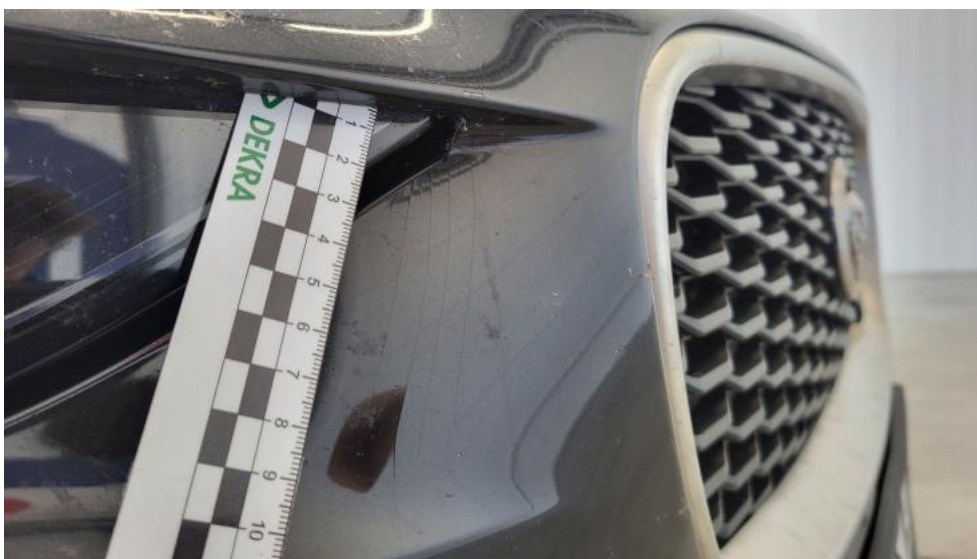
**Photo 47.**

Zderzak - Pęknięcie/rozerwanie 2

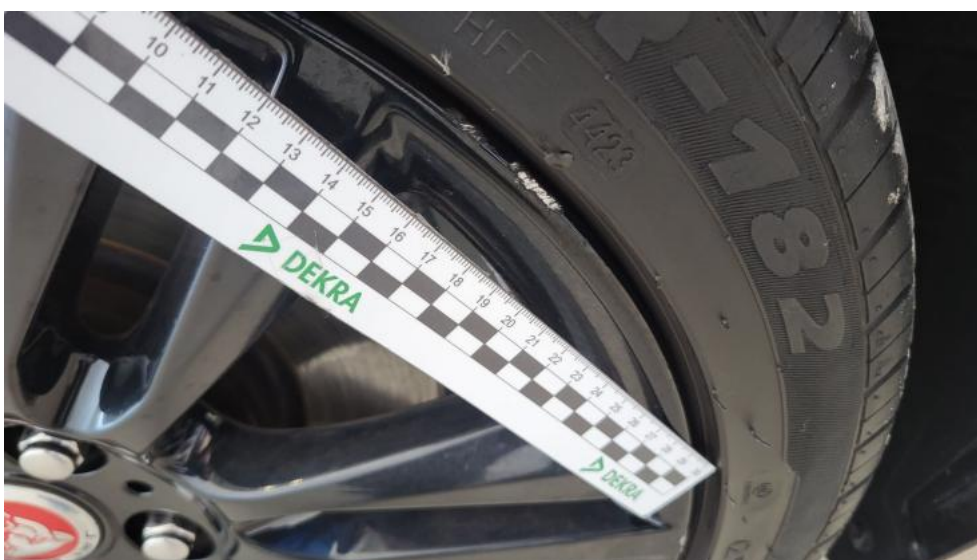
**Photo 48.**

Felga aluminiowa przednia P - Rysa/odprysk 1

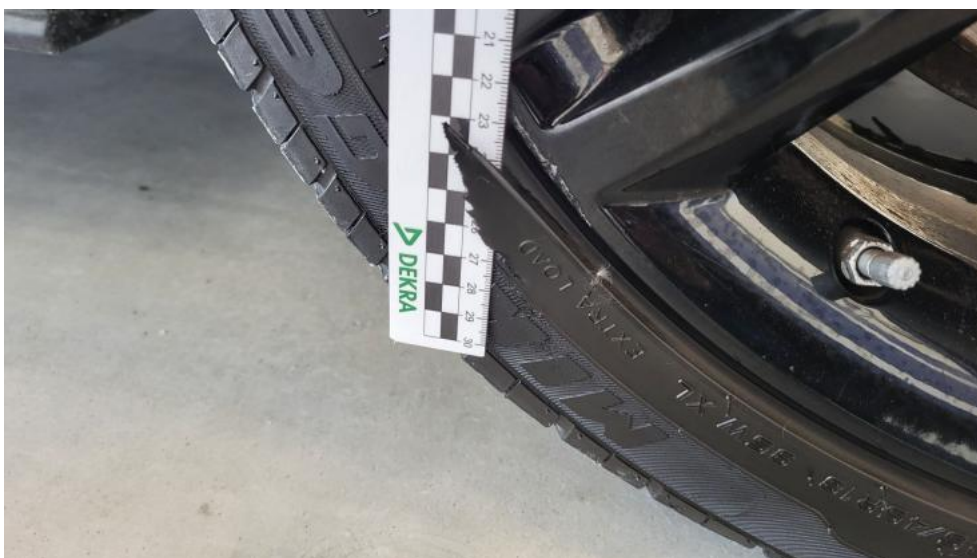
**Photo 50.**

Opona przednia P - Pęknięcie/rozerwanie 1

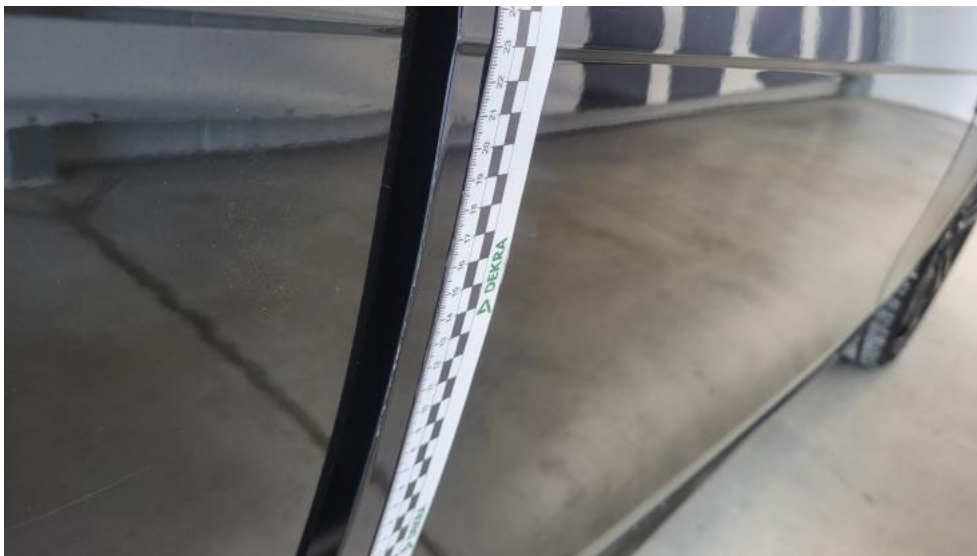
**Photo 51.**

Drzwi przednie P - Rysa/odprysk 1

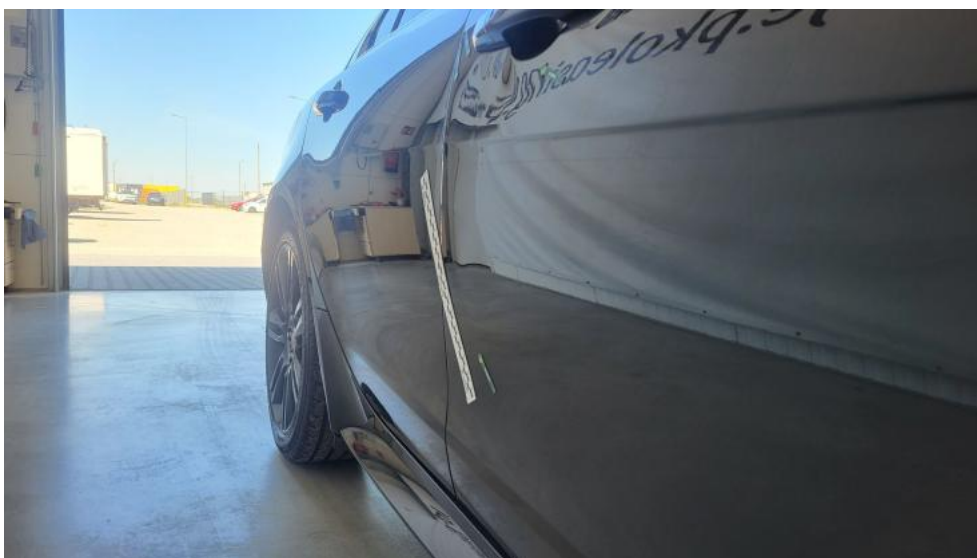
**Photo 52.**

Drzwi przednie P - Wgniecenie/odkształcenie 1

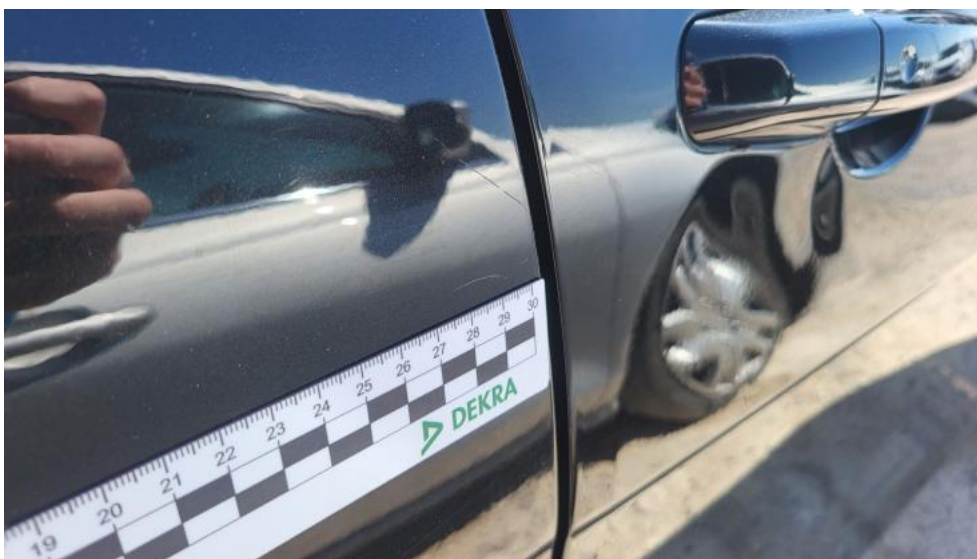
**Photo 53.**

Drzwi tylne P - Rysa/odprysk 1

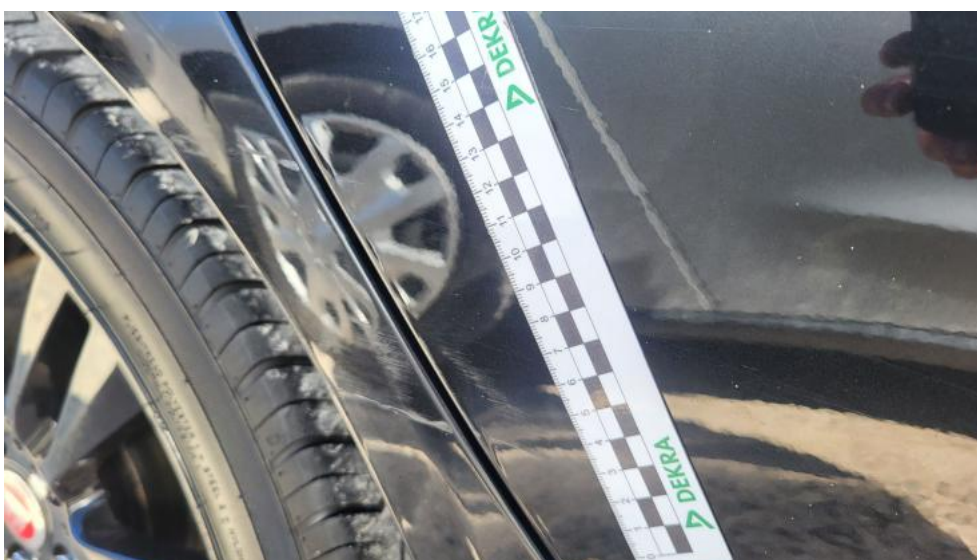
**Photo 54.**

Drzwi tylne P - Rysa/odprysk 2

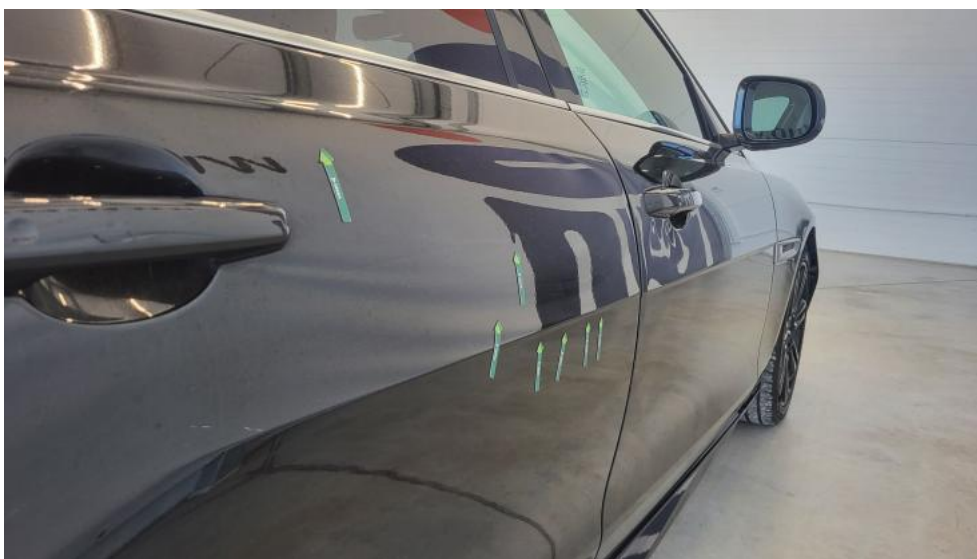
**Photo 55.**

Drzwi tylne P - Wgniecenie/odkształcenie 1

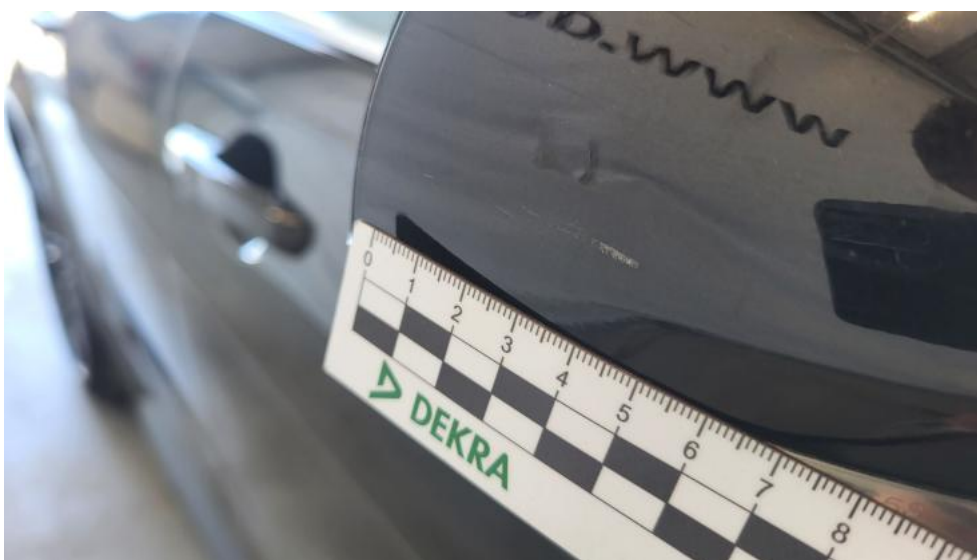
**Photo 56.**

Lusterko zew P - Rysa/odprysk 1

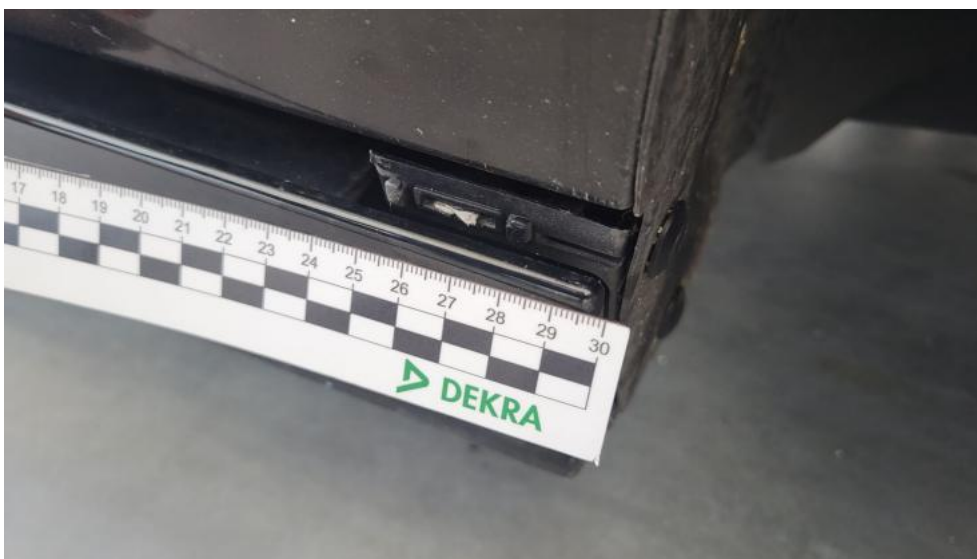
**Photo 57.**

Próg P - Pęknięcie/rozerwanie 1

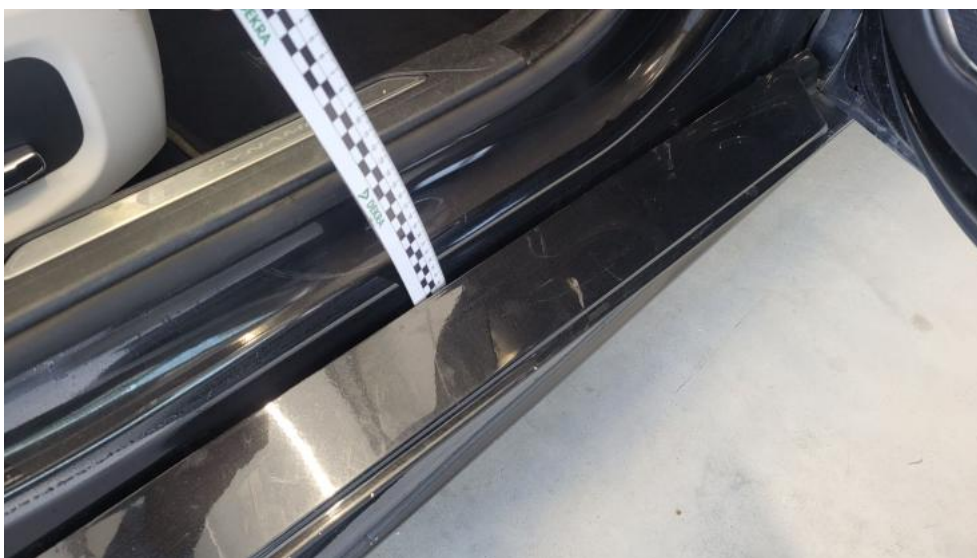
**Photo 58.**

Próg P - Inne 1

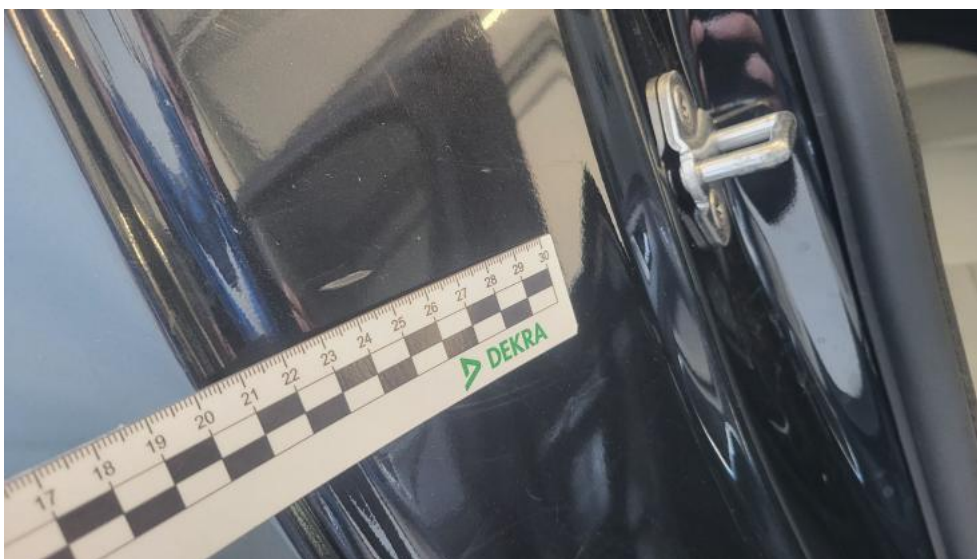
**Photo 59.**

Błotnik tylny P / Ściana boczna P - Rysa/odprysk 1

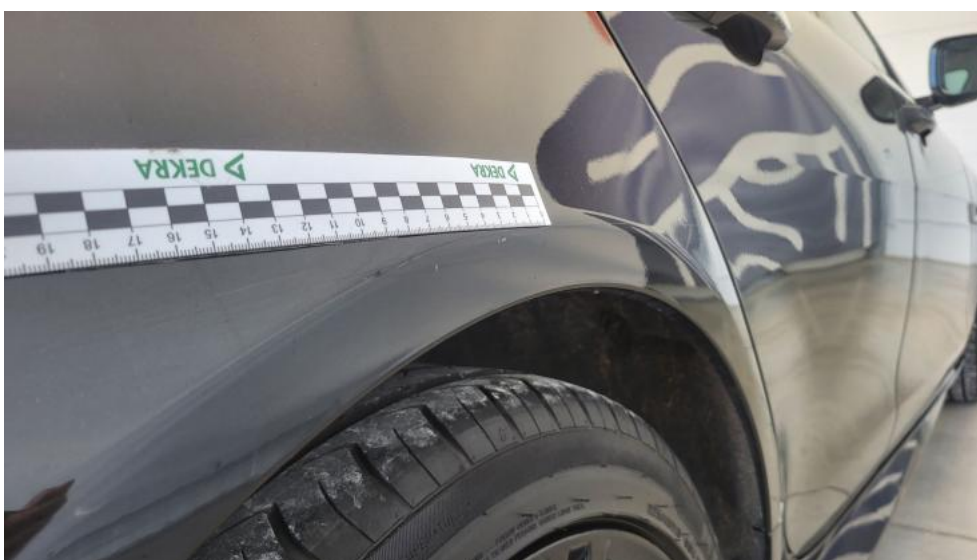
**Photo 60.**

Błotnik tylny P / Ściana boczna P - Rysa/odprysk 2

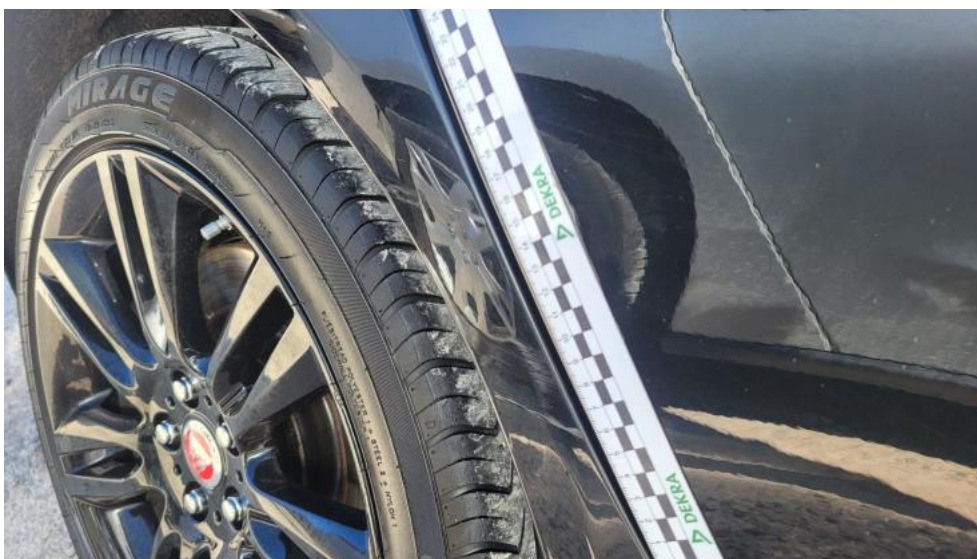
**Photo 61.**

Błotnik tylny P / Ściana boczna P() - Rysa/odprysk 3

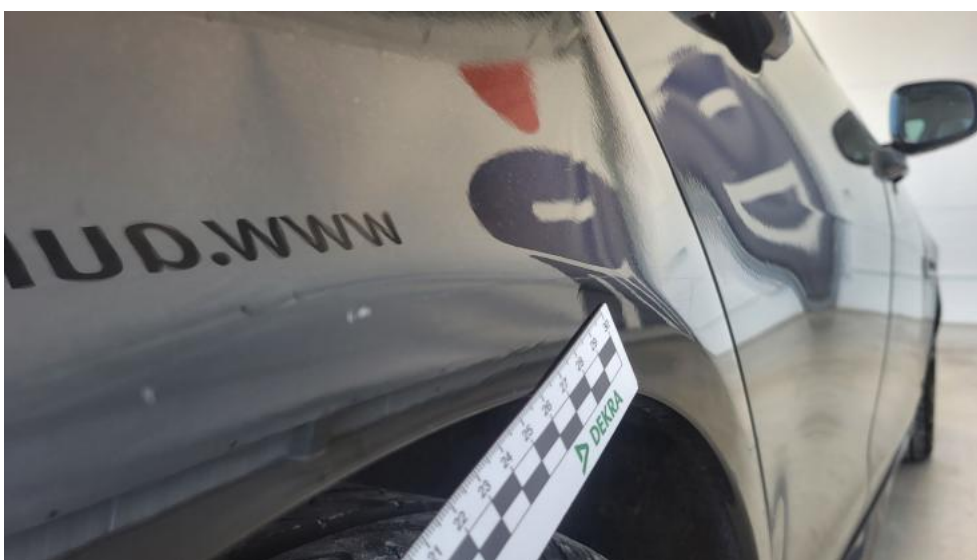
**Photo 62.**

Błotnik tylny P / Ściana boczna P - Wgniecenie/odkształcenie 1

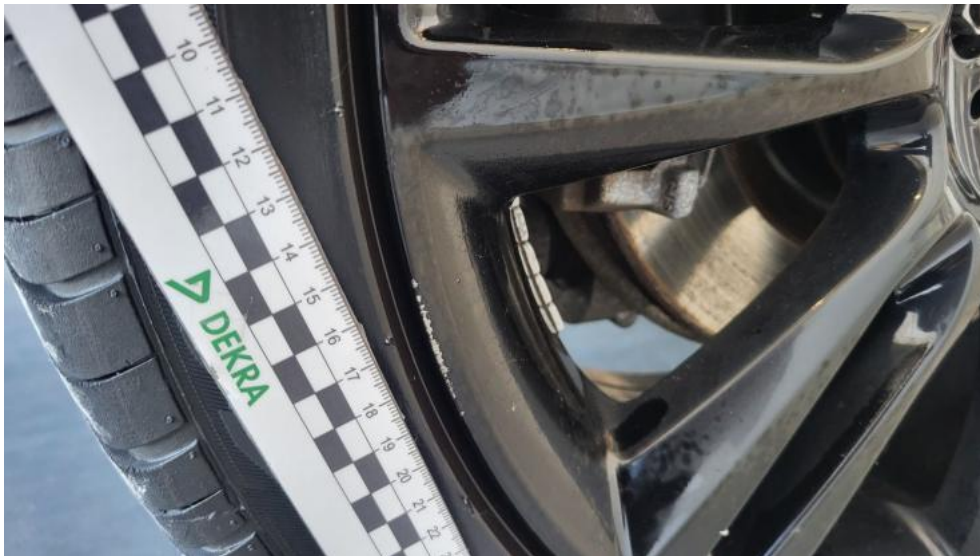
**Photo 63.**

Felga aluminiowa tylna P - Rysa/odprysk 1

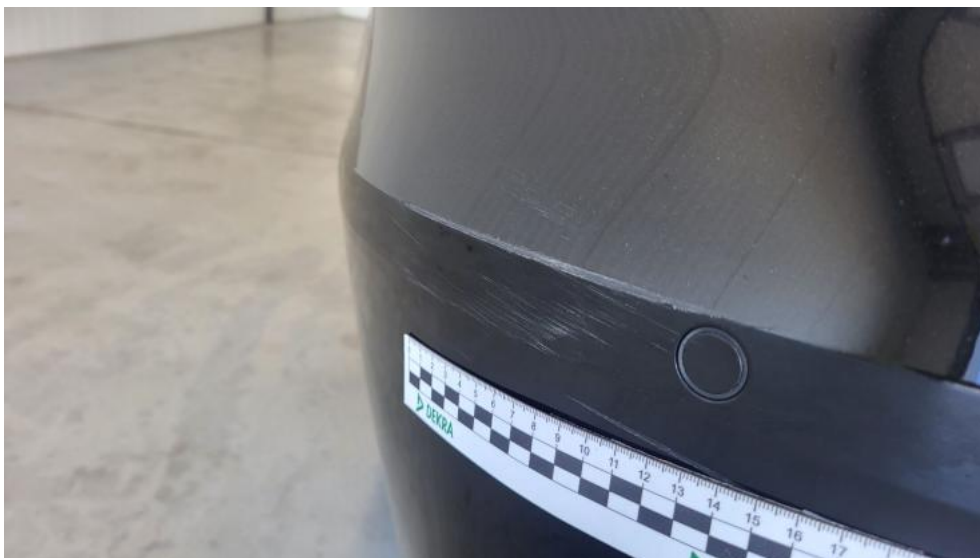
**Photo 64.**

Zderzak tylny - Rysa/odprysk 1

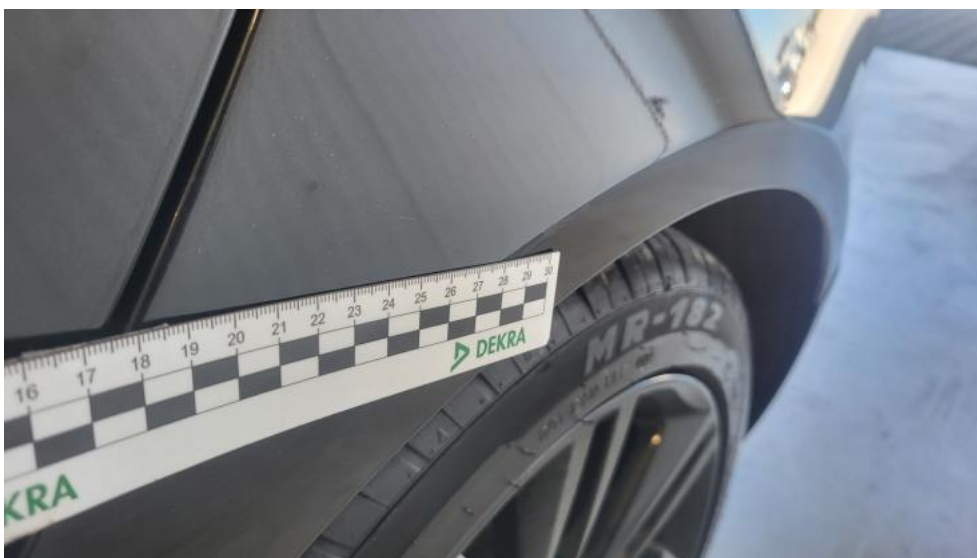
**Photo 66.**

Łotnik tylny L / Ściana boczna L - Rysa/odprysk 1

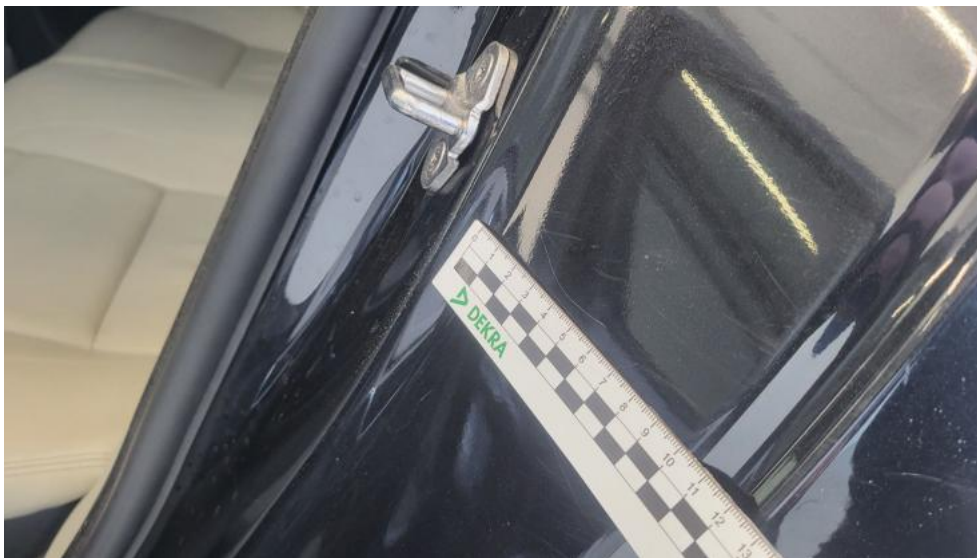
**Photo 67.**

Błotnik tylny L / Ściana boczna L - Rysa/odprysk 2

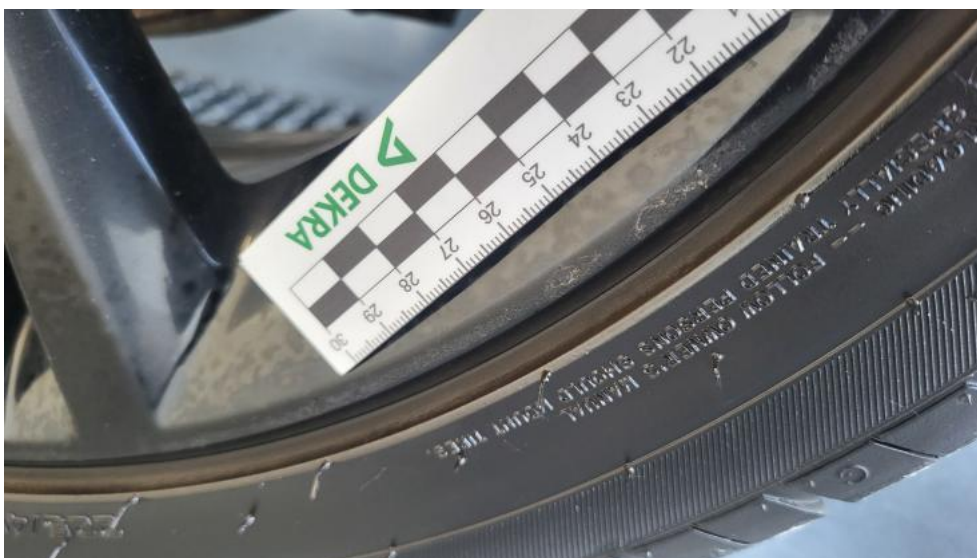
**Photo 68.**

Felga aluminiowa tylna L - Rysa/odprysk 1

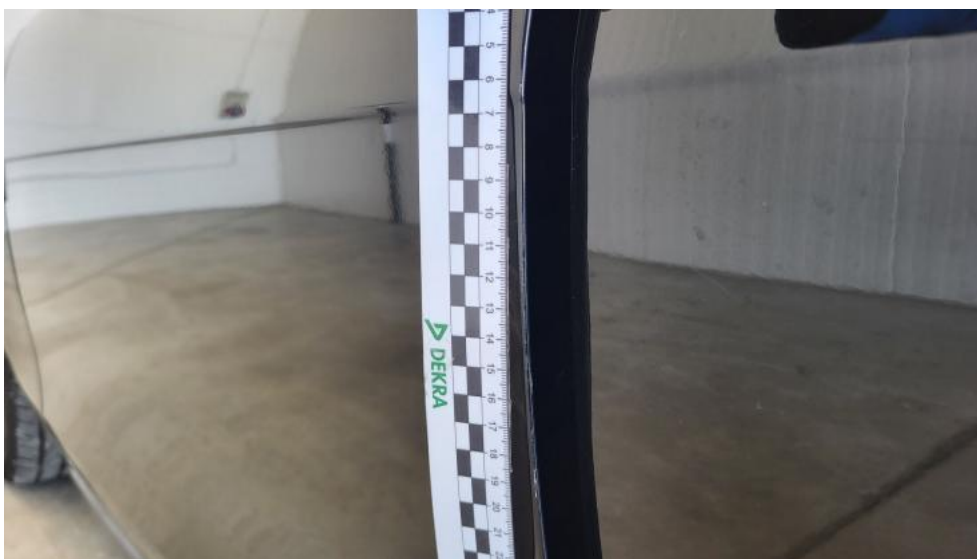
**Photo 69.**

Drzwi przed L - Rysa/odprysk 1

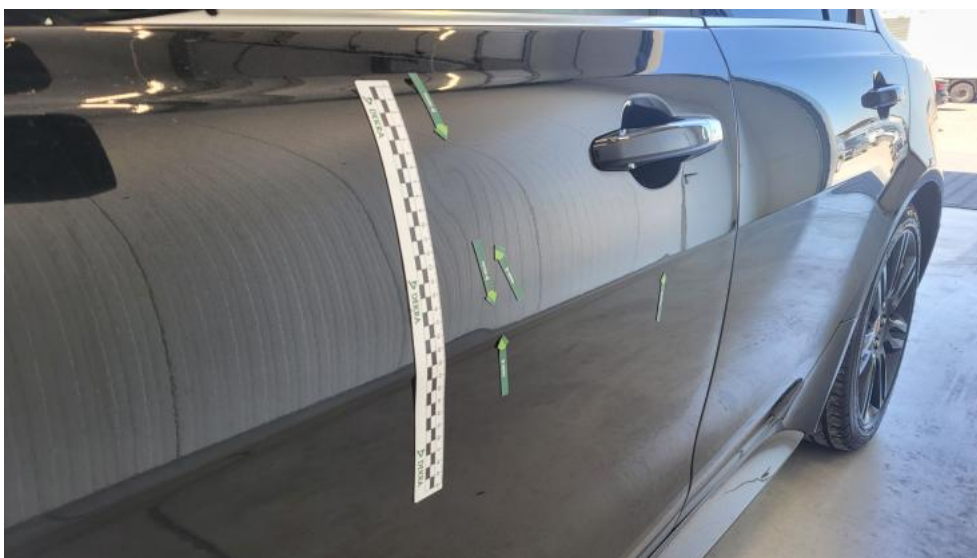
**Photo 70.**

Drzwi przed L - Wgniecenie/odkształcenie 1

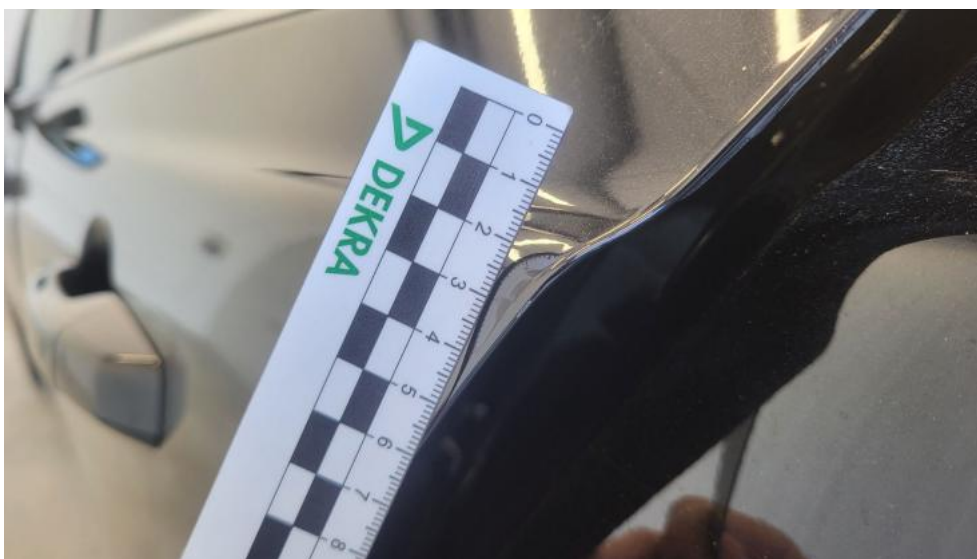
**Photo 71.**

Drzwi tylne L - Rysa/odprysk 1

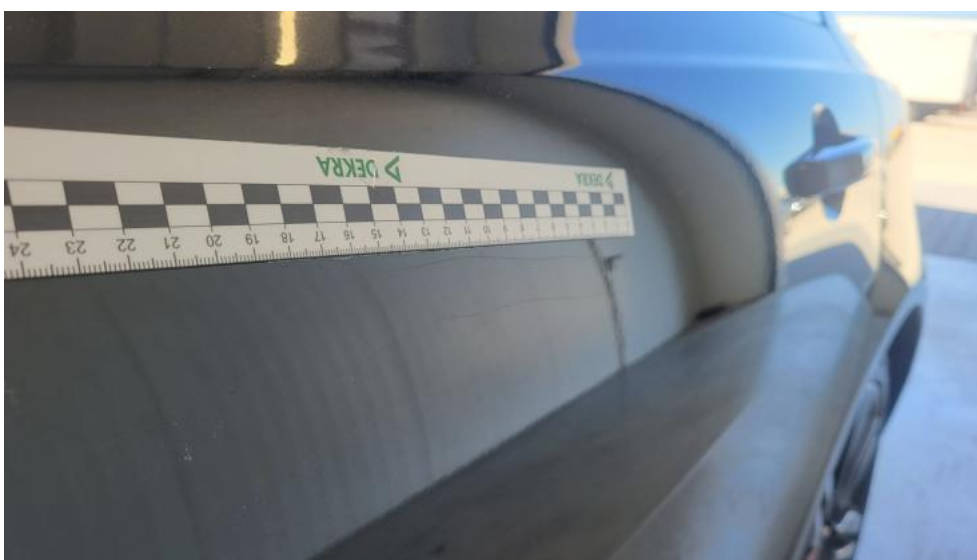
**Photo 72.**

Drzwi tylne L - Rysa/odprysk 2

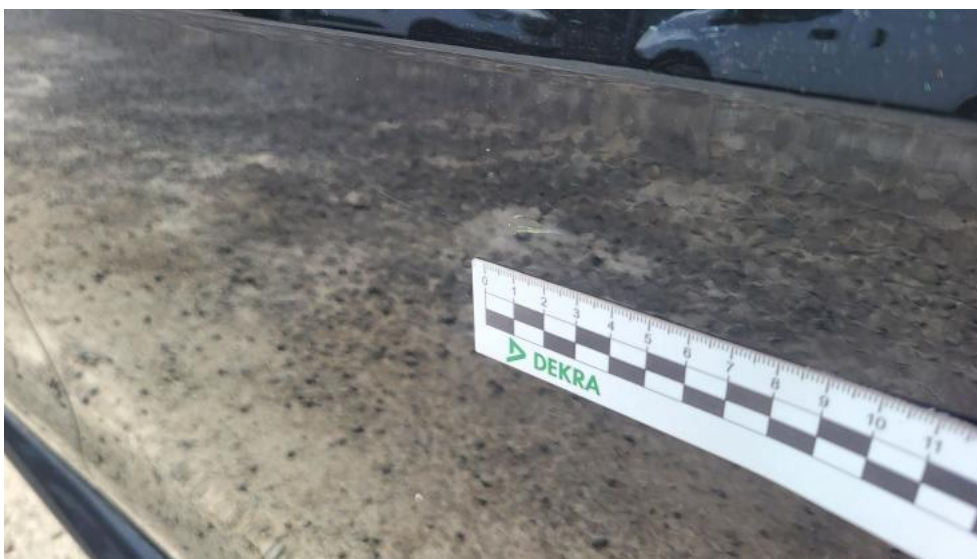
**Photo 73.**

Drzwi tylne L() - Rysa/odprysk 3

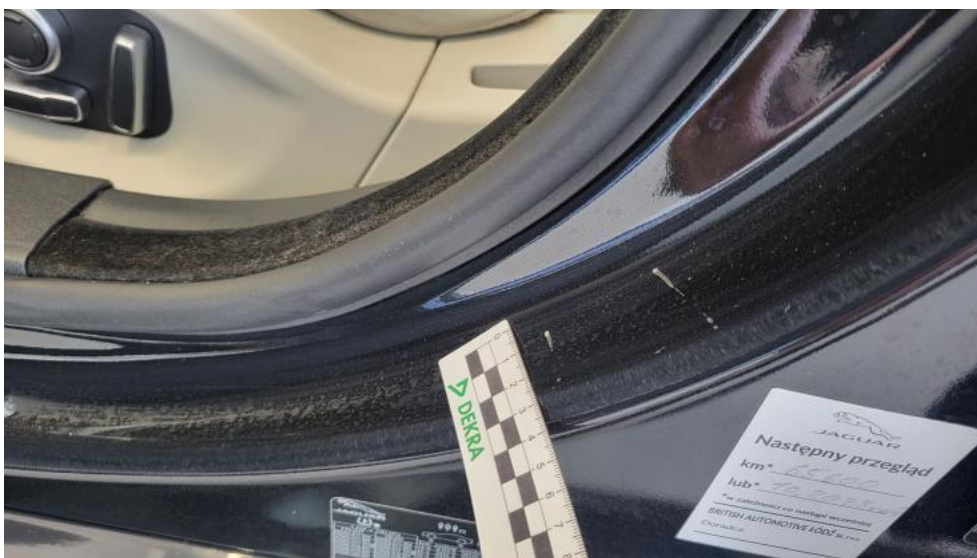
**Photo 74.**

Próg L - Rysa/odprysk 1

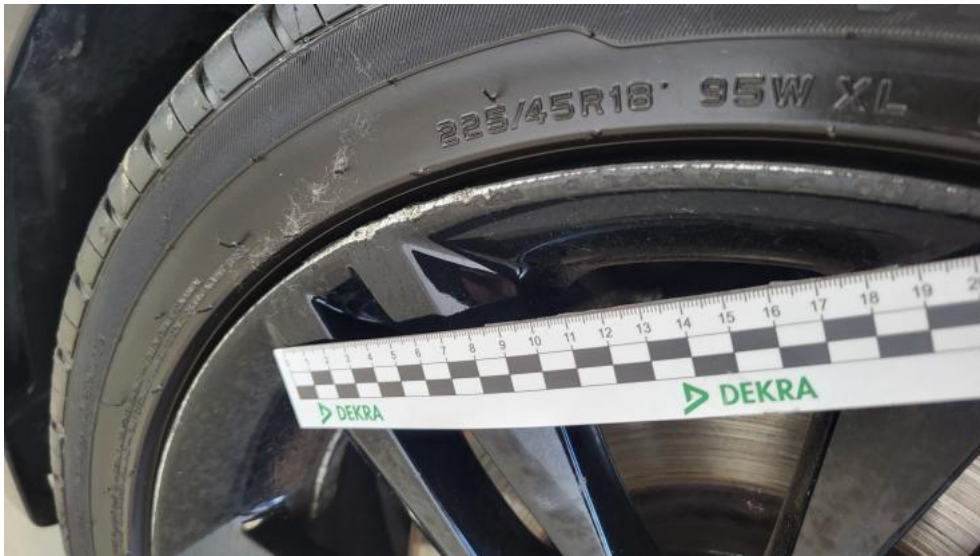
**Photo 75.**

Felga Aluminiowa przednia L - Rysa/odprysk 1

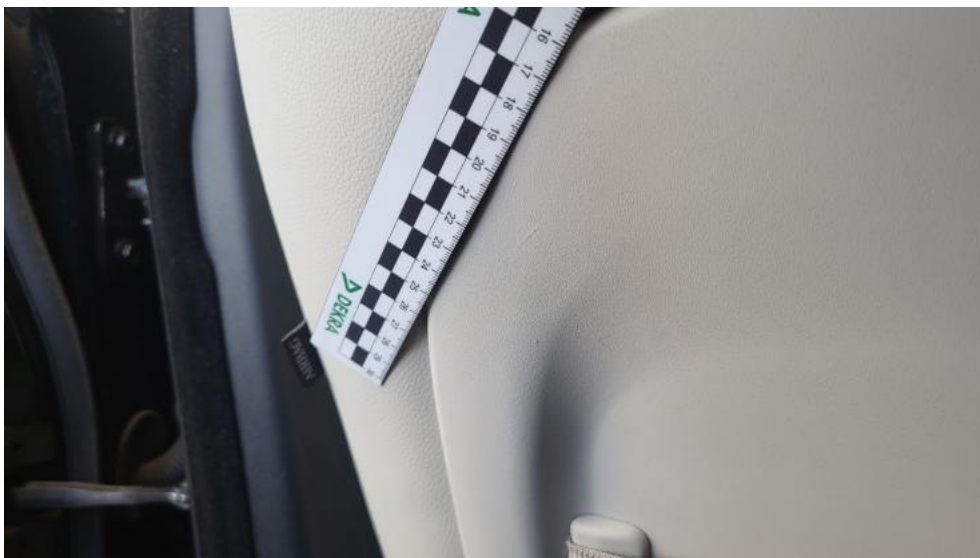
**Photo 76.**

Fotel prz. lew. - Rysa/odprysk 1

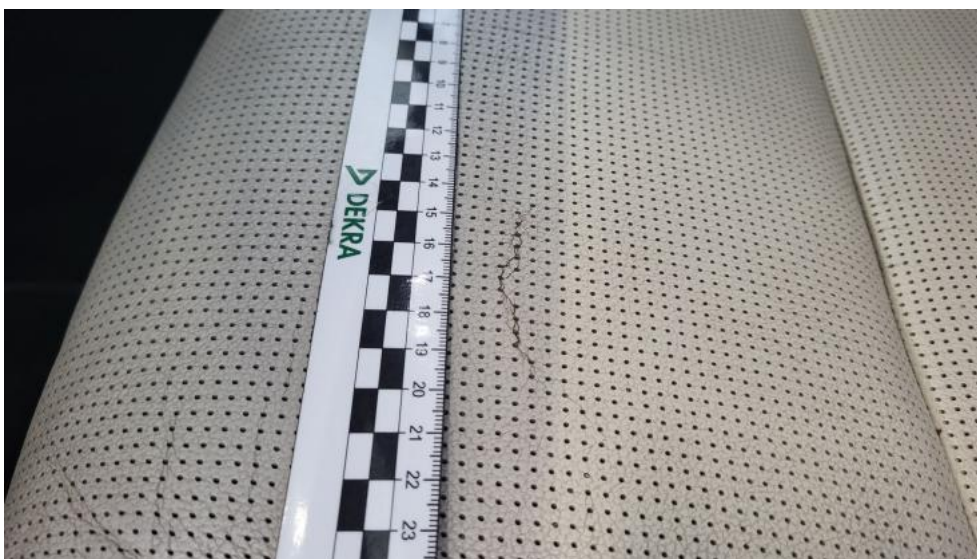
**Photo 77.**

Fotel prz. lew. - Pęknięcie/rozerwanie 1

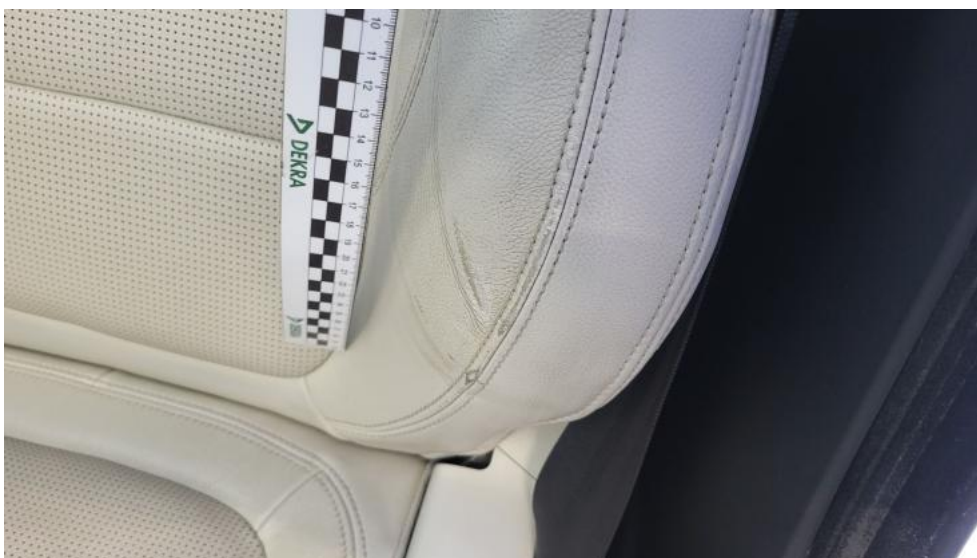
**Photo 78.**

Fotel prz. lew. - Inne 1

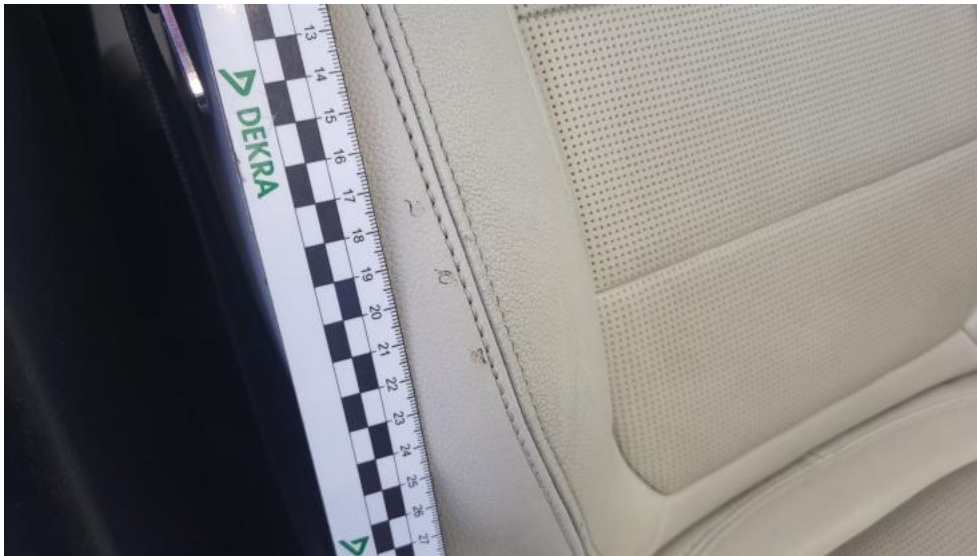
**Photo 79.**

Fotel prz. praw. - Pęknięcie/rozerwanie 1

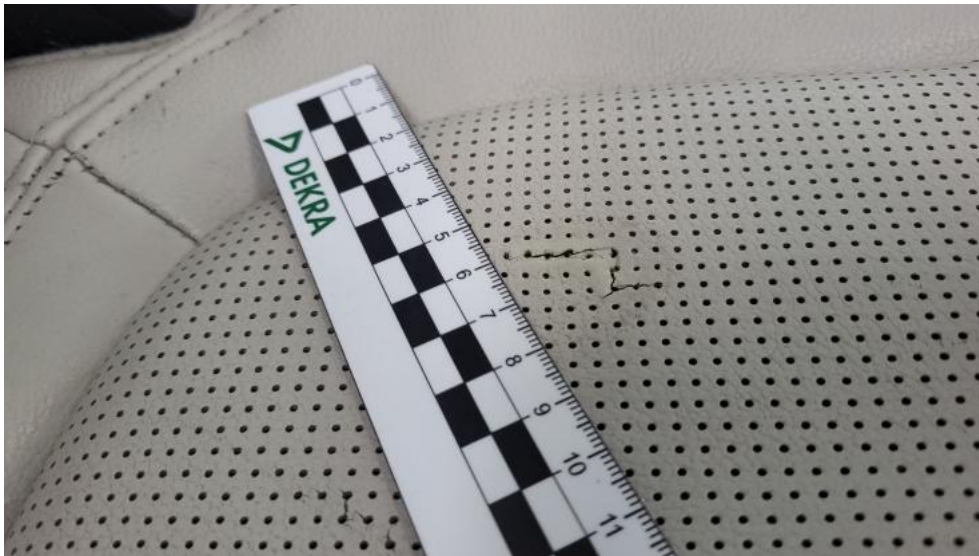
**Photo 81.**

Kanapa tyl. - Pęknięcie/rozerwanie 1

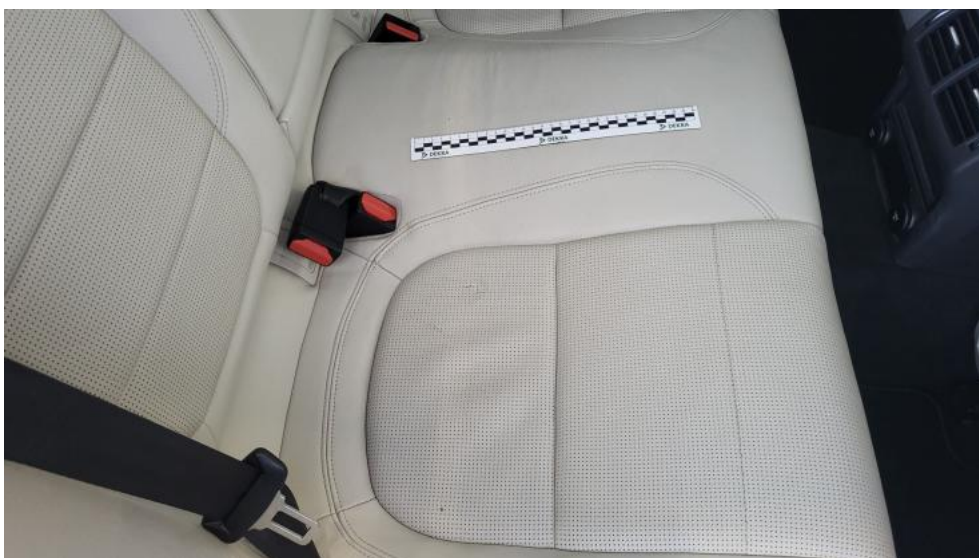
**Photo 82.**

Kanapa tyl. - Inne 1

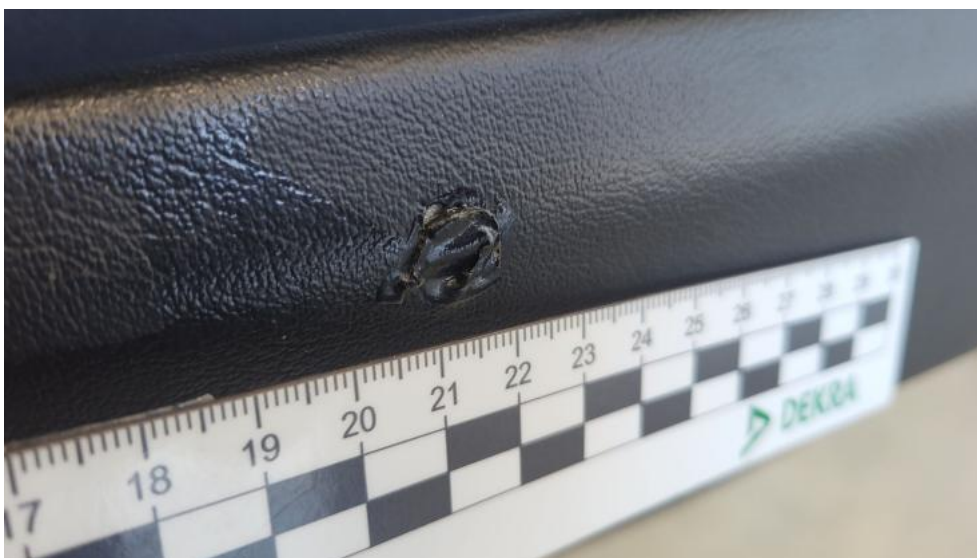
**Photo 84.**

Tapicerka drzwi przednich P - Inne 1
