DEKRA's commission No. : PKOL(W)/LODZ/33455/25/05/09  
 commission/ damage No. : 23/021318  
 Date of commission: 09-05-2025

| Manufacturer | JAGUAR |
| Model | XE 19-24 |
| Type / version | XE 2.0 D180 R-Dynamic SE aut |

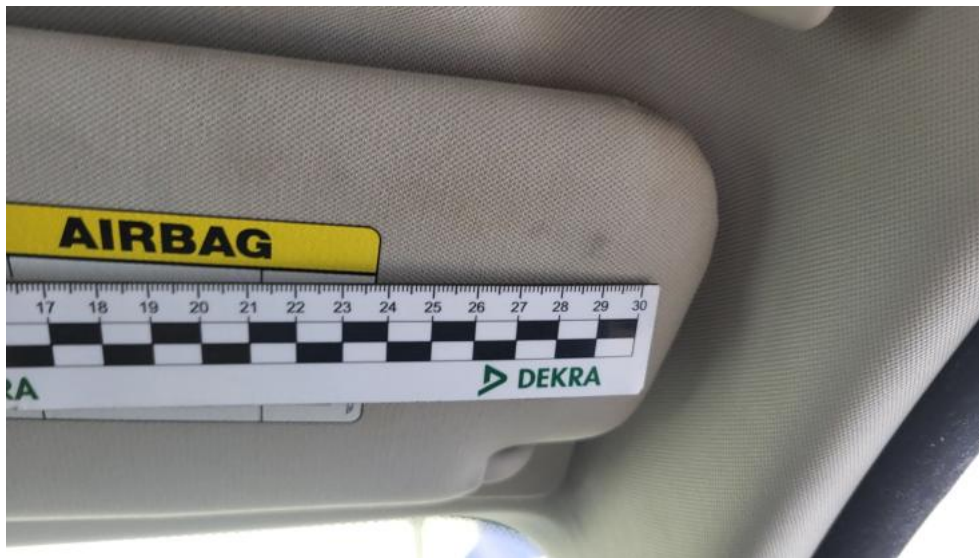
**Photo 85.**

Osłona p/słoneczna prawa - Inne 1

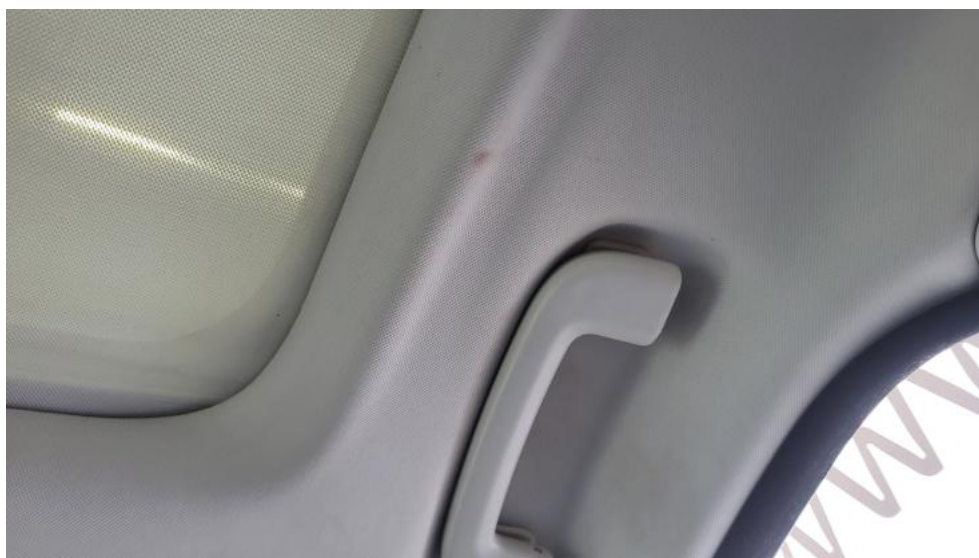
**Photo 86.**

Podsufitka - Inne 1
