DEKRA's commission No. : PKOL(W)/LODZ/19544/25/03/18
commission/ damage No. : 19/023079
Date of commission: 18-03-2025

Vehicle data

Measurement of thickness of the vehicle lacquer coating

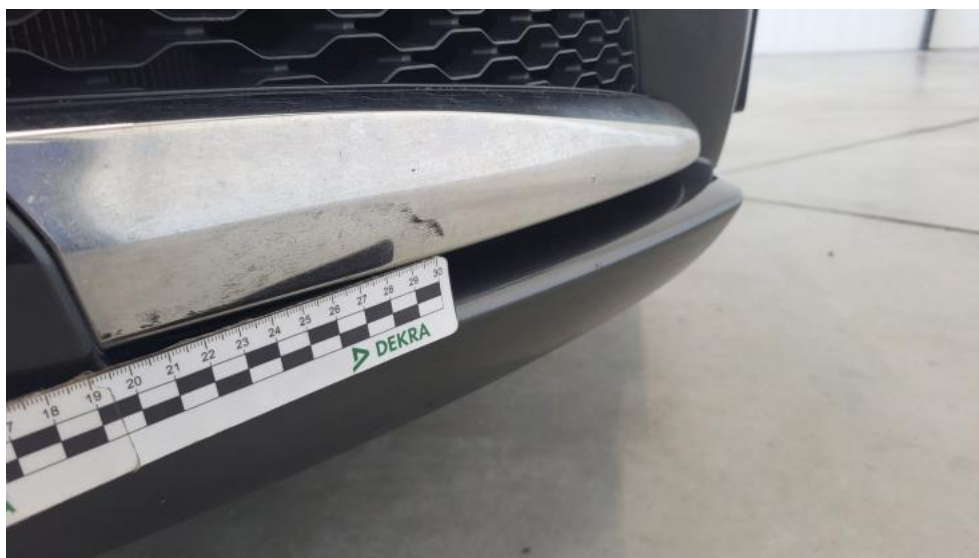
Photo 38.
Listwa śr zderzaka przedniego - Rysa/odprysk 1

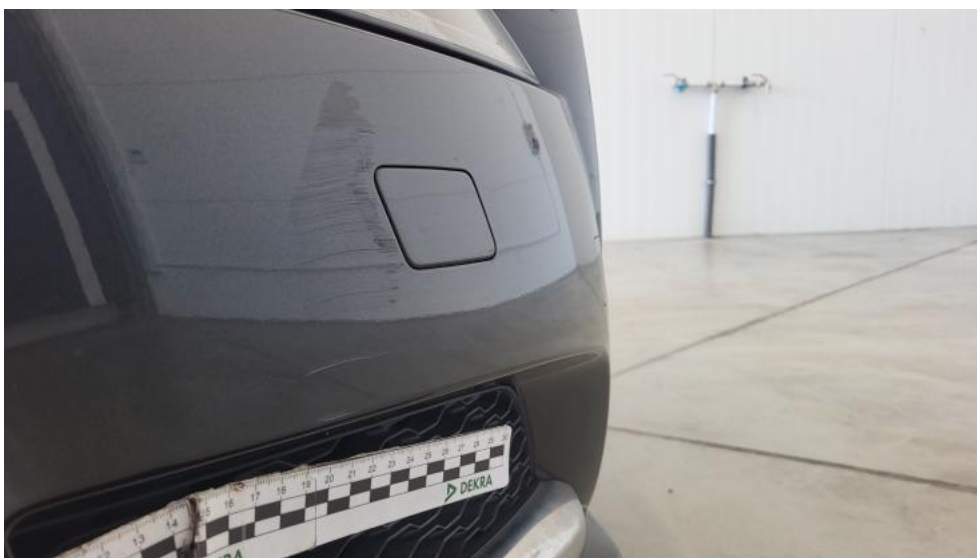
Photo 40.
Zderzak - Rysa/odprysk 2

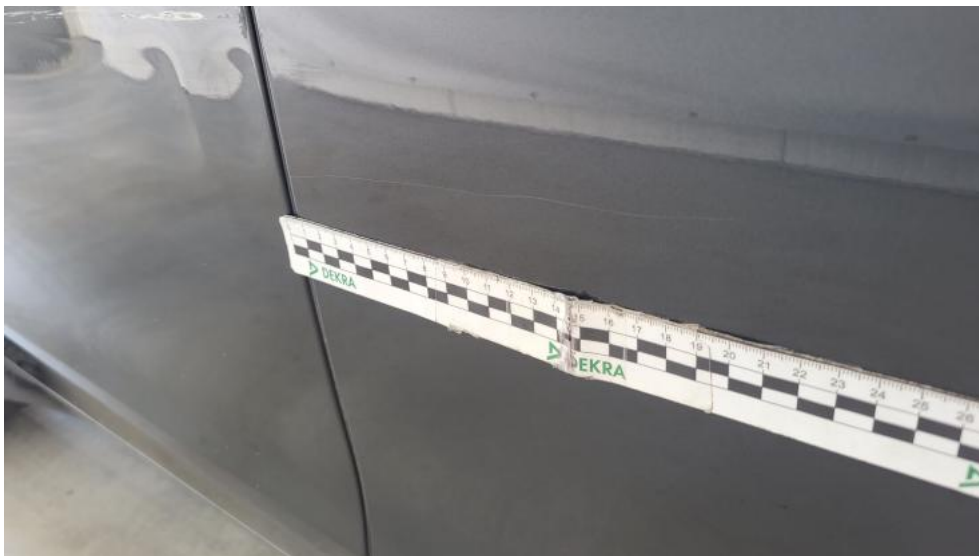
Photo 43.

Drzwi przednie P - Rysa/odprysk 1

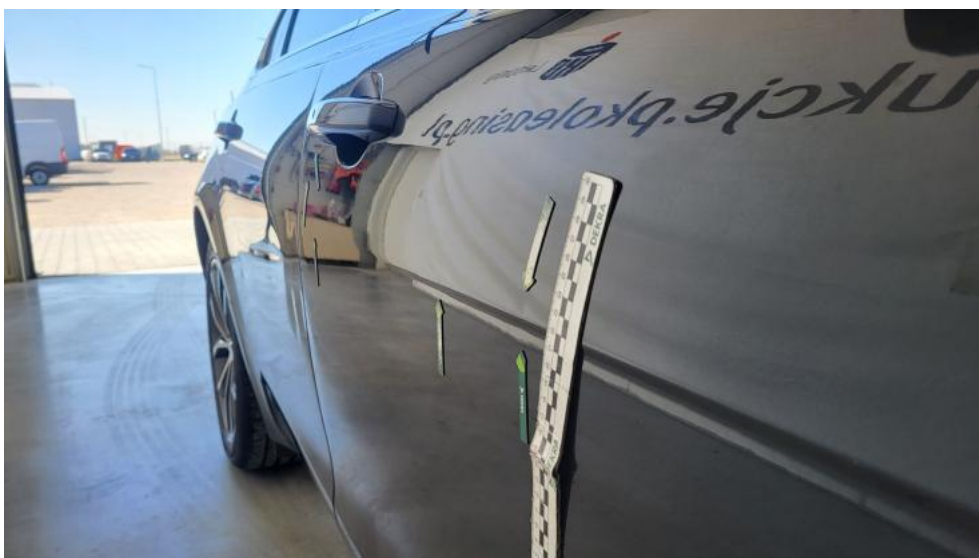
Photo 44.

Drzwi przednie P - Wgniecenie/odkształcenie 1

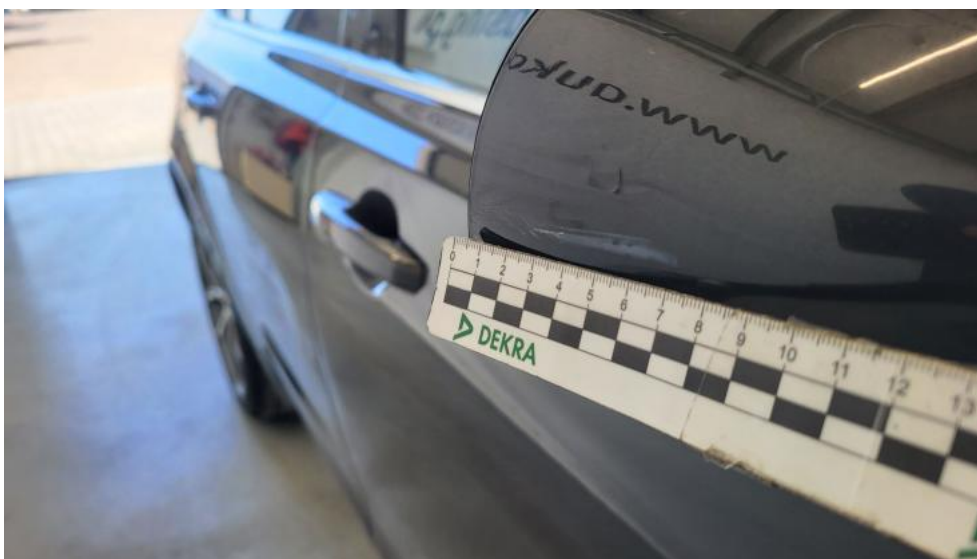
Photo 47.

Lusterko zew P - Rysa/odprysk 1

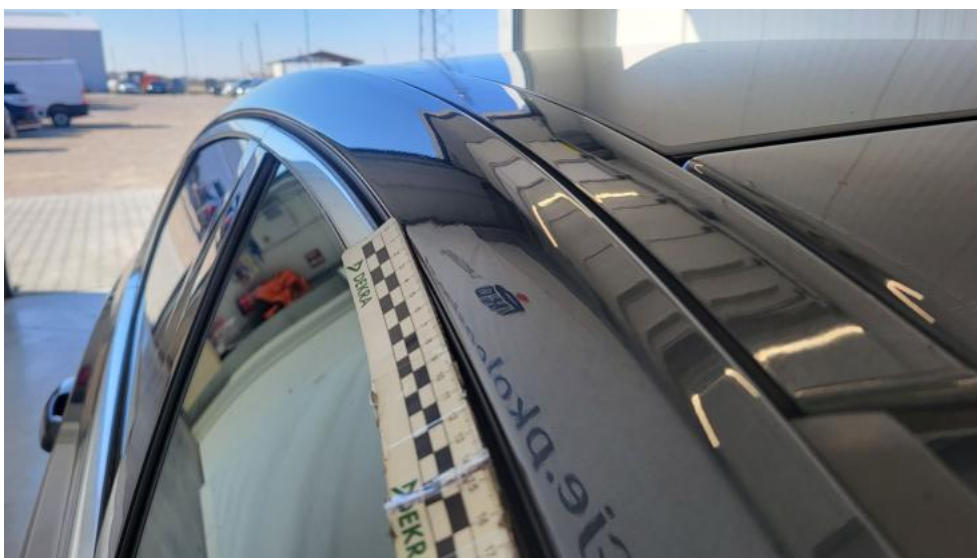
Photo 48.

Słupek przedni P - Wgniecenie/odkształcenie 1

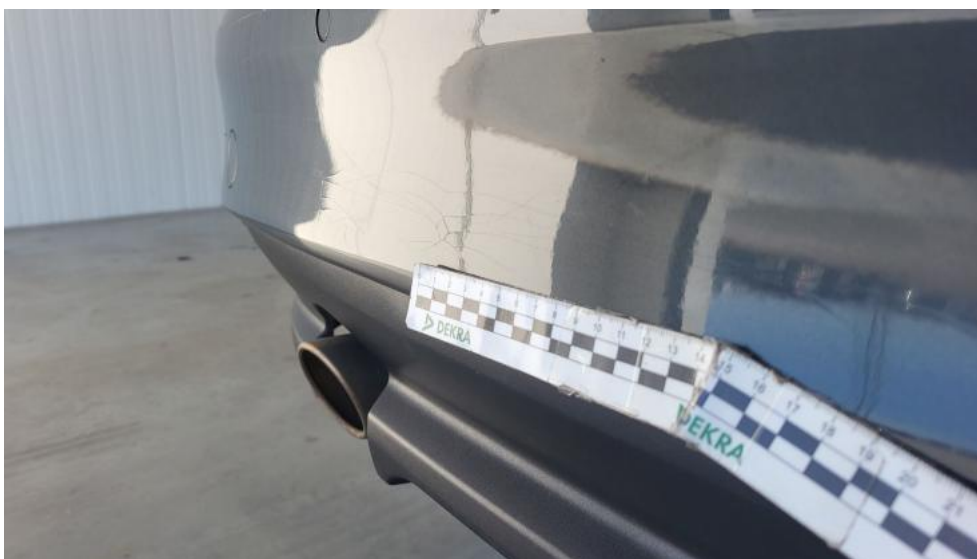
Photo 53.
Zderzak tylny - Pęknięcie/rozerwanie 1

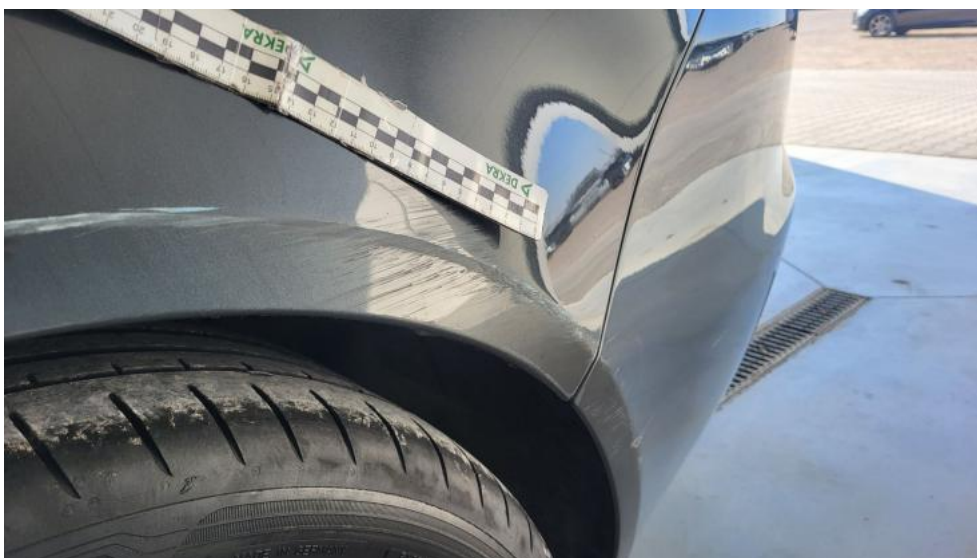
Photo 56.
Błotnik tylny L / Ściana boczna L() - Wgniecenie/odkształcenie 3

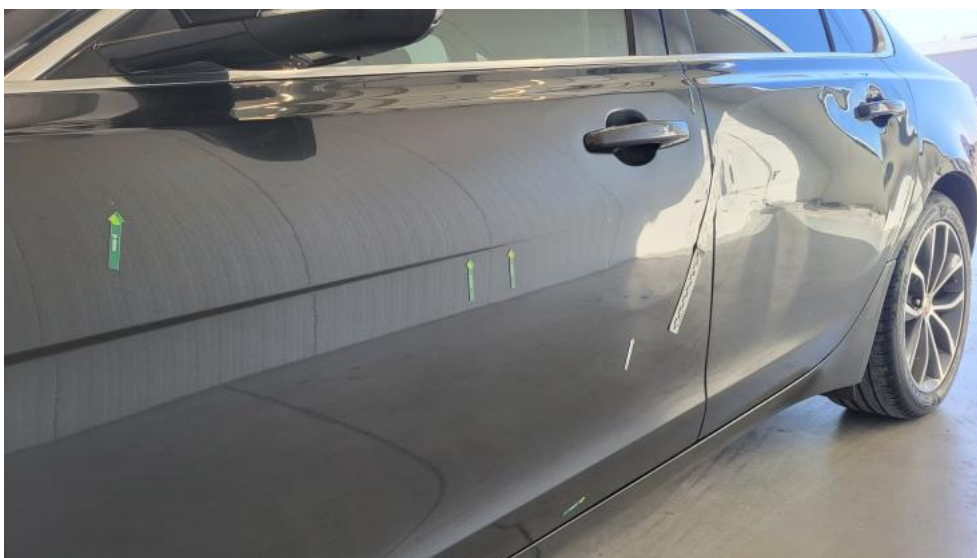
Photo 58.

Drzwi przed L - Wgniecenie/odkształcenie 1

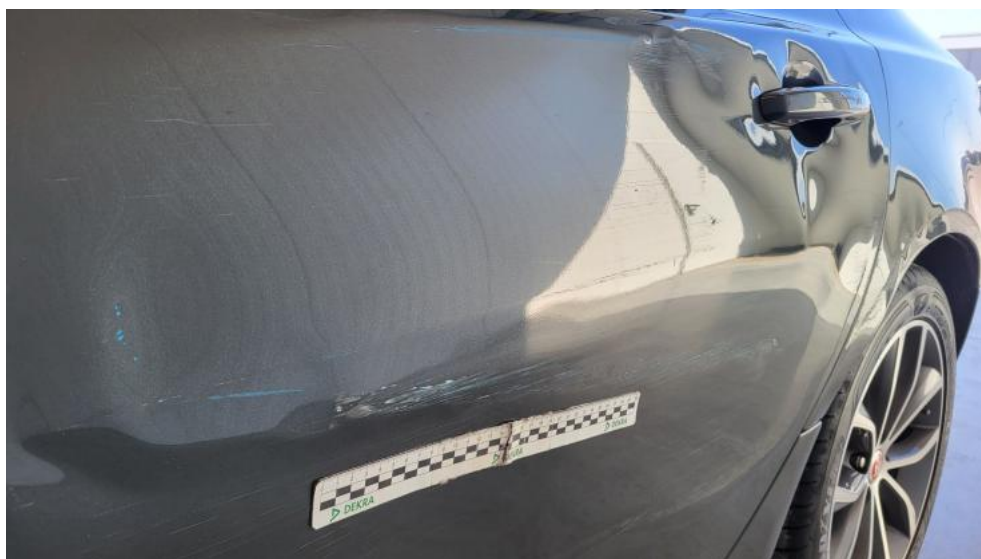
Photo 59.
Drzwi tylne L - Rysa/odprysk 1

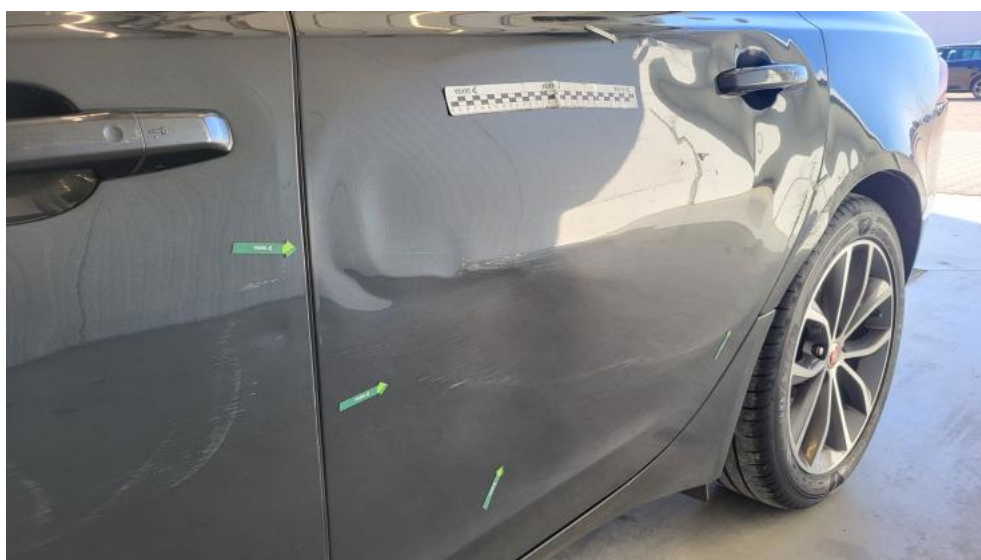
Photo 60.
Drzwi tylne L - Wgniecenie/odkształcenie 1

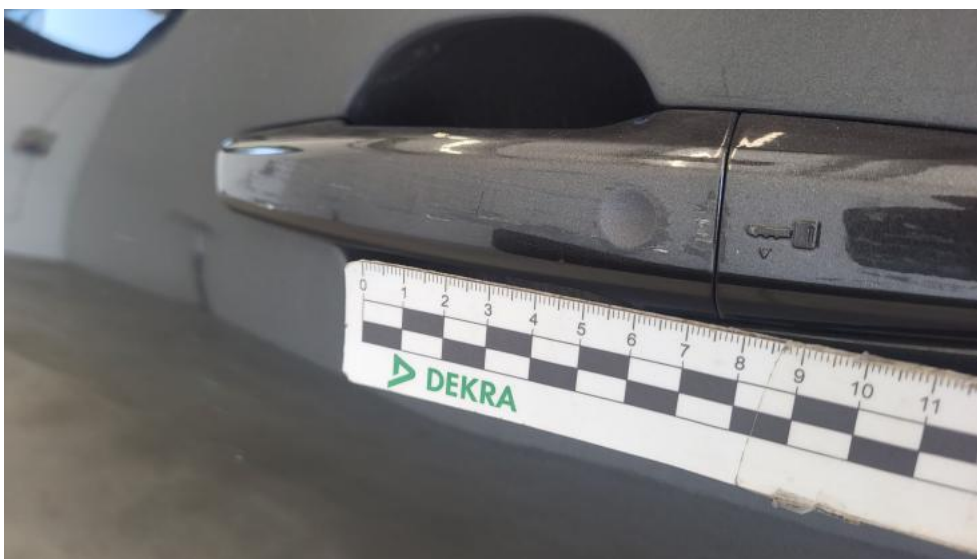
Photo 61.
Klamka drzwi prz L - Rysa/odprysk 1

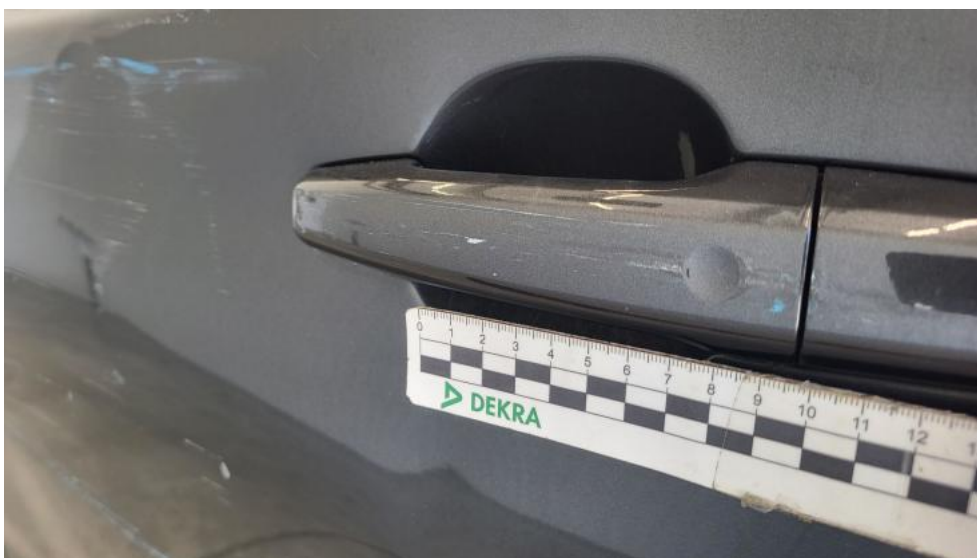
Photo 62.
Klamka drzwi tyl L - Rysa/odprysk 1

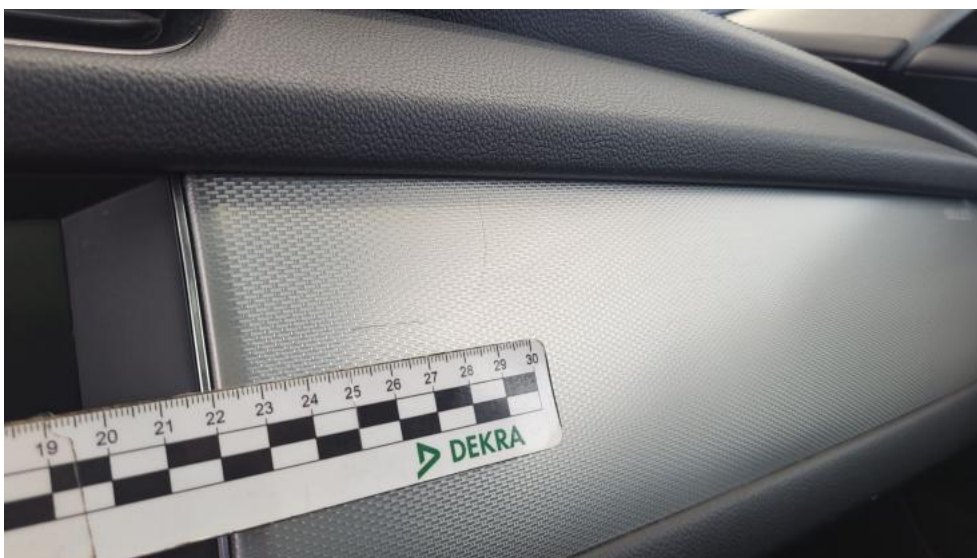
Photo 66.
Deska rozdzielcza - Rysa/odprysk 1

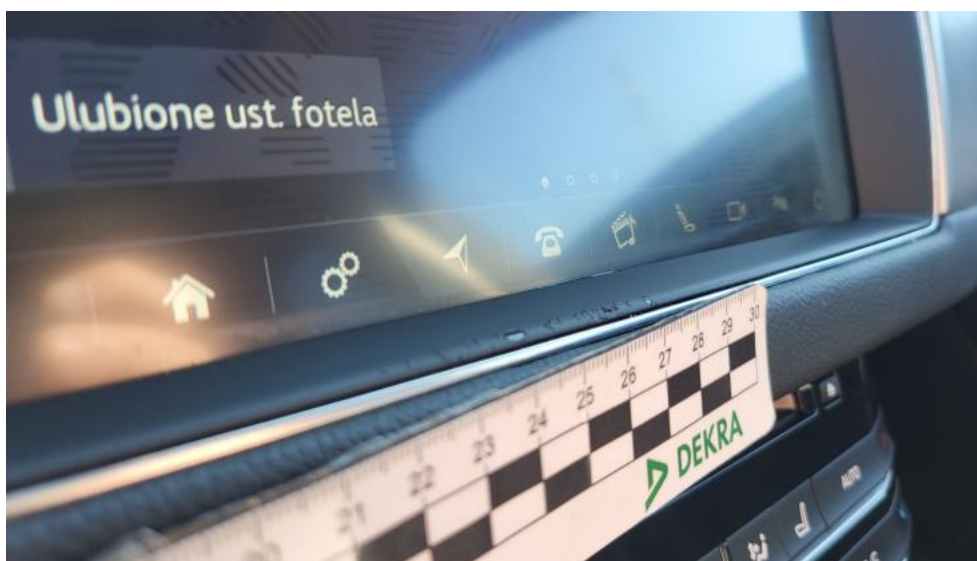
Photo 67.
Deska rozdzielcza - Rysa/odprysk 2

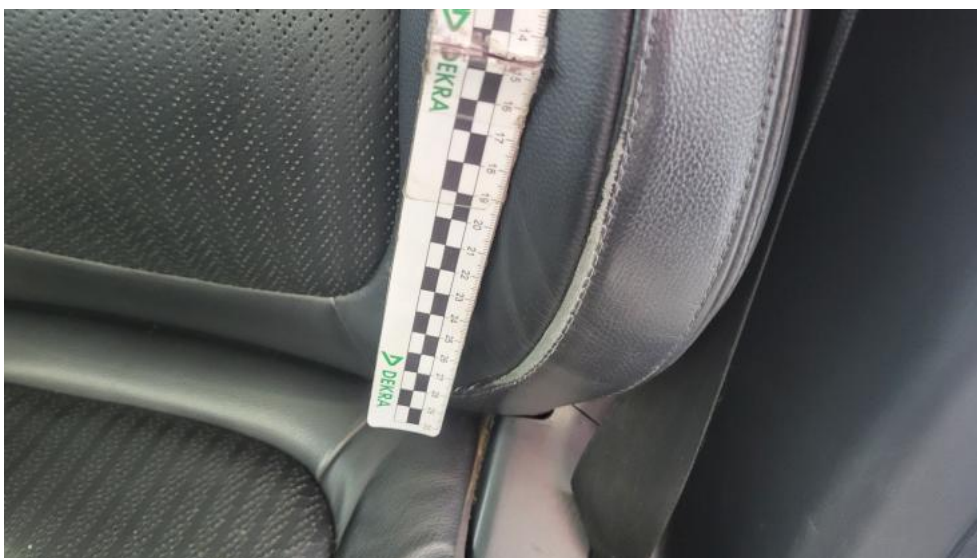
Photo 68.
Fotel prz. lew. - Inne 1

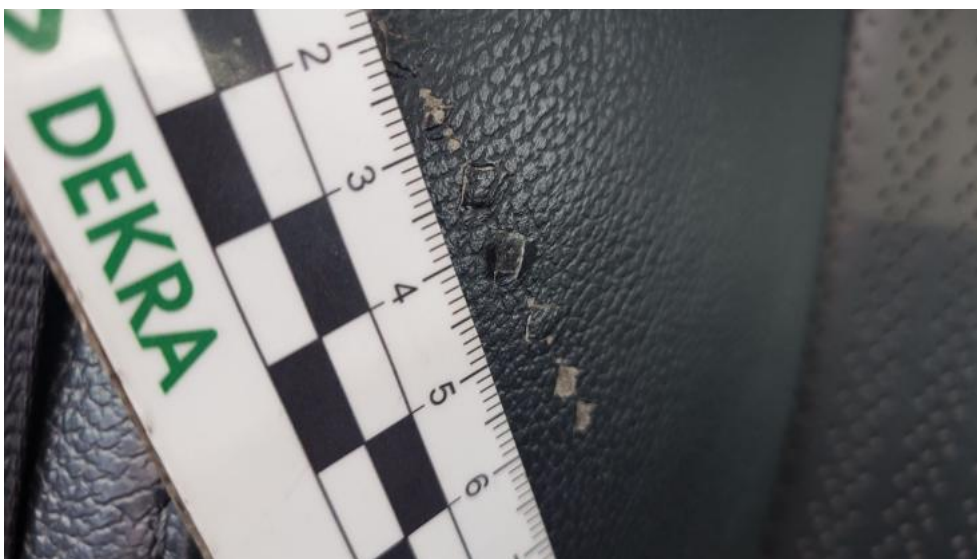
Photo 69.

Fotel prz. praw. - Pęknięcie/rozerwanie 1

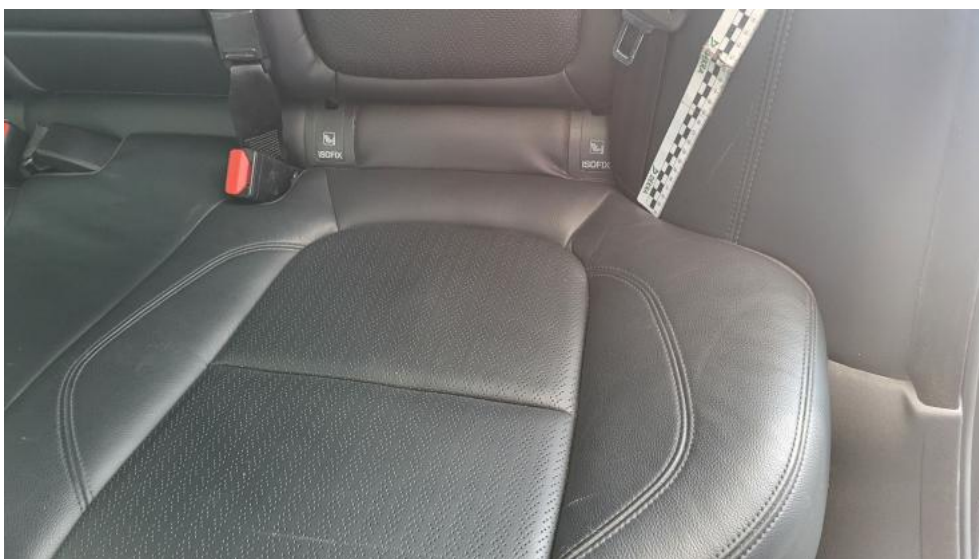
Photo 71.
Kanapa tyl. - Rysa/odprysk 1

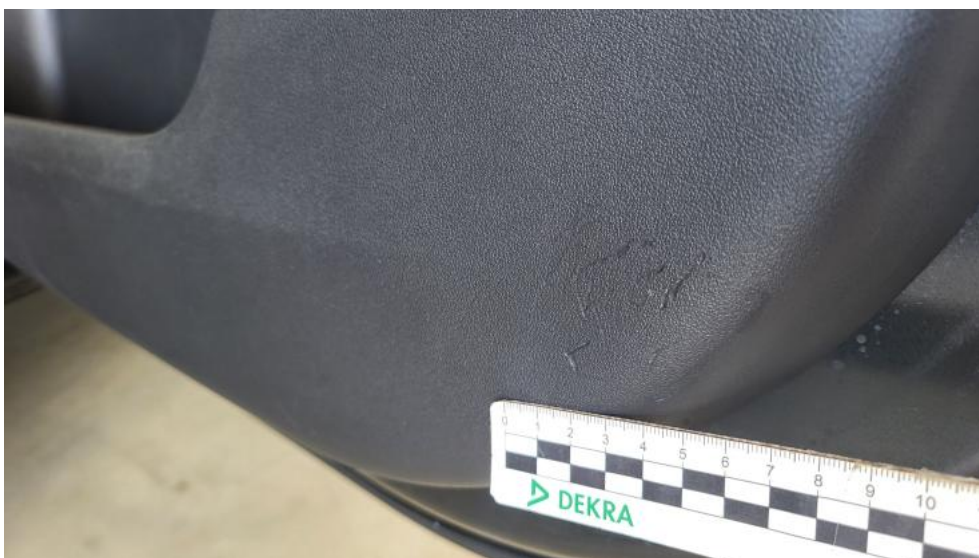
Photo 72.
Tapicerka drzwi przednich P - Rysa/odprysk 1

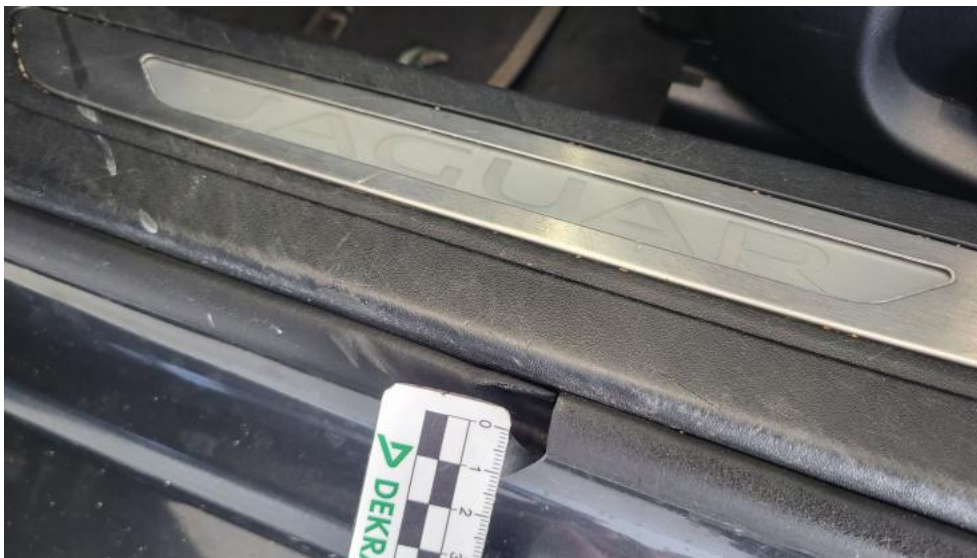
Photo 73.

Uszczelka drzwi przednich L - Pęknięcie/rozerwanie 1

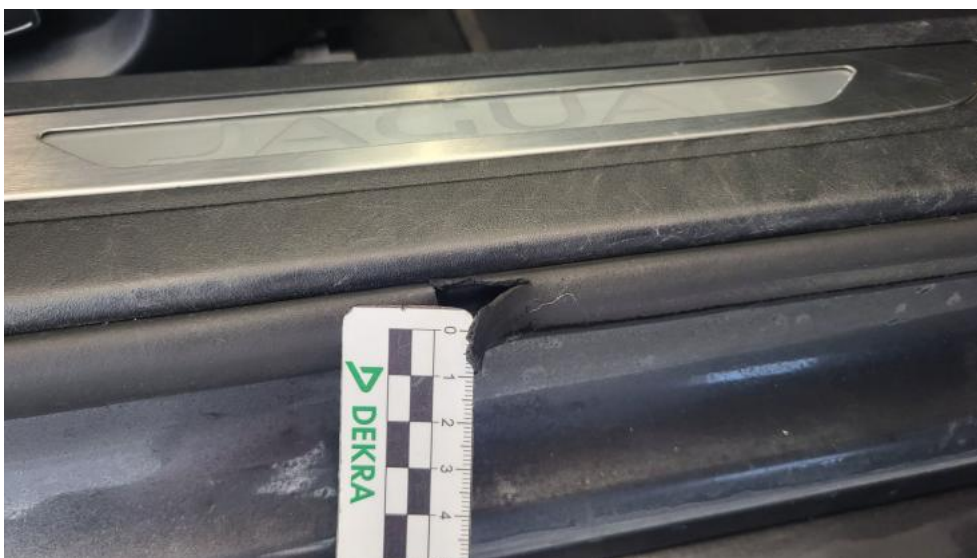
Photo 74.

Uszczelka drzwi przednich P - Pęknięcie/rozerwanie 1
