DEKRA's commission No. : PKOL(W)/LODZ/39175/25/05/30  
commission/ damage No. : 21/042740  
Date of commission: 30-05-2025

**DEKRA Poland - Headquarters**  
02-673 Warszawa, ul. Konstruktorska 12A

**Vehicle data**

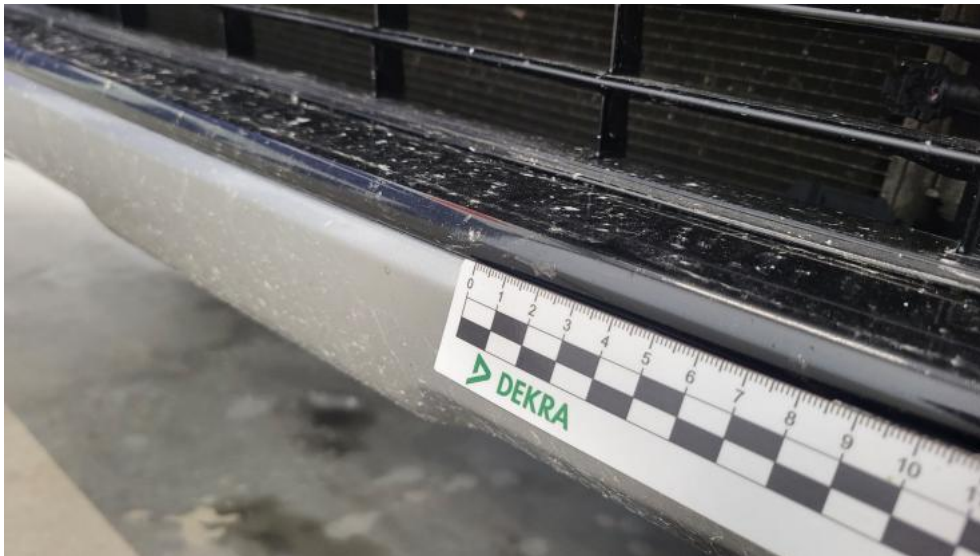
**Photo 41.**

Zderzak przedni cz dolna - Rysa/odprysk 1

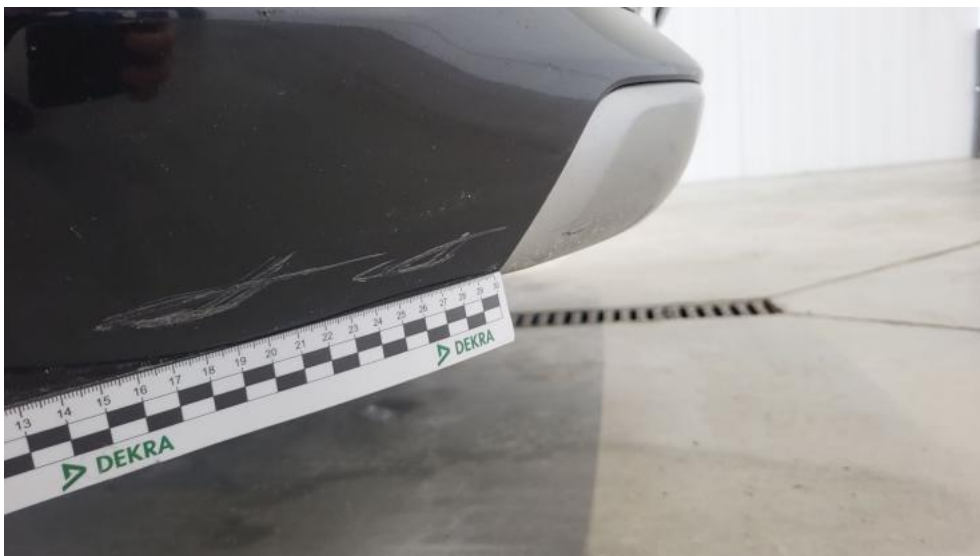
**Photo 42.**

Zderzak przedni cz dolna - Rysa/odprysk 2

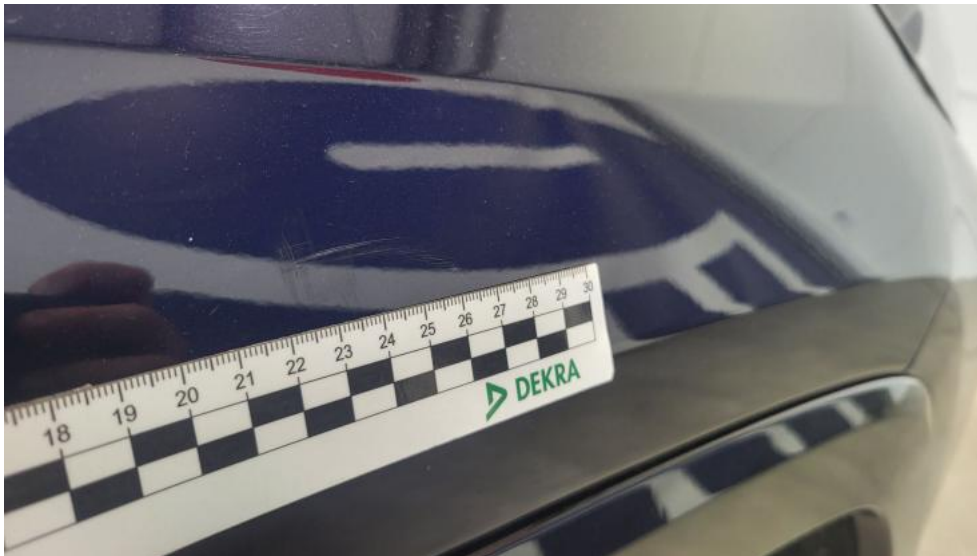
**Photo 43.**

Błotnik przedni P - Rysa/odprysk 1

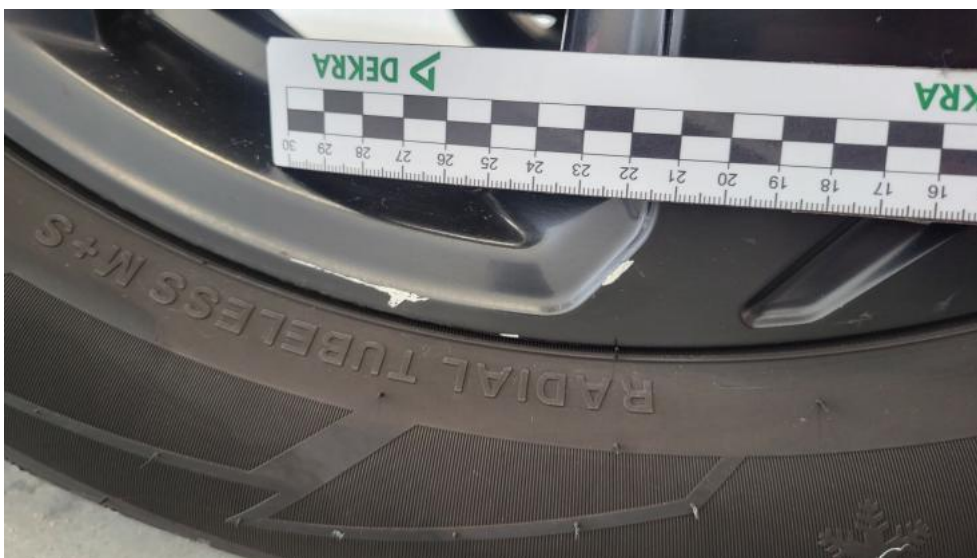
**Photo 44.**

Felga aluminiowa przednia P - Rysa/odprysk 1

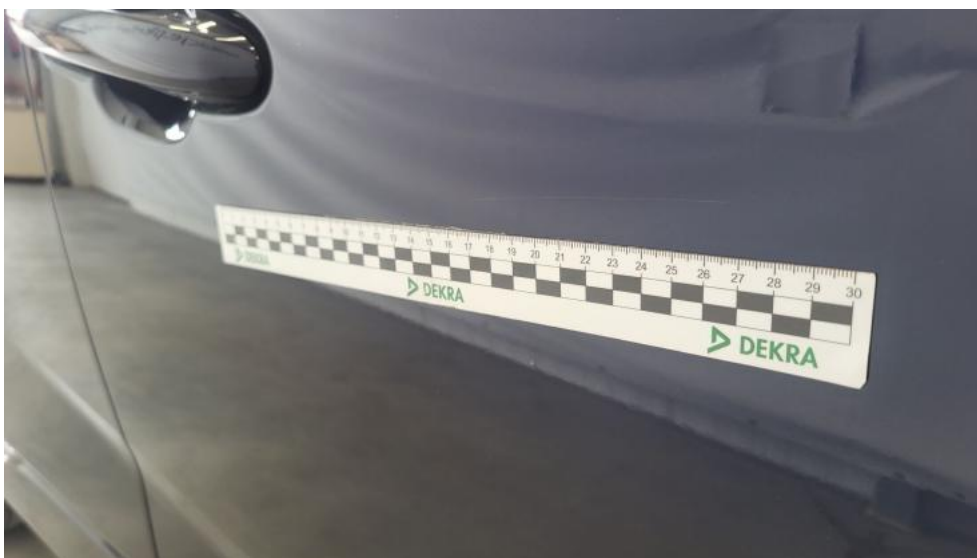
**Photo 46.**

Drzwi przednie P - Rysa/odprysk 1

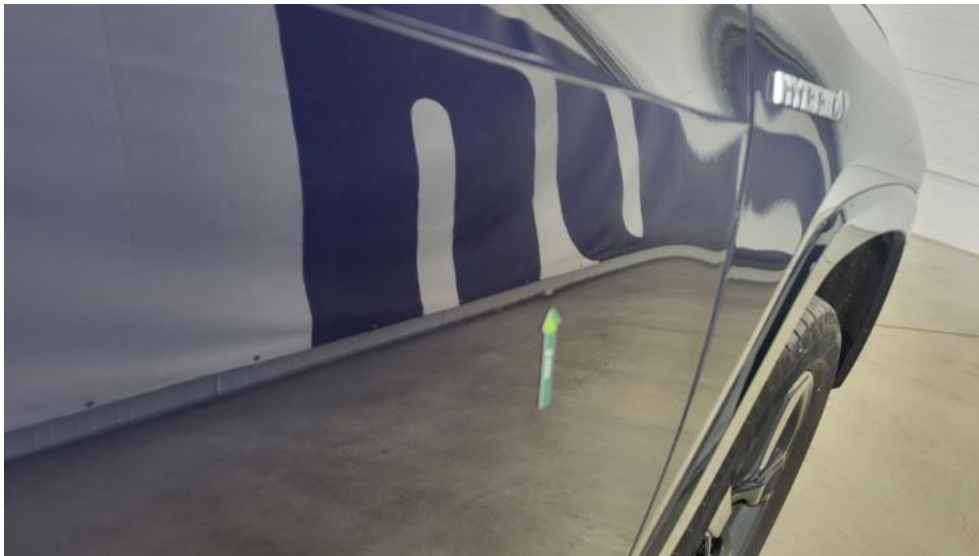
**Photo 47.**

Drzwi przednie P - Wgniecenie/odkształcenie 1

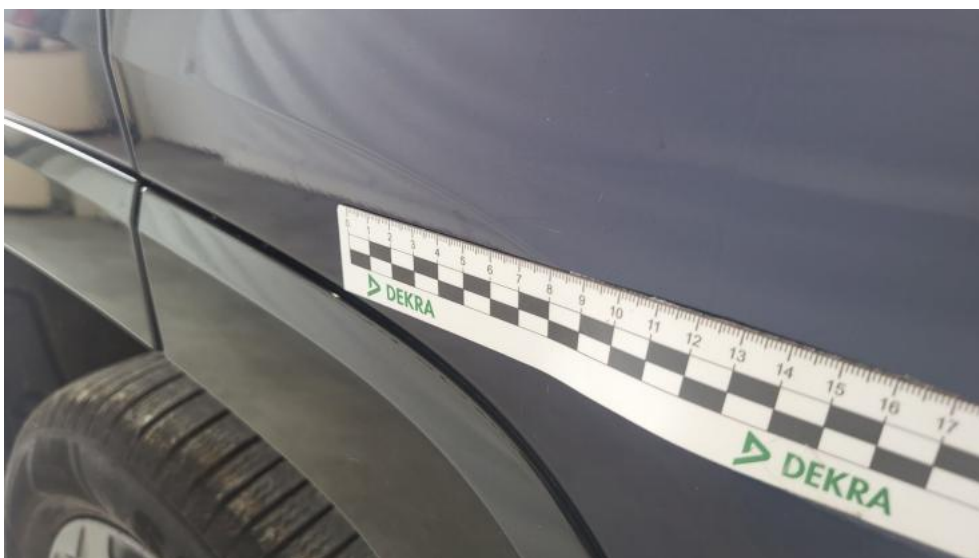
**Photo 48.**

Drzwi tylne P - Rysa/odprysk 1

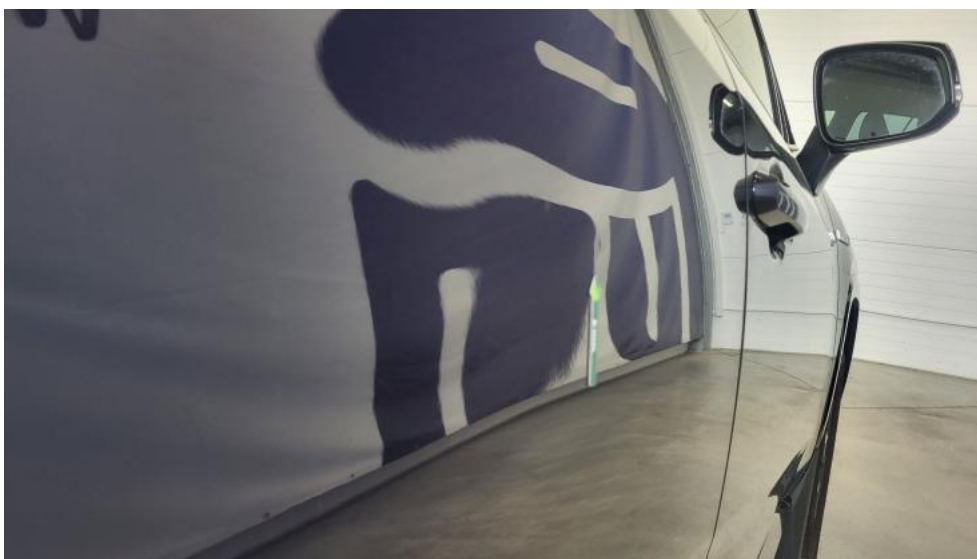
**Photo 49.**

Drzwi tylne P - Wgniecenie/odkształcenie 1

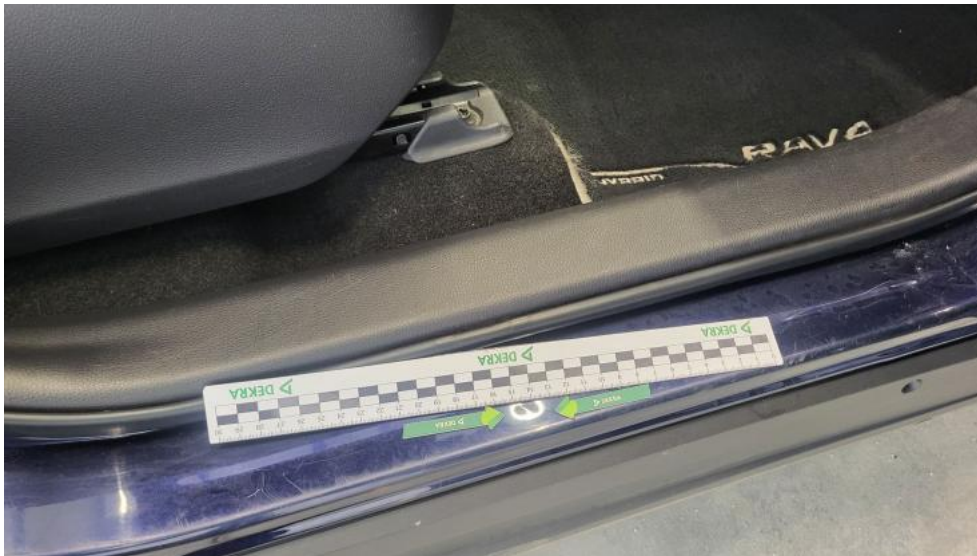
**Photo 51.**

Próg P - Wgniecenie/odkształcenie 1

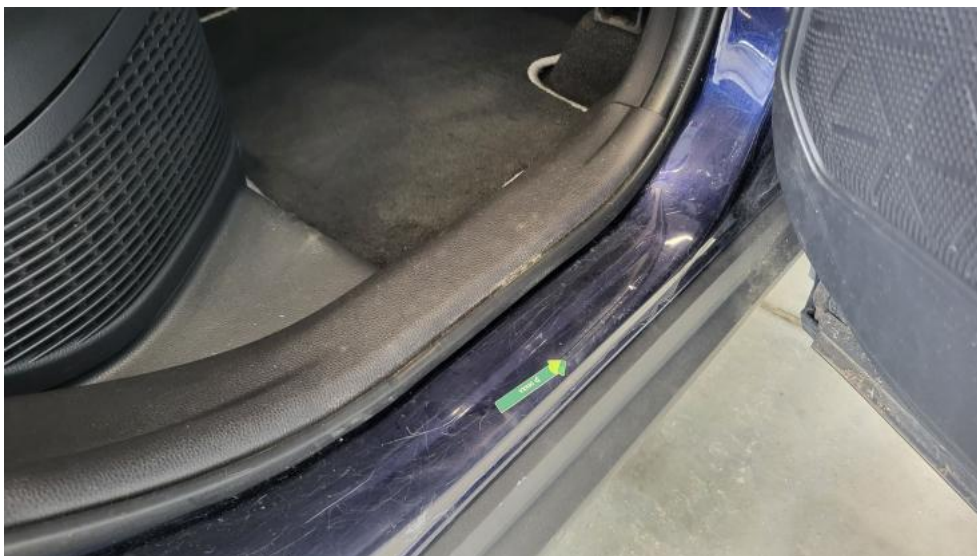
**Photo 52.**

Próg P - Wgniecenie/odkształcenie 2

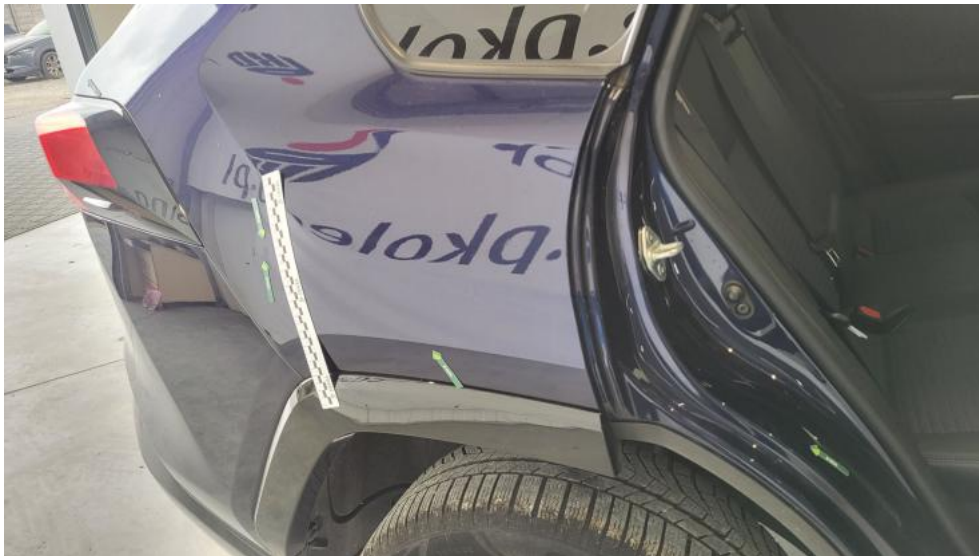
**Photo 53.**

Błotnik tylny P / Ściana boczna P - Wgniecenie/odkształcenie 1

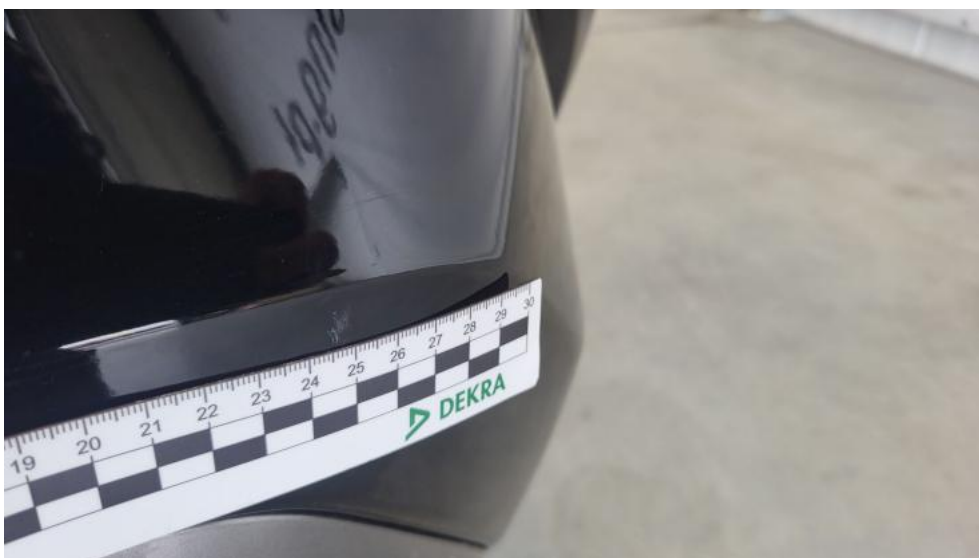
**Photo 54.**

Zderzak tylny - Rysa/odprysk 1

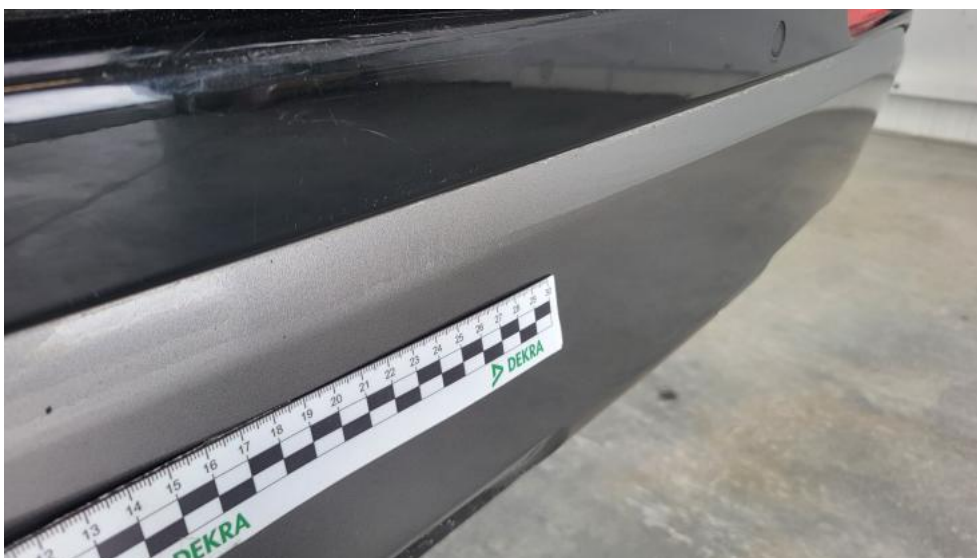
**Photo 56.**

Zderzak tylny cz dolna - Rysa/odprysk 1

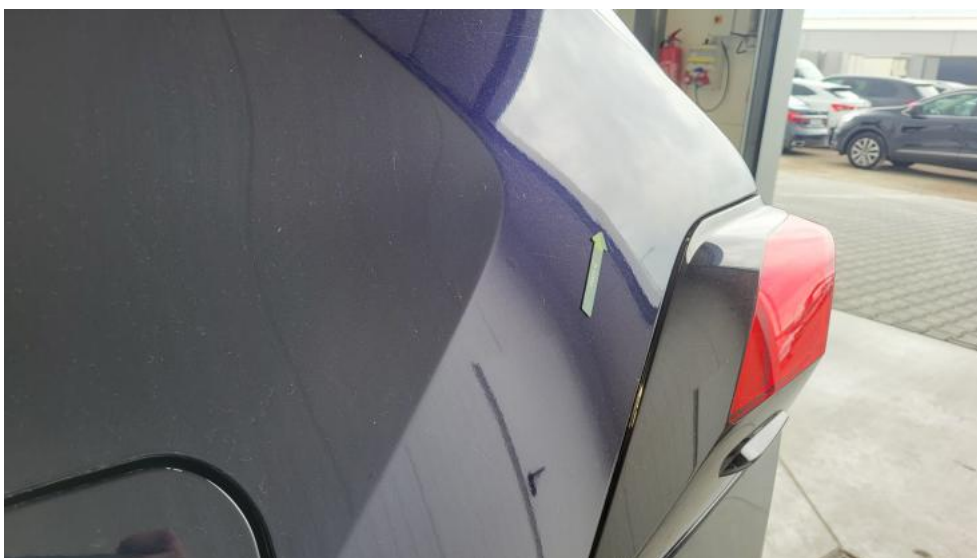
**Photo 58.**

Błotnik tylny L / Ściana boczna L - Wgniecenie/odkształcenie 2

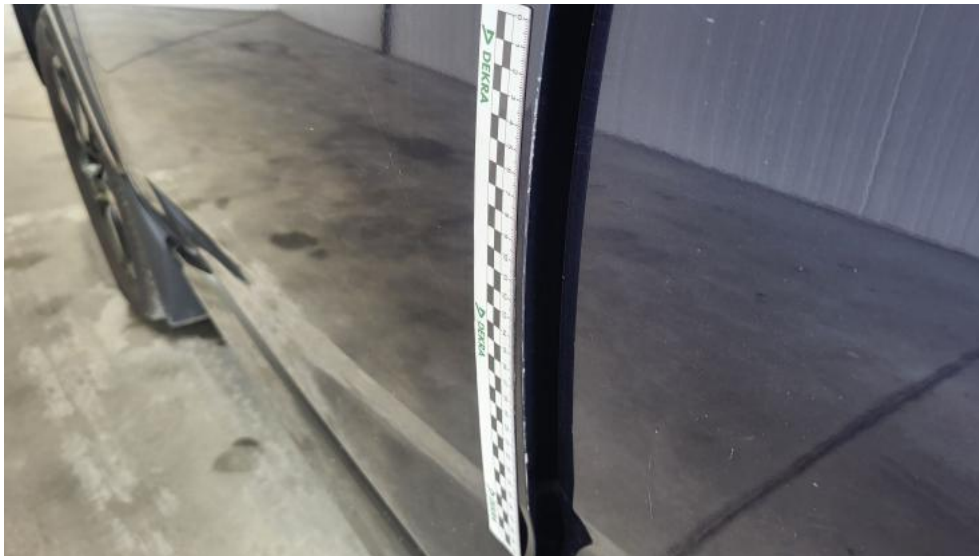
**Photo 59.**

Drzwi przed L - Rysa/odprysk 1

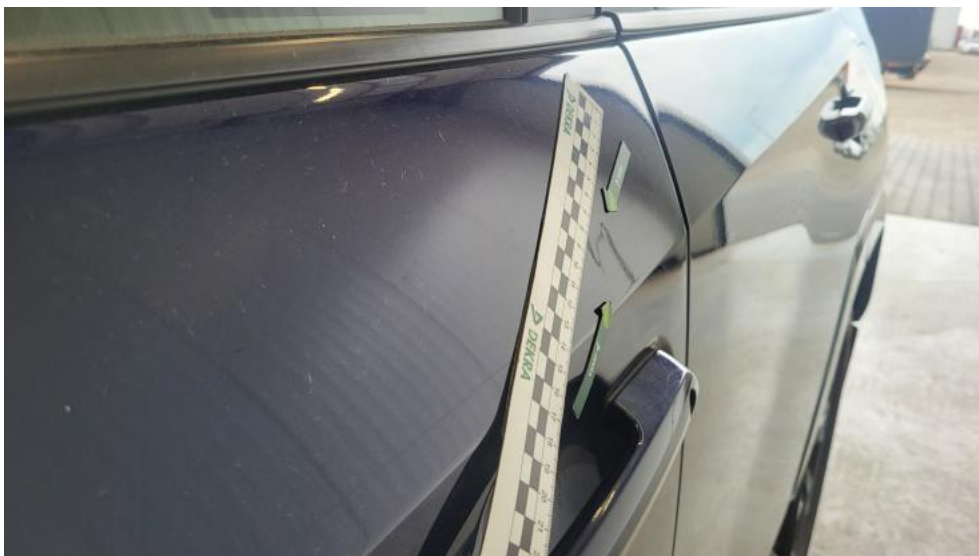
**Photo 60.**

Drzwi przed L - Wgniecenie/odkształcenie 1

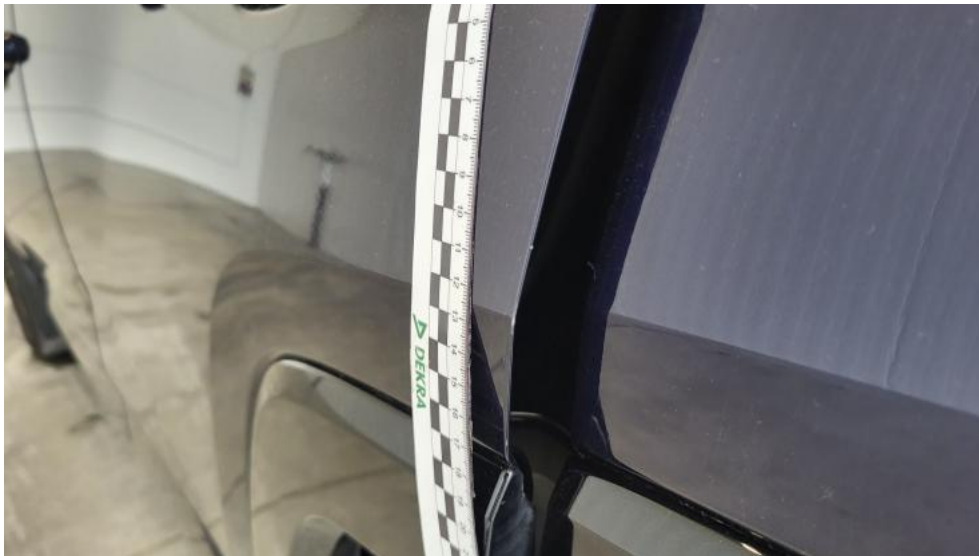
**Photo 61.**

Drzwi tylne L - Rysa/odprysk 1

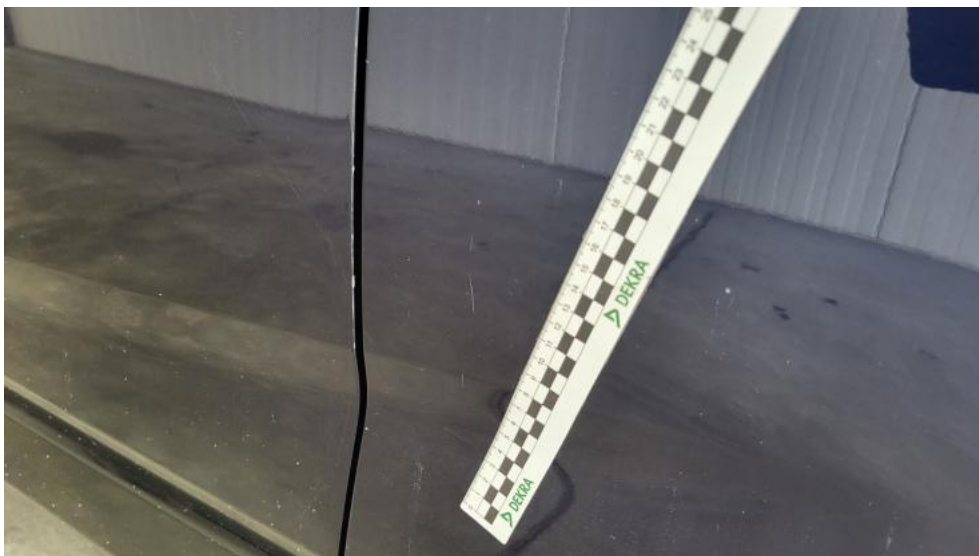
**Photo 62.**

Drzwi tylne L - Rysa/odprysk 2

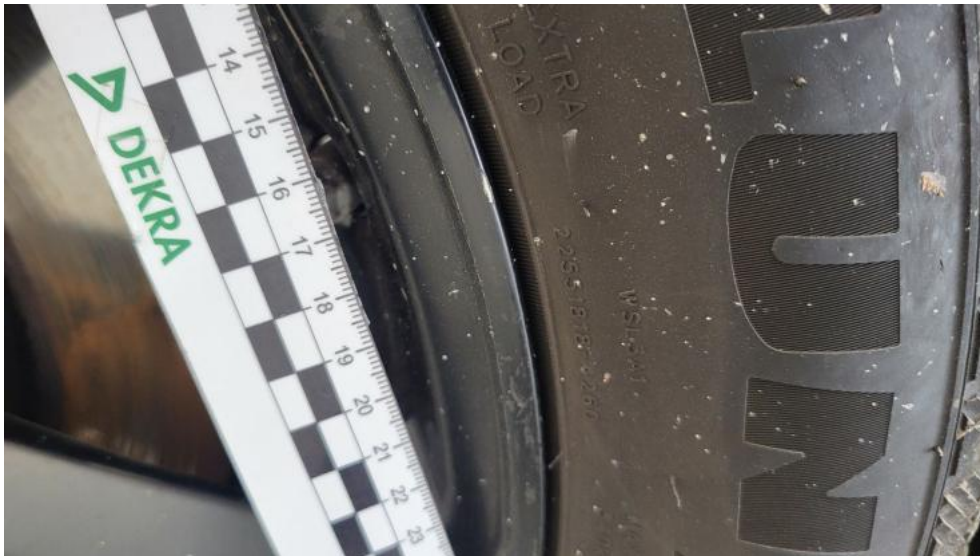
**Photo 65.**

Felga Aluminiowa przednia L - Rysa/odprysk 1

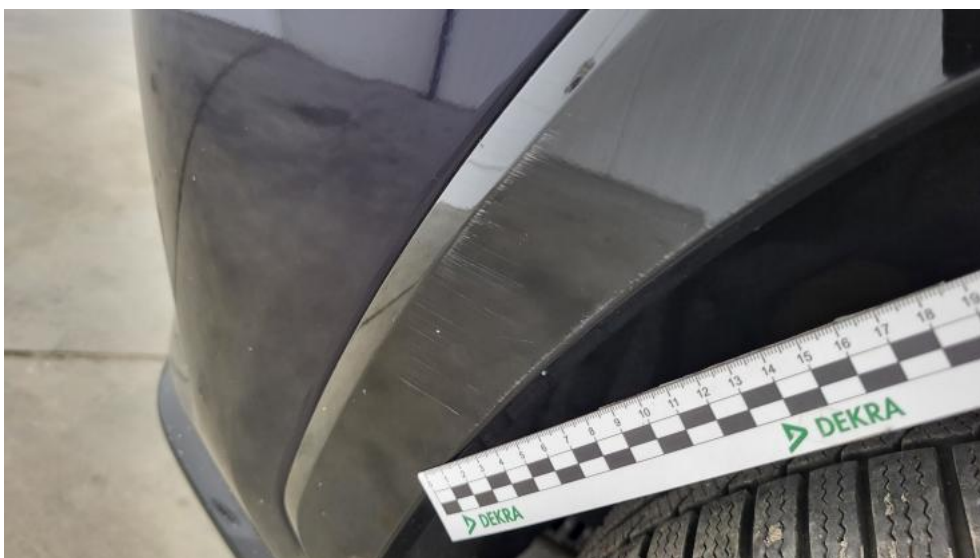
**Photo 66.**

Listwa błotnika przedniego L - Rysa/odprysk 1

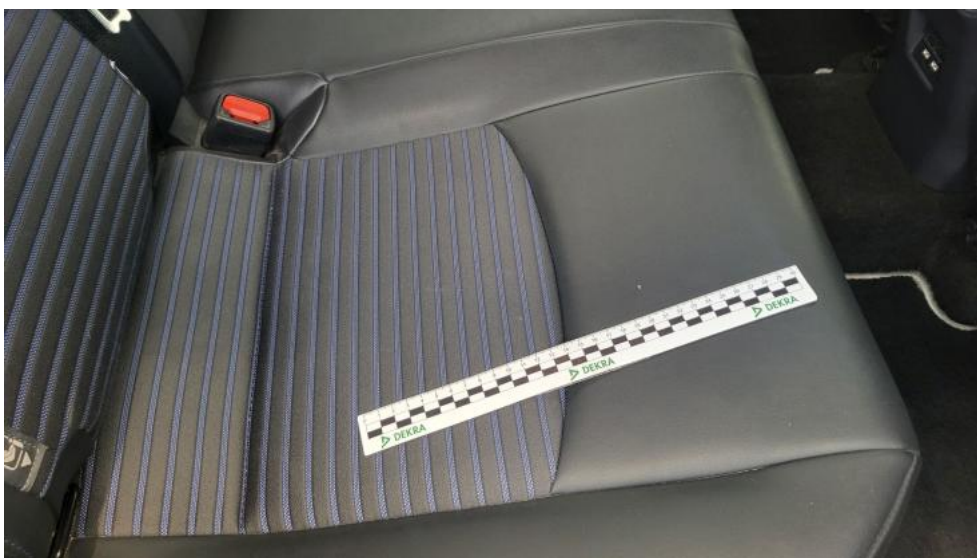
**Photo 70.**

Kanapa tyl. - Inne 1
