DEKRA's commission No. : PKOL(W)/LODZ/18004/25/03/12
 commission/ damage No. : 23/011923
 Date of commission: 12-03-2025

Vehicle data

Group of objects (Eurotax)	cars
EC code (Eurotax)	0134370
Manufacturer	CITROEN
Model	C5 Aircross 18-22
Type / version	C5 Aircross 1.6 PureTech Shine EAT8
Body type	hatchback
Number of doors / seats	5/5
Curb weight [kg]	1430
Gross vehicle weight [kg]	1990
Wheelbase 1/2	2730
Engine type	spark ignition
Pollution reduction system	GPF
Engine capacity [ccm]	1598
Engine Power [hp/kW]	180/133
Gearbox	automatic
Registration /record No.	WZ197GF
VIN / serial number	VR7A45GFSML029321
Date of first registration	26-05-2021
Date of next. tech. test	26-05-2026
Year of manufacture	2021 (year has been verified with the manufacturer's base)
Readout [km]	40 258 (read)
Body color / type of coating	silver/double-layered, metallized

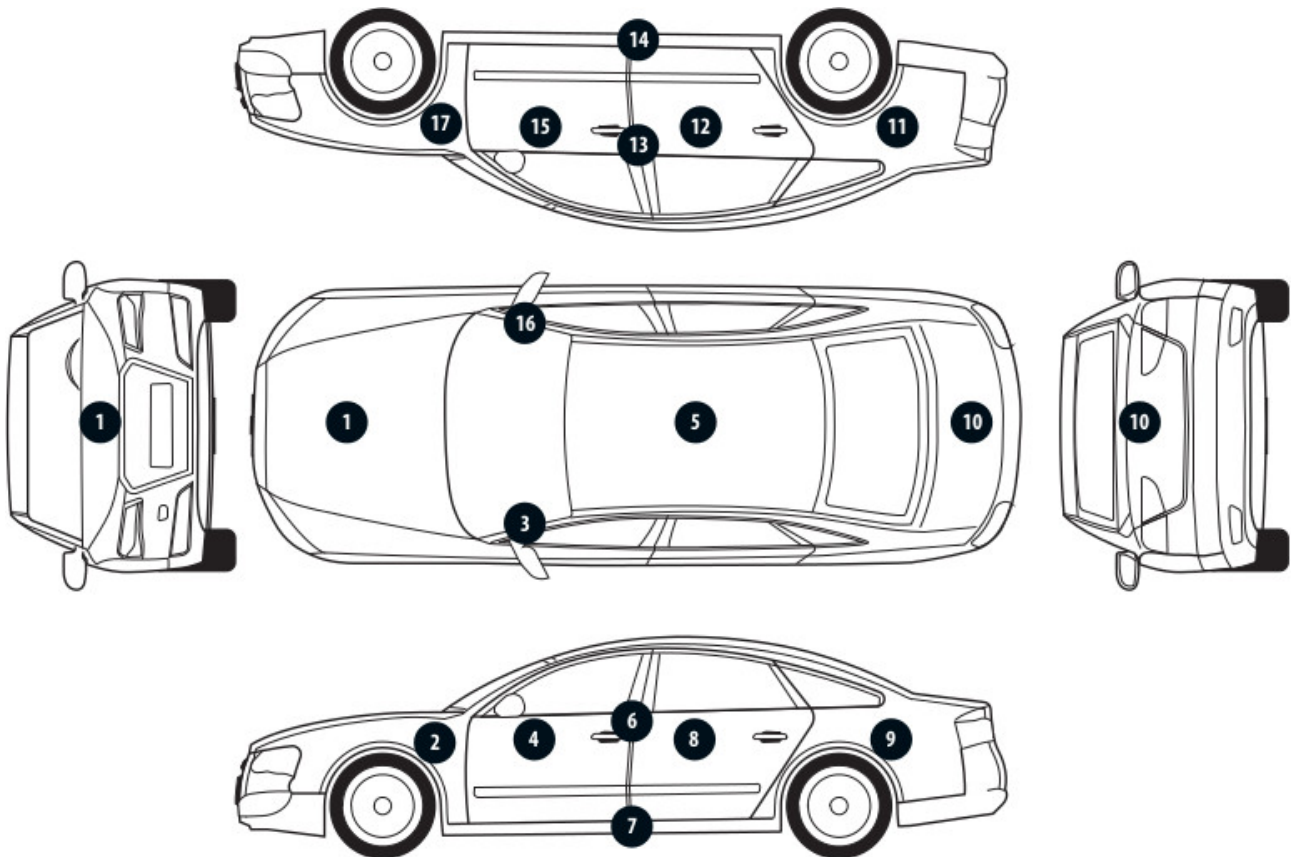
Measurement of thickness of the vehicle lacquer coating

No. of controlled item	Controlled item	Measured range of thickness of the lacquer coat [μm]
1	Front cover	150 - 300
2	Front left fender	to 150
3	Left front pillar	to 150
4	Front left door	to 150
5	Roof	to 150
6	Left middle pillar	to 150
7	Right side sill	to 150
8	Left rear door	to 150
9	Rear left fender	to 150
11	Right rear fender	to 150
12	Right rear door	to 150
13	Right middle pillar	to 150
14	Right side sill	to 150
15	Front right door	150 - 200
16	Right front pillar	to 150
17	Front right fender	to 150

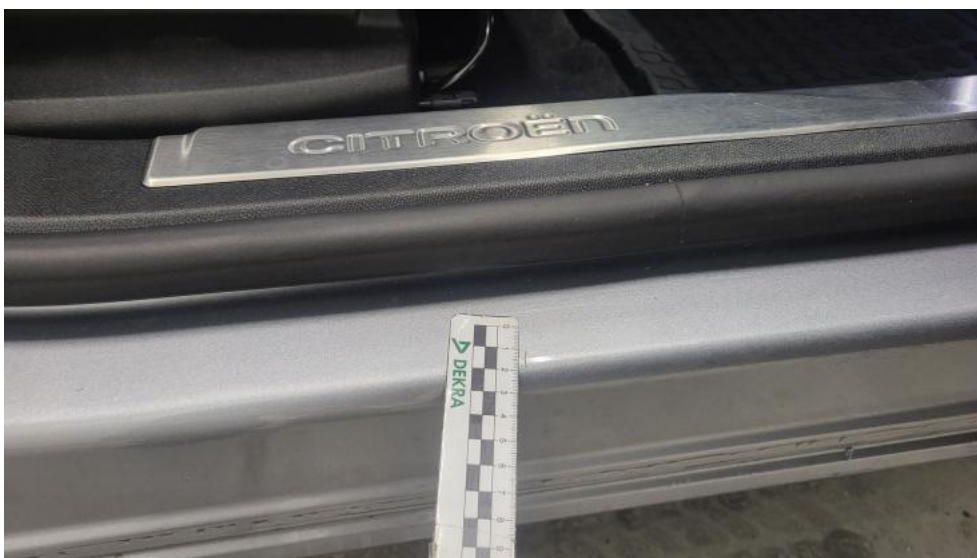
Photo 40.
Próg P - Rysa/odprysk 1

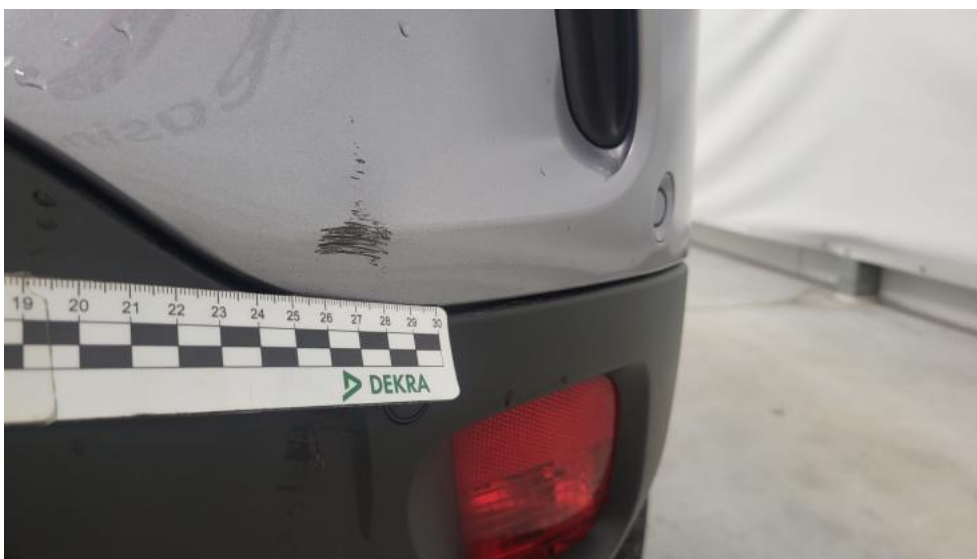
Photo 41.
Zderzak tylny - Rysa/odprysk 1

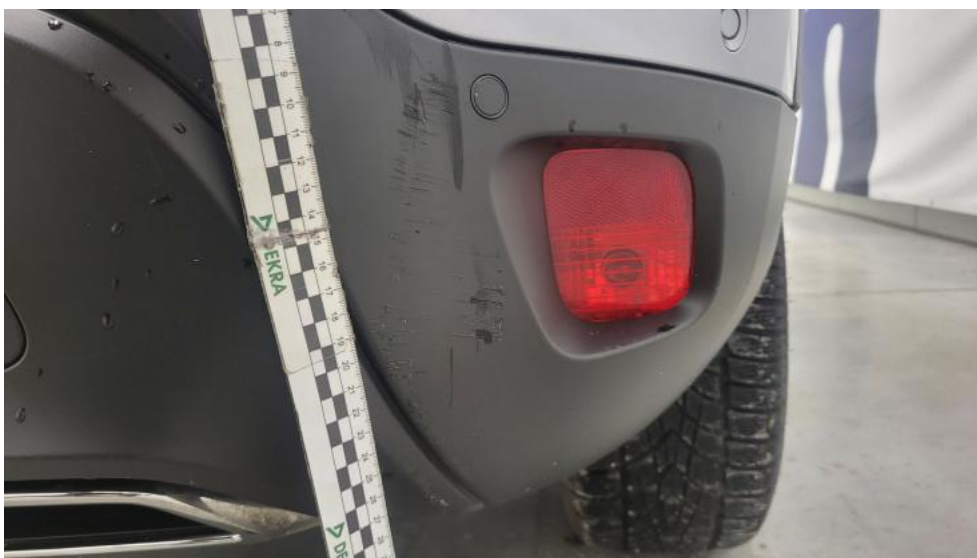
Photo 42.
Zderzak tylny cz dolna - Rysa/odprysk 1

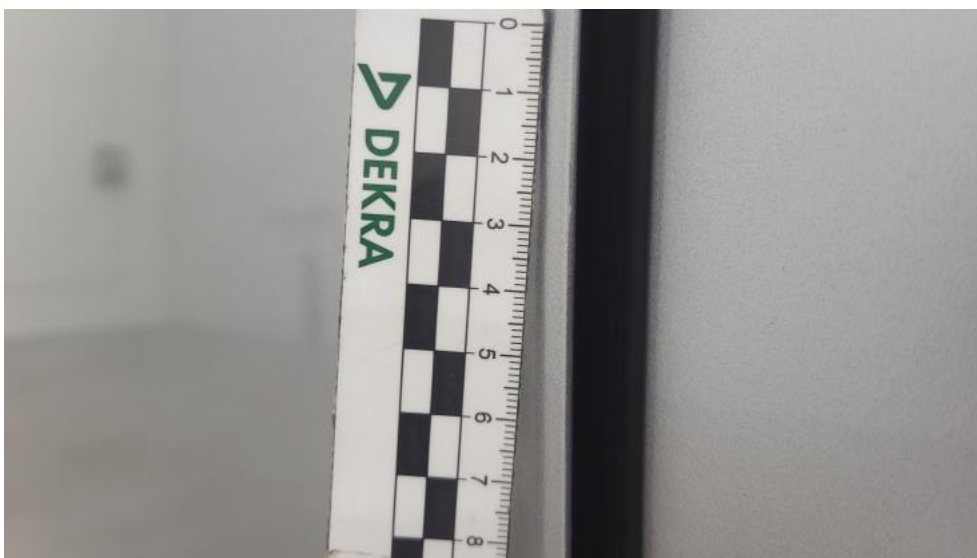
Photo 44.
Drzwi przed L - Rysa/odprysk 1

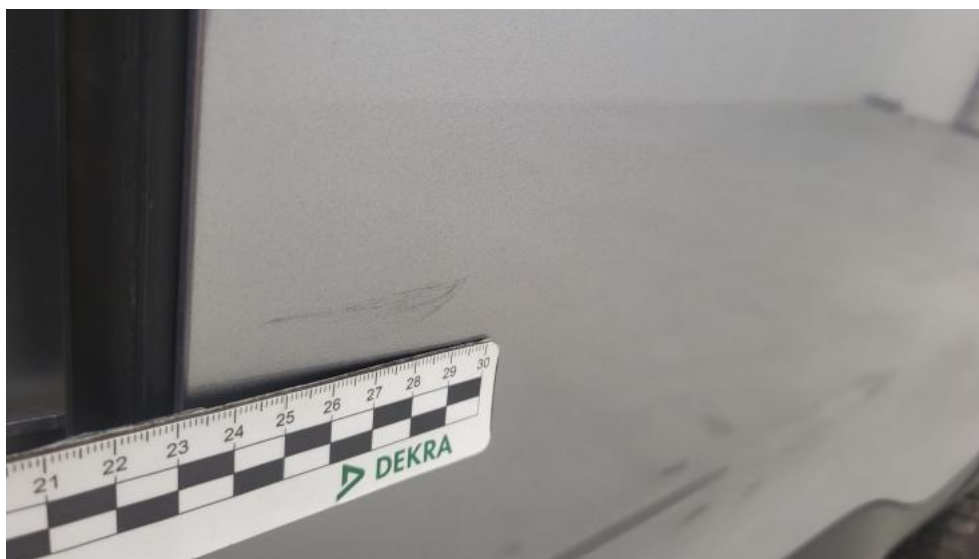
Photo 45.

Drzwi tylne L - Rysa/odprysk 1

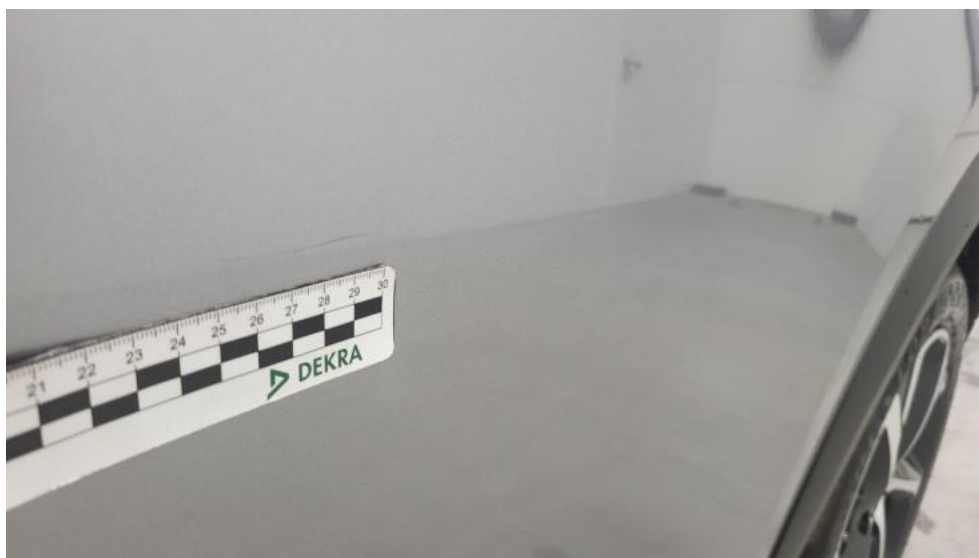
Photo 46.

Drzwi tylne L - Rysa/odprysk 2

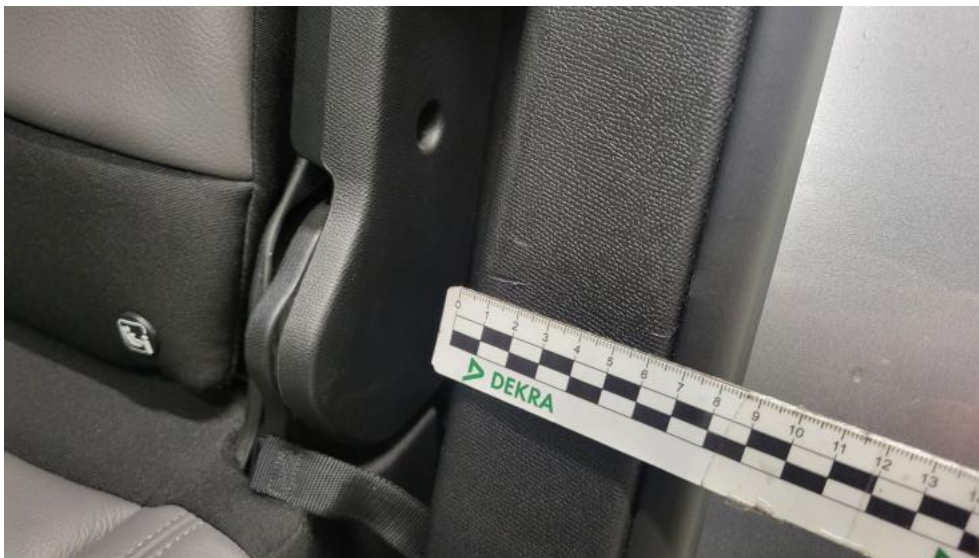
Photo 49.

Wykładzina(y) słupka tylnego L - Rysa/odprysk 1
