DEKRA's commission No. : PKOL(W)/LODZ/81171/24/10/21
commission/ damage No. : 23/016884
Date of commission: 21-10-2024

PKO Leasing SA
Świętokrzyska 36
00-116 Warszawa

Group of objects (Eurotax)	cars
EC code (Eurotax)	0047626
Manufacturer	CHEVROLET
Model	Corvette
Type	Corvette 6.2 Z51 Stingray
Body type	CPE
Number of doors / seats	2/2
Curb weight [kg]	1730
Gross vehicle weight [kg]	1980
Wheelbase 1/2	0
Engine type	spark ignition
Pollution reduction system	three-way catalytic converter
Engine capacity [ccm]	6162
Engine Power [hp/kW]	481/354
Gearbox	automatic 4- gear
Registration /record No.	DW1VU30
VIN / serial number	1G1Y92D47P5113337
Date of first registration	22-11-2022
Date of next. tech. test	13-06-2025
Year of manufacture	2022
Readout [km]	6 002 (read)
Body color / type of coating	white/METALIK

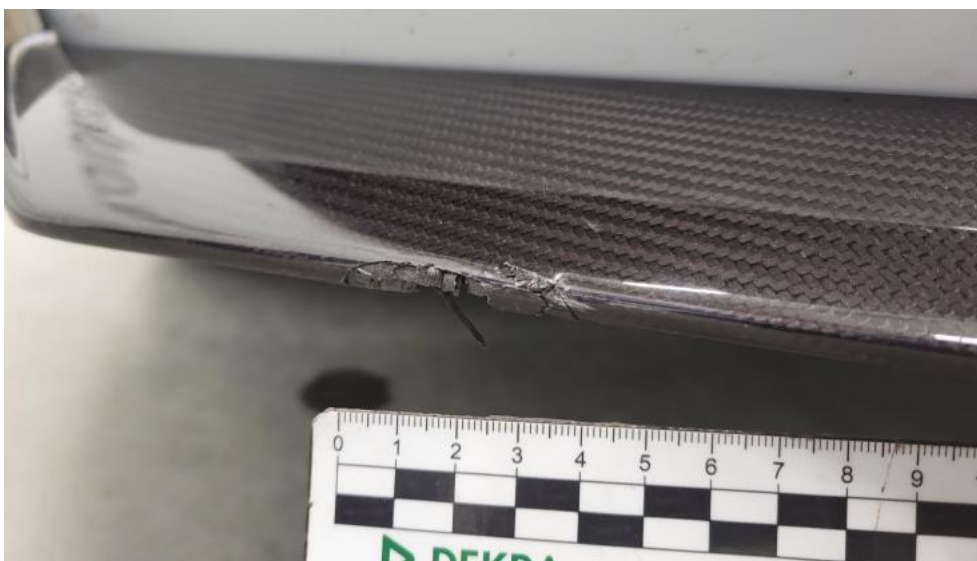
Photo 75.
Spoiler zderzaka przedniego() - Pęknięcie/rozerwanie 3
