DEKRA's commission No. : PKOL(W)/LODZ/38763/24/05/22
 commission/ damage No. : 011/PFKR/23
 Date of commission: 22-05-2024

Group of objects (Eurotax)	jeeps
EC code (Eurotax)	0131130
Manufacturer	JAGUAR
Model	I-Pace 18-23
Type / version	I-Pace EV400 AWD SE
Body type	KOM
Number of doors / seats	5/5
Curb weight [kg]	2133
Gross vehicle weight [kg]	2670
Wheelbase 1/2	2990
Engine type	elektryczny
Pollution reduction system	-
Engine capacity [ccm]	0
Engine Power [hp/kW]	400/294
Gearbox	automatic 1- gear
Registration /record No.	KR3YX27
VIN / serial number	SADHA2B17P1629717
Date of first registration	24-04-2023
Date of next. tech. test	24-04-2026
Year of manufacture	2023
Readout [km]	10 691 (read)
Body color / type of coating	silver/double-layered

Measurement of thickness of the vehicle lacquer coating

PHOTOGRAPHIC DOCUMENTATION

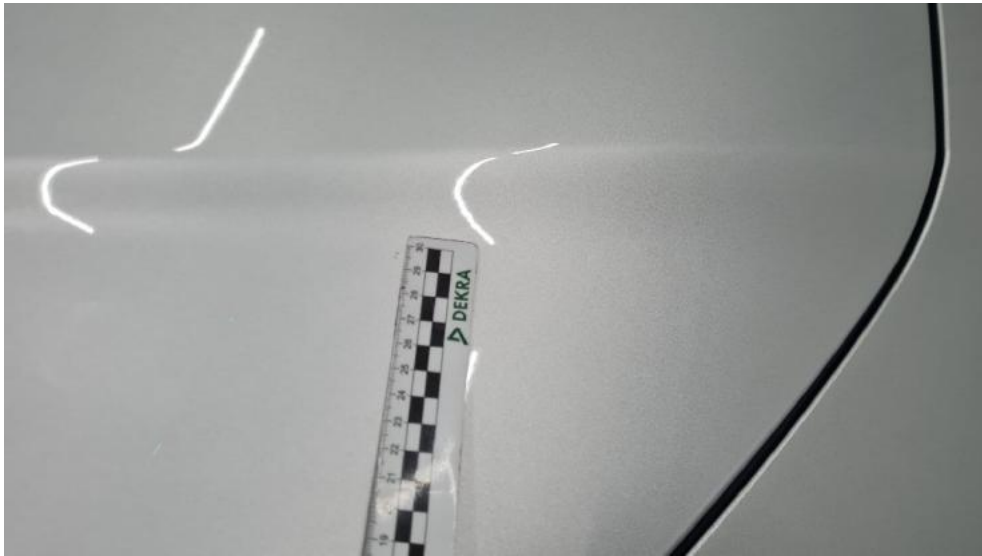
Photo 23.
Pokrywa komory silnika (Rysa/Odprysk)
