DEKRA's commission No. : PKOL(W)/LODZ/08113/25/02/03  
commission/ damage No. : 22/028918  
Date of commission: 03-02-2025

Group of objects (Eurotax)	cars
EC code (Eurotax)	0135587
Manufacturer	MERCEDES-BENZ
Model	A Klasa [W 177] 18-22
Type / version	A 200 d Progressive 8G-DCT
Body type	hatchback
Number of doors / seats	5/5
Curb weight [kg]	1490
Gross vehicle weight [kg]	1995
Wheelbase 1/2	2729
Engine type	Automatic ignition
Pollution reduction system	KSC
Engine capacity [ccm]	1950
Engine Power [hp/kW]	150/110
Gearbox	automatic
Registration /record No.	GA694HX
VIN / serial number	W1K1770121N236786
Date of first registration	22-04-2021
Date of next. tech. test	09-02-2024
Year of manufacture	2021 (year has been verified with the manufacturer's base)
Readout [km]	112 260 (read)
Body color / type of coating	white/UNI

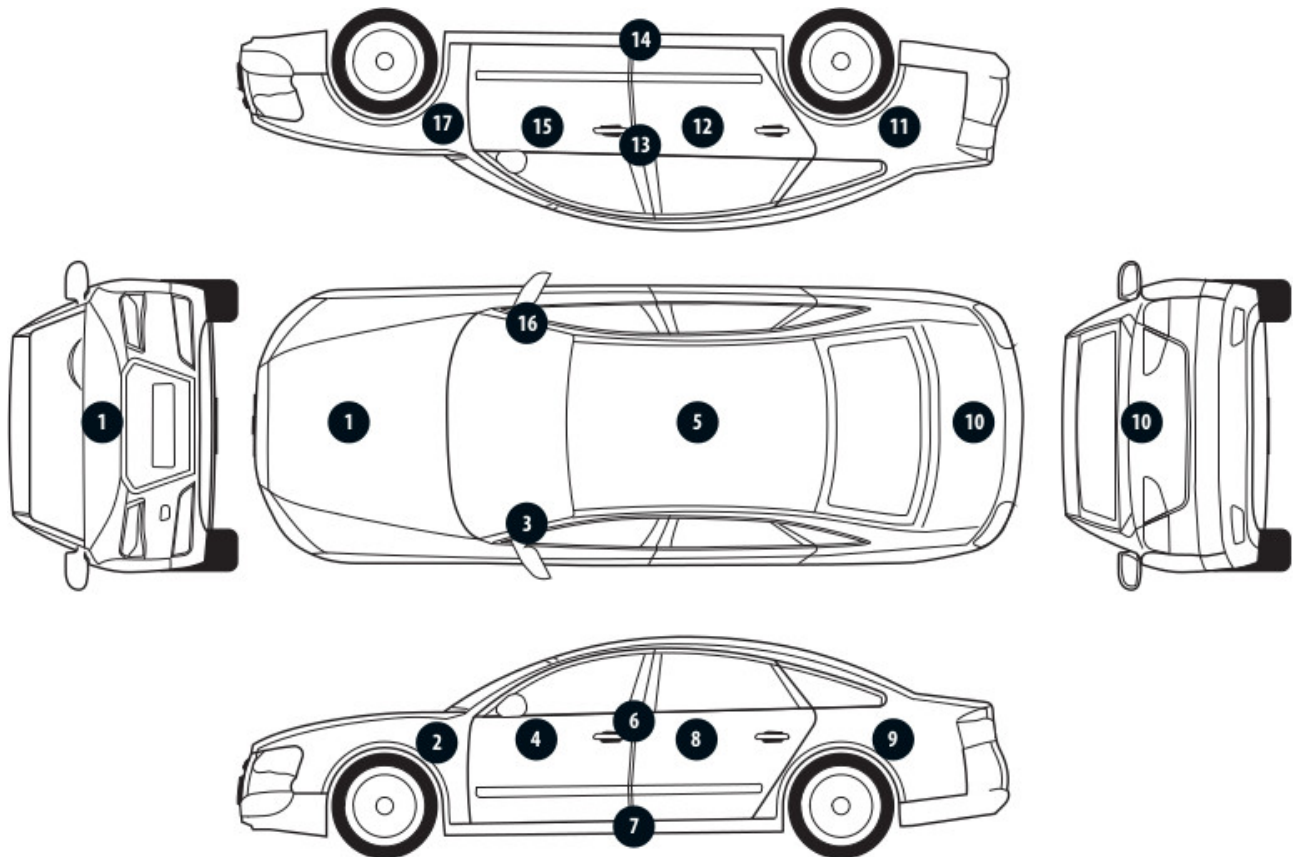
Measurement of thickness of the vehicle lacquer coating

No. of controlled item	Controlled item	Measured range of thickness of the lacquer coat [ $\mu\text{m}$ ]
1	Front cover	to 150
2	Front left fender	to 150
3	Left front pillar	to 150
4	Front left door	to 150
5	Roof	to 150
6	Left middle pillar	to 150
7	Right side sill	to 150
8	Left rear door	to 150
9	Rear left fender	to 150
10	Cover/lid	to 150
11	Right rear fender	to 150
12	Right rear door	to 150
13	Right middle pillar	to 150
14	Right side sill	to 150
15	Front right door	to 150
16	Right front pillar	to 150
17	Front right fender	150 - 300

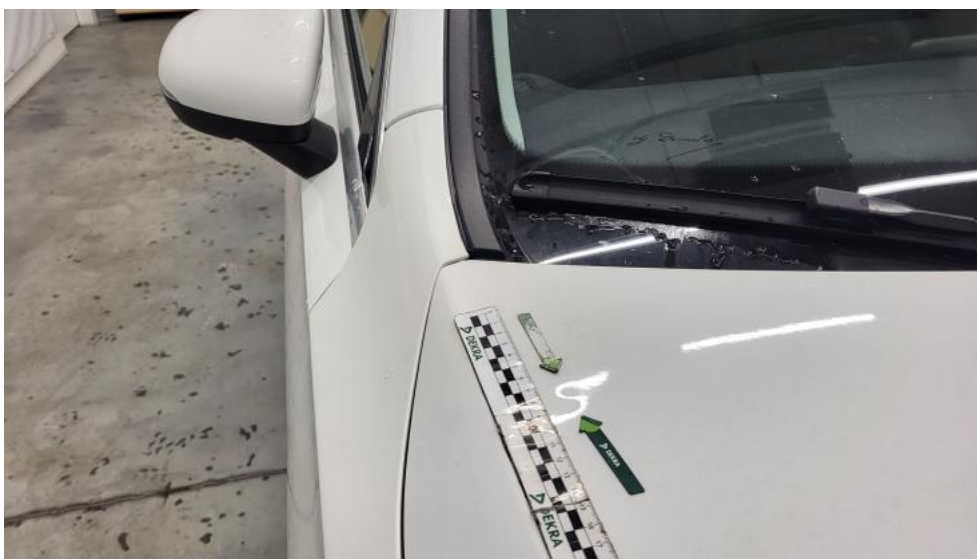
**Photo 37.**  
Pokrywa komory silnika - Wgniecenie/odkształcenie 1

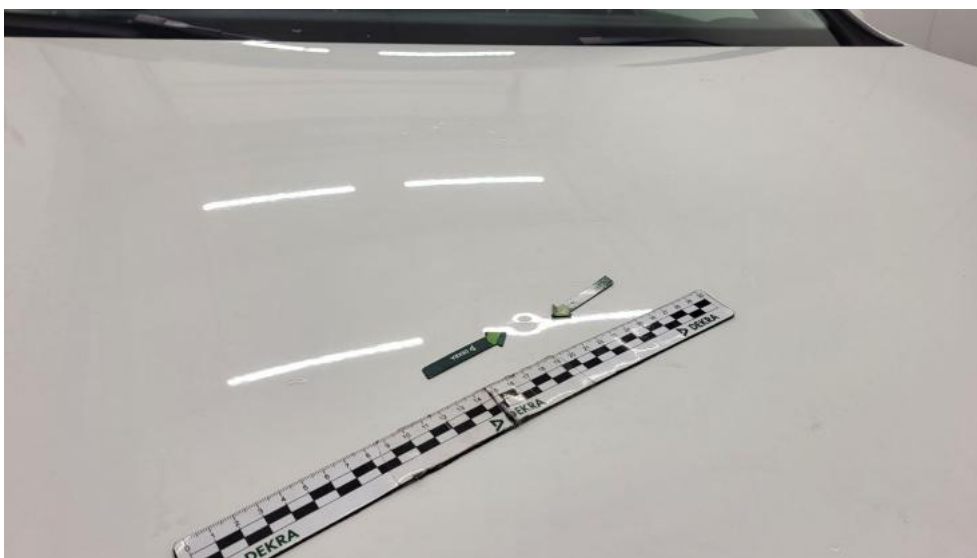
**Photo 38.**  
Pokrywa komory silnika - Wgniecenie/odkształcenie 2

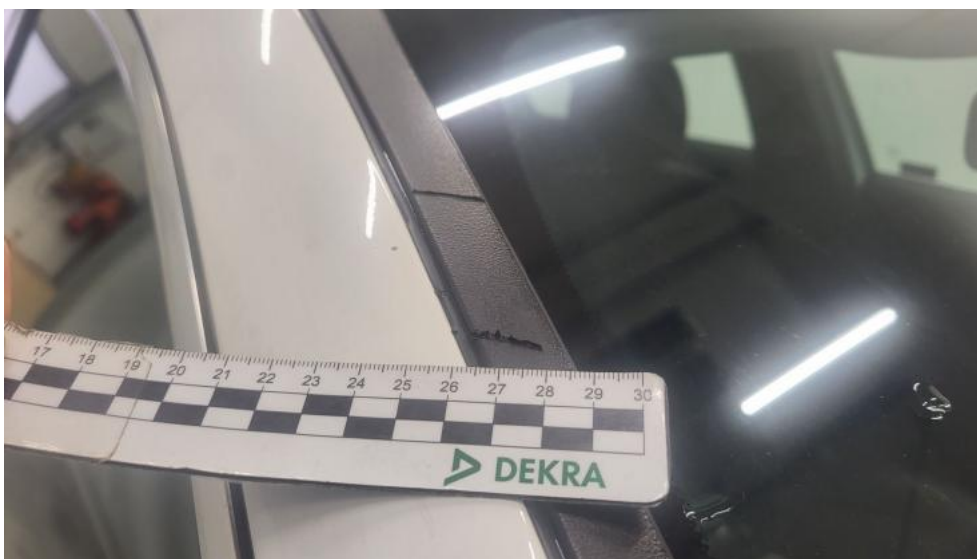
**Photo 39.**  
Uszczelka/listwa szyby czołowej - Rysa/odprysk 1

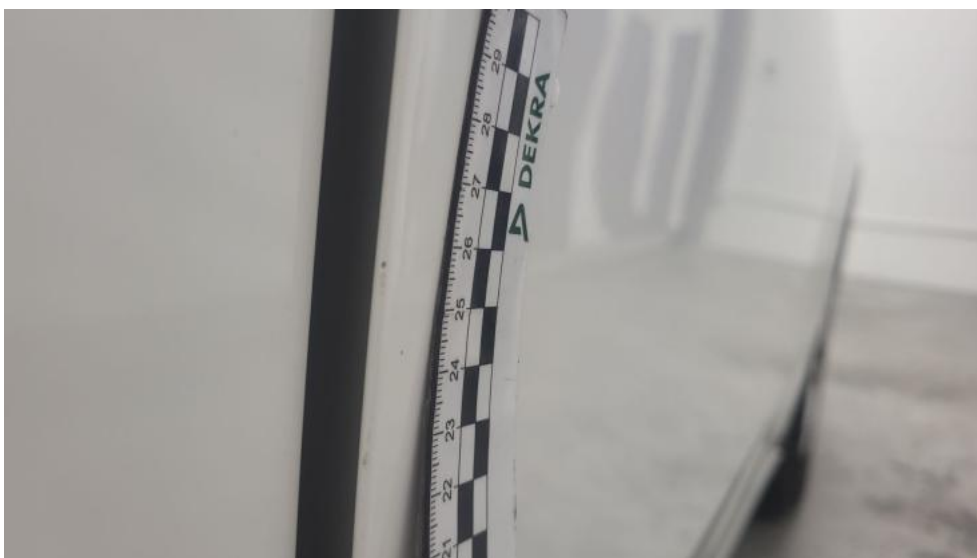
**Photo 40.**  
Drzwi przednie P - Rysa/odprysk 1

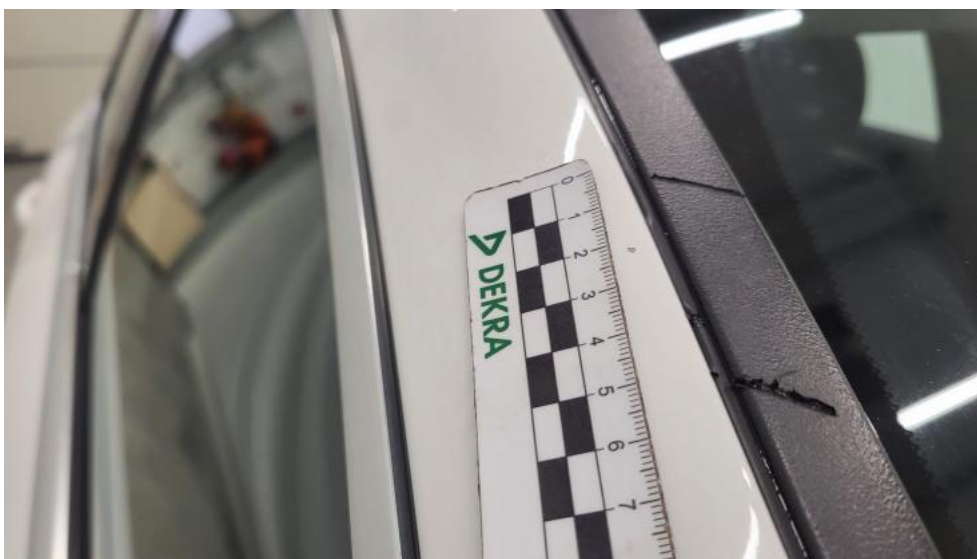
**Photo 41.**  
Stupek przedni P - Rysa/odprysk 1

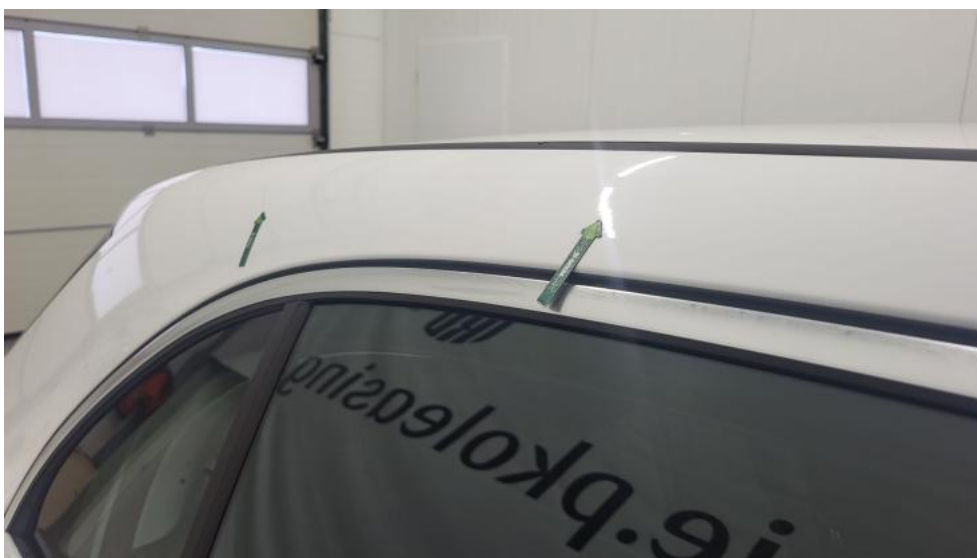
**Photo 42.**  
Błotnik tylny P / Ściana boczna P - Wgniecenie/odkształcenie 1

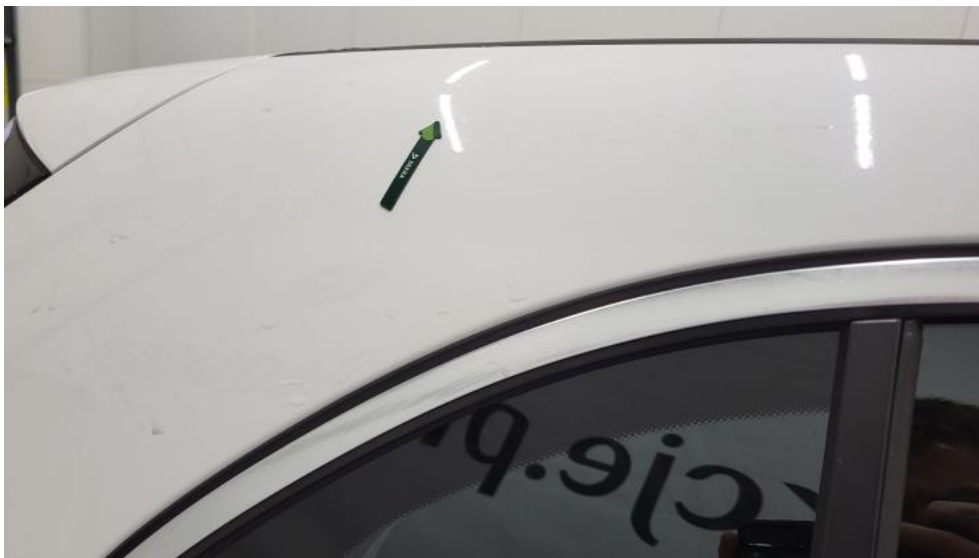
**Photo 43.**  
Błotnik tylny P / Ściana boczna P - Wgniecenie/odkształcenie 2

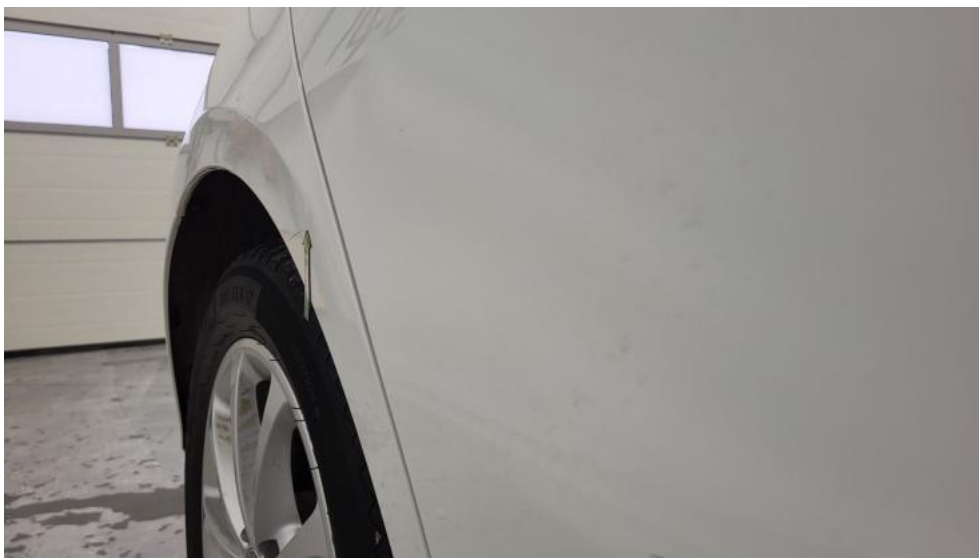
**Photo 44.**  
Błotnik tylny P / Ściana boczna P() - Wgniecenie/odkształcenie 3

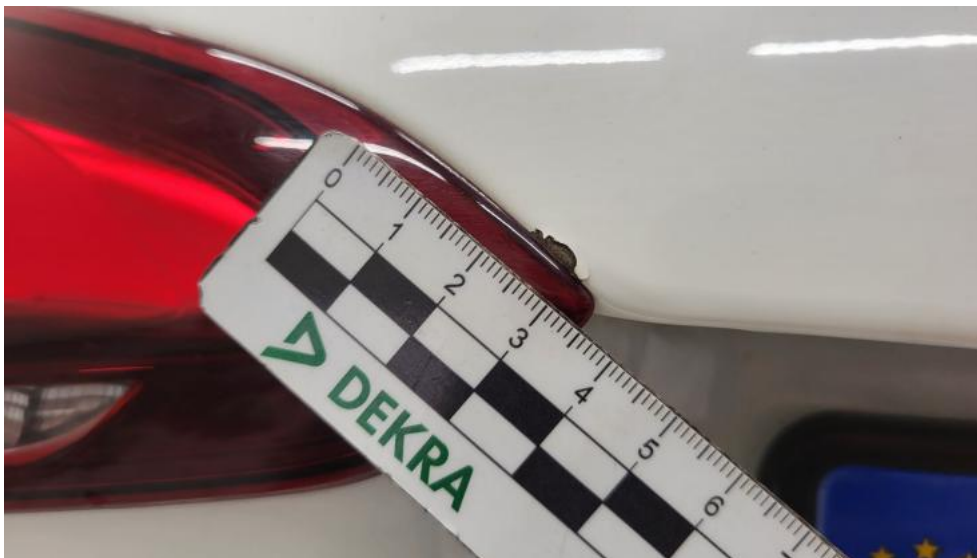
**Photo 45.**  
Pokrywy bagażnika - Rysa/odprysk 1

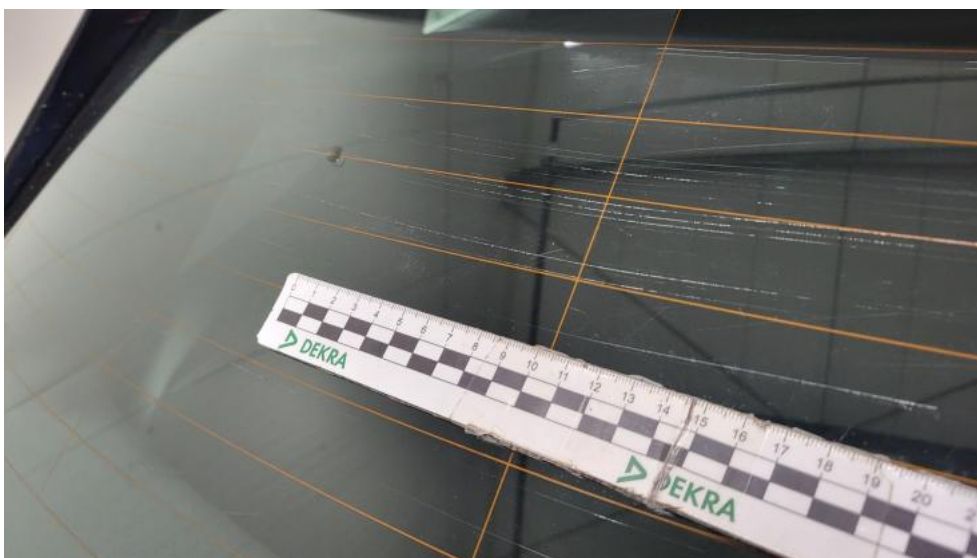
**Photo 46.**  
Szyba tylna() - Rysa/odprysk 3

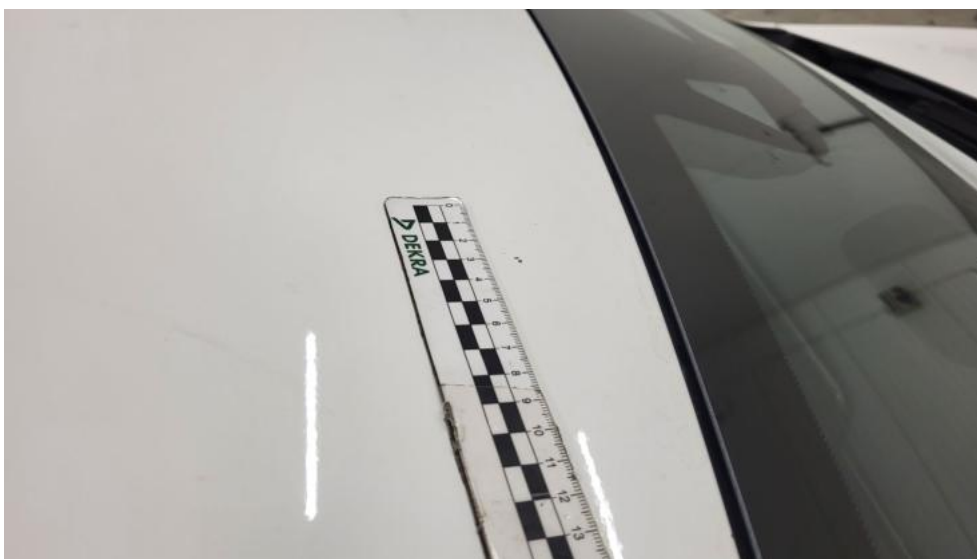
**Photo 47.**  
Dach - Rysa/odprysk 1

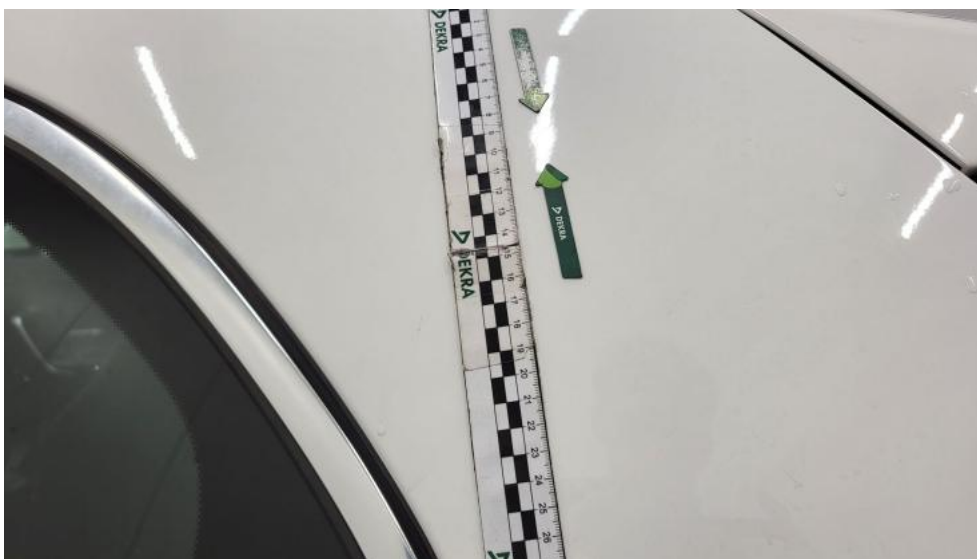
**Photo 49.**  
Błotnik tylny L / Ściana boczna L - Wgniecenie/odkształcenie 1

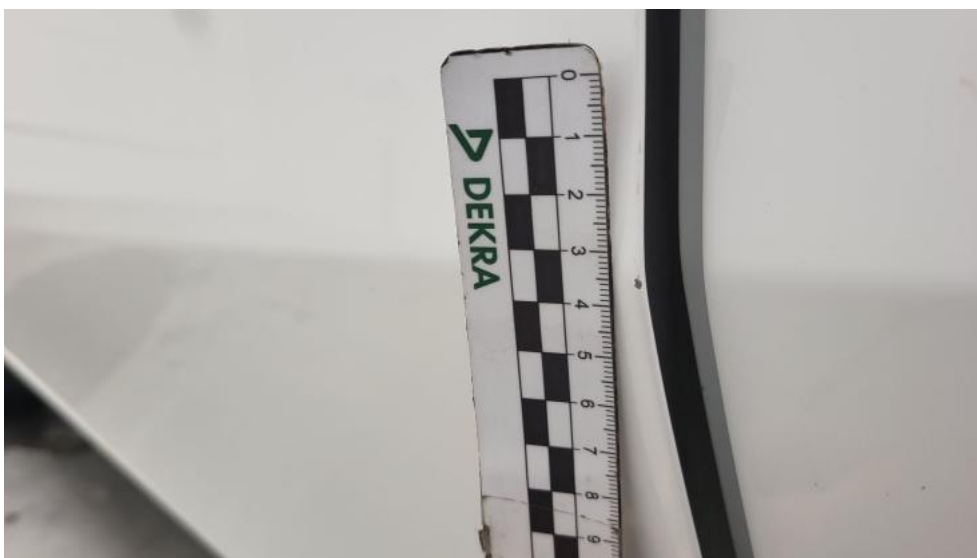
**Photo 50.**  
Drzwi przed L - Rysa/odprysk 1

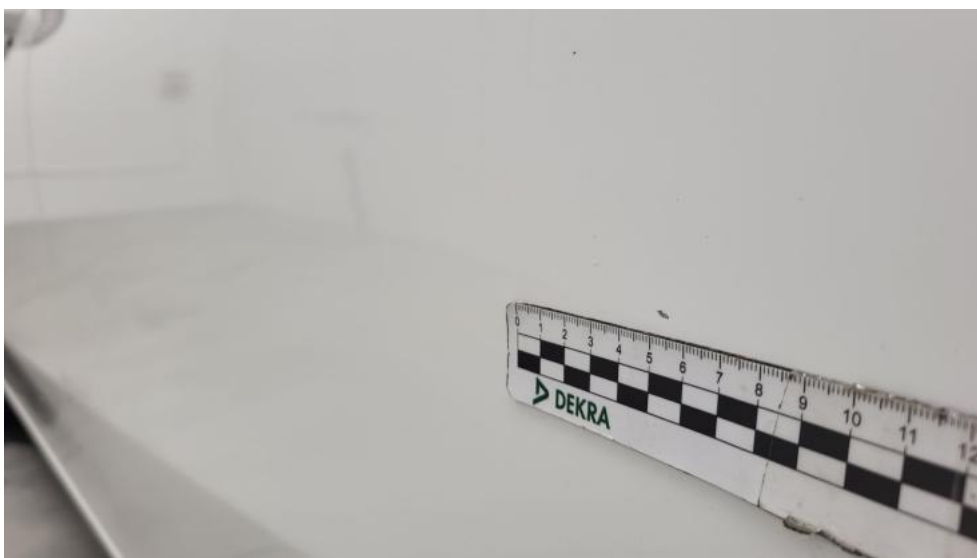
**Photo 52.**

Drzwi tylne L - Rysa/odprysk 1

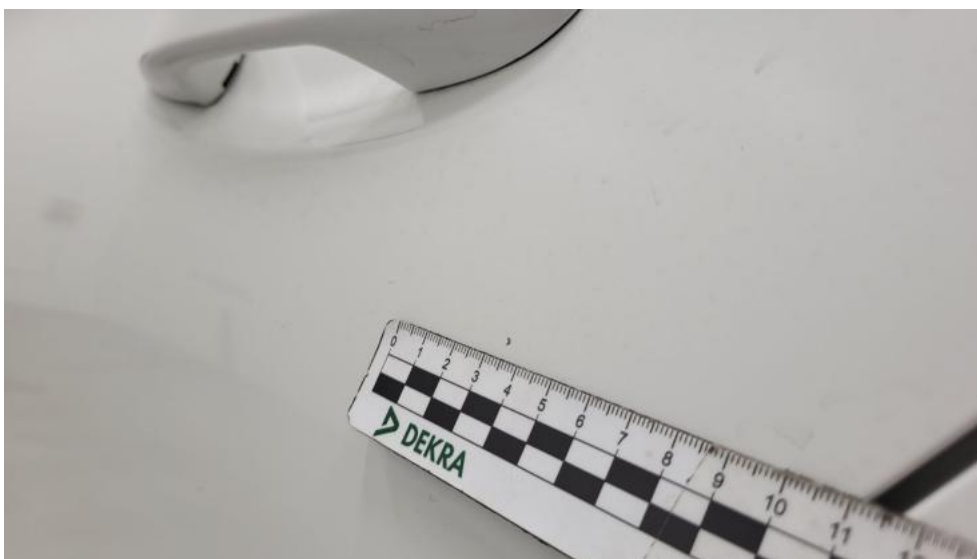
**Photo 53.**  
Drzwi tylne L - Rysa/odprysk 2

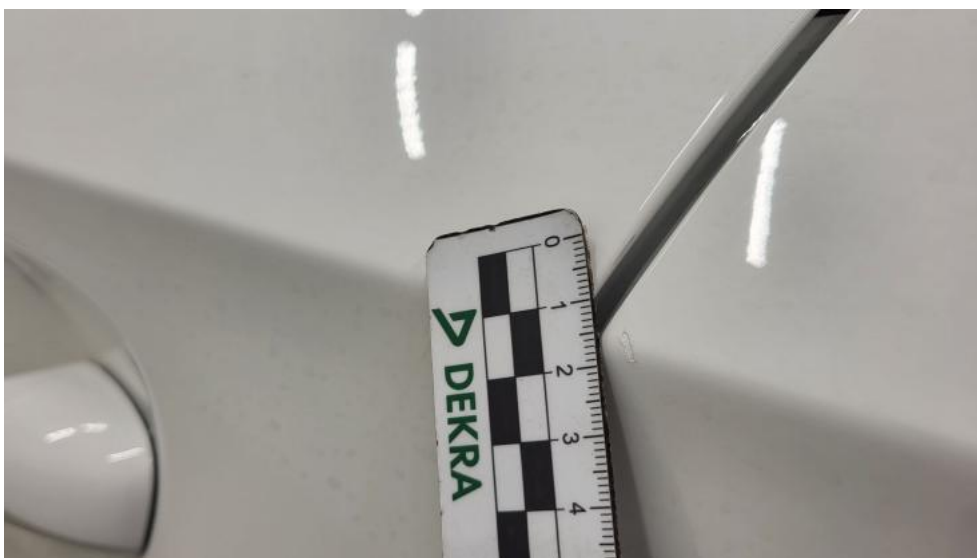
**Photo 54.**  
Drzwi tylne L() - Rysa/odprysk 3

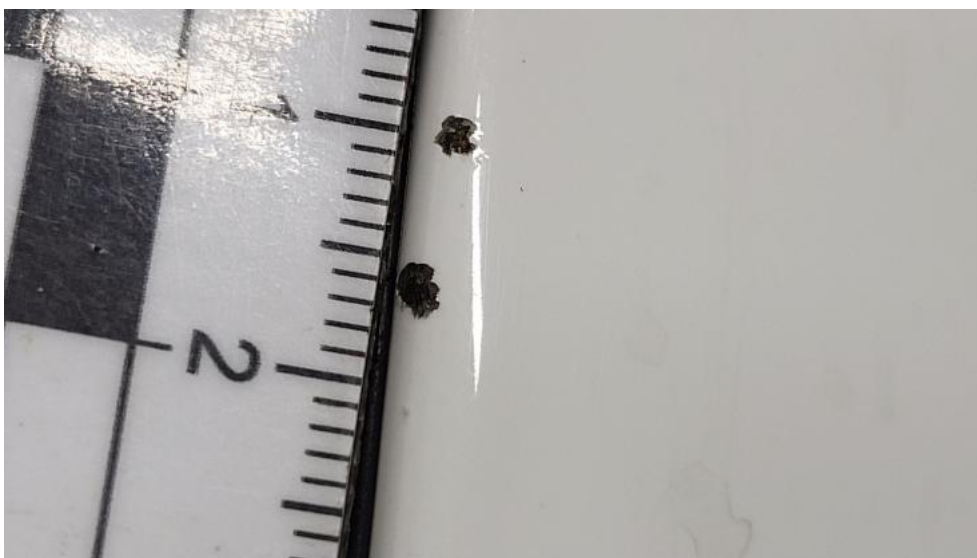
**Photo 56.**  
Stupek przedni L - Rysa/odprysk 2

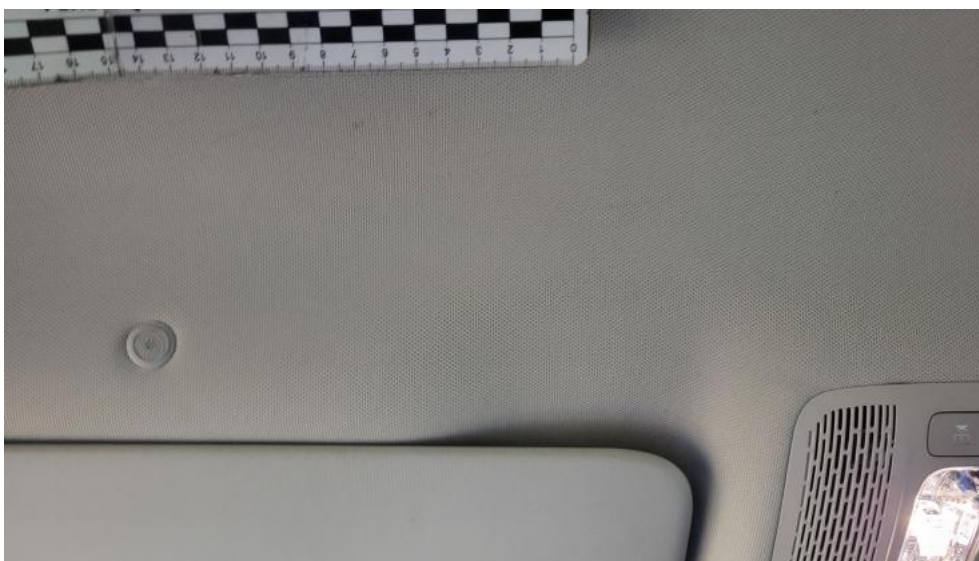
**Photo 59.**  
Podsufitka - Inne 1

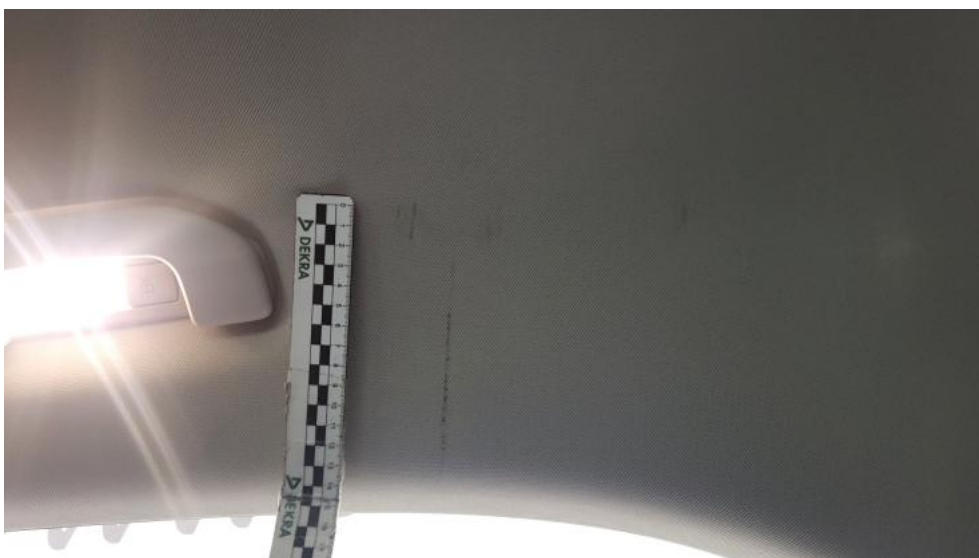
**Photo 60.**  
Podsufitka - Inne 2

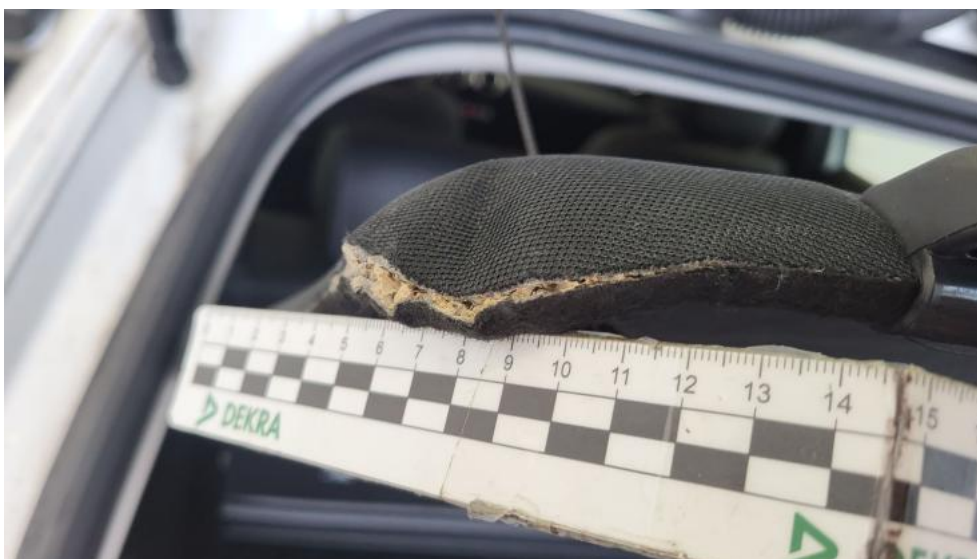
**Photo 61.**  
Półka/roleta tylna - Pęknięcie/rozerwanie 1

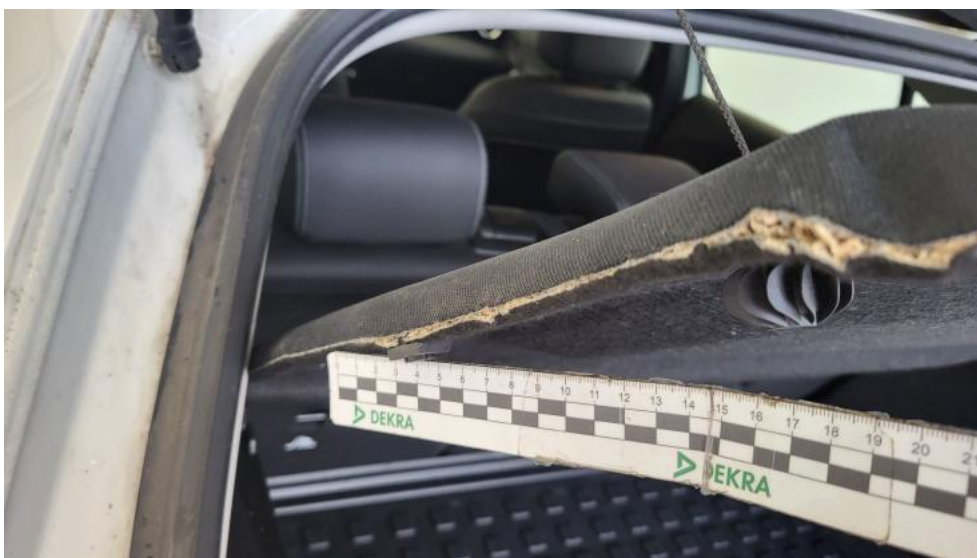
**Photo 62.**  
Półka/roleta tylna - Pęknięcie/rozerwanie 2
