DEKRA's commission No. : PKOL(W)/LODZ/12354/25/02/18
 commission/ damage No. : PS21/06002
 Date of commission: 18-02-2025

Vehicle data

Measurement of thickness of the vehicle lacquer coating

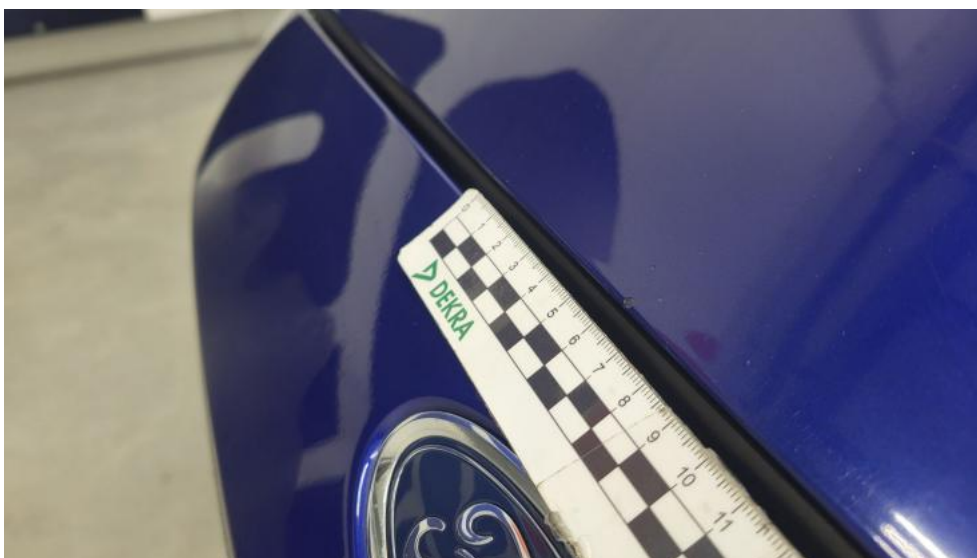
Photo 36.

Pokrywa komory silnika - Rysa/odprysk 1

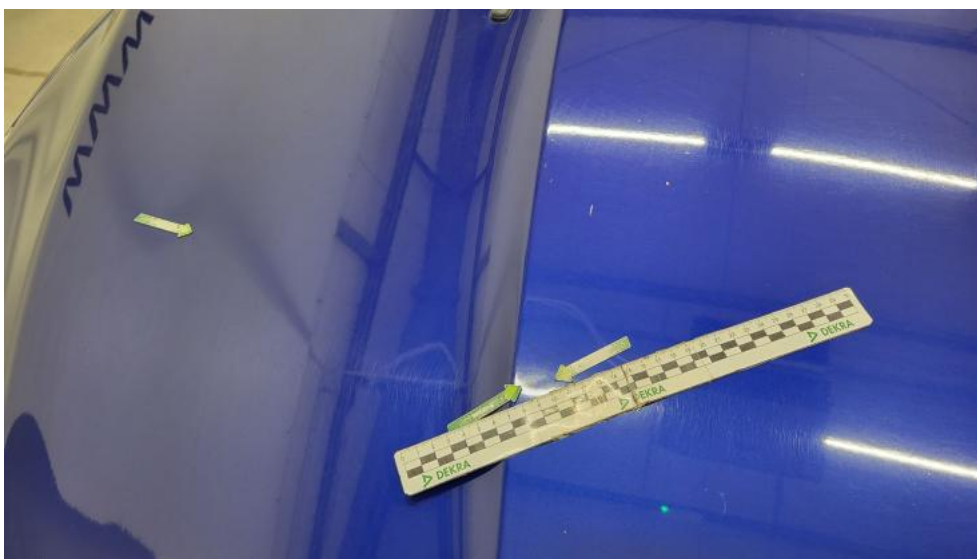
Photo 37.
Pokrywa komory silnika - Wgniecenie/odkształcenie 1

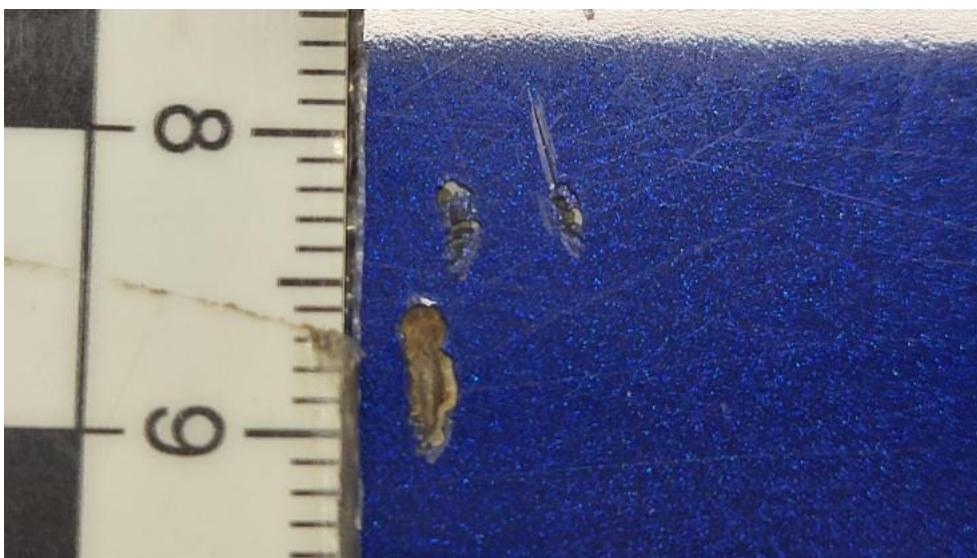
Photo 38.
Pokrywa komory silnika - Inne 1

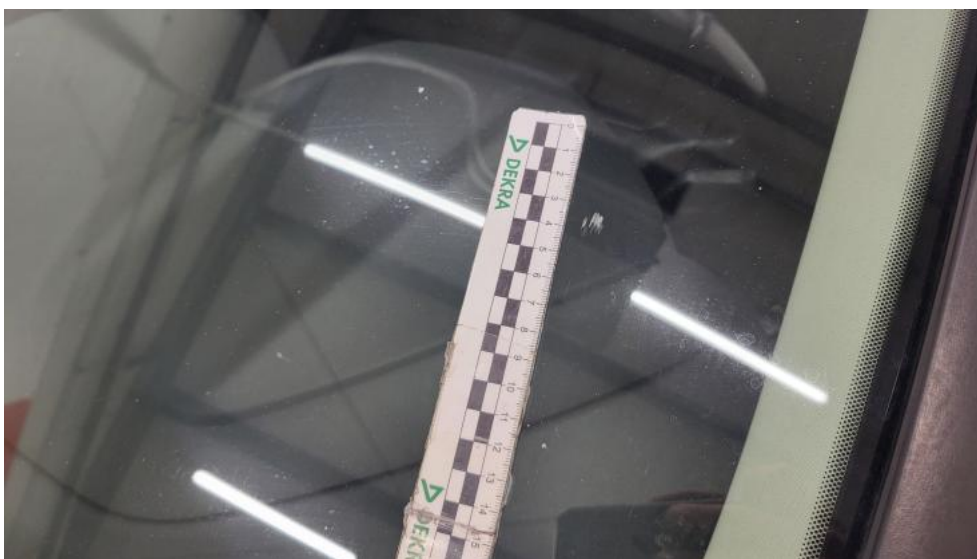
Photo 39.
Szyba czołowa - Rysa/odprysk 1

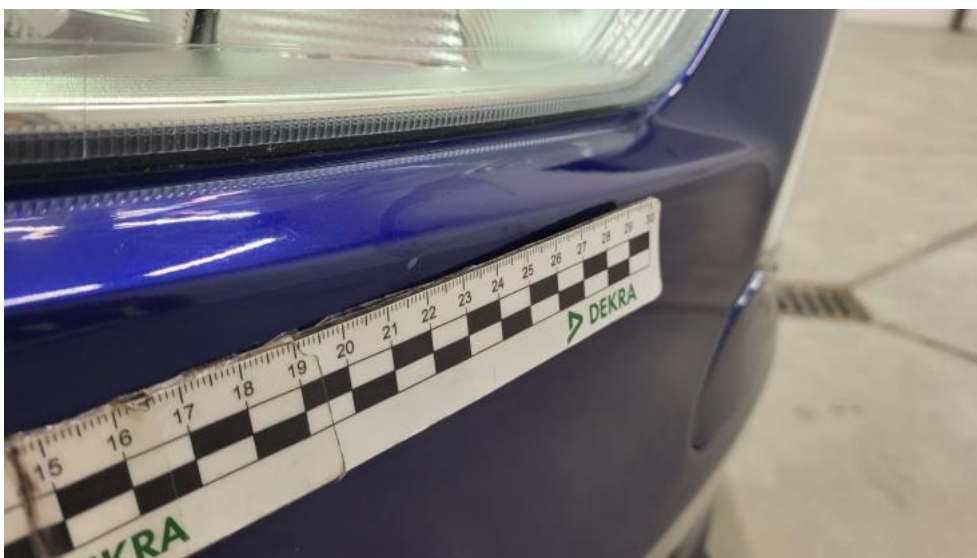
Photo 40.
Zderzak - Rysa/odprysk 1

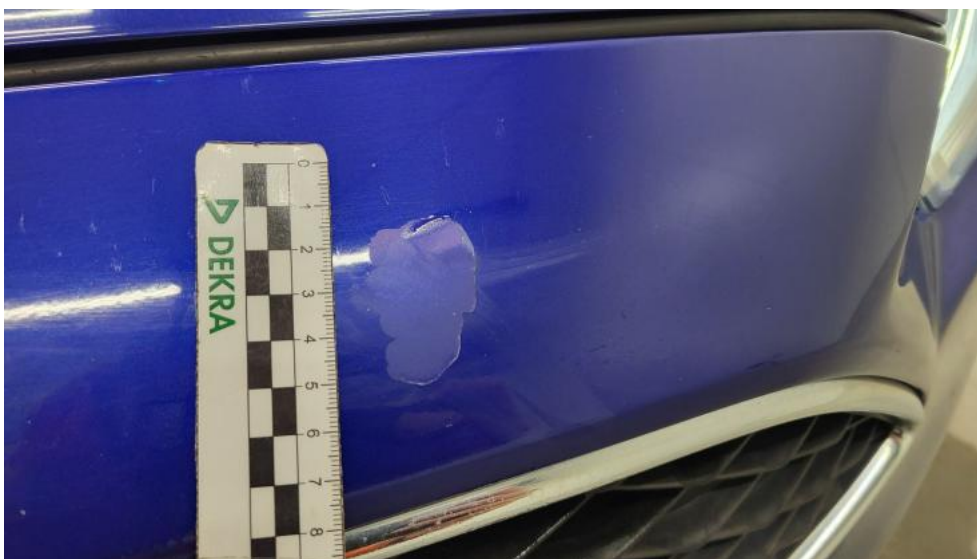
Photo 41.
Zderzak - Inne 1

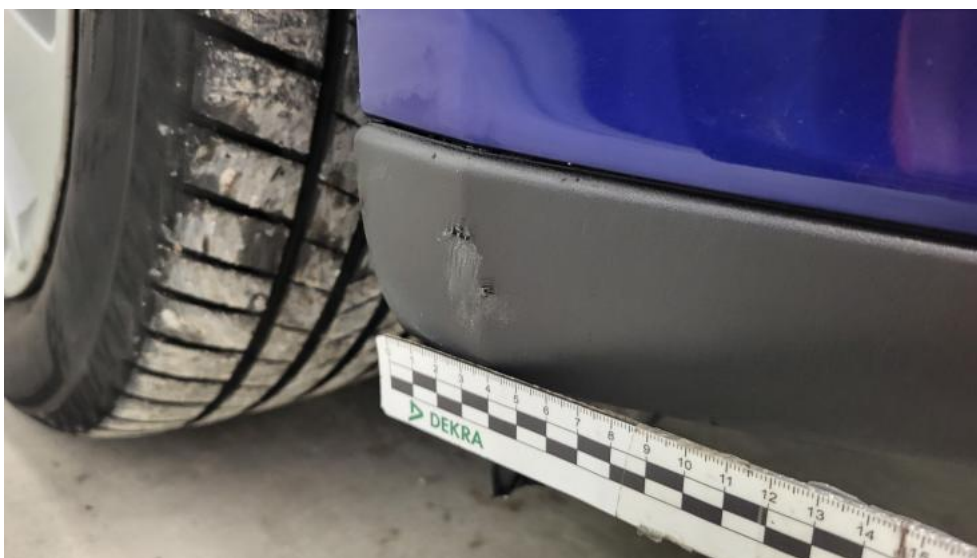
Photo 42.
Zderzak przedni cz dolna - Rysa/odprysk 1

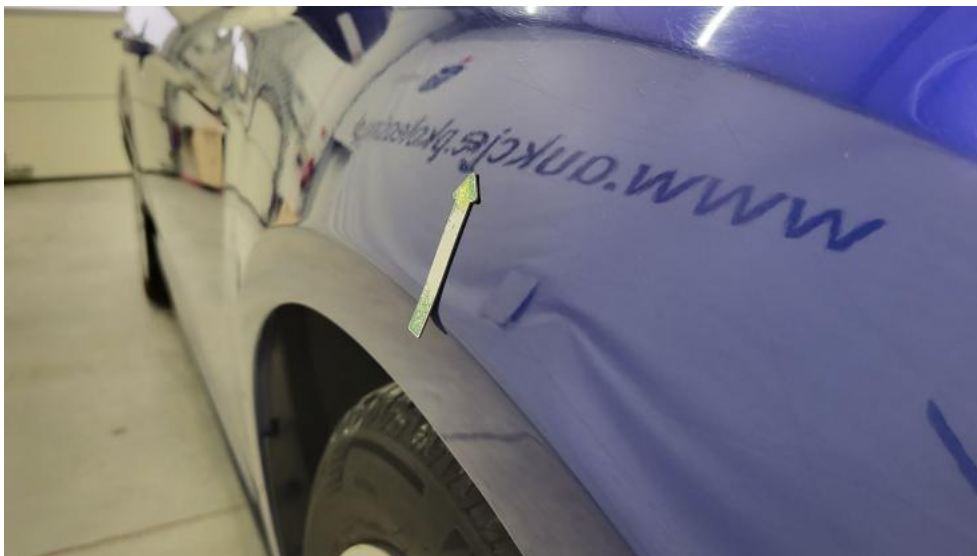
Photo 43.
Błotnik przedni P - Wgniecenie/odkształcenie 1

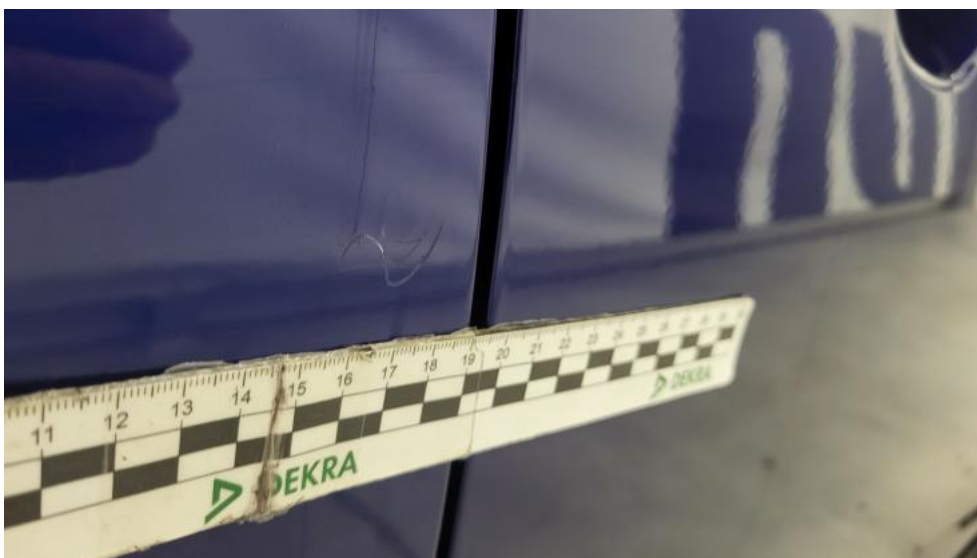
Photo 44.
Drzwi tylne P - Rysa/odprysk 1

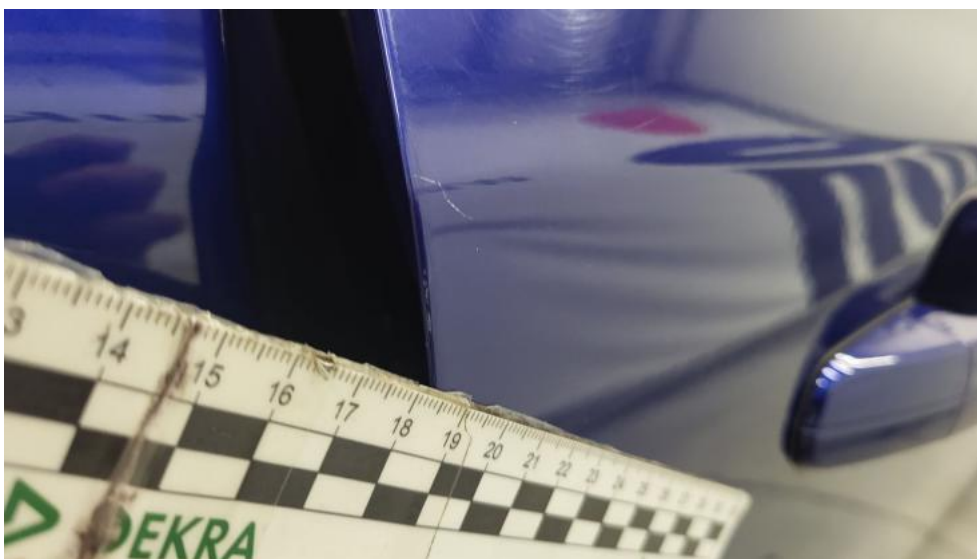
Photo 45.
Drzwi tylne P - Rysa/odprysk 2

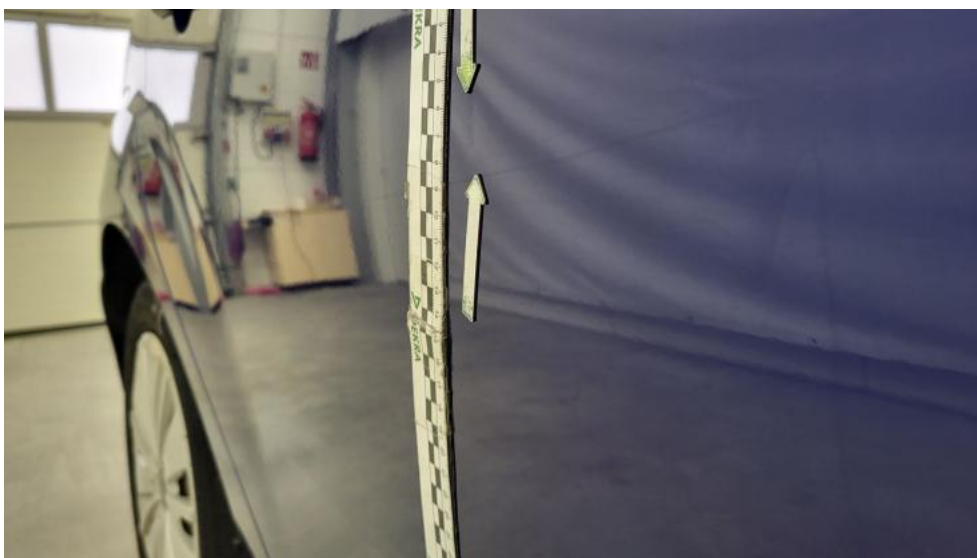
Photo 46.
Drzwi tylne P - Wgniecenie/odkształcenie 1

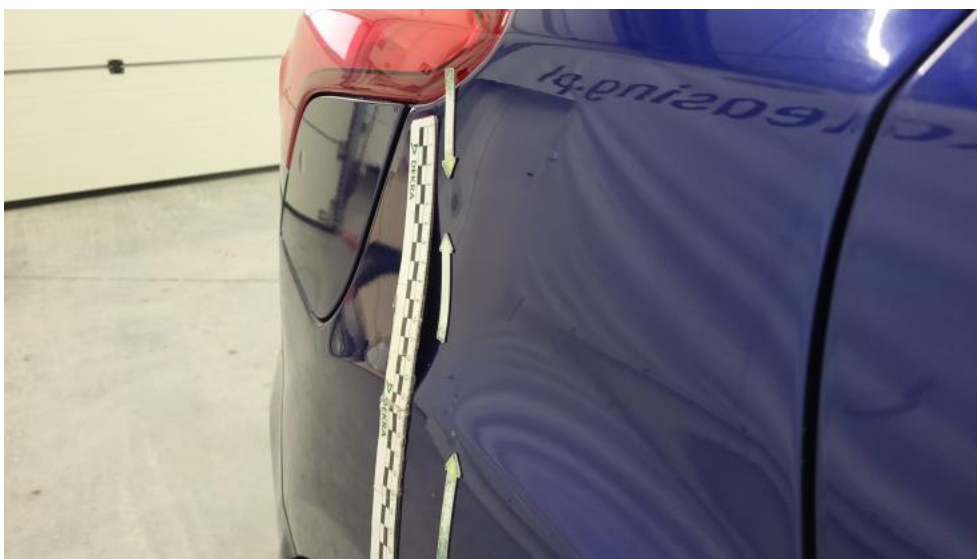
Photo 47.
Błotnik tylny P / Ściana boczna P - Wgniecenie/odkształcenie 1

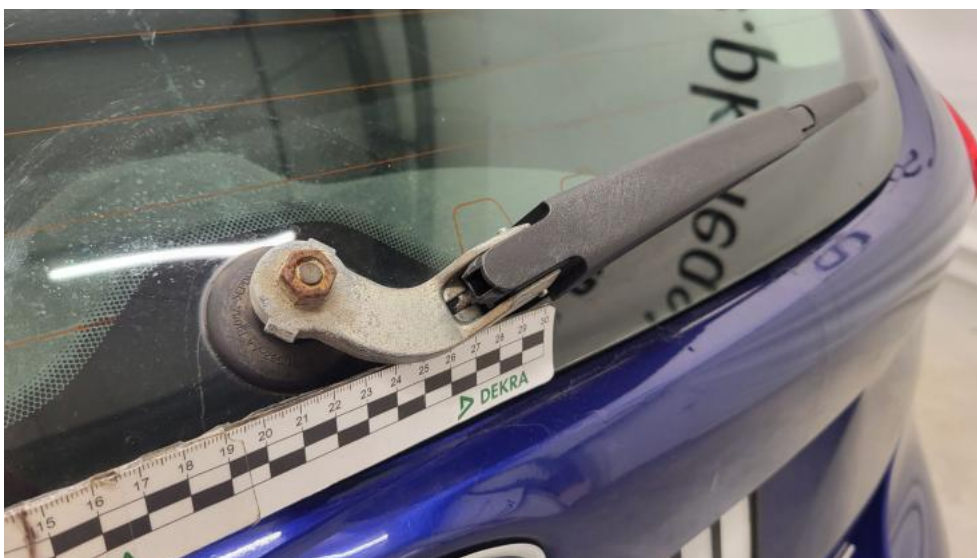
Photo 48.
Pióro wycieraczki szyby tył - Inne 1

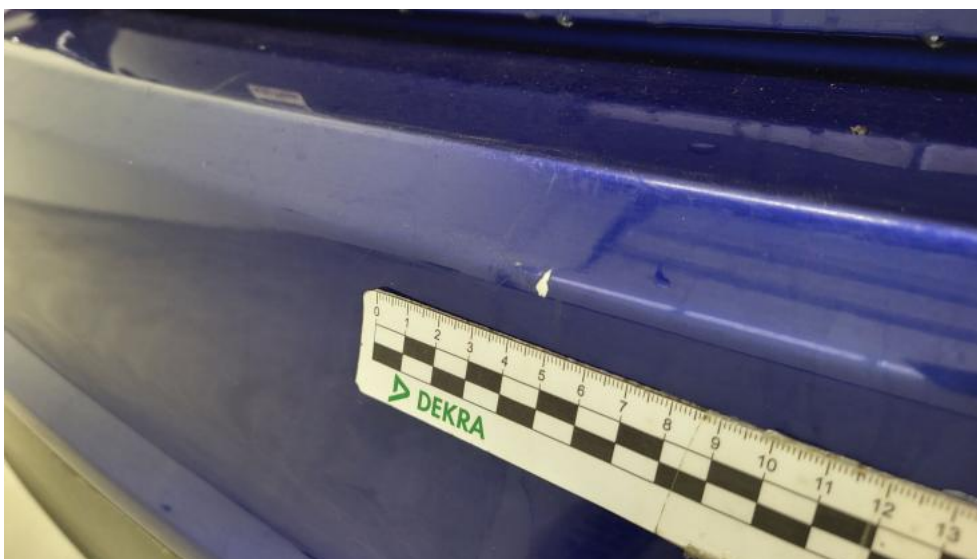
Photo 49.
Zderzak tylny - Rysa/odprysk 1

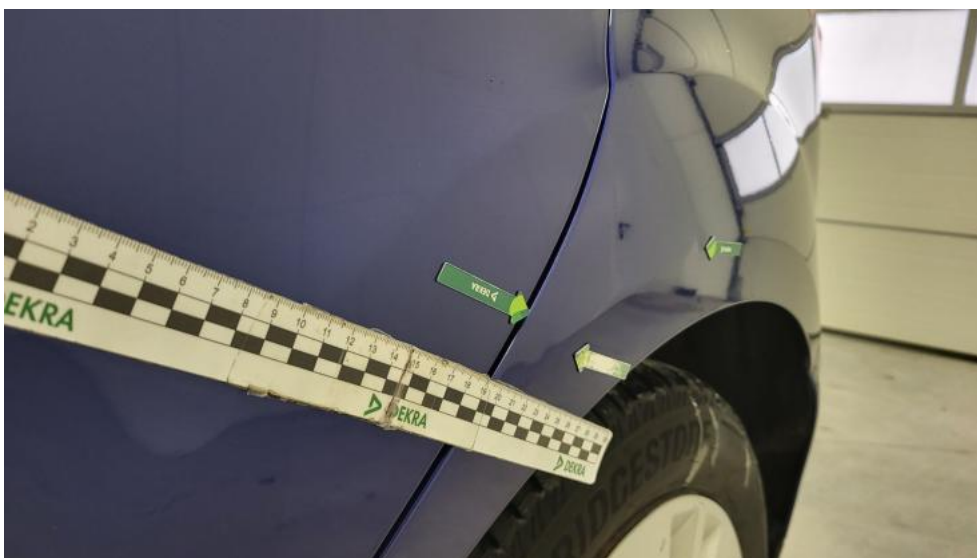
Photo 50.
Błotnik tylny L / Ściana boczna L - Wgniecenie/odkształcenie 1

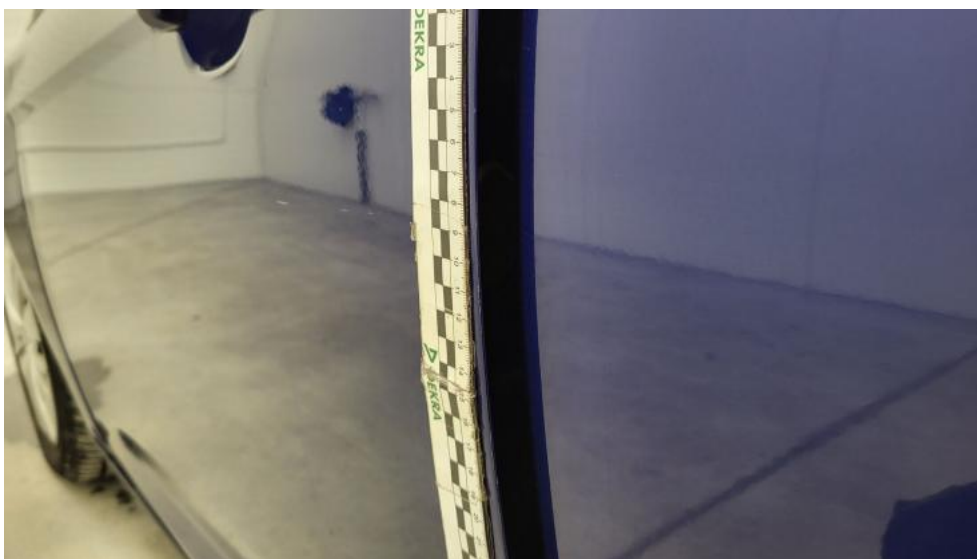
Photo 51.

Drzwi przed L - Rysa/odprysk 1

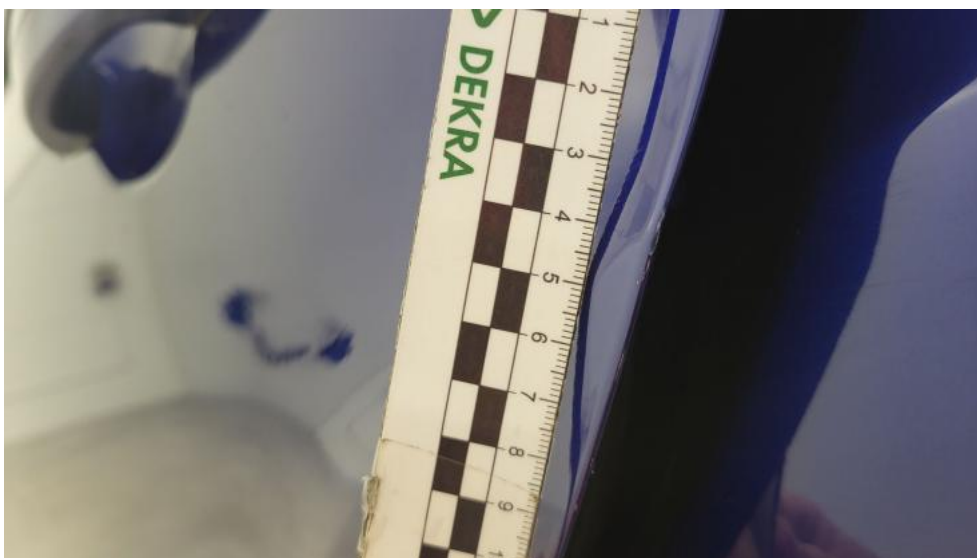
Photo 52.

Drzwi tylne L - Rysa/odprysk 1

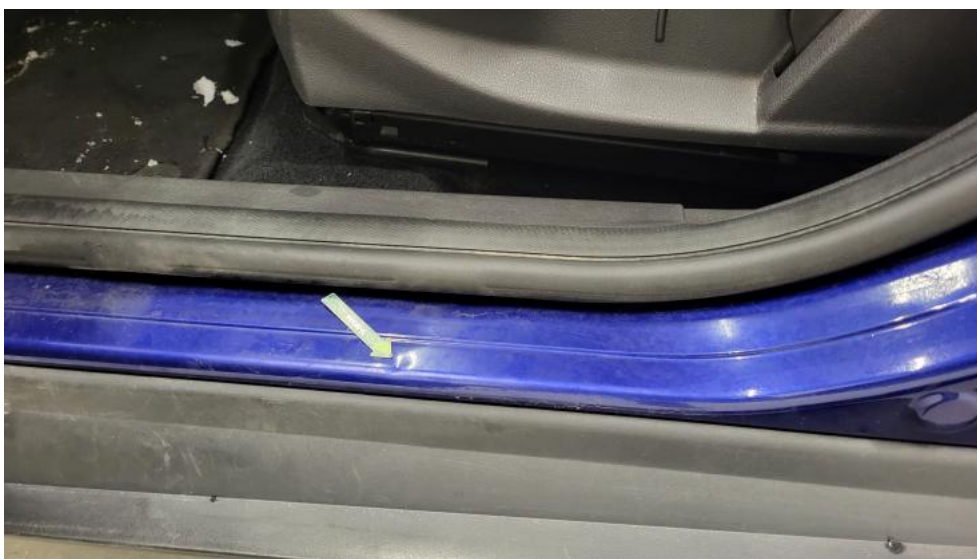
Photo 53.
Próg L - Wgniecenie/odkształcenie 1

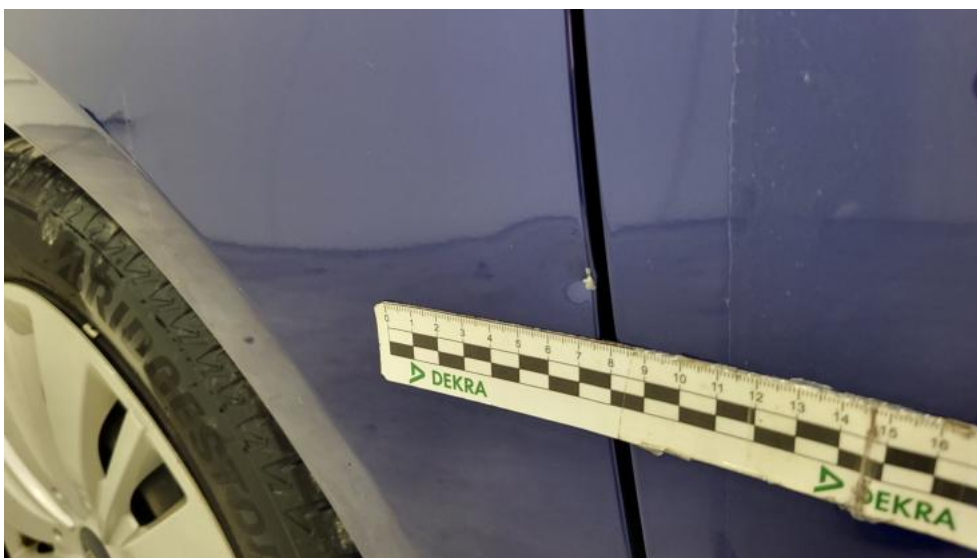
Photo 54.
Błotnik przedni L - Rysa/odprysk 1

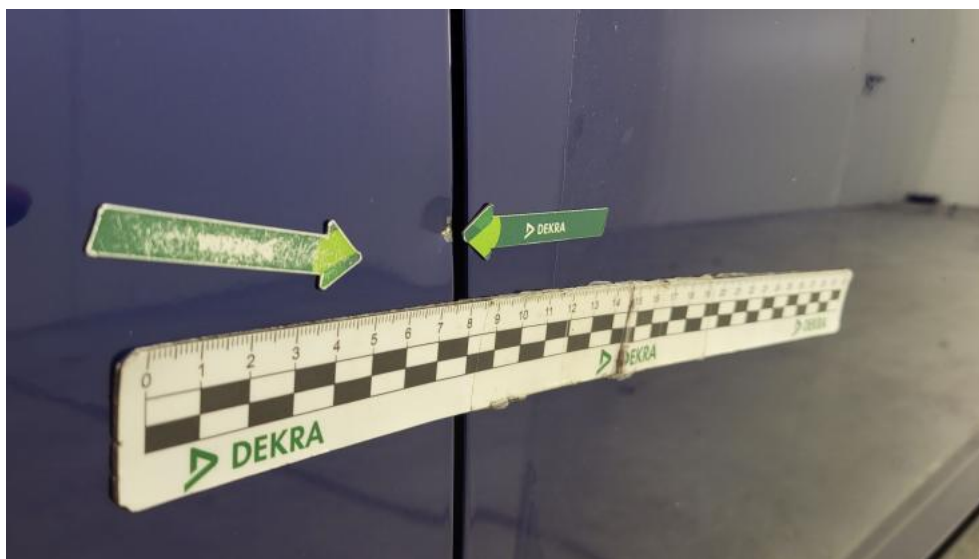
Photo 55.
Błotnik przedni L - Wgniecenie/odkształcenie 1

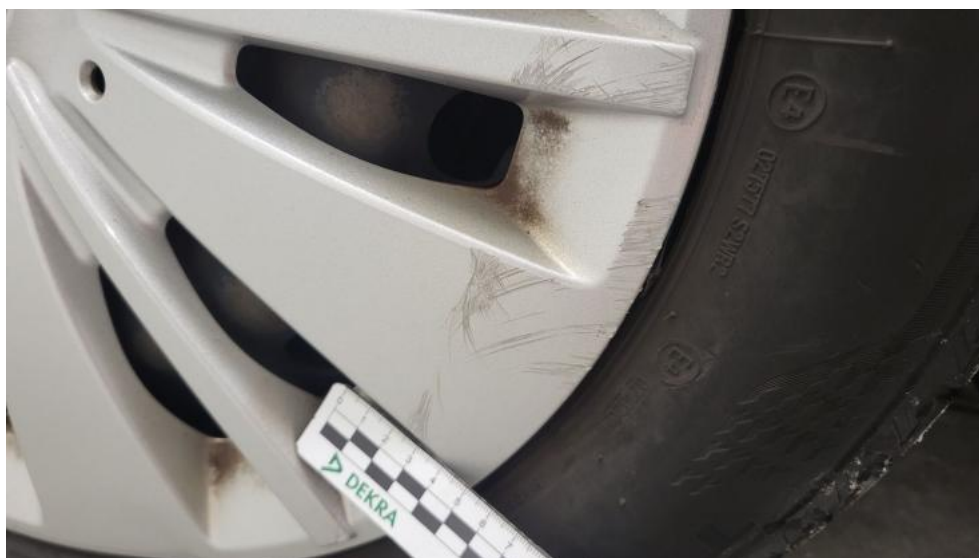
Photo 56.
Kołpak przedni L - Rysa/odprysk 1

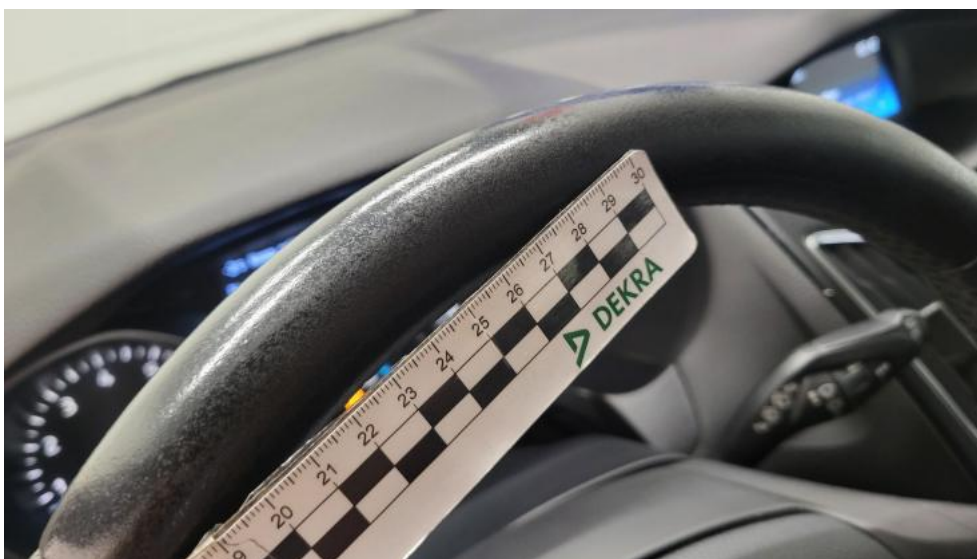
Photo 57.
Koło kierownicy - Inne 1

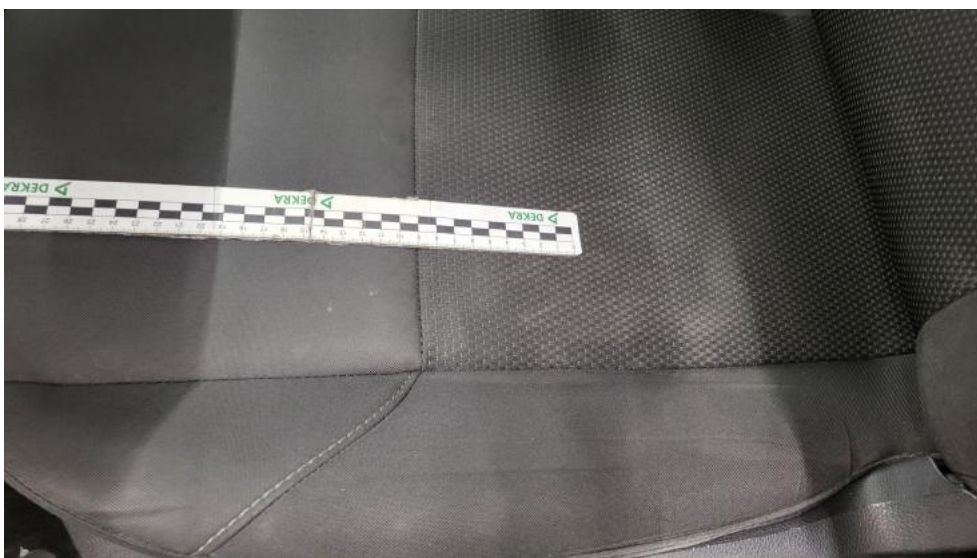
Photo 58.
Fotel prz. lew. - Inne 1

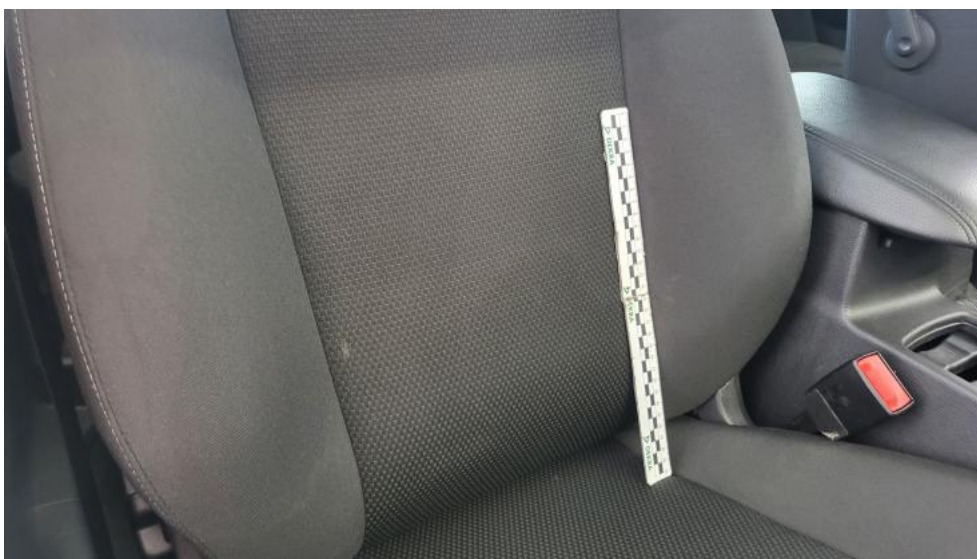
Photo 59.
Fotel prz. praw. - Inne 1

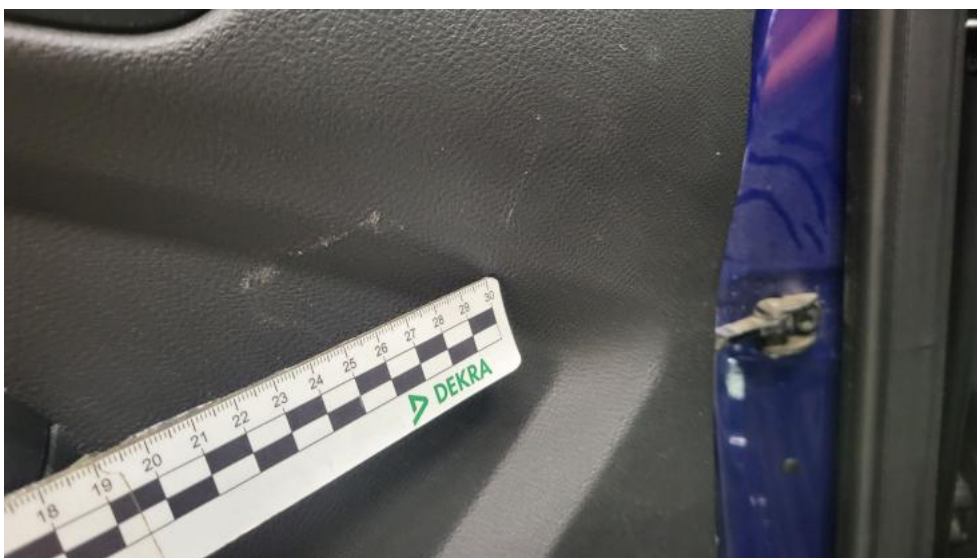
Photo 60.
Tapicerka drzwi tylnych L - Rysa/odprysk 1

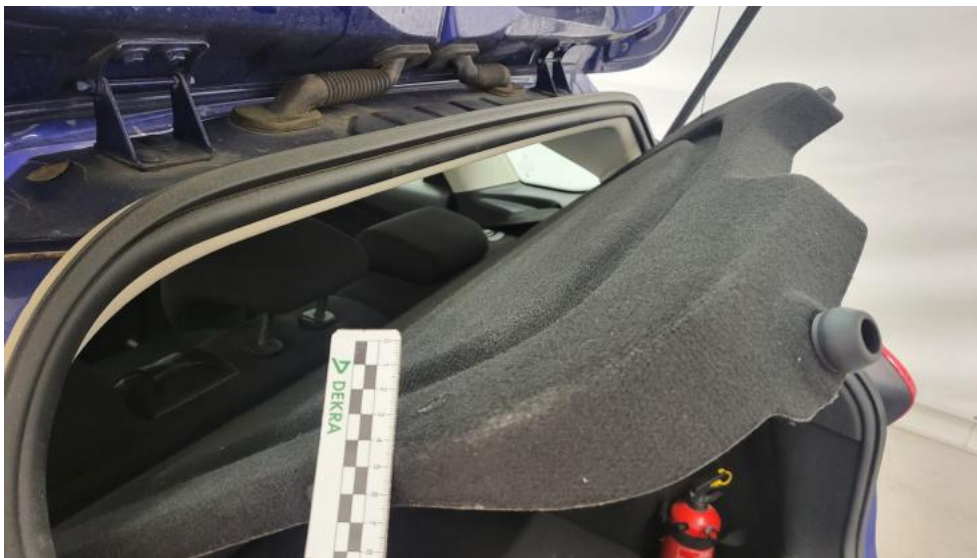
Photo 61.
Półka/roleta tylna - Inne 1
