DEKRA's commission No. : PKOL(W)/LODZ/15355/25/02/28  
commission/ damage No. : 21/018678  
Date of commission: 28-02-2025

Group of objects (Eurotax)	jeeps
EC code (Eurotax)	0146612
Manufacturer	LAND ROVER
Model	Range Rover Velar 20-23
Type / version	Velar 2.0 P250 S
Body type	KOM
Number of doors / seats	5/5
Curb weight [kg]	2007
Gross vehicle weight [kg]	2550
Wheelbase 1/2	2874
Engine type	spark ignition
Pollution reduction system	GPF
Engine capacity [ccm]	1997
Engine Power [hp/kW]	250/184
Gearbox	automatic
Registration /record No.	CB541ML
VIN / serial number	SALYA2BX7MA306398
Date of first registration	12-05-2021
Date of next. tech. test	12-05-2026
Year of manufacture	2021
Readout [km]	84 048 (read)
Body color / type of coating	black/double-layered, metallized

Measurement of thickness of the vehicle lacquer coating

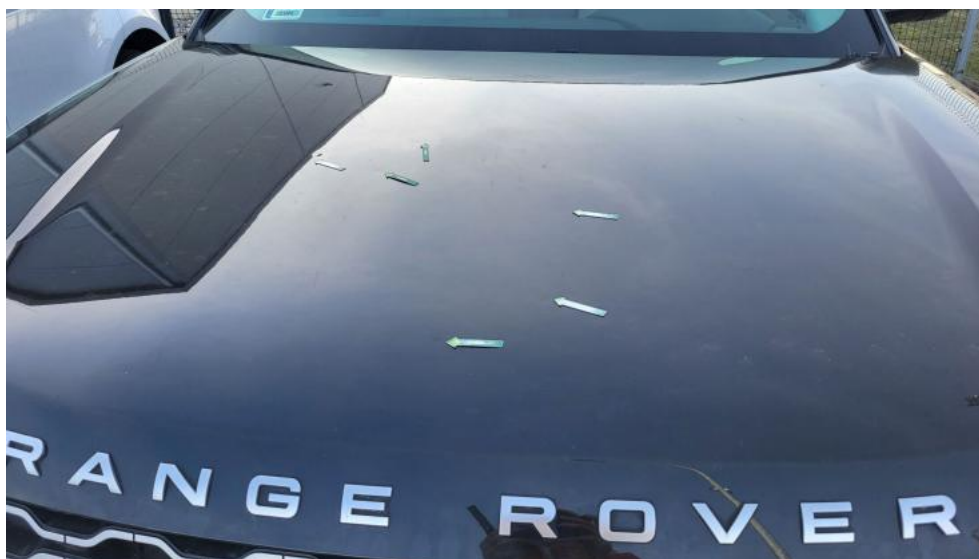
**Photo 45.**

Pokrywa komory silnika - Wgniecenie/odkształcenie 1

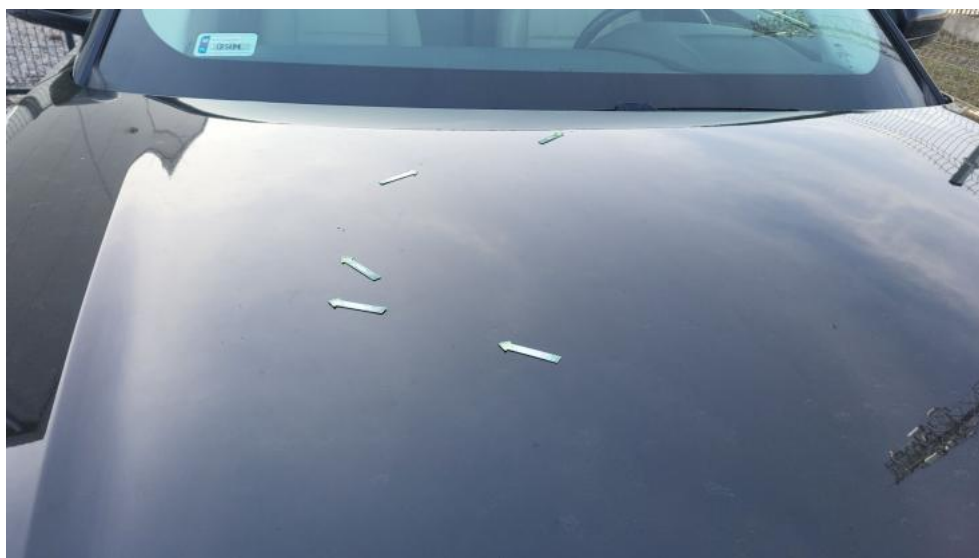
**Photo 46.**

Pokrywa komory silnika - Wgniecenie/odkształcenie 2

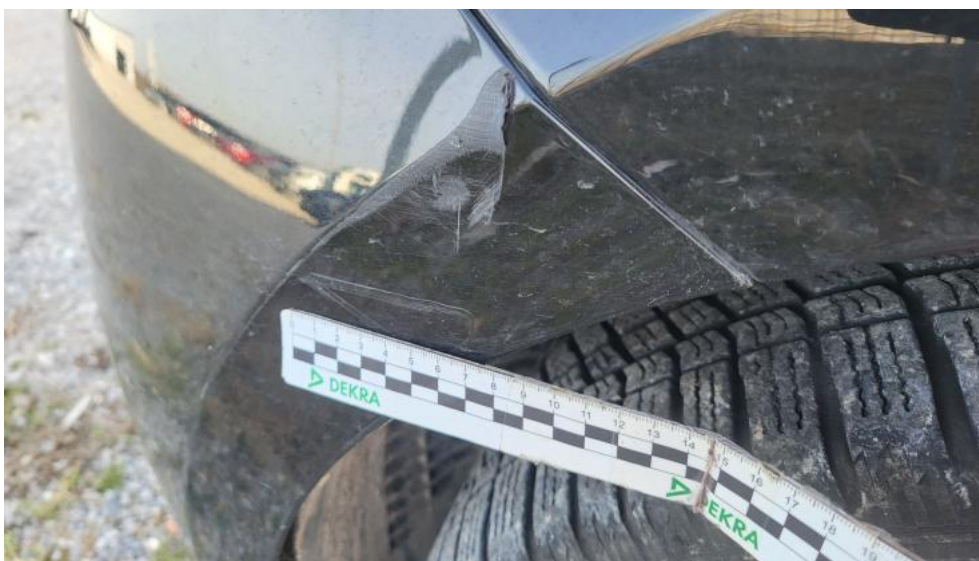
**Photo 47.**  
Zderzak - Rysa/odprysk 1

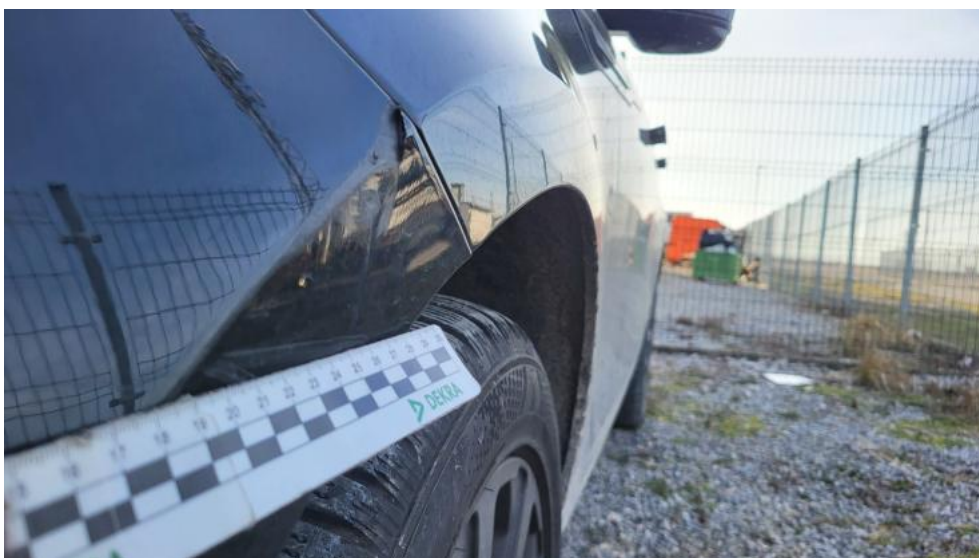
**Photo 48.**  
Zderzak - Wgniecenie/odkształcenie 1

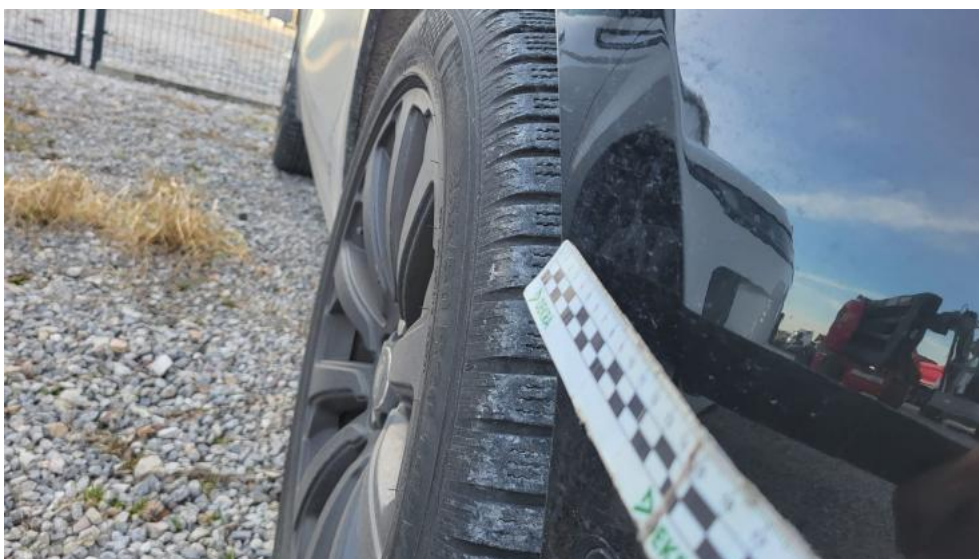
**Photo 49.**  
Zderzak - Wgniecenie/odkształcenie 2

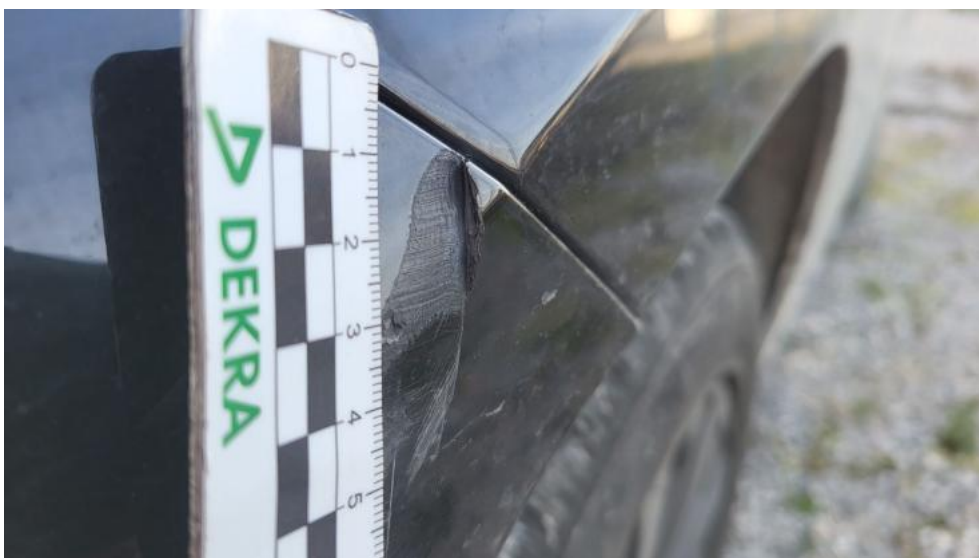
**Photo 50.**  
Zderzak - Pęknięcie/rozerwanie 1

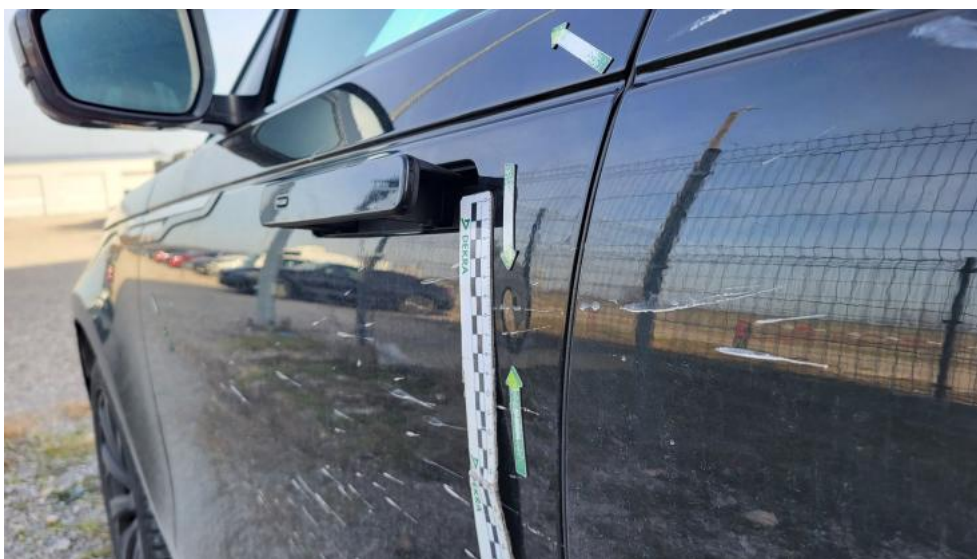
**Photo 53.**  
Drzwi przed L - Wgniecenie/odkształcenie 1

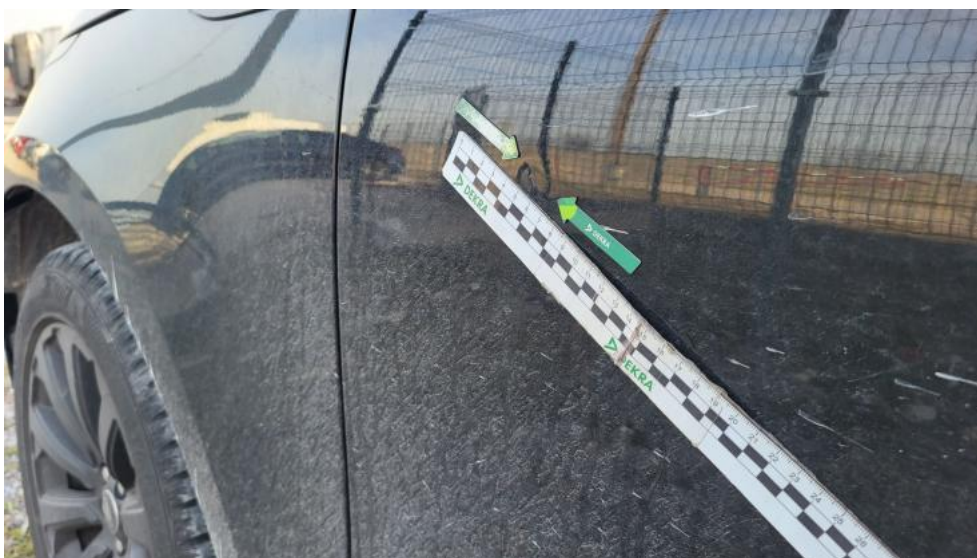
**Photo 54.**  
Drzwi przed L - Wgniecenie/odkształcenie 2

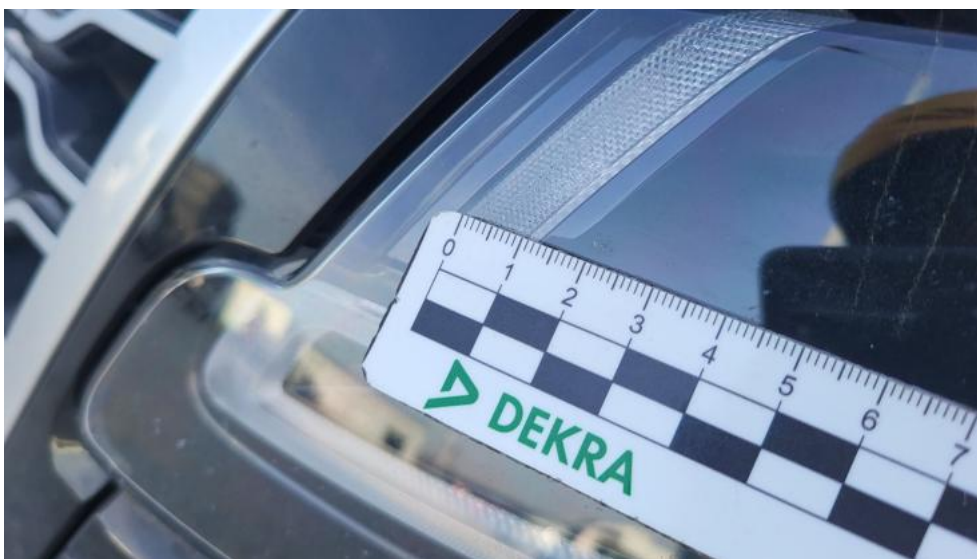
**Photo 55.**  
Reflektor L - Rysa/odprysk 1

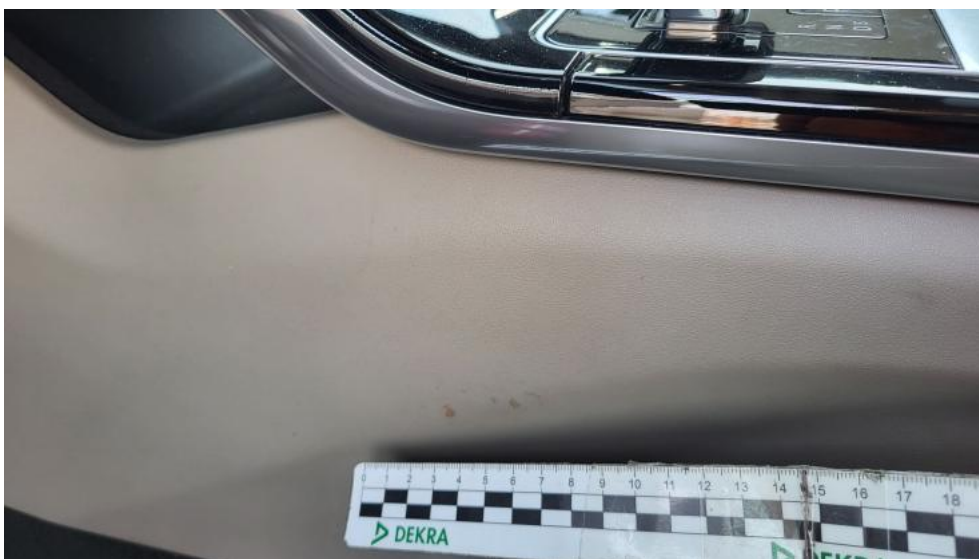
**Photo 57.**  
Konsola tunelu śr. - Inne 1

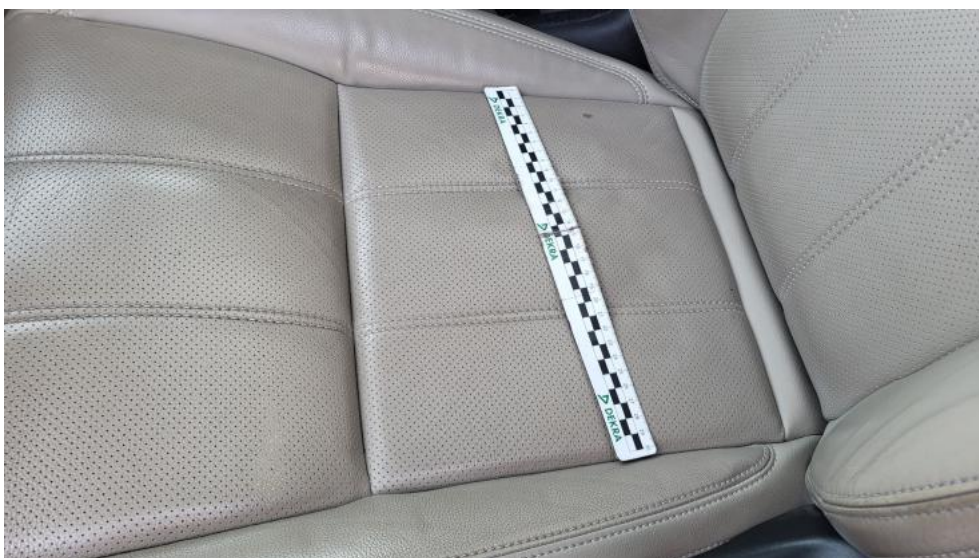
**Photo 58.**  
Fotel prz. lew. - Inne 1

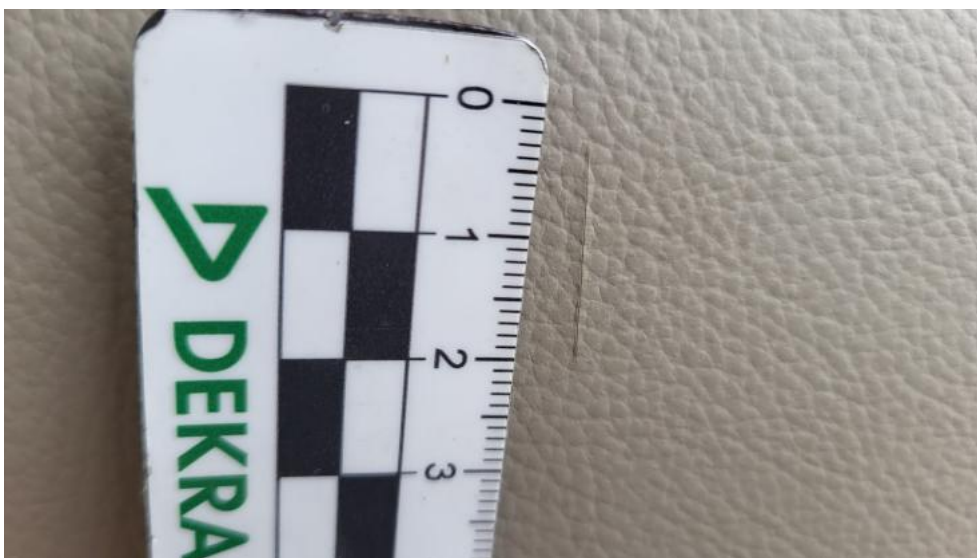
**Photo 60.**

Fotel prz. praw. - Pęknięcie/rozerwanie 1

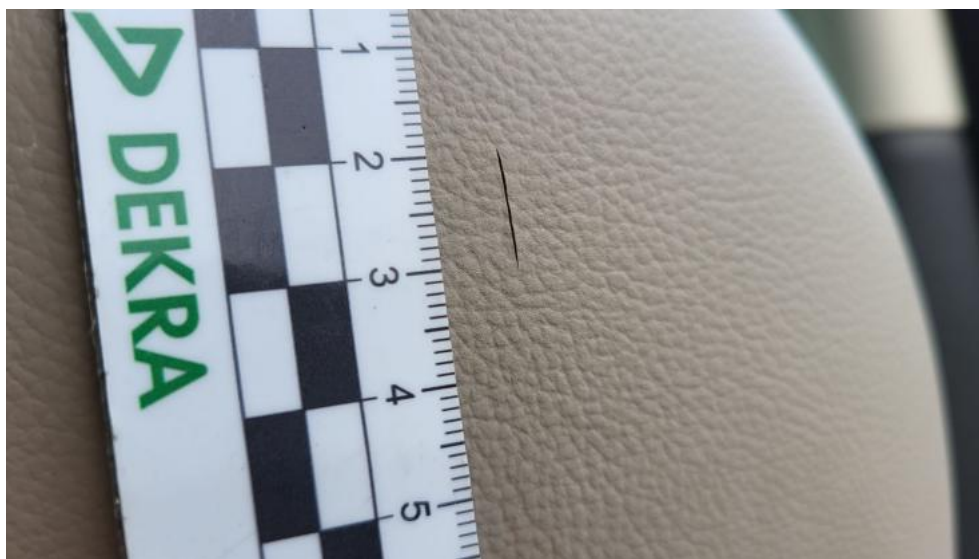
**Photo 61.**  
Fotel prz. praw. - Pęknięcie/rozerwanie 2

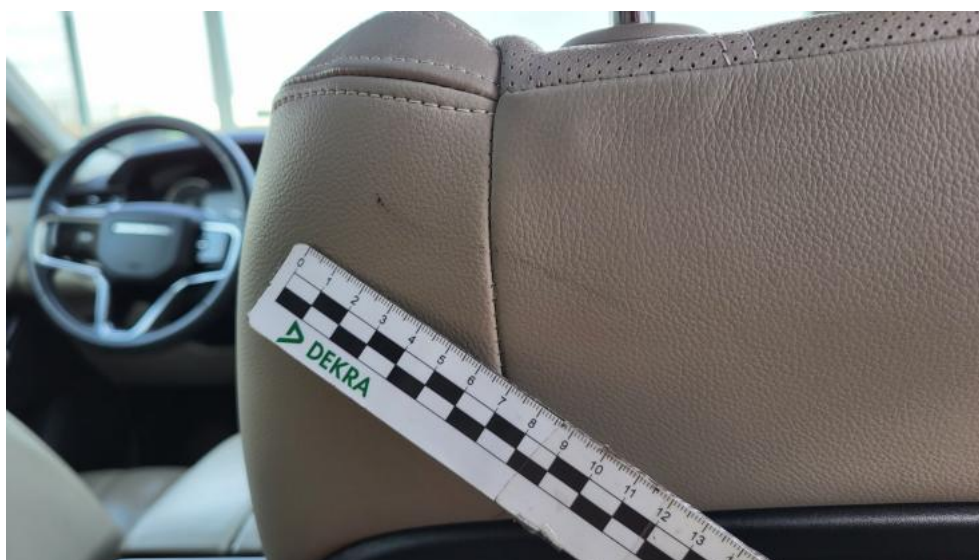
**Photo 62.**  
Fotel prz. praw. - Inne 1

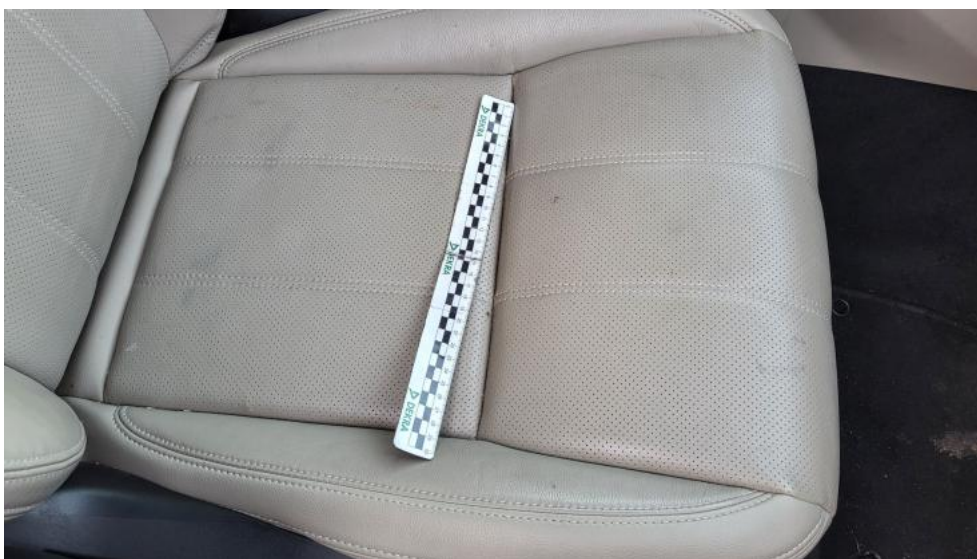
**Photo 63.**  
Fotel prz. praw. - Inne 2

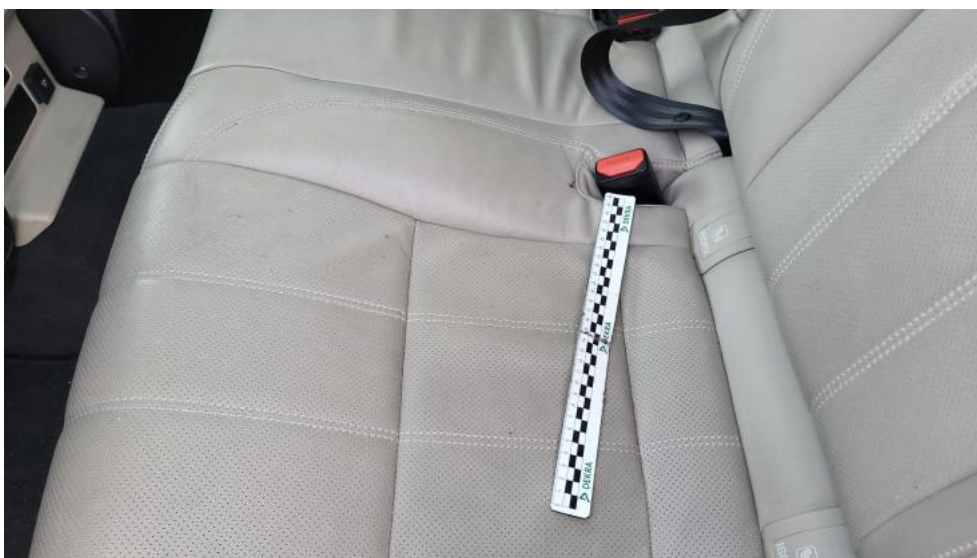
**Photo 64.**  
Kanapa tyl. - Inne 1

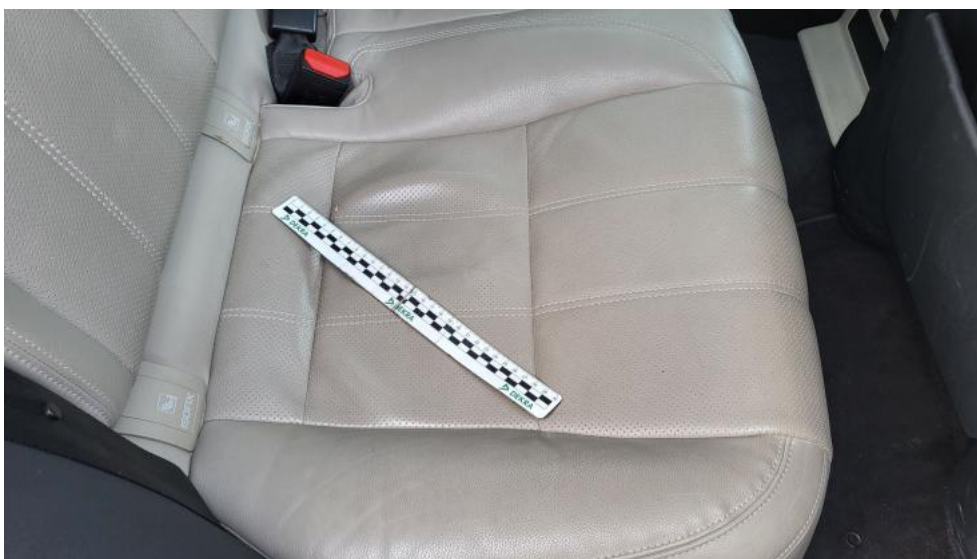
**Photo 65.**  
Kanapa tyl. - Inne 2

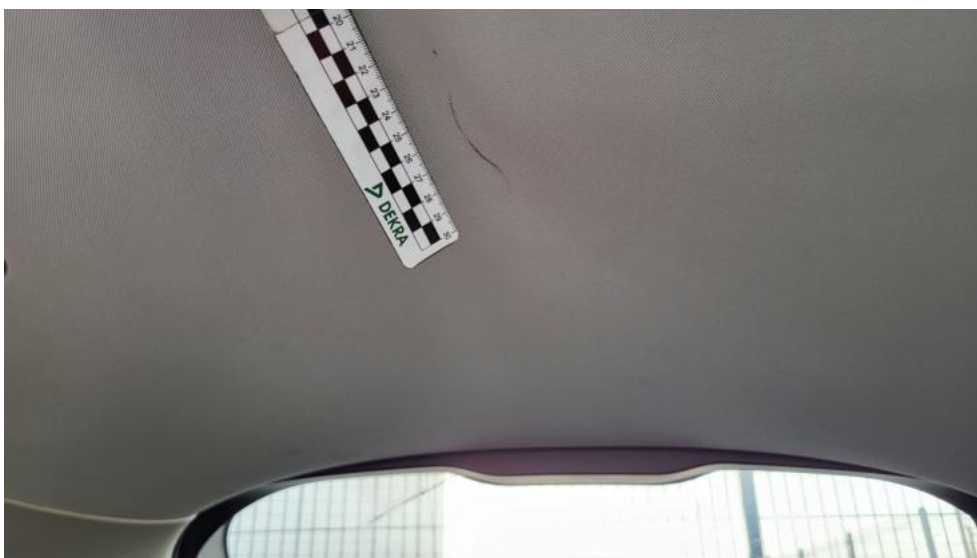
**Photo 66.**  
Podsufitka - Inne 1

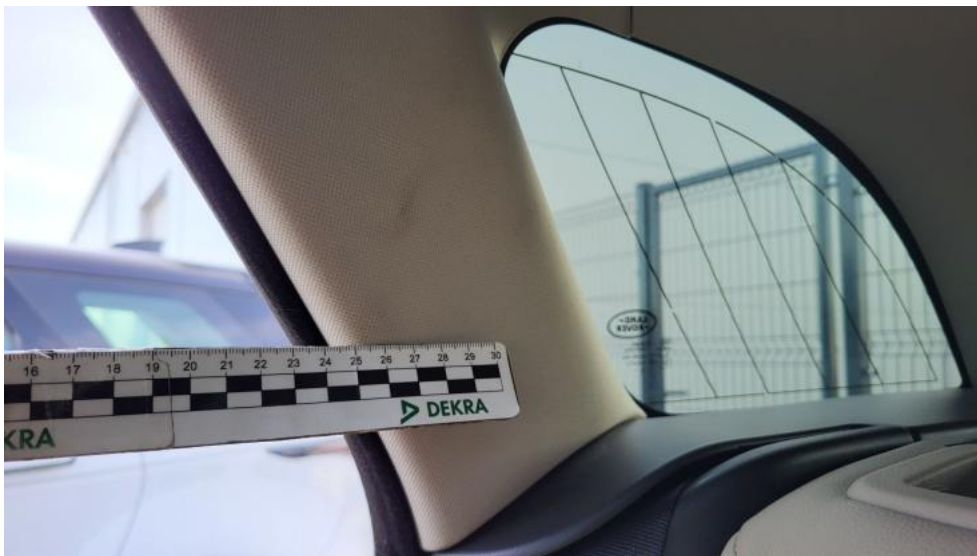
**Photo 67.**

Wykładzina(y) słupka tylnego P - Inne 1
