DEKRA's commission No. : PKOL(W)/LODZ/84709/26/09/09  
commission/ damage No. : 25/038160  
Date of commission: 09-09-2026

**DEKRA Poland - Headquarters**  
02-673 Warszawa, ul. Konstruktorska 12A

| Model | X5 [F15/F85] 13-18 |
| Type / version | X5 xDrive40d |

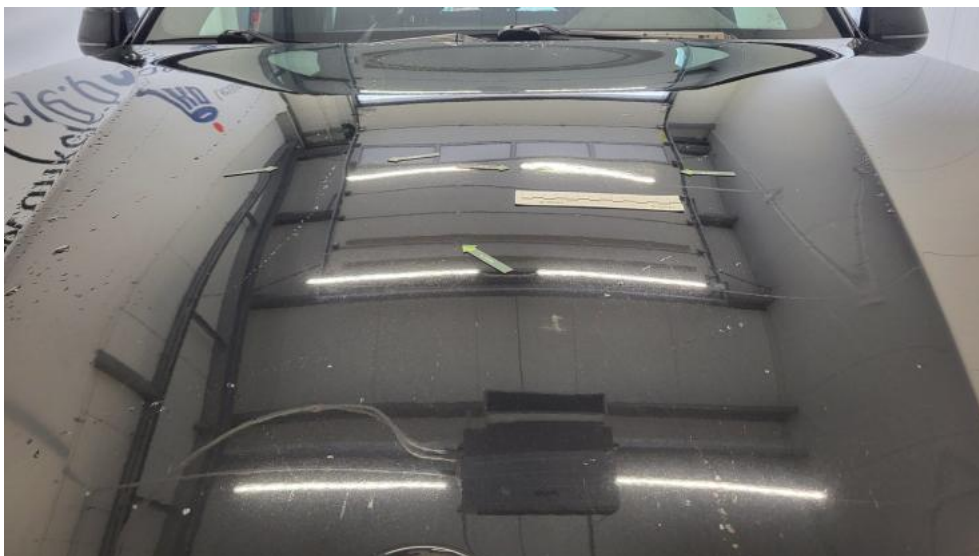
Pokrywa komory silnika - Wgniecenie/odkształcenie 1

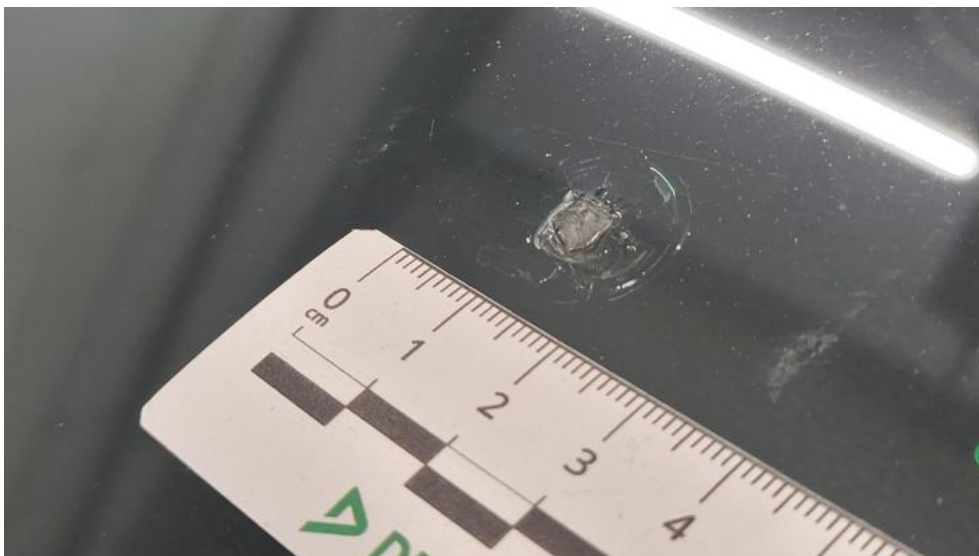
Szyba czołowa - Pęknięcie/rozerwanie 1

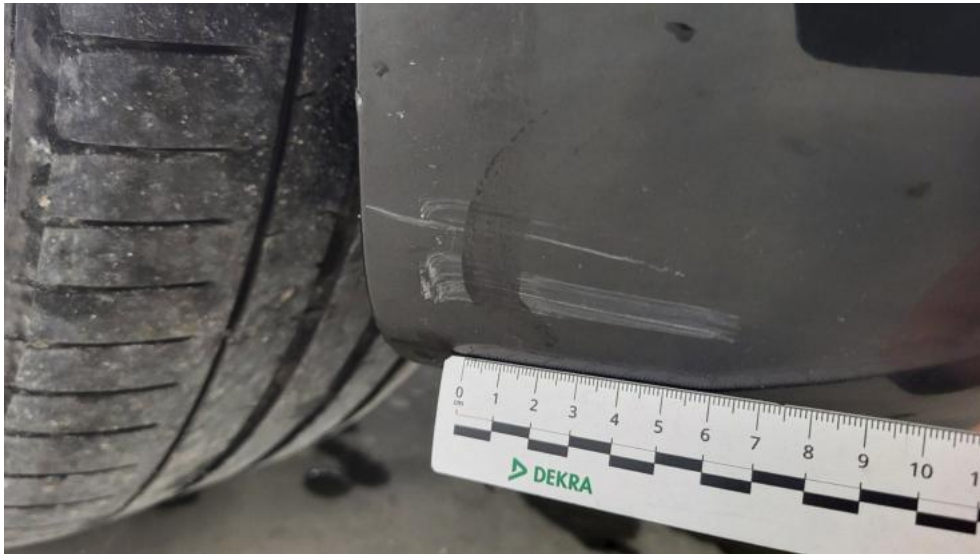
Zderzak - Rysa/odprysk 1

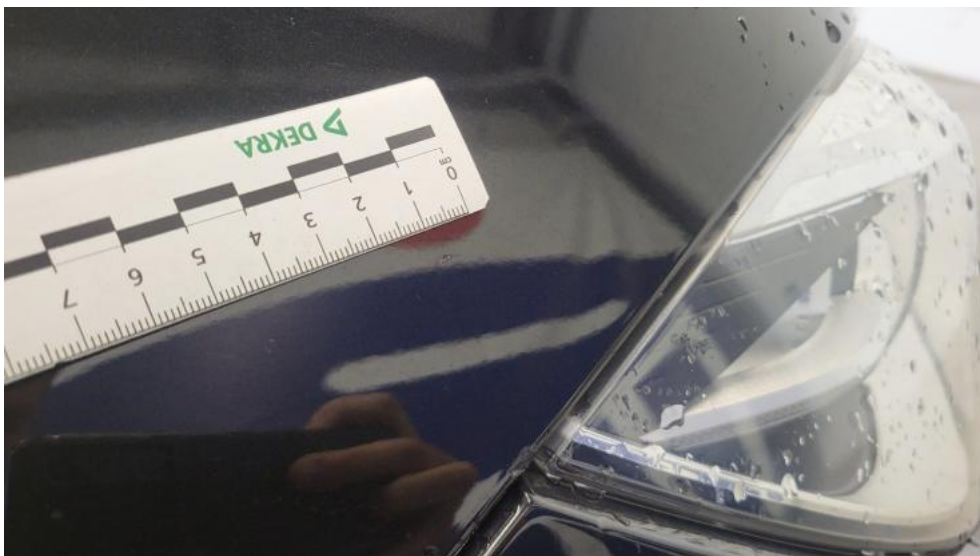
Błotnik przedni P - Rysa/odprysk 1

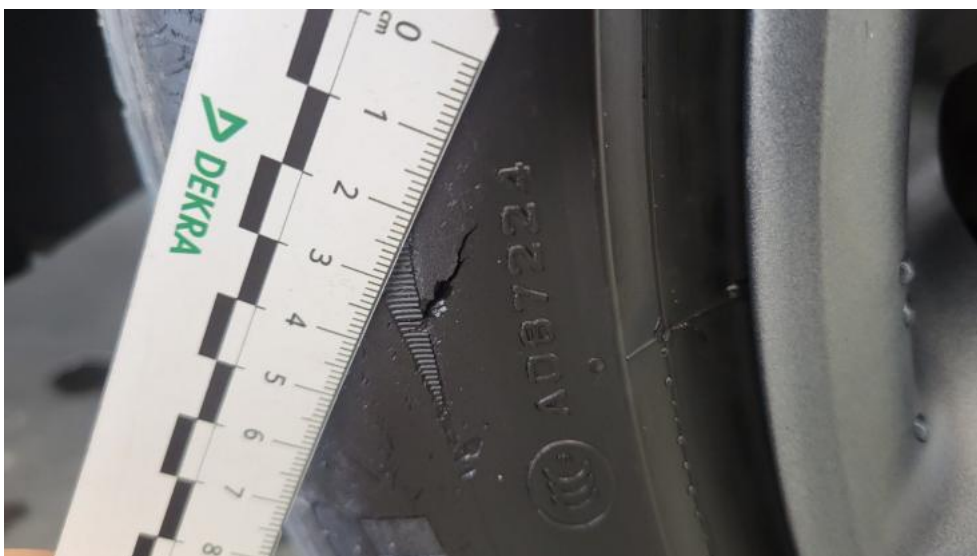
Opona przednia P - Pęknięcie/rozerwanie 1

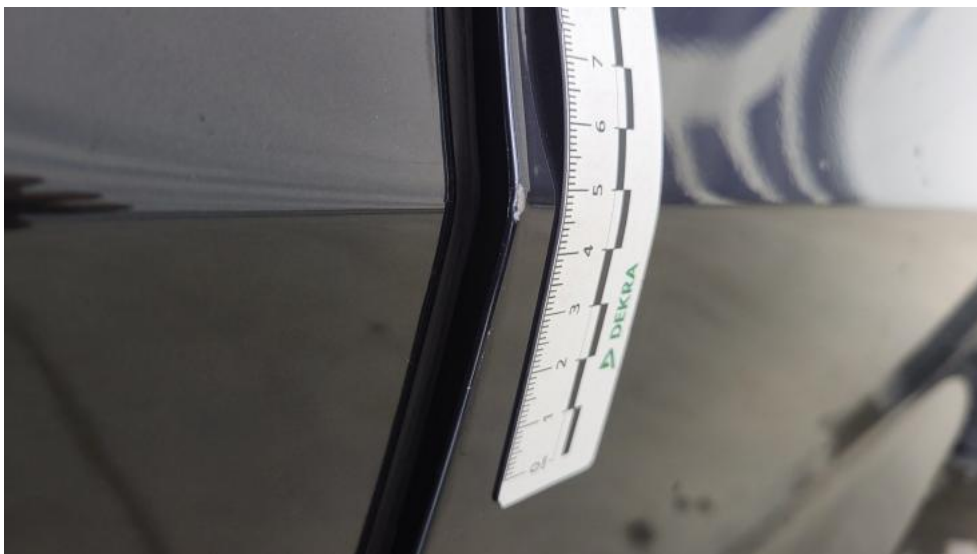
Drzwi przednie P - Rysa/odprysk 1

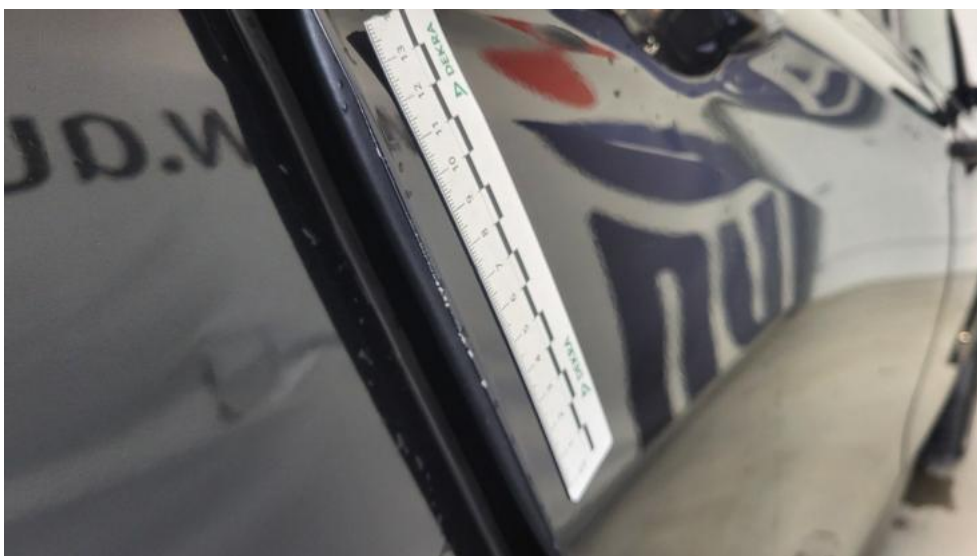
Drzwi tylne P - Rysa/odprysk 1

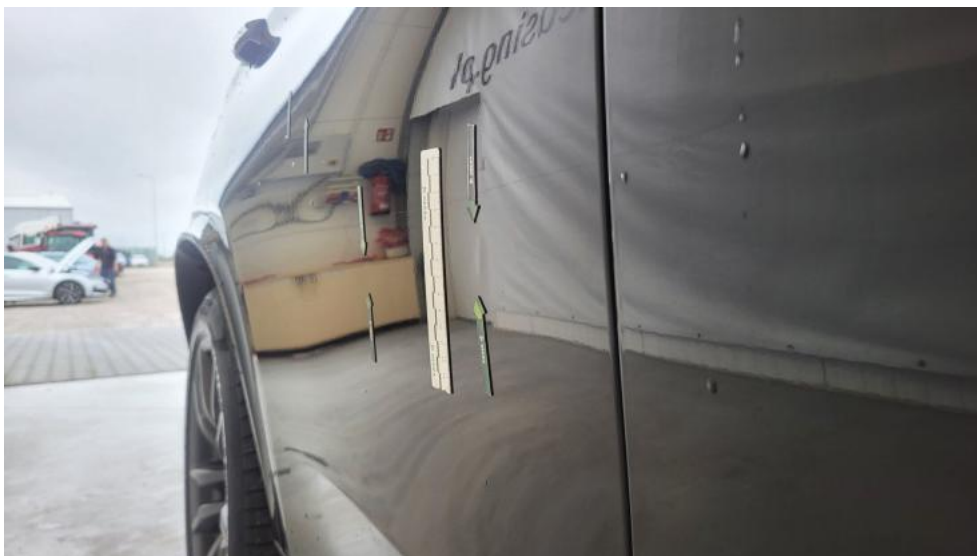
Drzwi tylne P - Wgniecenie/odkształcenie 1

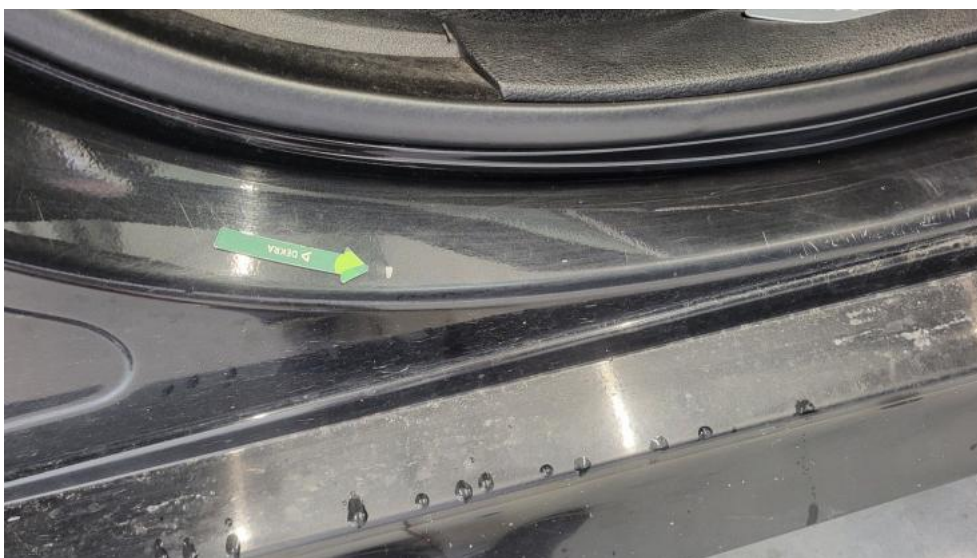
Próg P - Wgniecenie/odkształcenie 1

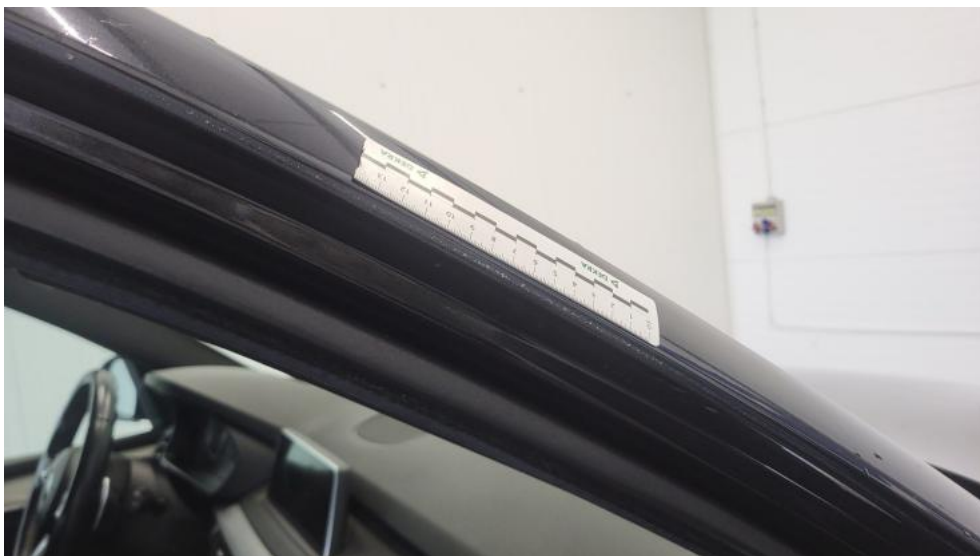
Słupek przedni P - Rysa/odprysk 1

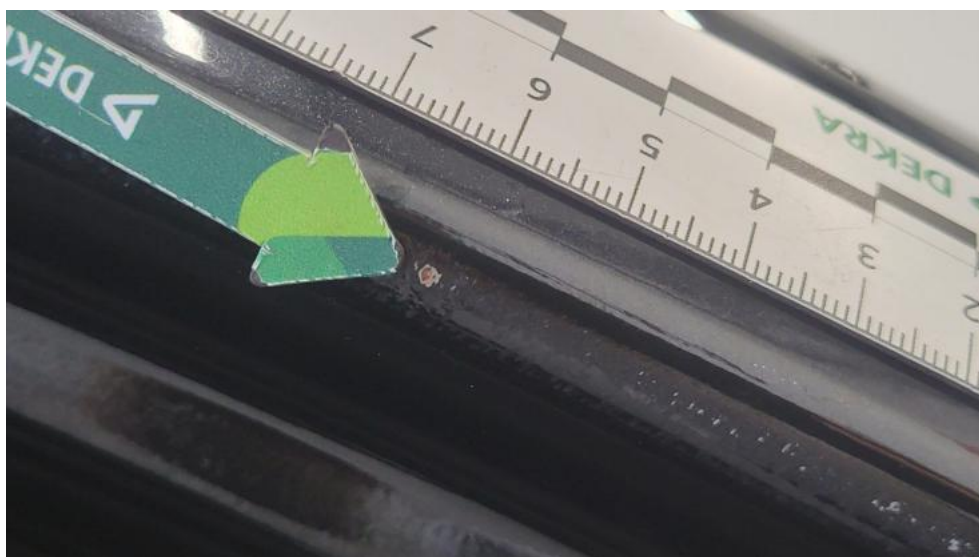
Słupek przedni P - Inne 1

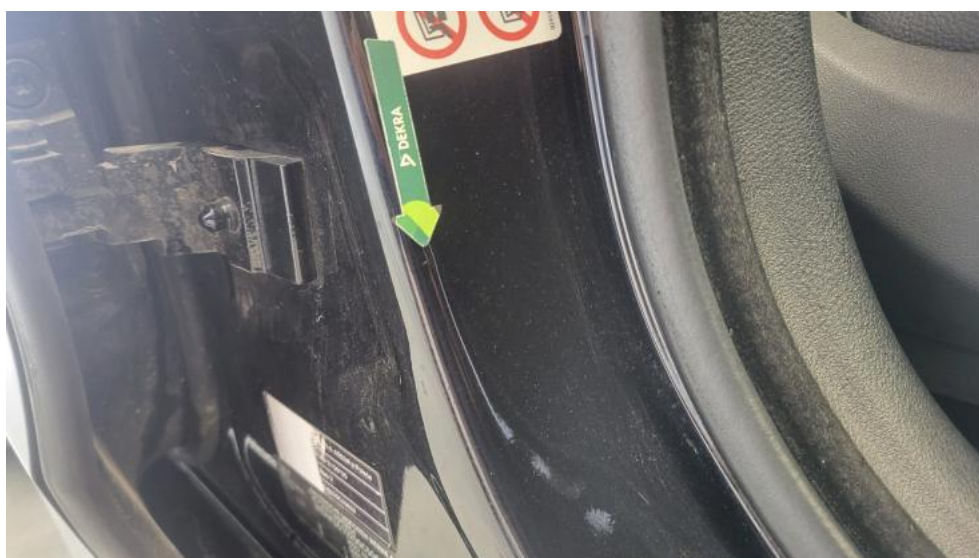
Słupek środkowy P - Wgniecenie/odkształcenie 1

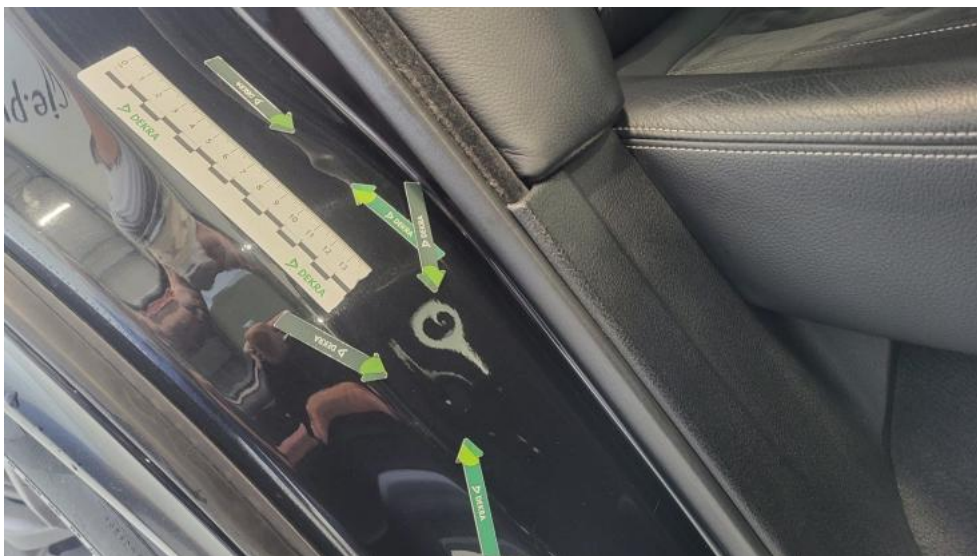
Błotnik tylny P / Ściana boczna P - Wgniecenie/odkształcenie 1

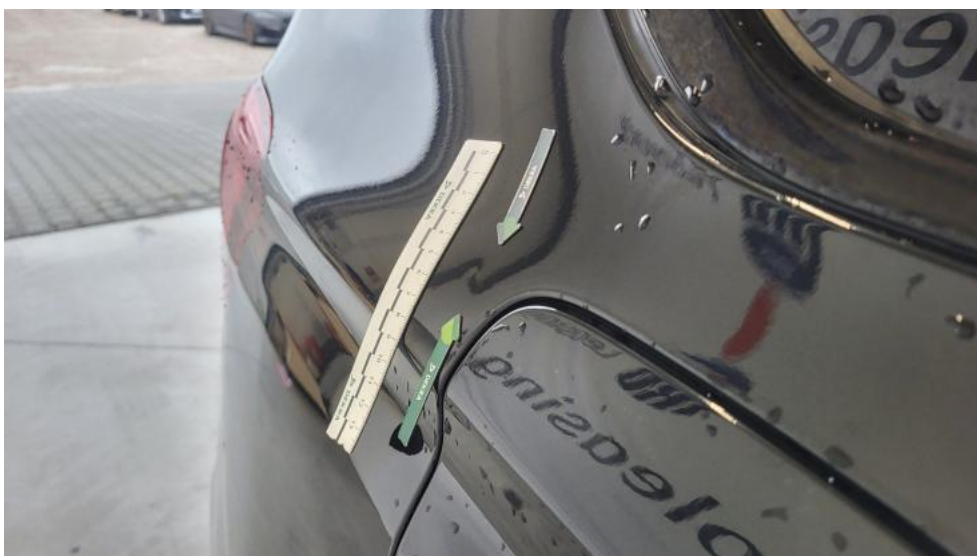
Błotnik tylny P / Ściana boczna P - Wgniecenie/odkształcenie 2

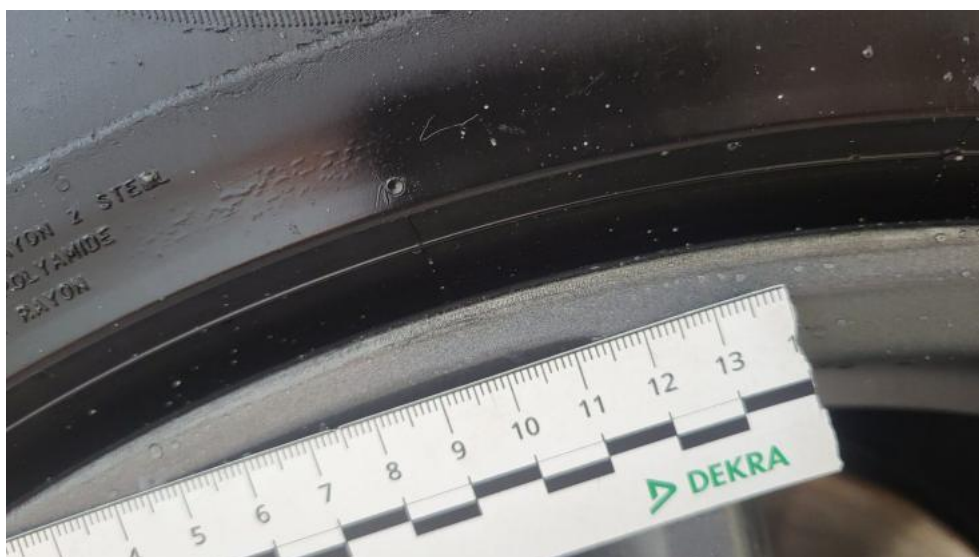
Felga aluminiowa tylna P - Rysa/odprysk 1

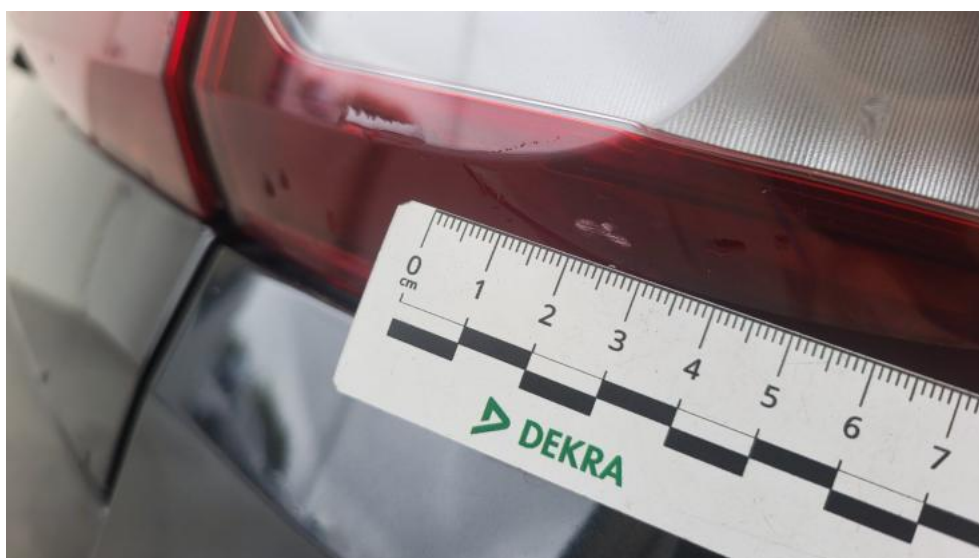
Lampa tylna zew P - Rysa/odprysk 1

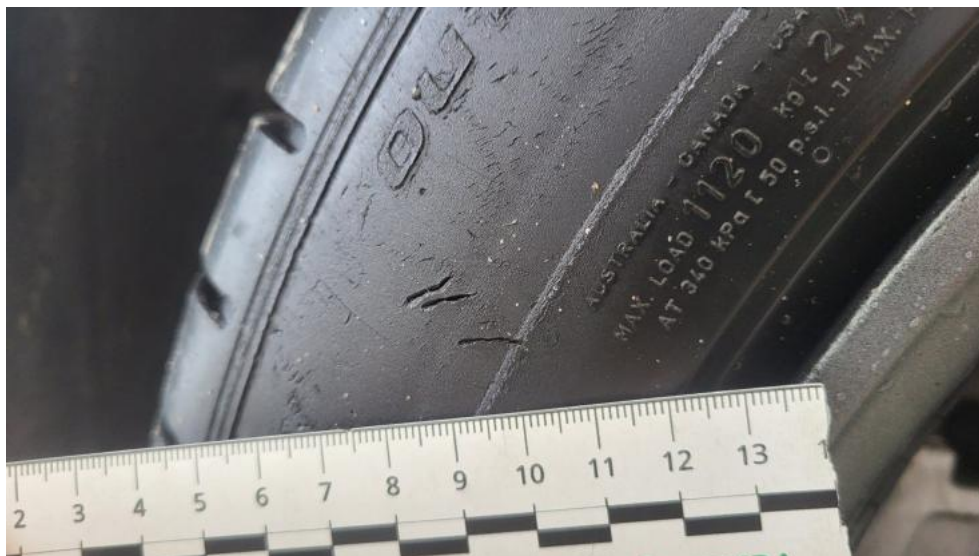
Opona tylna P - Pęknięcie/rozerwanie 1

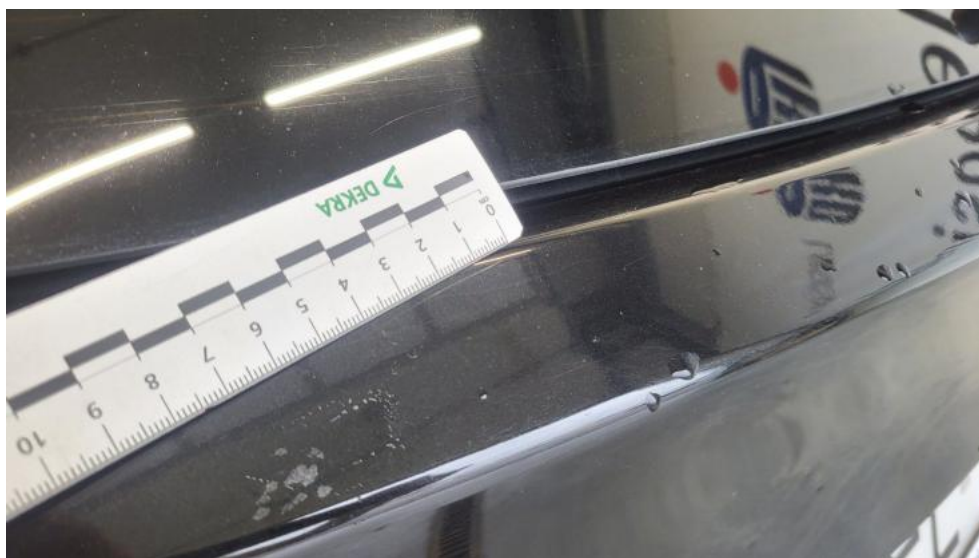
Pokrywy bagażnika - Rysa/odprysk 1

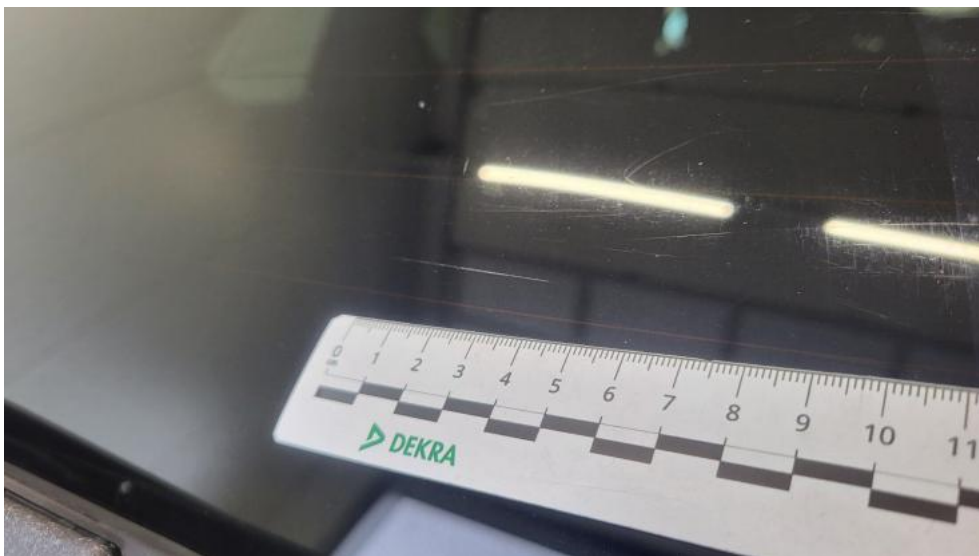
Szyba tylna - Rysa/odprysk 1

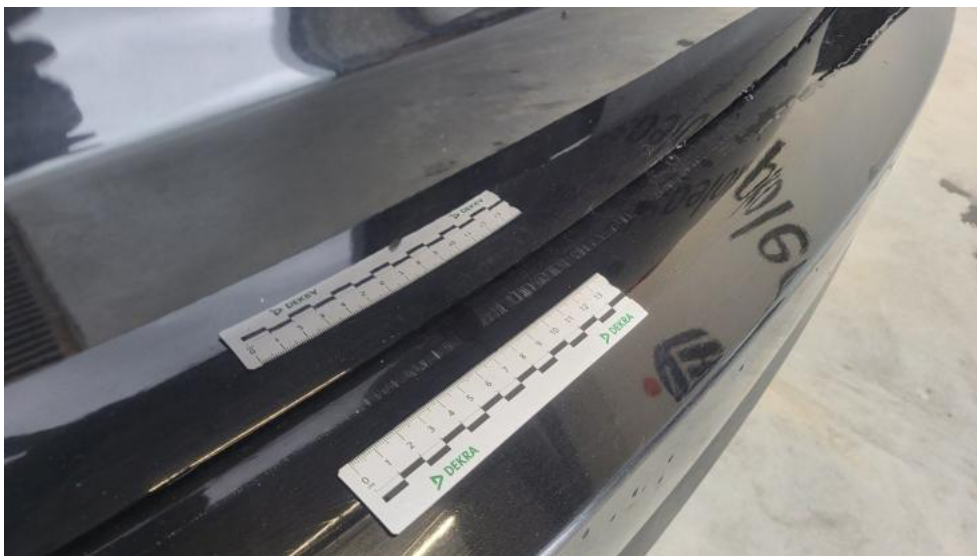
Zderzak tylny - Rysa/odprysk 1

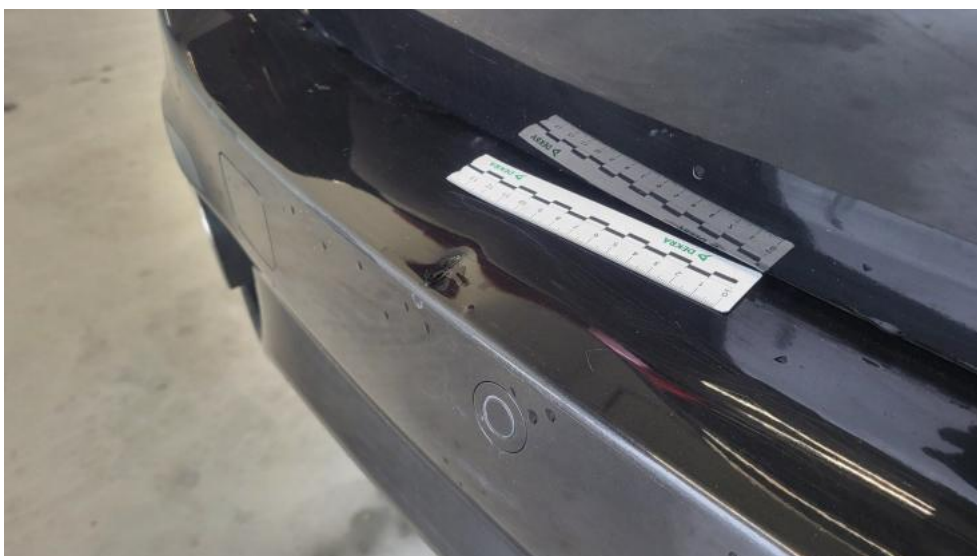
Zderzak tylny - Wgniecenie/odkształcenie 1

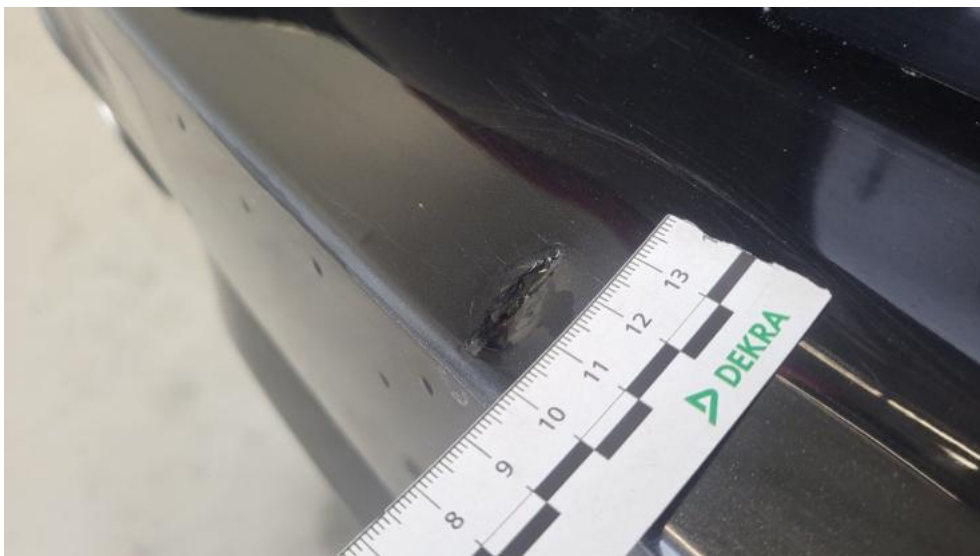
Zderzak tylny - Pęknięcie/rozerwanie 1

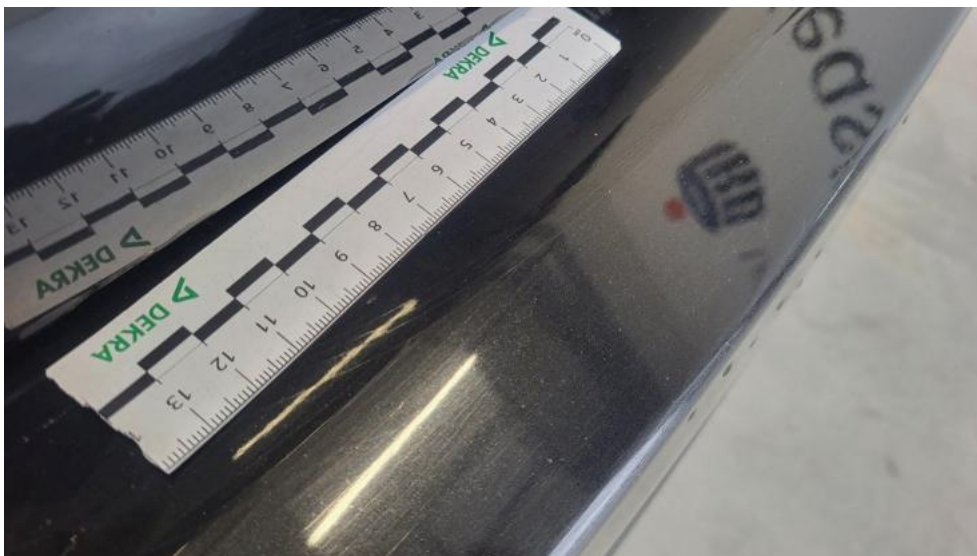
Zderzak tylny - Pęknięcie/rozerwanie 2

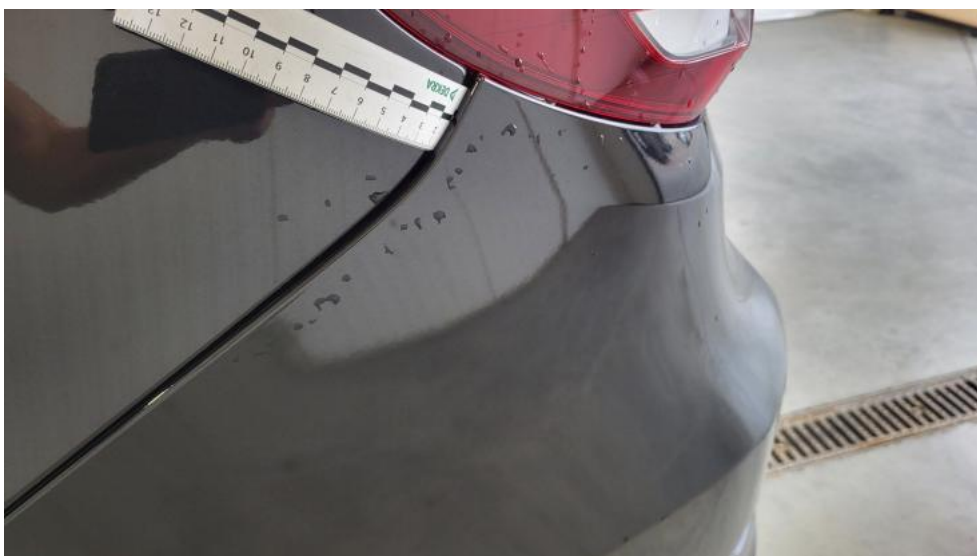
Zderzak tylny - Inne 1

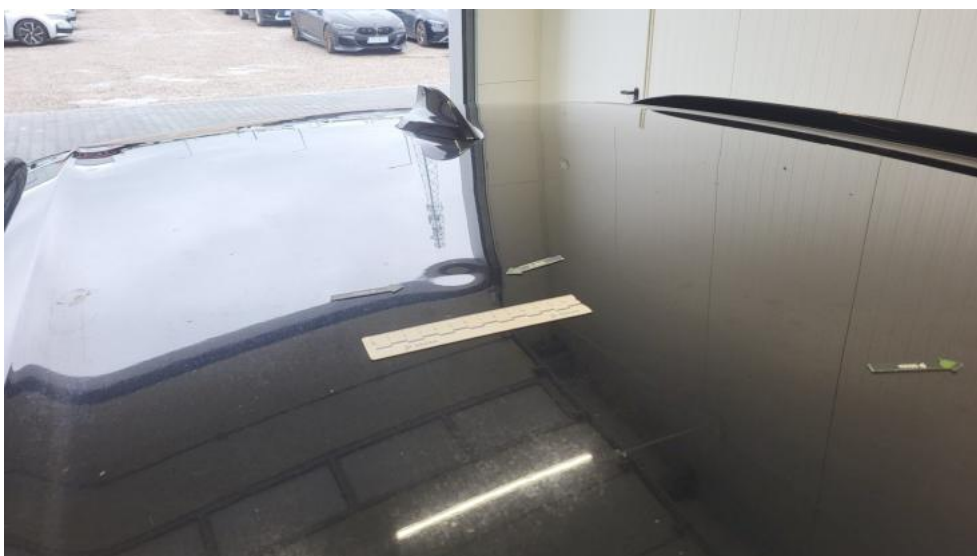
Dach - Wgniecenie/odkształcenie 1

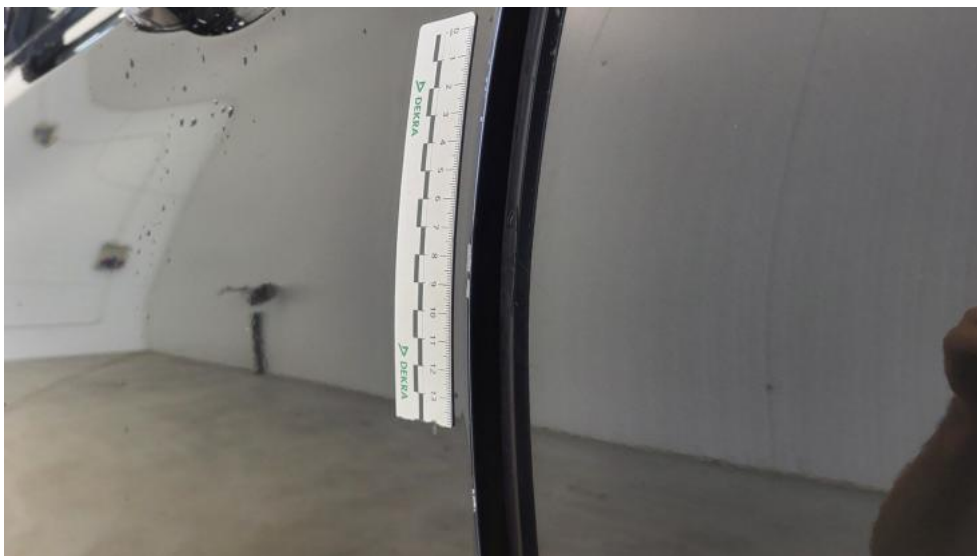
Drzwi przed L - Rysa/odprysk 1

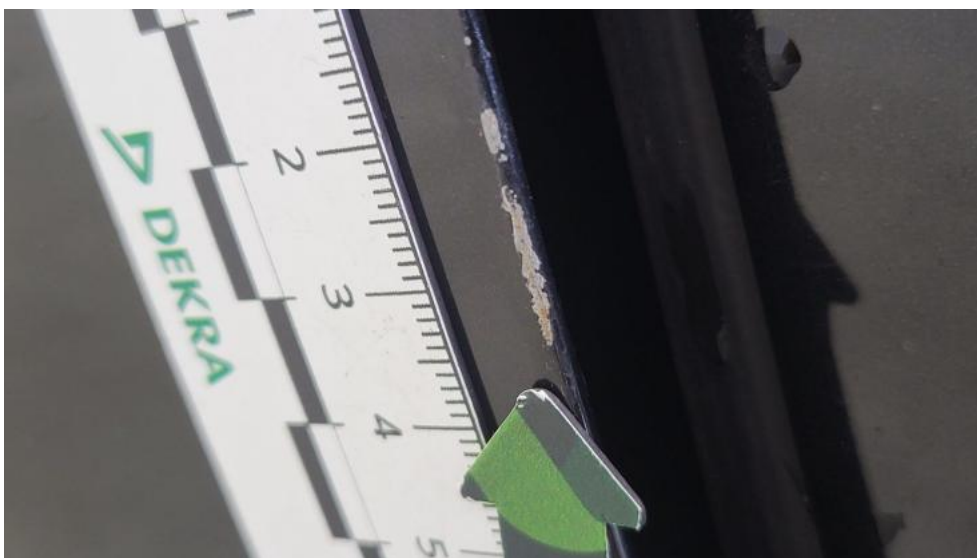
Drzwi przed L - Inne 1

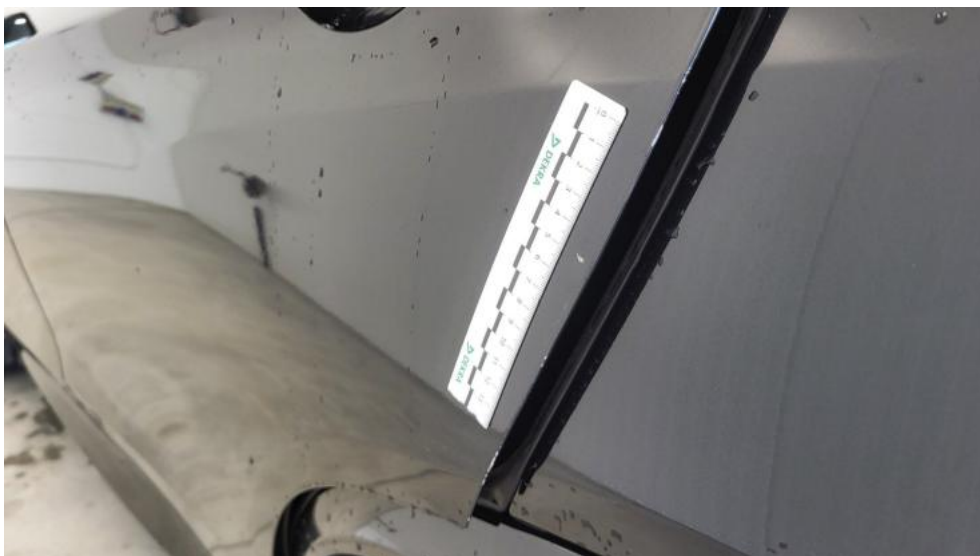
Drzwi tylne L - Rysa/odprysk 1

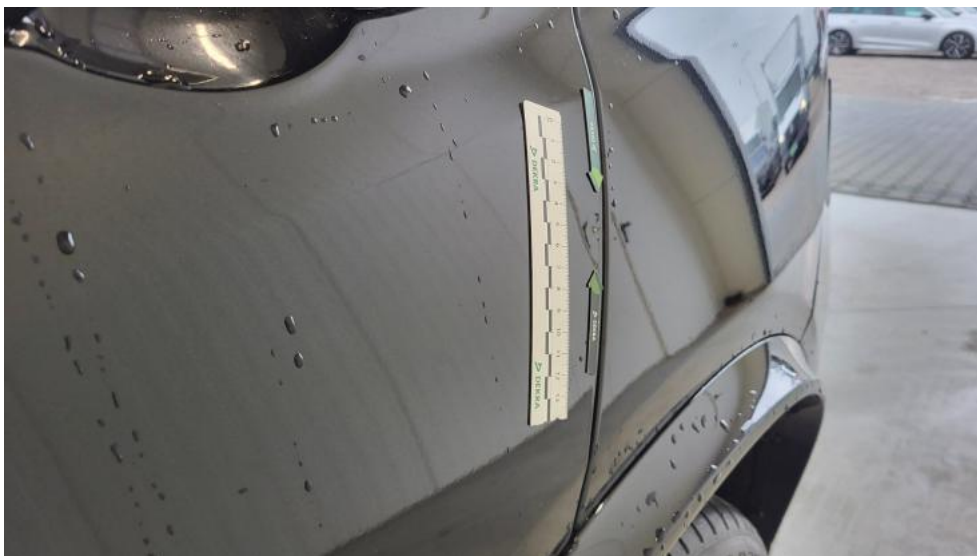
Drzwi tylne L - Wgniecenie/odkształcenie 1

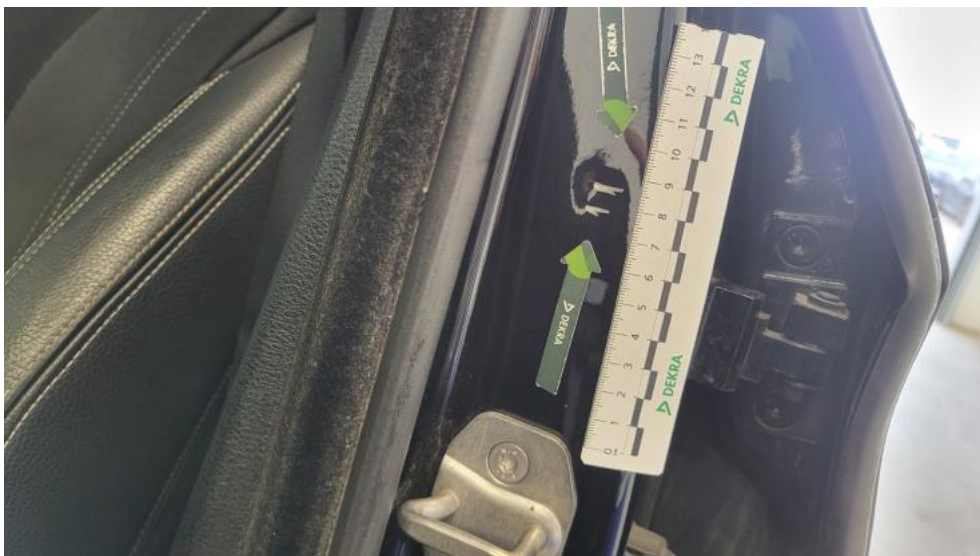
Słupek środkowy L - Wgniecenie/odkształcenie 1

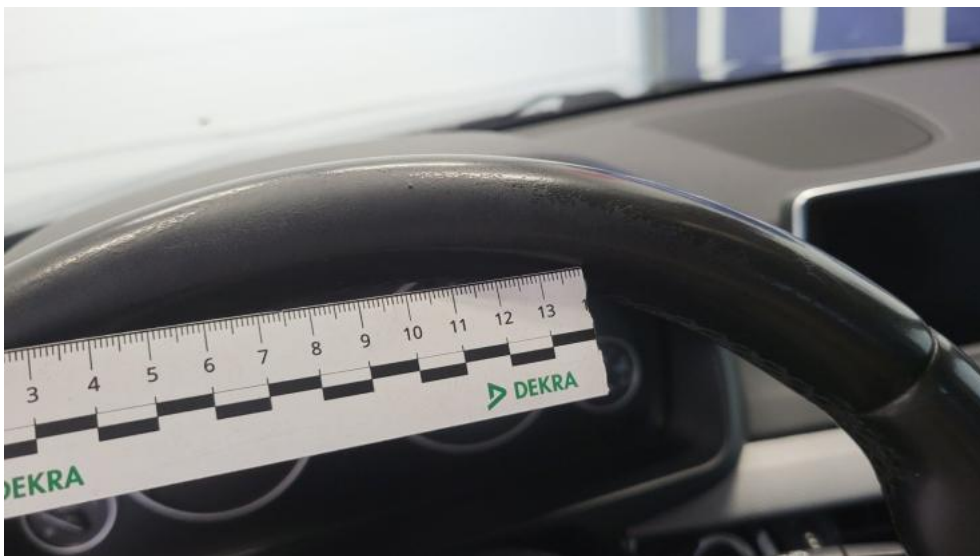
Koło kierownicy - Inne 1

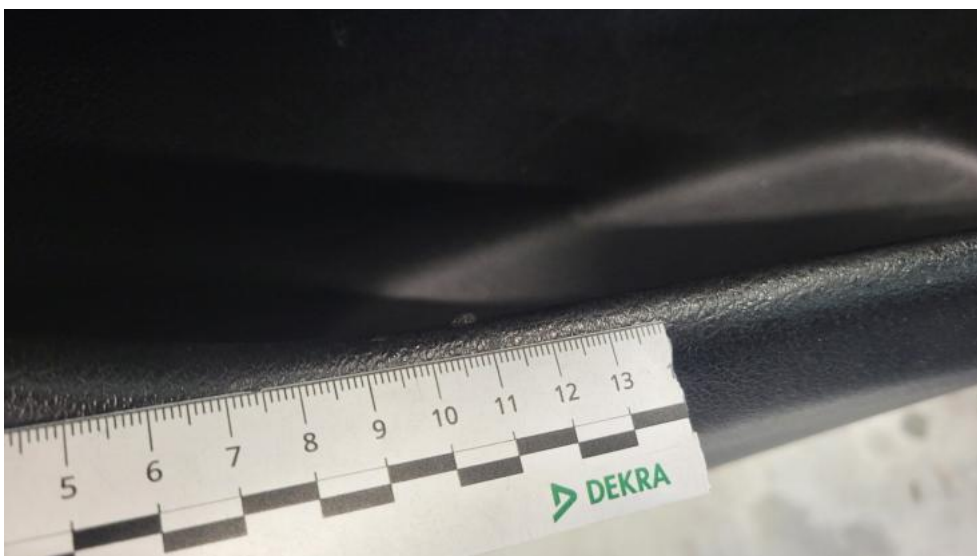
Tapicerka drzwi przednich L - Pęknięcie/rozerwanie 1

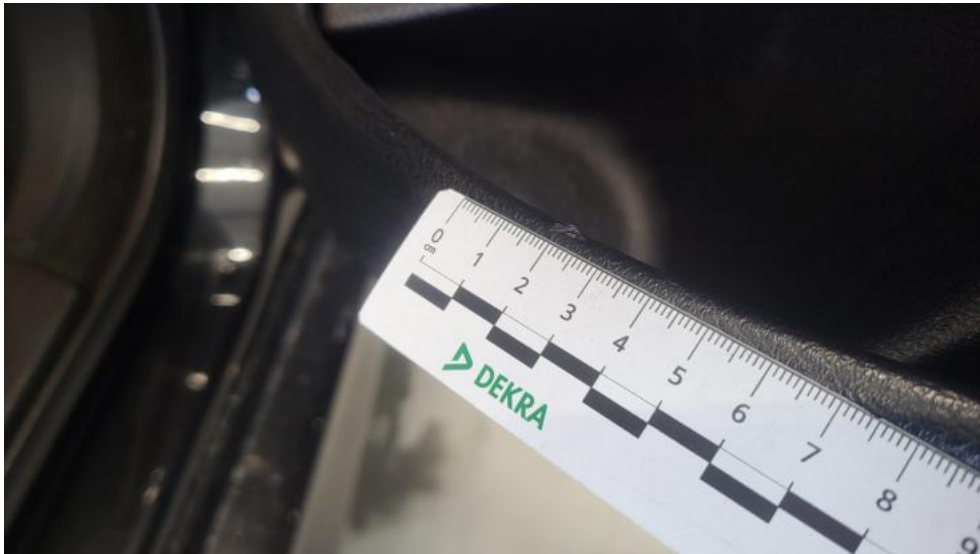
Tapicerka drzwi przednich P - Rysa/odprysk 1

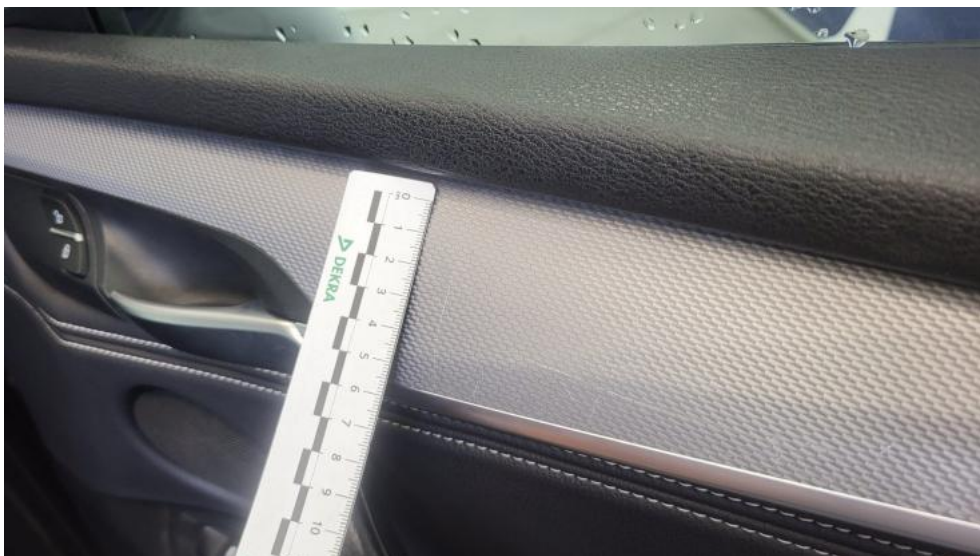
Tapicerka drzwi przednich P - Rysa/odprysk 2

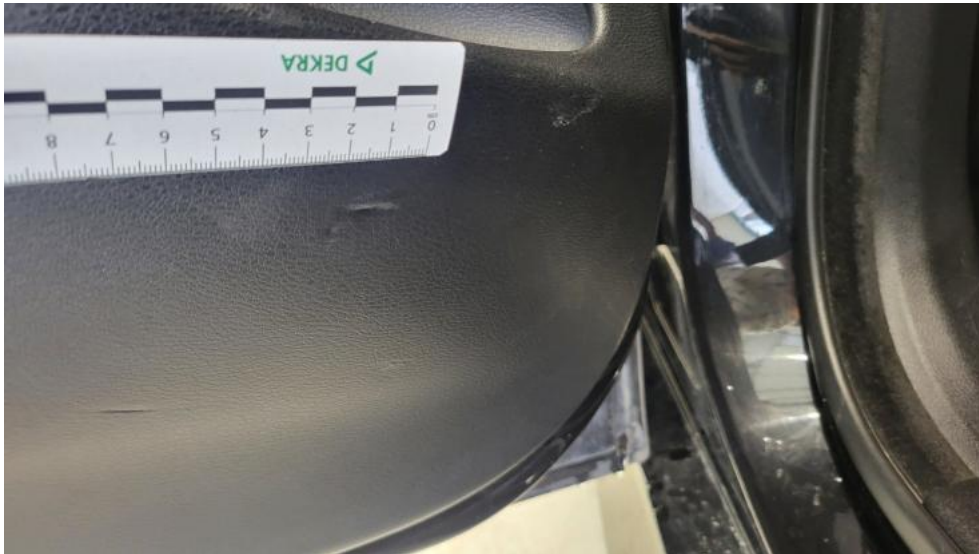
Tapicerka drzwi tylnych L - Pęknięcie/rozerwanie 1

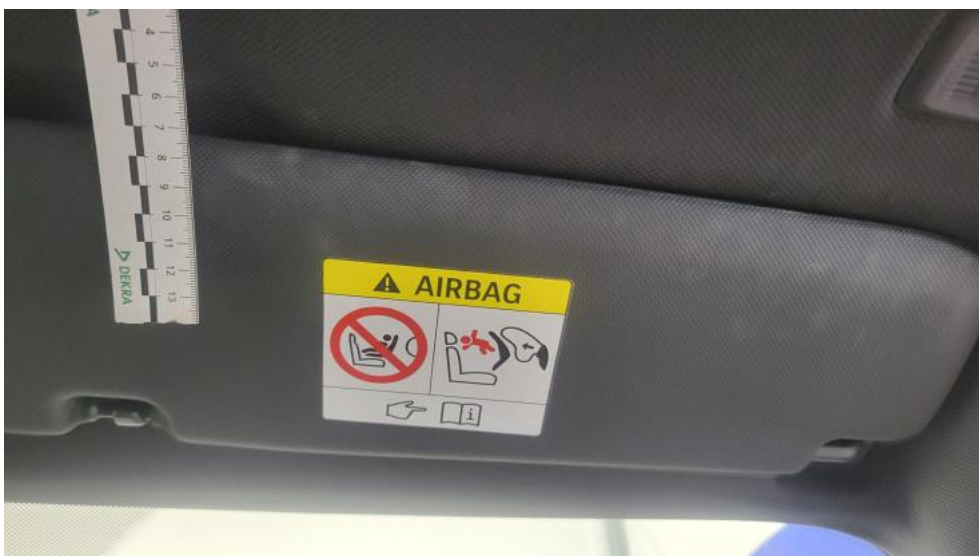
Osłona p/słoneczna prawa - Inne 1
